## CHAPTER 4: HISTORIC STRUCTURE REPORT

### LONG ISLAND INTRODUCTION

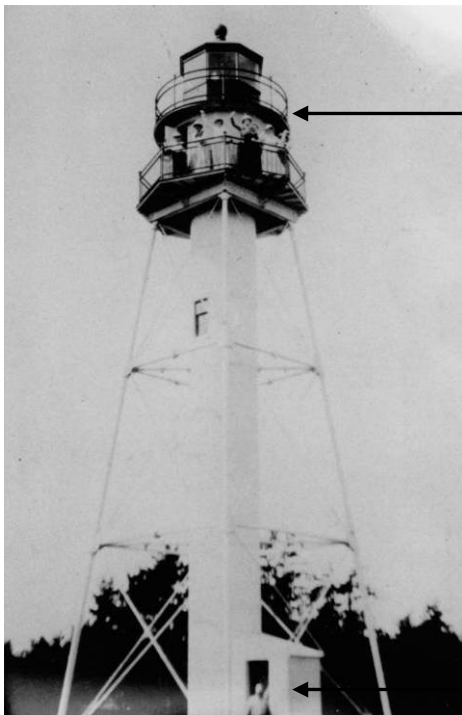
Platforms, Railings and  
Lantern Painted Black

Shed Entrance

*Historic Image LI-01: LaPointe Metal Tower, c.1900 (Source: NPS APIS Archives)*

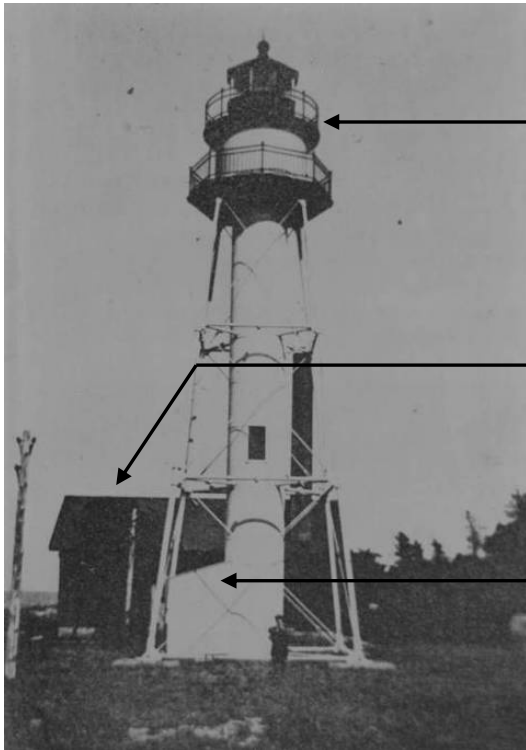
Platforms, Railings and  
Lantern Painted Black

Non Extant Fog Signal  
Building

Shed Entrance

*Historic Image LI-02: LaPointe Tower, c. 1910 (Source: NPS APIS Archives)*

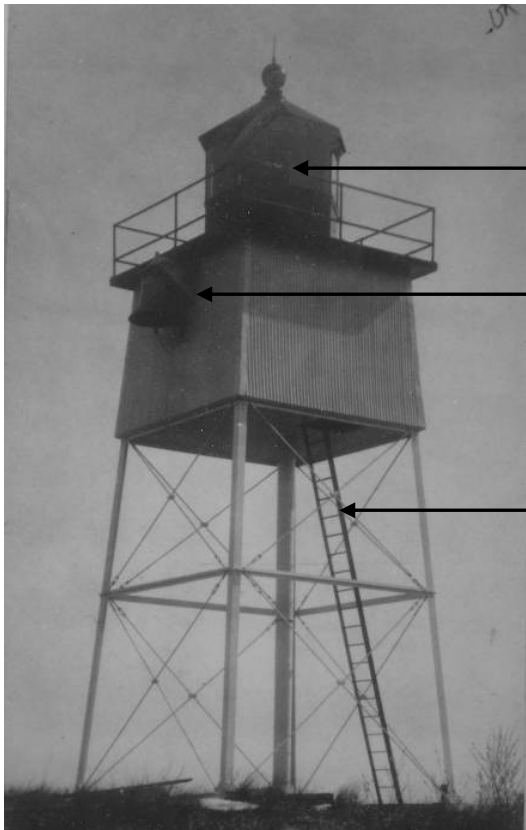
Platform, Railing and Lantern  
Painted Black

Fog Signal Bell

Ladder to Watch Room

1 Historic Image LI-03: Chequamegon Point Tower, c. 1910 (Source: NPS APIS Archives)

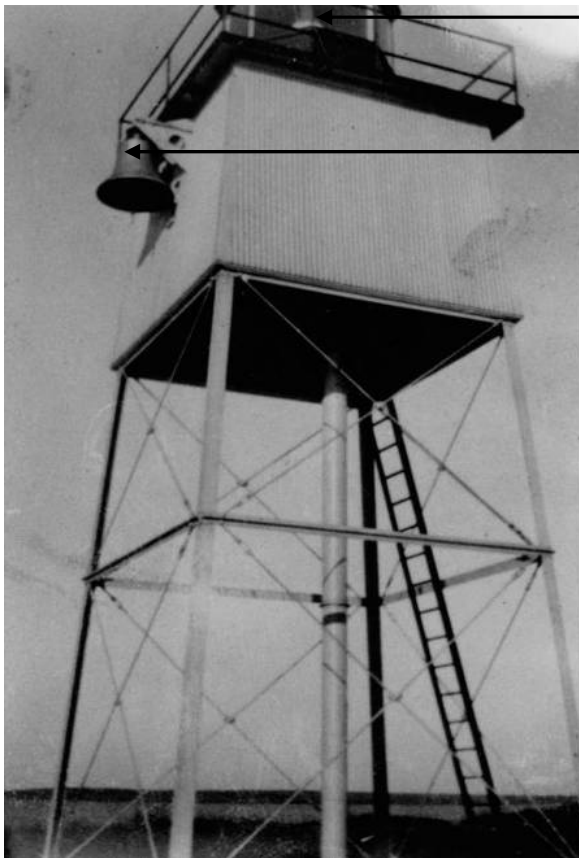
Platform and Railing Painted Black;  
Railing No Longer Exists

Fog Signal Bell

4 Historic Image LI-04: Chequamegon Point Tower, c. 1910 (Source: NPS APIS Archives)

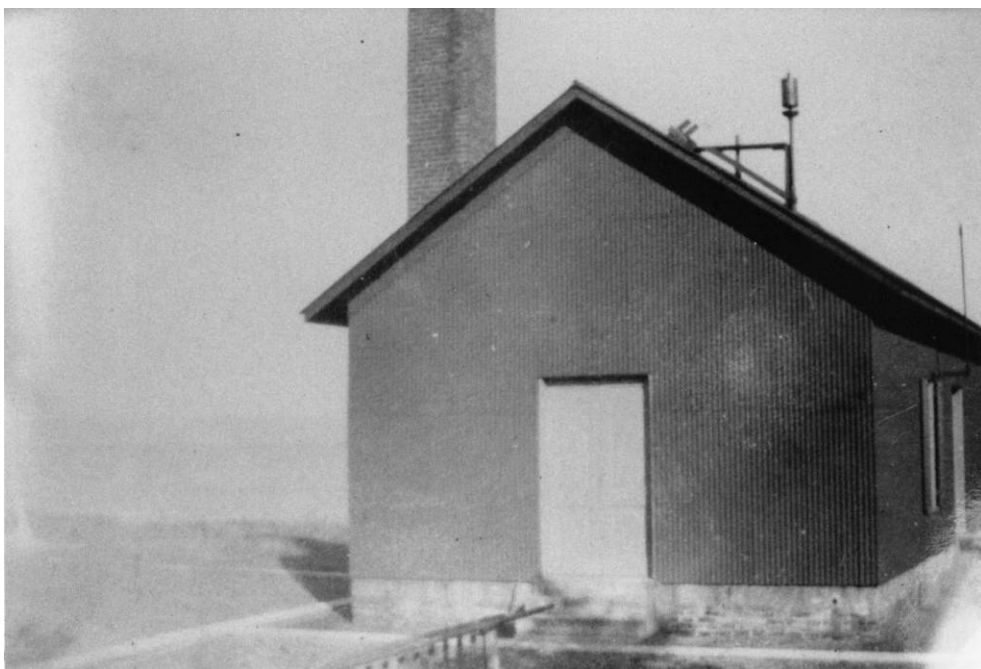
1 *Historic Image LI-05: Fog Signal Building with steam whistle, pre-1925 (Source: NPS APIS Archives)*

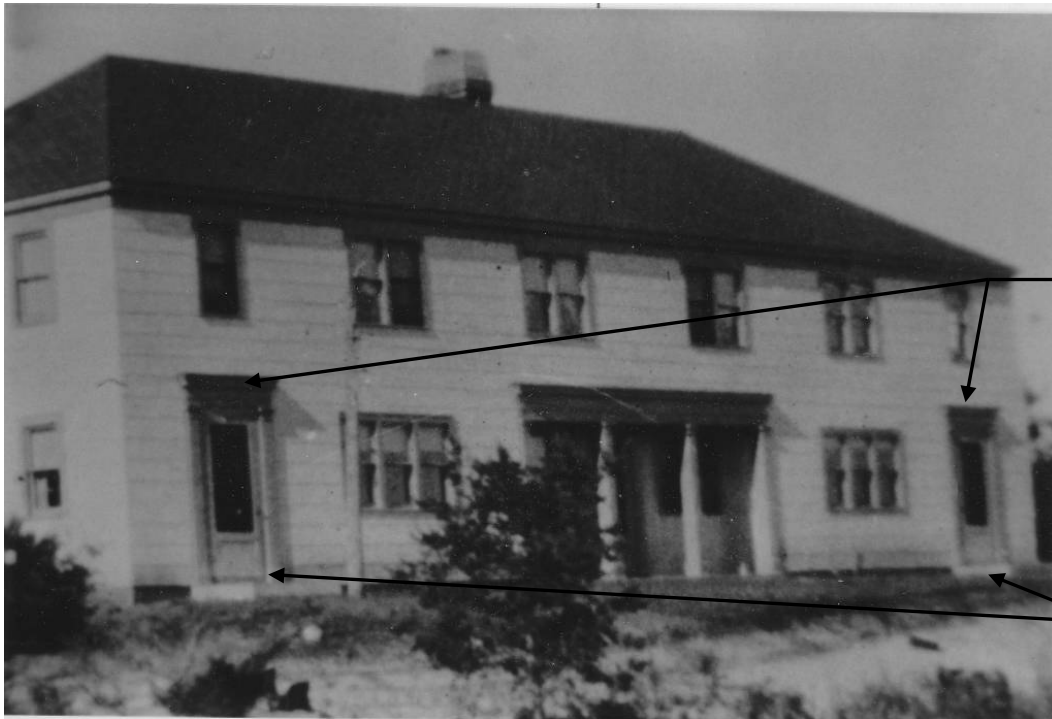
Door Surrounds

Front Stoops

Historic Image LI-10: Triplex, north elevation, 1942 (Source: NPS APIS Archives)

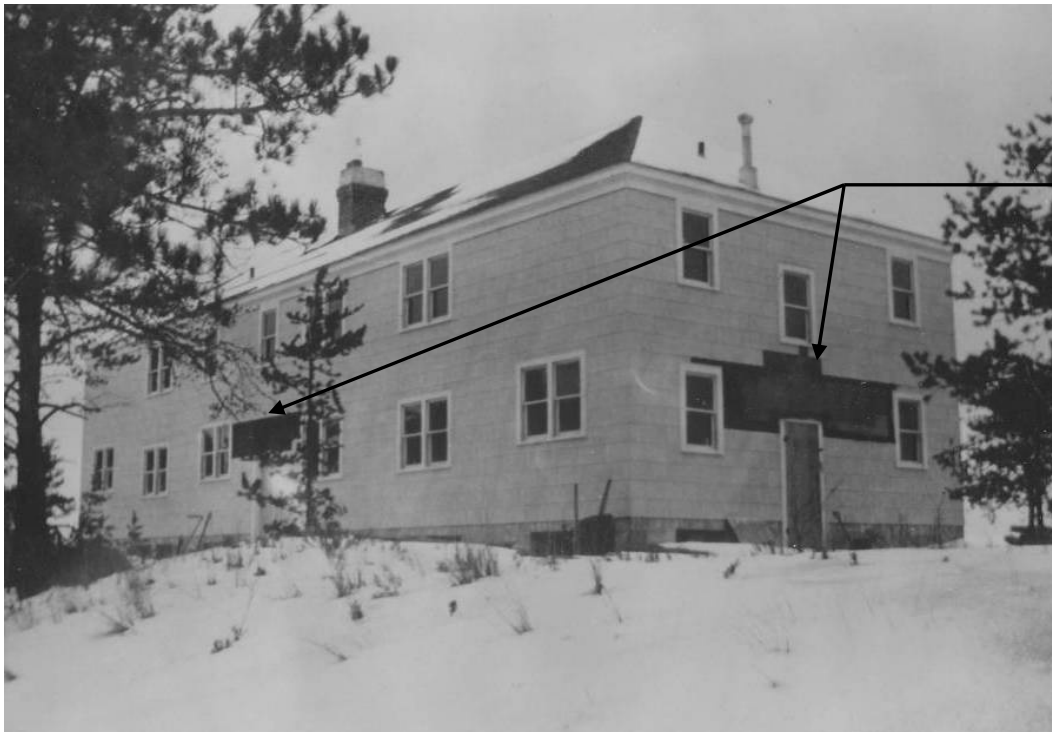
Siding Removed  
Above Doors to  
Receive New  
Overhangs

Historic Image LI-11: Triplex, south and east elevations, c. 1945 (Source: NPS APIS Archives)

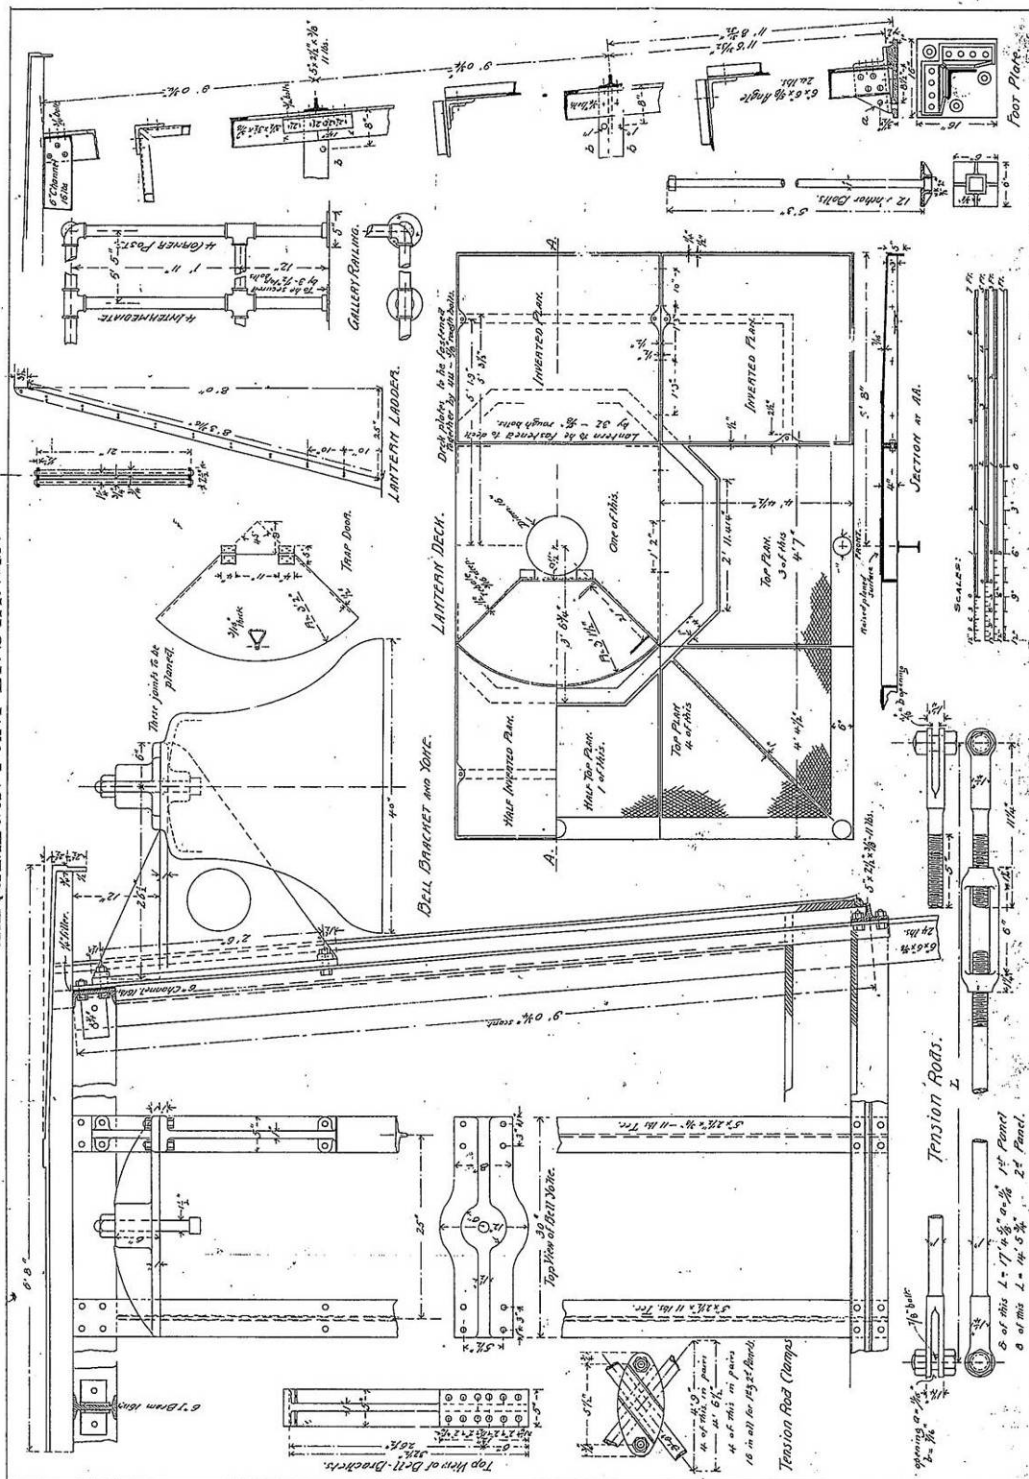
Historic Drawing LI-03: Detail of Fog Signal Bell on Chequamegon Point Tower (most likely 1896)

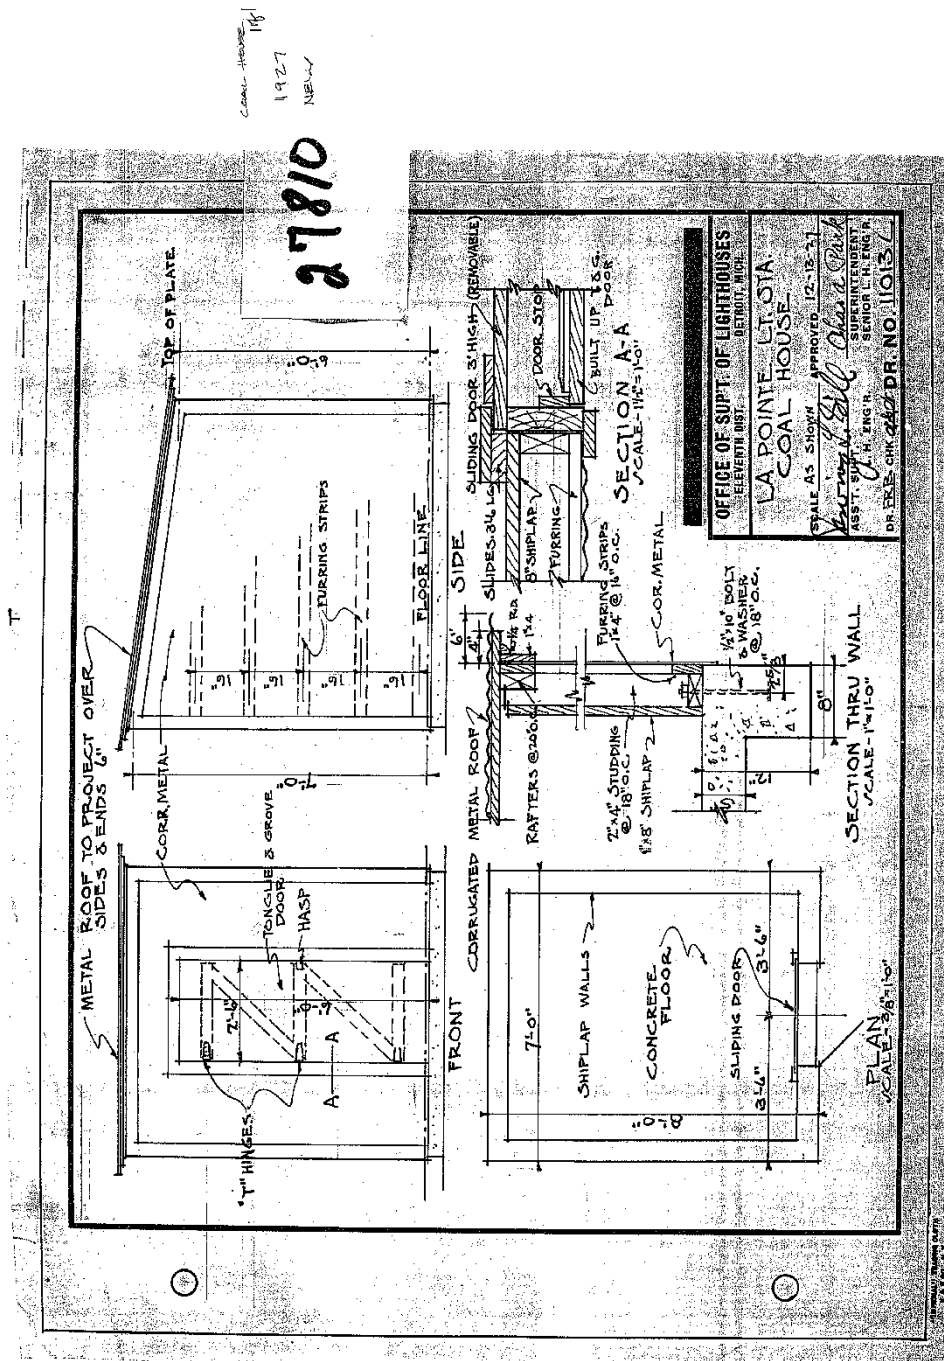
Historic Drawing LI-14: Coal house, 1927 construction drawing
