## CHAPTER 1: INTRODUCTION

# CHAPTER 3: CULTURAL LANDSCAPE REPORT

## SAND ISLAND EXISTING CONDITION

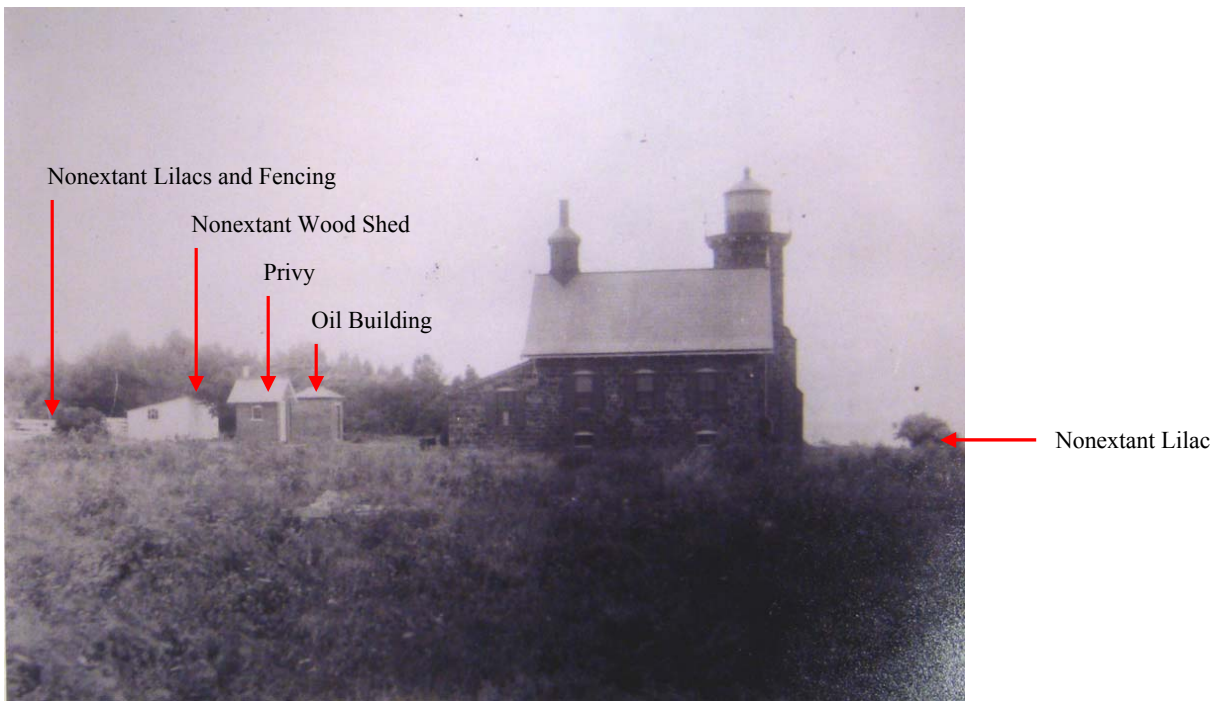
Site Image SI-03: Sand Island Light Station showing, from left, the fenced garden, Shed, Privy, Oil Building and Light Station Quarters. Note the extent of the clearing, c. 1913 (Source: NPS APIS Archives)

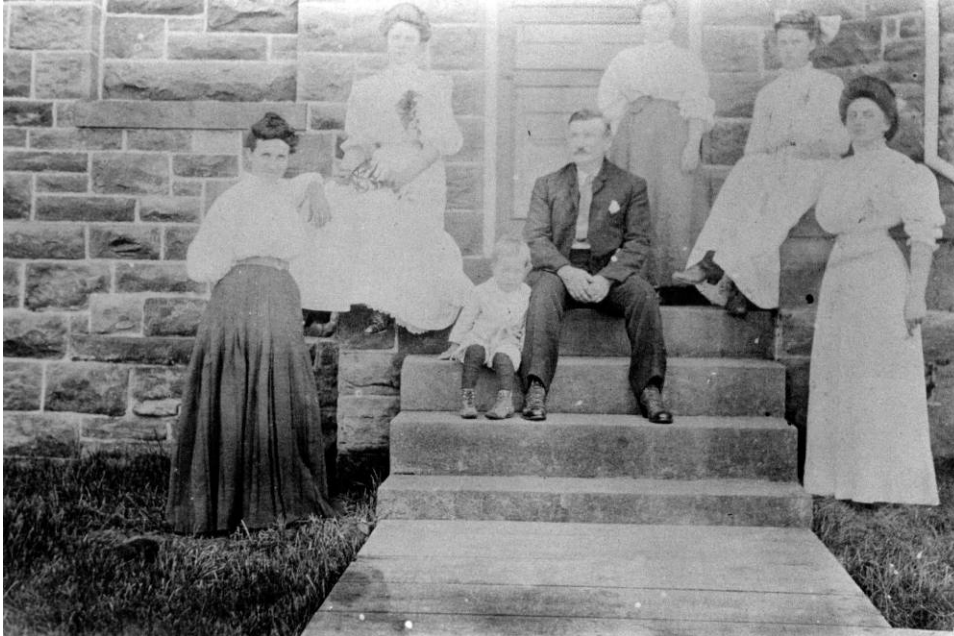
Site Image SI-04: Sand Island Light Station Quarters showing north entry steps and wooden plank walk, c. 1905-1909 (Source: NPS APIS Archives)

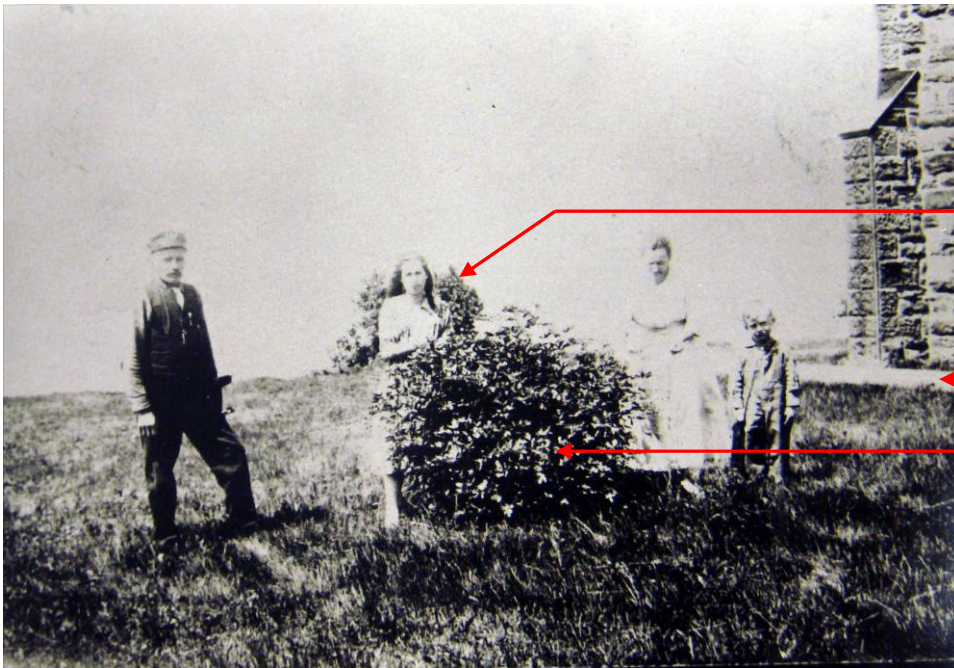
Nonextant Lilac

Concrete Walk

Site Image SI-05: Sand Island Light Station showing from right, northwest corner of Light Station Quarters, concrete walk, and two lilac bushes, one in the foreground, and one in the background along shoreline, c. 1913 (Source: NPS APIS Archives)

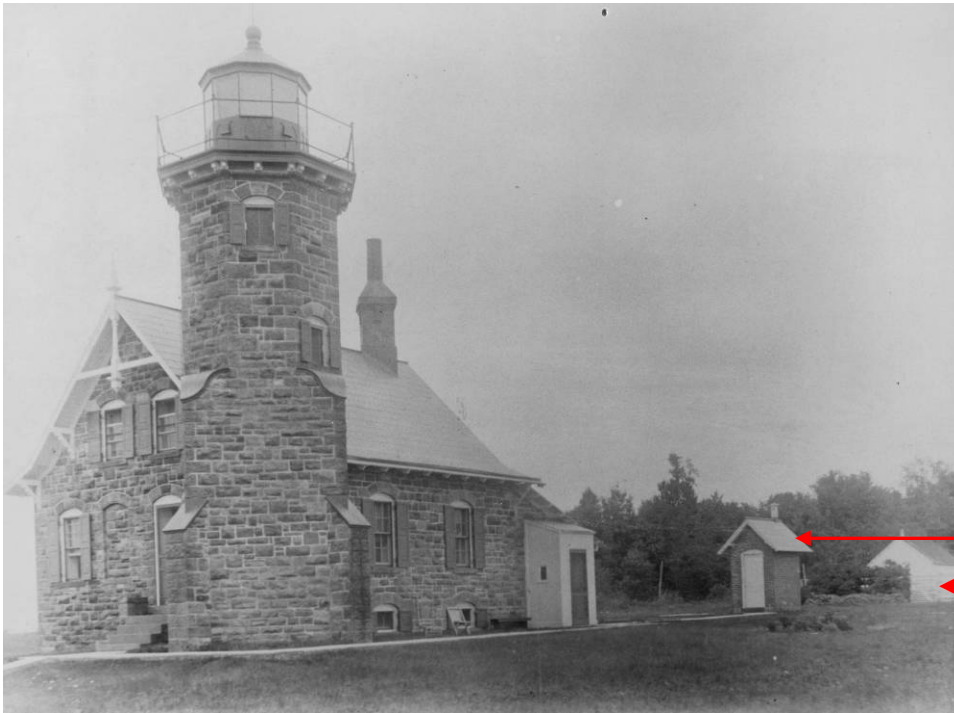
Privy  
Nonextant  
Tool Shed

Site Image SI-06: Sand Island Light Station viewed from the northwest, c. 1913 (Source: NPS APIS Archives)

In 1881, along with the construction of the Light Station Quarters, a brick Privy was built and connected to the Light Station Quarters with a wooden plank walk. In 1901, the brick Oil Building was built on the Light Station grounds, and also connected to the Light Station Quarters by a wooden plank walk.<sup>16</sup> Wooden plank walks were built as the initial circulation for the light station grounds. Historic photographs indicate these were replaced by concrete walks by 1913. Many of the concrete walks remain today.

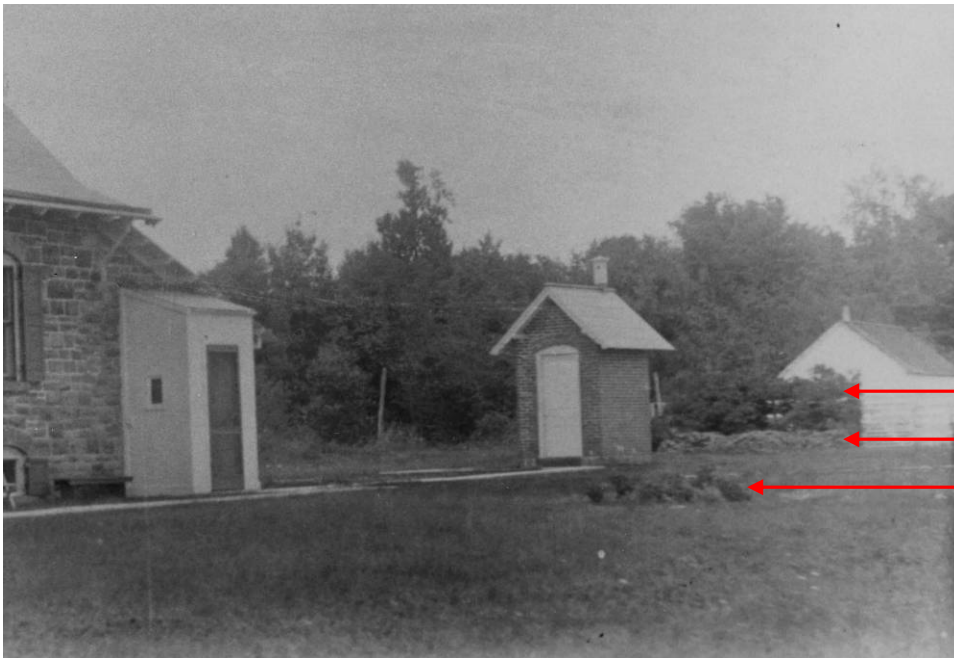
Lilacs  
Vinca  
Small Planting  
Bed

Site Image SI-07: Enlargement of SI-06, above; Sand Island Light Station viewed from the northwest, c. 1913 (Source: NPS APIS Archives)

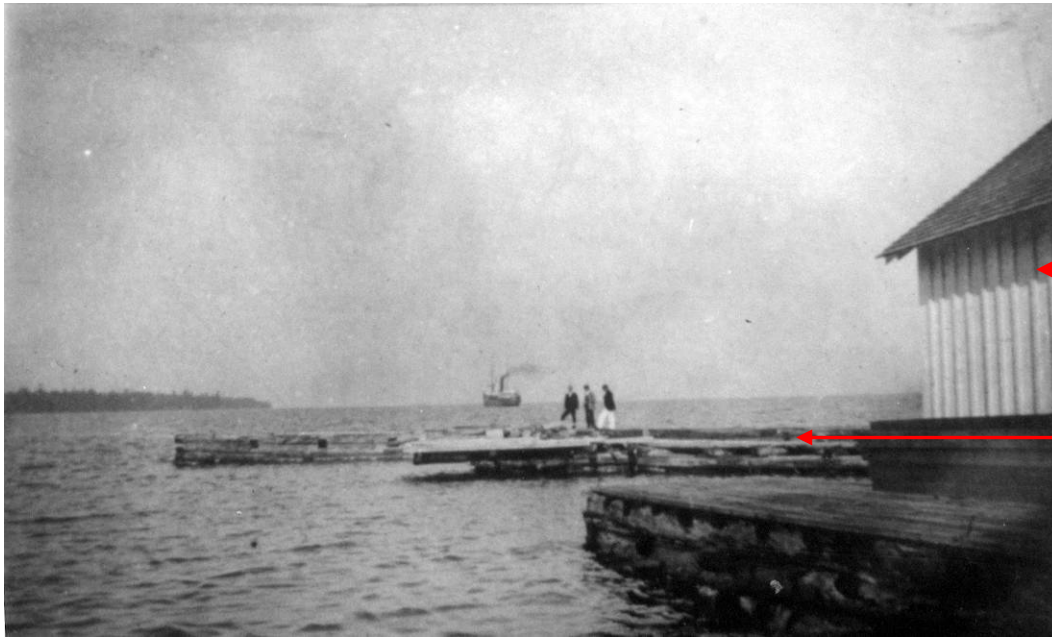
Nonextant  
Boathouse

Nonextant  
Boat Dock

Site Image SI-10: Boat harbor showing the Boathouse and Dock, c. 1904 (Source: NPS APIS Archives)

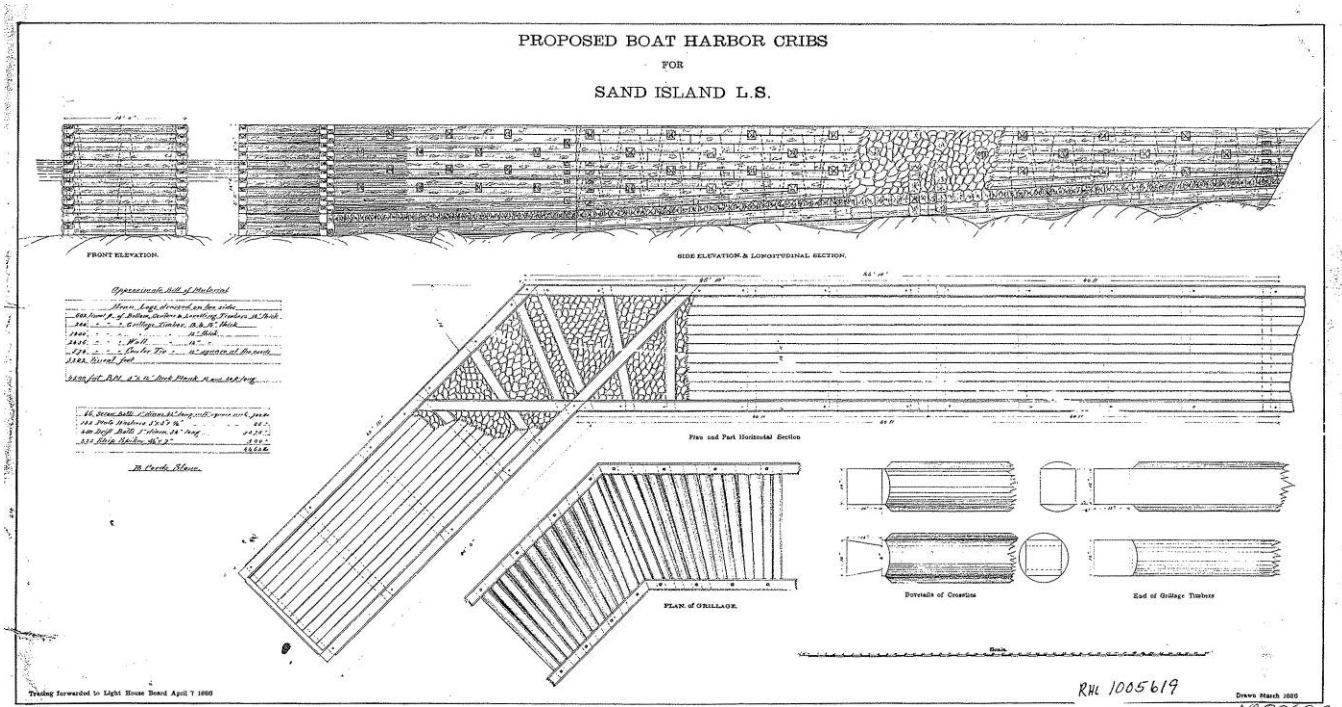
Site Image SI-11: Proposed Boat Harbor Cribs and Dock (pictured above in Site Image SI-10), 1886 (Source: NPS APIS Archives)

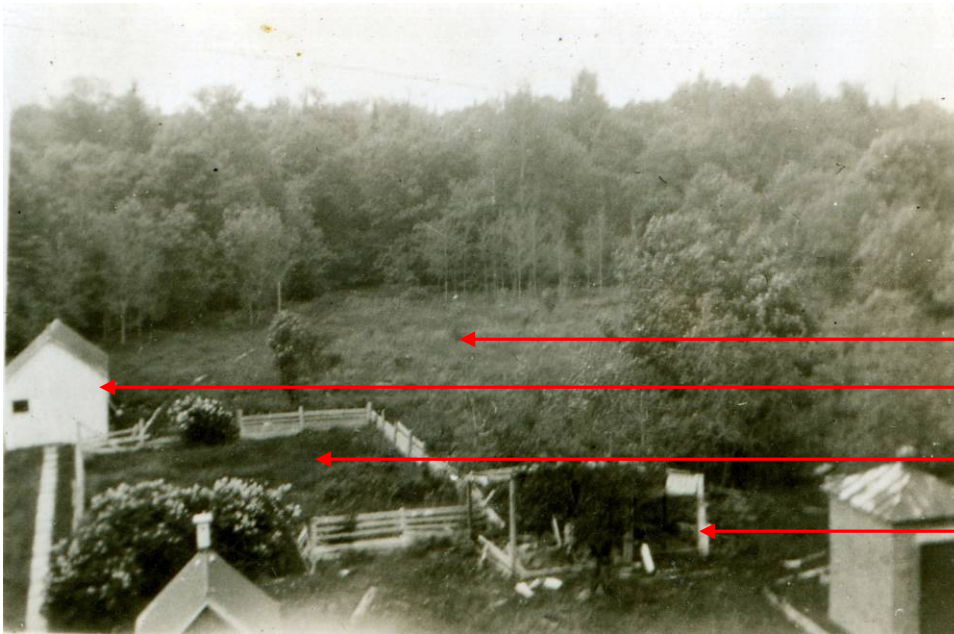
Note Extent of Clearing

Nonextant Tool Shed

Nonextant Wood Shed

Site Image SI-16: Sand Island Light Quarters from the Light Station Quarters Tower. Note clearing, Tool Shed, Garden Area, Lilacs, Fencing and Wood Shed (remnant by this period), c. 1925-1939 (Source: Robert Wellisch Collection)

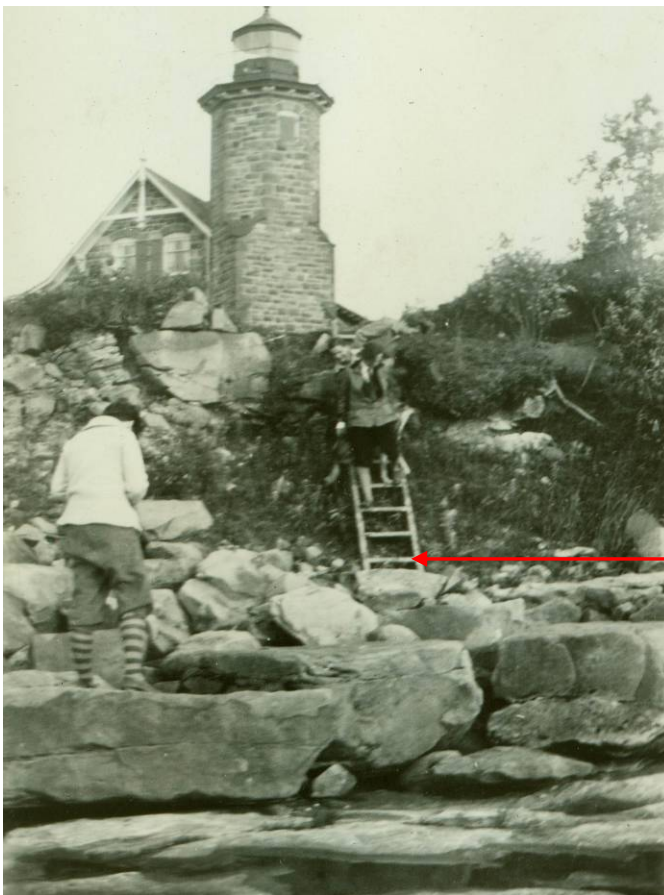
Note Ladder from North Landing

Site Image SI-17: North Landing, c. 1925-1939 (Source: Gertrude Wellisch Collection)

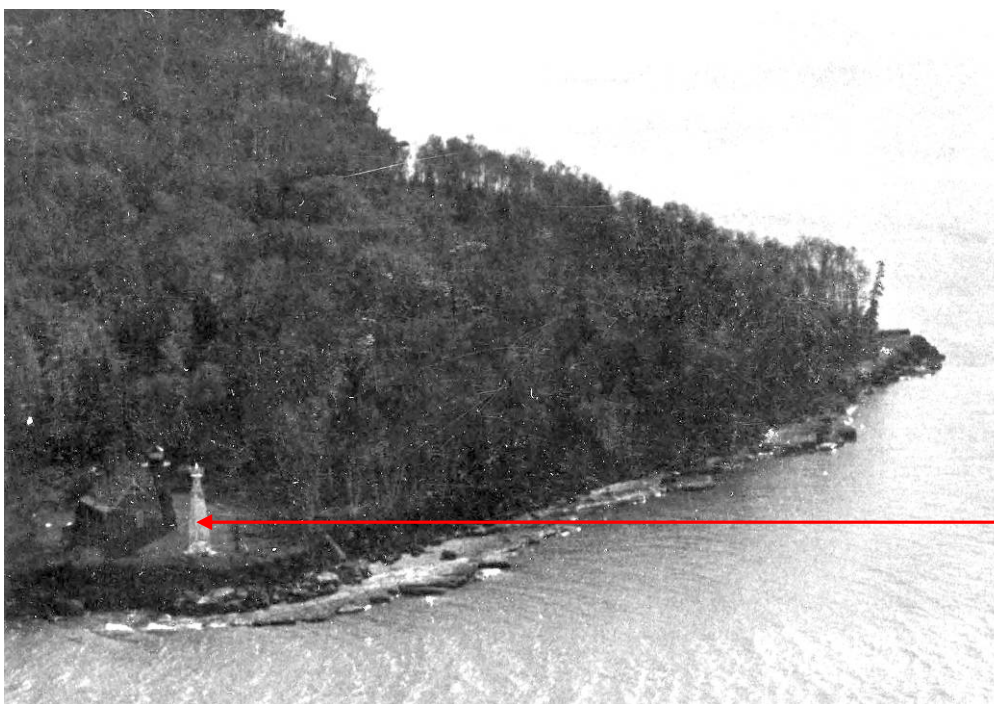
Nonextant Sand Island  
Light Tower

Site Image SI-21: Sand Island Light Station showing, from left, Light Station Quarters, and Sand Island Light Tower, date unknown (Source: NPS APIS Archives)

The most notable physical change was the addition in 1933 of a 40 foot tall steel frame light tower in the front of the Light Station Quarters. The light was removed from the original tower in the Light Station Quarters, and a new light was placed onto the steel frame tower (Sand Island Light Tower).

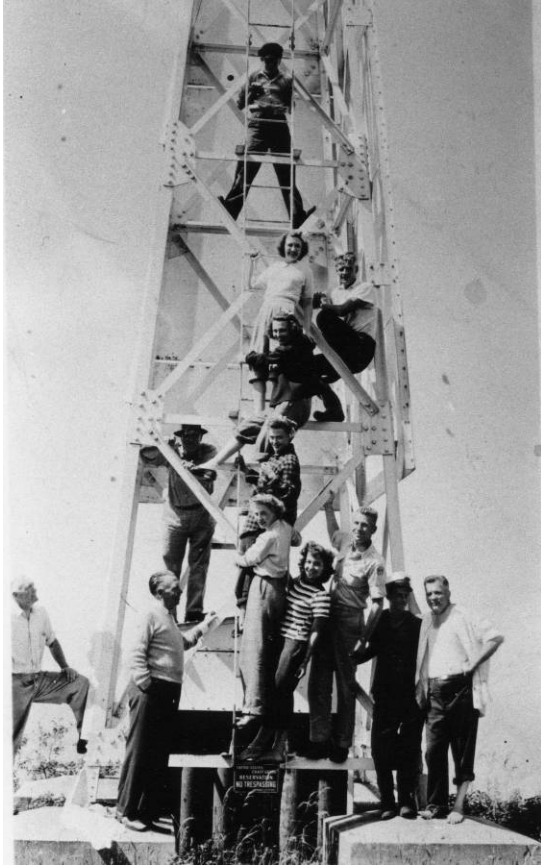
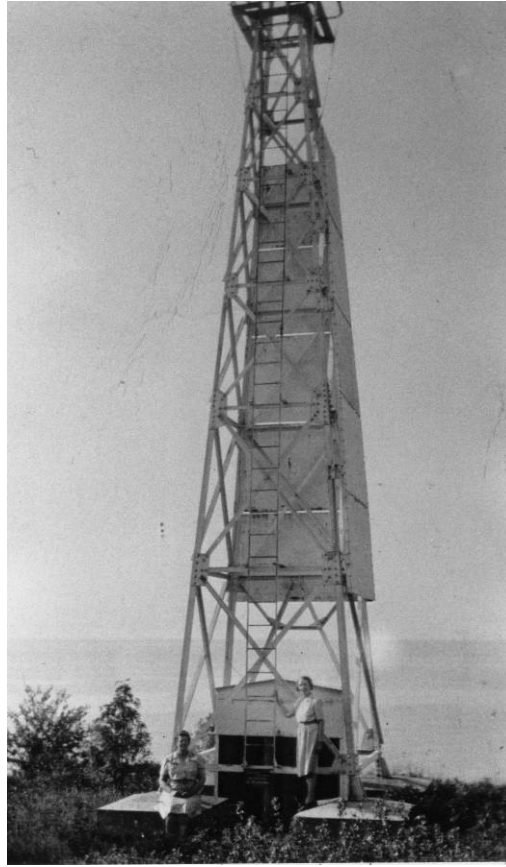
Site Image SI-22: Sand Island Light Tower, date unknown (Source: NPS APIS Archives)
