National Historic Landmark
Steam Schooner *Wapama*

Salvage and Disassembly Feasibility Study

December 21, 2009

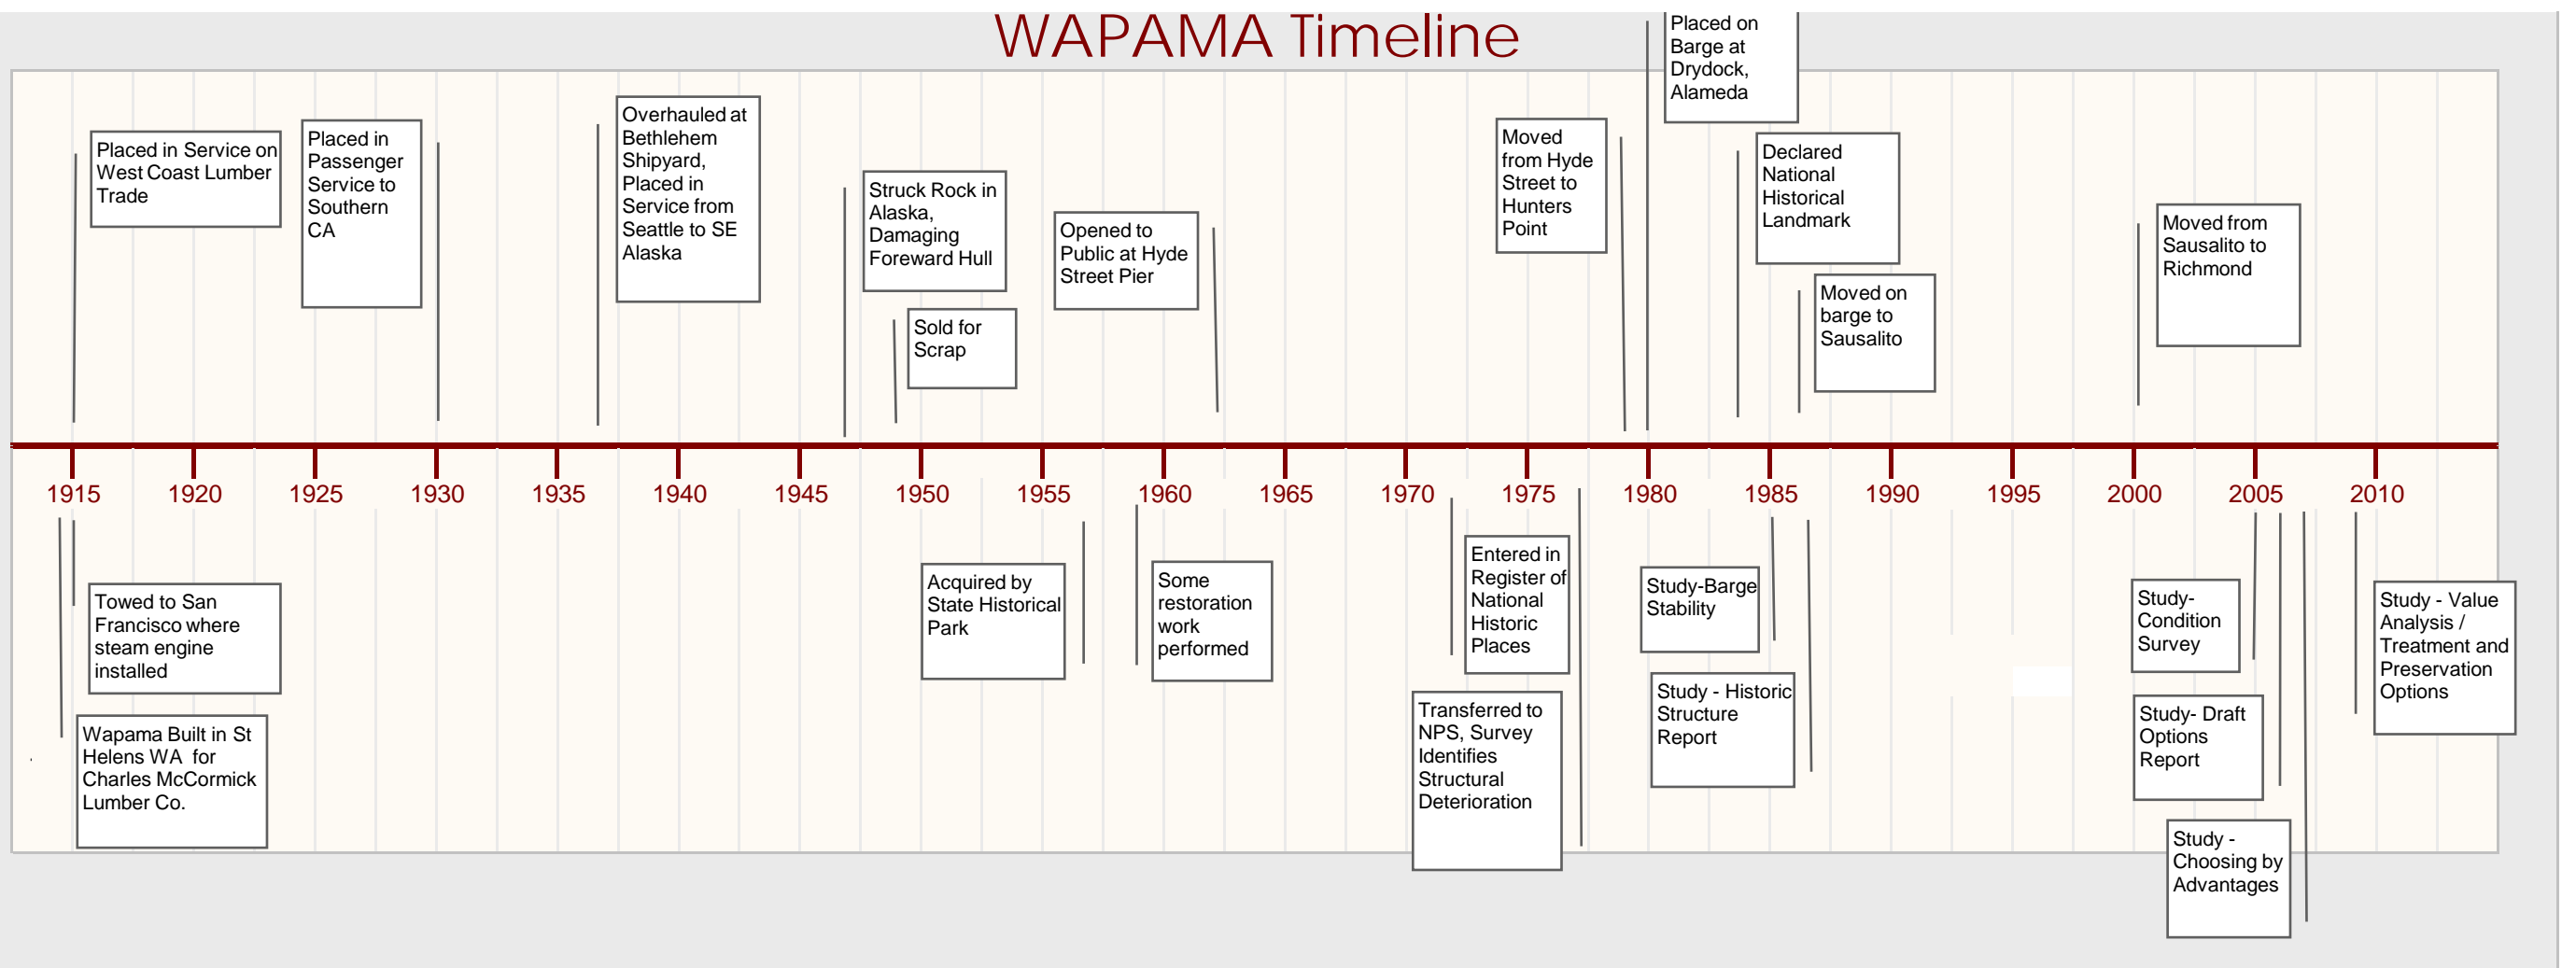
WAPAMA Timeline

Wapama was taken out of service in 1947 and has largely been in a deteriorating condition since. A summary of *Wapama*'s history is presented on a timeline On Exhibit 1. Numerous studies, naval and architectural, have been performed and have indicated that portions of the ship have deteriorated well beyond restoration and have become unsafe. These studies are referenced in this report and summaries of their findings are presented in Appendix A.

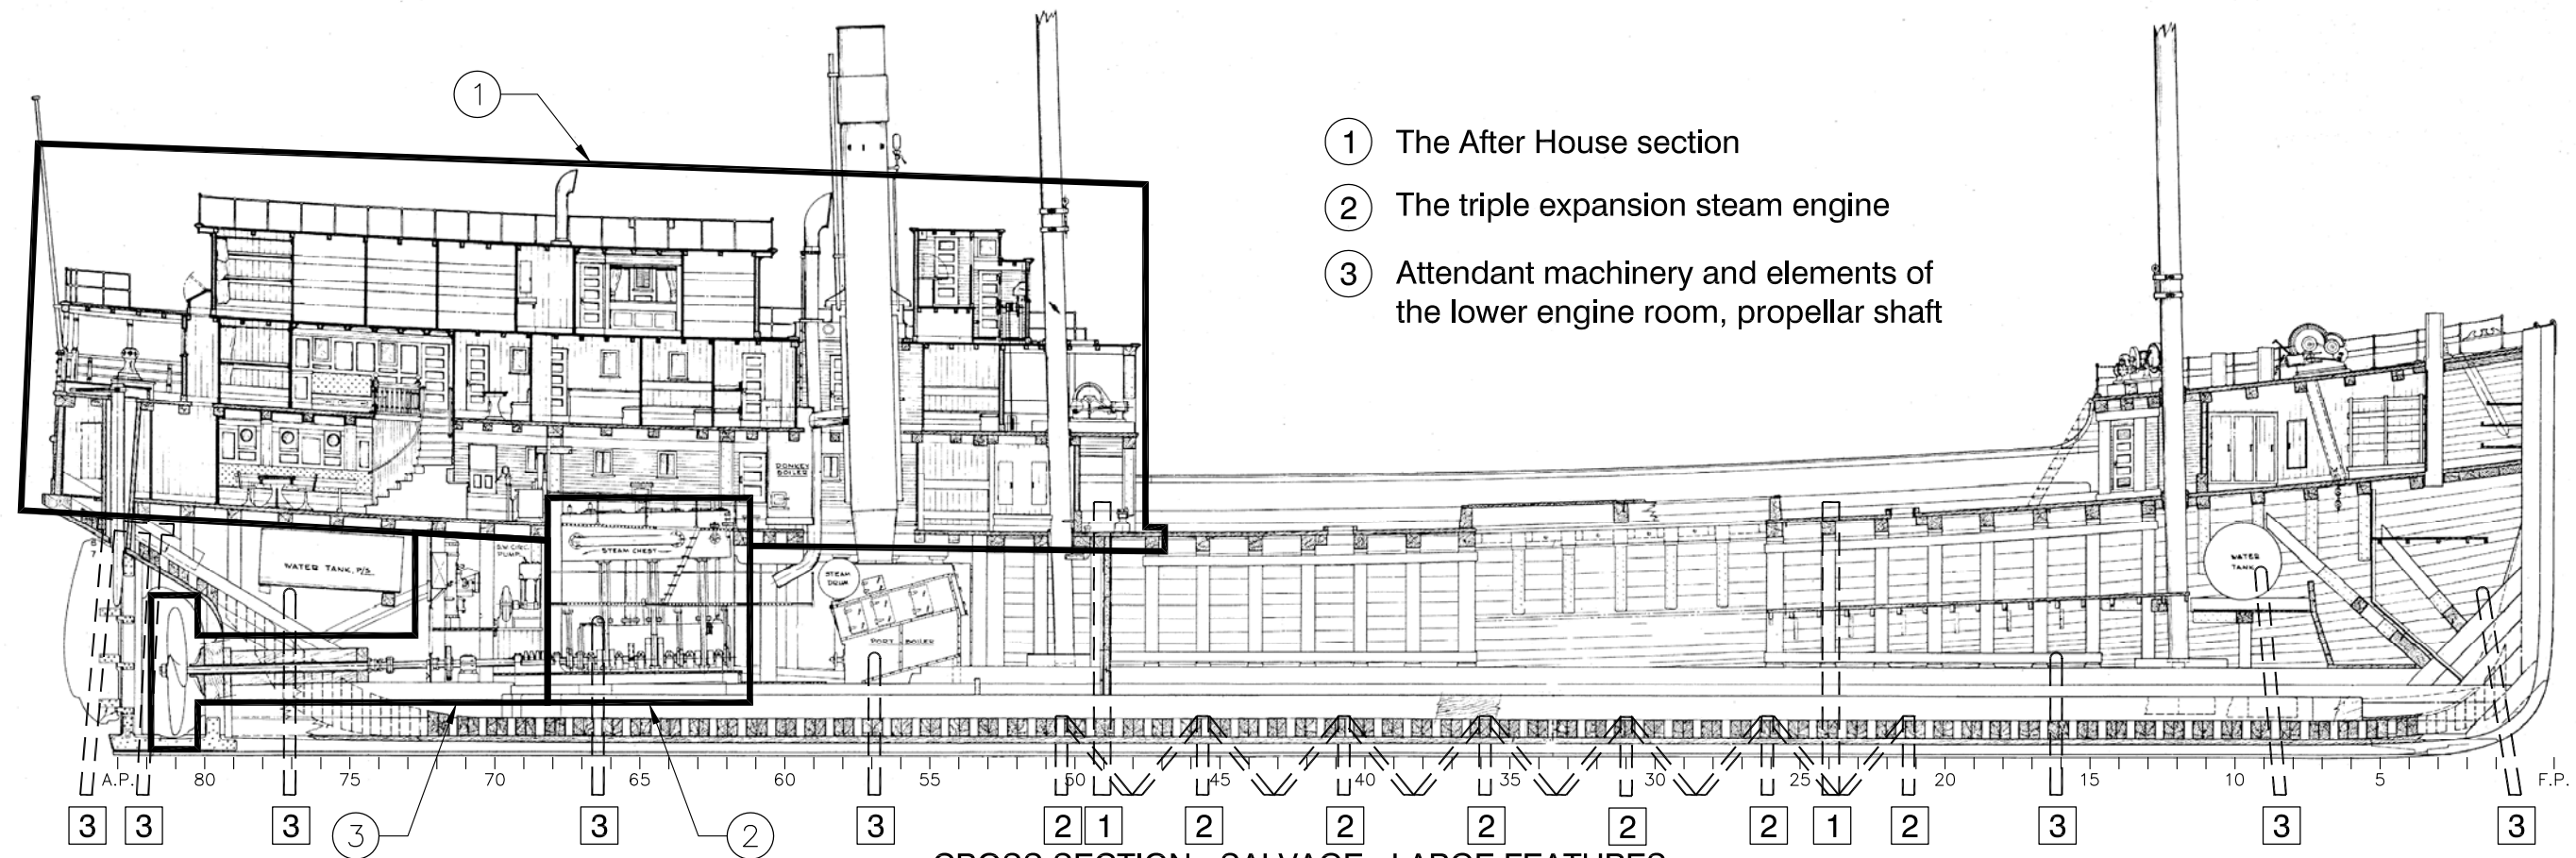
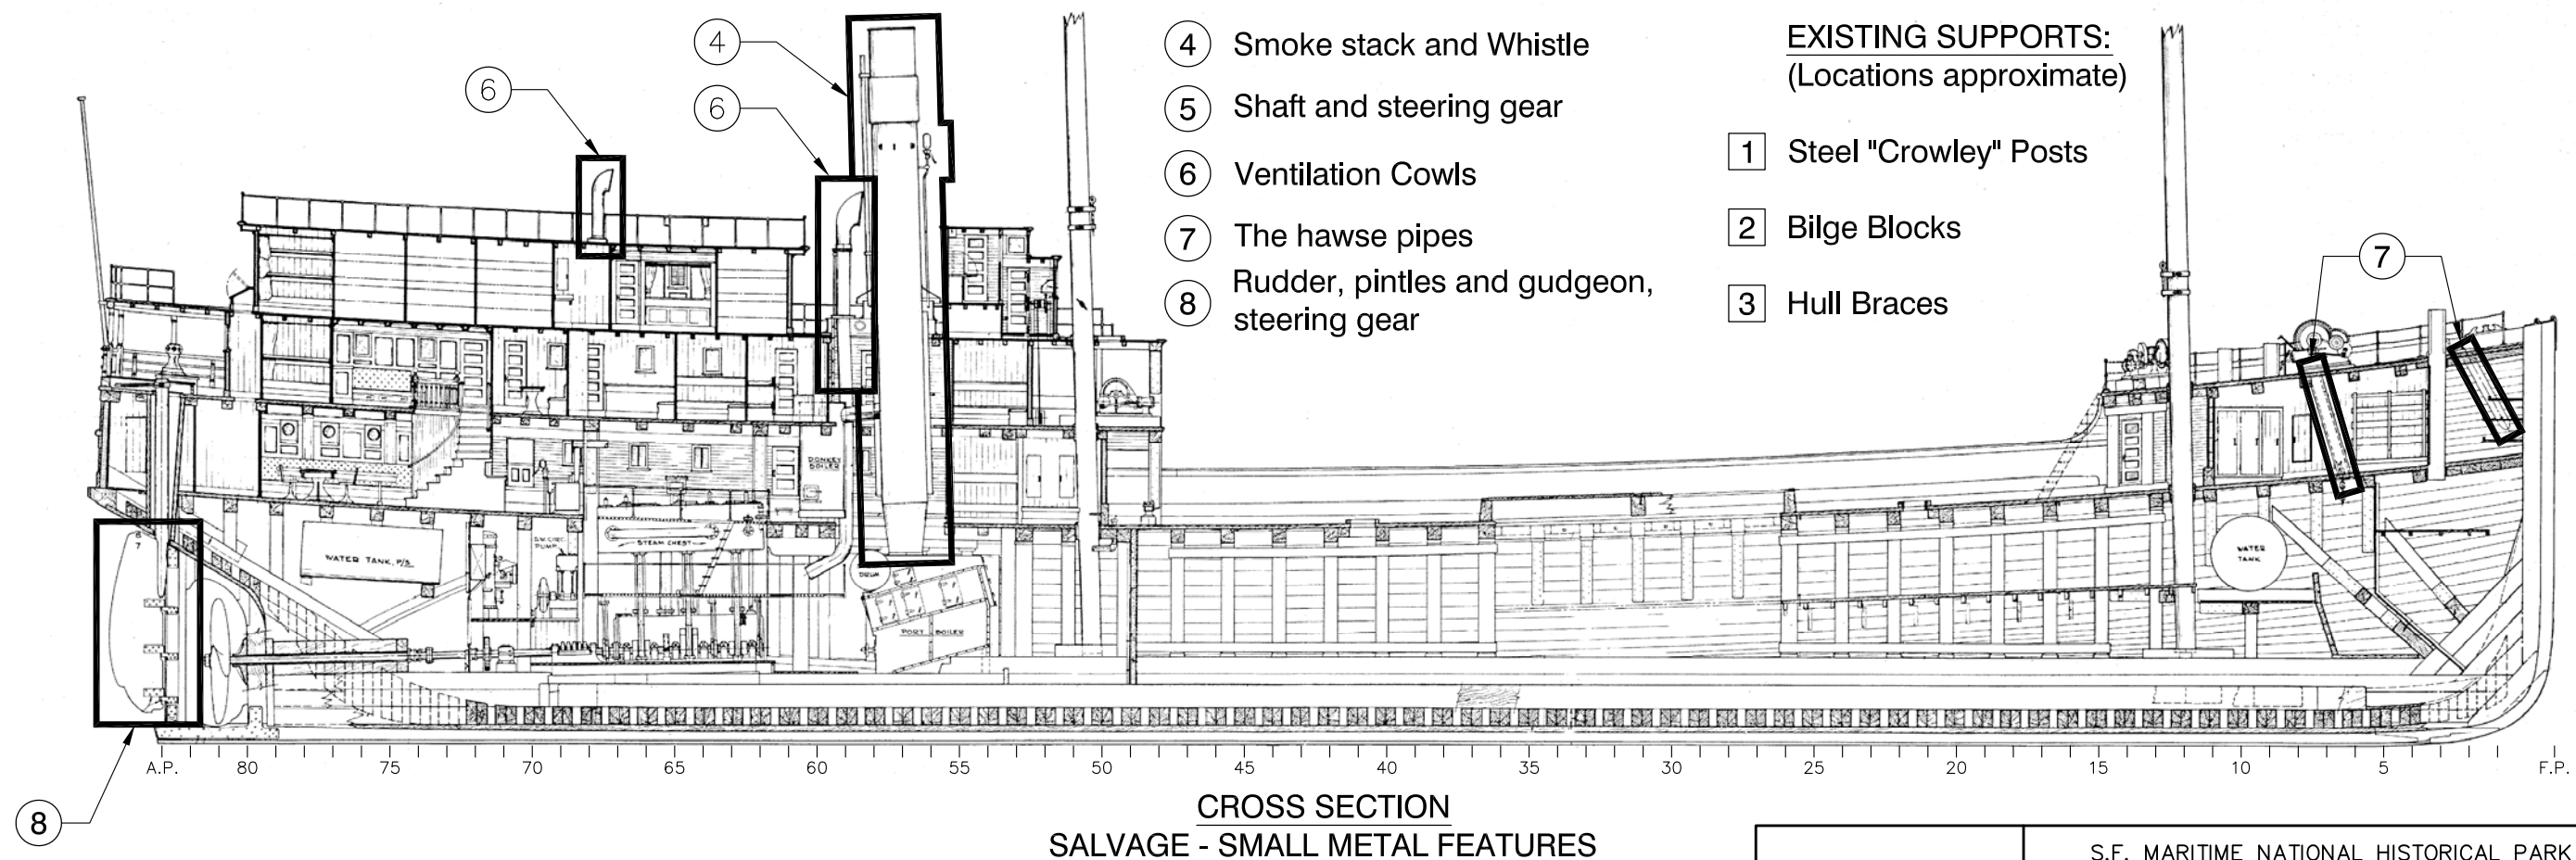
FIG. 1

EXISTING SUPPORTS:
(Locations approximate)

- 1 Steel "Crowley" Posts
- 2 Bilge Blocks
- 3 Hull Braces

CROSS SECTION
SALVAGE - METAL FEATURES

Figures 1 and 2 show the major items to be salvaged and Figures 3.1 to 3.3 show the phasing of the work on barge 214. From this, a work plan with sequencing of the major

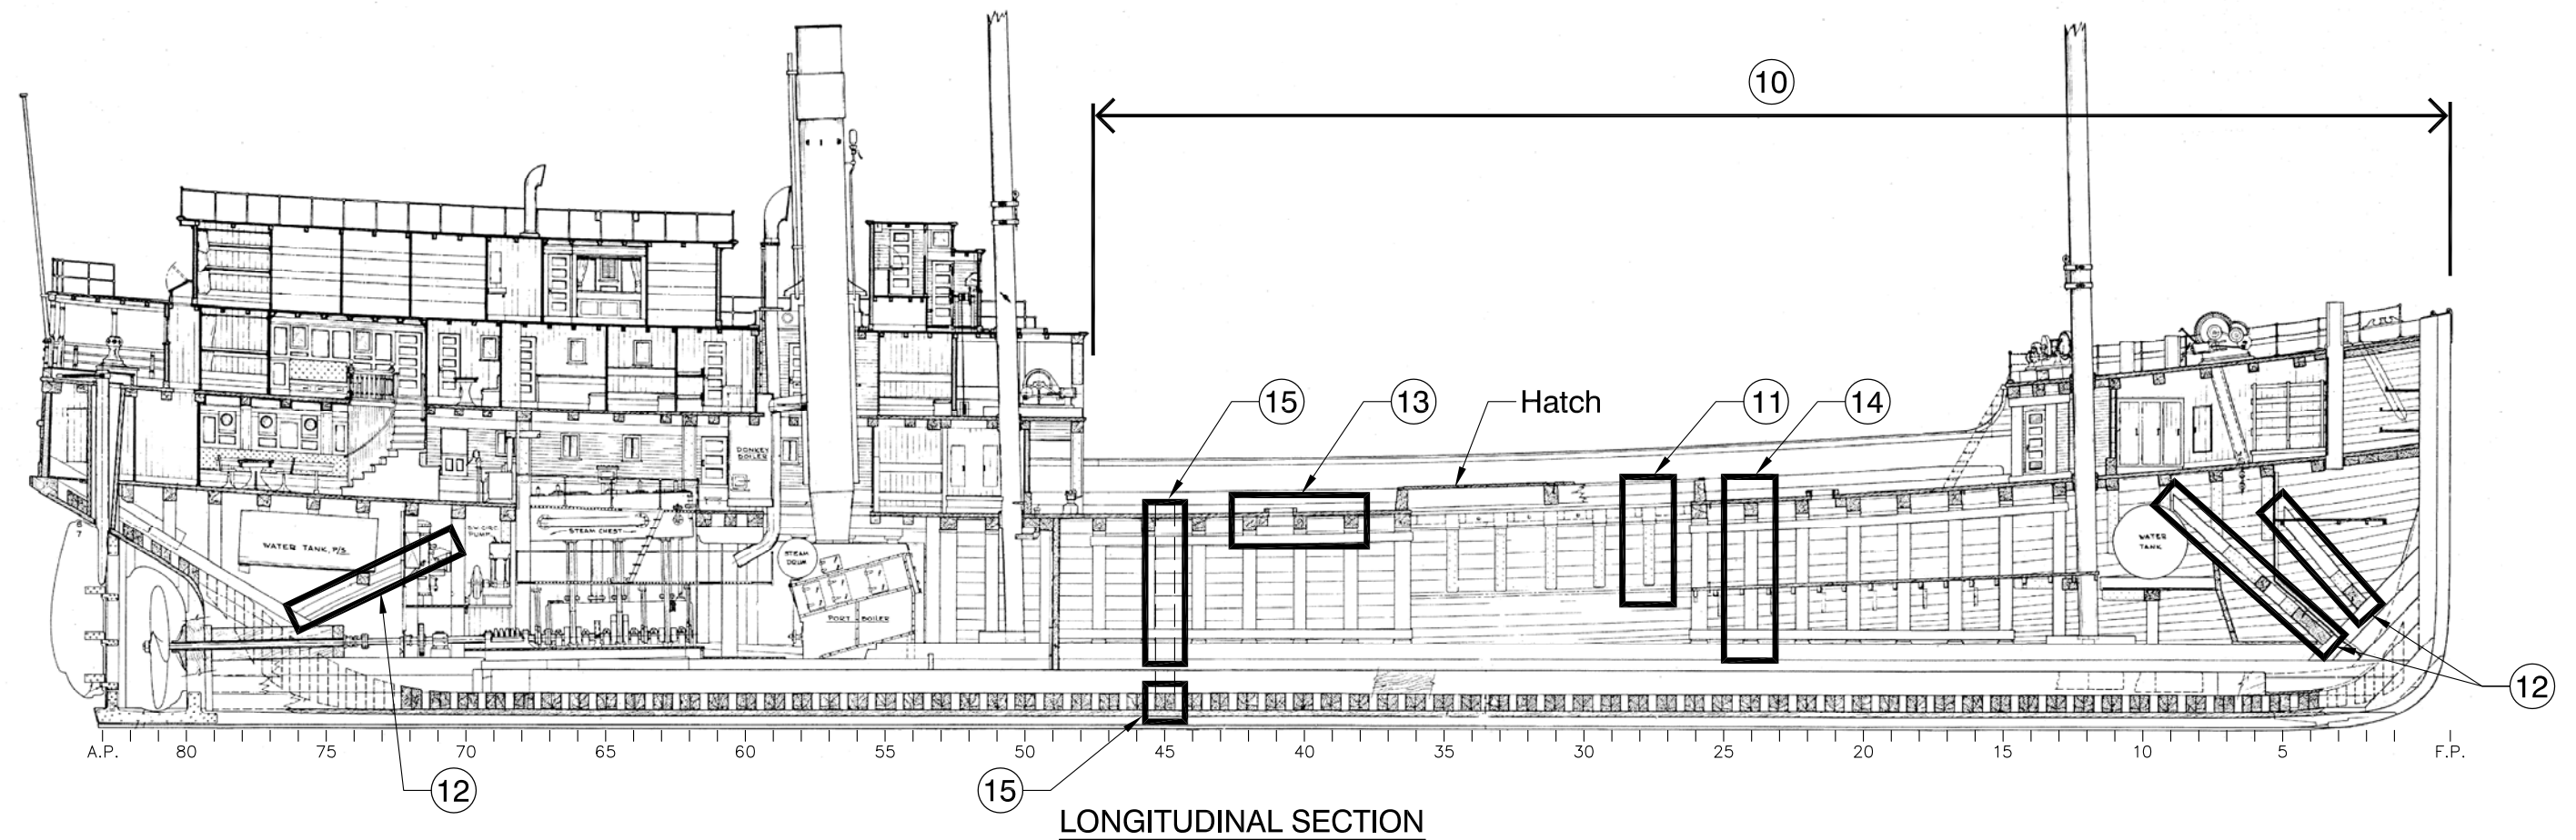
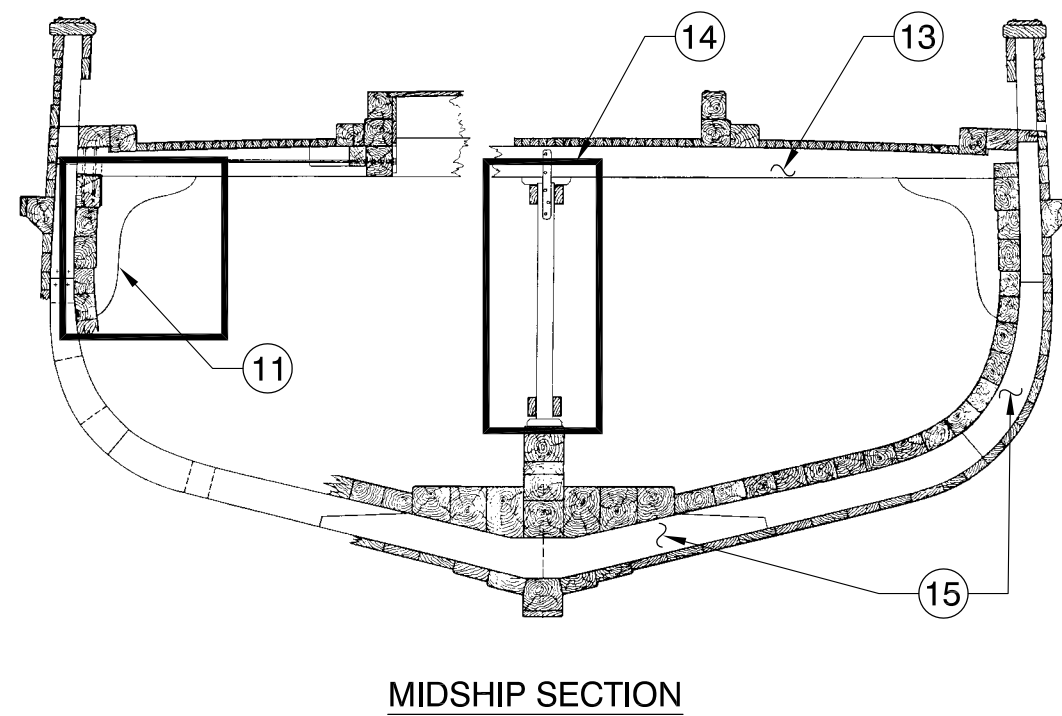
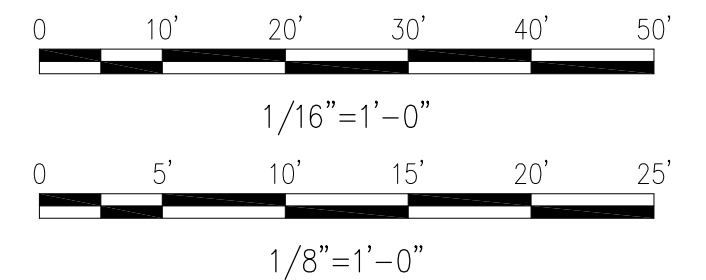
FIG. 2

- ⑩ Salvage selected great timbers forward of frame 48:
- ⑪ Wooden knees - adaptive reuse
- ⑫ Pointers
- ⑬ Beams
- ⑭ Stanchions
- ⑮ Frames

CROSS SECTION
SALVAGE - WOODEN FEATURES

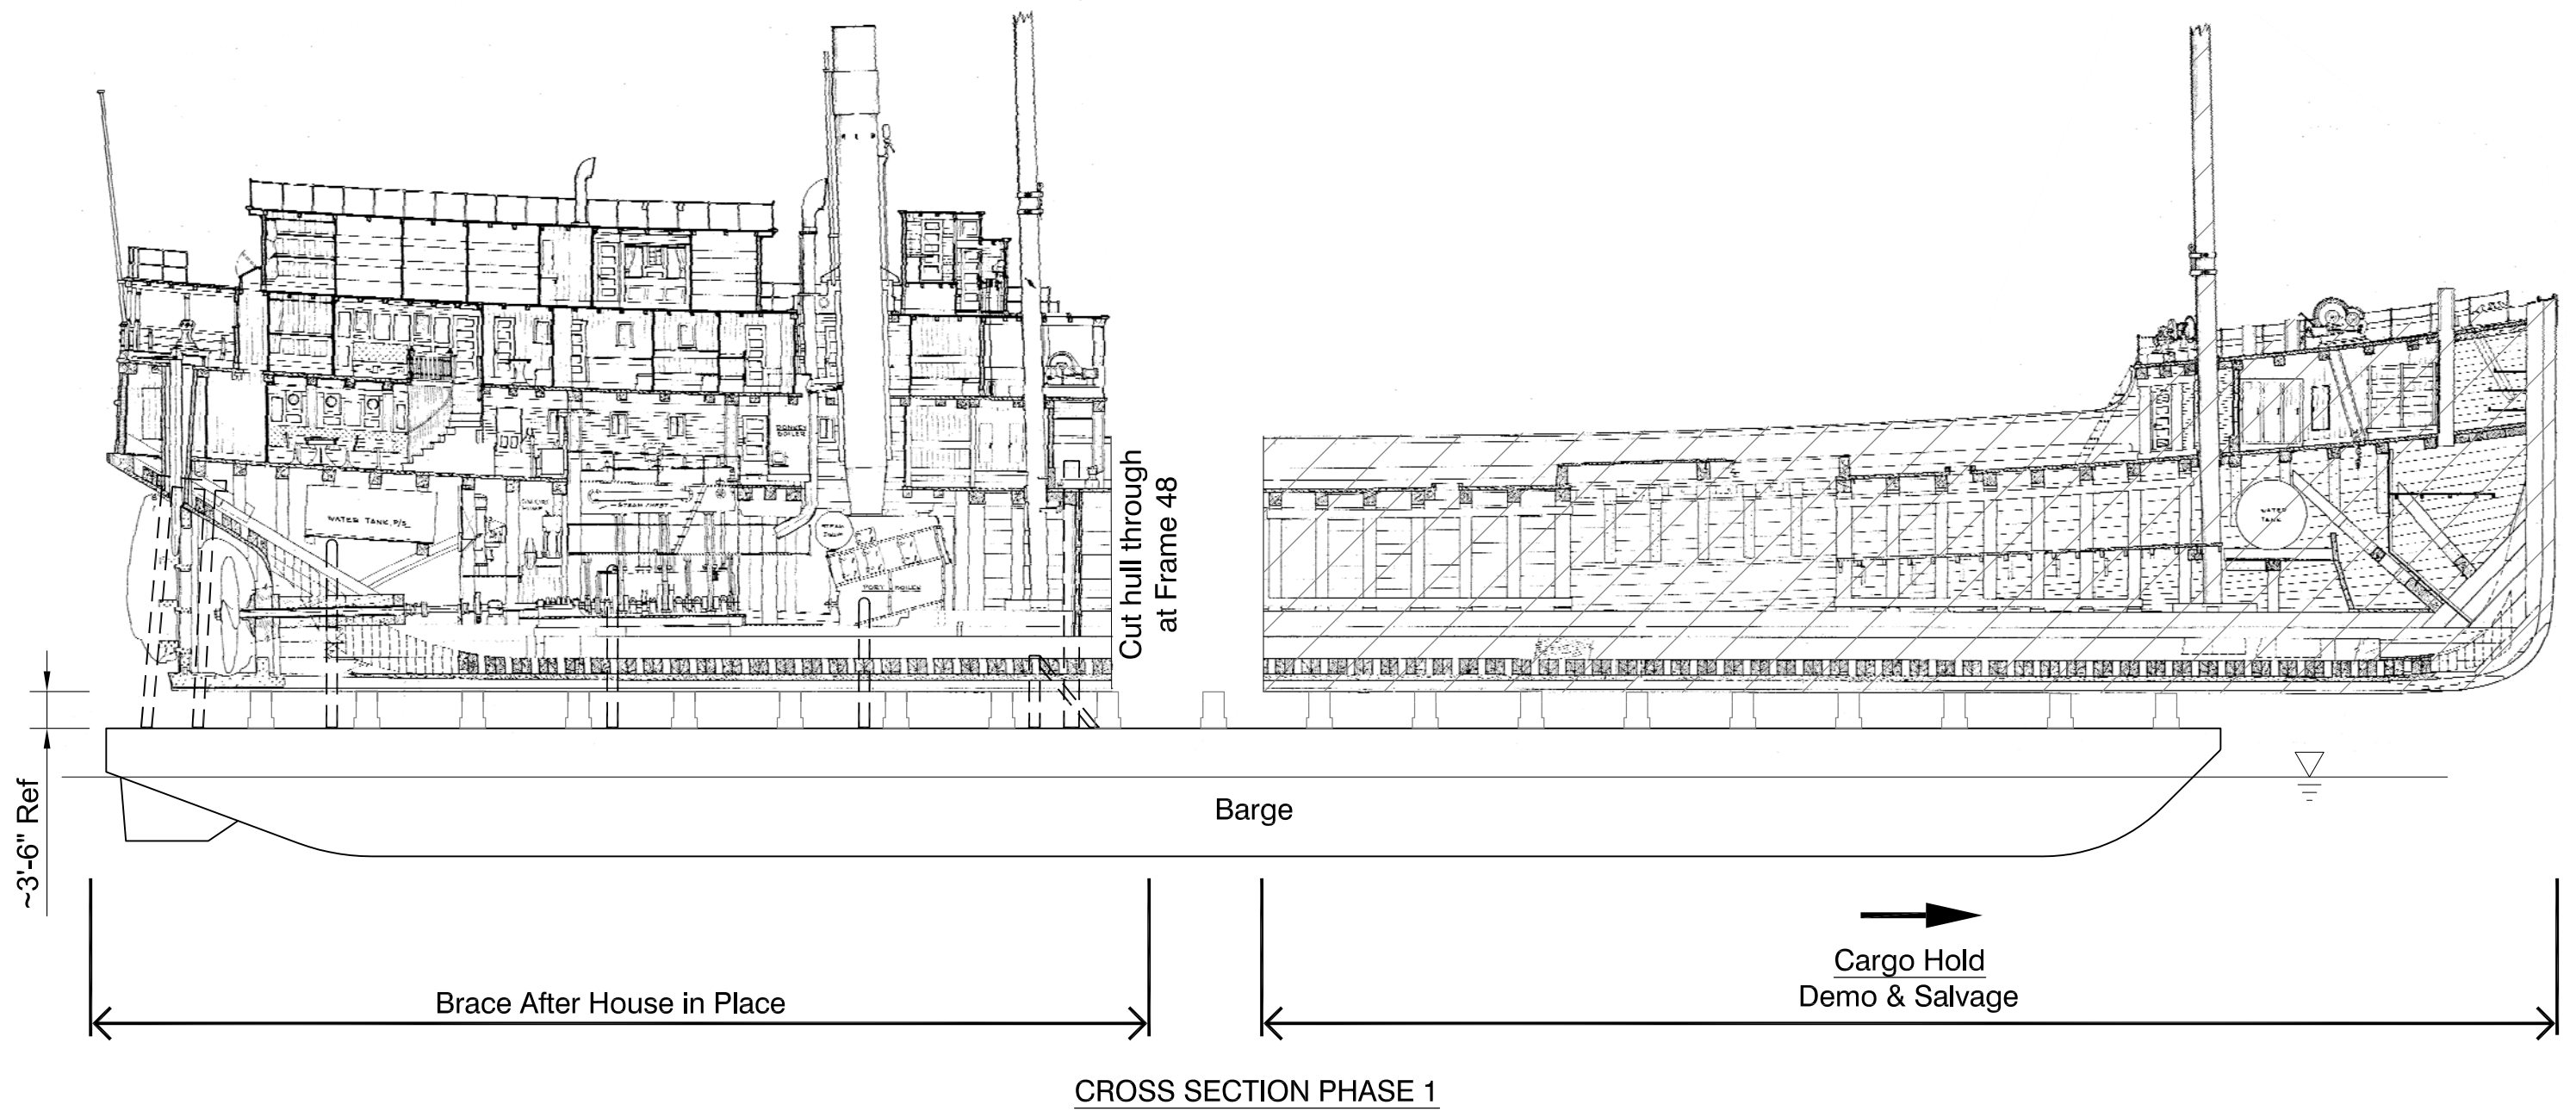
FIG. 3.1

AFTER HOUSE SECTION LIFT
PHASE 1

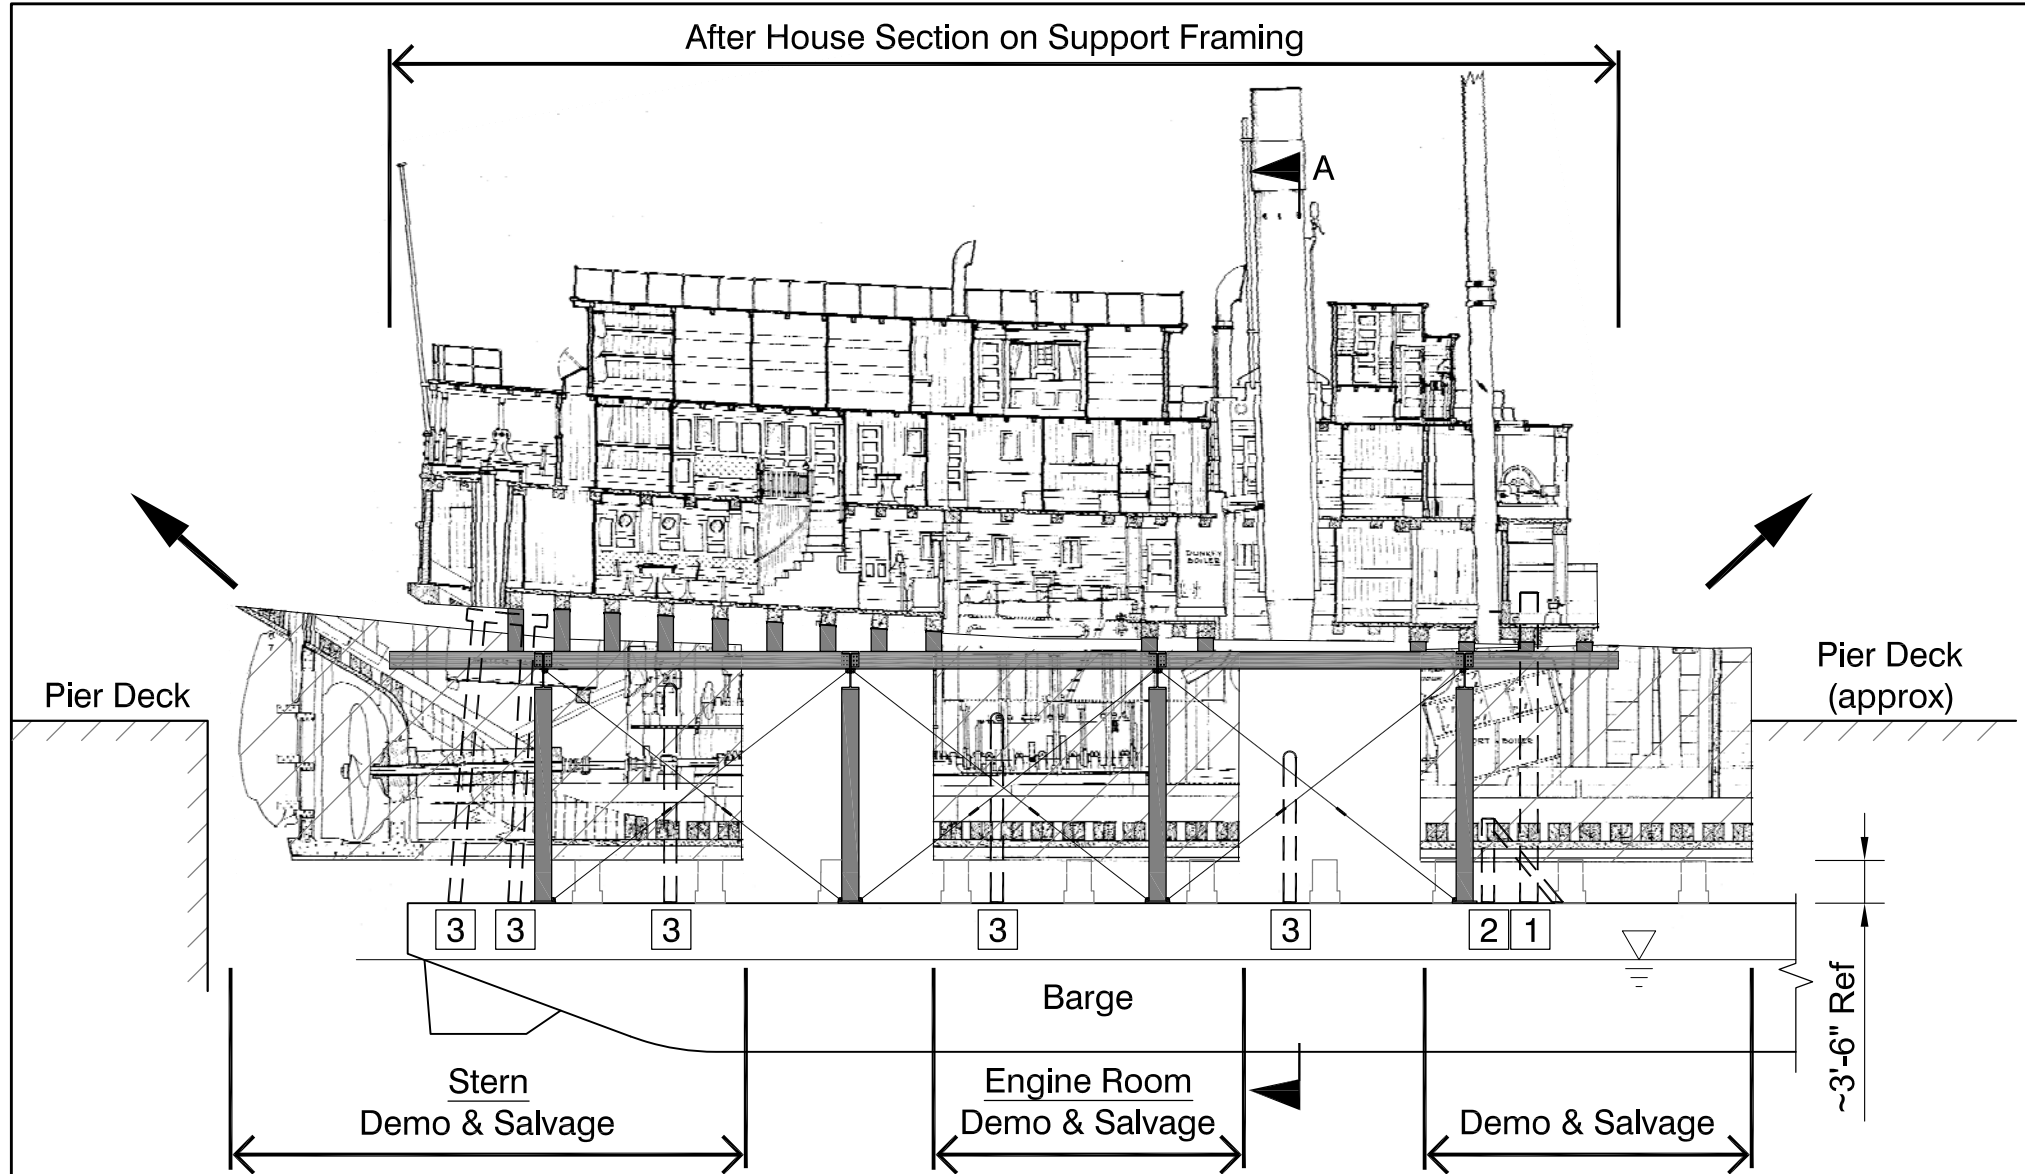
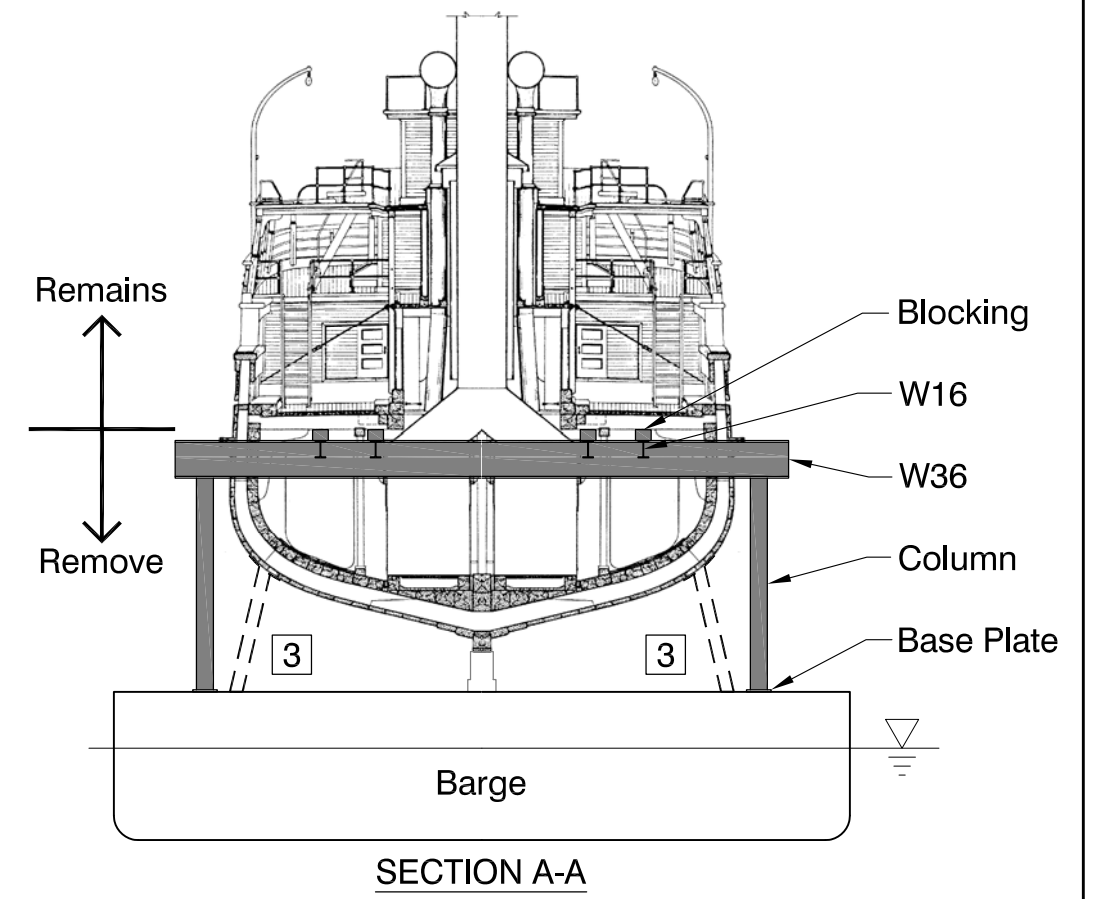
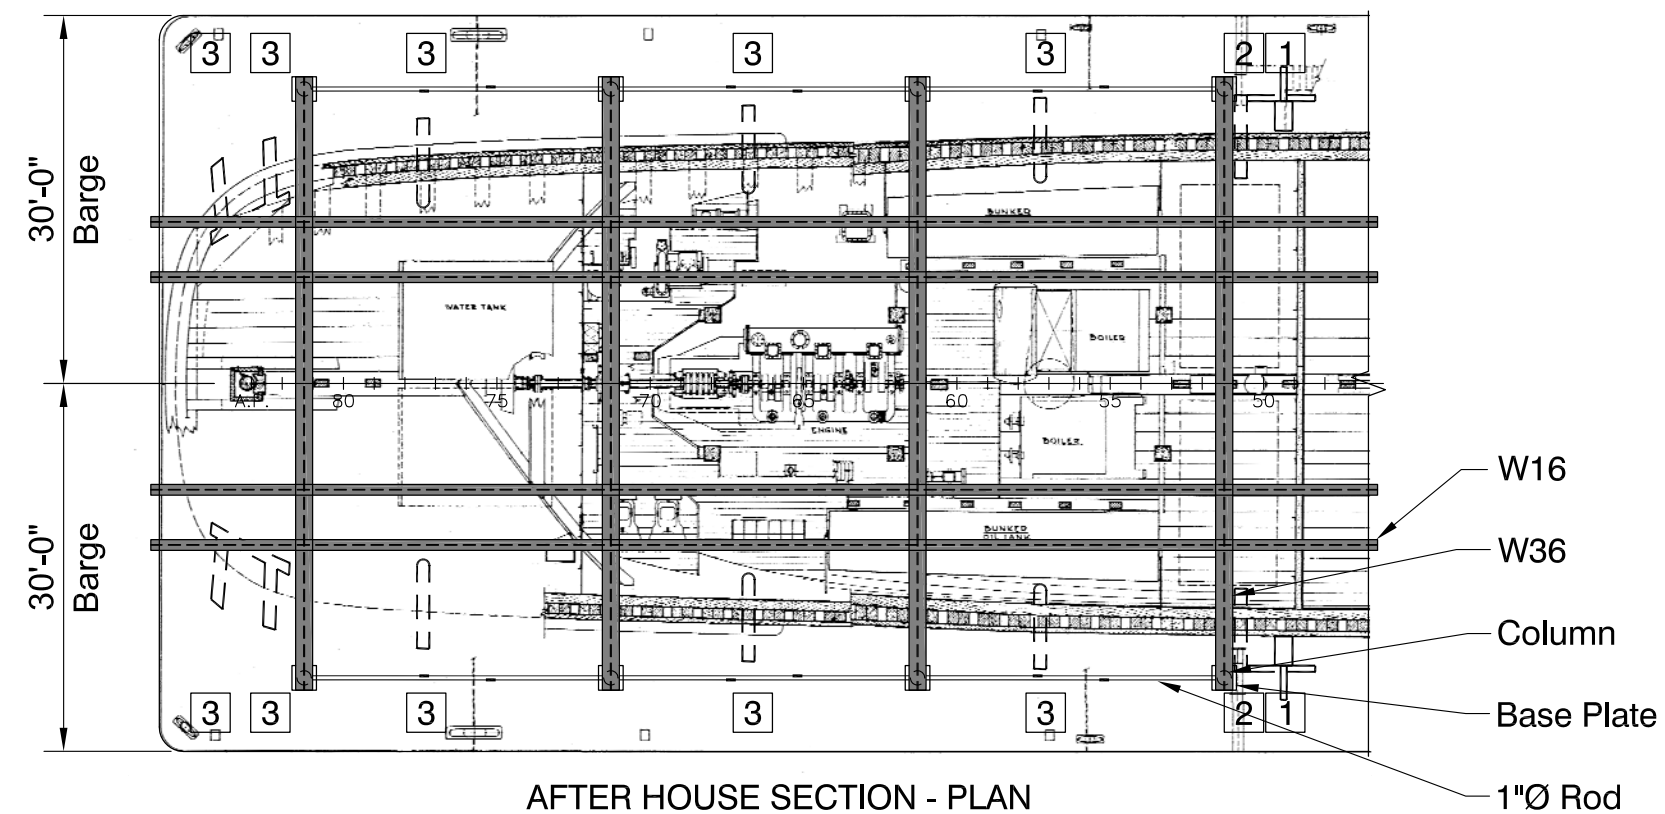
FIG. 3.2

EXISTING SUPPORTS:
(Locations approximate)

- 1 Steel "Crowley" Posts
- 2 Bilge Blocks
- 3 Hull Braces

S.F. MARITIME NATIONAL HISTORICAL PARK
NHL STEAM SCHOONER WAPAMA
SALVAGE FEASIBILITY
AFTER HOUSE SECTION LIFT
PHASE 2

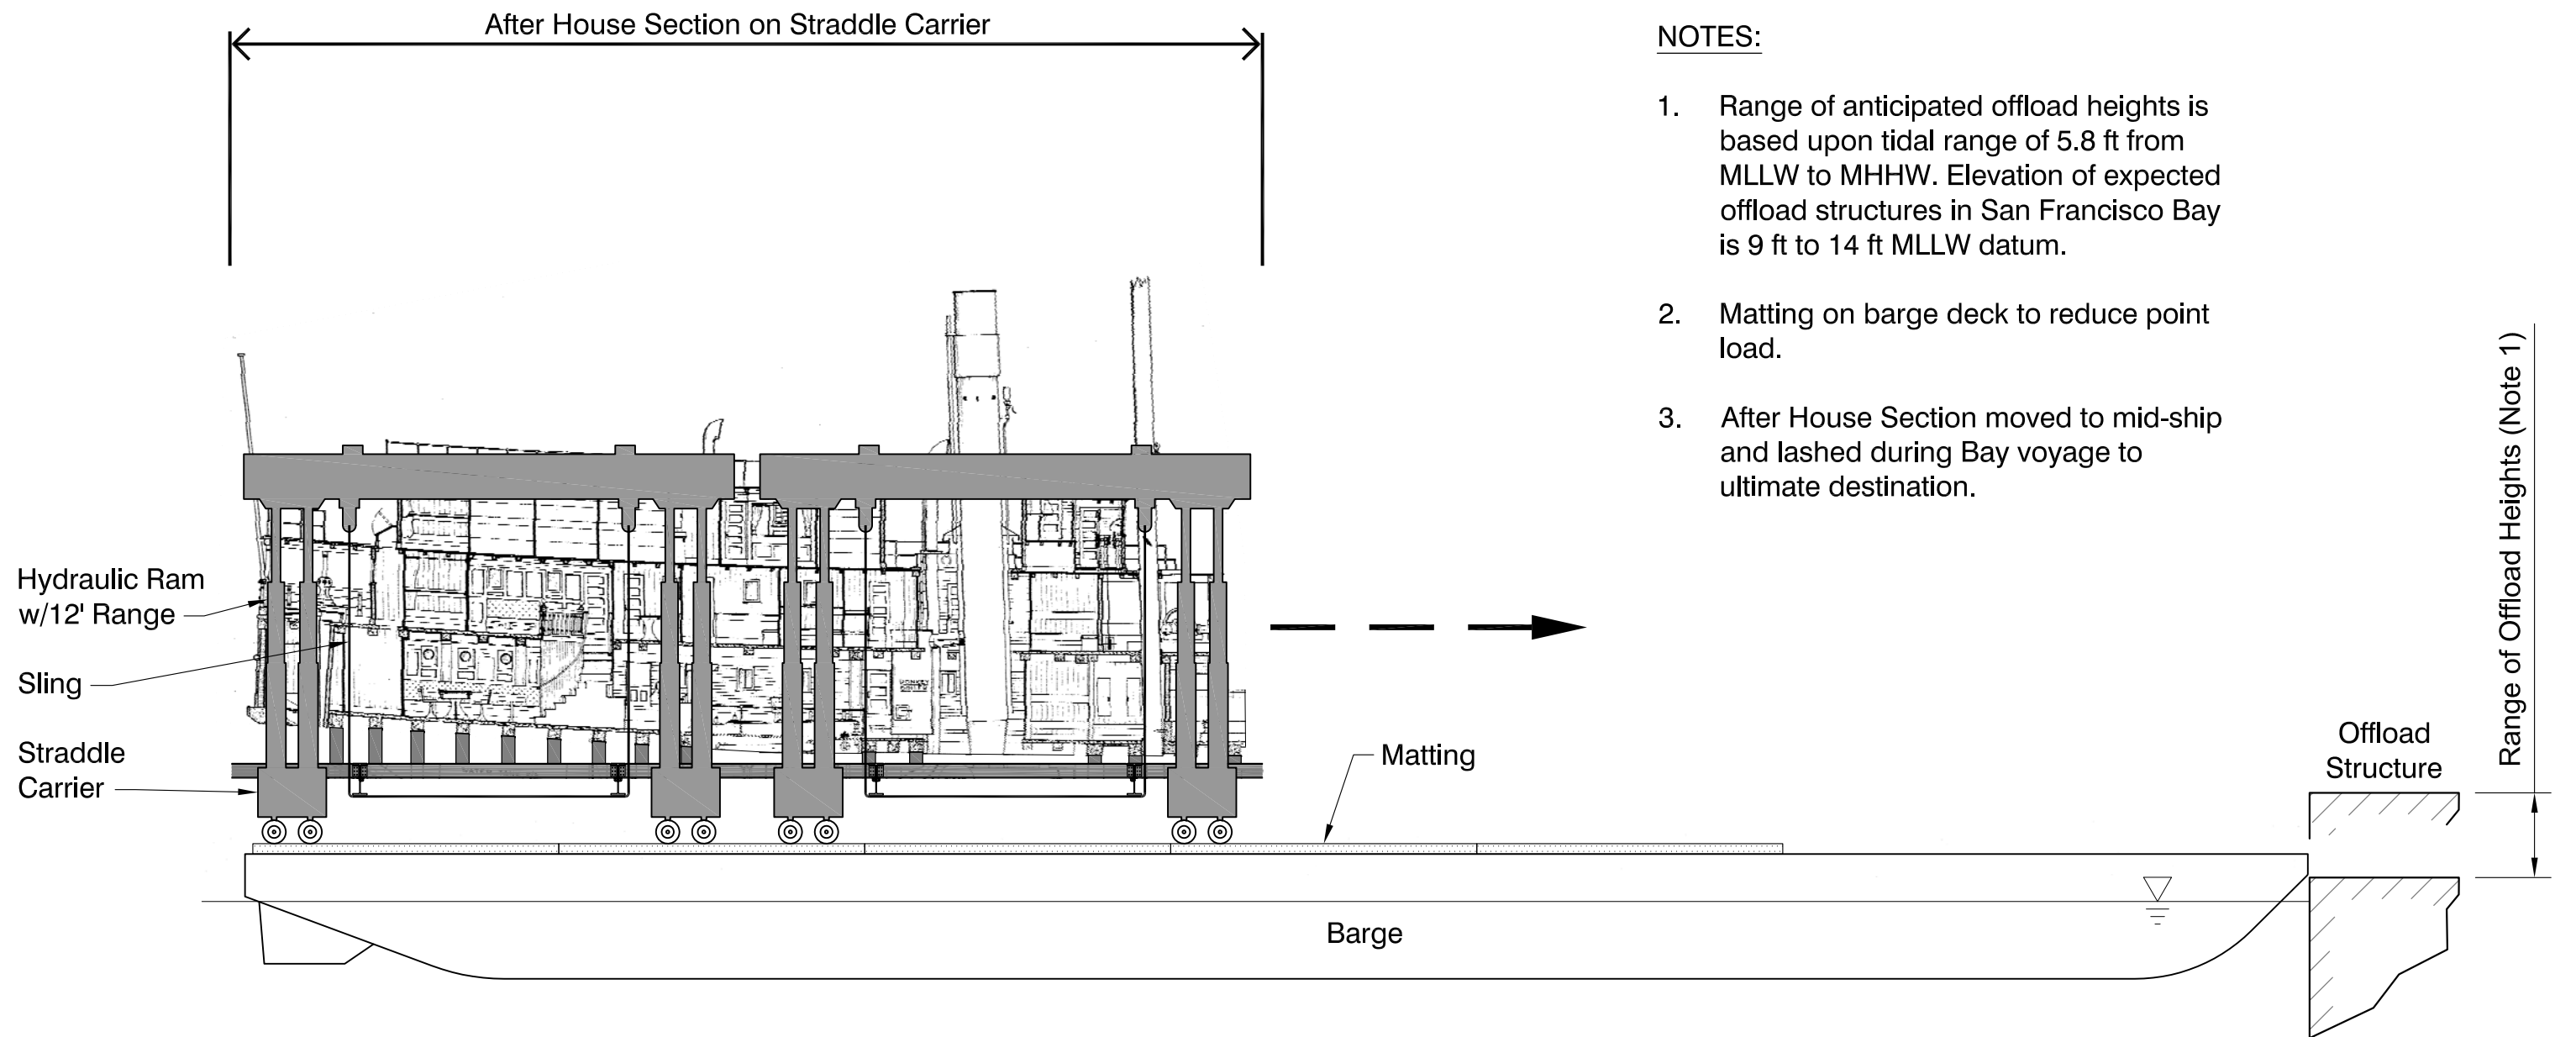
FIGURE 3.3: AFTER HOUSE CROSS SECTION SALVAGE – PHASE 3
