National Historic Landmark
Steam Schooner *Wapama*

Salvage and Disassembly Feasibility Study

December 21, 2009

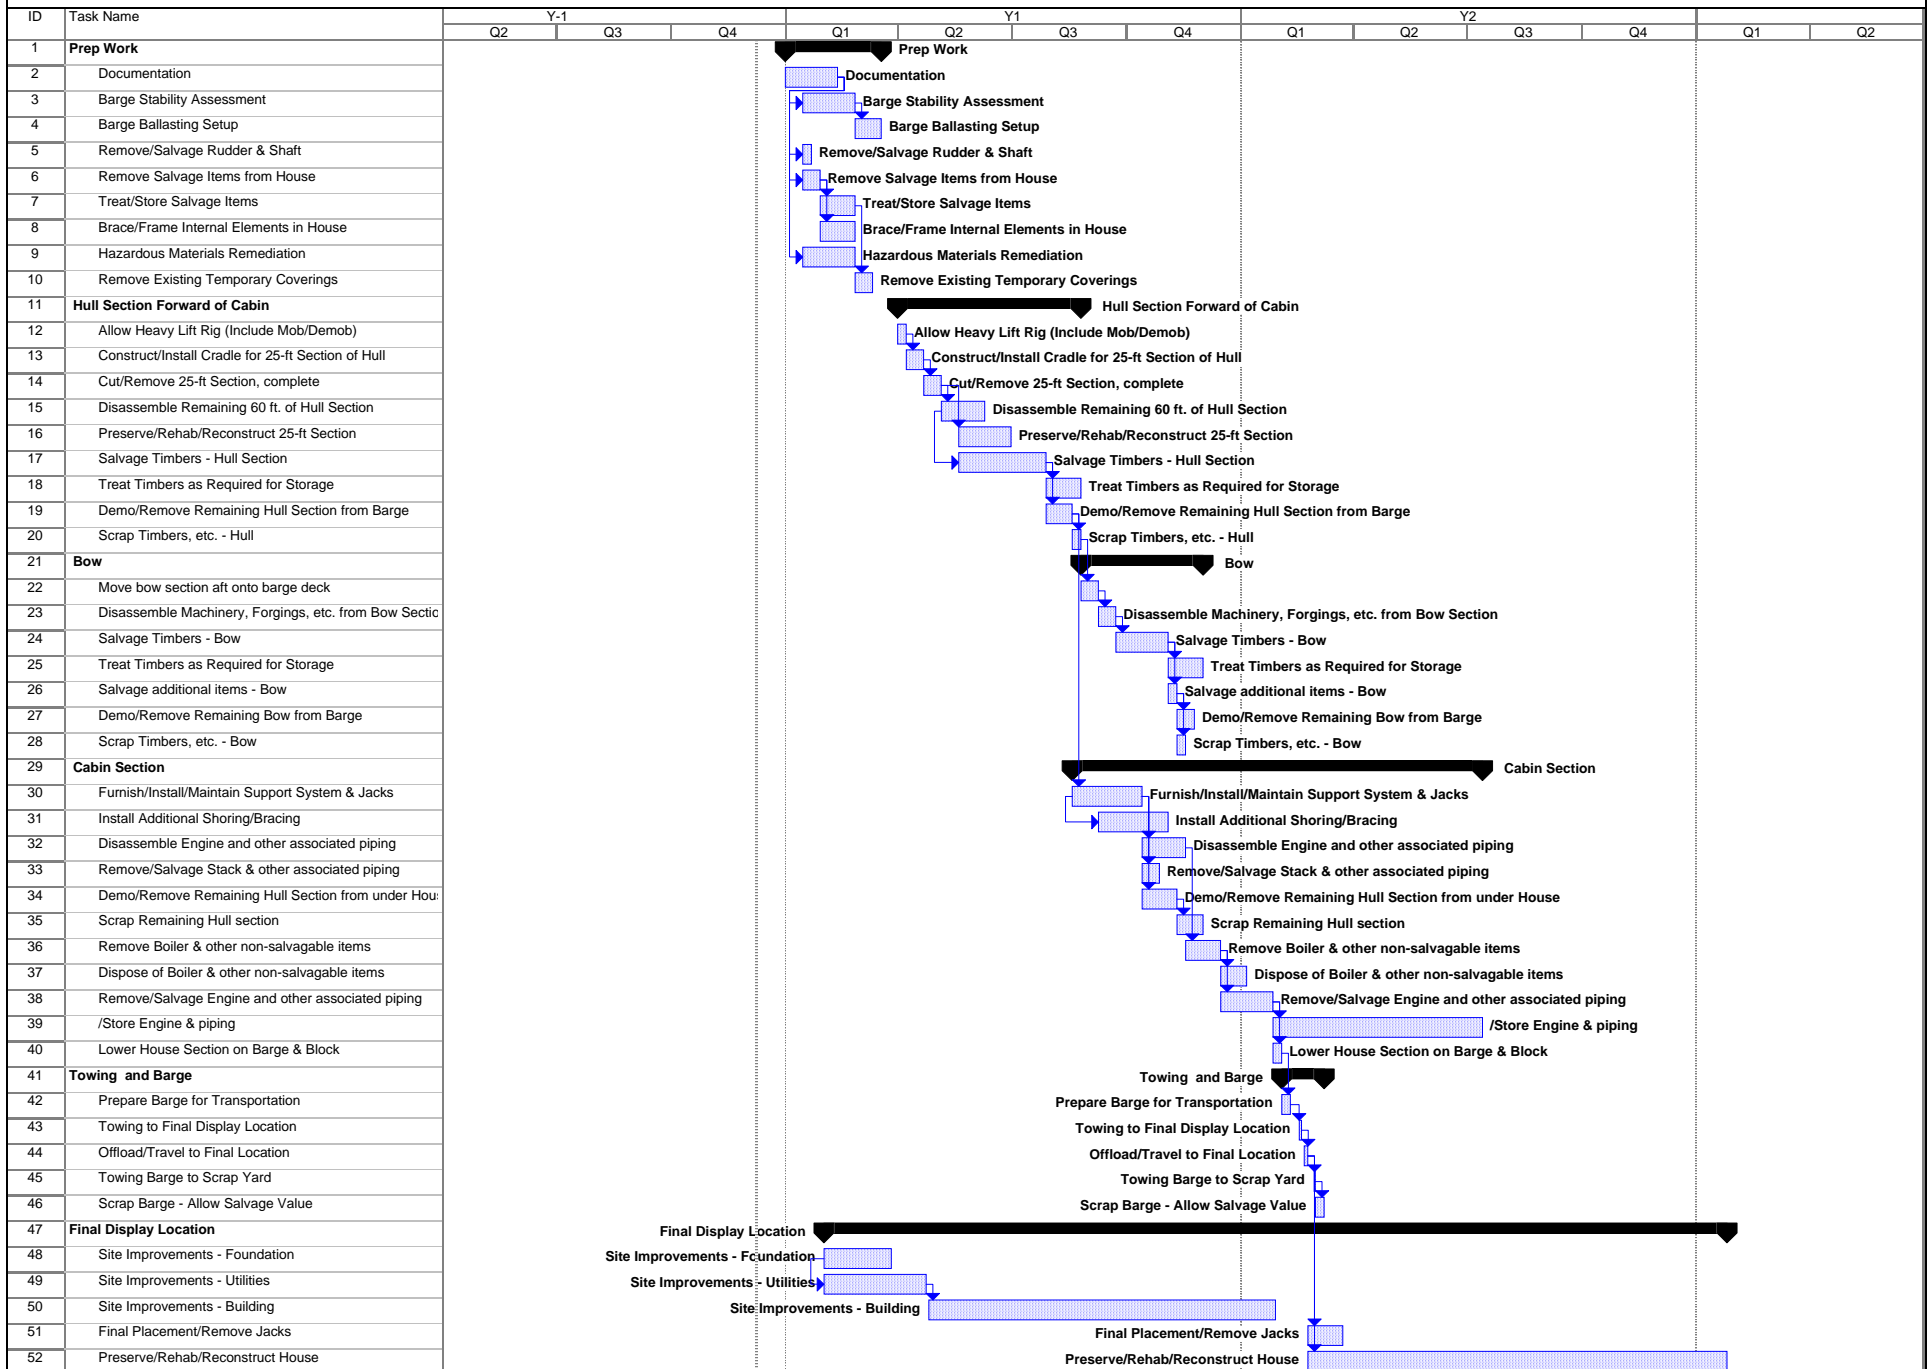
WAPAMA Work Sequence and Schedule

work elements was developed and is presented in Appendix C and summarized as follows:

- Document—Develop drawings of ships lines (may use laser scan in process) as called for in Historic Report (ref 2, III-B-3)
- Brace section aft of frame 48 and sever from forward section
- Dismantle and selective salvage cargo section
- Control bow section so no portion is directly over the water during salvage/demolition operations (move back onto barge deck or provide catchment below).
- Underpin After House below main deck, install steel beams through hull
- Remove Steam Engine and associated equipment
- Move After House forward on barge with straddle carriers / wheeled jacks and secure to barge
- Transport on barge to final location (to be determined)
- Slide After House off barge onto land with straddle carrier / wheeled jacks
- Set After House with steel beam supports onto permanent foundation on shore

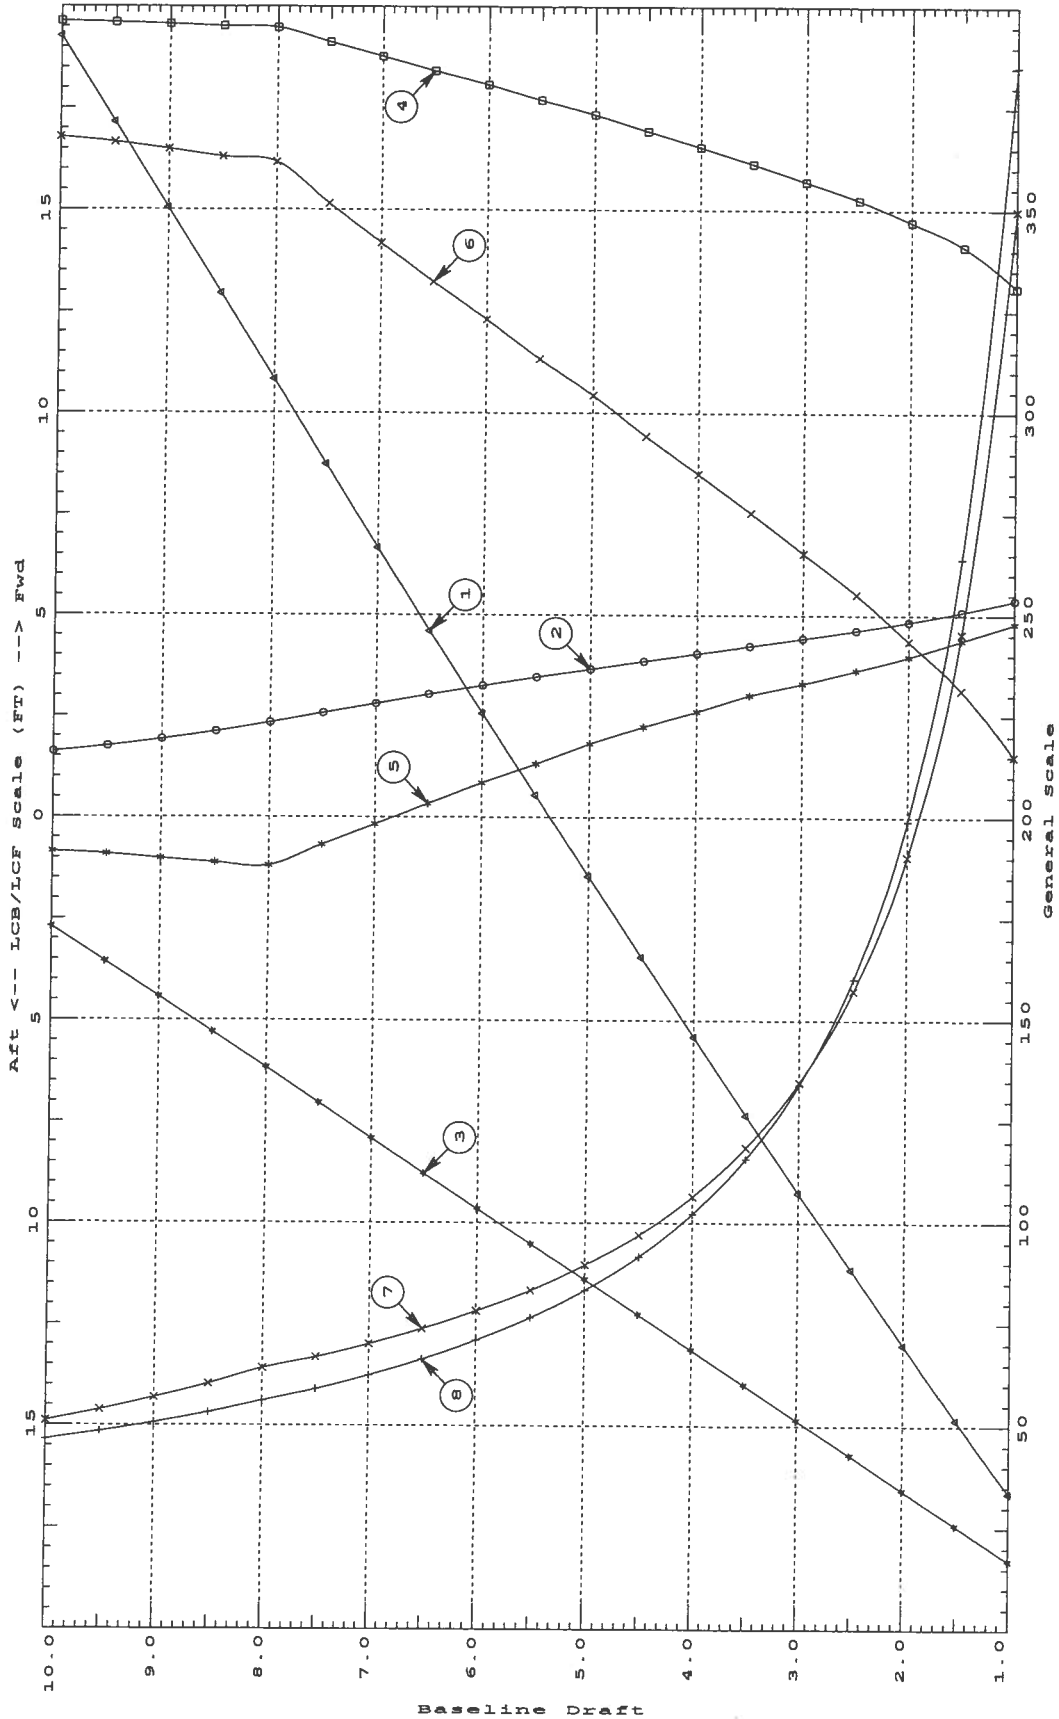
HYDROSTATIC PROPERTIES AT LEVEL TRIM

- 1 Displacement 1=9 ST
- 2 LCB (use top scale)
- 3 VCB (KB) 1=.03 FT

- 4 Immersion 1=.08 ST/IN
- 4 WPA 1=30 Sq.FT
- 5 LCF (use top scale)
