*Reconstruct the Basement Stairway Entrance Roofs at Chatham*

**Photos**

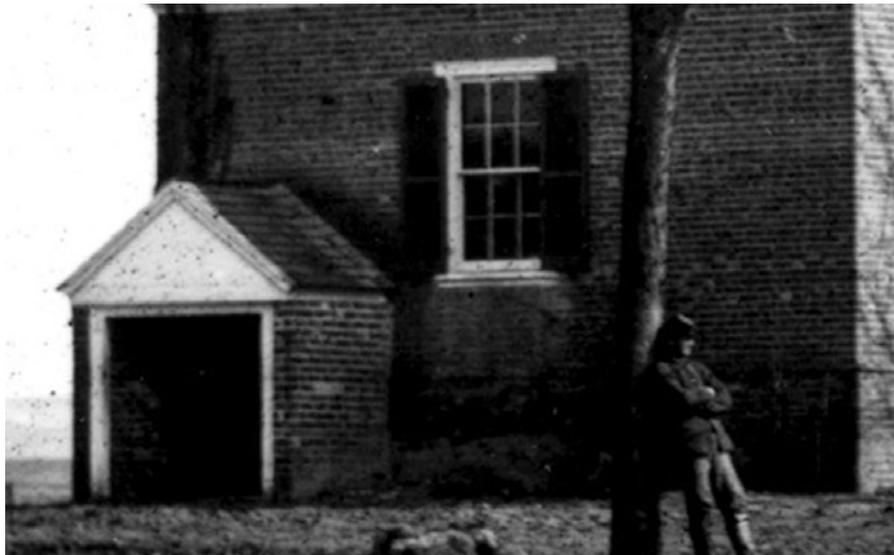
Cropped view of the northern basement stairway entrance. Photo dated 1863.

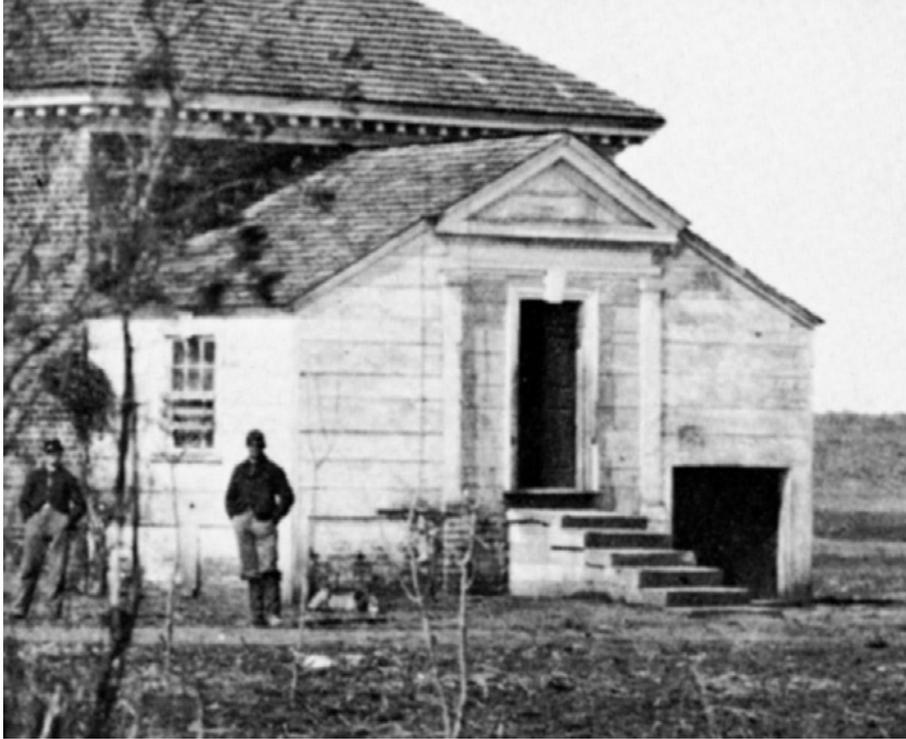
Cropped view of the southern basement stairway entrance. Photo dated 1863.

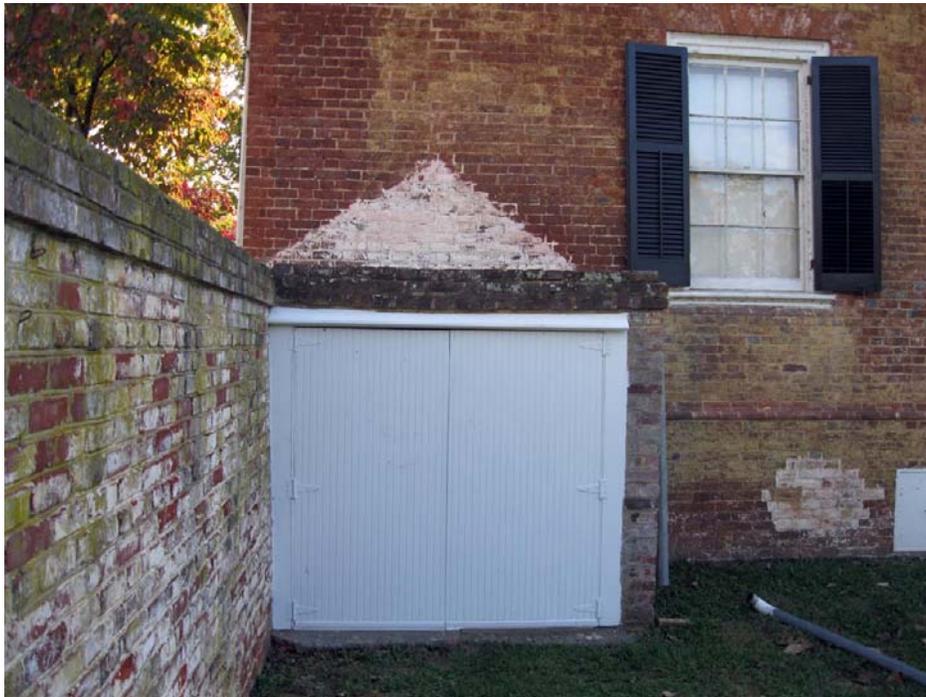
Current view of northern basement stairway entrance. Garden wall added in 1920s. Note ghost lines for pitched roof on wall of the house. The park proposes to reconstruct the missing roof.

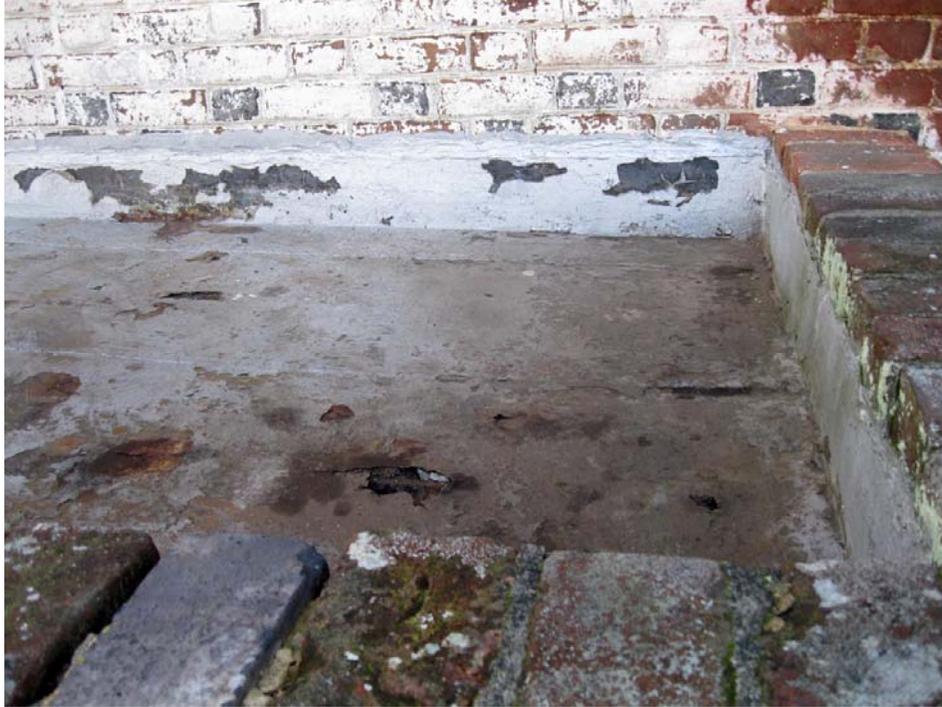
Current view of the flat roof on the northern basement stairway entrance. This area fills with rainwater that eventually seeps into the basement.

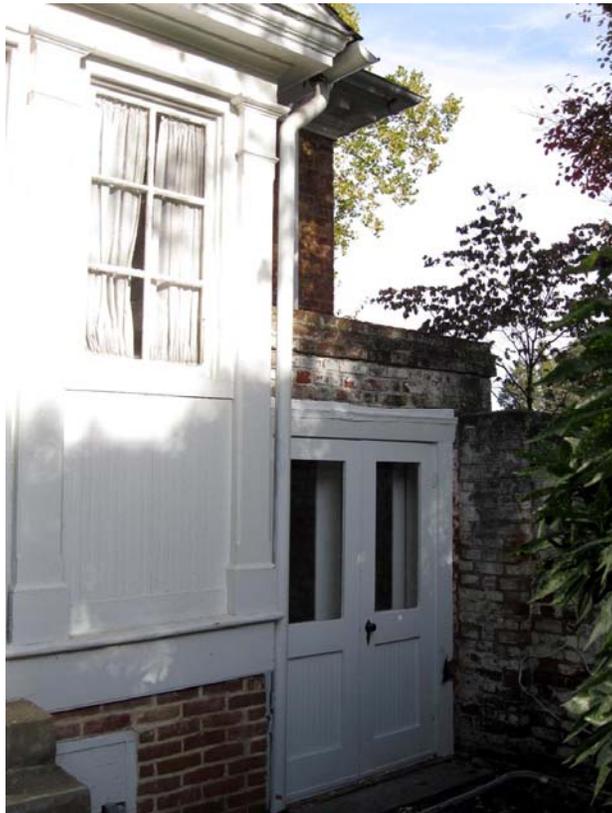
Current view southern basement stairway entrance. Garden wall added in 1920s. The park proposes to reconstruct the missing roof.

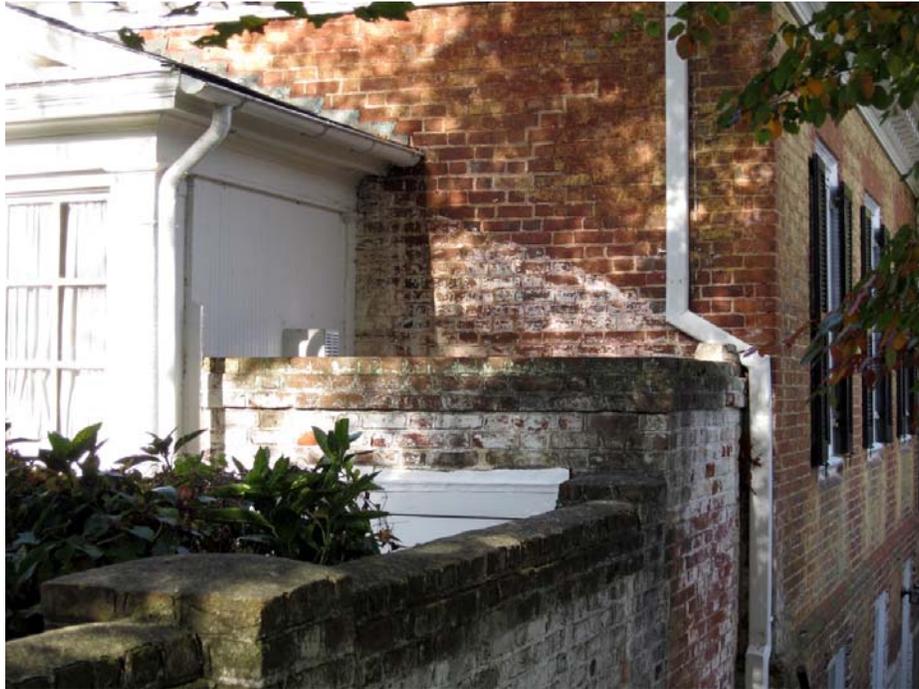
Current view northern basement stairway entrance. Garden wall added in 1920s. Note ghost lines for pitched roof on wall of the house. The park proposes to reconstruct the missing roof.

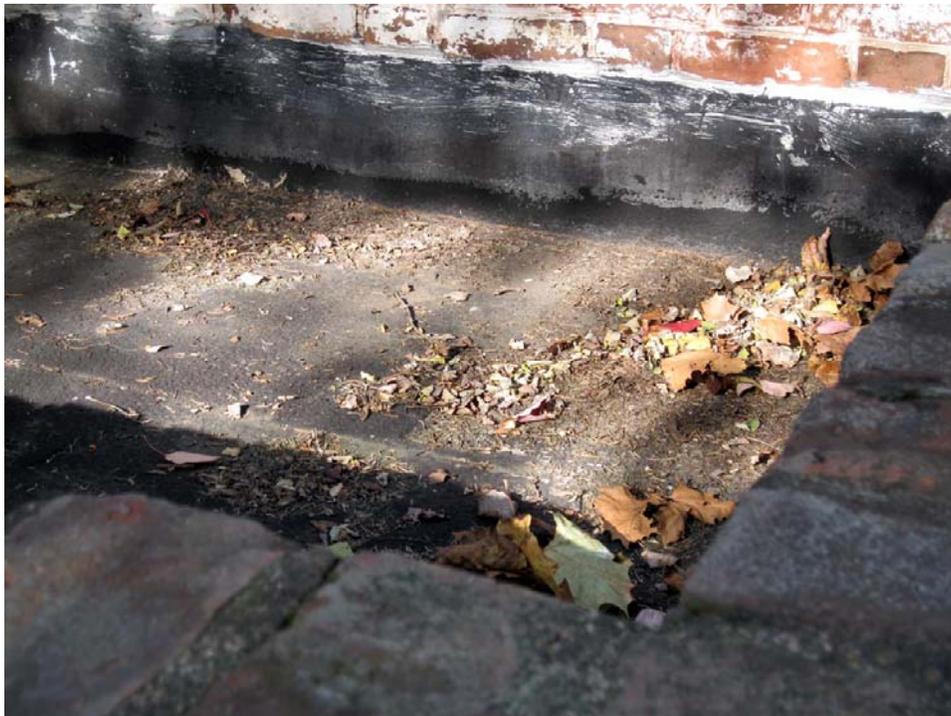
Current view of the flat roof on the southern basement stairway entrance. This area fills with rainwater that eventually seeps into the basement.
