# Fort Hancock Rehabilitation Guidelines

Sandy Hook, New Jersey March 1999

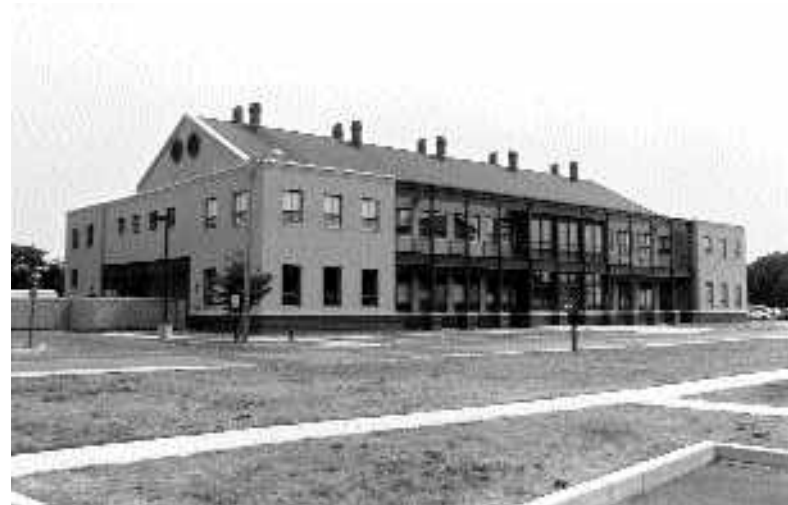
The new NOAA building, constructed in 1992, uses a compatible palette of building materials to fit into the Parade Ground area.

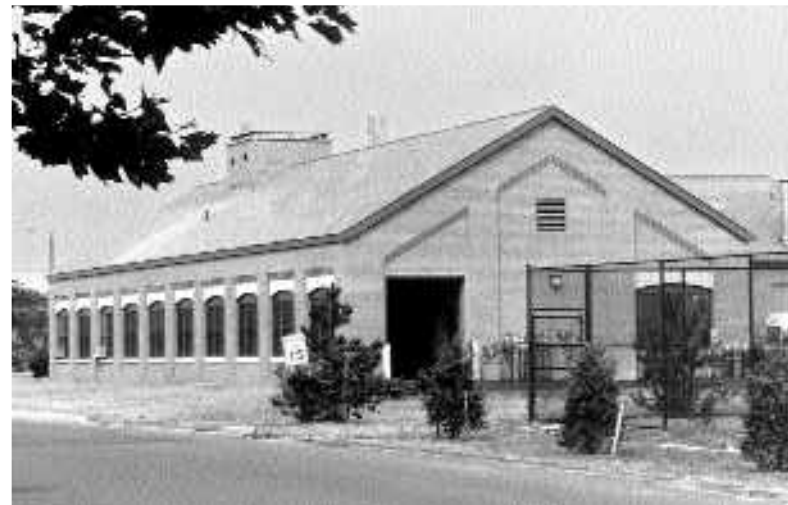
This new Coast Guard building employs masonry details and building forms found in the historic warehouses.

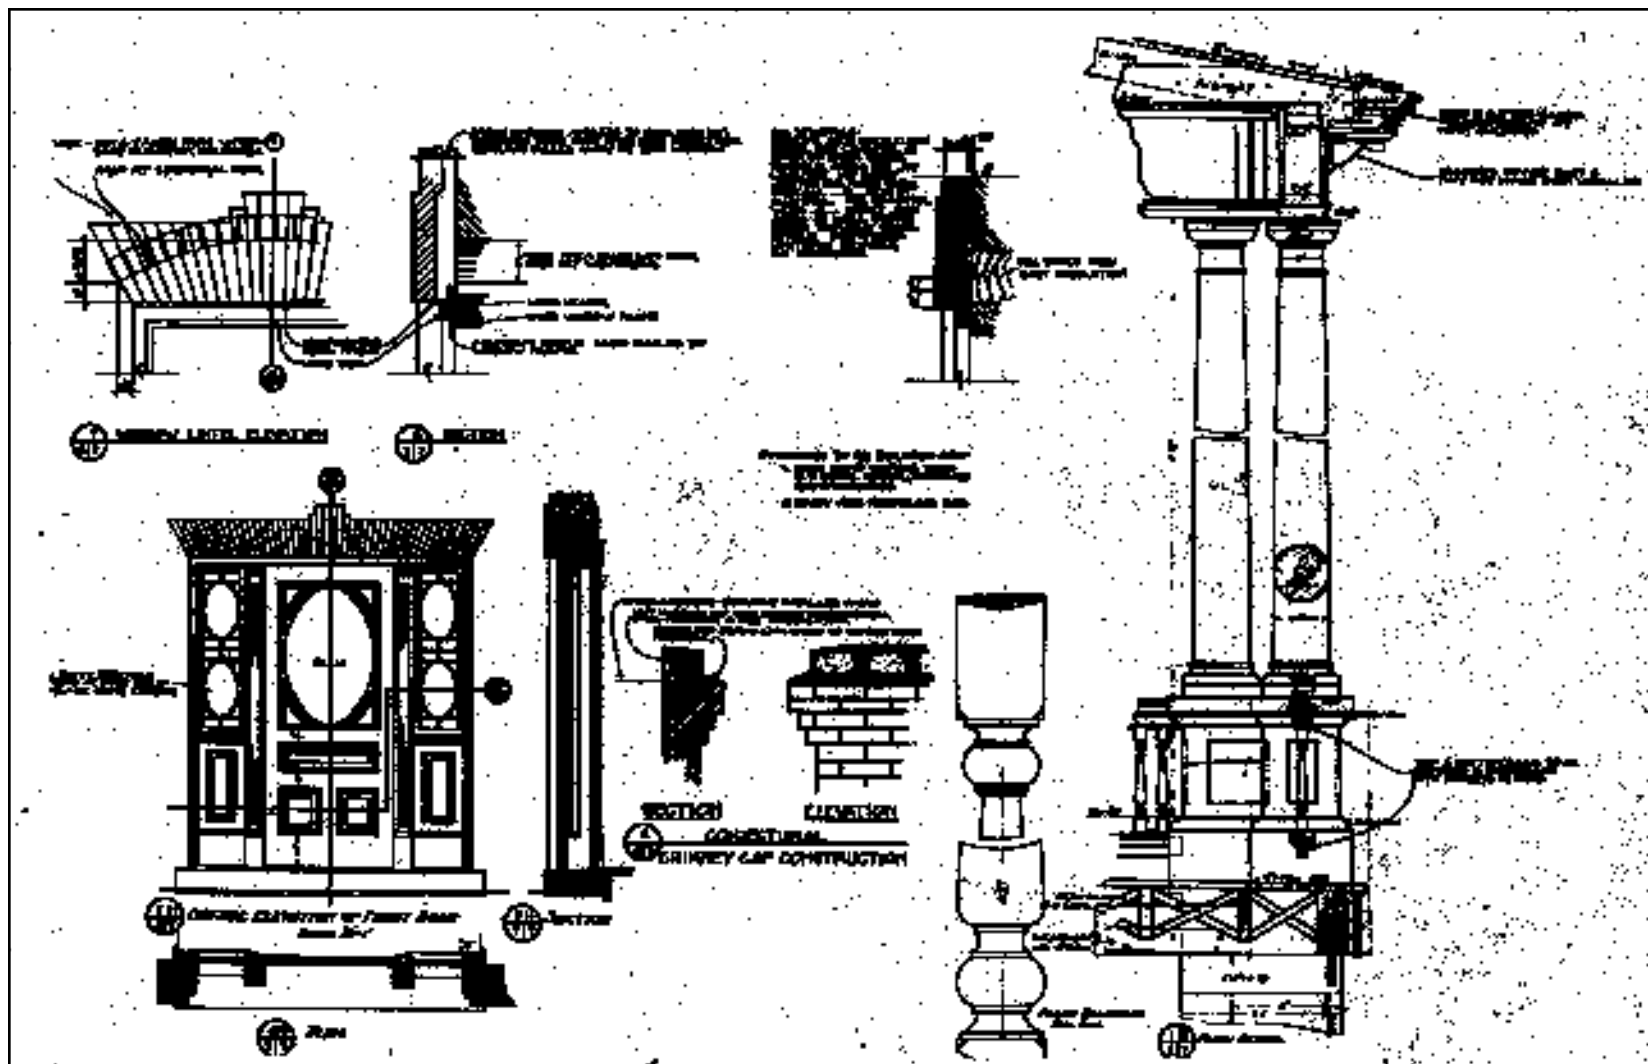
Millwork frequently defines the character of the Fort Hancock structures, such as these Officer's Row details.

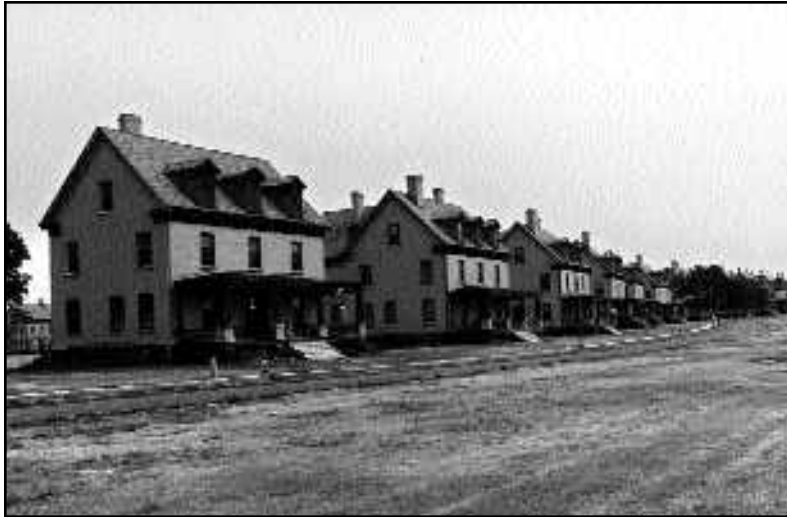
## Lieutenant, Captain and Commanding Officer's Quarters

**Constructed:** 1898-1899  
**Building Type:** Masonry  
**Gross Floor Area:** ranges from 7420SF–10,044 SF  
**Number of stories:** two stories, basement and finished attic

These Officer's Quarters exhibit some of the most developed architectural detail found at Sandy Hook, and as such, these buildings warrant special attention. The high level of design and the restrained use of classical revival detailing which characterize most of the Fort Hancock buildings are especially refined in these residences. Because they are essentially uniform in appearance, and are located side-by-side, changes that significantly alter the appearance of one building will have an adverse effect on the whole row of buildings. There should be a standardization of design for the new features that is repeated for each building whenever it is needed. Appendix A shows examples of lift designs which can be used for any building on Officer's Row. Garages should be repaired, not demolished.

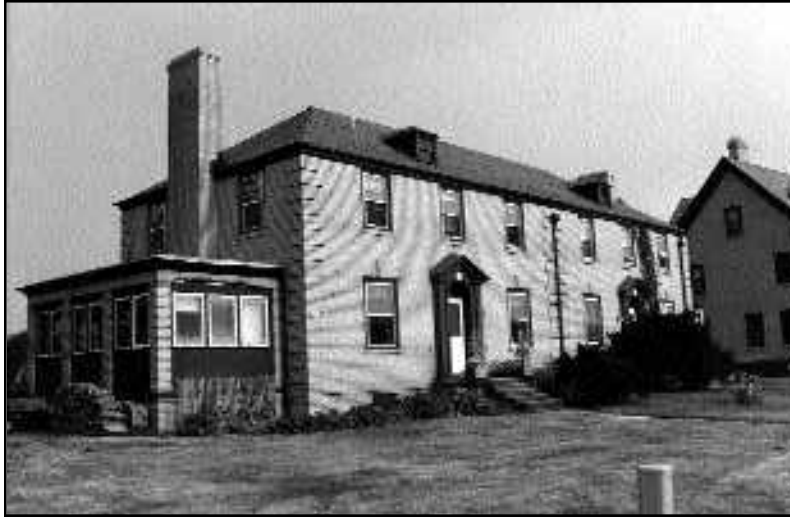
## Officer's Quarters; Buildings 21, 144 & 145

**Constructed:** 1939  
**Building Type:** Masonry  
**Gross Floor Area:** 5715 SF  
**Number of Stories:** two stories and basement

The enclosed side porches on both units are in poor condition, and use incompatible materials and design.

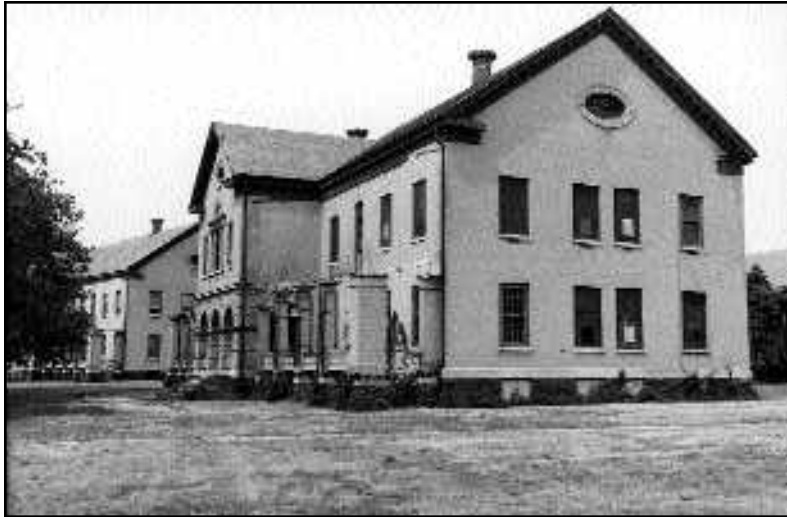
### Barracks, Buildings 23 and 24

**Constructed:** 1899  
**Building Type:** Masonry  
**Gross Floor Area:** 17,116 SF  
**Number of stories:** two story, basement and finished attic

These are exceptionally fine examples of the use of classical revival architecture for military uses, and show a greater level of finish and detail than is usually found at an army base. Particularly noteworthy is the use of terra cotta elements, used to greatest effect on the Palladian windows centered on the projecting central bay. Two sections of two-story porch framed this central bay, which unfortunately are no longer standing. The bottom story of the porches was supported by square brick columns (still standing), with simple Doric columns on the second story. The balustrades comprising the railings were cast iron.

In 1989, the two-story front porches were removed from the barracks because they posed a safety hazard. The brick piers were capped and stabilized. It is the desire of the NPS to have the porches rebuilt, based on the original drawings and on record photographs made prior to their dismantling.

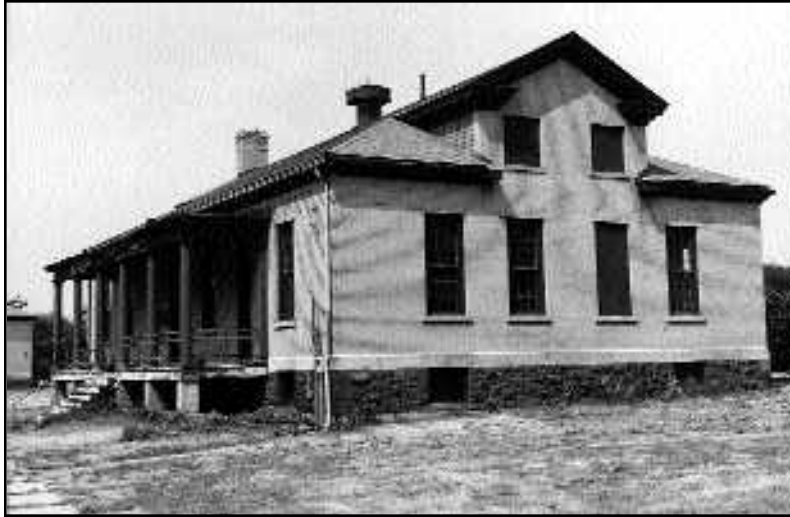
## Mess Halls, Buildings 56, 57

**Constructed:** 1905  
**Building Type:** Masonry  
**Gross Floor Area:** 6676 SF  
**Number of stories:** one story, basement and unfinished attic

The mess halls were added six years after the barracks were constructed after it was found that the mess halls and kitchens originally included within the barracks were too small. Architecturally, they pick up on the Palladian references found in the Barracks and are seamlessly integrated into the earlier building complex. Yet their scaled back detailing make it clear they are subservient structures. The spaces created between the Mess Halls and Barracks are well defined and have a comfortable human scale.

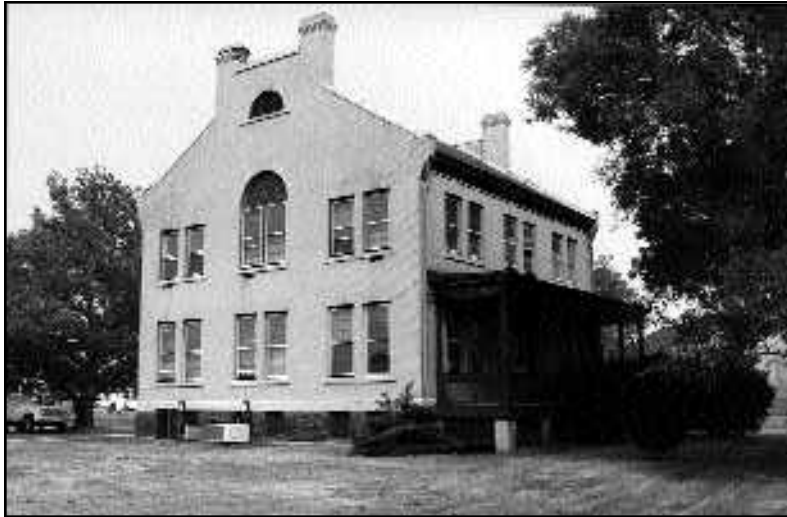
### Post Headquarters, Building 26

**Constructed:** 1899  
**Building Type:** Masonry  
**Gross Floor Area:** 5390 SF  
**Number of stories:** two stories, basement

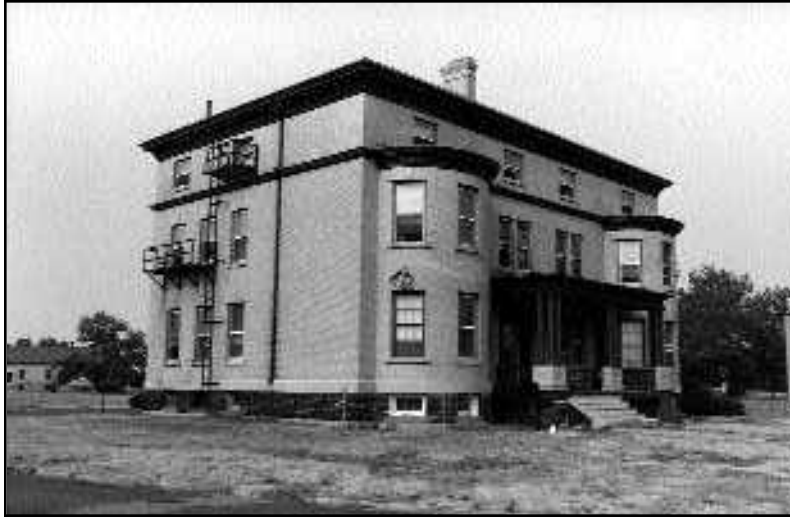
## Bachelor Officer's Quarters, Building 27

**Constructed:** 1899  
**Building Type:** Masonry  
**Gross Floor Area:** 10,303 SF  
**Number of stories:** three stories, basement

The existing metal fire escape will require repair and partial rebuilding.

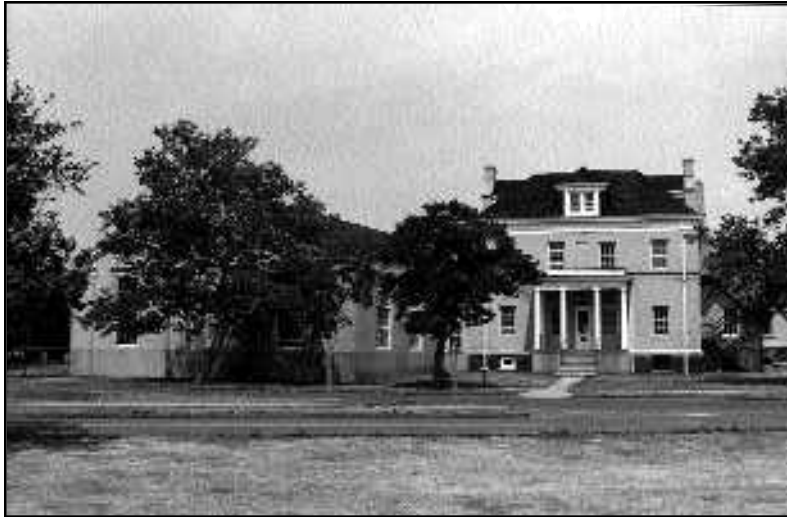
### YMCA and Gymnasium, Building 40

**Constructed:** 1901/1940  
**Building Type:** Masonry  
**Gross Floor Area:** 18,890 SF  
**Number of stories:** two stories, basement and finished attic

The existing metal fire escapes can be retained provided that repair work is performed to ensure structural stability.

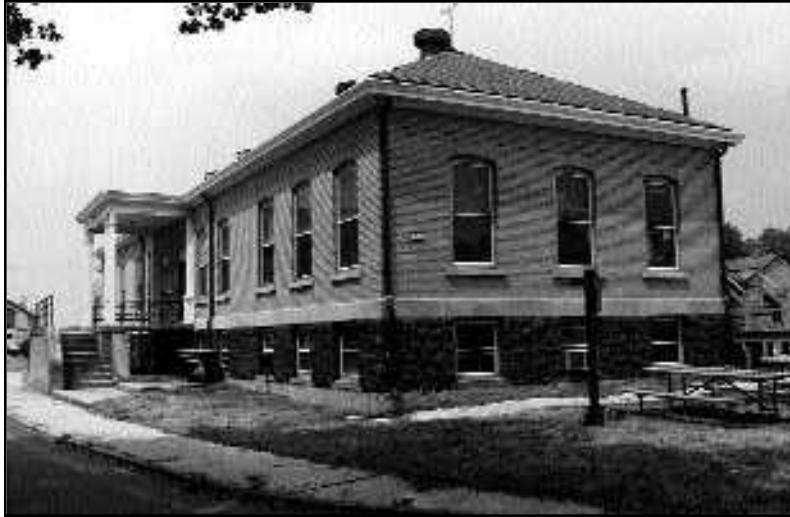
## Post Exchange, Building 53

**Constructed:** 1905-1910  
**Building Type:** Masonry  
**Gross Floor Area:** 6180 SF  
**Number of stories:** one story, basement and attic

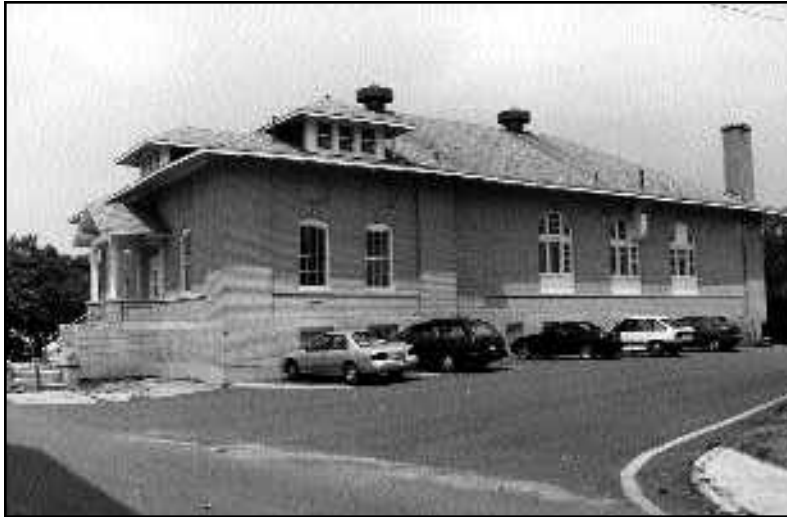
### Post Exchange/Gymnasium, Building 70

**Constructed:** 1909  
**Building Type:** Masonry  
**Gross Floor Area:** 8747 SF  
**Number of stories:** two stories, including finished basement.

Building 70 is a unique structure at Fort Hancock with a high level of architectural detail. The craftsman detailing of the wood members at the porch and roof overhangs is an unusual departure from the classical revival detailing normally found at the fort, although this building also has fine classical revival details, especially the tall, arched windows. The shed addition on the rear is non-historic. The basement level bowling alley fittings and finishes are from the 1960's, but the bowling alley function is original to the building.

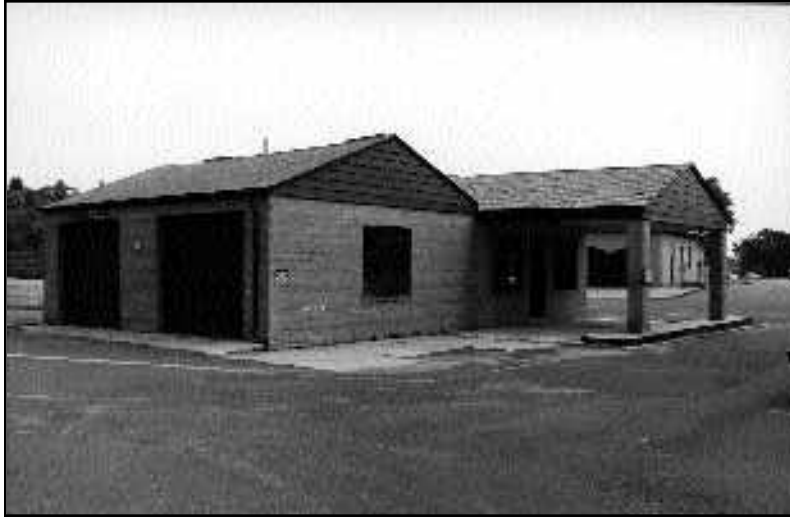
## Gas Station, Building 60

**Constructed:** 1936 and 1939  
**Building Type:** Masonry  
**Gross Floor Area:** 1325 SF  
**Number of stories:** one story

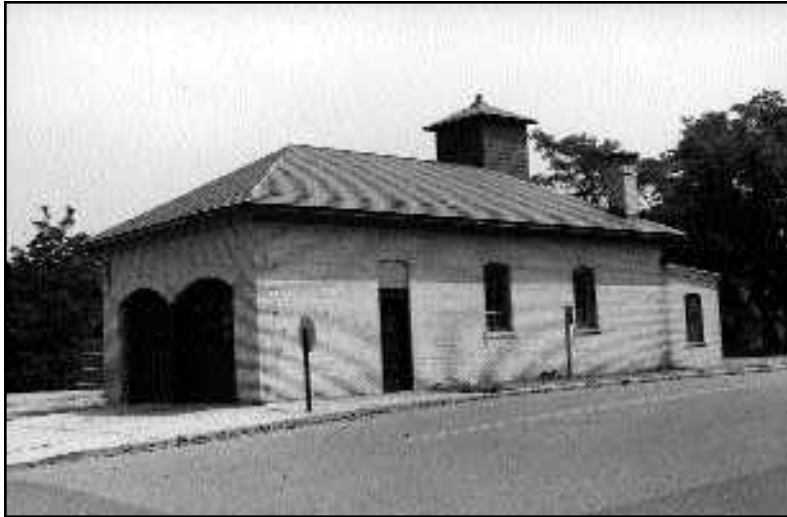
### Fire Station #2, Building 76

**Constructed:** 1910  
**Building Type:** Masonry  
**Gross Floor Area:** 1350 SF  
**Number of stories:** one story plus hose-drying tower

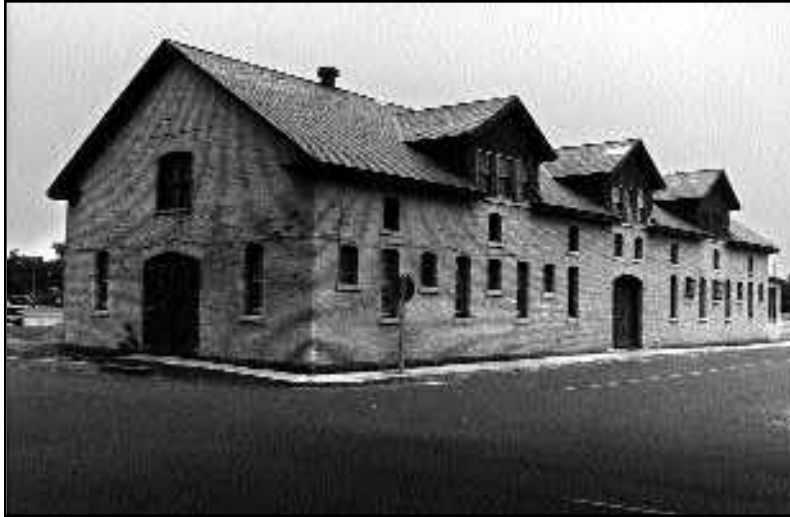
## Mule Barn, Building 36

**Constructed:** 1899  
**Building Type:** Masonry  
**Gross Floor Area:** 7629 SF  
**Number of stories:** two stories

The mule barn is highly distinctive and expresses its original function in its design. The ground floor has been modified to such an extent that most original finishes and features are missing. There are two additions to the original barn which may be removed; the east facing room is in especially bad condition due to roof failure. One of the dormer windows has been closed in, but it is desirable to open it and reinstall windows in this opening.

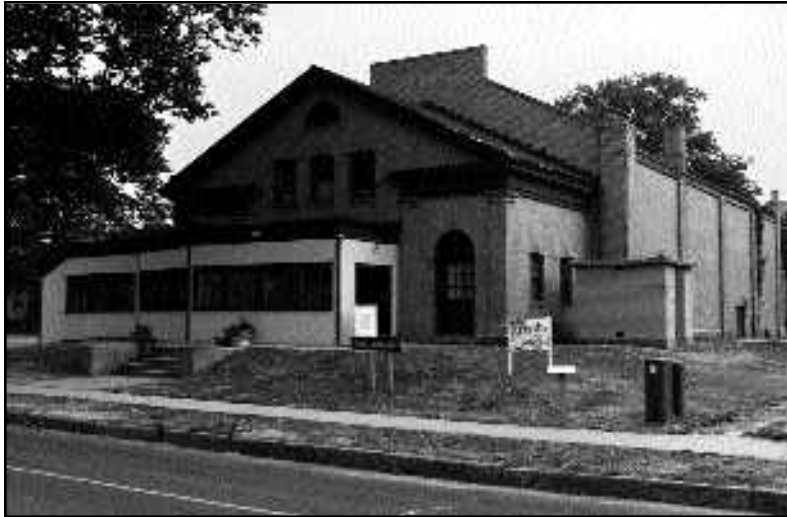
### Post Theater, Building 67

**Constructed:** 1933  
**Building Type:** Masonry  
**Gross Floor Area:** 6151 SF  
**Number of stories:** one story

The entrance marquee has been enclosed and a windblock has been created which obscures the original design. It is the NPS goal to remove the enclosure and replace it with a transparent enclosure to reveal the original marquee. The uses for this building may be expanded if an addition is added to the side or rear to create more backstage space or by reconfiguring mechanical/utility rooms backstage. Severe rust jacking has damaged the front corners of the building and needs to be corrected to prevent water infiltration. The NPS has completed a design for accessibility for this building, which creates ADA bathrooms and wheelchair spaces in the auditorium, which will be made available upon request.

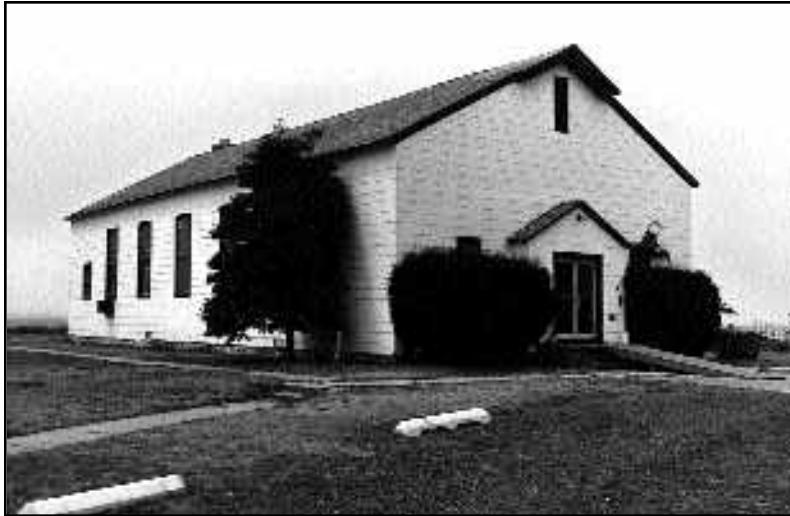
## Post Chapel, Building 35

**Constructed:** 1941  
**Building Type:** Wood Frame  
**Gross Floor Area:** 3277 SF  
**Number of stories:** one story

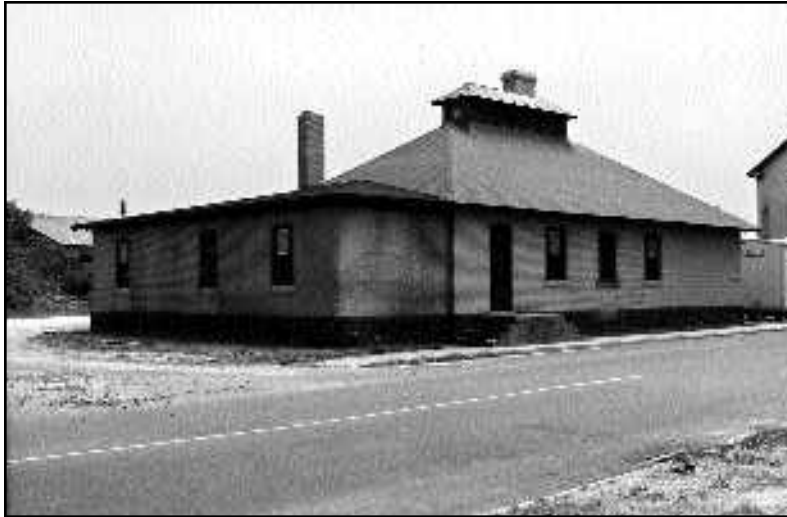
### Bakery, Building 33

**Constructed:** 1899  
**Building Type:** Masonry  
**Gross Floor Area:** 2740 SF  
**Number of stories:** one story

Portions of the original bread ovens still remain, especially the front face of the oven made of glazed brick with steel doors. Despite the deteriorated state of most of the oven, the NPS would like to see portions of the oven retained.

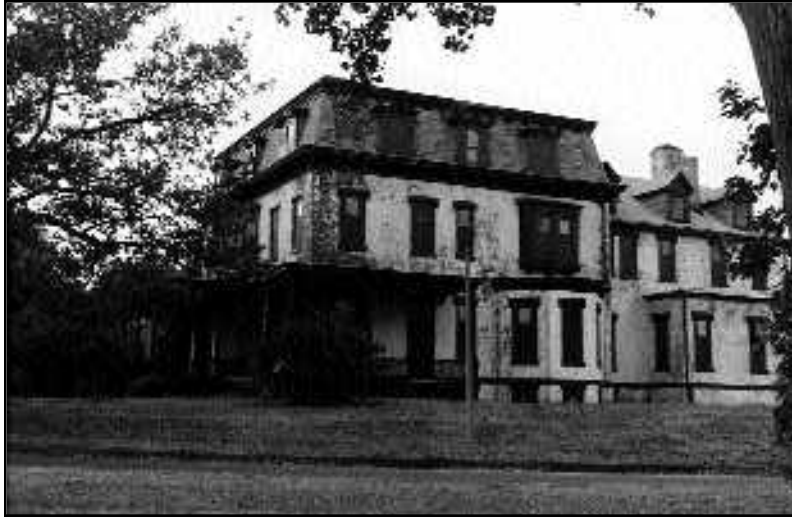
## Officer's Club, Building 114

Constructed: 1878  
 Building Type: Wood Frame  
 Gross Floor Area: 23,616 SF  
 Number of stories: three stories and basement

One of the oldest buildings on Sandy Hook, the Officer's Club also is one of the most architecturally distinct, designed in the Second Empire style. The building was originally red brick and was later painted yellow to match Fort Hancock. It is not necessary to retain the paint color; in fact, returning it to red brick would better express its original appearance. The additions on the east side include a bar and a dining room, added in the 1940's. These additions are stylistically incompatible with the building and have a negative impact on the 1870's structure. They may be removed, or replaced with new additions which are compatible with the historic building. Although the building is seriously deteriorated, every attempt should be made to retain interior character defining features; these interiors are perhaps the finest at Fort Hancock. It is desirable to reduce the amount of asphalt paving around the kitchen and west wall. Parking adjacent to the building will be limited to accessible parking and delivery functions.

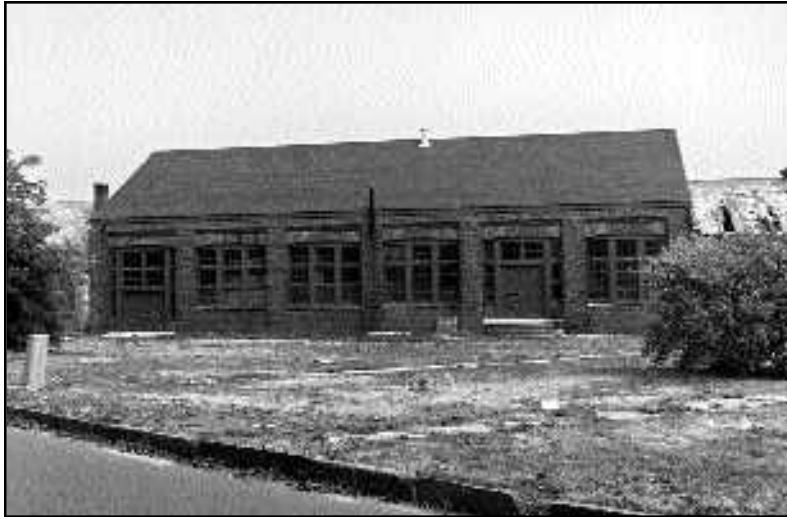
## Instruction Building/Warehouse, Building 124

**Constructed:** 1880  
**Building Type:** Masonry  
**Gross Floor Area:** 3845 SF  
**Number of stories:** one story

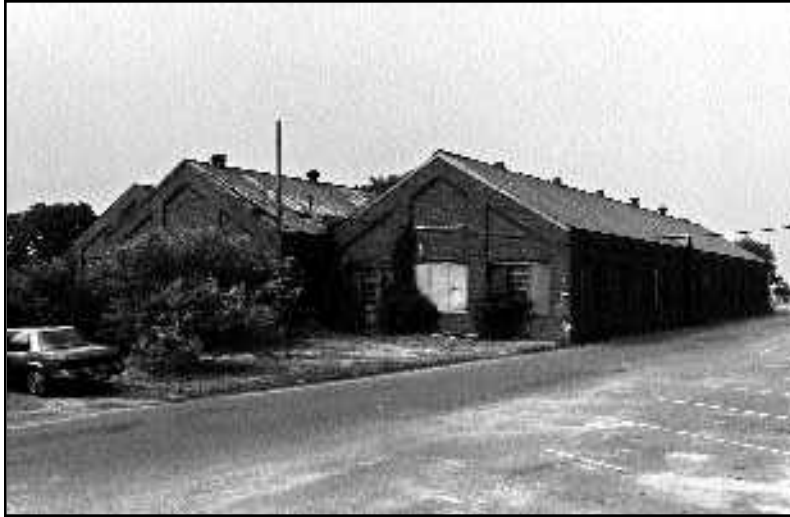
## Motor Shop, Building 125

**Constructed:** 1880  
**Building Type:** Masonry  
**Gross Floor Area:** 11,694 SF  
**Number of stories:** one story

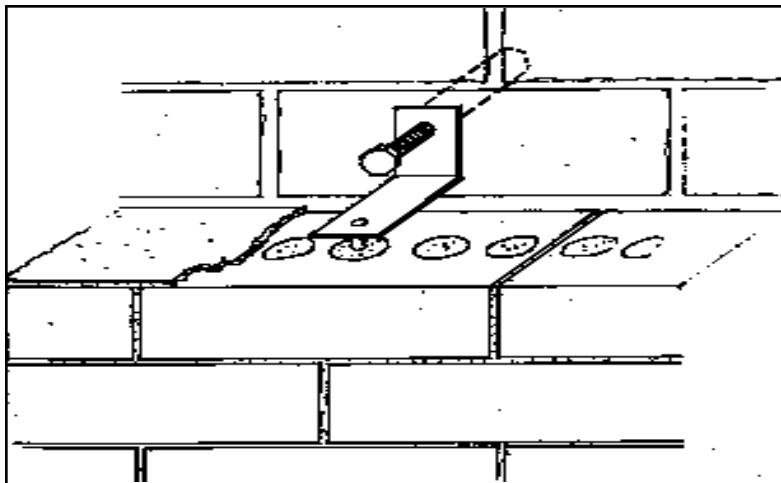
Detail of brick anchor used to repair walls at Officer's Row.

Efflorescence, or the white residue seen on the face of the brick, is evidence of mortar deterioration or salts leeching out of the mortar and brick. This problem is usually caused by water damage to the brick wall. Correcting the source of the water infiltration, either at the coping or parapet, or at a leaking roof, is frequently the first step in repairing the problem. If it is a result of the mortar washing out of the joints, repointing is the solution.

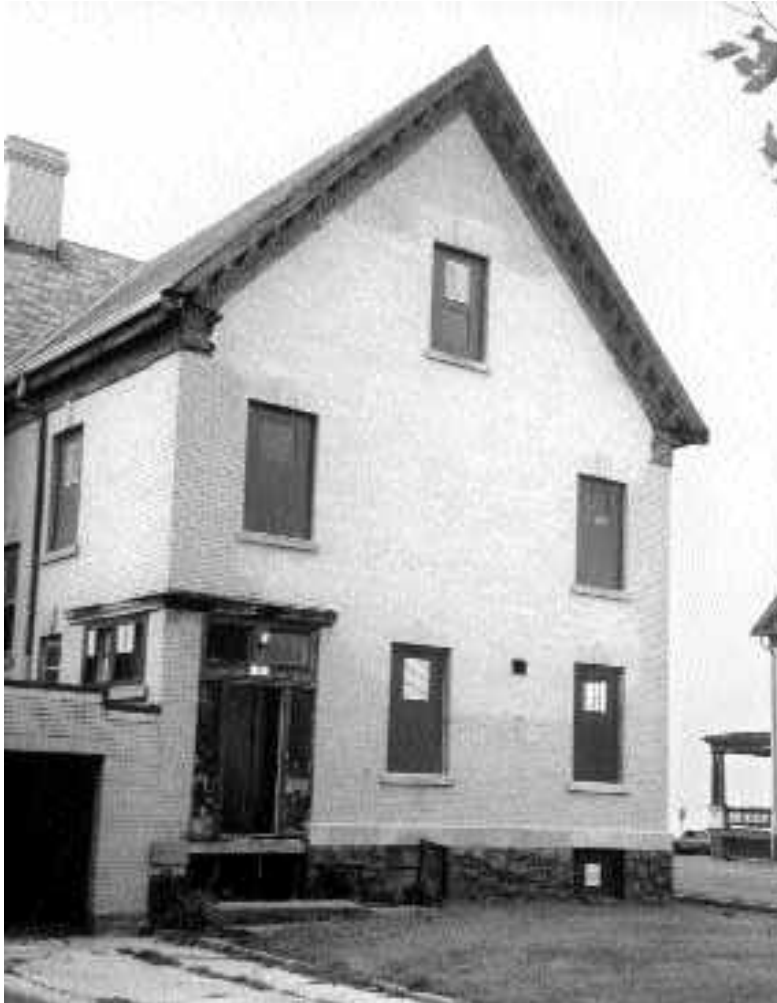
East wall of Building 10, which was rebuilt using new anchoring system, new brick and replacement steel in lintels.

Steel lintels and other structural pieces embedded in brick walls are prone to "rust jacking", a situation where water infiltrates the brick wall, and corrodes the steel. The swelling that is caused by the corrosion jacks the bricks out of alignment, which then further breaks up mortar joints and allows more water to enter the wall cavity. Where this has happened, it is often necessary to remove both the bricks and the corroded lintel. Replacement of new steel lintels is best done using stainless steel or, if that is not feasible, regular steel that has a sturdy rust-proof, water repellent coating.

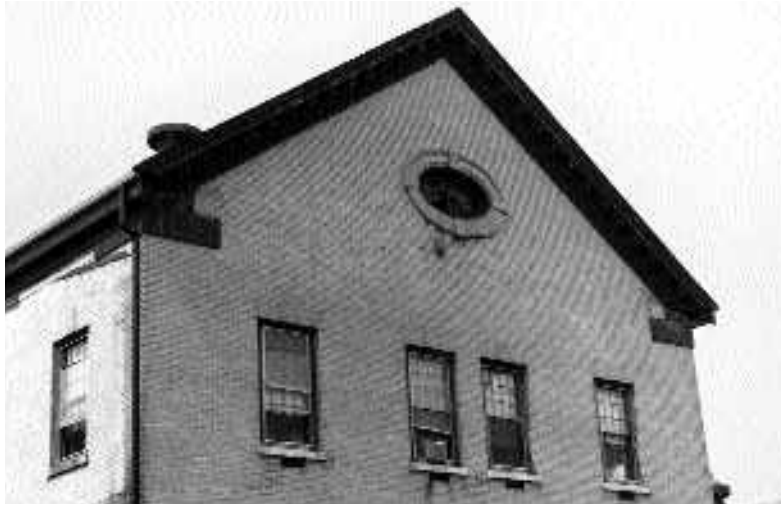
Roof rakes and gutters require attention on many Fort Hancock buildings.

Flashing materials should also match the existing materials, which in most cases are copper. This includes valley and chimney flashing. Many of the built-in gutters at roof eaves that were original to the Fort Hancock buildings have been covered over, (especially on Officer's Row and the Barracks) and surface mounted metal gutters have been added. Reconstructing the absent built-in gutter, following the original appearance, is the preferred course of action. Retaining the surface mounted gutter may be acceptable in some cases. However, installation of a new surface mounted gutter will require custom fabrication to fill the space and provide adequate drainage.

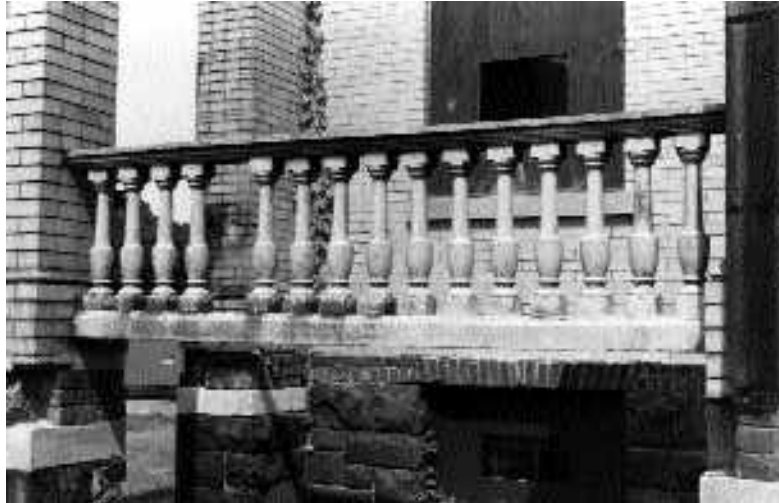
Cast iron balustrades still exist on some barracks' porches.

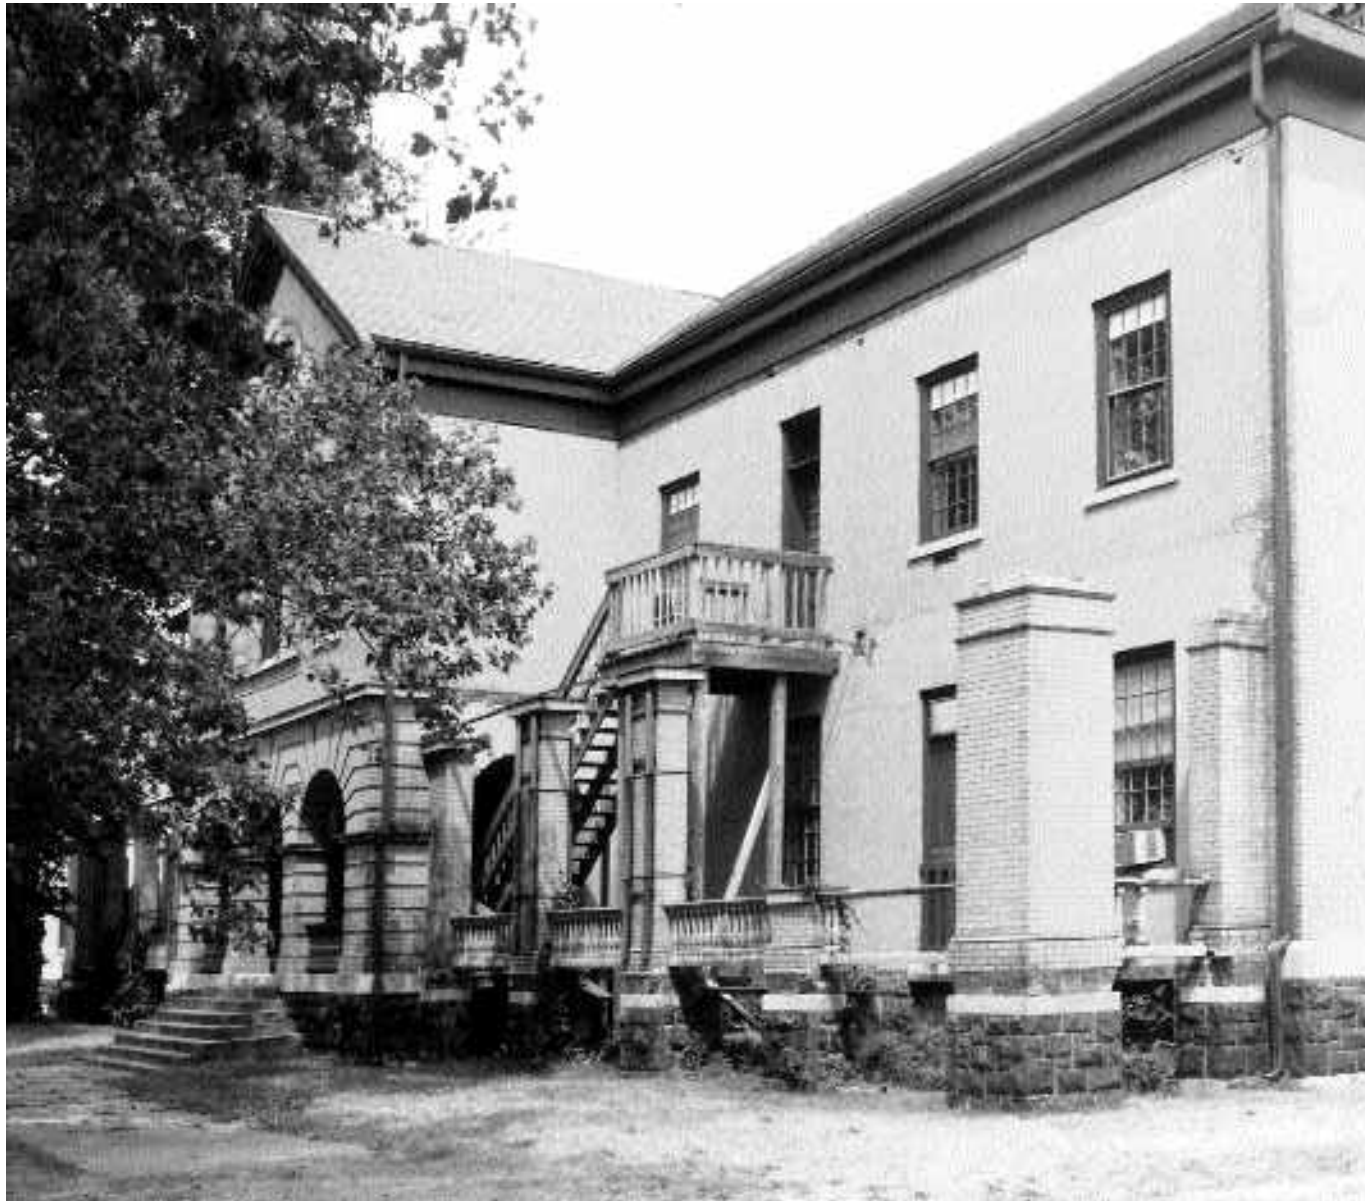
Rebuilding porches on the Barracks Buildings would not only reestablish their historical appearance but would also allow for the inconspicuous addition of secondary exit stairs.

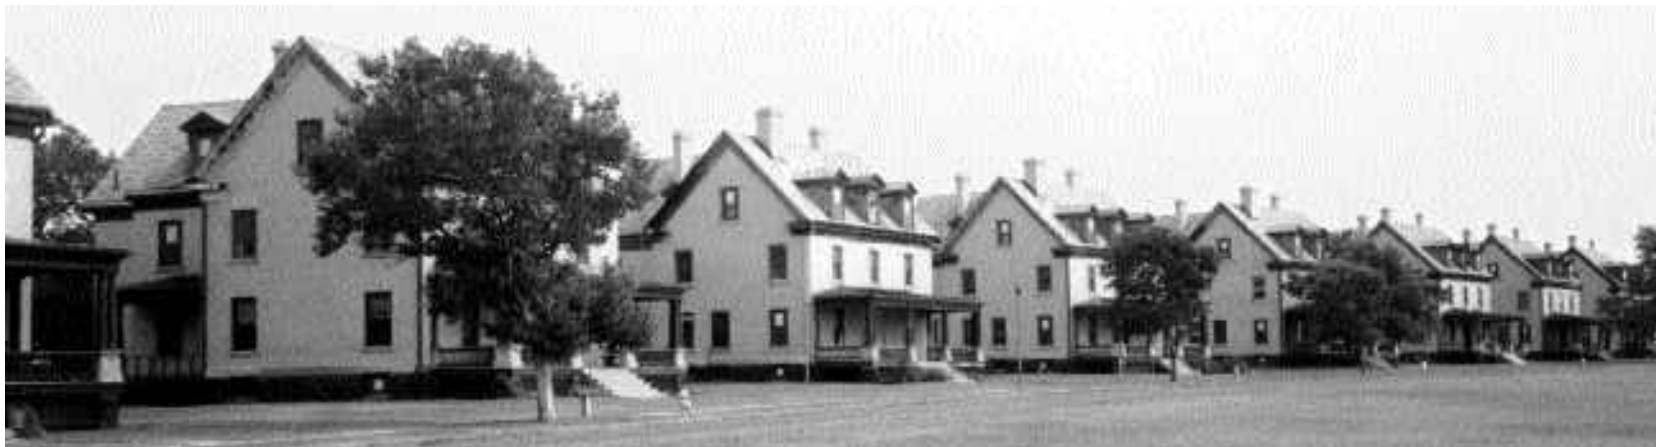
New elements added to Officer's Row buildings should not compromise the uniform character of the ensemble.

- For the Officer's Row houses, the NPS will assist the lessee(s) in developing a prototypical exterior metal stair, and will require all Officer's Row houses to use this prototype. It will be necessary to construct the stairs in the same location on each building.
- For the Barracks, reconstructing the front and back porches will provide an excellent opportunity to add an exterior stair without it being visible. Existing exterior doors at the second floor already exist can be used for the purpose of providing emergency egress.
- For buildings which are not facing the Parade Ground, exterior exit stairs should be located on a secondary building elevation, in such a way as to be inconspicuous from the main public areas of Fort Hancock.

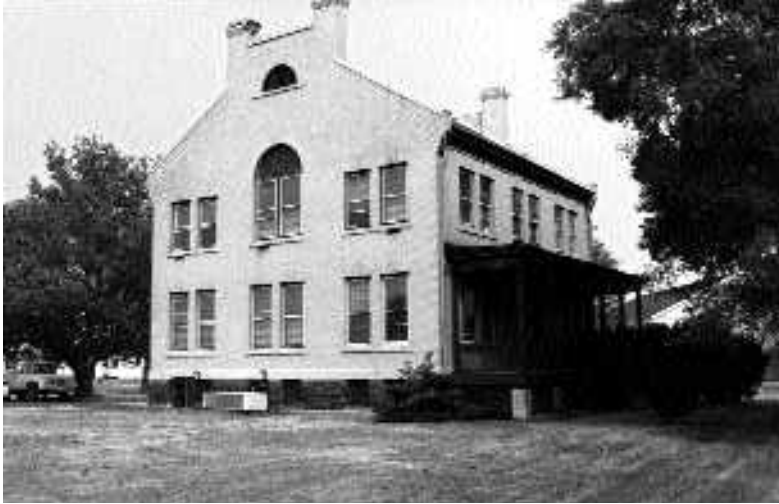
Mechanical equipment is barely visible when placed close to the building foundation.

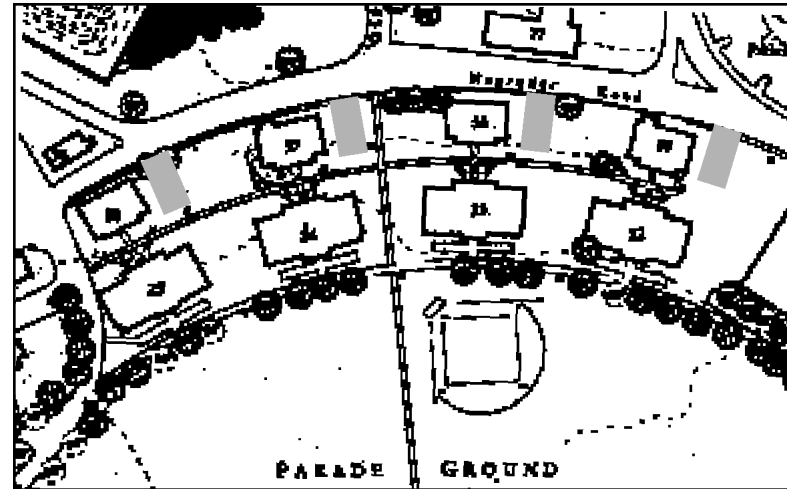
Locations for small, three to four car parking lots next to the Mess Halls is indicated with grey shading

There are three small "quadrangles" between each Barracks and Mess Hall grouping that are important secondary spaces in the landscape. Each of these three spaces may accommodate a small parking lot for up to four parking spaces, for a total of twelve spaces. These parking lots should be located perpendicular to Magruder Road, placed close to the side of the Mess Hall so as to be hidden from view from the Parade Ground, thereby maintaining unimpaired views into the Parade

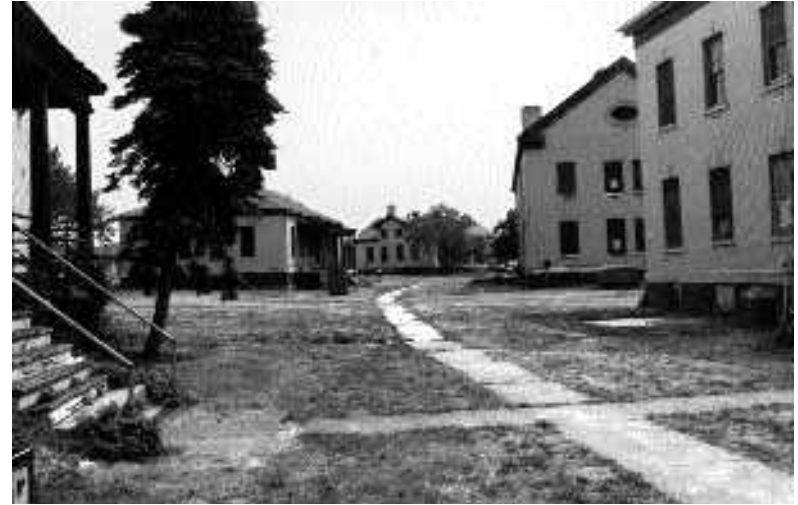
The existing layout of sidewalks will be retained.

Existing sidewalk materials present on site should be preserved, and where severely deteriorated, should be replaced “in-kind.” No effort should be made to alter existing materials in order to effect a more “historical looking” appearance or to create a more pleasing result. For instance, the replacement of existing concrete sidewalks with brick or stone is unwarranted. Where brick and stone pavements or stone curbs do survive in association with any given leased building, these surfaces should be retained. Curb cuts will be needed to allow compliance with ADA in some cases and these will be reviewed by the Park in advance.

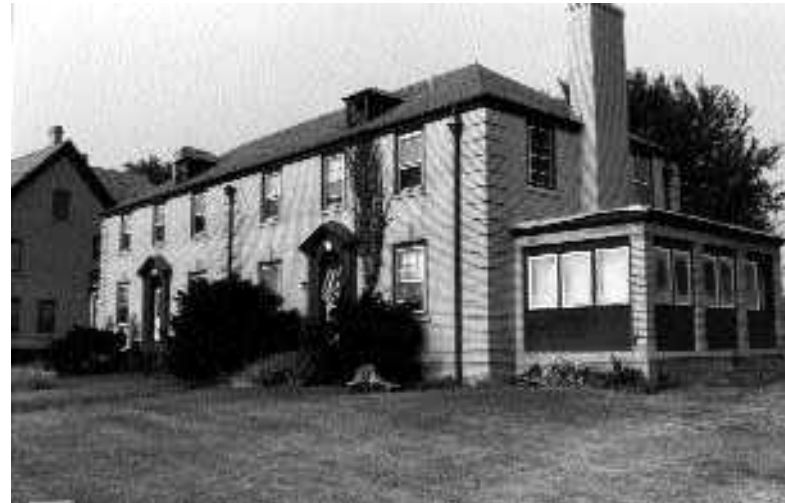
Foundation plantings, as seen at Building 21.

Decorative foundation plantings are only historically appropriate when installed next to buildings which historically served residential, recreational, civic or administrative functions. Examples of such buildings include the Chapel, Theater, Headquarters, Barracks and Officer’s Quarters buildings. In keeping with photographic evidence from the historical period, a measure of planting variety from building to building appears to be appropriate. The close relationship of the planting material to the foundation of the building, seems to be a consistent trait, with the planting envelope extending no farther than four feet from any exterior wall. In order to maintain the historic landscape appearance free floating “island” flower beds or shrub massings be not be permitted at all. Lessees may design and periodically alter both herbaceous and shrub foundation plantings based on a palette of appropriate plants to be specified by the NPS.
