# Merced Wild and Scenic River Values Draft Baseline Conditions Report

April 2011

Prepared by ESA for the  
National Park Service, Yosemite National Park

# **DRAFT MERCED WILD AND SCENIC RIVER OUTSTANDINGLY REMARKABLE VALUES RIVER VALUES BASELINE CONDITIONS REPORT**

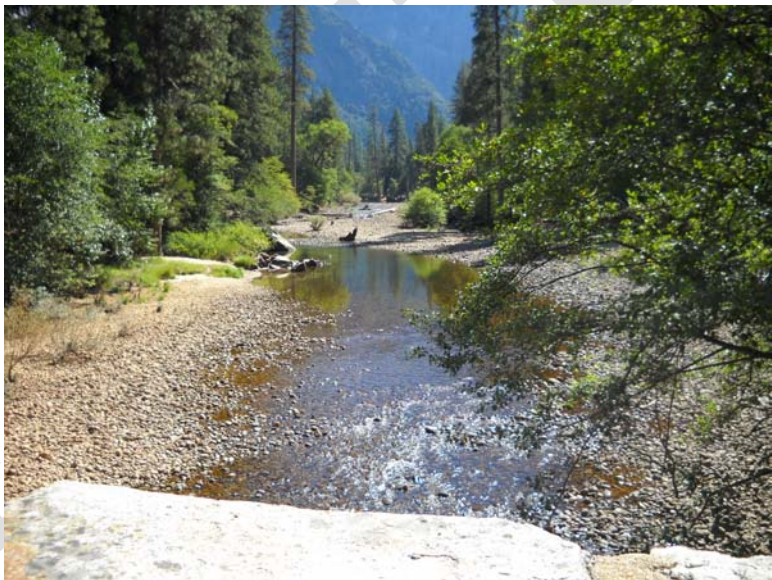
**Photo 2.1-3:** Riparian Habitat

**Riparian Ecosystems.** Riparian zones extend outward from the banks of the Merced River and its tributaries into adjacent meadow and forest communities (Photo 2.1-3). Riparian habitat plays a critical role in a variety of dynamic processes. Situated at the interface between terrestrial and aquatic ecosystems, the riparian zone acts to buffer hydrologic and erosional cycles, control and regulate the biogeochemical cycles of nitrogen and other key nutrients, limit fire movements, and create unique microclimates for animal species (Rundel and Stuner 1998).

Riparian habitat in Yosemite Valley is characterized by broadleaf deciduous trees such as white alder (*Alnus rhombifolia*), black cottonwood (*Populus balsamifera* ssp. *trichocarpa*), and willow species. Such areas provide a structural complexity that supports rich species diversity. Within riparian zones, vegetation is regularly disturbed through the deposition and removal of sediment and soil and the scouring force of floodwaters. As a result of these natural forces, riparian plants readily colonize newly formed riverine deposits. The distribution of riparian communities varies with soil saturation and frequency of disturbance. For example, big-leaf maple riparian forests grow in protected spots on moist, gravelly, alluvial soils bordering streams, whereas sandbar willow woodlands flourish on point and mid-channel bars that are inundated annually by spring floods (NPS 1994).

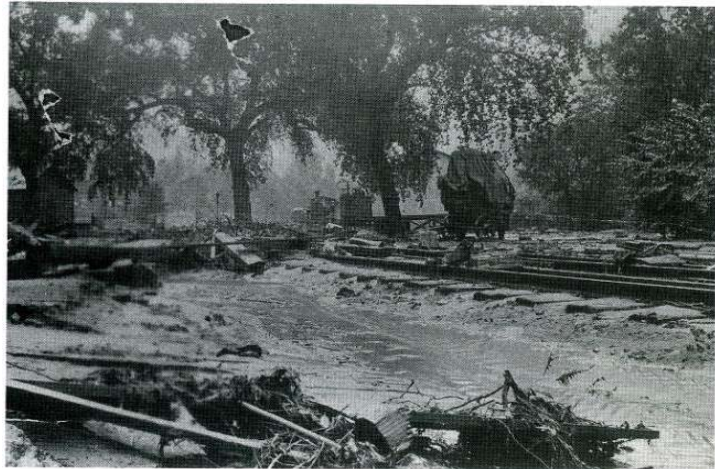
Looking east at the results of the August 13, 1913 cloudburst and flood from the vicinity of the present Standard Oil Co. plant in El Portal.  
*Jim Law collection*

Another impact on the valley oak population at the time of designation was the loss of overbank flooding in the El Portal floodplain (see **Photo 2.1-6**). Construction of the Yosemite Valley Railroad terminus in El Portal and the El Portal Road (Highway 140), and subsequent road repairs after regular flood events, effectively blocked flooding throughout the population, except during very large flood events. Flooding rejuvenates riparian systems, creating a dynamic system and depositing nutrients. Prior to this construction, and long before designation of the river, the valley oak population likely had a robust understory, with flooding typically occurring every one to five years (Howard 1992).

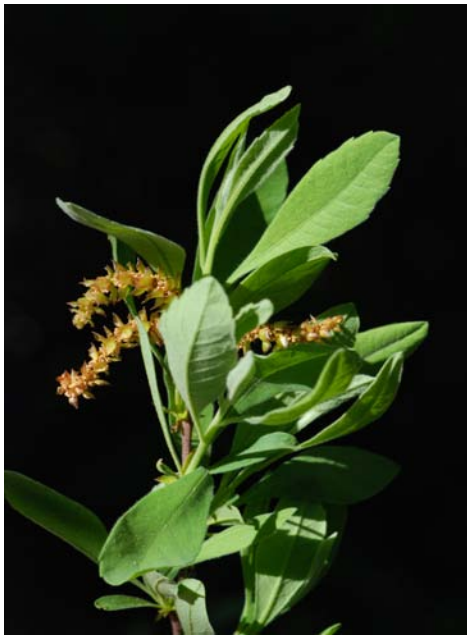
**Photo 2.1-7:** Sierra Sweet Bay Female Plant

Sierra sweet bay is a deciduous shrub with male and female flowers occurring on separate plants (**Photo 2.1-7**). The species ranges in height from approximately 3 to 6 feet and typically blooms from May to June. Sierra sweet bay is usually found on streambanks in pine forests or riparian habitat. Most sources characterize Sierra sweet bay as a plant that can grow in wetlands but is not restricted to them, although it prefers relatively moist environments (Calflora 2010; USDA 2010). The species has not been formally listed as rare, threatened, or endangered by the federal or state government, but is listed by the California Native Plant Society (2010) as a plant of limited distribution whose populations are not known to be under immediate threat (CNPS List 4.3). Sierra sweet bay is also listed as a sensitive species in Yosemite National Park (NPS 2002).

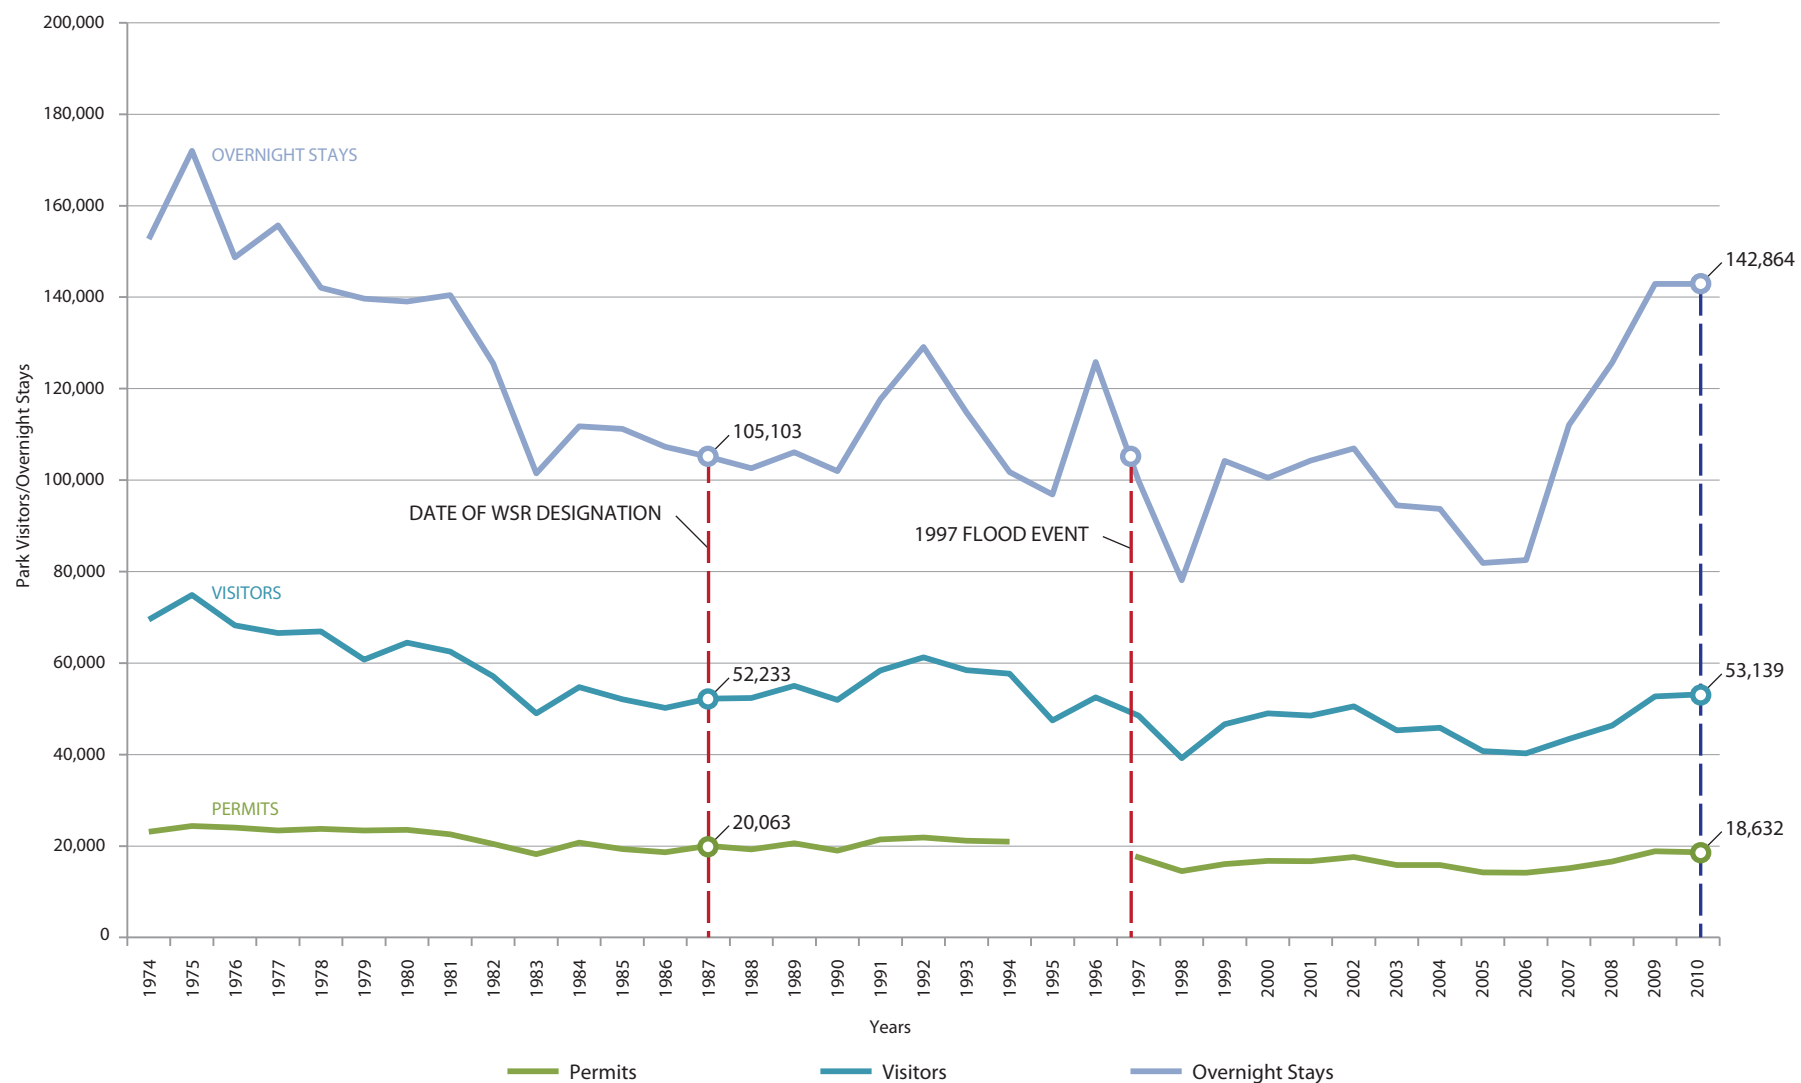
# Yosemite Wilderness Permits, Visitation and Overnight Use (1974-2010)

NOTE: Visitation counts do not include day use visitors to the Yosemite backcountry.  
No permit data available for 1995 and 1996.

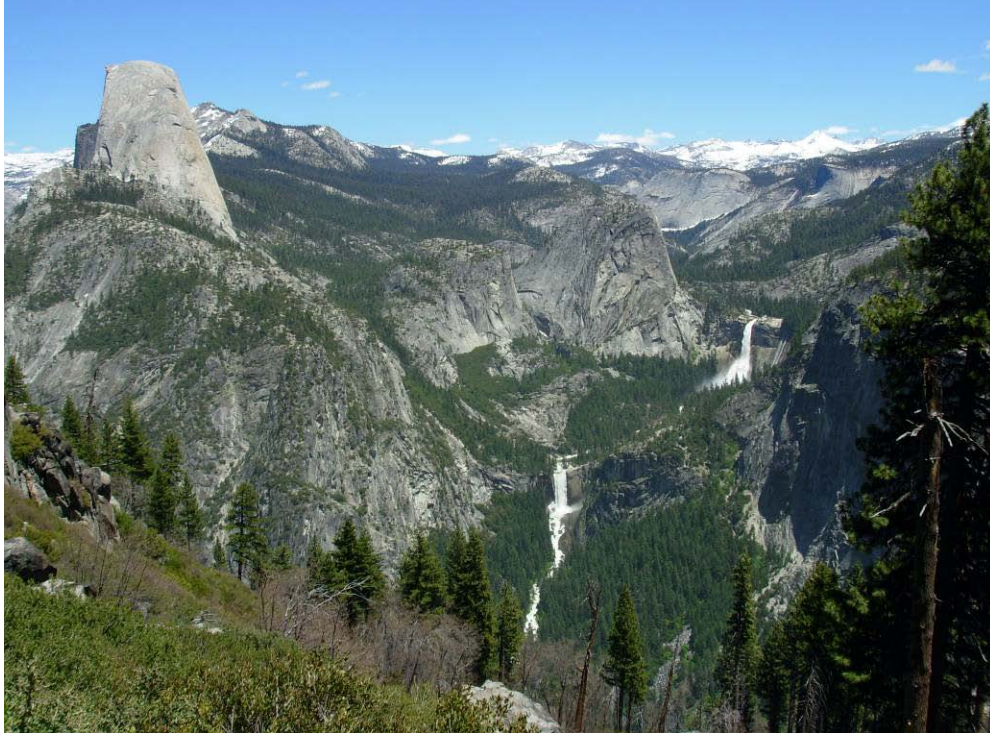
**Figure 2.3-6**  
The Giant Staircase along the Merced River

*The Giant Staircase.* The Giant Staircase, which includes Vernal and Nevada Falls, is one of the finest examples of stair-step river morphology in the country (**Figure 2.3-6**). The abrupt elevation changes of this feature illustrate the variability of the Merced River's hydrology. The Giant Staircase is a large-scale geologic feature created by the combined actions of past glaciers and local differences in the resistance of the underlying granite rock to erosion. The ORV element had not been perceptibly modified (e.g., alteration of topography via quarrying or blasting) at the time of designation.

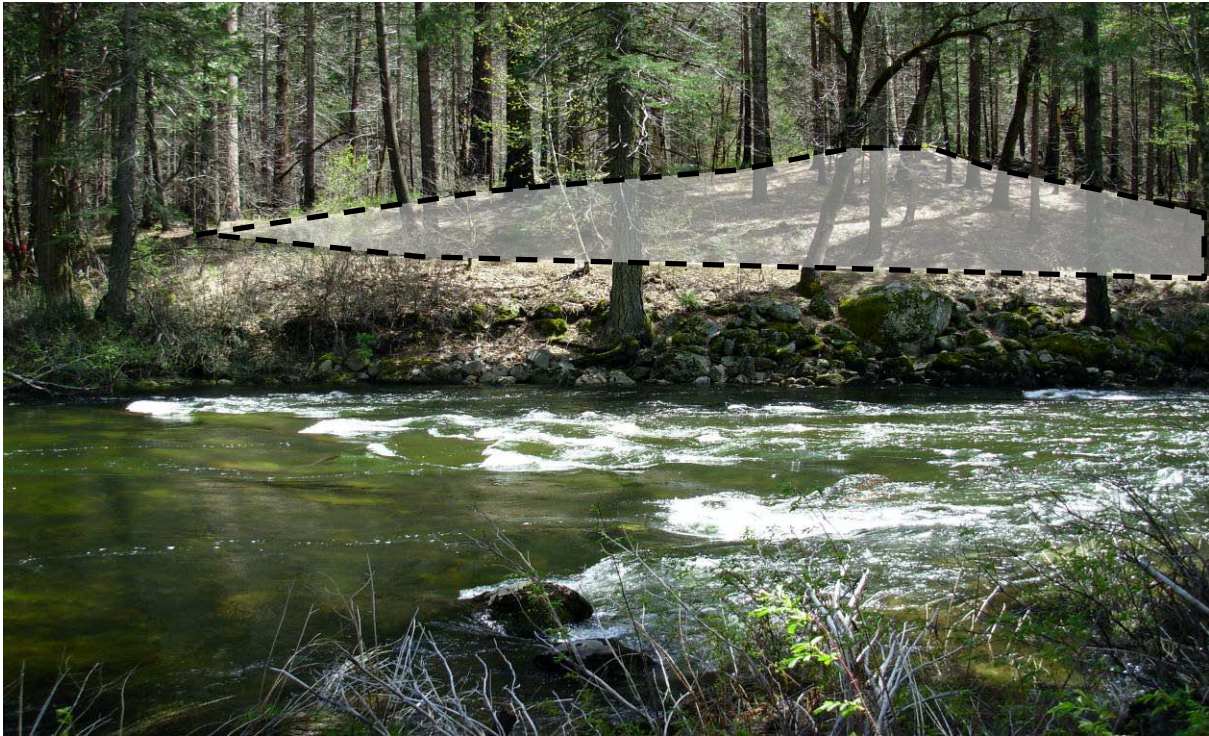
**Figure 2.3-7**  
The El Capitan Recessional Moraine

*El Capitan Recessional Moraine.* The El Capitan moraine, located in the west Valley, is a textbook example of a recessional moraine (**Figure 2.3-7**). At the time of designation, this ORV element had been slightly modified. In 1879, a guardian of the valley (Galen Clark) blasted large boulders where the Merced River crosses the moraine, thereby lowering its original elevation by 4 to 5 feet along the river corridor (Milestone 1978). In addition, a barrow pit was dug near the northwest side of the moraine, but not into the moraine itself (Yochim 2010). As discussed above, the blasting had notable

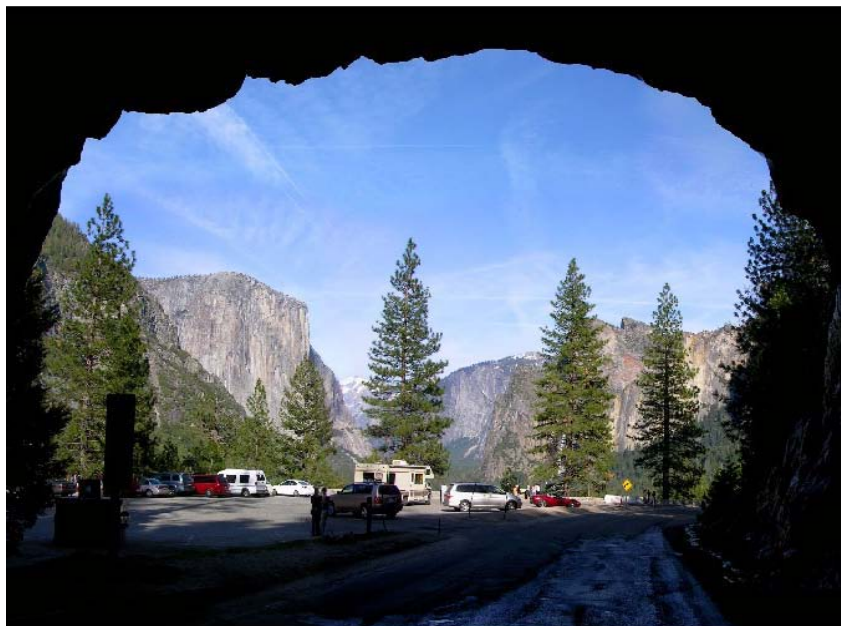
**Photo 2.4-10.** Wawona Road Tunnel View (Prior to the Tunnel View Rehabilitation Project) – undated (NPS 2009c)

The Tunnel View Rehabilitation Project, completed in 2008, restored views of Yosemite Valley, including El Capitan, Bridalveil Fall, and Half Dome, which were obscured by over time by trees and brush (see Photos 2.4-10 and 2.4-11).
