Environmental Health Survey Report

NPS Owned Wilsonia Cabins

2007 Environmental Health Survey Report

NPS Owned Linzmeier Cabin - Wilsonia

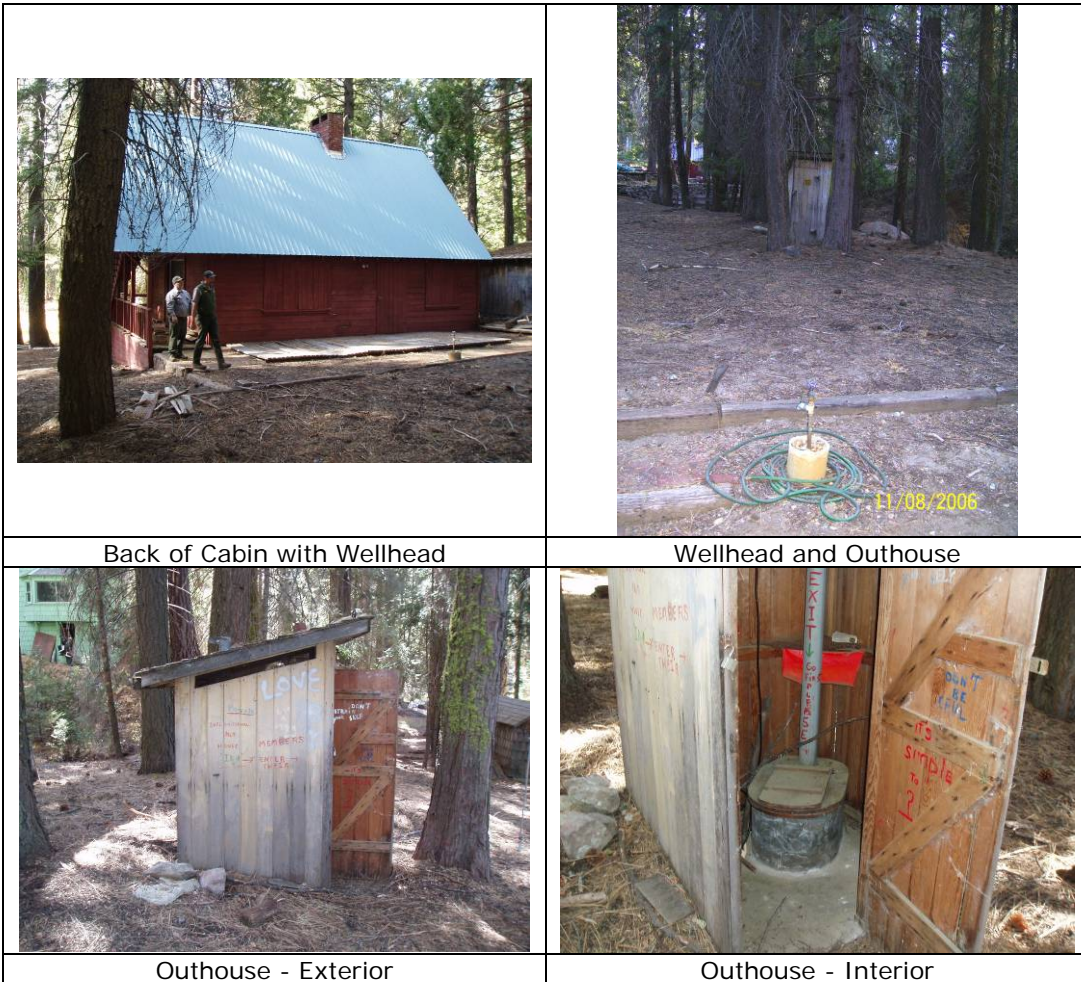
The well could not be located with certainty, but all indications point to the hose bibb in the backyard, 15' from the cabin foundation. This well has no sanitary seal and is located 20' downslope of the outhouse. This source is classified as ground water under the direct influence of surface water (GWUDI) and will require filtration along with disinfection to meet potability.

This property can not meet onsite waste disposal requirements and thus should not be used. Additionally, this property needs a hazmat survey because of the pesticides, chemicals and asbestos wiring noted during the inspection. The outhouse structure could be saved, but it must be made non-functional.

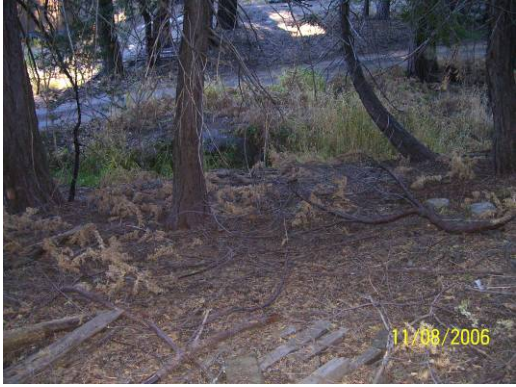
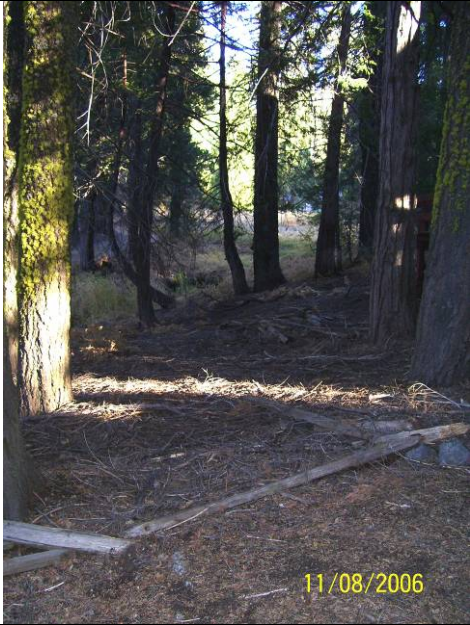
The waste system tank could not be located either visually or by smoke testing. The Disposal area appears to be located in the front yard. The north end of the area is only 13' from surface water. During this very dry time, there was still water flowing.

Edge of Leechfield with Creek	Leechfield looking toward creek

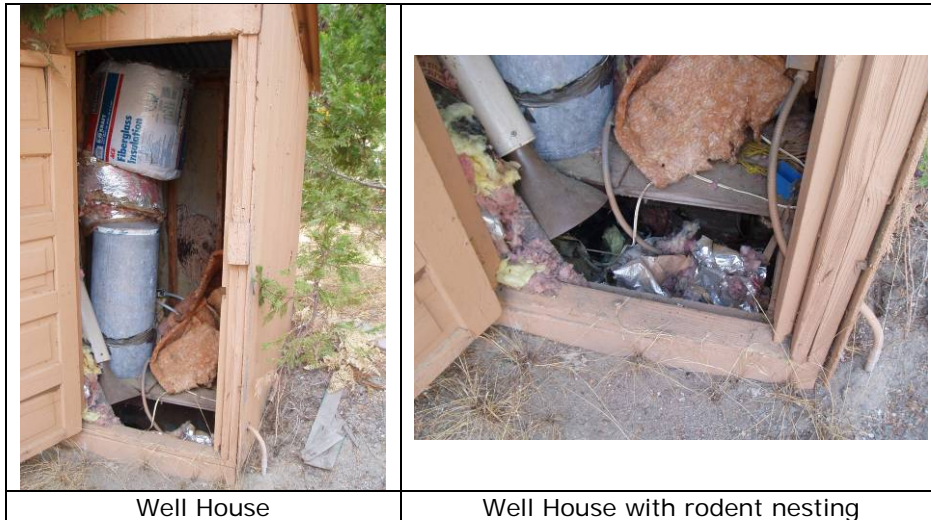
The well has no sanitary seal and is located 20' downslope of the disposal area for the neighboring property. This source is classified as ground water under the direct influence of surface water (GWUDI) and will require filtration along with disinfection to meet potability.

This property can not meet onsite waste disposal requirements and should not be used. At a minimum, the septic tank needs to be pumped, clothes washer water line reconnected and the overflow lines disconnected. The well house needs to be clean and protected from contamination from rodents and hazardous materials. Additionally, the property needs to be cleaned to prevent hazardous materials from entering into the meadow and creek.

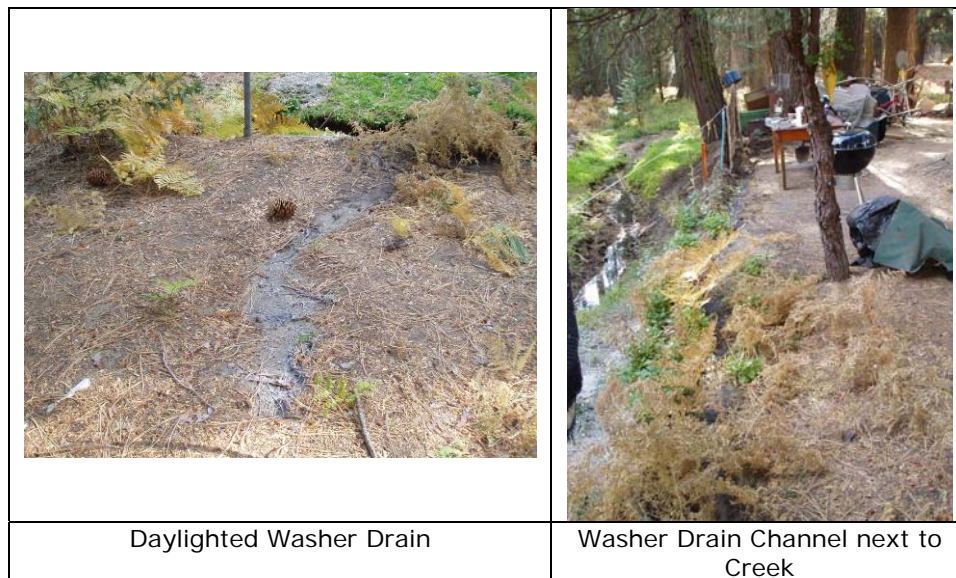
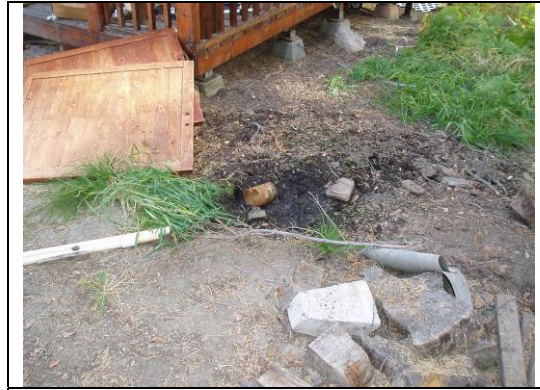
The septic tank is backing up. The occupants have installed overflow pipes on the tank to allow blackwater to flow on the surface toward the disposal area. The Disposal area is located within 50' of the creek. Additionally the occupants have disconnected the waste line from their washer and plumbed the line to daylight next to the creek.

Overflowing Septic Tank

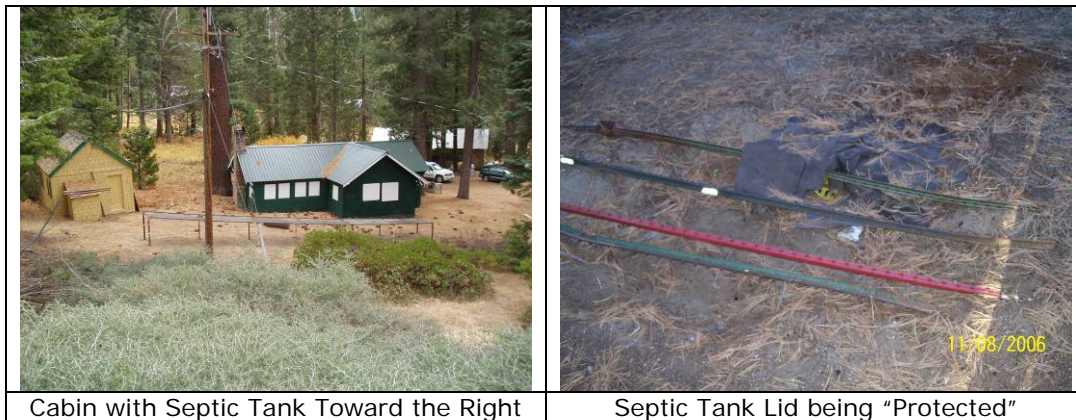
The waste system tank appears to be located toward the south end of the lot. A depression with moist soil and rotten timbers was located in a likely area for a waste tank. This is the tank that an NPS DNR employee broke through the lid and was injured several years ago. The Disposal area appears to be located towards the end of the lot.

This property can not meet onsite waste disposal requirements and should not be used. At a minimum, the septic tank opening should be secured to prevent collapse.

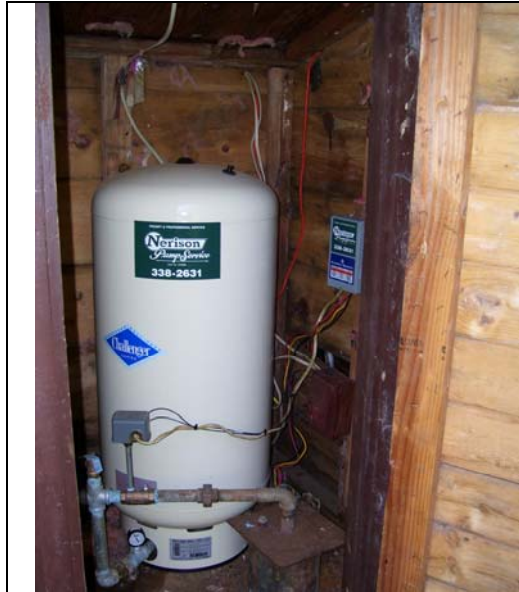
The well is located on the northwest back corner of the house. This well appears to have a sanitary seal and is located approximately 39' north of the septic tank and 18' east of the disposal area. There are no accessible records for this well, but talking with Nerison Pump Service, Squaw Valley, CA; The well is estimated at 40'-60'.

Wellhead

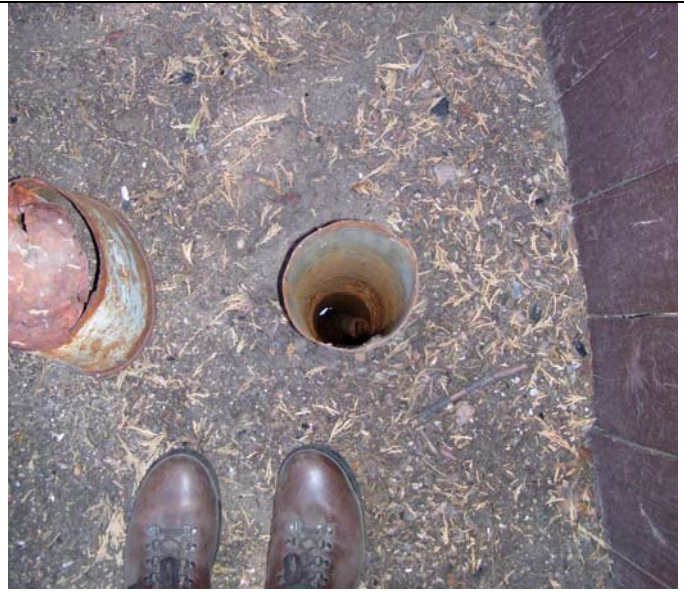
There appears to be a water valve located on the south side of the cabin which appears to control the water supply to the neighboring cabin.

Water Valve South side of Cabin

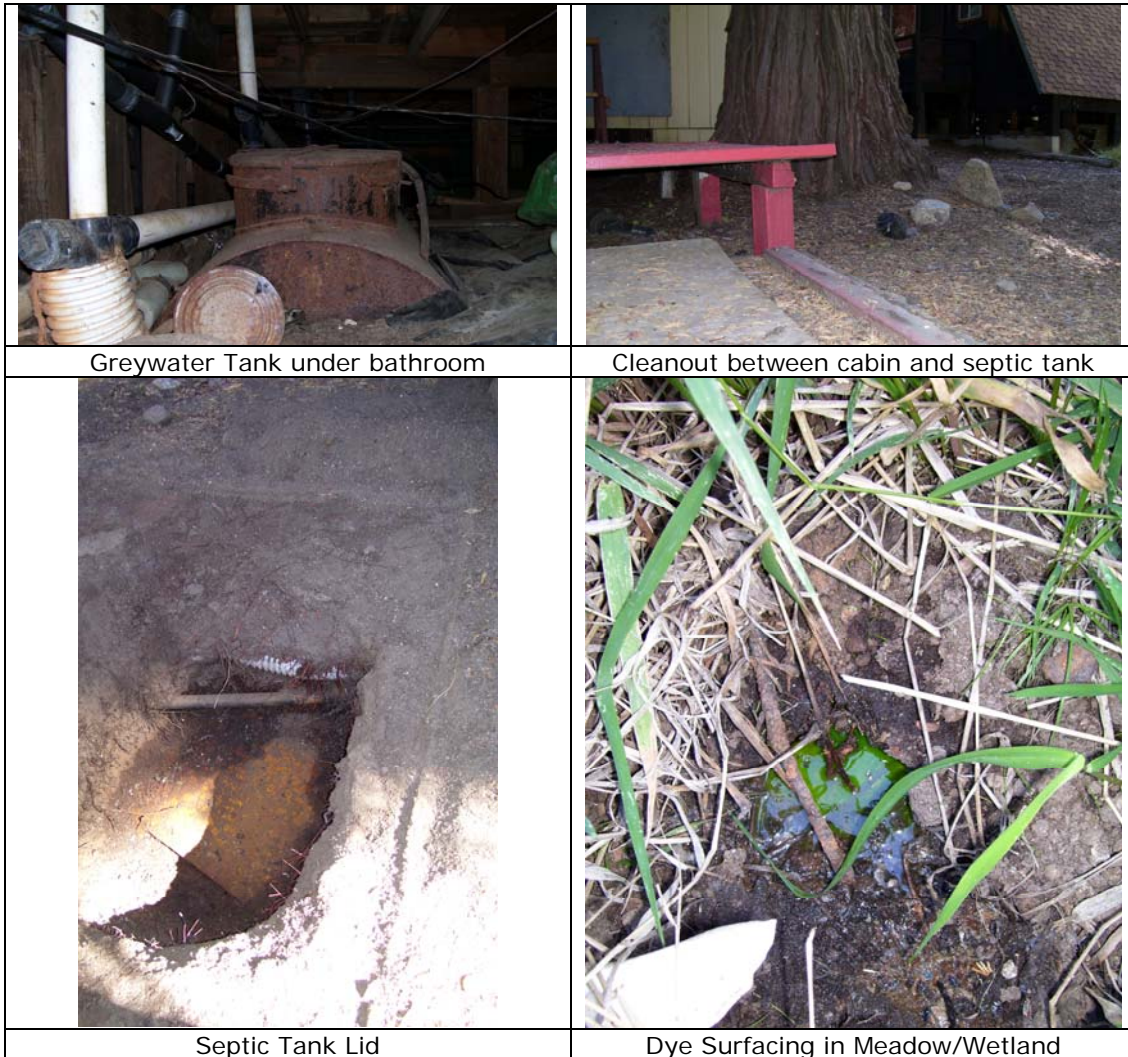
The greywater tank is located under the bathroom handling sink waste. This greywater tank is not plumbed into the septic tank but is plumbed out into the meadow. The septic tank appears to be a single chamber steel tank covered with a plywood cover. The disposal area was located in the meadow by placing fluorescent dye tablets in the kitchen sink and finding dye in the meadow within 5 minutes.

This property has a failed septic system and can not meet onsite waste disposal requirements because of 1) lot size, 2) minimum separation distance between the domestic well and the disposal area and 3) disposal area located in a meadow/wetland.

I recommend that use of this cabin should cease as soon as possible, at which time the septic and greywater tanks should be pumped empty and secured. Alternative means for sewage disposal and domestic water supply should be sought prior to the cabin being again occupied.
