Summary

Wilonia Fire Safe Project

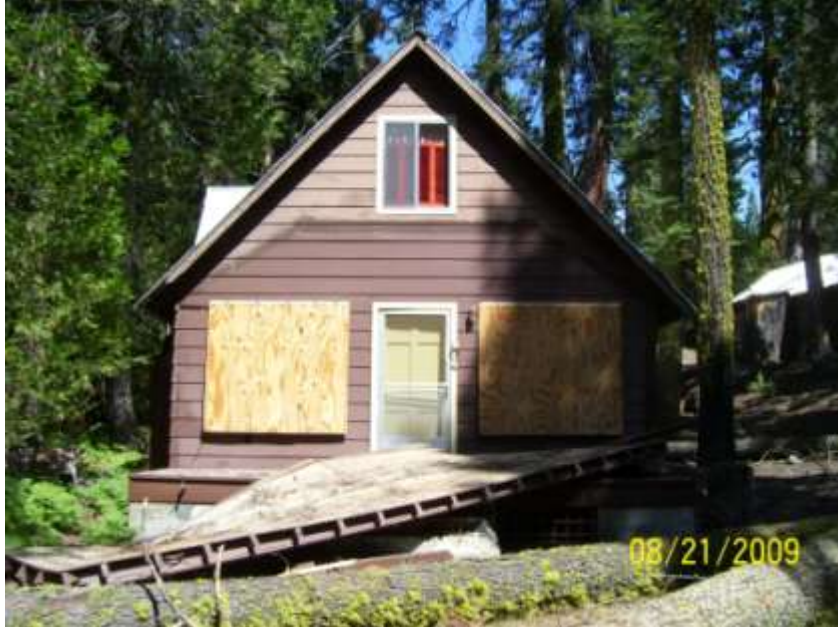
83736 Park Road

Porch roof collapsed, heavy fuel in front of cabin, duff and litter to foundation of cabin.

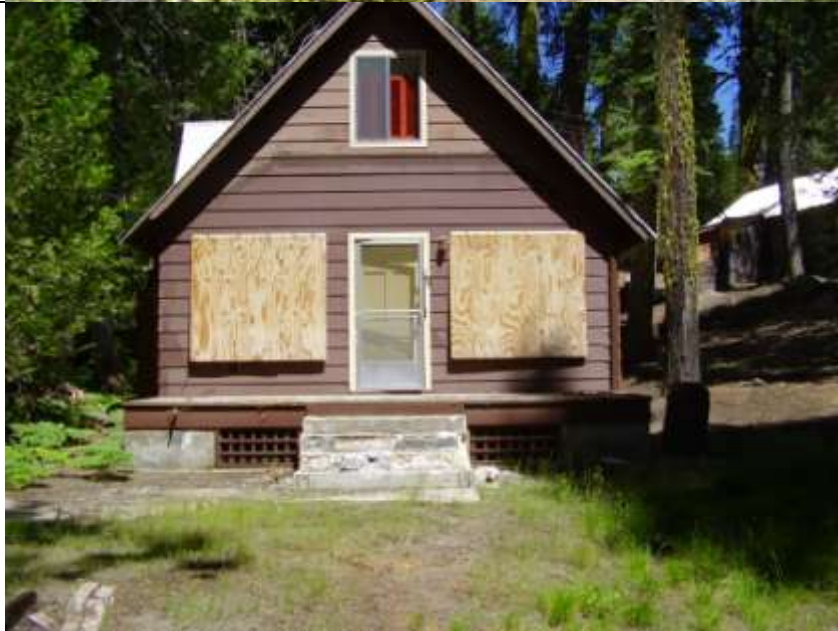
83736 Park Road

Porch roof removed, heavy fuel in front of cabin removed, duff and litter raked 30 feet away from cabin.

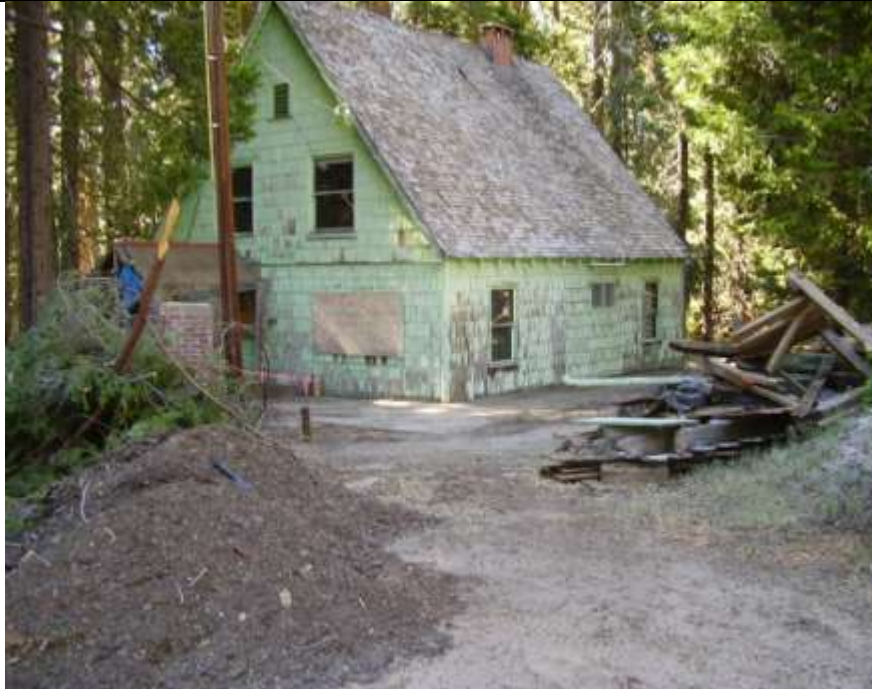
83681 President's Way

Typical types and volume of debris which was removed. Natural duff and vegetation on left, manmade debris on right.

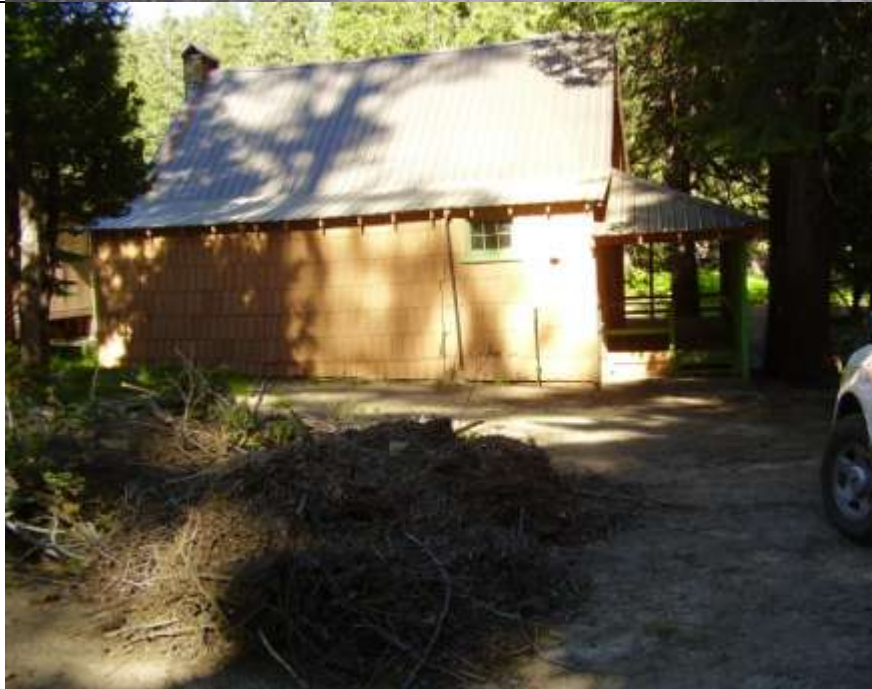
83691 Fir Lane

Typical type and volume of duff removed.

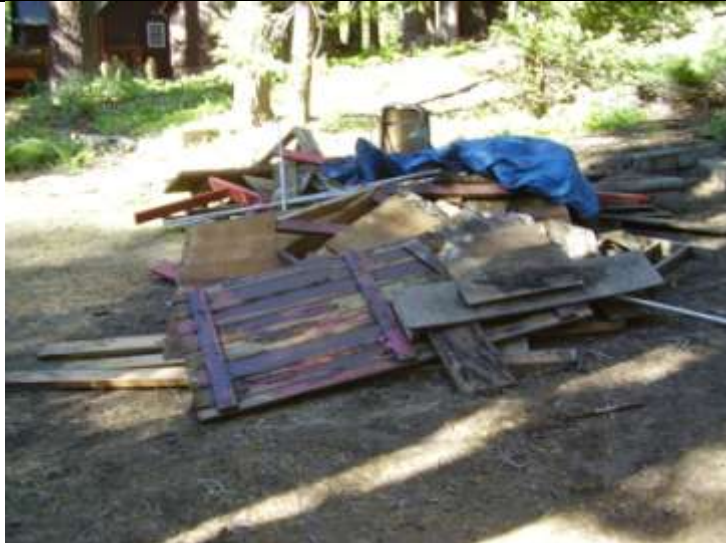
83663 Chinquapin Lane

Typical types of man made material removed.

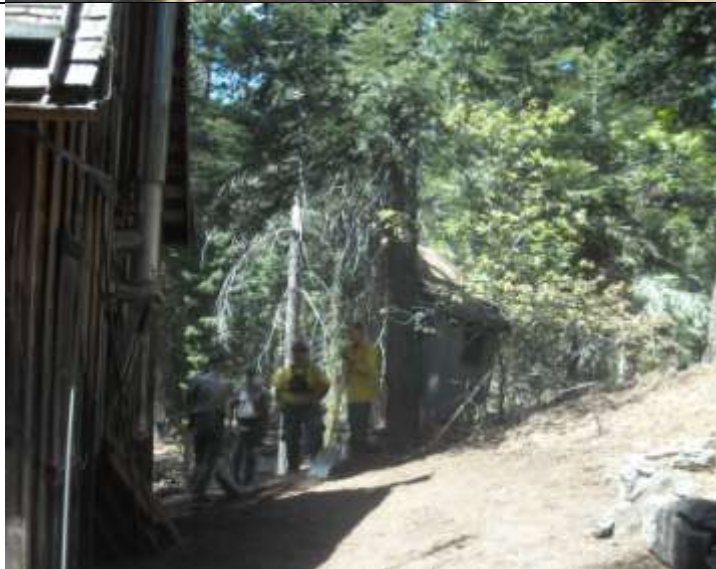
83740 Hazel Lane

Crew 51 and rangers at working on clearing defensible space.

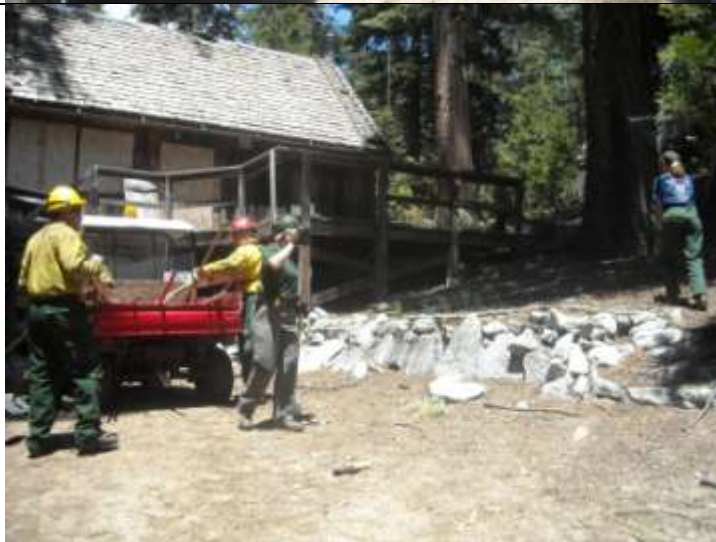
83740 Hazel Lane

Crew 51 and rangers at working on clearing defensible space.
