Chapter 3. Analysis

NHS Building Analysis

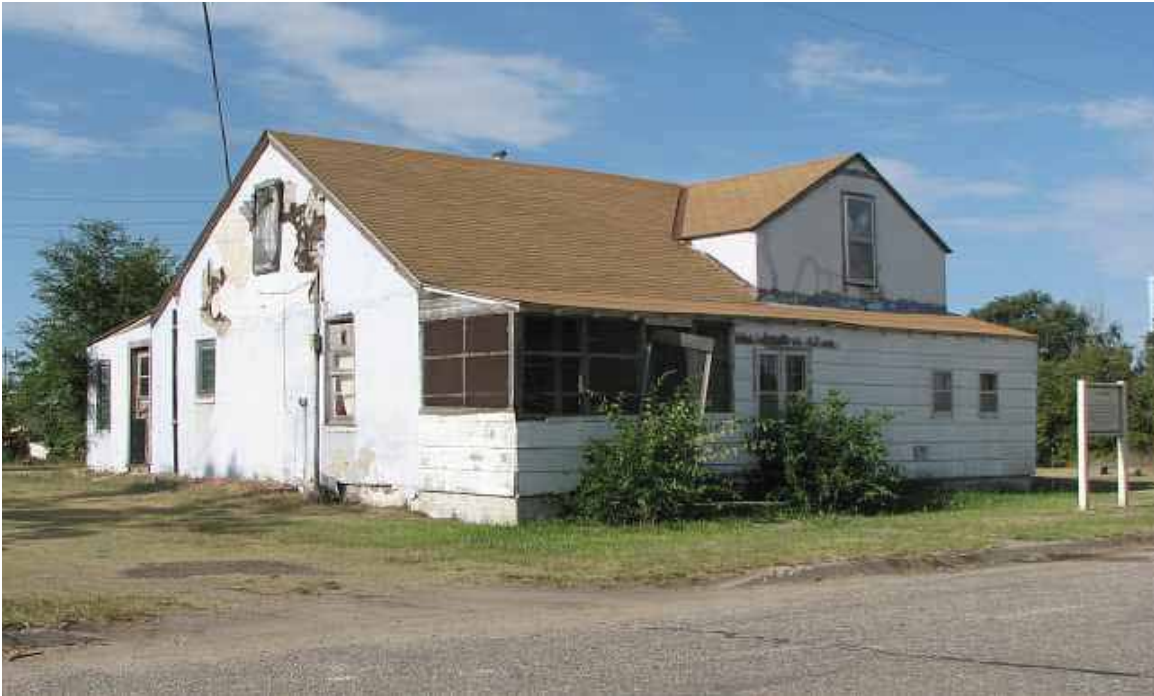
St. Francis Hotel

- **St Francis Hotel** is a one and a half story structure with one story shed roof additions across the north and south facades. The original portions of the building are constructed of limestone masonry, while the additions were constructed with light wood framing.

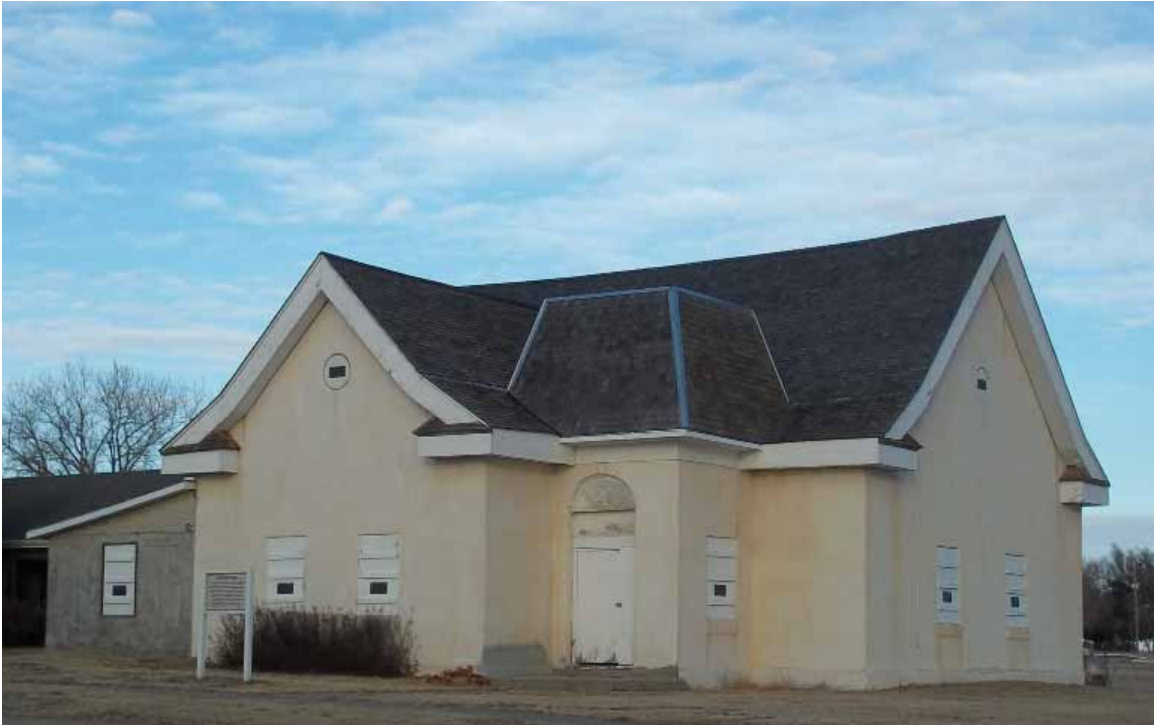
First Baptist Church

- **First Baptist Church** is a one story structure, T-shaped in plan, with intersecting gable roofs. The interior is an open plan with the kitchen opening into the main sanctuary space. The exterior walls are limestone masonry covered with a stucco finish.

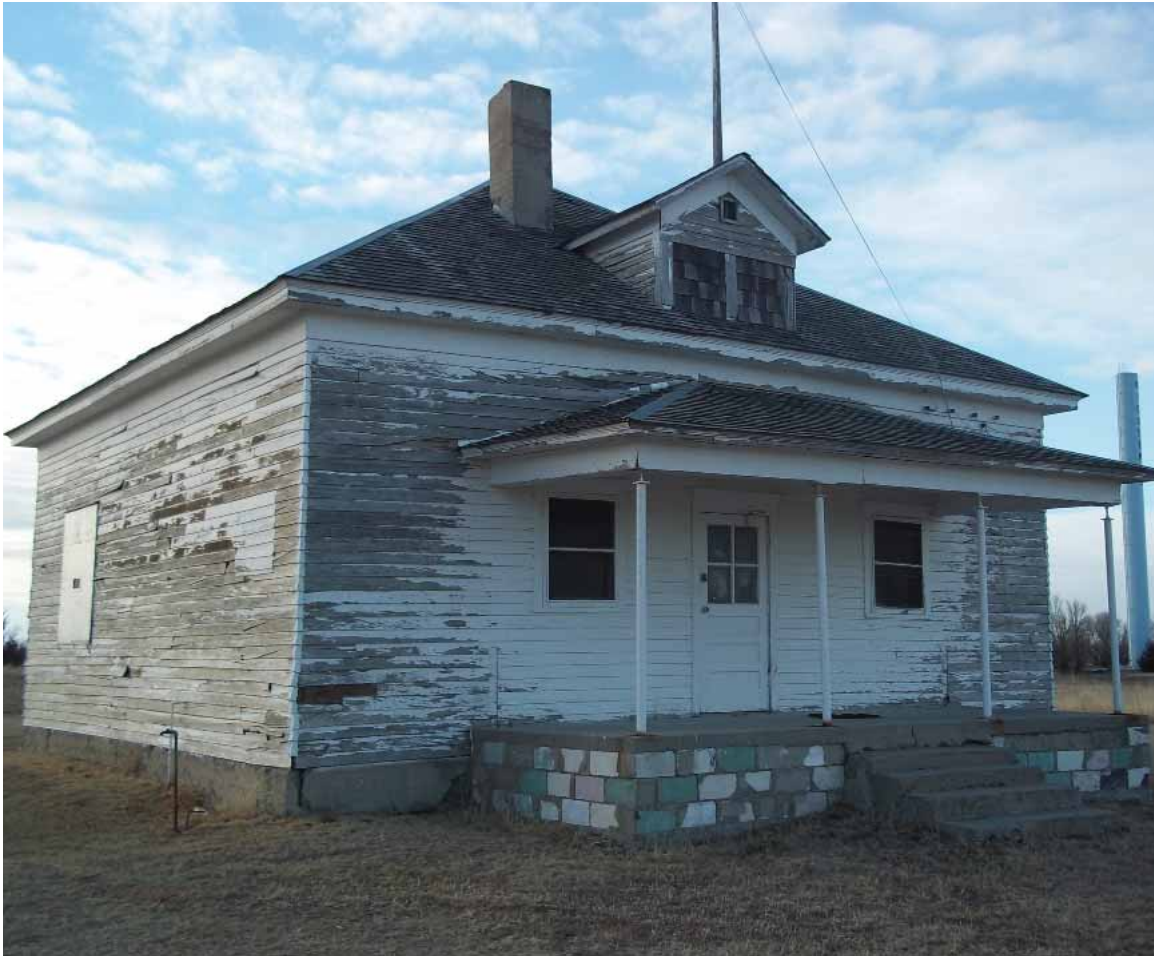
- **Nicodemus School** varies significantly in character from the other four NHS buildings. Although the square footage is similar, the construction type is not. The Nicodemus School is a wood framed structure with wood siding, square in plan with a hipped roof and open, elevated entry porch.

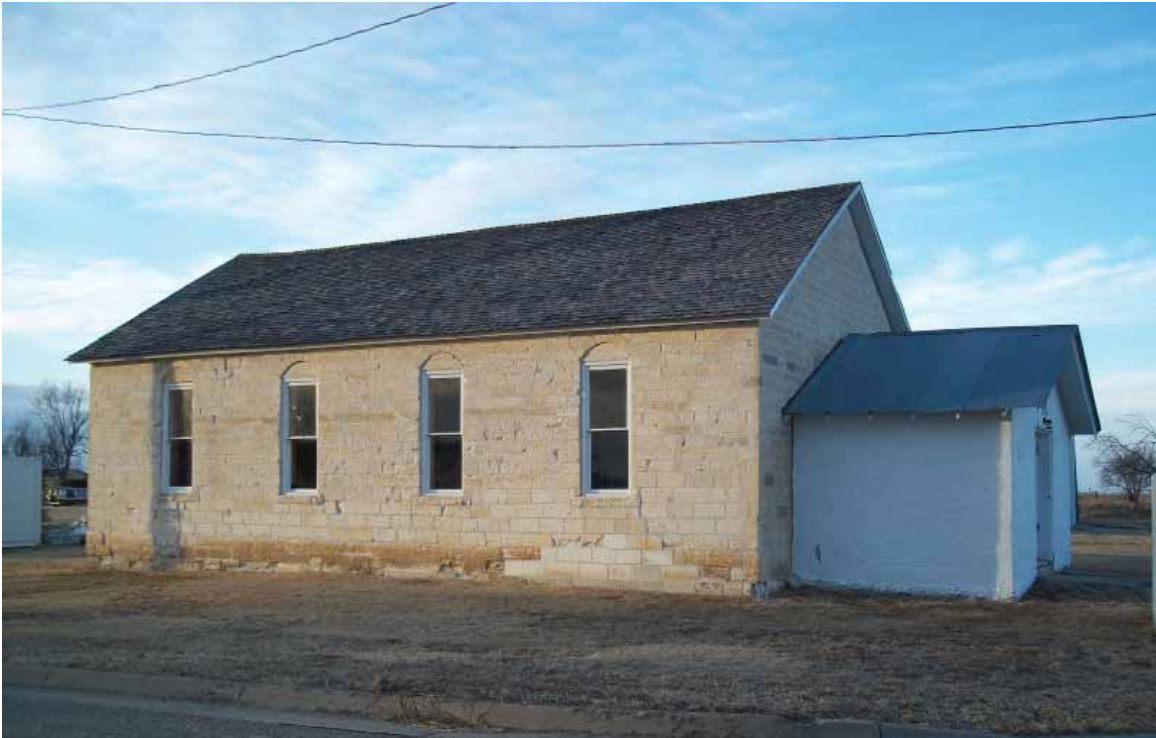
AME Church

- **AME Church** is typical of the building character of the Nicodemus NHS buildings. The building is built of limestone walls, is rectangular in plan, and has a gabled roof with a pitch of approximately 8:12.

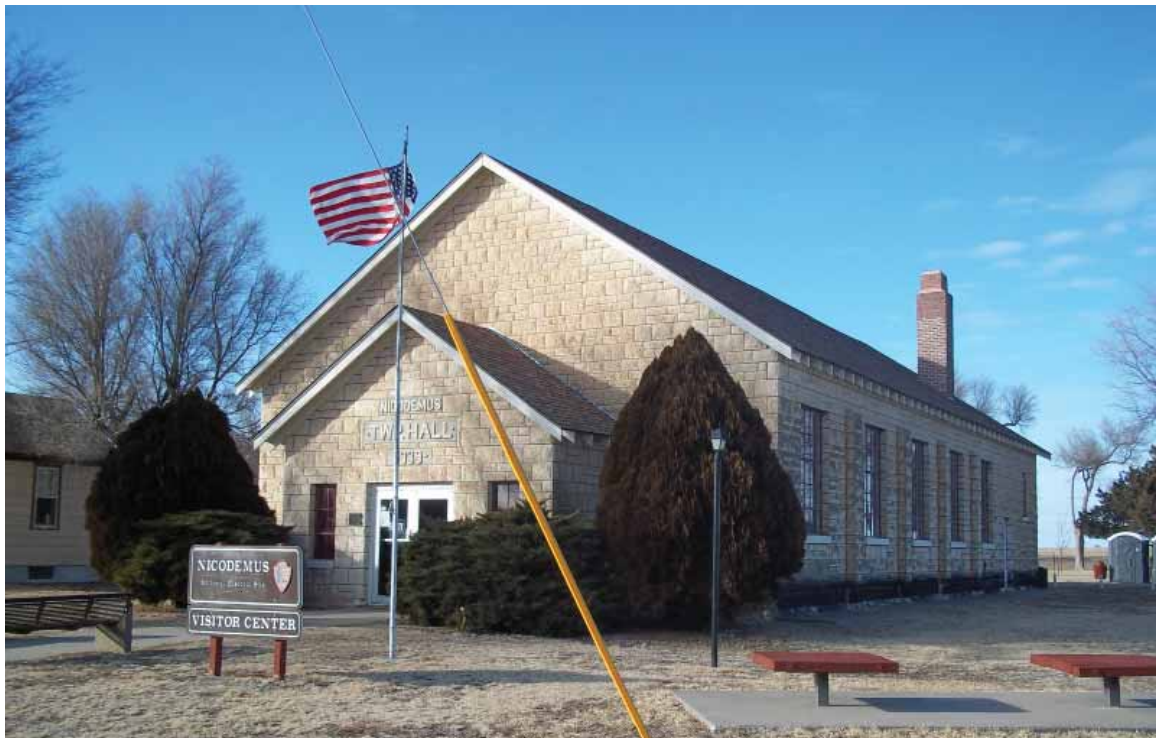
- **Township Hall** is very similar to the construction of the AME Church, only on a much larger scale. The Township Hall is more than double the square footage of the AME Church. Both exemplify the common building character of the NHS buildings.

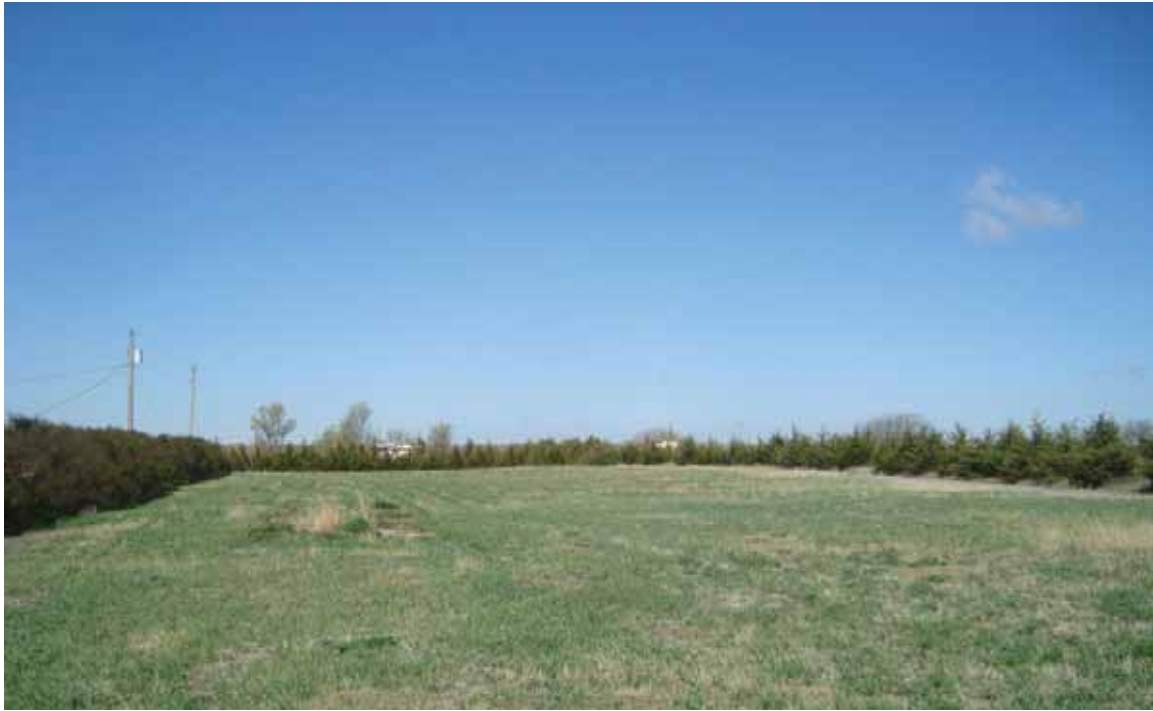
Evergreen Windbreak

In the Townsite, vegetation primarily includes grassy and agricultural fields, and trees associated with residences and buildings. Large shade trees occur at Township Hall and lines of smaller shade and ornamental trees line its north and west property boundaries. Two large *Arborvitae* trees flank the Township Hall entrance. Lawns are found at Township Hall, Roadside Park and Township Park. A wind break of evergreen trees defines the north edge of Township Park and low spreading junipers surround the Masonic Hall Monument.

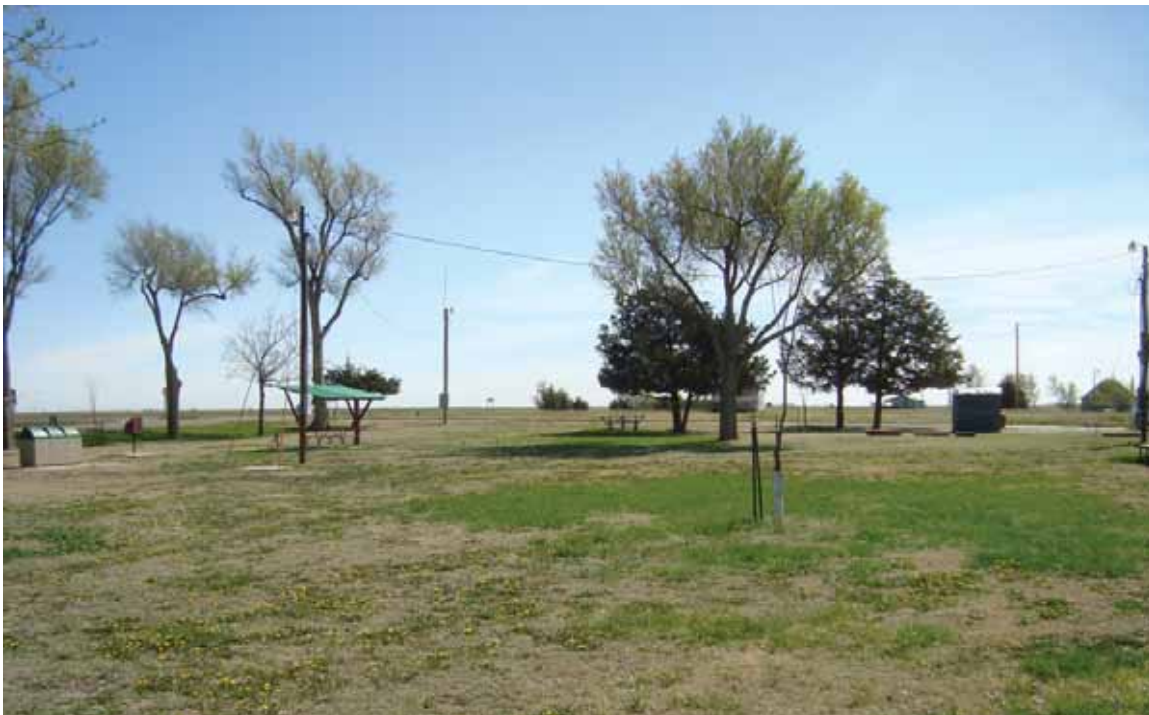
Shade Trees in Roadside Park

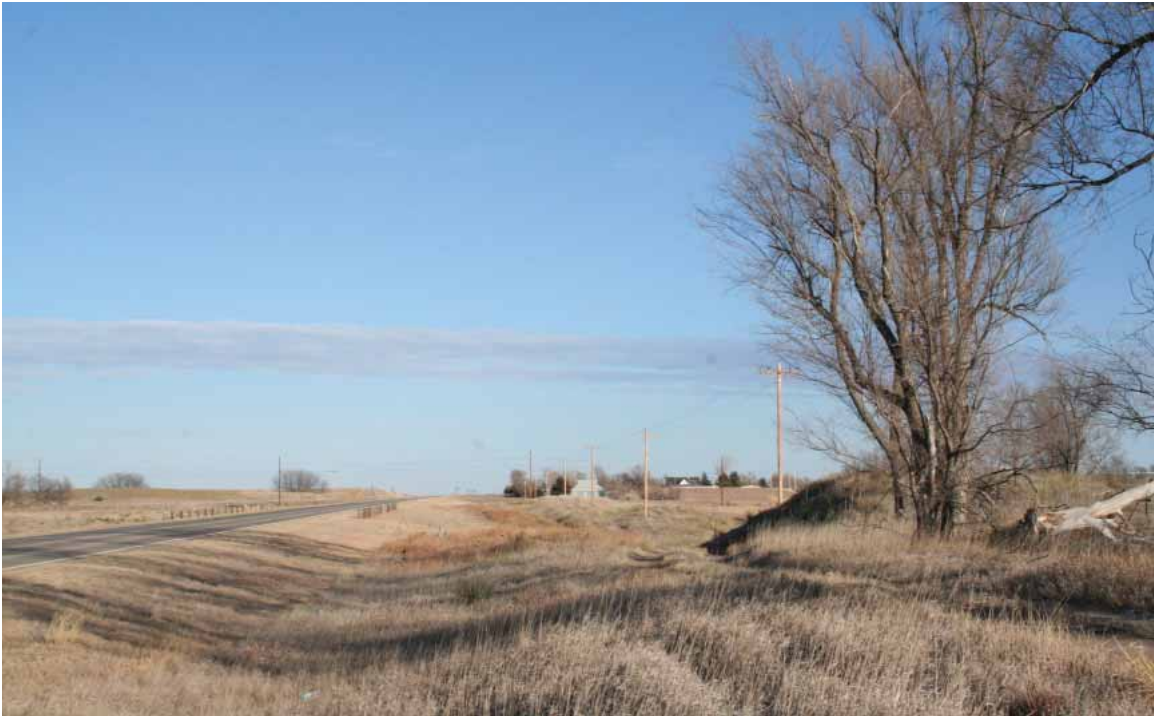
View to Townsite from the west along Highway 24

The views from U.S. Highway 24 into the Townsite are primarily open and afford long views of the countryside. The agricultural lands provide little tree cover to obstruct views. Geographical landforms such as knolls and plateaus are readily visible, and municipal water towers serve as locating elements.

The Townsite is visible from U.S. Highway 24 from approximately a quarter-mile away as approached from both the east and west. The water tower is the tallest visible feature and can easily be seen. No structures, fences or large vegetation block the views between the NHS buildings. These unobstructed views retain the open character of the agricultural lands that define the Nicodemus setting.

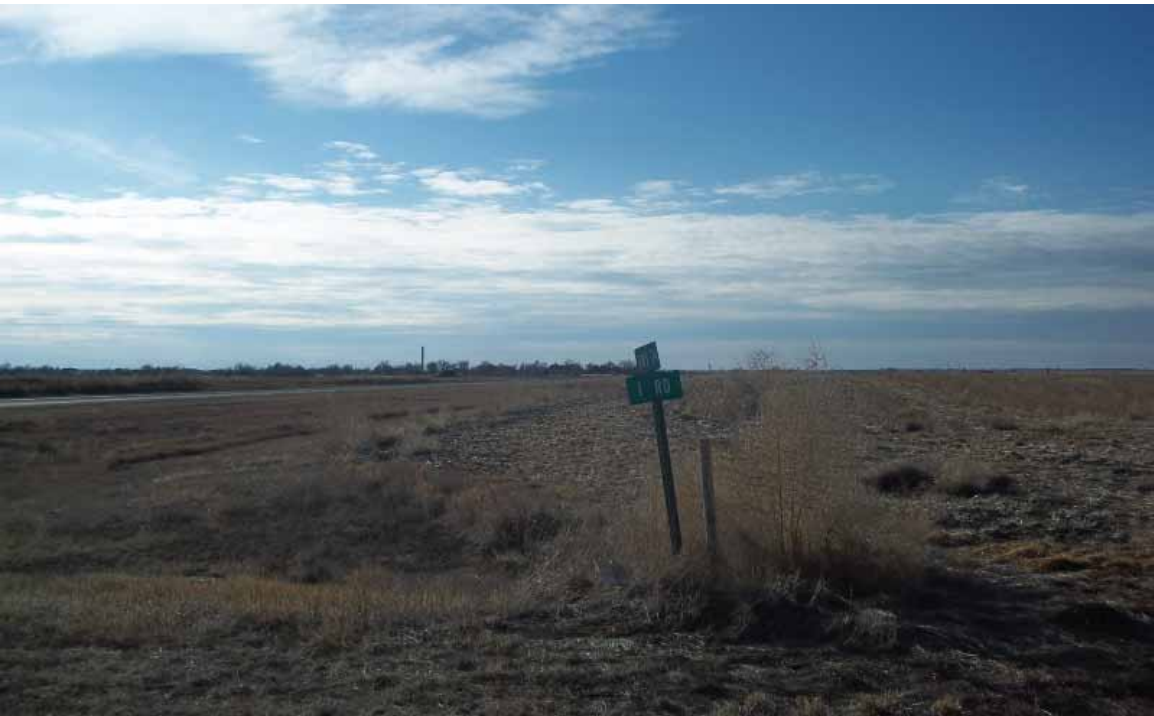
View west to Townsite along US Highway 24
