## 3.0 Affected Environment

The purpose of this chapter is to describe park resources within and adjacent to the Spruce Railroad Trail (SRRT) Lake Crescent and Sol Duc project areas that would be affected by the alternatives described in Chapter 2. This provides a baseline for evaluating environment consequences in Chapter 4.

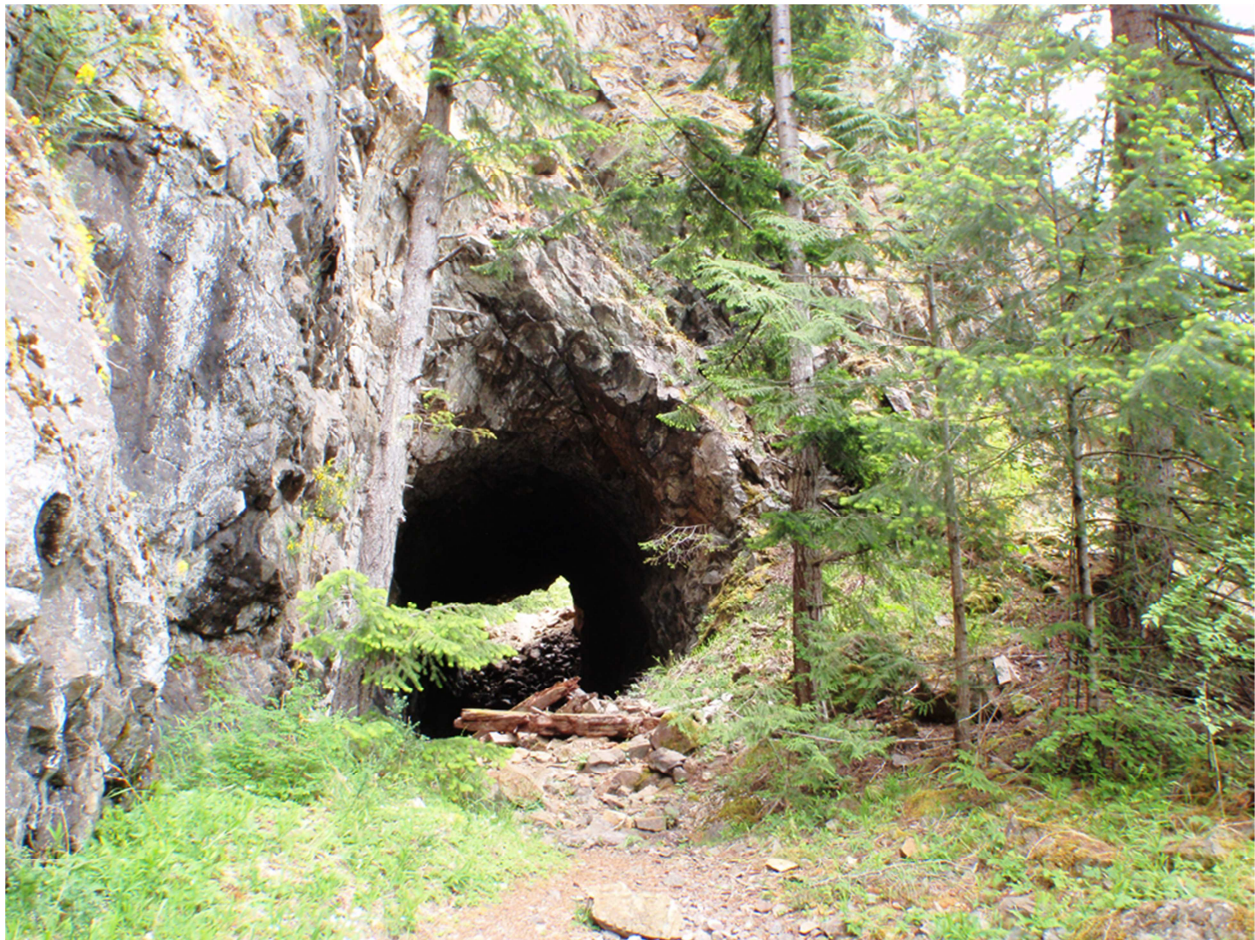
Figure 2. West Tunnel (short tunnel)

rocks of the Aldwell, Lyre, and Twin Rivers Formation north of the Crescent Formation outcrop. The Spruce Railroad grade and tunnels are within the Crescent Basalt and the Aldwell Formation of marine sedimentary rocks (PanGEO, Incorporated 2011).

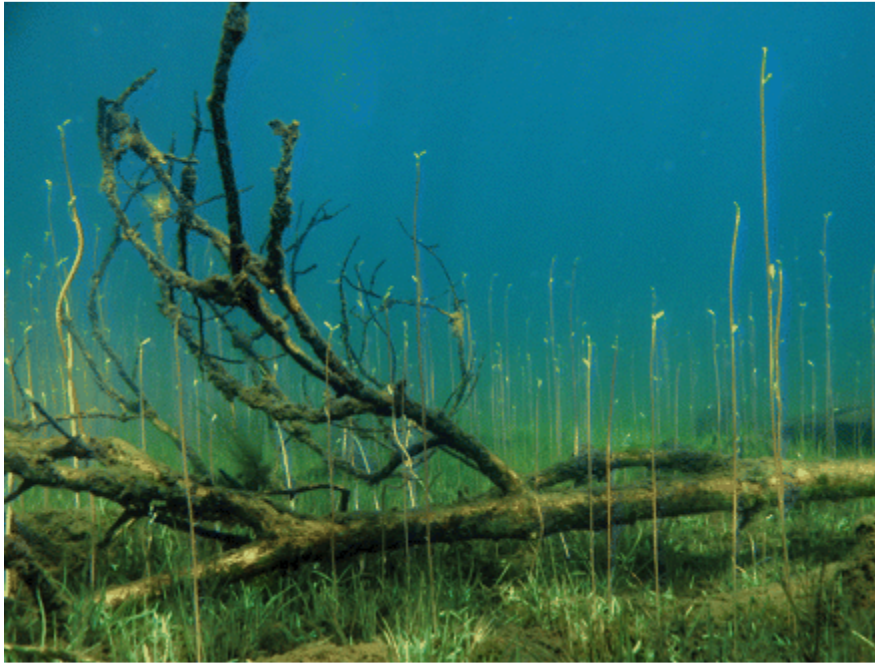
Figure 6. Water lobelia (*Lobelia dortmanna*) “with peduncles raising flowers towards the water surface. *Lobelia dortmanna* grows in low-alkaline lakes and is one out of several submerged plants that takes up CO<sub>2</sub> for photosynthesis from the sediment” (USGS)

Water lobelia is an evergreen, perennial aquatic plant which is usually submerged except for some flowering stalks. The leaves consist almost entirely of a basal rosette. The plant is found in shallow water on the edges of lakes and ponds. The species occurs in nutrient-poor water bodies with exceptionally clear water. The basal leaves of the *Lobelia* are harmed by sediment, which can't photosynthesize if they are covered. It is susceptible to damage from application of herbicides to control aquatic weeds, shoreline development, water pollution from recreational equipment, and trampling (Washington Natural Heritage Program Field Guide to Selected Rare Plants, <http://www1.dnr.wa.gov/nhp/refdesk/fguide/htm/fgmain.htm>, viewed June 22, 2011).

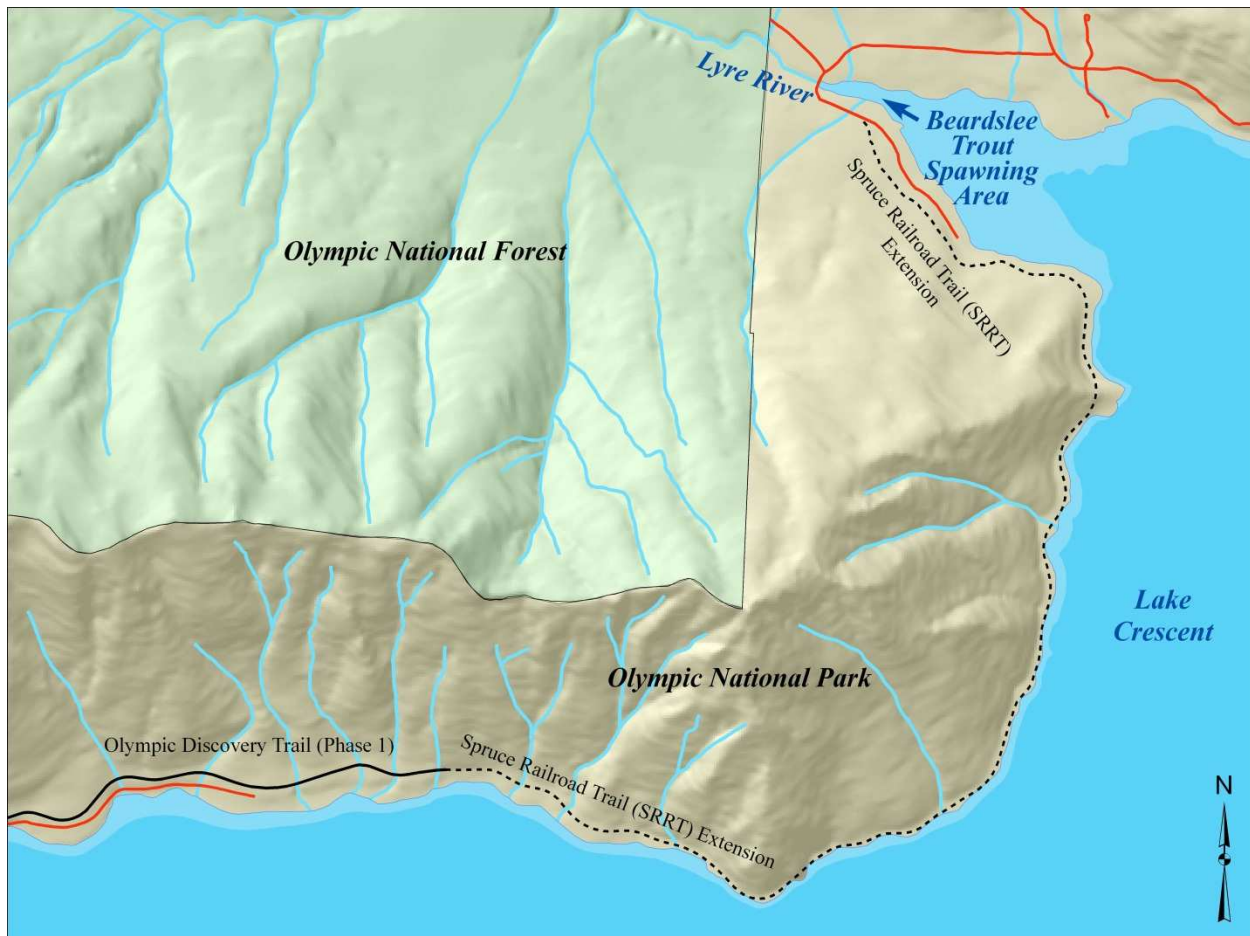
Figure 11. Map showing Beardslee Trout spawning area.

In the early 1990s, both Beardslee trout and Crescenti trout appeared to be at risk of extirpation. Annual spawning ground surveys accounted for less than 100 individuals of each species (Meyer and Fradkin 2002). Beardslee trout in particular were at risk, as they are known to spawn solely in a 1-acre section of gravel at the outlet of Lake Crescent. Crescenti trout, also in very low abundance, have developed a number of unique life history traits - including multiple spawning locations that include tributaries to the lake, the lakeshore, and downstream in the Lyre River

lake outlet. These several locations buffer the potential for a catastrophic event to decimate the population.

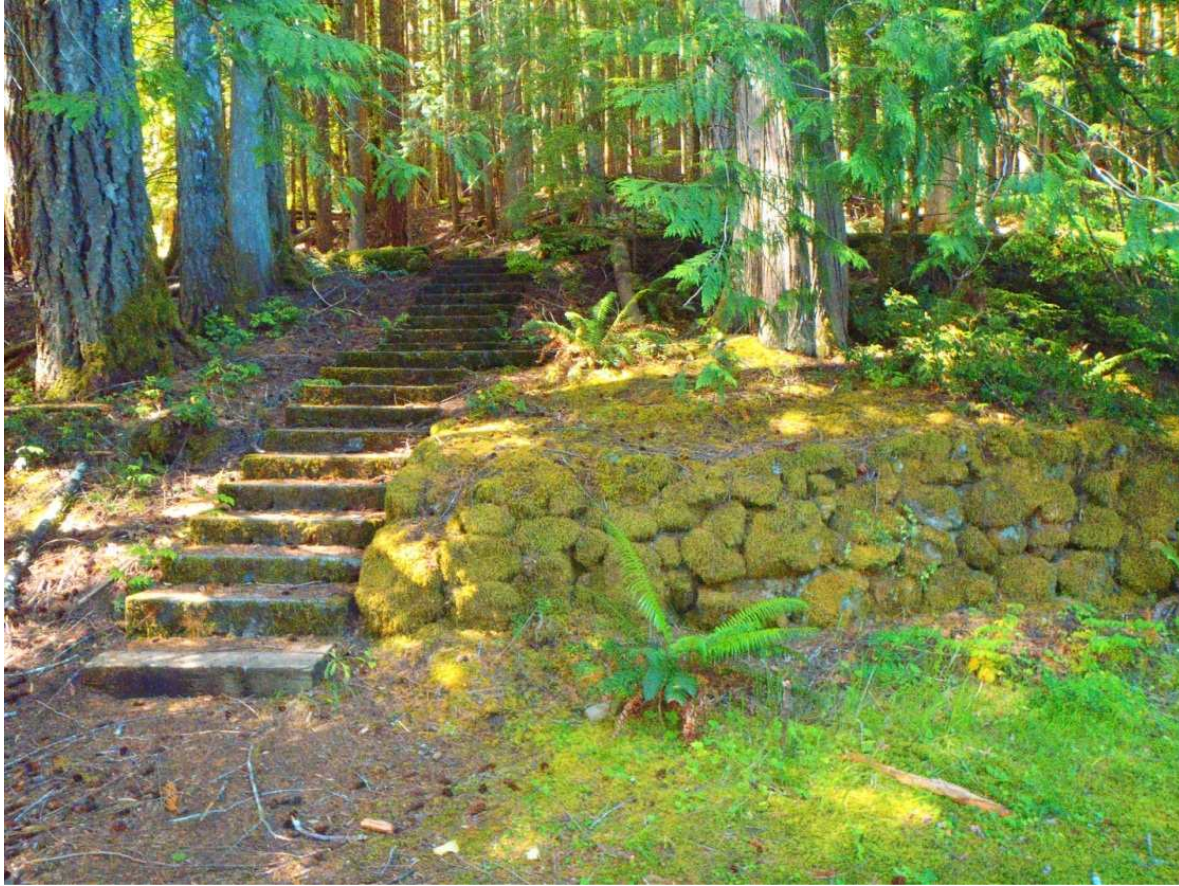
Figure 18. Rock wall and steps from Ovington's Resort within the park's North Shore picnic area (NPS)

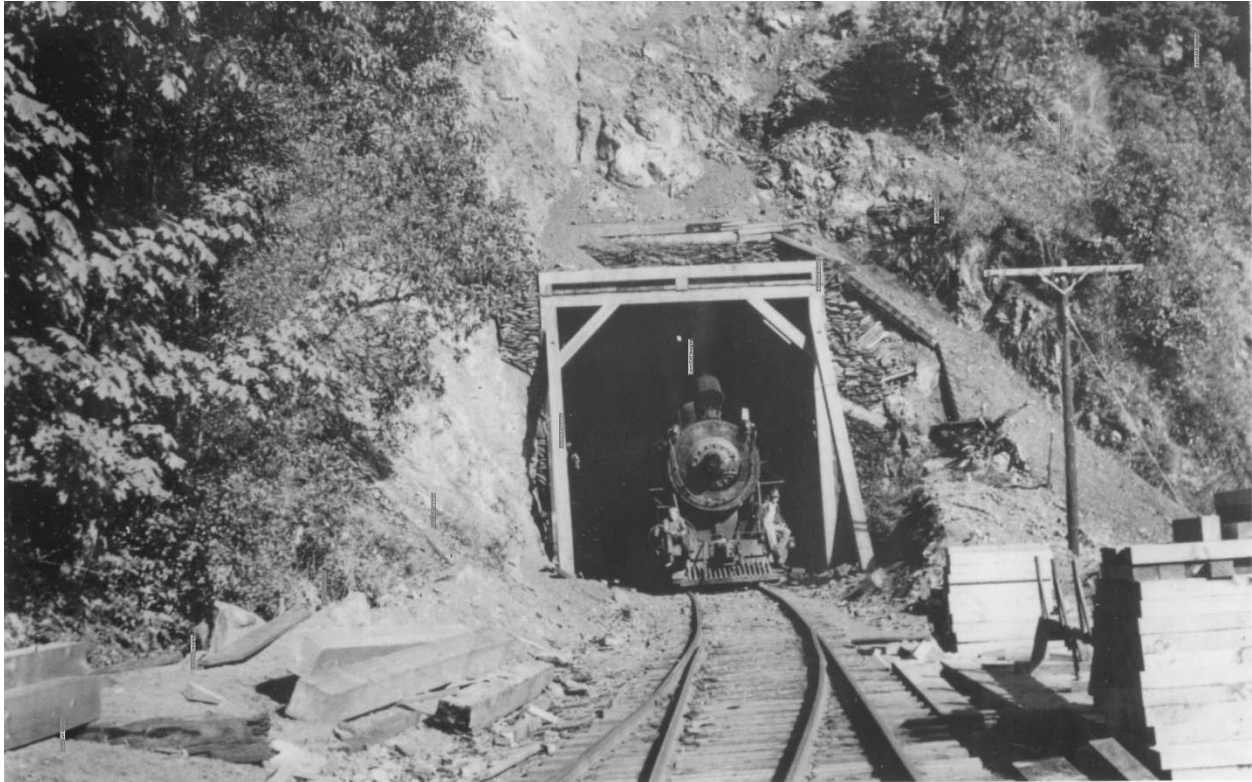
Figure 19. Train coming out of railroad tunnel, courtesy of Dan Peacock

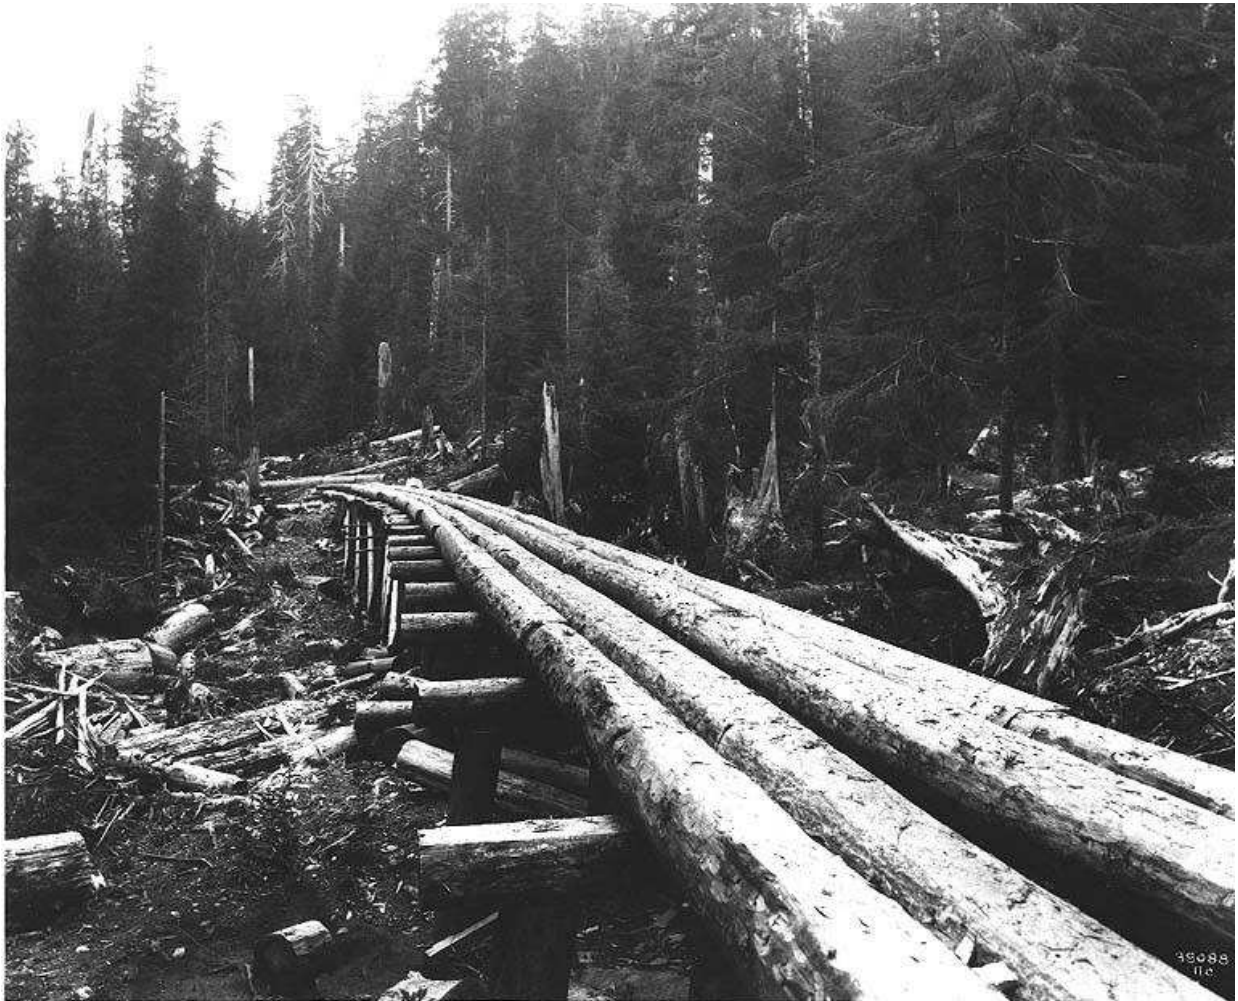
Figure 20. “Log railroad bridge under construction, U. S. Army Signal Corps Railroad, Spruce Production Division, Lake Crescent area.” Asahel Curtis Photo Collection (PH Coll. 482,

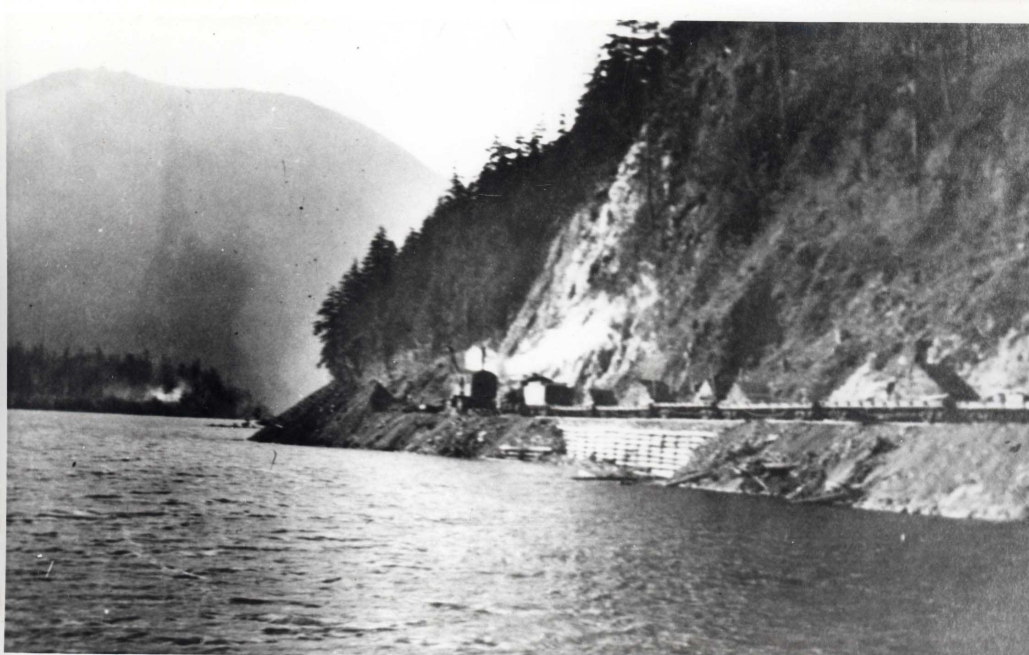
Figure 25. Historic image of timber half-bridge

Much of the construction of the proposed trail work would involve adaptive reuse of this eligible National Register District. Associated character defining features that still exist include earthwork cuts, fills, and borrows that lowered or raised the grade; drainage systems and wooden culverts; retaining walls or revetments and timber half-bridges to create grade on the steep lakeshore. The latter two are visible from both the trail and the lake.

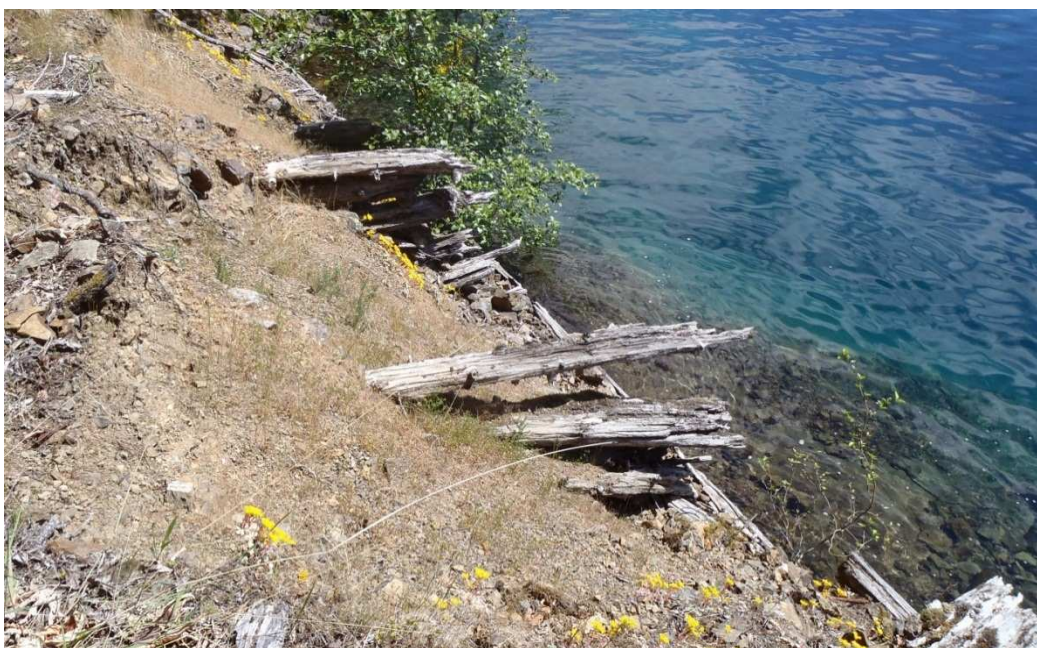
Figure 26. Timber half-bridge remains, mile 1.98 (Wray 2011)

As noted above, historic structures can be a building or other type of structure. The Spruce Railroad was found eligible as a 36-mile long structure. The roadbed or grade being the structural foundation for the track and evaluated to the national register based on the integrity of its features. In the Sol Duc area of the project, a section of historic railroad grade has retained high integrity that demonstrates construction with falsework that has been backfilled (Figure 26).

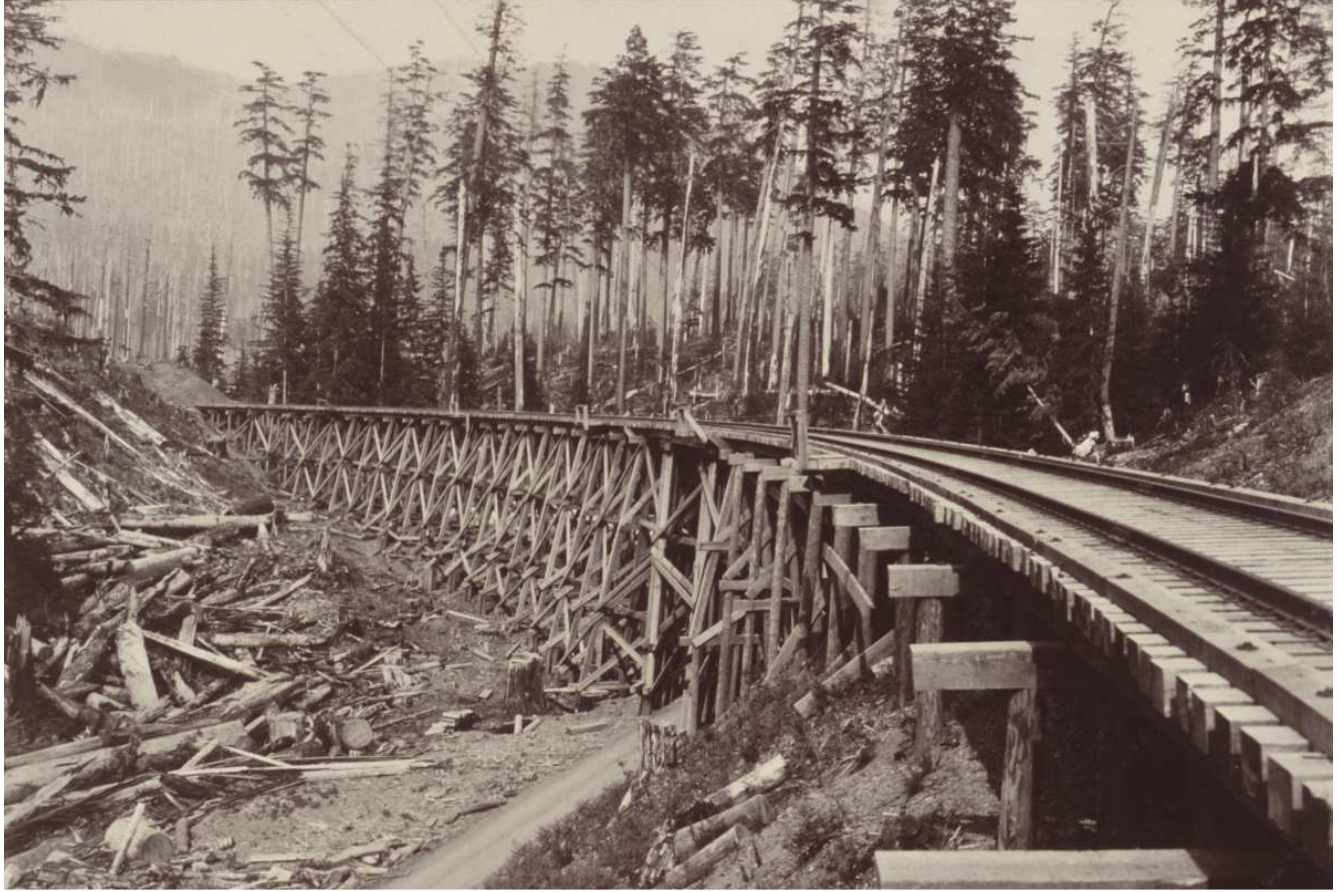
Figure 27. Sol Duc area (falsework)
