# **Wetland Statement of Findings**

## ***For Proposed Reconstruction and Rehabilitation of Rock Creek and Potomac Parkway Southbound At Waterside Drive***

***Rock Creek Park***

July 2012

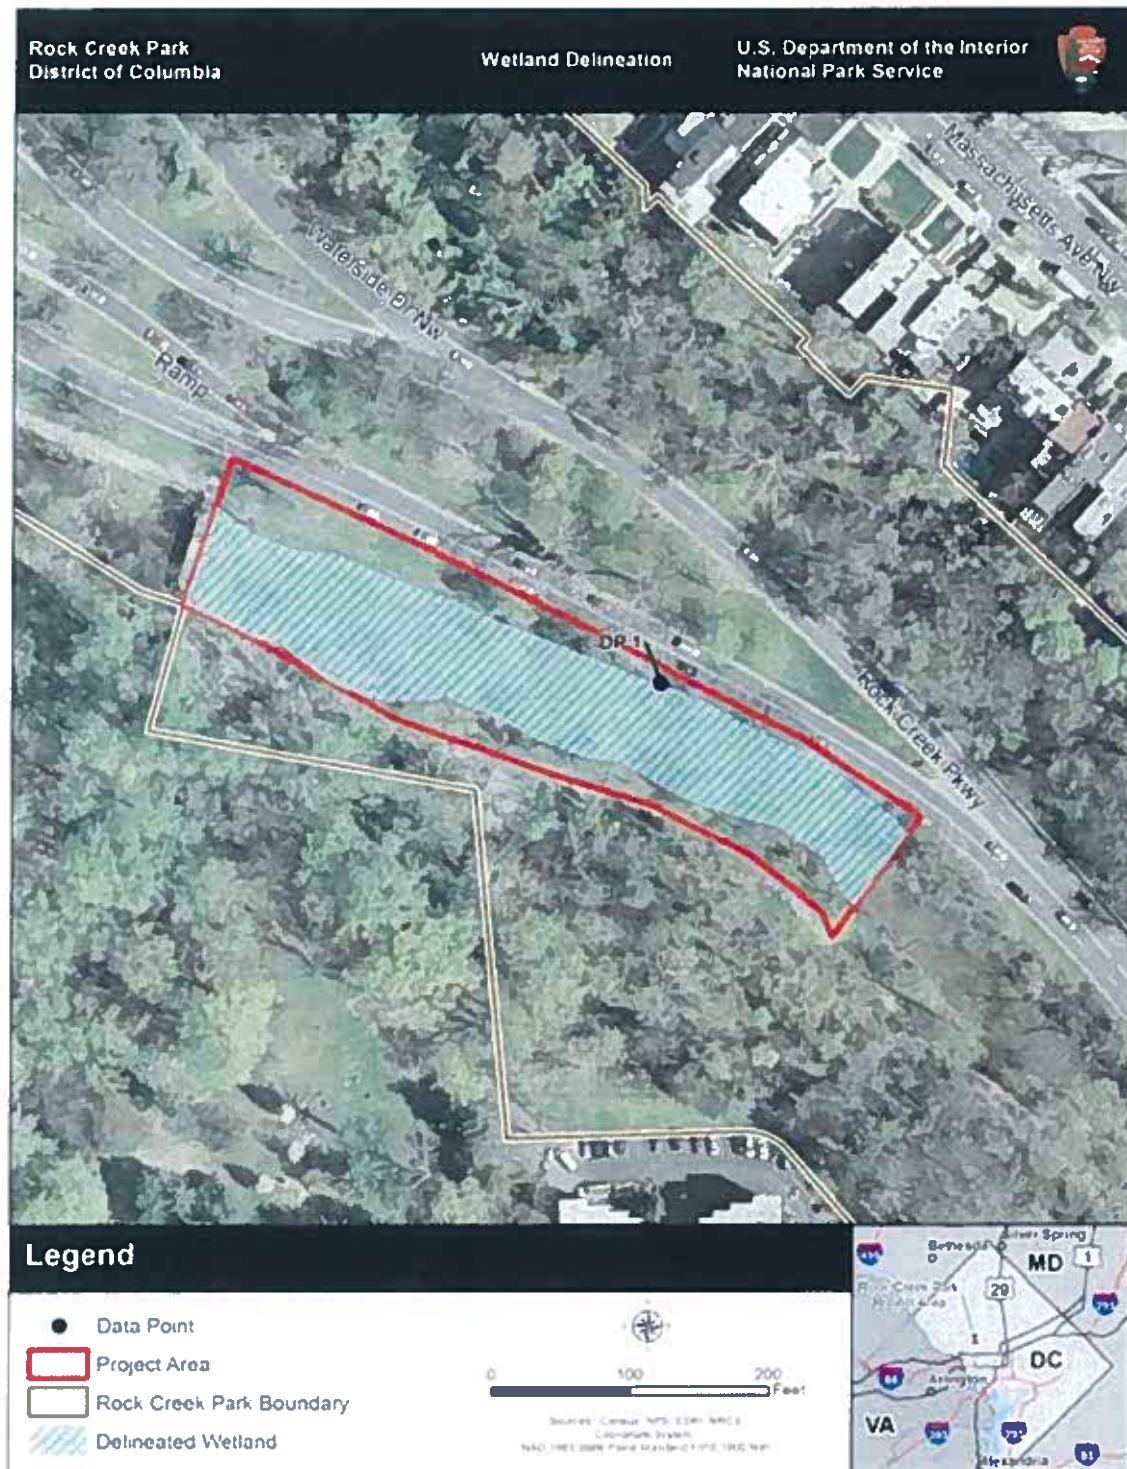
**Figure 1. Delineated Section of Rock Creek within the Project Area**

One non-vegetated riverine system was identified within the project area (figure 1). Based on the Cowardin classification system (Cowardin et al., 1979), the portion of Rock Creek delineated (0.93 acres) is riverine, upper-perennial, unconsolidated bottom (R3UB1). It is expected that the proposed project would not have net negative impacts to Rock Creek. The preferred alternative would require in-stream activities to restore the stream banks along Rock Creek. This activity would have short-term, minor, adverse impacts; however, successful stream bank restoration would have long-term, beneficial impacts to Rock Creek by reducing the sediment load to the waterway.

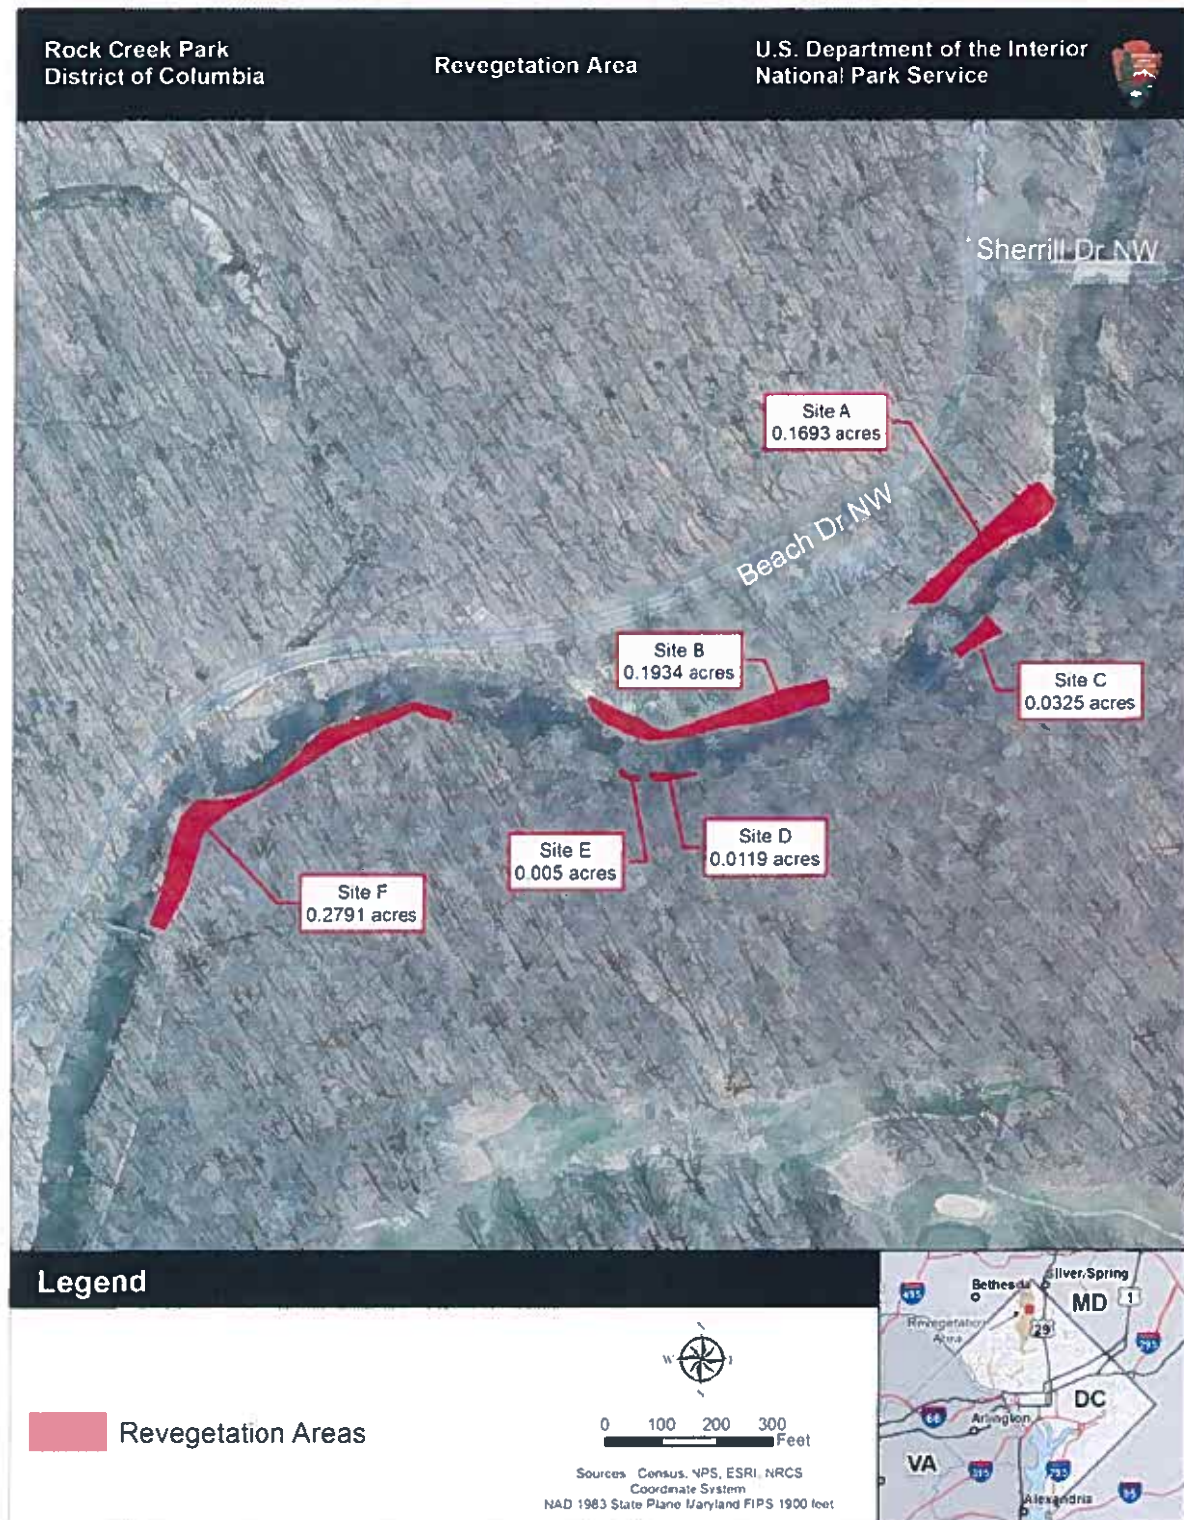
Figure 2. Rock Creek Riparian Revegetation Area

The revegetation area is composed of six riparian sites located along the banks of Rock Creek between Bingham Drive, NW and Sherrill Drive, NW (figure 2). The six proposed sites range between 0.005 acres and 0.279 acres and are immediately adjacent to the banks of Rock Creek. Throughout the proposed revegetation area, the banks of Rock Creek are very steep and practically vertical from the edge of the riparian zone to the creek bed. Scouring of the stream banks is present throughout the revegetation area. During a field visit by an NPS Regional Botanist and a ROCR Natural Resource Specialist, the existing
