City Homes at Fort Lincoln

Phase I Environmental Site Assessment

Eastern Avenue and Fort Lincoln Drive

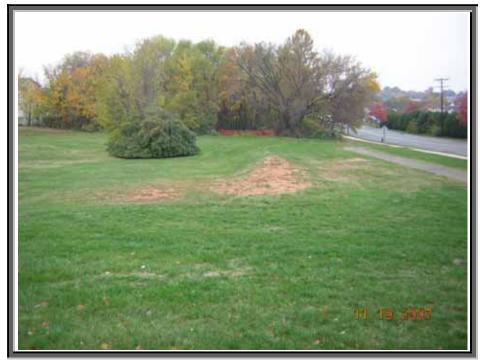
PHOTO 1: VIEW OF SITE (FACING NORTHWEST)

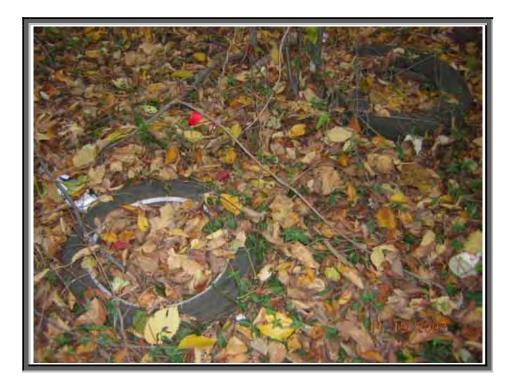
GeoConcepts observed some household trash, three tires, construction fencing, and a wood debris pile on Site. We did not observe any dumpsters or hazardous waste on Site.

PHOTO 2: VIEW OF TIRES ON CENTRAL PART OF SITE

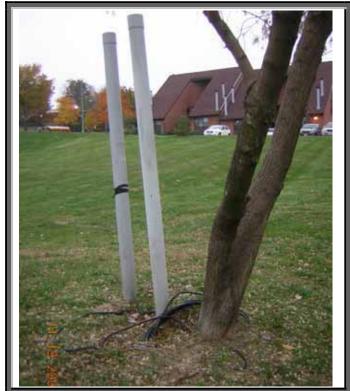
- Unknown and unidentified gray PVC pipes with apparent electrical wires were observed near a tree around the pad-mounted transformer in the central portion of the Site. The apparent use of the PVC pipes and electrical wires could not be identified.

GeoConcepts observed a pole-mounted transformer in the overhead utility lines at the north end of the Site at the intersection of Eastern Avenue, N.E. and Bladensburg Road, N.E. A pad-mounted transformer is located at the southern end of the Site. Unknown and unidentified gray PVC pipes with apparent electrical wires were observed near a tree around the pad-mounted transformer. The apparent use of the PVC pipes and electrical wires could not be identified.

PHOTO 3: VIEW OF UNKNOWN PVC PIPE AND ELECTRICAL WIRE

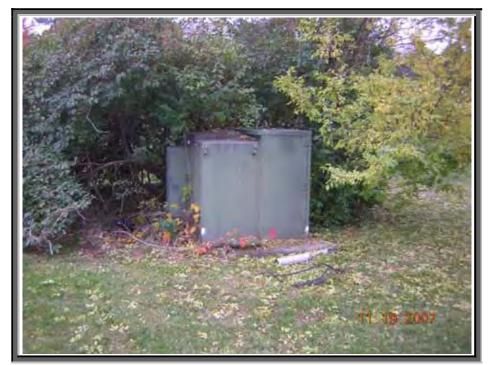
The Site is currently vacant land; however, PEPCO provides electrical service to the adjacent properties via aboveground and underground lines. A pad-mounted transformer was observed on the Site. Additionally, large electrical wires were observed around two trees and appeared to be going into the ground on the Site.

PHOTO 4: VIEW OF PAD-MOUNTED TRANSFMORMER ON SOUTHEASTERN SIDE OF SITE (NOTE ADJACENT ELECTRICAL WIRE AND PVC PIPE)

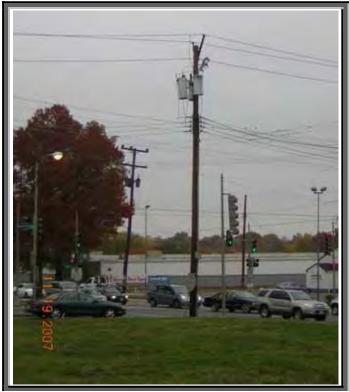
PHOTO 5: VIEW OF POLE-MOUNTED TRANSFORMER ON NORTH SIDE OF SITE AT THE INTERSECTION OF BLADENSBURG ROAD AND EASTERN AVENUE

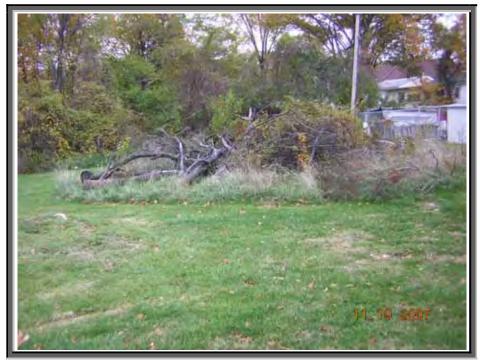
PHOTO 6: VIEW OF WOOD AND VEGETATION DEBRIS PILE ON NORTHWESTERN SIDE OF SITE

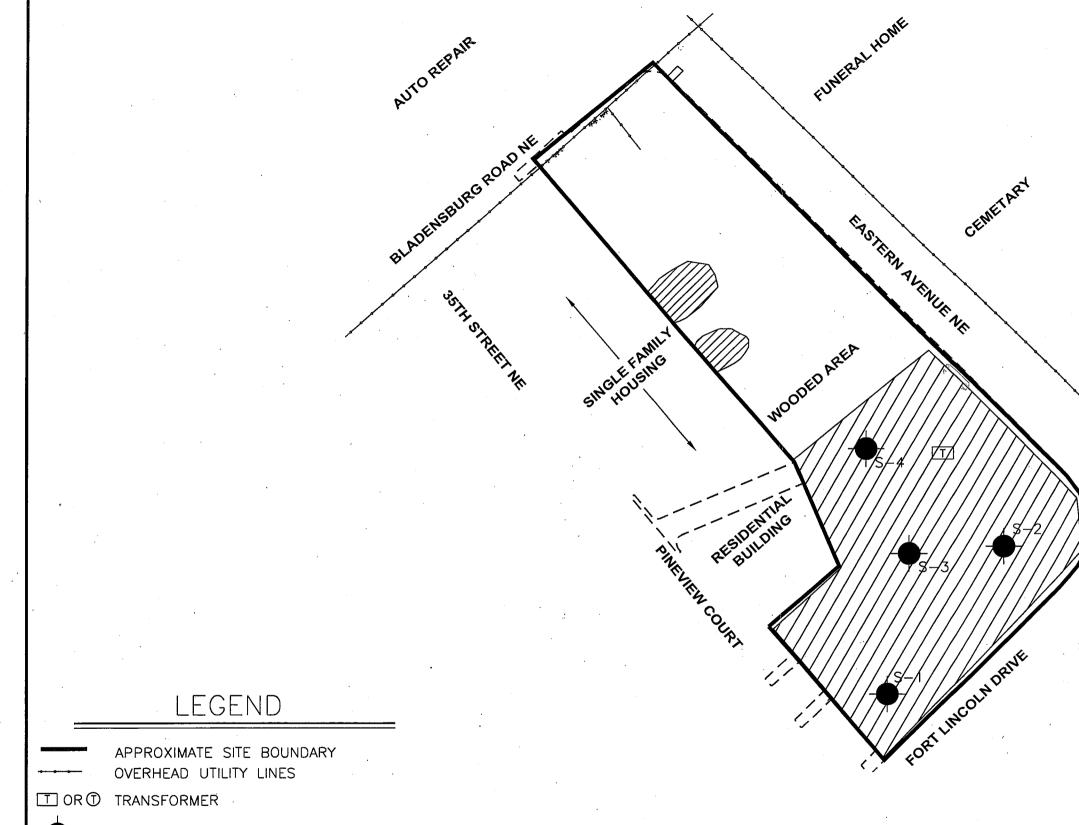
APPROXIMATE SAMPLING LOCATION

A former orchard was located on a southern portion of the Site. Historically, orchard operations have caused soil contamination from the application of pesticides. Heavy metals contamination may be present as they were constituents of older pesticides. Typically, the areas of the highest contamination are located in and around the mixing and packing sheds and in the upper 1 foot of soil of the orchard area. It appears that the mixing shed was located off-Site. To determine if the Site's soils have been impacted by previous orchard operations, GeoConcepts performed a limited Phase II subsurface investigation.

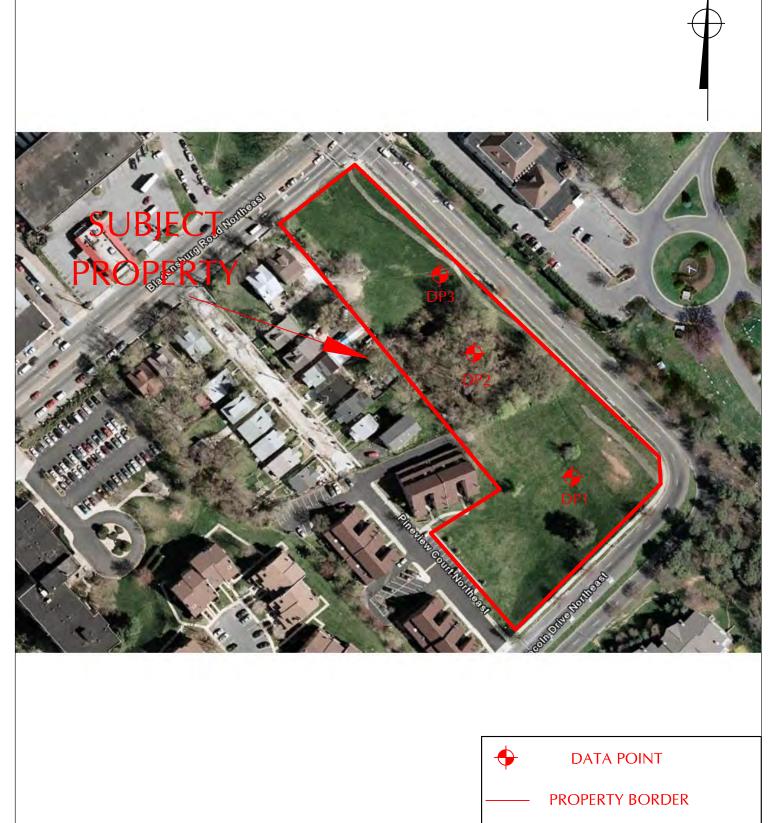
| 8809 SUDLEY RDSTE,101 MANASSAS, VA 20110 TELEPHONE: (703) 396-6730 FACSIMILE: (703) 396-6743 | FIGURE 1 | Date: May 5, 2008 | Project Name: City Homes at Fort Lincoln |

On April 15, 2008, Apex hand augured in three locations to determine the soil composition. The three data point locations (DP) are depicted in **Figure 1**. The site is located on a hill that slopes toward DP3. The only soil series mapped within the property limits is Christiana Silt Loam, which is a well-drained, non-hydric soil according to the United States Department of Agriculture (USDA).

DP1 and DP3 are located in two atypical, mowed, grassy areas on either side of the wooded area (Figure 1). DP2 is located in the wooded area near the center of the site. DP1 did not meet
