Statement of Findings for Wetlands

for Morefield Maintenance Area Mesa Verde National Park

Montezuma County, Colorado

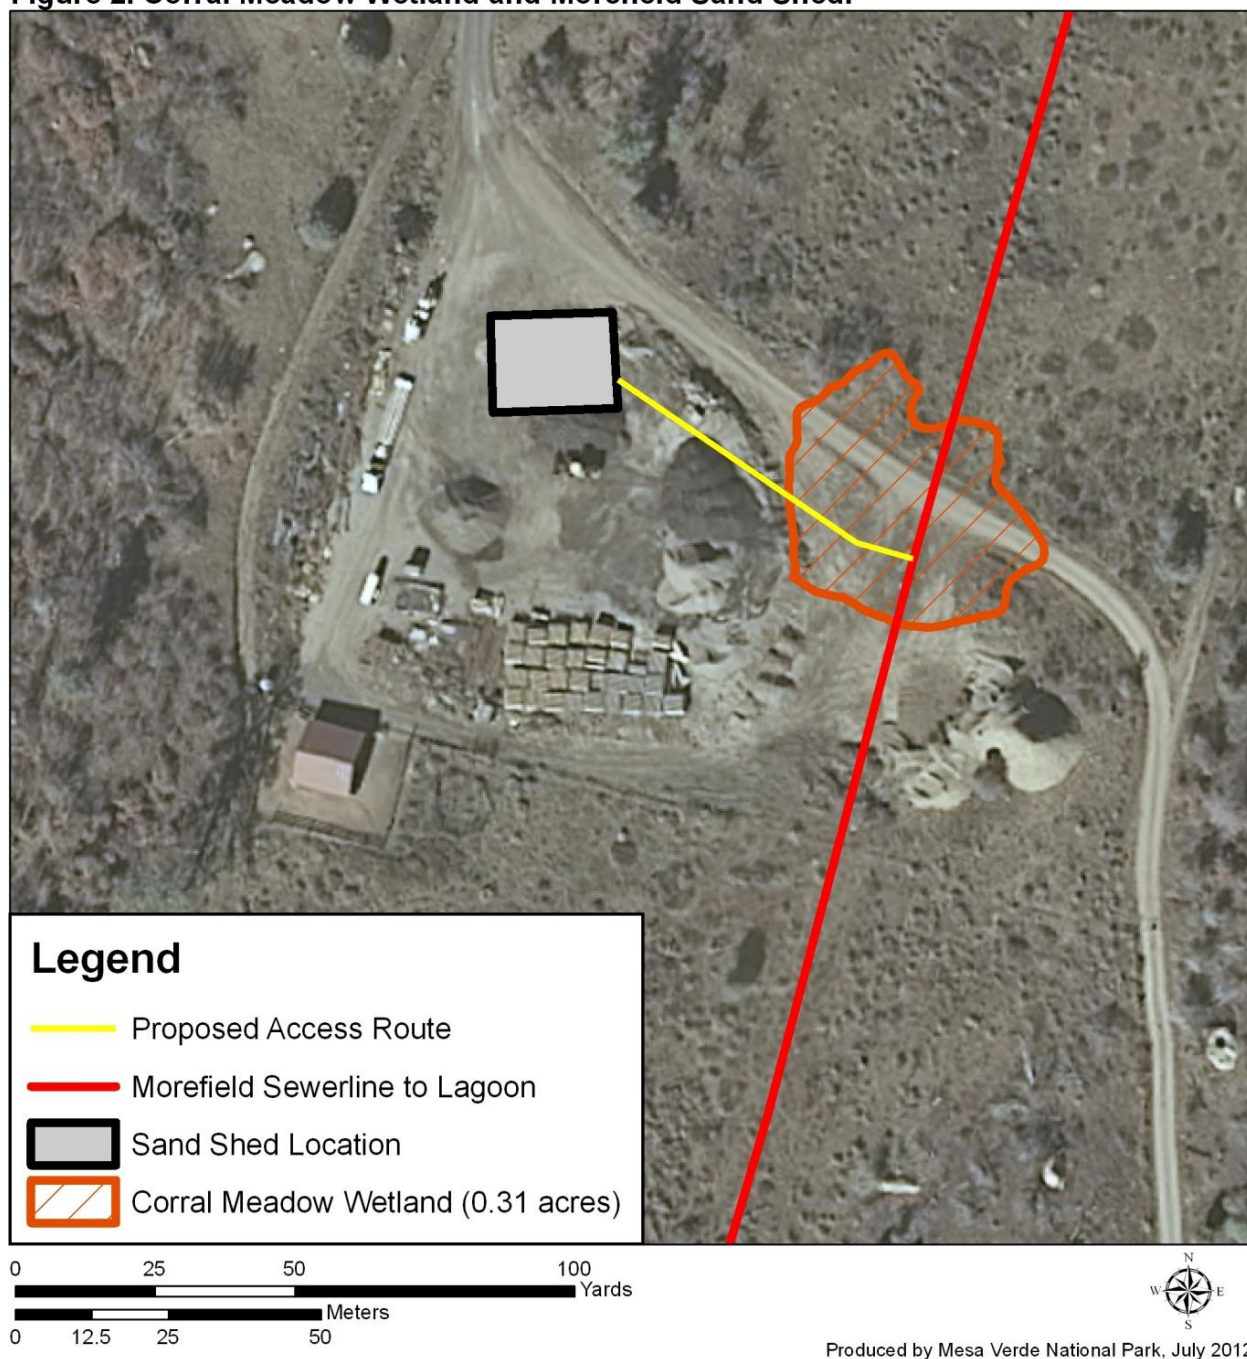
Figure 2. Corral Meadow Wetland and Morefield Sand Shed.

Figure 2. The current layout of the development around the corral meadow wetland is shown with the proposed sewer line access route which extends 27.3 yards into the remnant wetland.

Figure 2 shows the current layout of the development around the corral meadow wetland with the proposed sewer line.

The cumulative actions desired at and around the sand shed now and in the future include a documented action that would directly impact the corral meadow wetland. This entailed trenching a new sewage line from the sand shed to the existing main sewer line, which currently passes under the corral meadow wetland. This new sewage line would be placed through

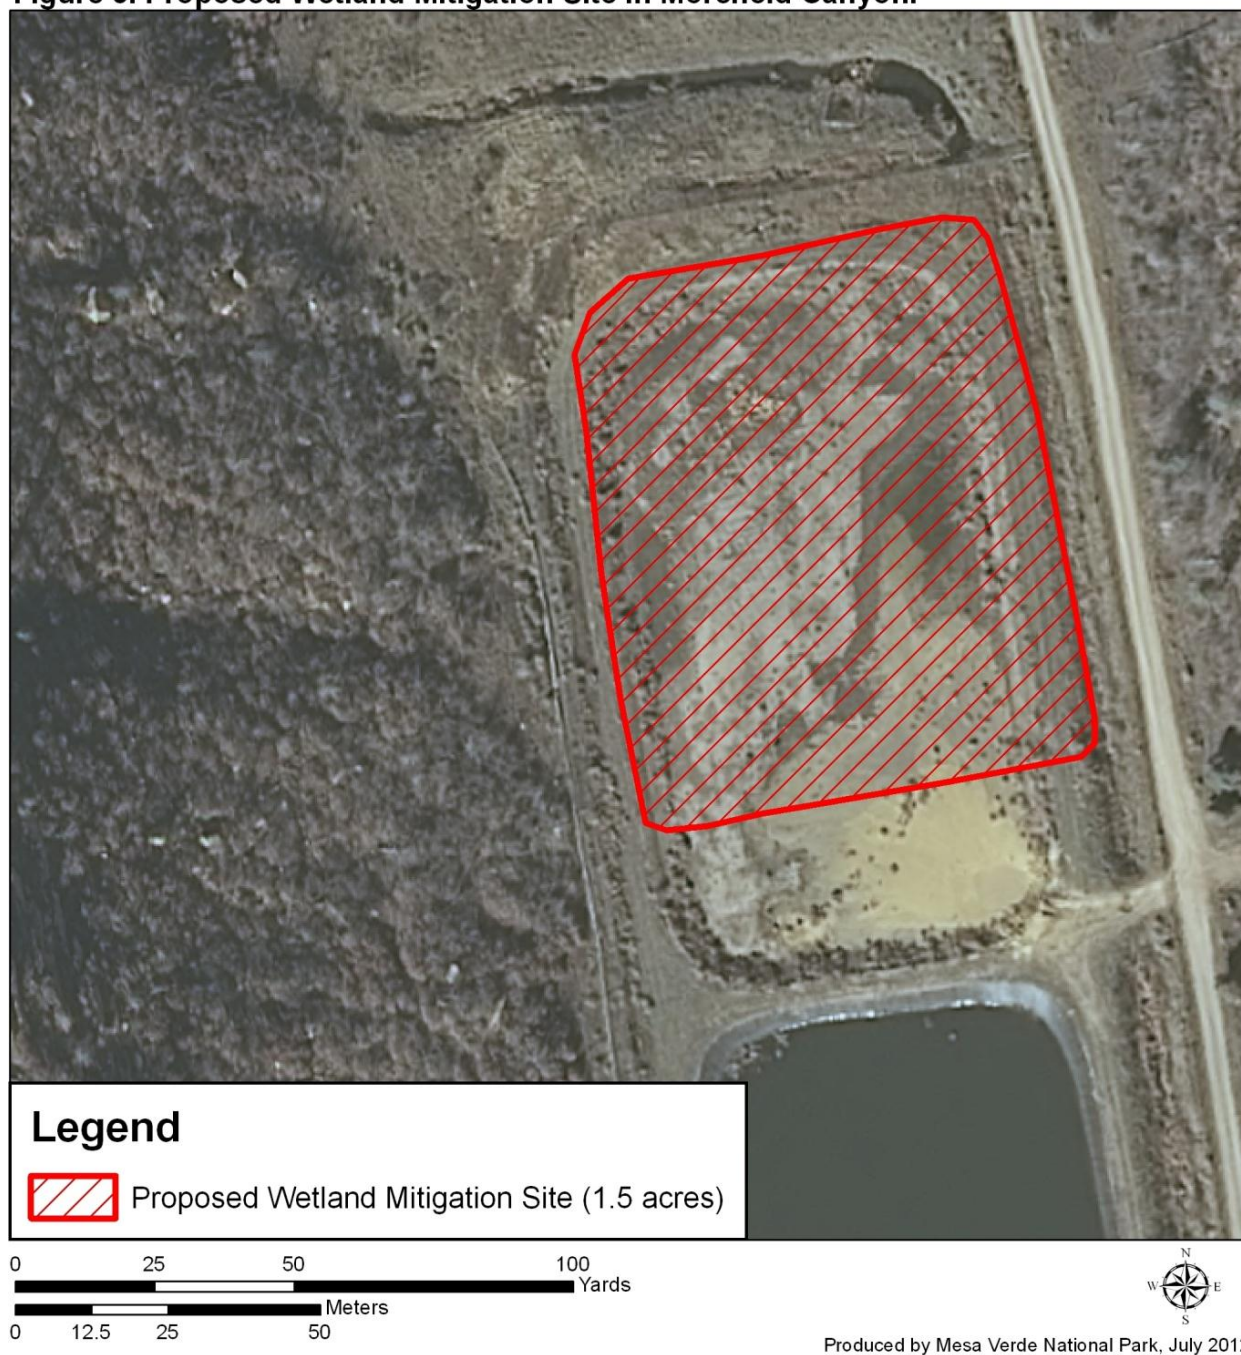
Figure 3. Proposed Wetland Mitigation Site in Morefield Canyon.

Figure 3. The proposed 1.5 acre wetland mitigation site is shown within abandoned cell 1 of the Morefield sewage lagoons.

Figure 3 shows the proposed 1.5 acre wetland mitigation site at the Morefield sewage lagoons.

The boundaries of the potential restoration site are delineated by surrounding physiographic features and infrastructure (Figure 3). On the north and east side of cell 1, the excavated ditch provides a well-defined boundary that already intersects the water table for a portion of the year. The west boundary of the project would ultimately be the existing hill slope. The southern extent of the project would be limited to some distance above cell 2, presently assumed to be the recently excavated cutoff ditch, which is about 50 feet north of cell 2's north levee. The actual footprint of the proposed wetland restoration includes the entire bottom area of cell 1 excluding the southern 50 feet or so, the entire east levee, and a portion of the north levee. The western levee, which grades into the existing hill slope, is identified as the disposal area for the excavated material. If an off-site disposal area or a different use for the excavated material is identified, then the actual wetland area could be expanded a little to include some of the footprint of the west levee.

- 1) Remove the east levee beginning near the inlet culvert and continue south to the end of the levee fill. The outer cut line (the east boundary) will begin at an elevation equal to the elevation of the ditch bottom and continue westward, matching design grade with the cell bottom (approximately 12" – 18" below present grade).
- 2) Remove approximately 12" – 18" of material (primarily bentonite) from the bottom of cell 1.
- 3) Reshape the top and side of the north levee creating topography conducive to willow and other riparian/wetland species establishment.
- 4) Place cut material on top of west levee matching grade with hillside.

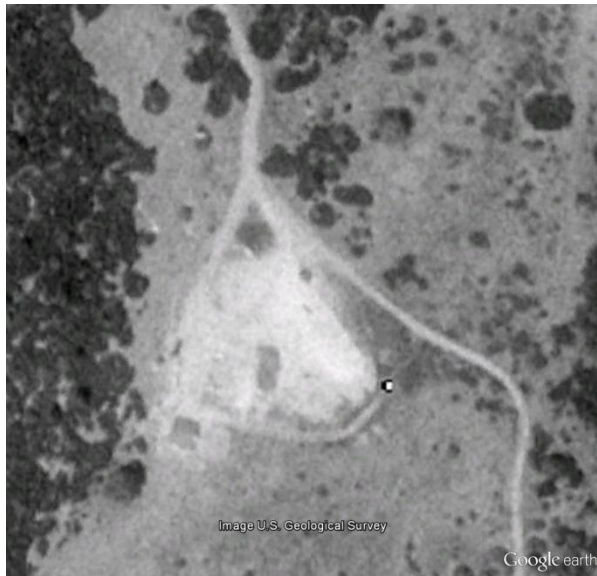
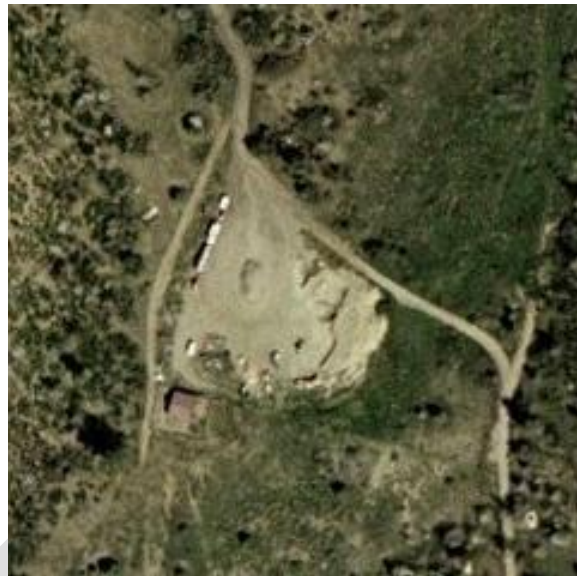
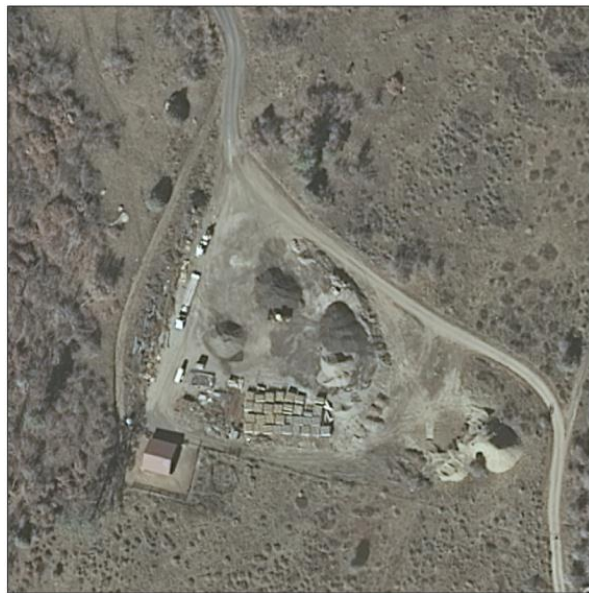
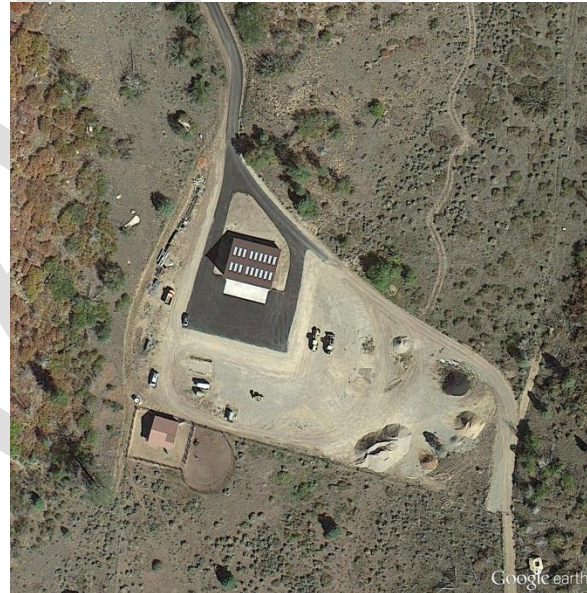
Figure 4. These aerial images show an expansion of the park maintenance fill pad and storage yard next to and into the corral meadow wetland from 1993 to after the sand shed's construction in 2012. (7/9/1993 and 10/6/2012 images obtained from Google Earth).

Figure 4 shows the expansion of the park maintenance operation next to the corral meadow wetland over the past 20 years.

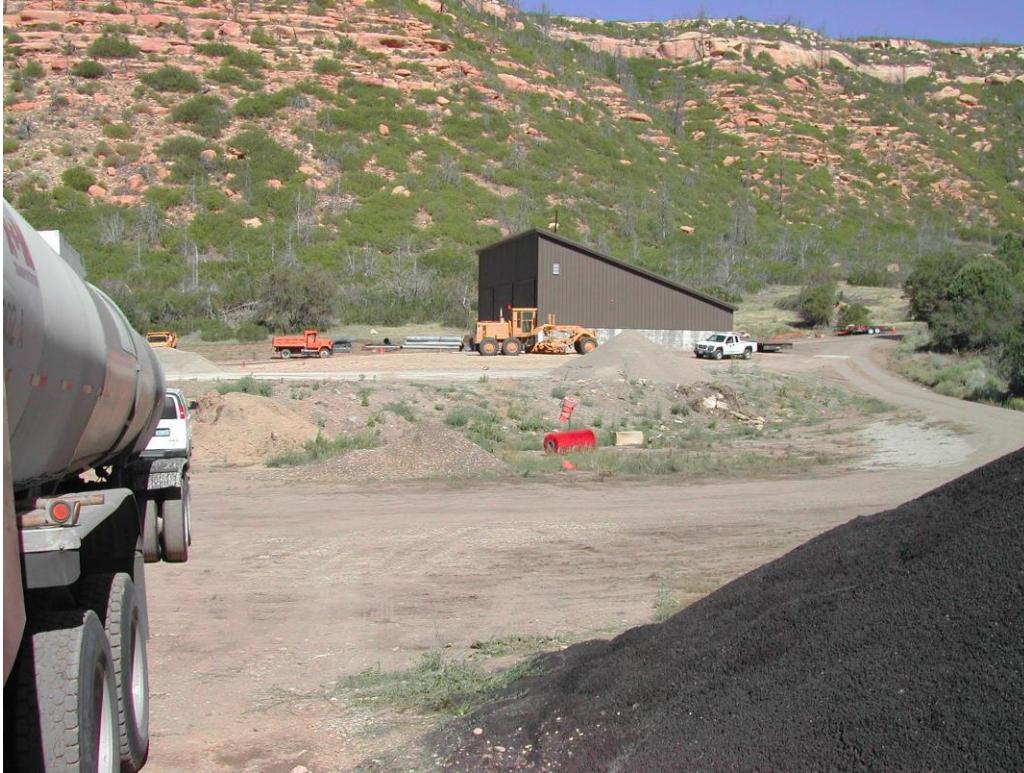
Photo 1. Center of the corral meadow wetland impacted by vehicle traffic and the piling of road maintenance supplies. Fill pad, storage yard, and sand shed are shown in the background.

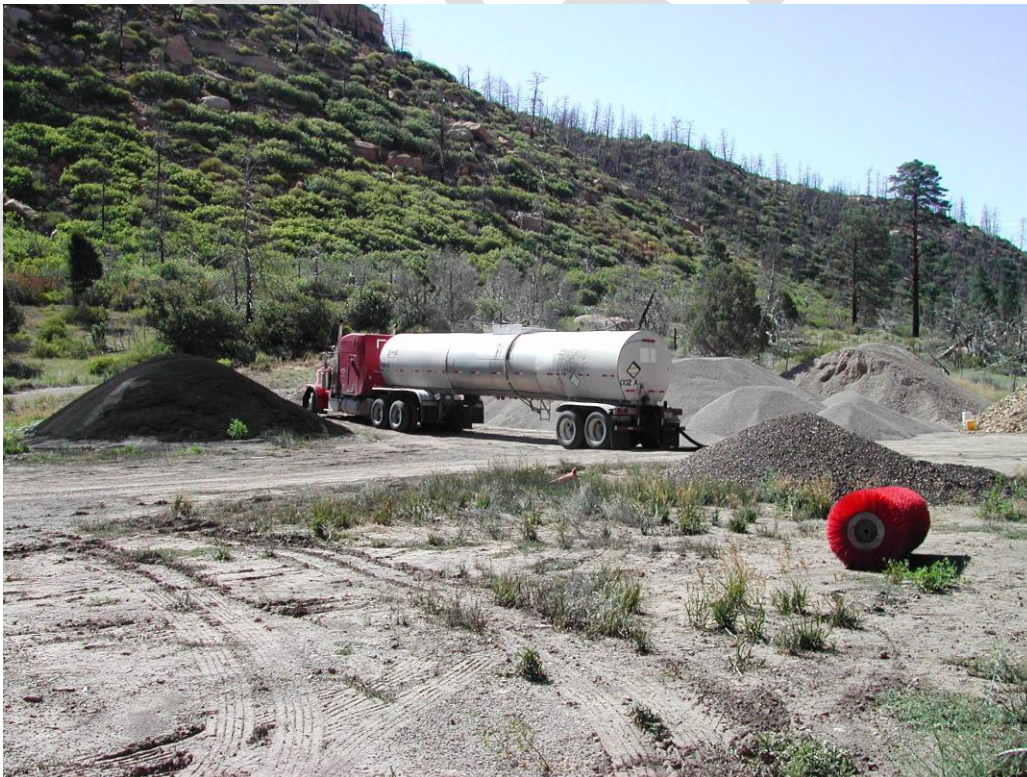
Photo 2. Main part of the corral meadow wetland experiencing heavy sedimentation and compaction from park maintenance operations.

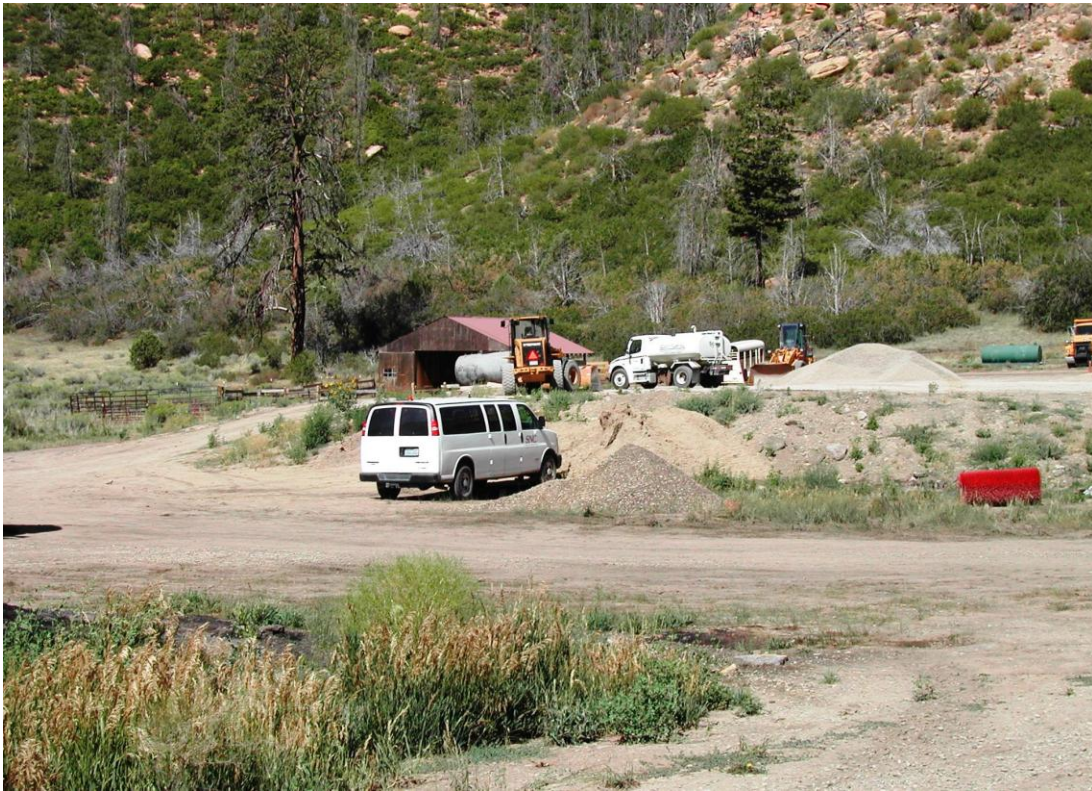
Photo 3. Morefield corral, barn, fill pad and storage yard next to the corral meadow wetland.

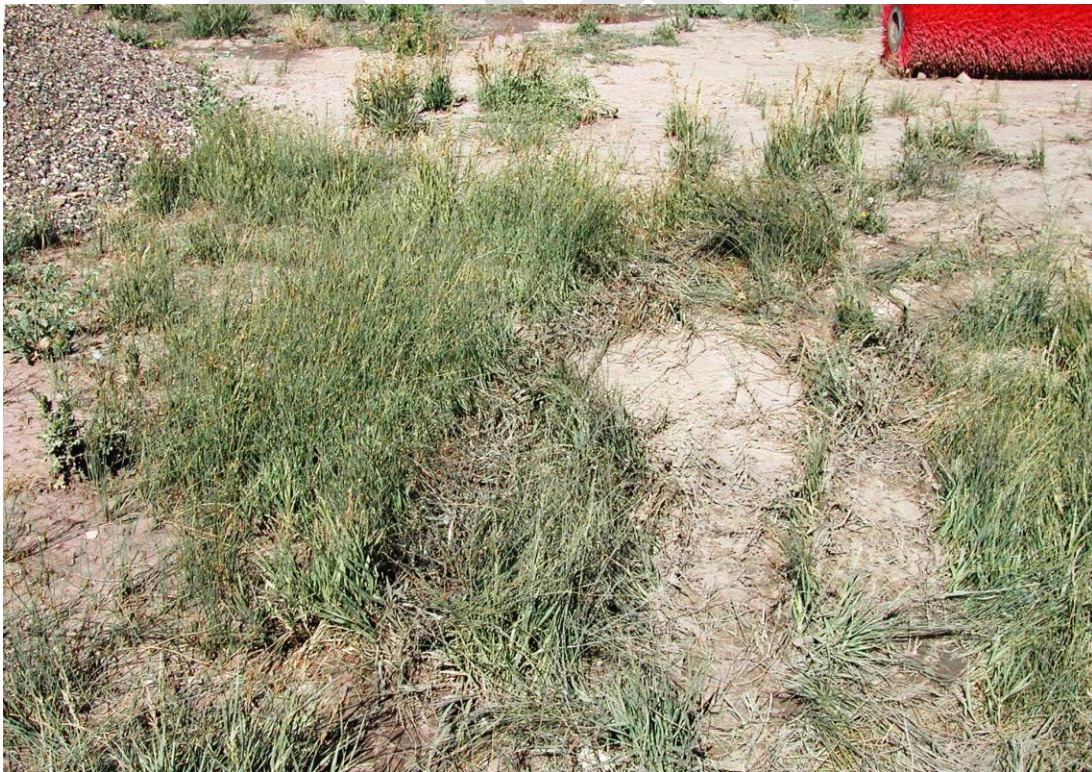
Photo 4. Patch 3 remnant rush wetland and weedy vegetation in the corral meadow wetland south of the access road in Morefield Canyon, affected by park maintenance operations.

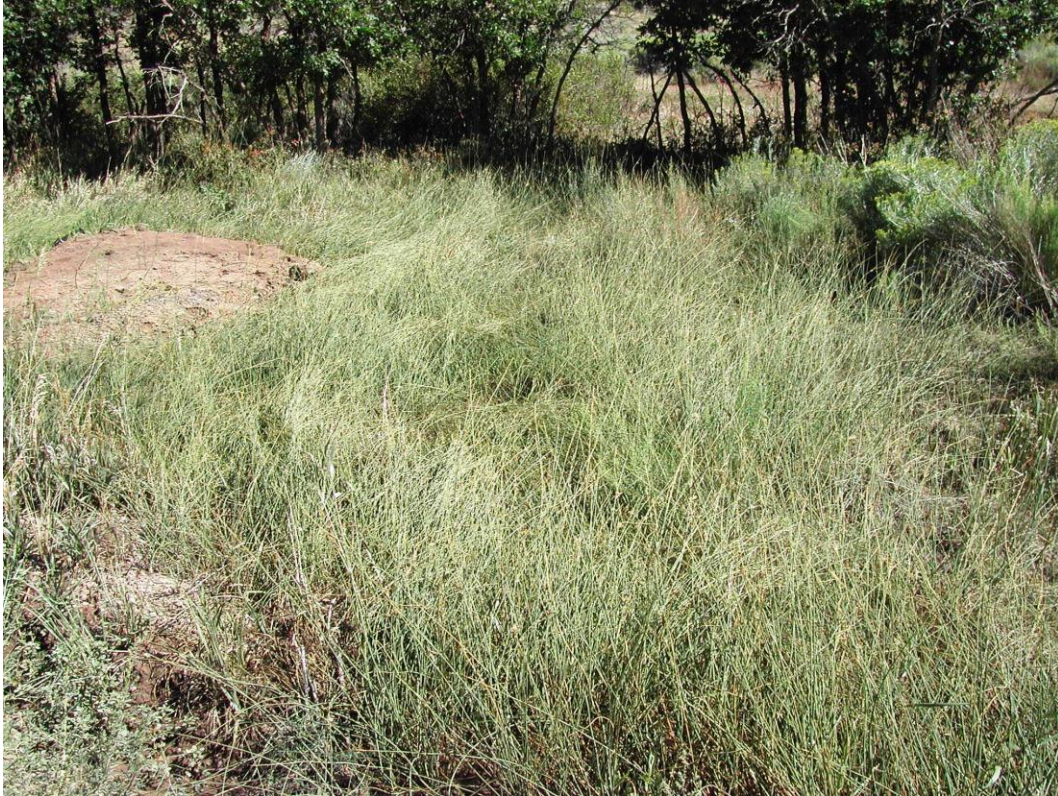
Photo 5. The remnant patch 2 of rush wetland vegetation on the north side of the access road in Morefield Canyon, the side less affected by park maintenance operations.

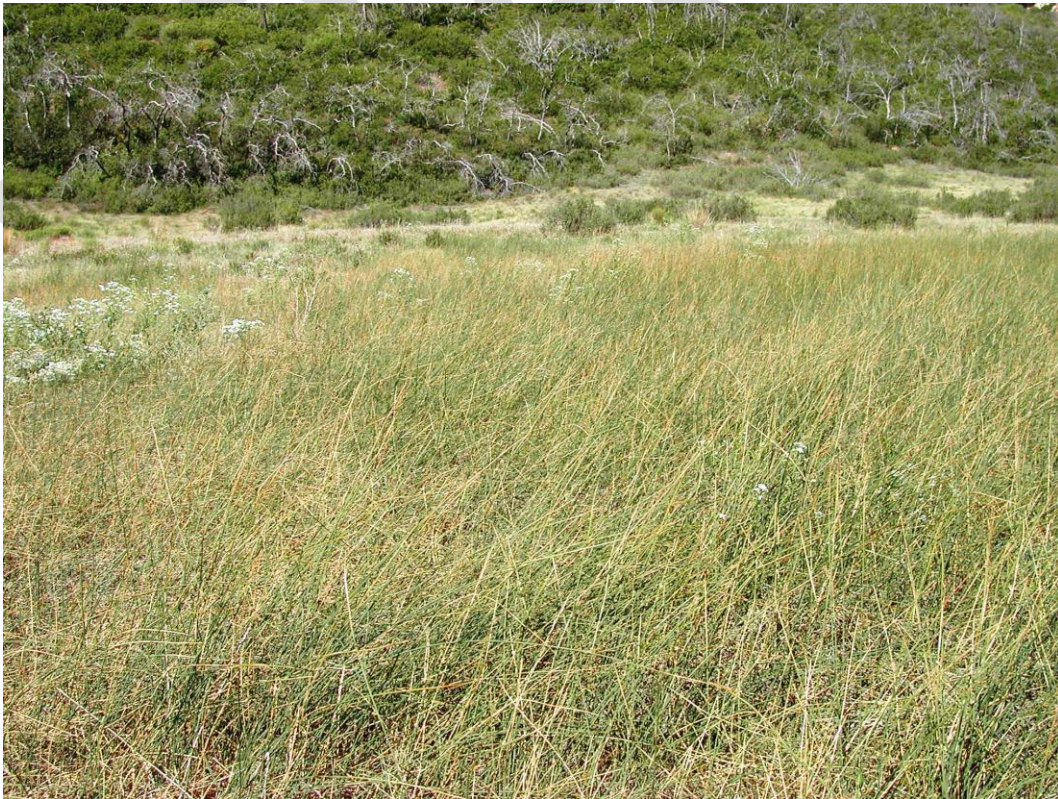
Photo 6. Sample view of the seasonally wet marsh habitat in Prater Canyon.

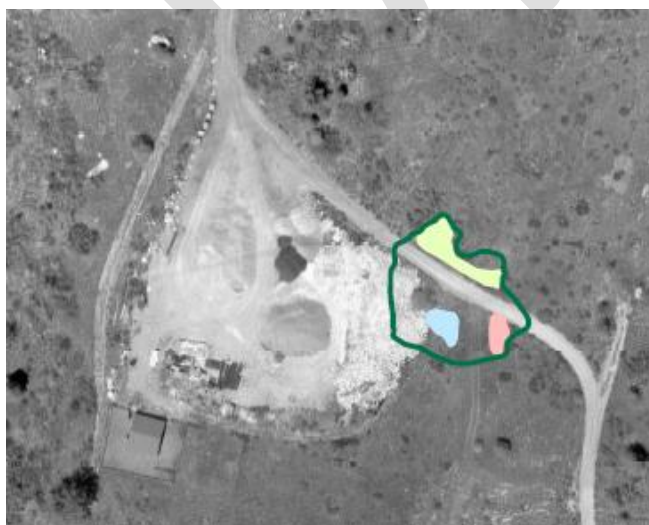
- Degraded wet meadow bisected by a road, approximately 13,667 ft² total area by GPS.
- Residual wetland vegetation persists in three patches.
- Two patches south of the road (patch 1 at 623 ft² and patch 3 at 801 ft² on attached map):

- Extremely degraded.
 - Growing through fill material and fines from adjacent gravel and soil piles.
 - Subjected to heavy equipment traffic.
- One patch north of the road (patch 2 on attached map at 1,833 ft²):

- Retains more wetland characteristics than patches 1 and 3.
 - Moderately impacted by fines from the gravel road and adjacent soil pile.
 - Plant cover (mean of two 1-m² plots):
