Elkhorn Tavern / Williams Hollow

This section describes and evaluates the existing landscape conditions of the Elkhorn Tavern / Williams Hollow landscape character area. The existing condition plan for the landscape character area is located at the end of this section (Figure 3-154) followed by an the existing condition plan for the immediate area of Elkhorn Tavern (Figure 3-155).

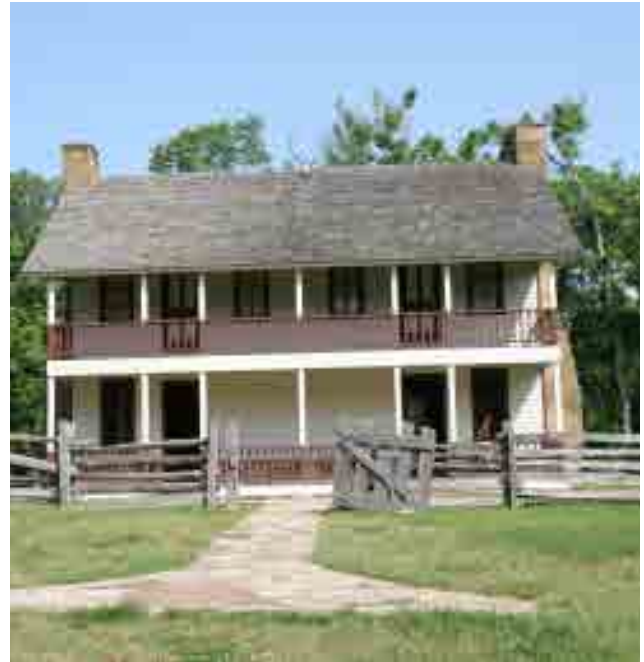
Figure 3-118. Elkhorn Tavern, 2013 (MB: IMG_5746.jpg).

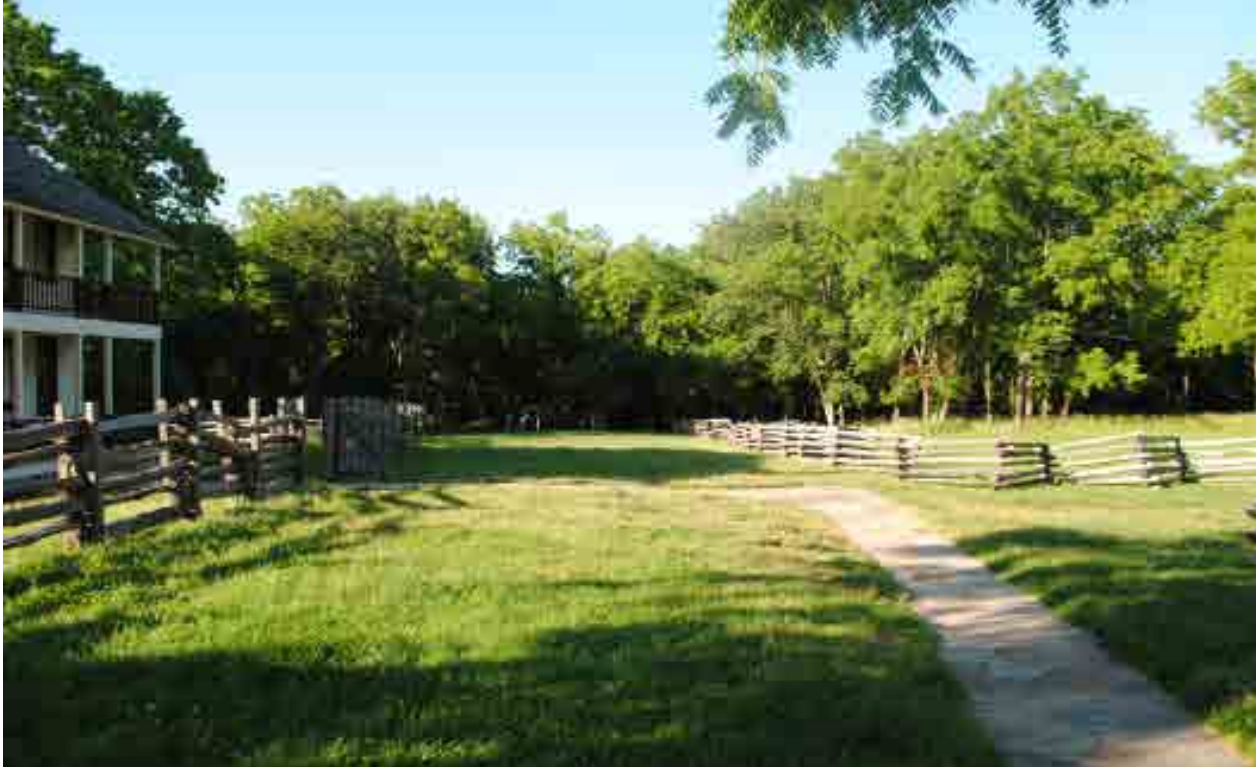
Figure 3-119. Elkhorn Tavern and its immediate surroundings consist of an open clearing of small fields defined by fences. The building is towards the north edge of the clearing (MB-DSC_0200.jpg).

Immediately surrounding Elkhorn Tavern are open clearings of smaller fields defined by fences with the building set near the northwest edge of the space. Northwest of the building is the dense forest vegetation and steep topography of Elkhorn Mountain that defines the north and west edges of the space. Between the building and hillside is a contemporary orchard of small fruit trees. Fields occur to the south and southwest. Extending from the center of the building to the east is the mown path that indicates Huntsville Road. Another mown path to the south of the building indicates the alignment and linear space of Telegraph Road.

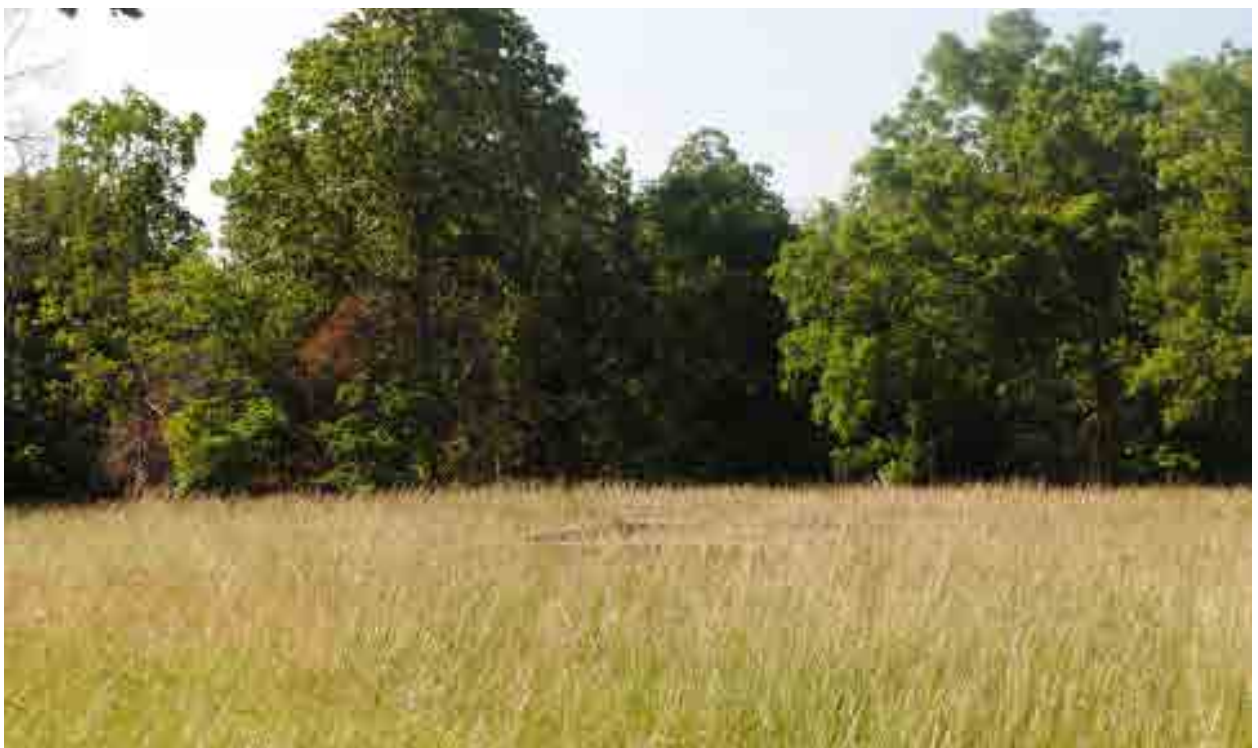
Figure 3-120. The Clemens' House site and field is a smaller clearing, visually and spatially separated from Elkhorn Tavern by densely forested woodlands (MB-DSC_0385.jpg).

The Clemens' House site and field are a smaller clearing, visually and spatially separated from Elkhorn Tavern by densely forested woodlands. The two spaces are connected by the mown path of Huntsville Road. The Clemens' House site is a relatively level open field edged by a fence on two sides, and by dense woodlands on the west, north and east. On the north, the space is bounded by the forest and Williams Hollow.

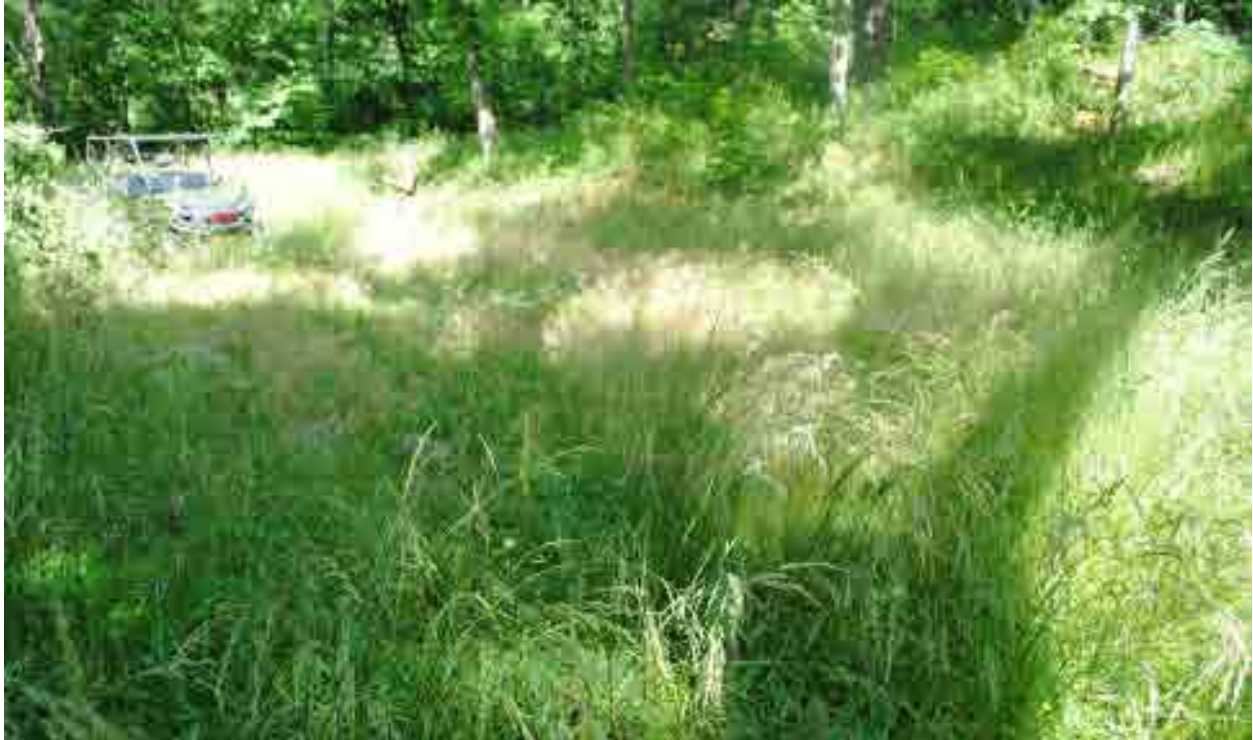
The tanyard is a small clearing located approximately three-quarters of a mile to the northeast of Elkhorn Tavern along Telegraph Road. The clearing is set within the steeply descending topography and narrow ravine of Cross Timber Hollow. Across Broad Ridge

Figure 3-121. The tanyard is a small clearing, located approximately $\frac{3}{4}$ mile to the northeast of Elkhorn Tavern along Telegraph Road. The clearing is set within the steeply descending topography and narrow ravine of Cross Timber Hollow (MB-DSC_0382.jpg).

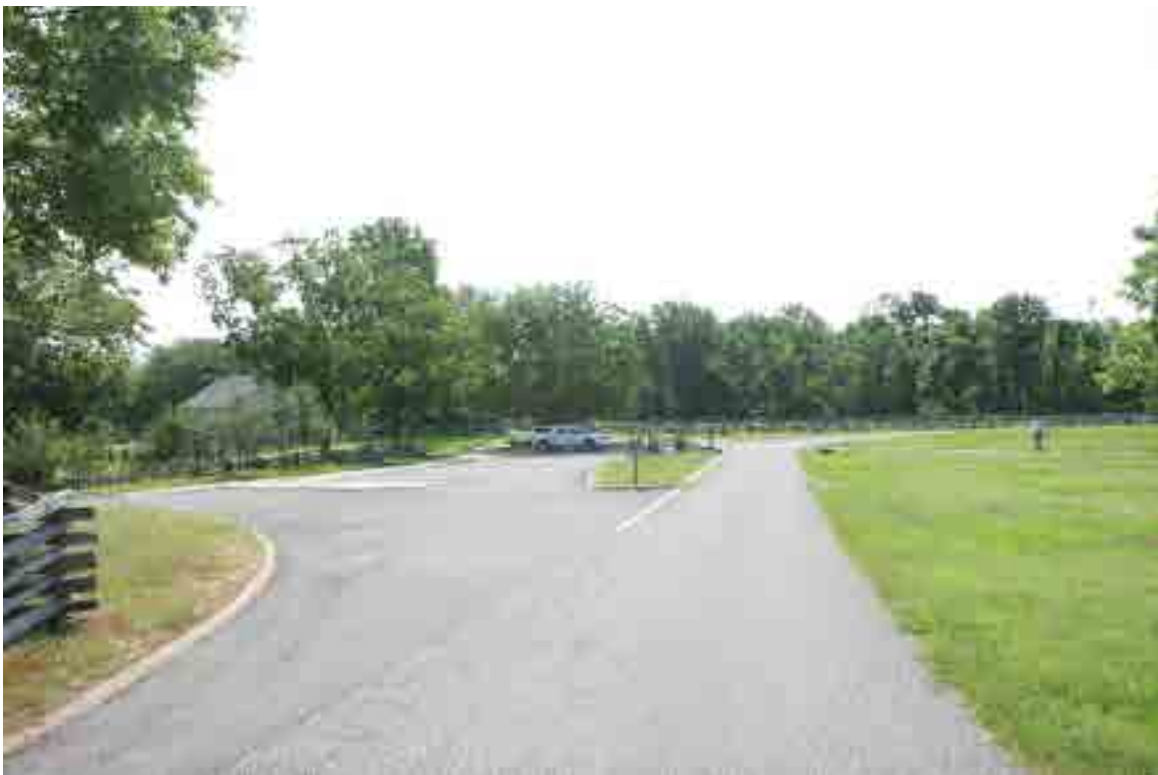
Figure 3-122. The Tour Road and parking area at the Elkhorn Tavern disrupts the spatial organization of the historic setting. The road crosses what was historically an open field (MB: IMG_5717.jpg).

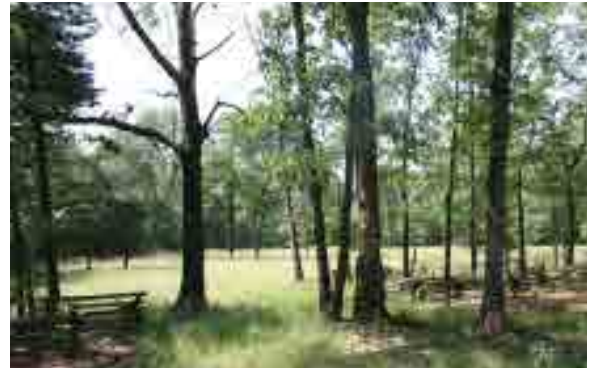
Figure 3-123. The smaller Clemens' Field (MB-DSC_5791.jpg).

The spatial arrangement of Clemens' House site and field remain similar to that which existed during the period of significance. The loss of the Clemens' buildings and structures (outbuildings and a barn) has diminished the spatial arrangement. The delineation of open fields edged by dense forest assists in presenting the historic spatial organization. The relationship between Clemens' Field and the steep topography to the north remains as it was during the period of significance. The tanyard is spatially very similar to its

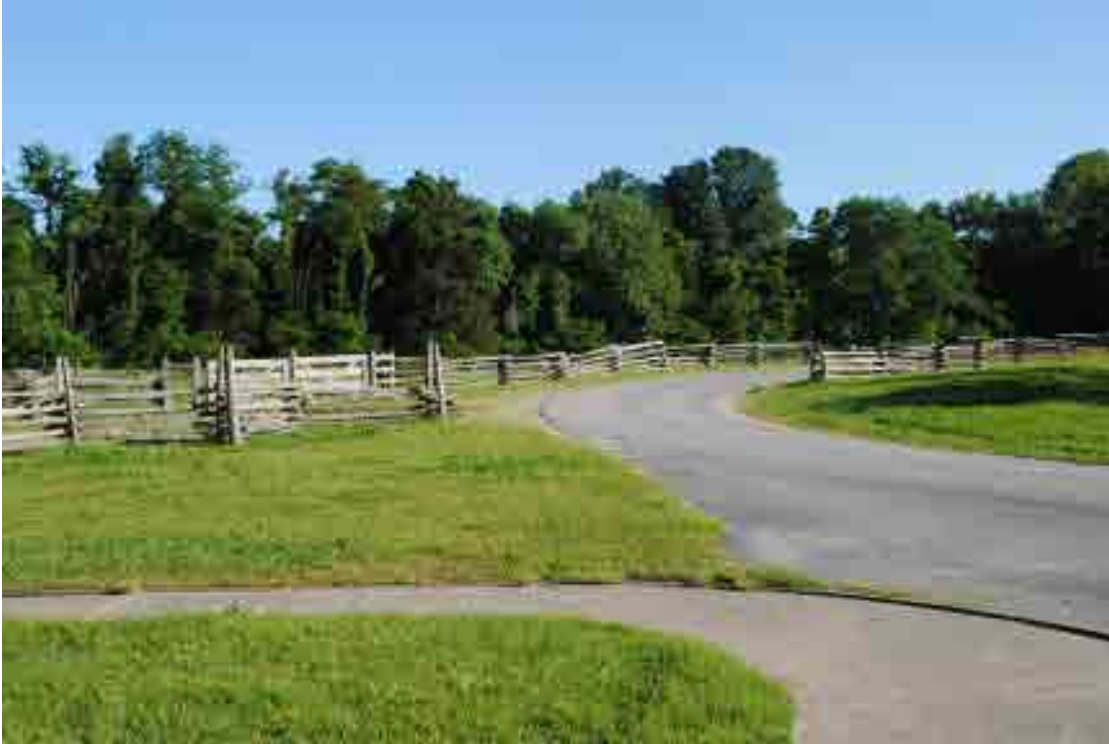
Figure 3-125. The Tour Road extends westward from Elkhorn Tavern towards the visitor center as a one-way route. Portions of the road, east of Elkhorn Tavern, disrupt the original Telegraph Road alignment (MB: DSC_0190.jpg).

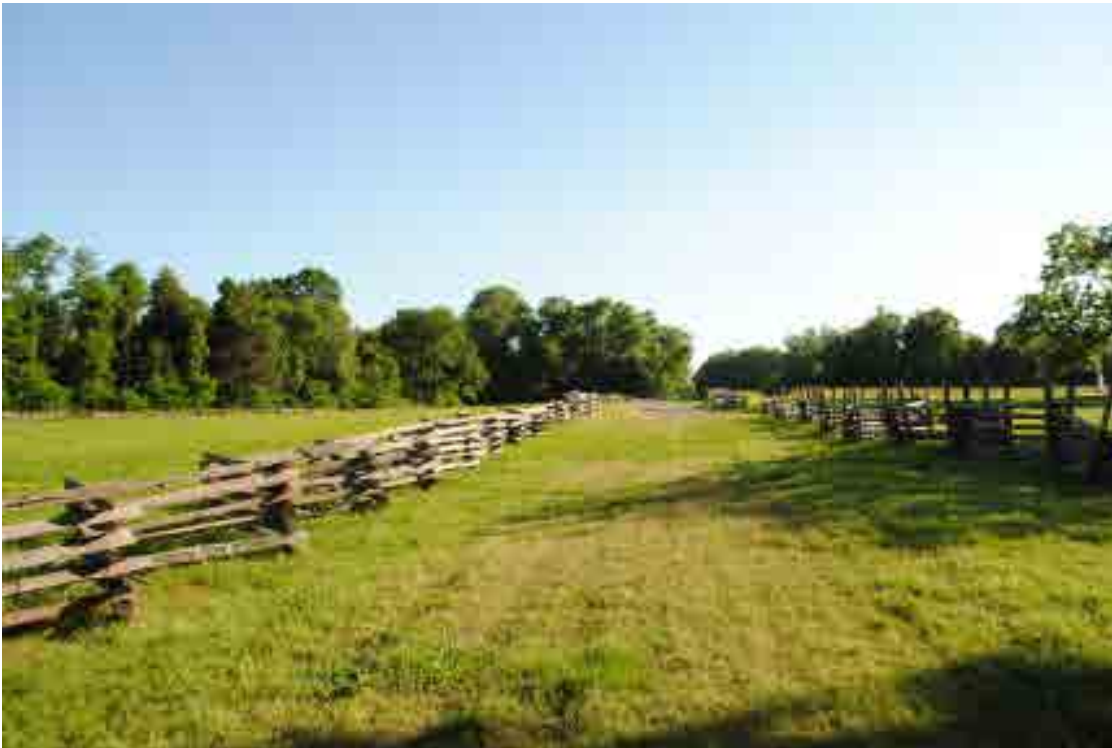
Figure 3-126. Telegraph Road, just east of the Elkhorn Tavern. The route is no longer used in this location and is maintained as mown grass (MB: DSC_0197.jpg).

At Elkhorn Tavern, Telegraph Road is a mown path, lined by fences. Just beyond, it becomes a narrow worn two-rut road and then a rocky road trace as it enters Cross Timber Hollow. Southwest of Elkhorn Tavern, the Tour Road overlaps the historic alignment of Telegraph Road. In this location, the road is one-way and surfaced with asphalt.

Telegraph Road is in poor to good condition.

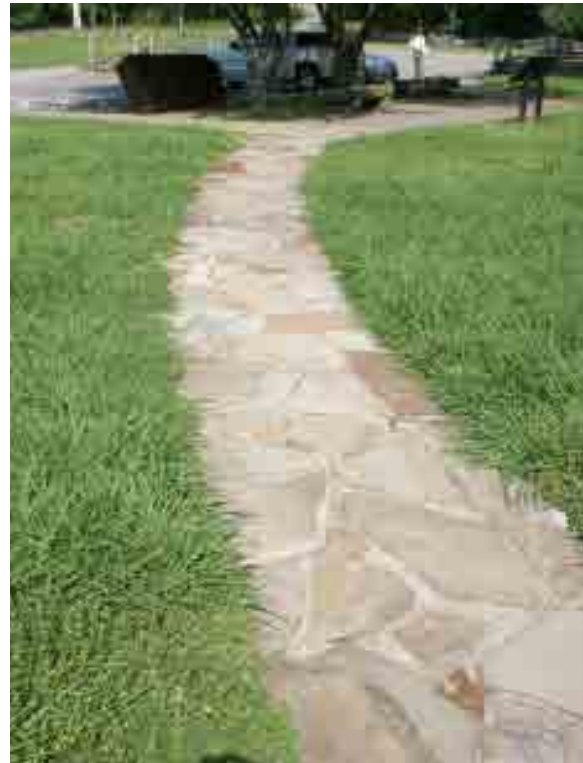
Figure 3-127. The flagstone walkway from the parking area to the Elkhorn Tavern (MB: IMG_5739.jpg).

A narrow pedestrian path connects the parking area along the Tour Road with the entrance to Elkhorn Tavern. The flagstone path is approximately four-feet wide and widens near the parking area to provide space for seating. The path is in good condition.

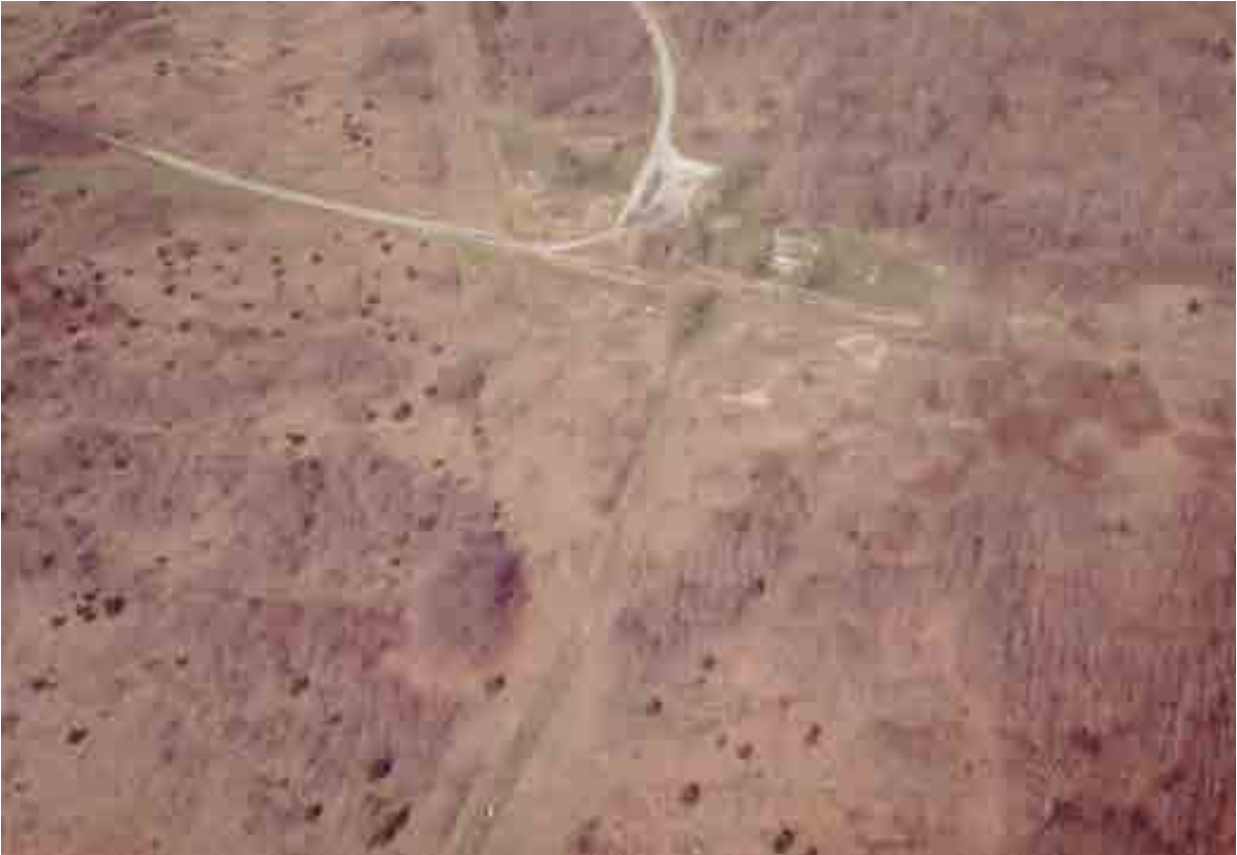
Figure 3-128. In the 1960s, the Tour Road and parking area were built to the west of Elkhorn Tavern. Telegraph Road extends east/west in front of (southeast) of the building and Huntsville Road extends east. The road trace of Old Highway 72 is visible in this aerial photograph. Today it is no longer evident (PICT0116).

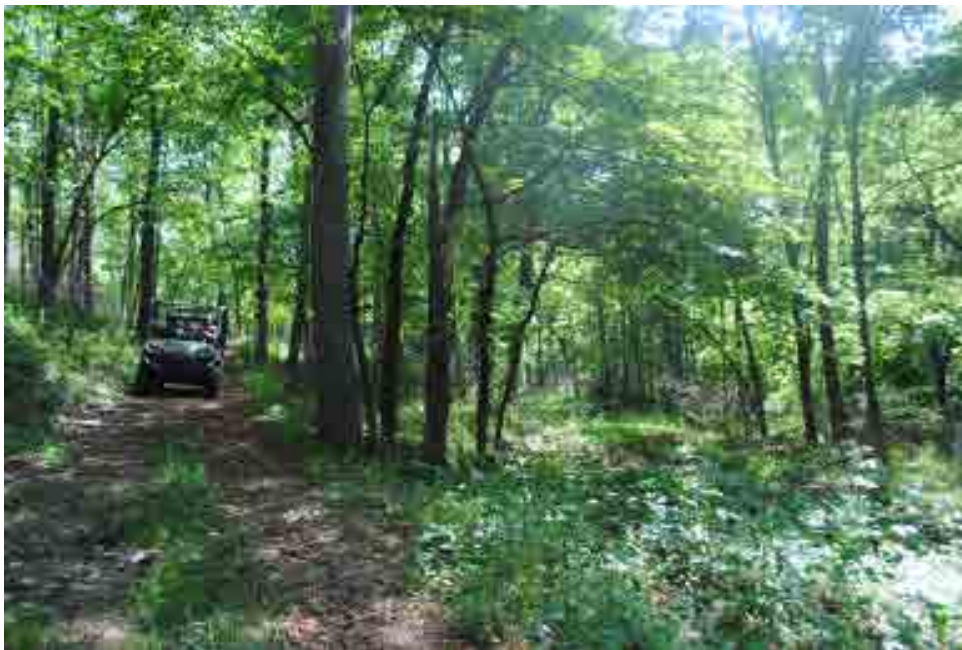
Figure 3-129. Telegraph Road near the tanyard (MB: DSC_0356.jpg).

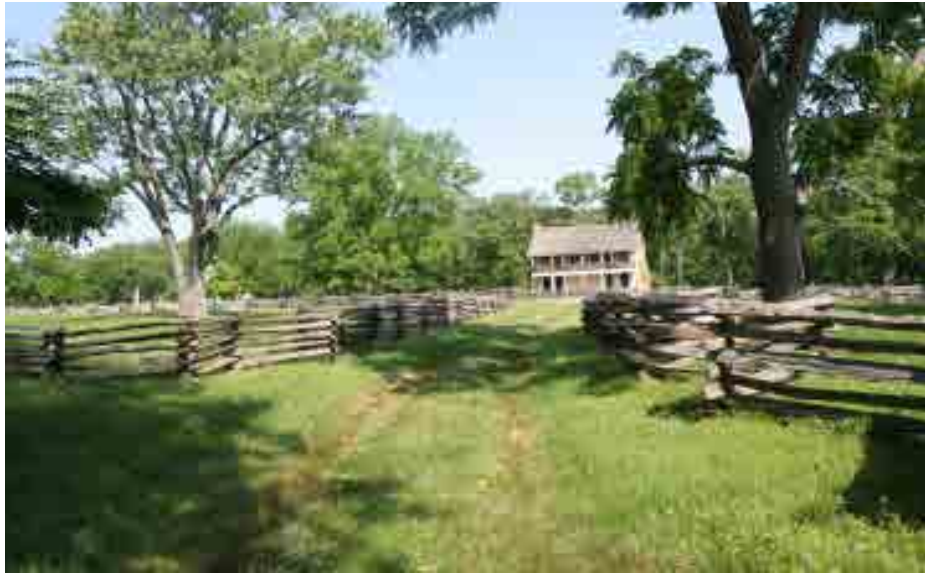
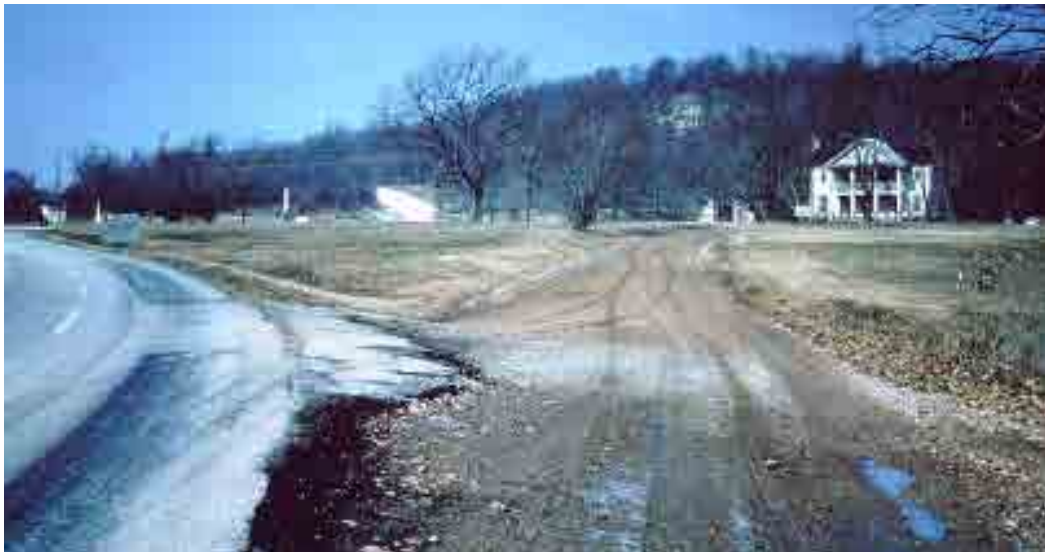
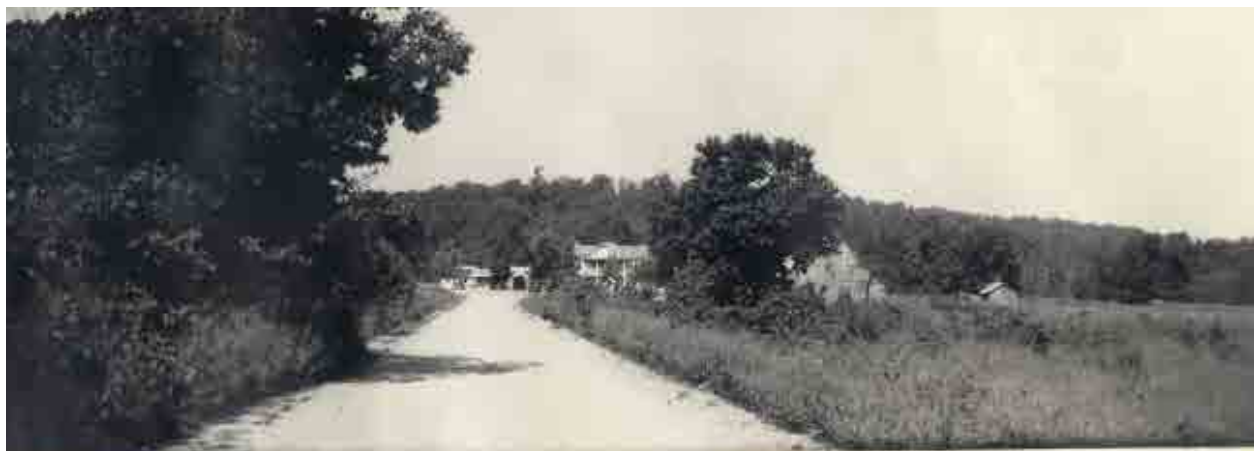
Huntsville Road is a grass-covered road trace that provides a pedestrian path from Elkhorn Tavern to Clemens' House and field. The road is in fair/good condition.

Figure 3-130. Present-day Huntsville Road is a narrow two-track route lined by worm fences, top (MB: IMG_5752.jpg). Huntsville Road, c. 1960s, center (PICT0048.jpg). Huntsville Road, c. 1940s, bottom (copy of Elkhorn Tavern and Museum with mountain and tower in background-1940).

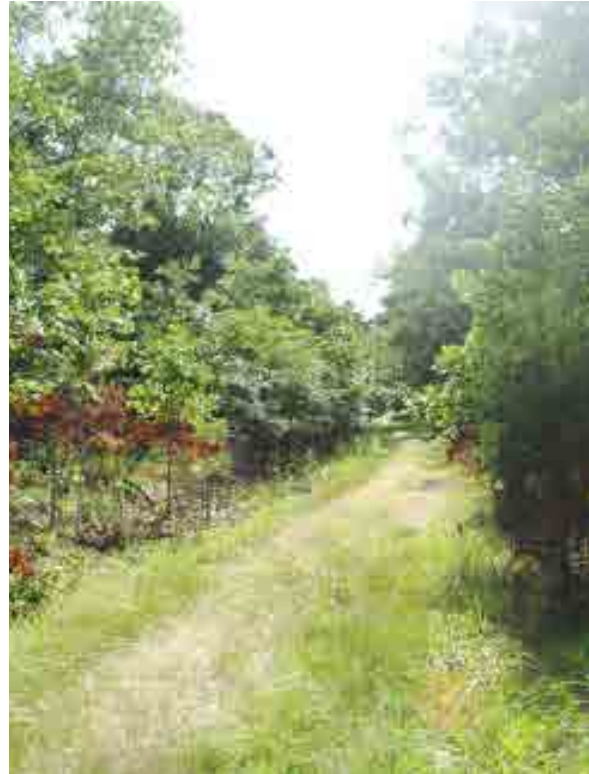
Figure 3-131. Huntsville Road is a two-rut track, maintained as a mown path. (MB: DSC_0382.jpg).

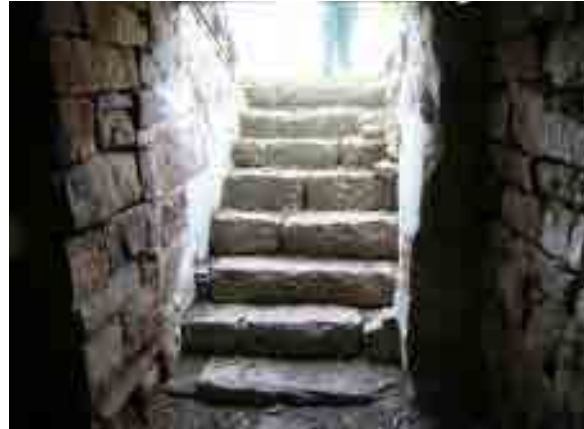
The building retains important historic fabric, namely the 1865 south chimney and the stone foundation originally rebuilt by the Cox

Figure 3-132. The stone foundation and basement of the Elkhorn Tavern were initially rebuilt using original materials from the period of significance. (MB: IMG_5774.jpg)

family. It has been reconstructed to resemble its battlefield appearance using available documentation.

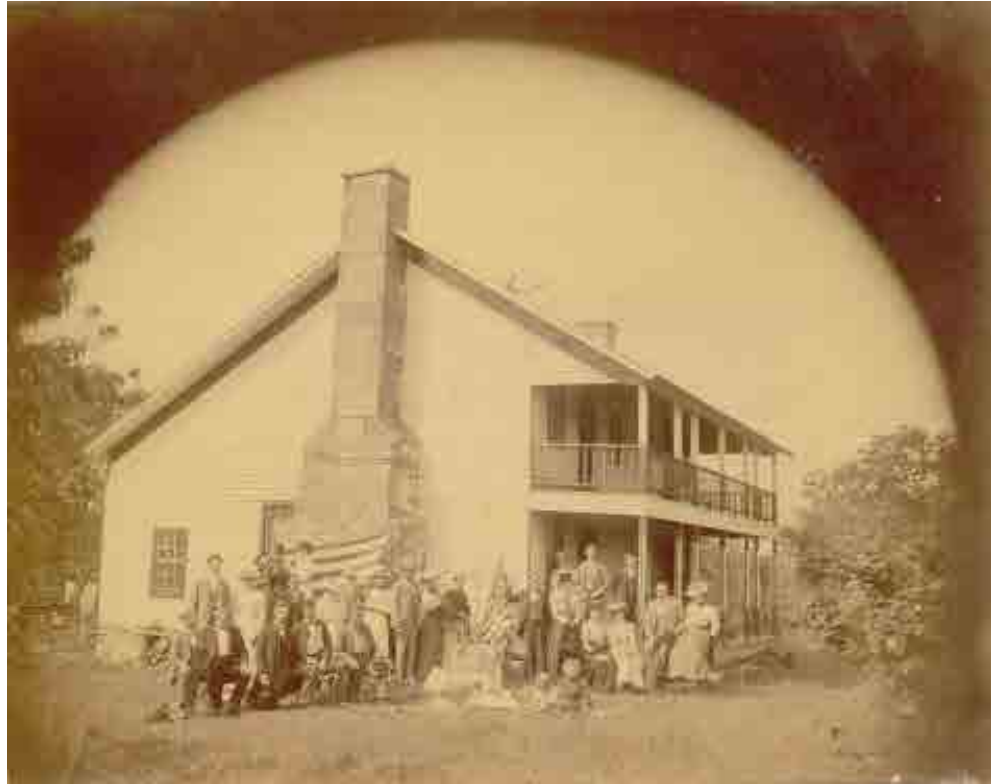
Figure 3-133. Elkhorn Tavern was destroyed after the Battle of Pea Ridge and rebuilt c. 1866 by the Cox family (Ceremony at Tavern_c1880_PRNMP.jpg).

set on a stone foundation with two stone chimneys and a full-length porch. Prior to the Civil War, Elkhorn Tavern served as trading post, post office, and place of worship as well as a tavern. It was well-known as an unofficial stop for the Butterfield Overland Stage where travelers along Telegraph Road stopped to eat, rest their horses and stay the night. The building was rebuilt by the Cox family after it was burnt in 1863, using stones from the original building for the new foundation and chimneys.

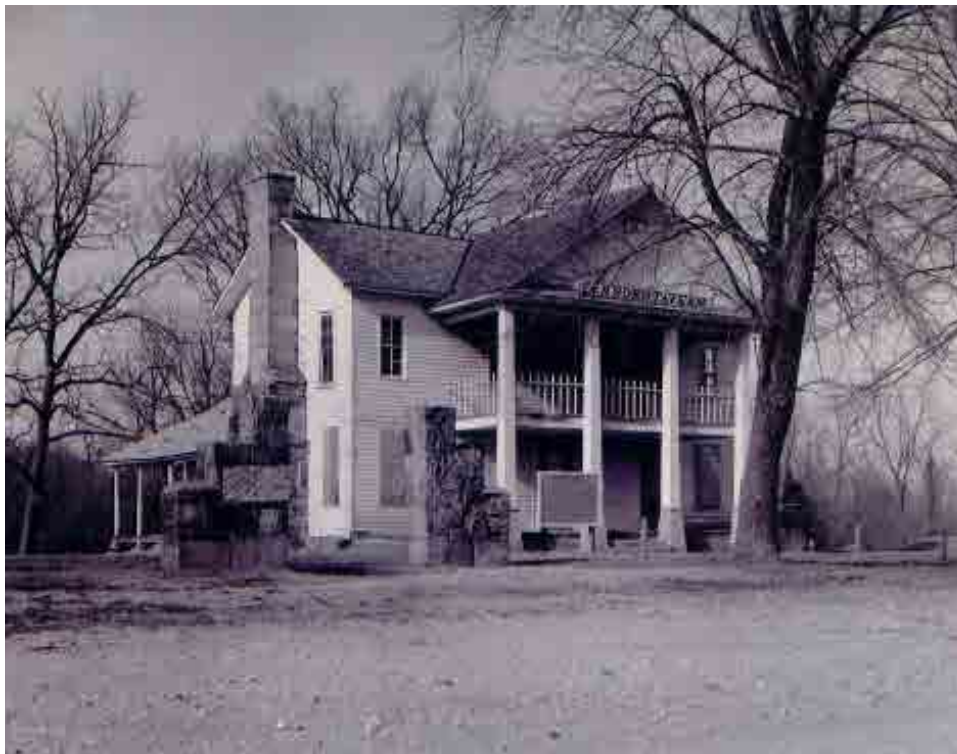
Figure 3-134. When the park was established, Elkhorn Tavern had a single-story addition on the west side. A stone wall was in front of the building, which once held a sign stating that it was the site of the Butterfield Overland Stage route (Southeast corner, front and south walls circa 1960.jpg).

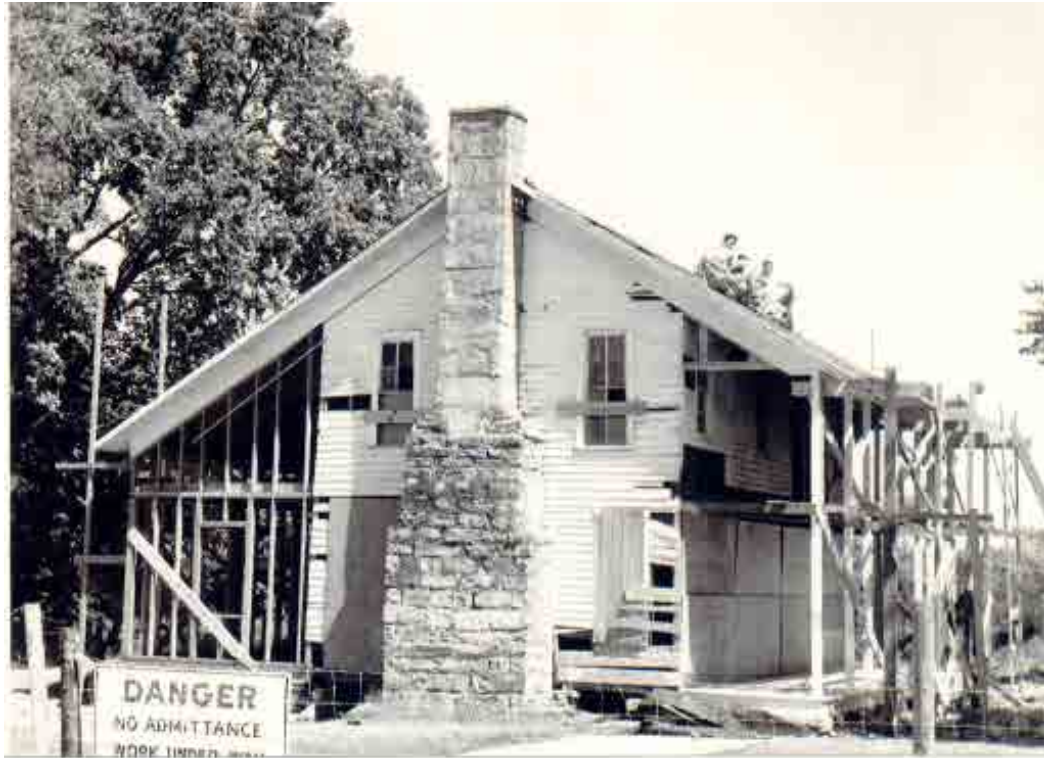
During the 20th century, the building served as a museum. The NPS took ownership in 1960, and in 1964, the building was partially demolished due to the deteriorated condition and early 19th century modifications. The NPS reconstructed the building to resemble its 1880s appearance, taking five years to complete.

Figure 3-135. Elkhorn Tavern was rebuilt in the 1960s to reflect to its 1880s appearance. Work included removing the rear (west) extension and modifying the double porch at the building's front facade (B&W Southeast corner under restoration.jpg).

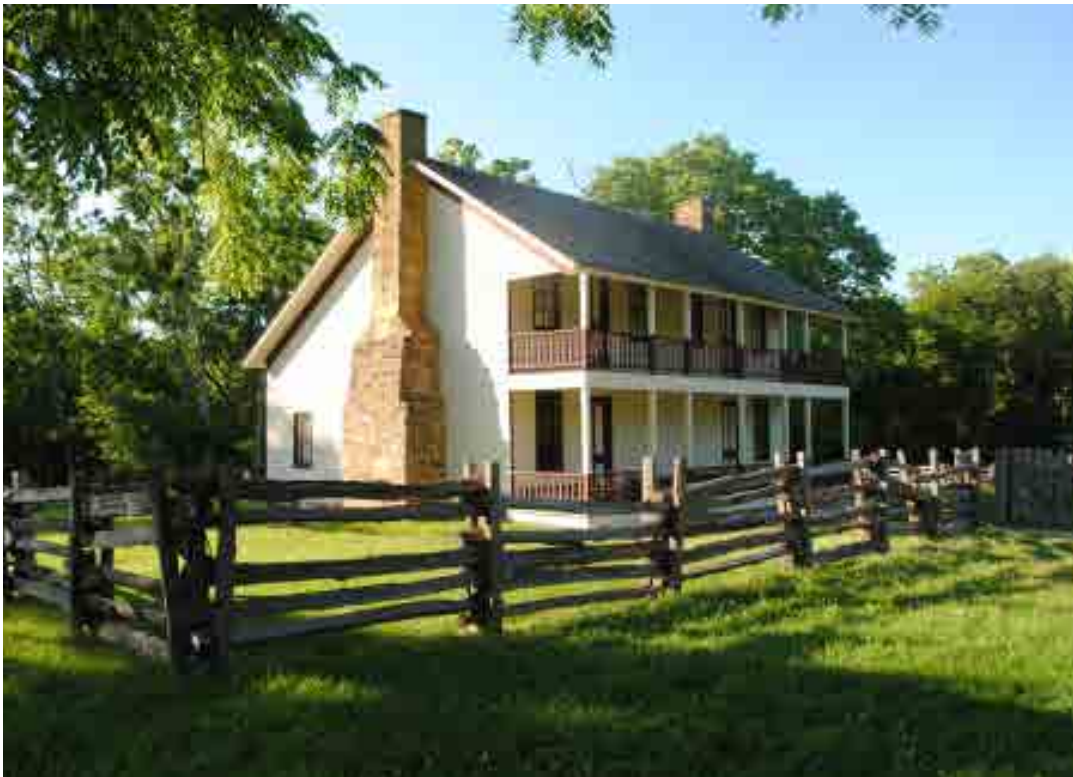
The standing building was rehabilitated by the NPS in 1964, to resemble its appearance as noted in a 1880s photograph.^{3.90} Set on the original foundation stones, the building is a clapboarded two-story structure with a covered porch that extends for the full length of the south façade on both floors. Twin stone

chimneys flank the east and west façades. The building is painted white and has a skull of an elk on the roofline as it had during the battle. The building consists of a basement, first floor and second floor. The building is in good condition.

Figure 3-136. Elkhorn Tavern, 2013 (MB: DSC_0199.jpg).

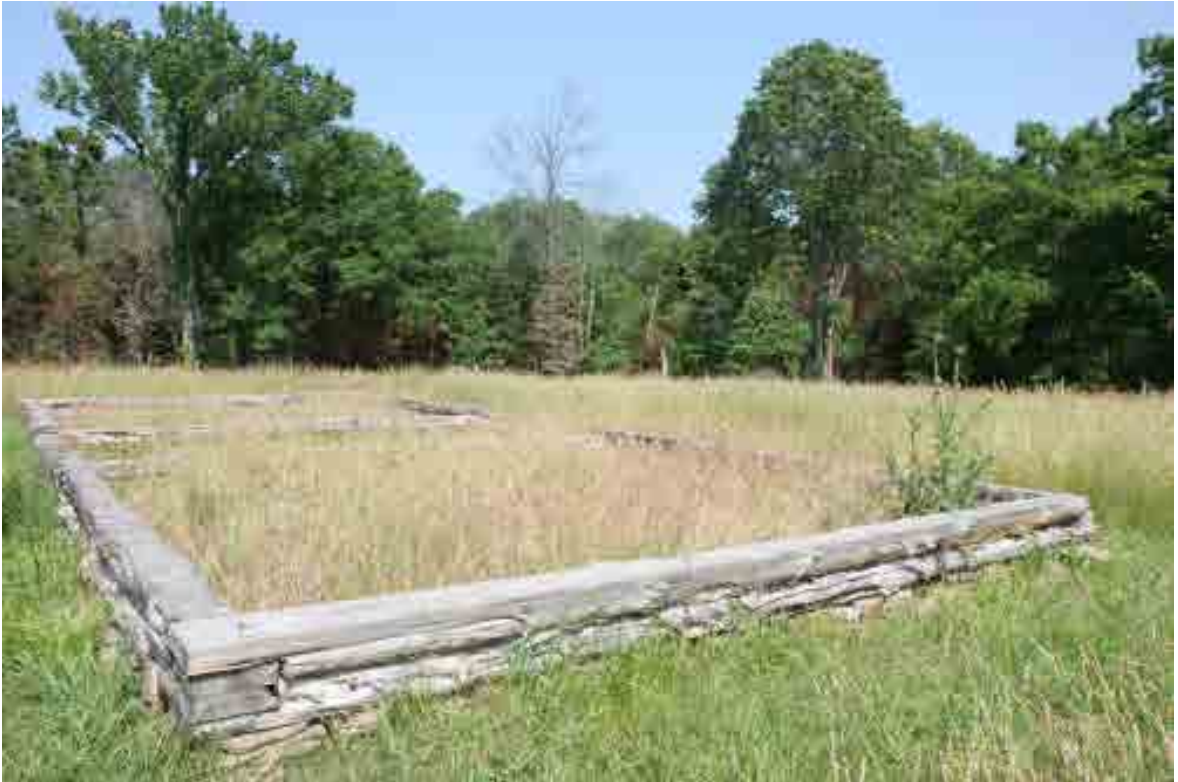
Figure 3-137. The Clemens' House foundation was semi-reconstructed by the park (MB:IMG_5779.jpg)

The foundation of the Clemens' House is extant and consists of fieldstone in a rectangular shape of thirty-two-feet by fourteen-feet. The foundation was made more visible by the park when they added a course of wood logs adjacent to the original stones. The Clemens' House foundation is in good condition.

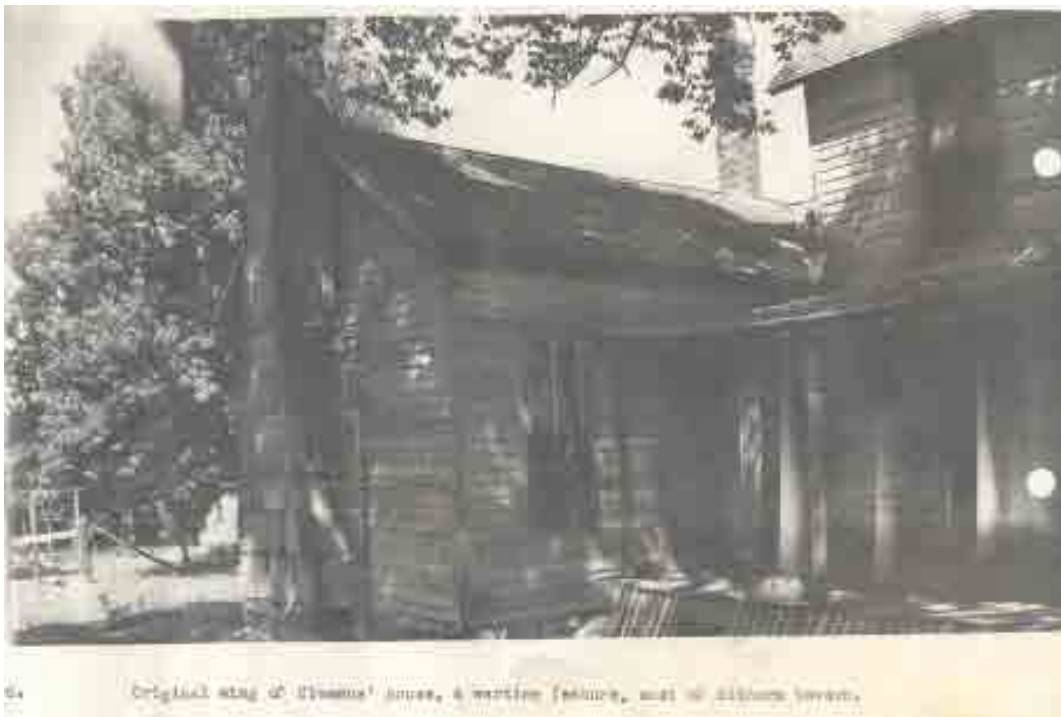
Figure 3-138. A portion of Clemens' House that was standing at the time of the battle was still extant in 1940. Today, this building is non-extant. It is unknown when it was removed (Original wing of Clemens' House-1940. jpg).

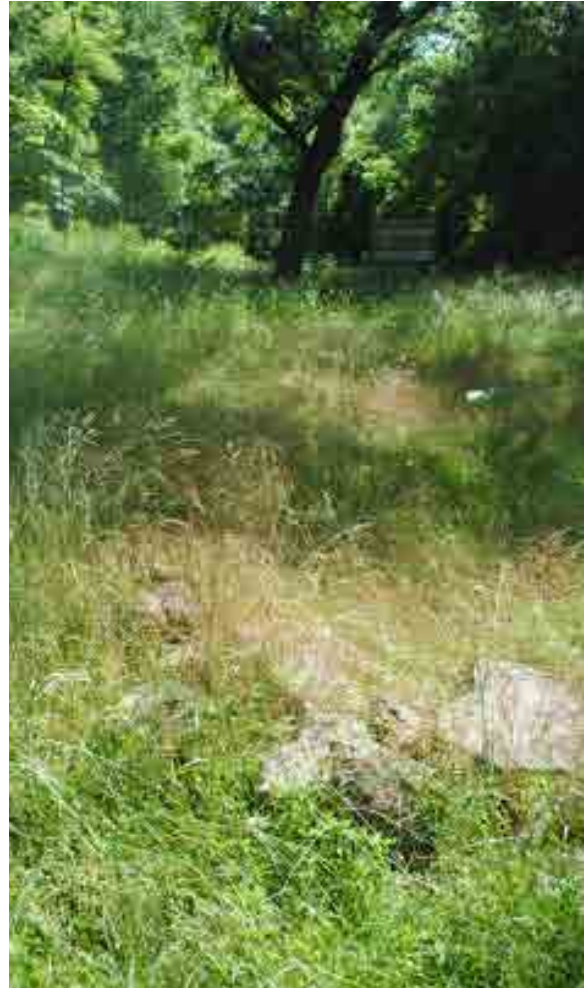
This structure is non-extant, but the stone foundation is visible. During the June 2013 field investigations, the foundation was difficult to discern due to overgrown vegetation, primarily tall grasses, obscuring the feature.

The extant foundation is most likely that of the Bart Green house that was built after the battle over one of the earlier tanyard vats. The house was removed after the park was established in the 1960s.

Figure 3-139. Extant stone foundation at the tanyard (MB-DSC_0360.jpg)

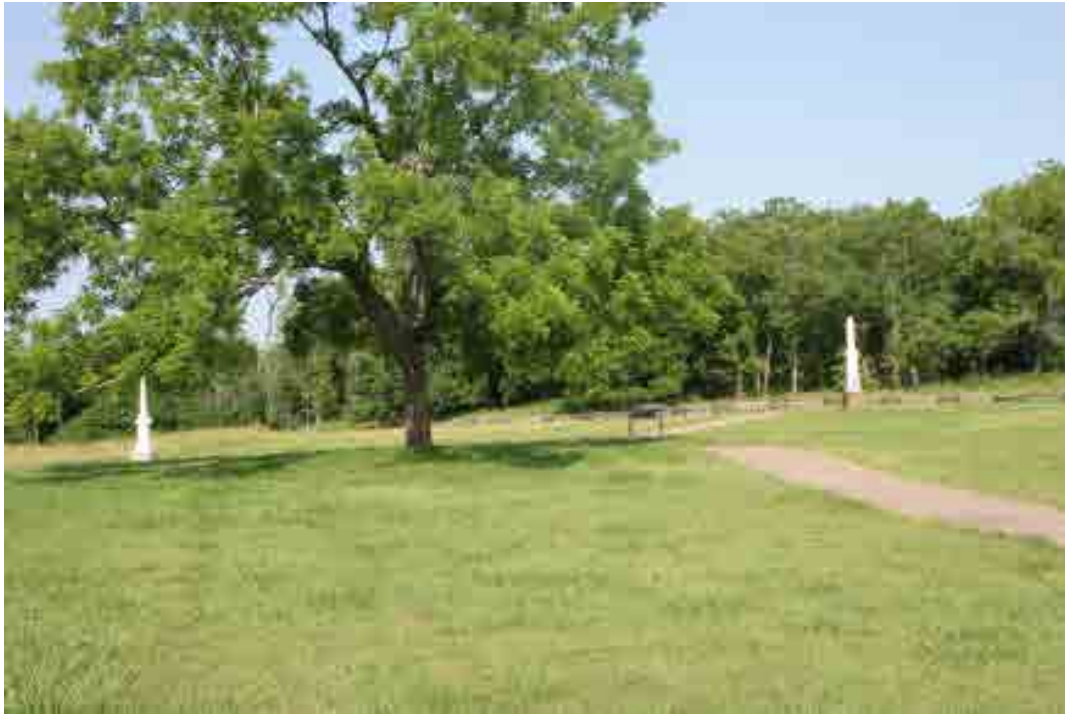
Figure 3-140. The two commemorative monuments are located across the Tour Road from Elkhorn Tavern (MB: IMG_5706.jpg).

A concrete path connects the parking area associated with the Tour Road with the two commemorative monuments south of the road. The path is approximately three-feet wide. It splits into a v-shape to reach each monument, where it broadens to form a circular concrete pad around each structure. The path is in good condition.

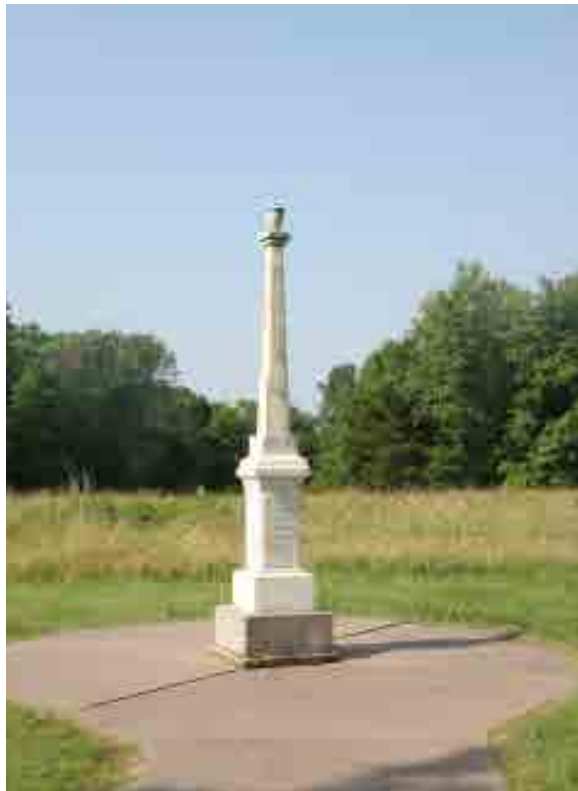
Figure 3-141. The Monument to the Brave Confederate Dead (MB: IMG_5710.jpg).

The monument is a slender limestone pillar topped with a funeral urn that is approximately fifteen-feet in height. The pillar is mounted on a square inscribed column that sits on a circular concrete pad. The monument is located in an open field, near the Monument of the Reunited Soldiery. They are connected by a concrete path. Both monuments are visible from the Tour Road. The inscription on the monument bears the names of the Confederate commanders who were killed during the battle: McCulloch, McIntosh and Slack. The monument is in good condition.

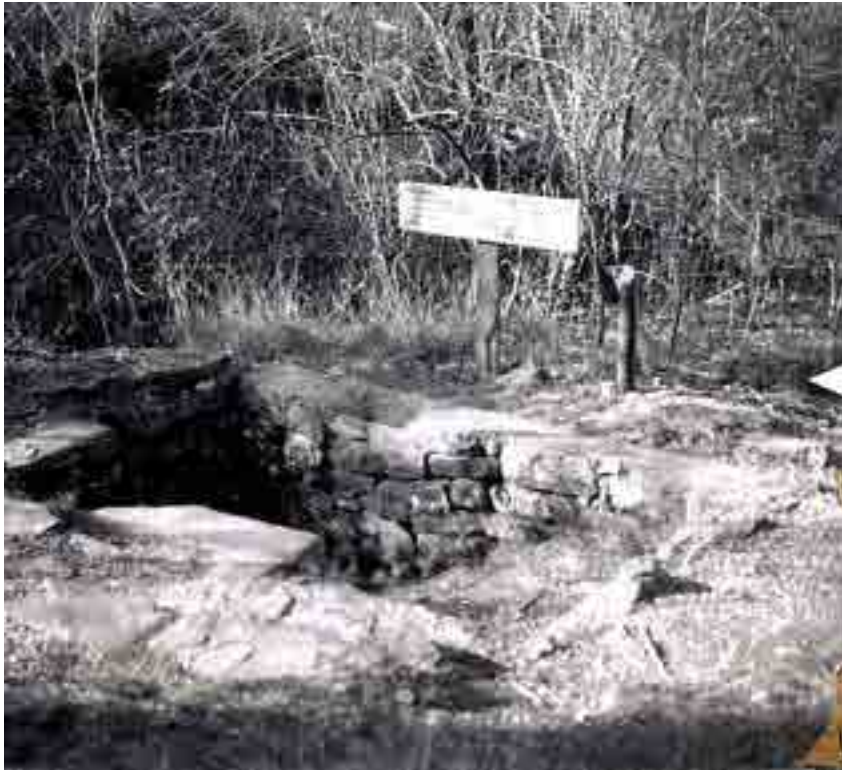
Figure 3-143. The spring box at Elkhorn Tavern is built of stone, and is approximately eight-feet square (5-04-67 trail to spring.tif).

A park interpretive sign describes the spring box. The cistern was filled with water, and the bottom was full of dirt and debris at the time of the June 2013 field investigations. The spring box appears functional and in good condition.

The spring box is a contributing feature as it was built c. 1840 to 1860, and was in place at the time of the Battle of Pea Ridge.

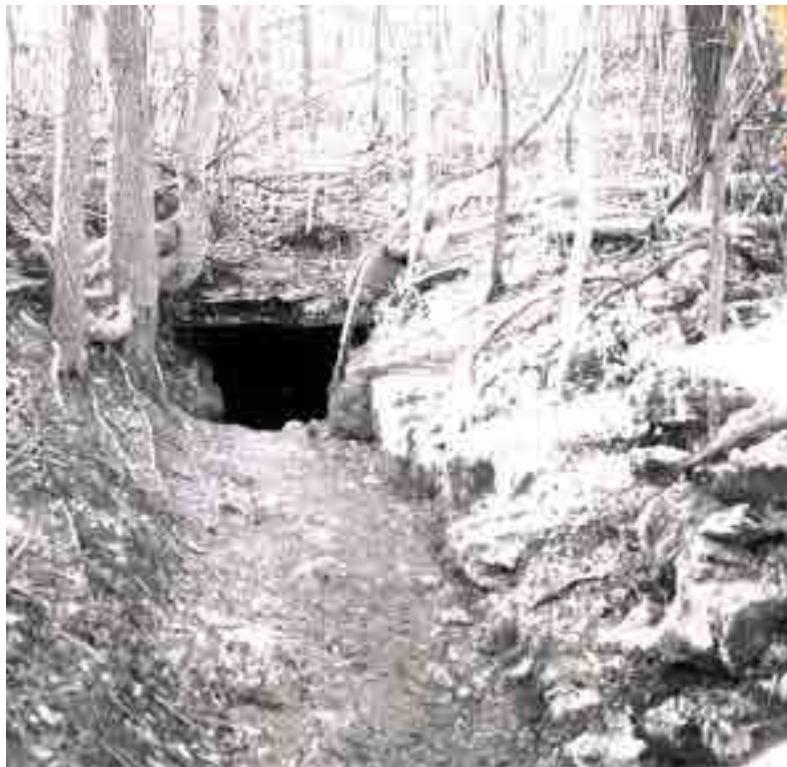
Figure 3-144. The cave is a natural limestone formation with a man-made carved entrance. It was used by the inhabitants of Elkhorn Tavern to keep provisions cool during summer months (1960s trails to cave.tif).

This feature is part natural landform and part man-made structure. The cave is a natural limestone opening located within the hillside of Elkhorn Mountain to the west of Elkhorn Tavern. It is accessed by a narrow, worn path. The cave extends approximately ten-feet in one direction and twenty-feet or more in the opposite direction with an overhead clearance of about five to six-feet. The cave's entrance has been formed into a formal, neat square opening in the rock.

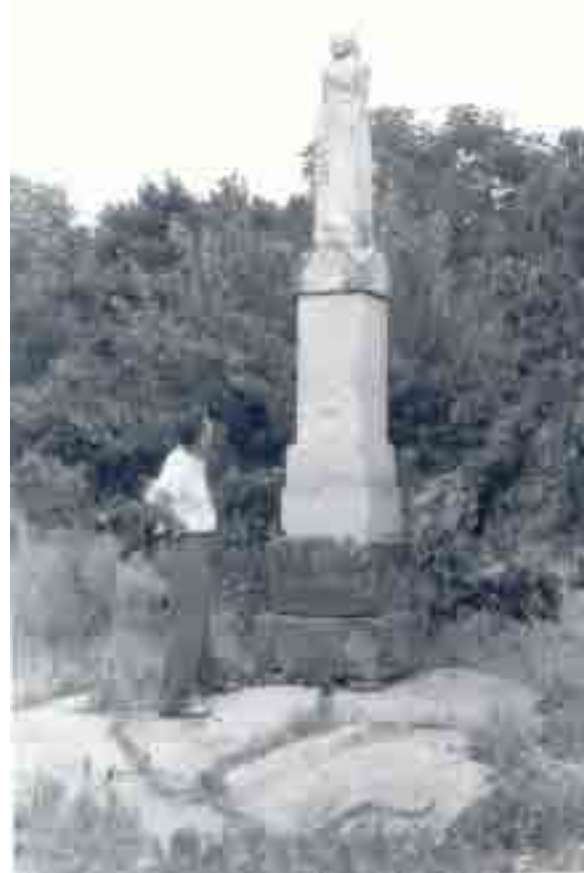
Figure 3-145. Originally, the Monument to the Reunited Soldiery was built upon a natural bed of exposed limestone bedrock, surrounded by native vegetation (Monument with trees in background, pre-1963.jpg).

This monument is a limestone carved female figure mounted on a limestone block with a fieldstone/brownstone block base. It is located in the open field, visible from the Tour Road. The monument is in good condition.

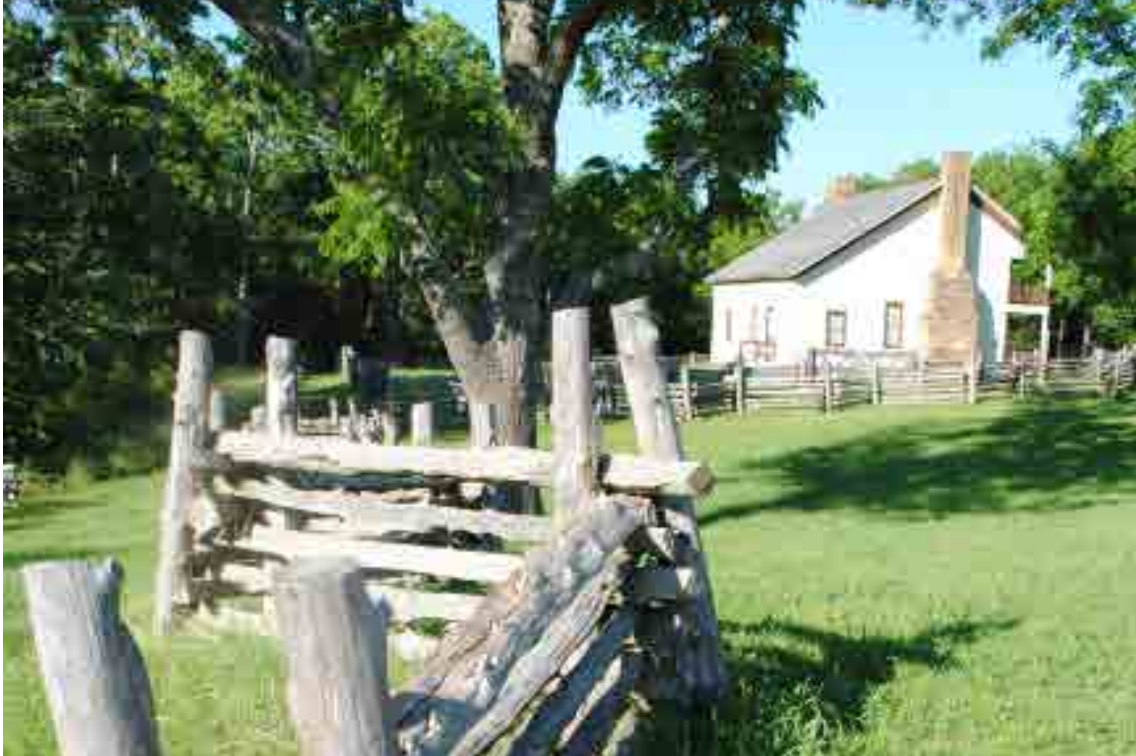
Figure 3-146. Worm fences are used to delineate the extents of fields, barnyards, farmhouses and orchard spaces, and as a means to control visitor access (MB: DSC_0188.jpg).

The fences are in good condition. The split rail fences are non-contributing features.
