Elkhorn Tavern / Williams Hollow

This section describes and evaluates the existing landscape conditions of the Elkhorn Tavern / Williams Hollow landscape character area. The existing condition plan for the landscape character area is located at the end of this section (Figure 3-154) followed by an the existing condition plan for the immediate area of Elkhorn Tavern (Figure 3-155).

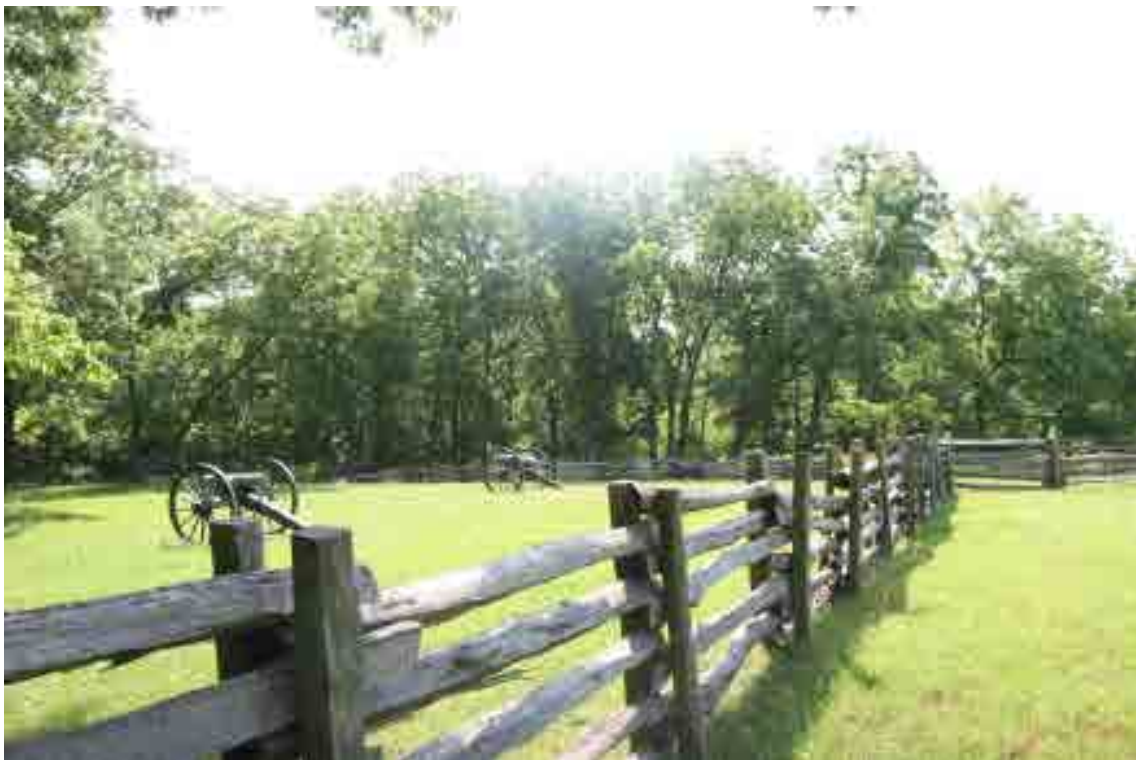
Figure 3-147. Split rail fence at the Elkhorn Tavern (MB: IMG_5762.jpg).

The fences are in good condition. The split rail fences are non-contributing features.

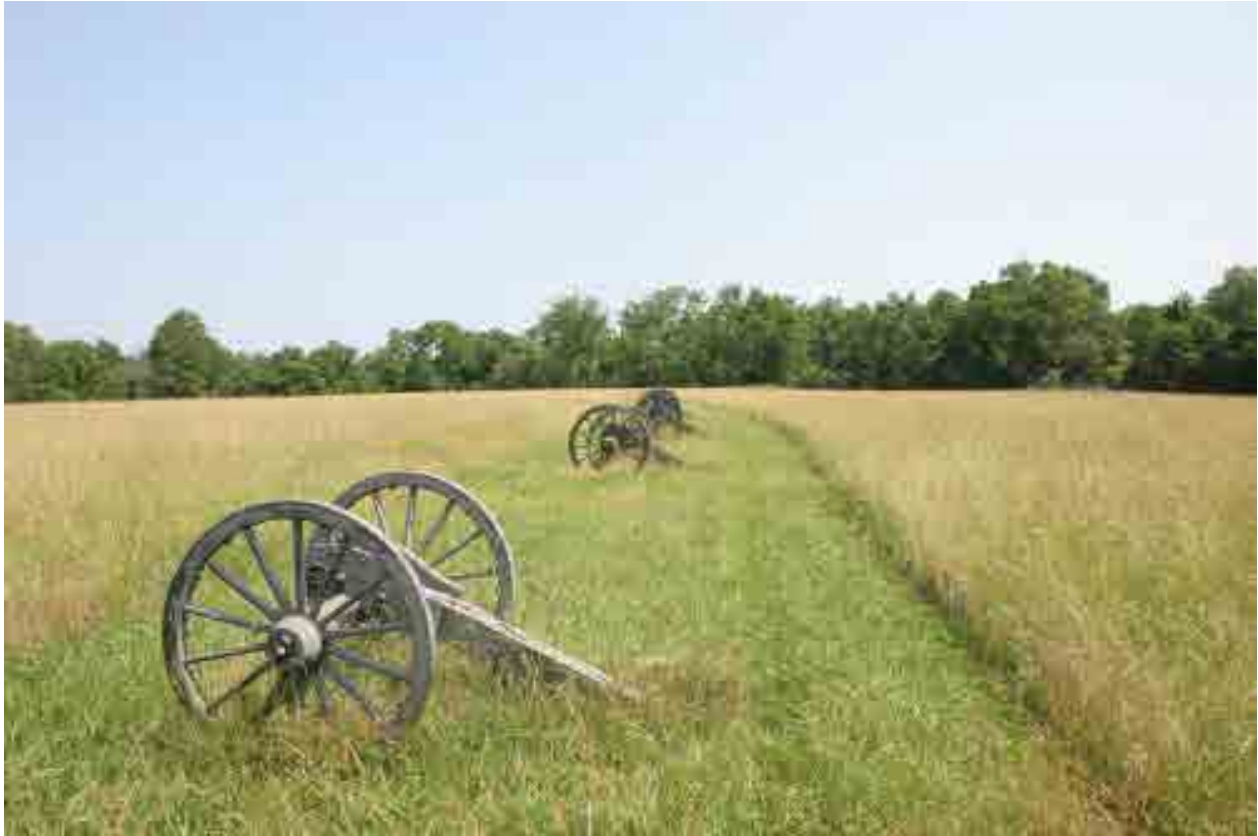
Figure 3-148. Artillery in Clemens' field have been placed in the direction they were oriented during the battle (MB: IMG_5788.jpg).

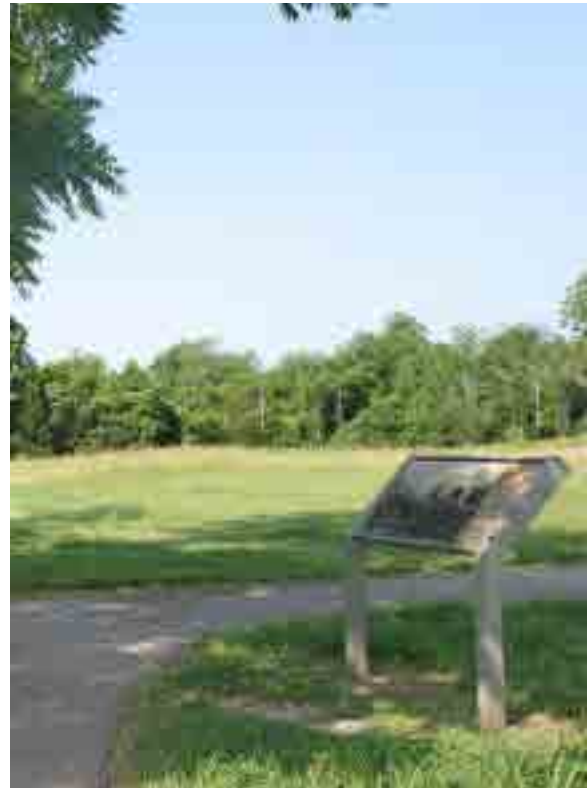
Figure 3-149. Standard NPS signage at the Elkhorn Tavern (MB: IMG_5709.jpg).

Signs within the landscape character area provide regulatory information such as identifying universal accessible spaces in the Elkhorn Tavern parking area.

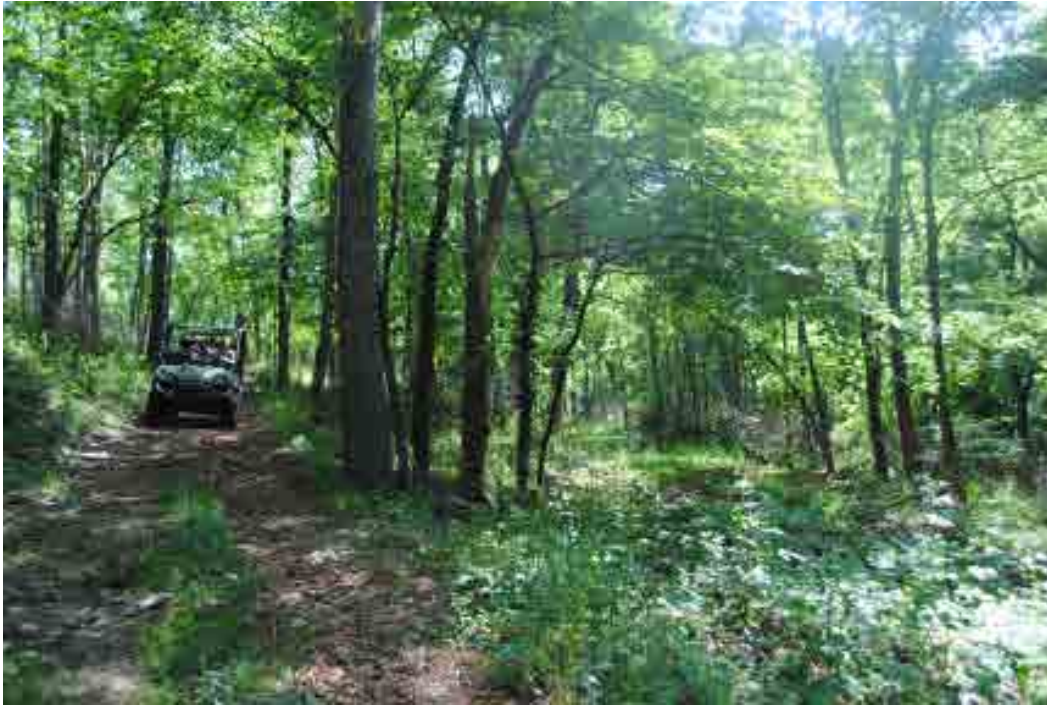
Figure 3-150. Vegetation in Cross Timber Hollow is deciduous woodland with dense undergrowth (MB: DSC_0356.jpg).

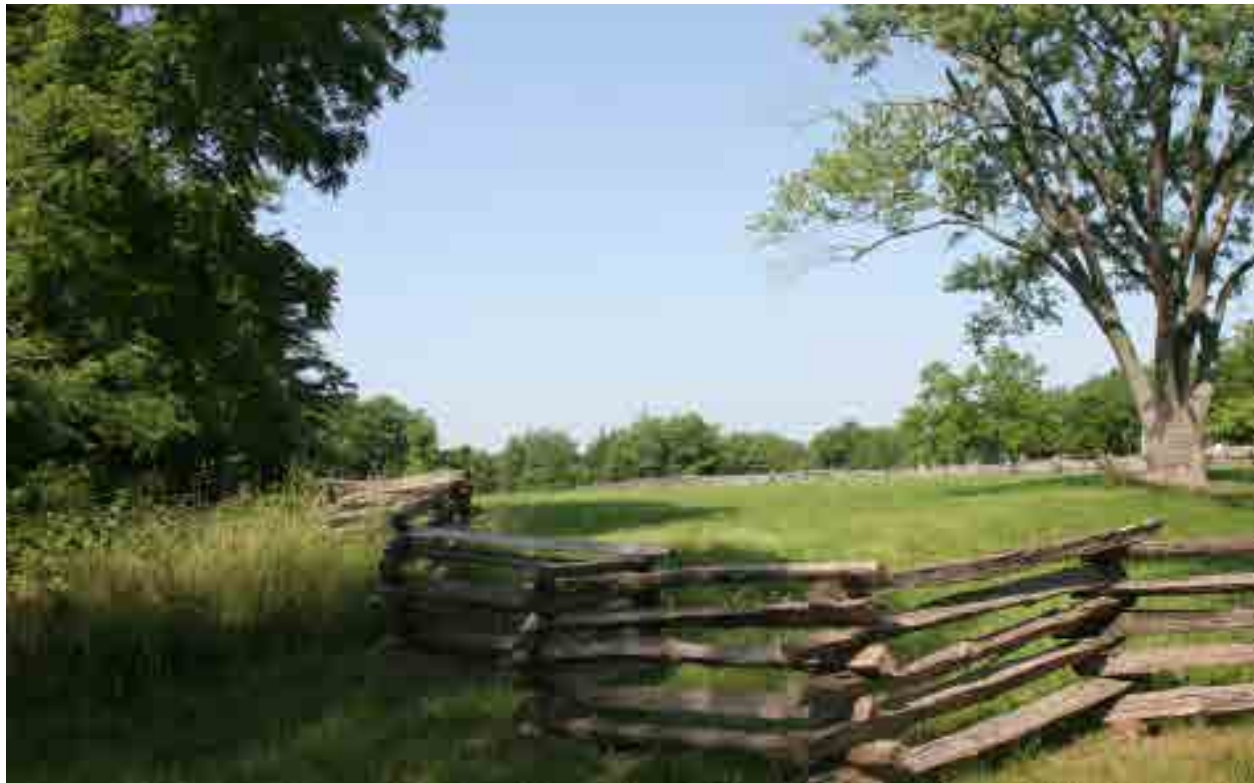
Figure 3-151. The extant patterns and type of vegetation remain similar to those in existence during the period of significance. Areas of forest remain, although the density has increased significantly, and open areas remain that would have historically been cultivated crops or pastures (MB: IMG_5751.jpg).

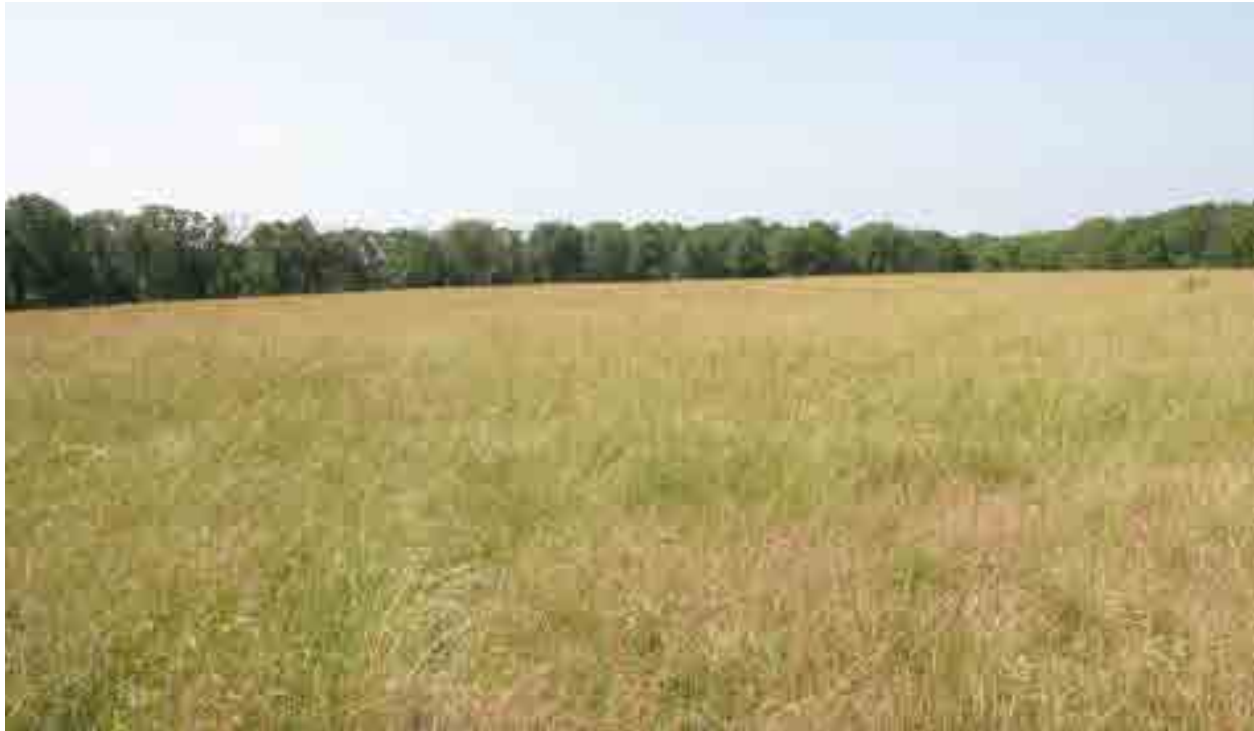
Figure 3-152. The extant patterns and type of vegetation within Clemens' Field remains similar to what existed historically (MB: DSC_5786.jpg).

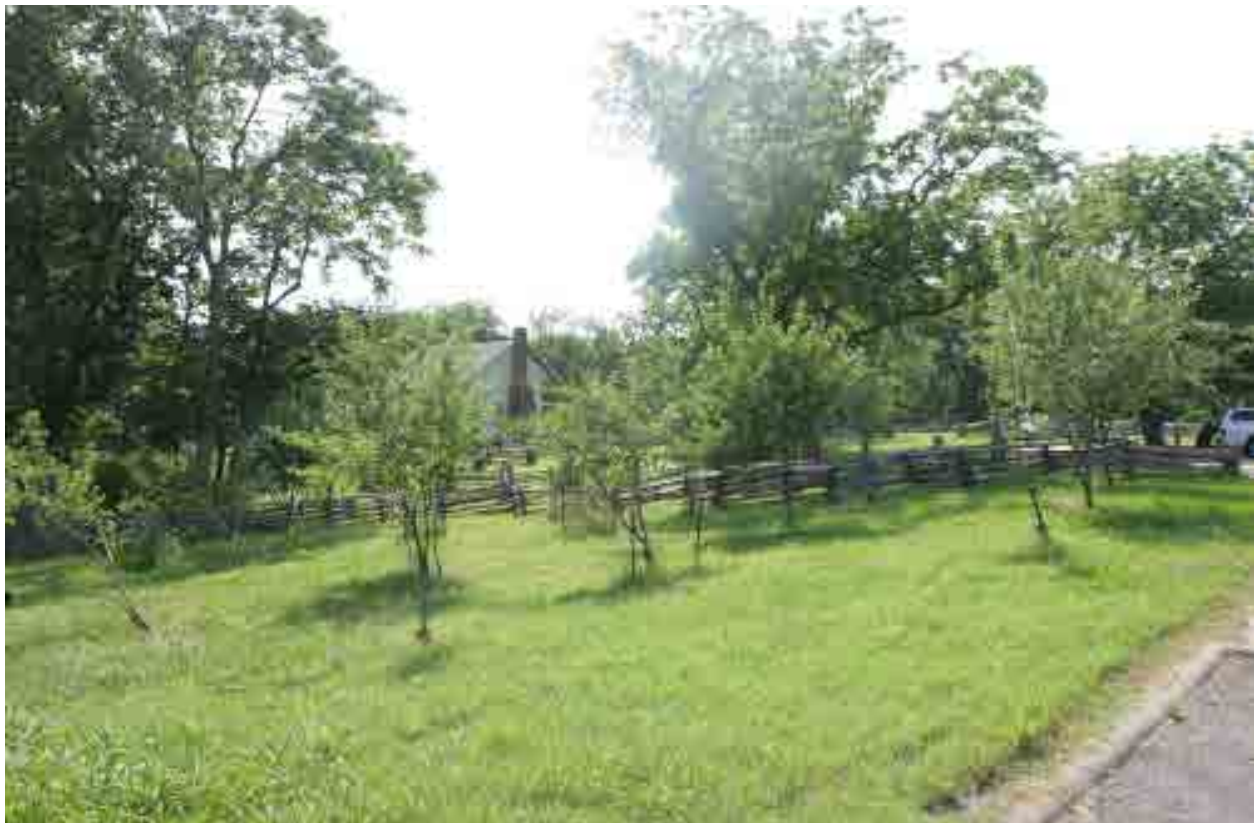
Figure 3-153. The apple orchard at Elkhorn Tavern was replanted with apple varieties common in 1862 (MB: IMG_5725.jpg).

During the battle, the area around Elkhorn Tavern was described by soldiers as having been a field of ten to twenty acres with an apple orchard.^{3.115} During the winter of March 1862, the fields would have been dormant with remnant vegetation from crops or pasture grass, and edged with trees. Today the appearance of this area is similar, although the full acreage is not discernable and the fields are no longer in cultivation. The exact extent of individual historic fields is not completely known.
