## Chapter 3. Existing Condition Assessment and Landscape Analysis

The evaluation of the existing condition of Pea Ridge NMP's cultural landscape is presented in this chapter, accompanied by the analysis of its integrity. The existing condition assessment provides an overview of the current physical condition of the cultural landscape. The analysis evaluates the significance and integrity of the cultural landscape by assessing each characteristic within the context of the landscape as a whole. This is accomplished by evaluating the 2013 physical conditions against the condition of the 1862 to 1865 landscape.

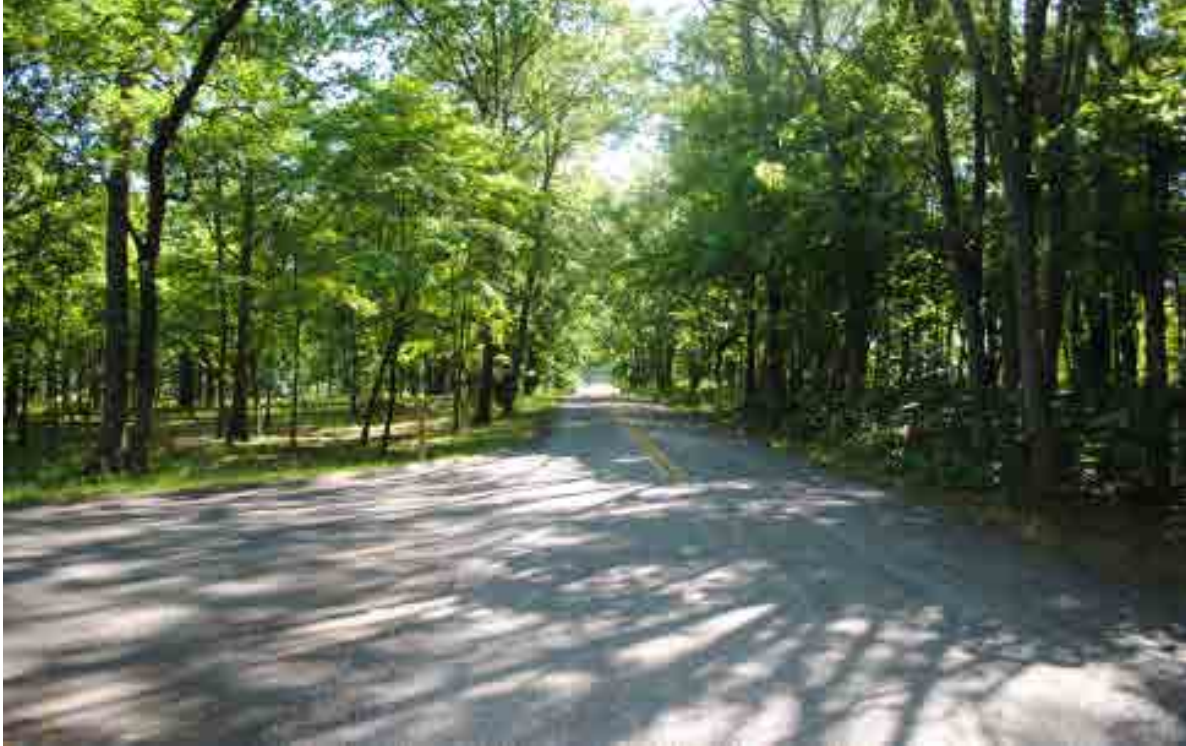
Figure 3-16. The Tour Road provides a looped route through the park. The southern end is a two-way road, providing access to the horse trail parking trailhead at Winton Springs (MB: DSC\_0053.jpg).

The Tour Road is in fair condition, although it has been prone to sinking since its construction in 1963. Repairs were made to the asphalt surface, gravel shoulder, culverts and bridges in the late 1980s and again in 1992.

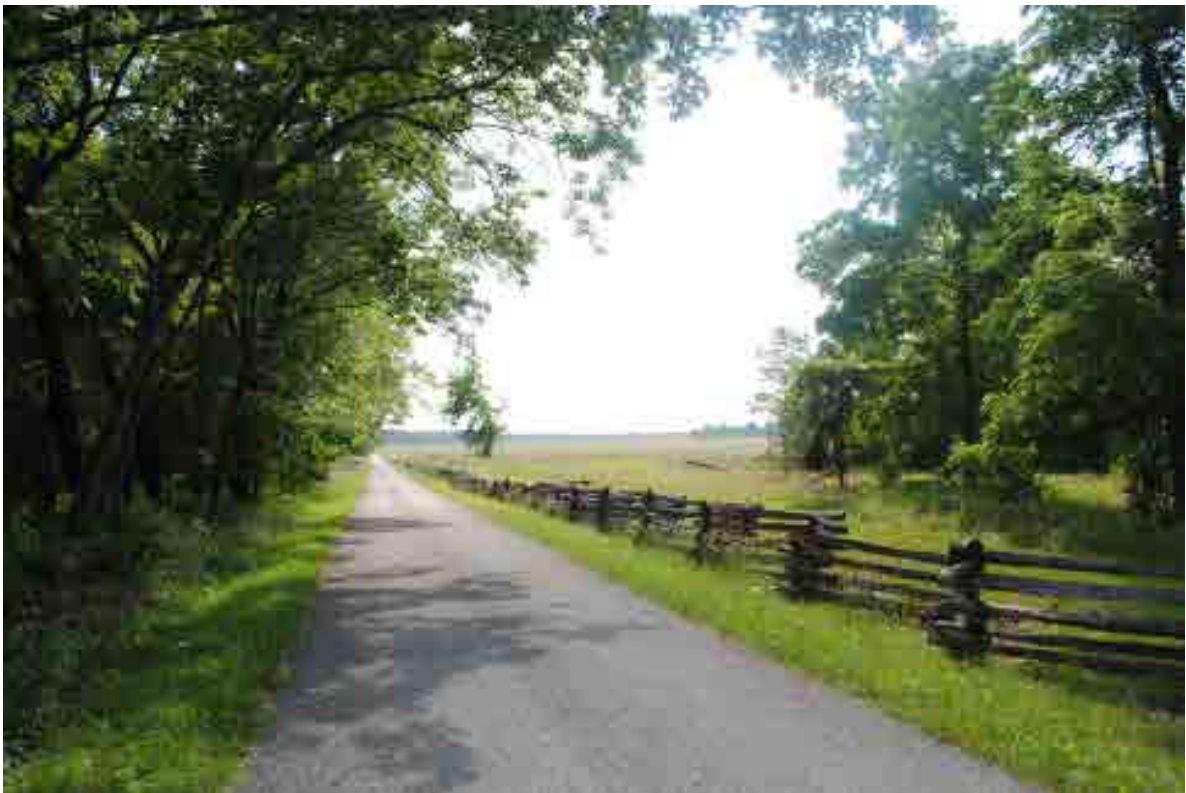
Figure 3-17. For a portion of its length south of Elkhorn Tavern, the Tour Road follows the historic alignment of the Telegraph Road (MB: DSC\_0673.jpg).

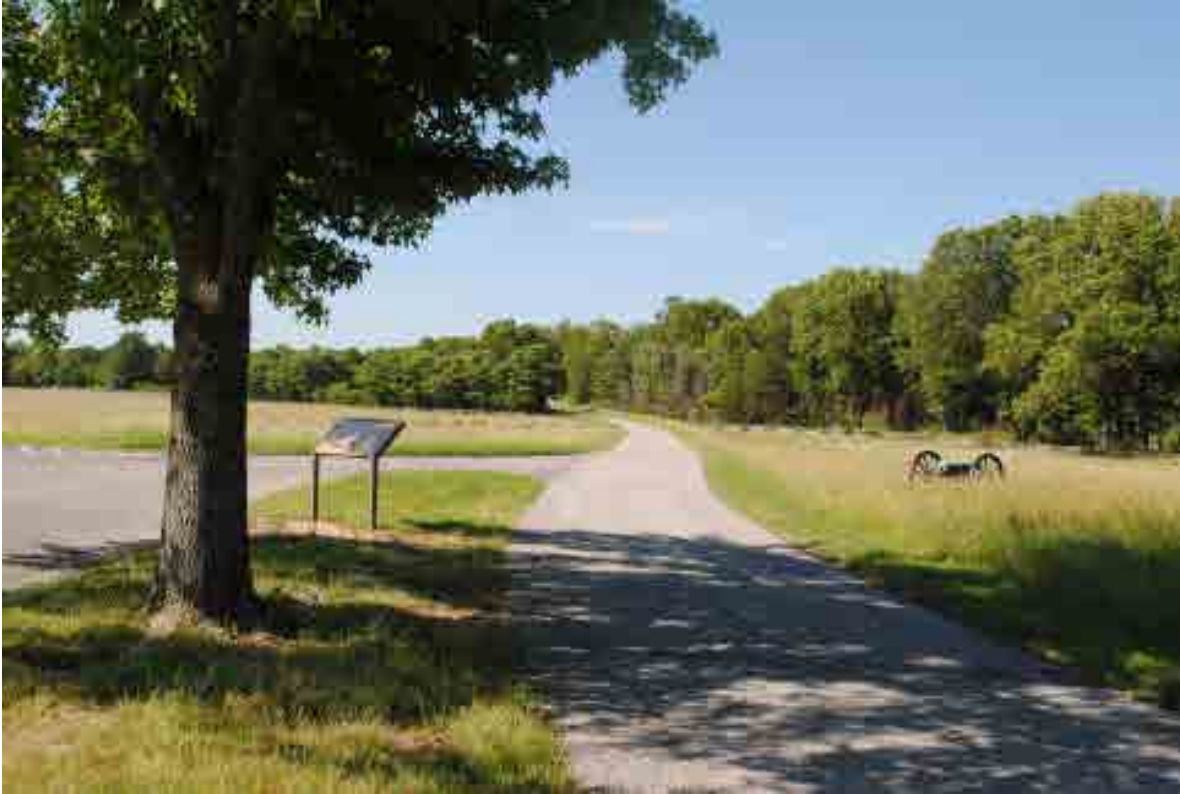
Figure 3-18. The tour road and parking area at Leetown Battlefield (MB: DSC\_0605.jpg).

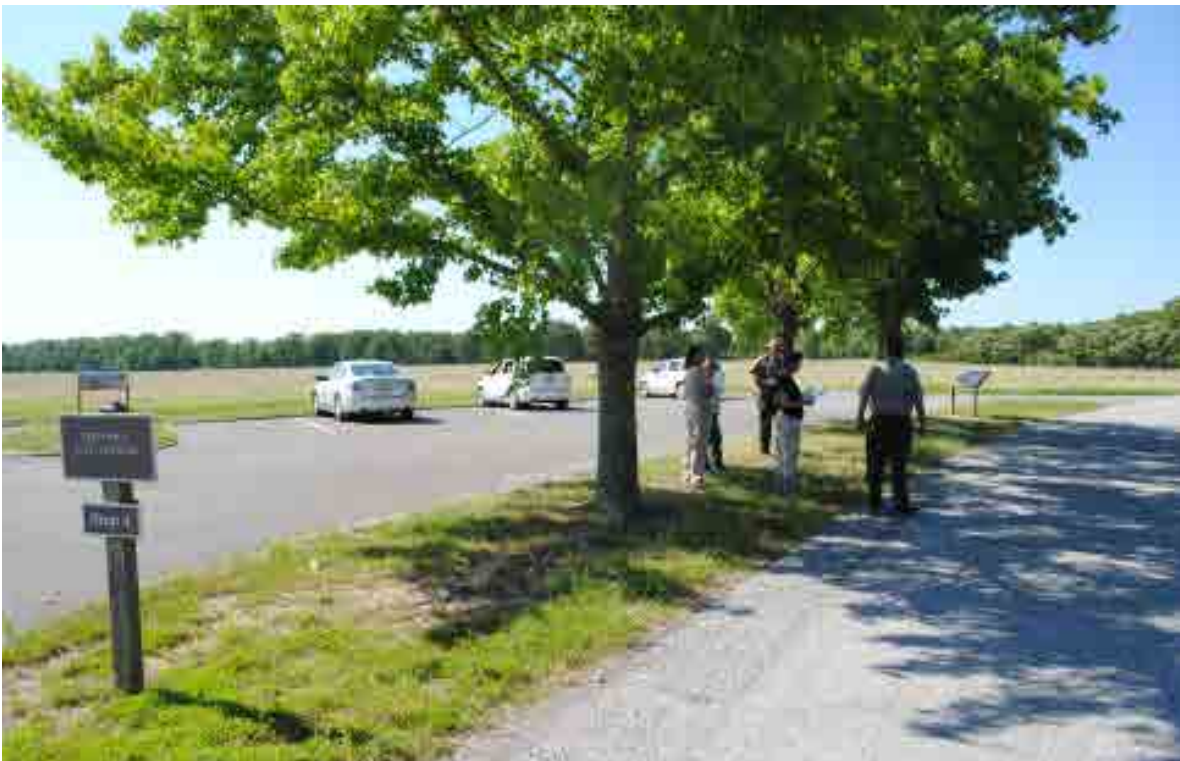
Figure 3-19. The tour road includes ten stops. Each stop includes a parking area and interpretation. Stop 4, at Leetown Battlefield, is in an open clearing. This stop is located within the historic battlefield (MB: DSC\_0127.jpg).

- Leetown Battlefield is the fourth stop. Both the Tour Road and parking area are within the battlefield where, on March 7th, the Confederate attack through the woods failed to defeat the Union army deployed along Oberson's south fence line. This is the location where two Confederate generals, Ben McCulloch and James McIntosh, were killed. The parking area consists of twelve spaces and two RV/bus spaces, interpretive signs, artillery that depicts the battle, and mown paths into the field to access the artillery pieces.

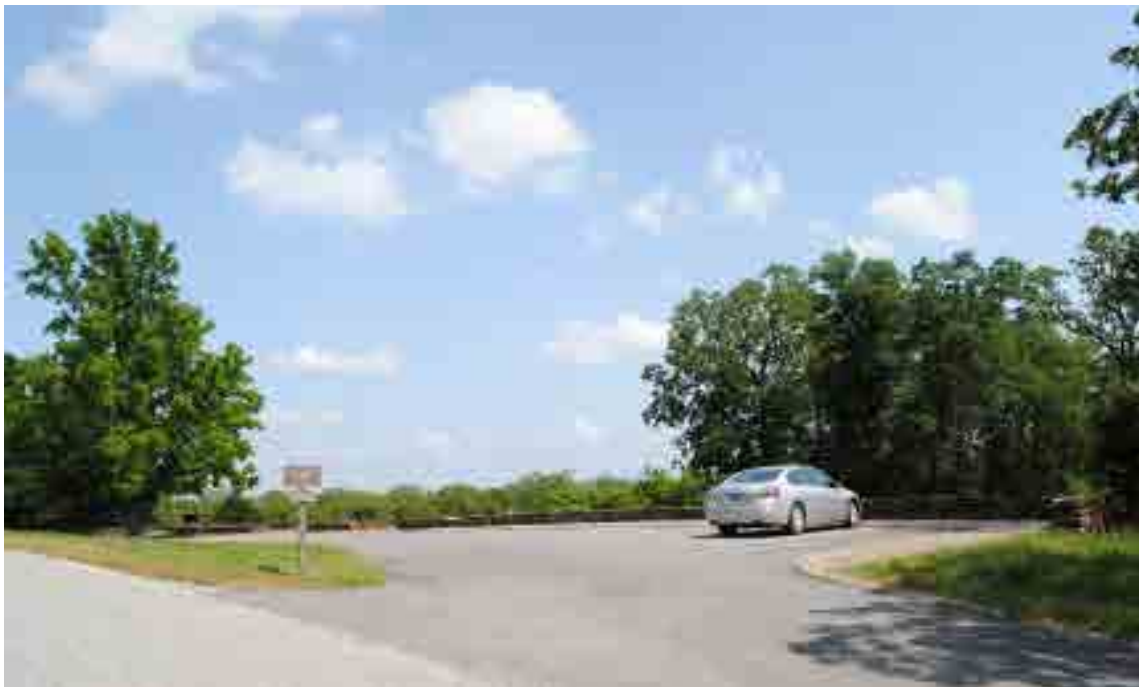
Figure 3-22. Tour stop 6 is the west overlook (MB: DSC\_0605.jpg).

buses. An ADA-compliant concrete path extends downhill from the southwest edge of the parking area for 460 feet into the forest, arriving at a small shelter and round terrace. The shelter, built as part of the Mission 66 program, affords a broad open view of the battlefield landscape. Along its exterior wall are interpretive signs that describe the battle that was fought below.

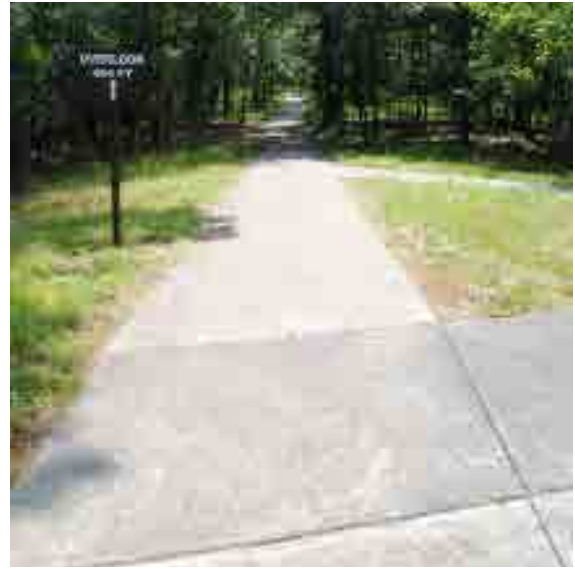
Figure 3-23. An asphalt path leads from the parking area to the east overlook (MB: DSC\_0610.jpg).

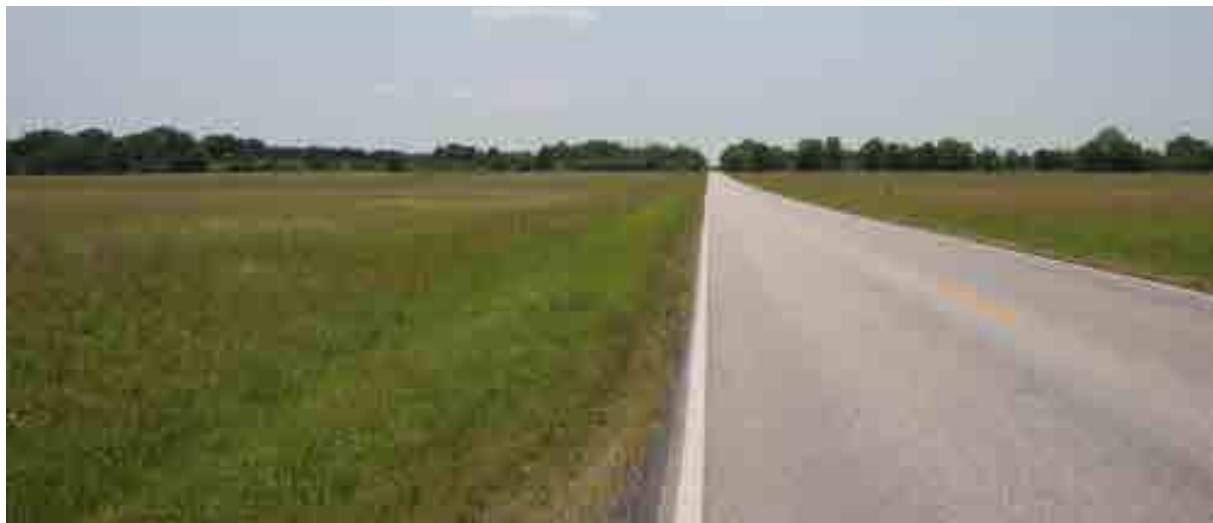
Figure 3-25. Highway 72 transects the park, dividing Leetown Battlefield into two parts of which the westernmost section is not accessible (MB: DSC\_5806.jpg).

Highway 72 is an Arkansas state highway. This two-lane asphalt paved road extends along a north / south route for most of the west side of the park. The highway turns west towards the town of Pea Ridge on the park's north edge. Within the park, Highway 72 connects with U.S. Highway 62 near the park's south boundary. Highway 72 is in good condition.

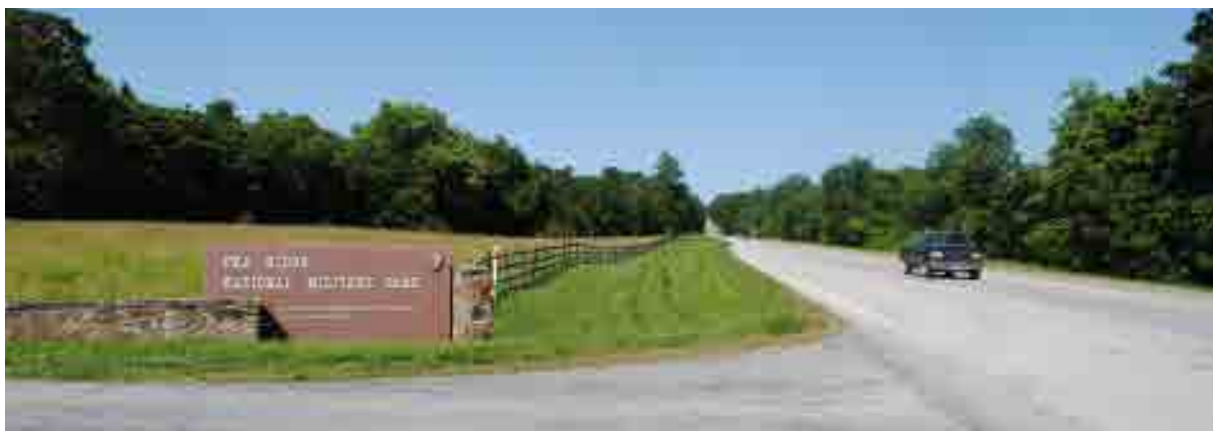
Figure 3-26. U.S. Highway 62 provides vehicular access to the park. The route of the highway is being reconsidered with plans for its relocation south of the park boundary (MB: DSC\_0573.jpg).

U.S. Highway 62 is a two-lane asphalt paved road that extends across northern Arkansas and connects the towns of Bentonville and Eureka Springs. The road was built in the 1930s. This road currently extends through the park at the south edge. It is the primary vehicular access into the park and to the visitor center. The portions of U.S. Highway 62 within

the park are under consideration for re-routing. The road is scheduled to be removed from the park in 2014. A portion of the road will become the new entrance road into the park. The future alignment of the highway is expected to be along the park's southern boundary. Most of the existing road within the park will be demolished.

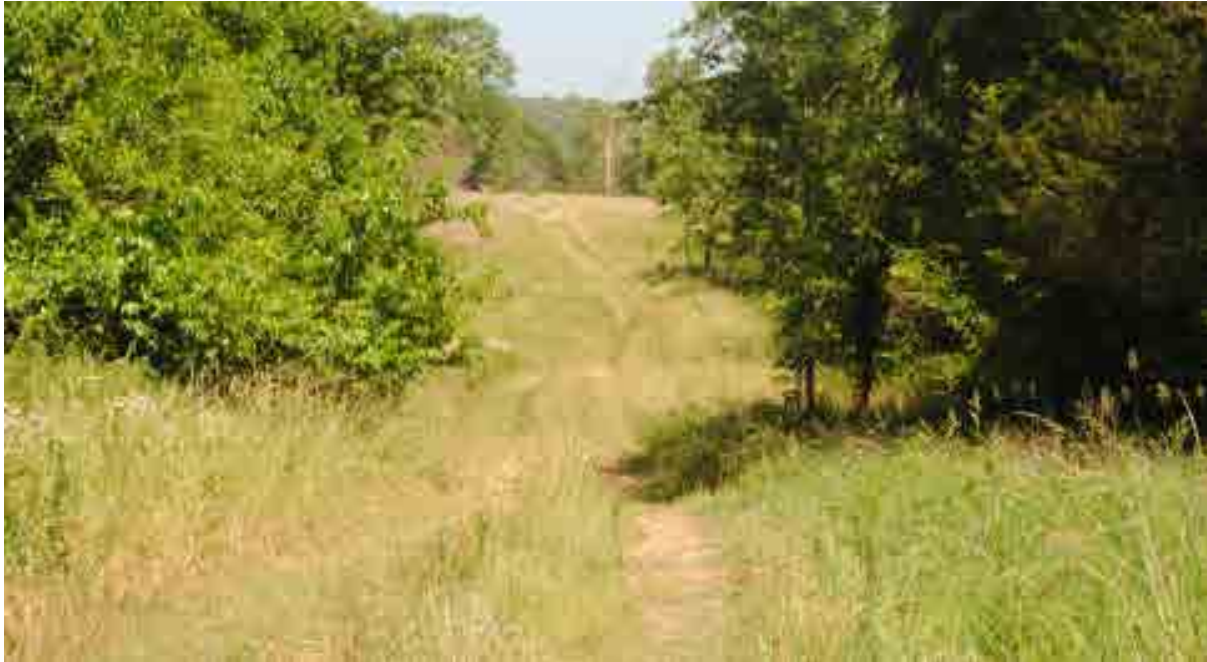
Figure 3-27. Ford Road along with portions of the demolished Highway 72 are used by park staff and by pedestrians, cyclists, and equestrians (MB: DSC\_0346.jpg).

Ford Road is a two-rut road trace extending east/west at the base of Elkhorn Mountain. It connects to Telegraph Road on the east. The road is approximately eight-feet wide, and is worn and rocky. The alignment is obscured in some sections, and in others it is eroded. Today, Ford Road serves as part of the park's loop trail and for bicycle use. Ford Road is in fair condition.

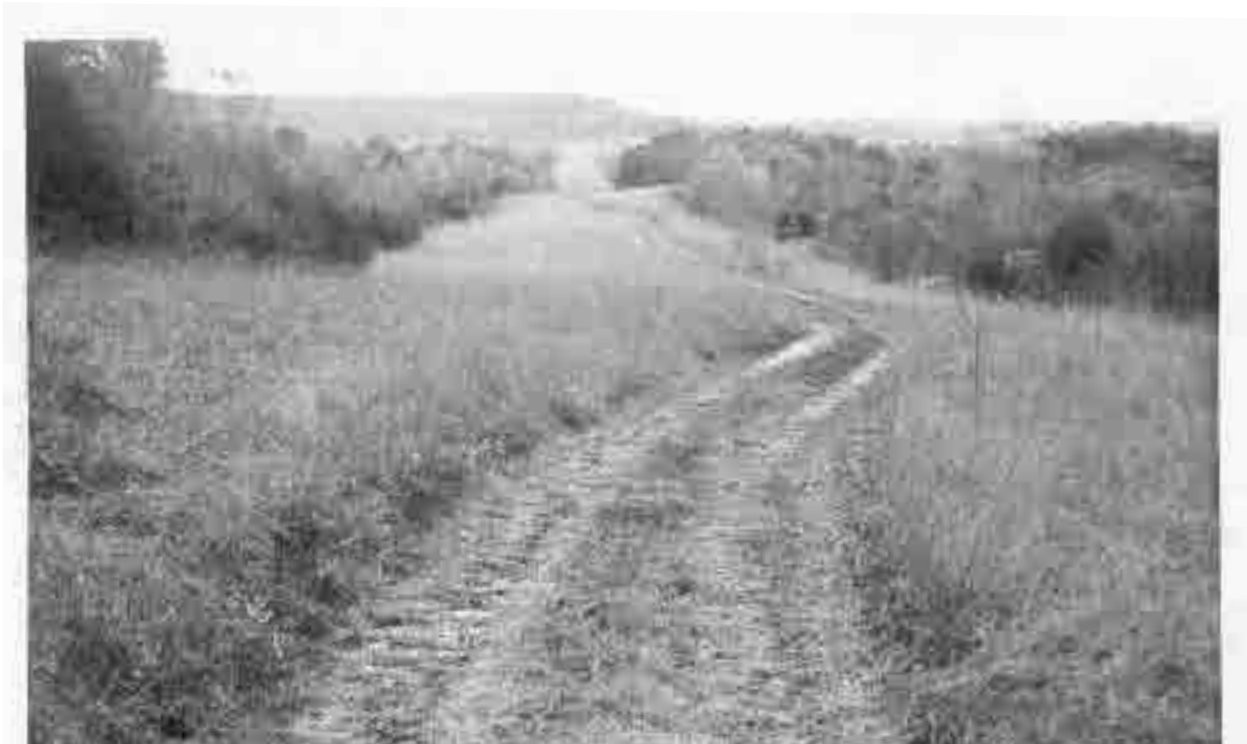
Figure 3-28. Portions of Ford Road were converted into Highway 72 in the 1920s, which followed the base of Elkhorn Mountain. The highway was removed after the establishment of Pea Ridge NMP in the 1960s (Ford Road old 72.jpg).

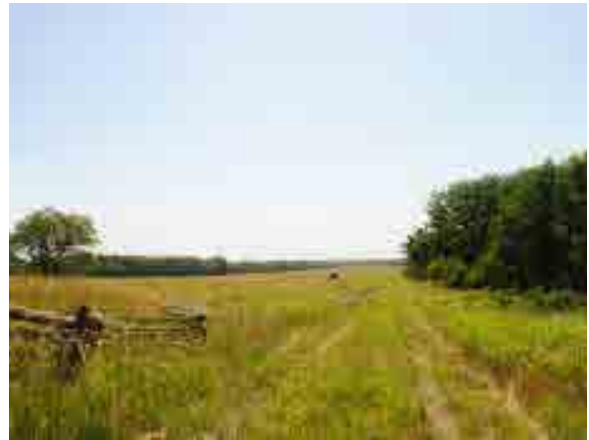
Figure 3-29. Ford Road is a worn, two-rut track road trace. (MB: DSC\_0331.jpg)

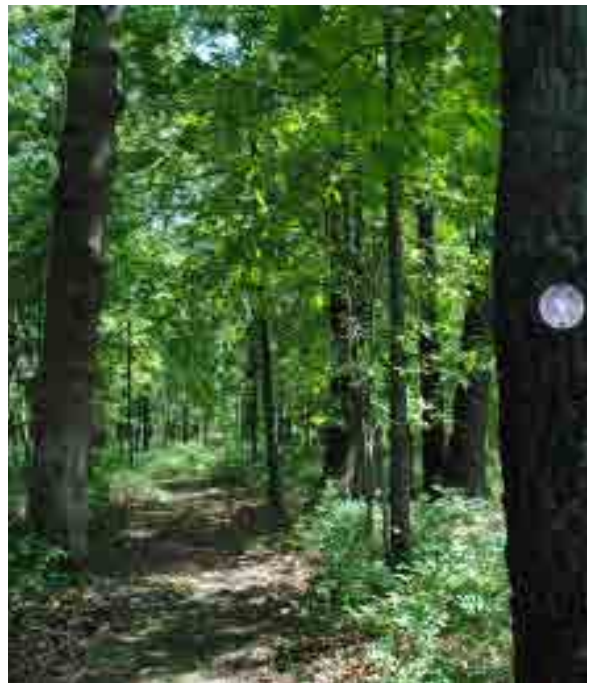
Figure 3-30. Foster's Lane is a narrow route that is part of the park loop trail. (MB: DSC\_0335.jpg)

north/south portion of the road is narrower, at approximately six- feet, and travels through dense forest. Foster's Lane is currently a pedestrian trail, and part of the park loop trail. It is in poor to good condition.

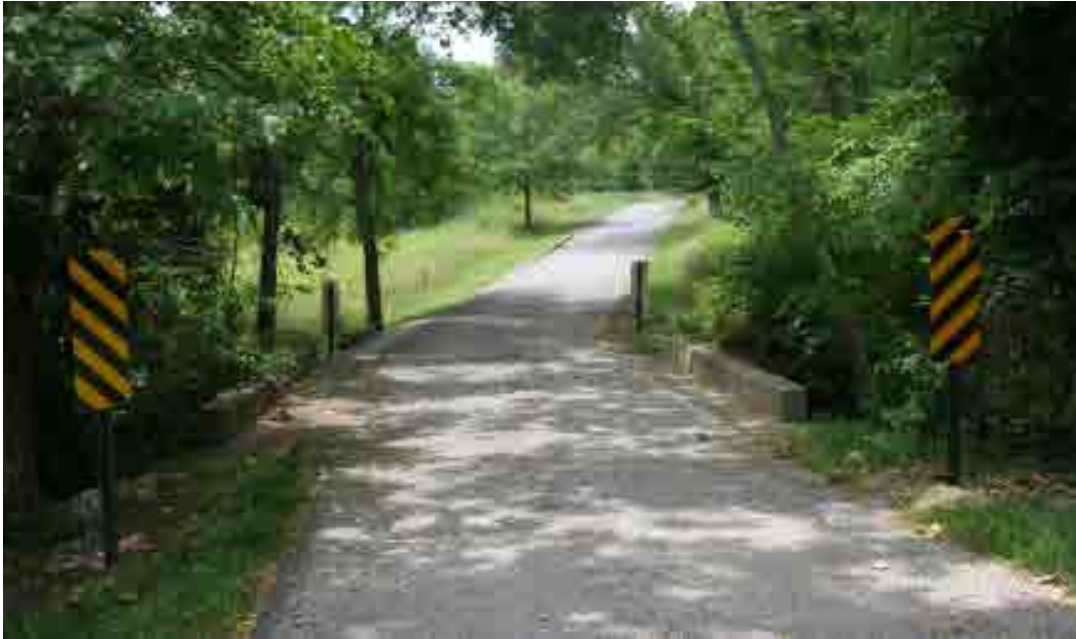
Figure 3-31. Winton Springs Road is paved, and the bridge has been rebuilt. It provides access to the horse trailhead (MB: IMG\_5835.jpg).

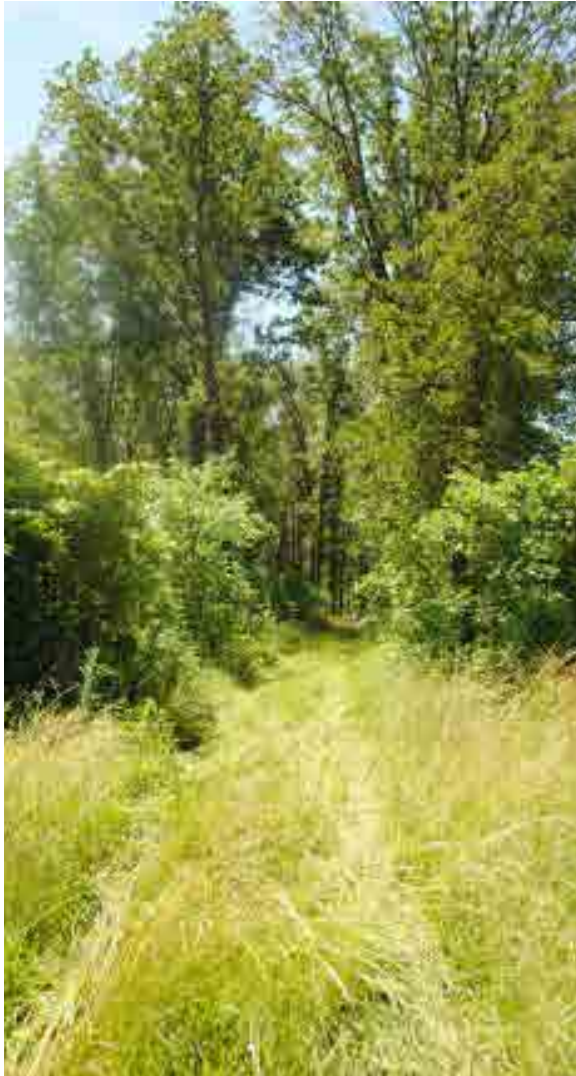
**Figure 3-33.** Leetown Road is a worn road trace covered with unmown grasses. It was an important route used by both armies during the Battle of Pea Ridge. It played an important role in transporting the wounded from Leetown Battlefield to the Union field hospitals in Leetown Hamlet. (MB: DSC\_0260.jpg).

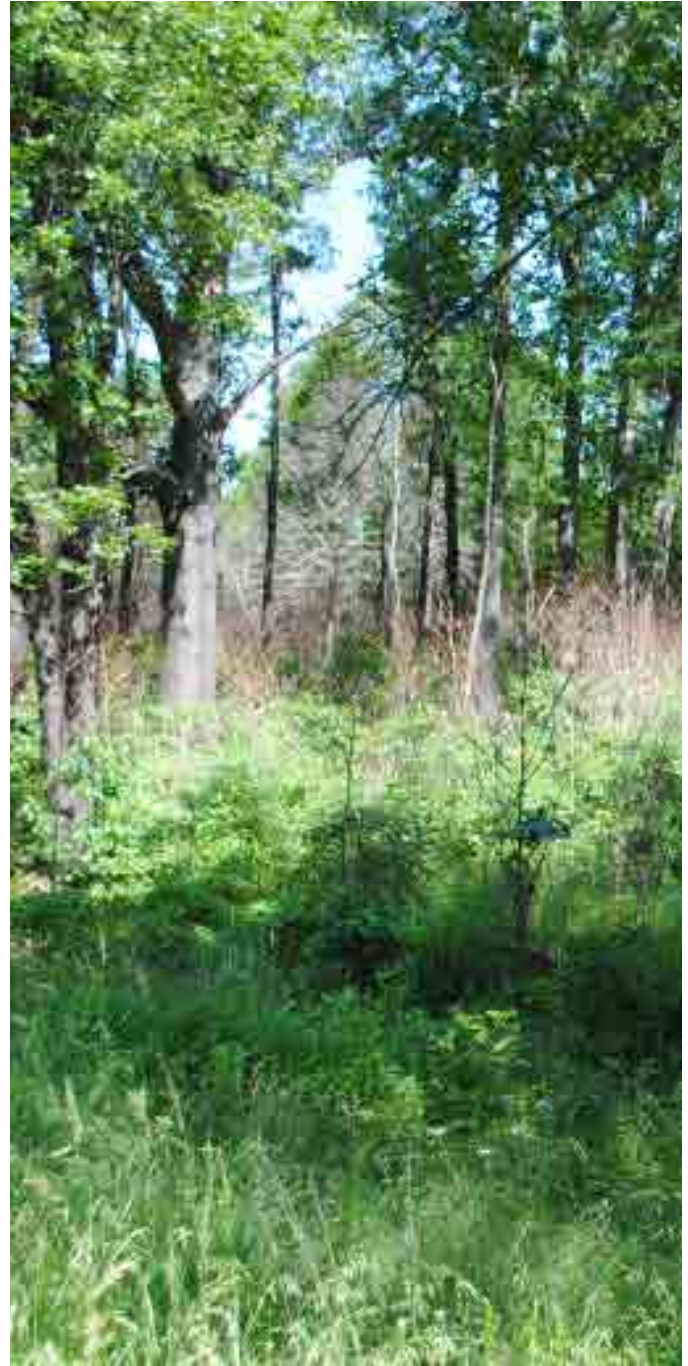
Old Leetown Road is an east / west route that extends from the park's western boundary to Leetown Hamlet, continuing east to U.S. Highway 62. The route varies from a gravel road of an approximate fifteen-foot width to an earthen alignment edged by rows of trees. The abandoned portion of Leetown Road between Highway 72 and Leetown Hamlet is overgrown and the road trace is barely visible. The park loop trail follows this road from Leetown Hamlet to U.S. Highway 62 where the trail turns northeast to follow the Tour Road. The condition of the route varies from poor to fair.

Figure 3-34. Old Leetown Road where it parallels the tour road (MB: DSC\_0113).

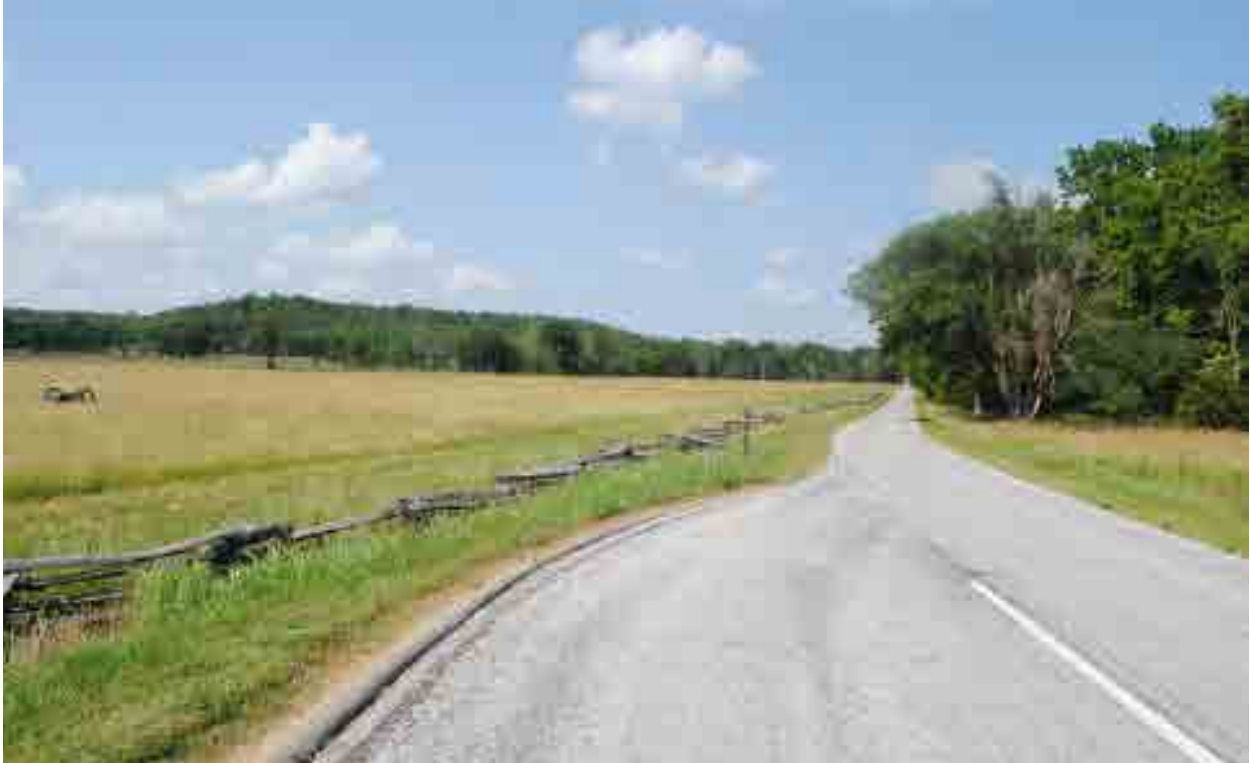
Figure 3-35. Portions of Telegraph Road were integrated into the Tour Road construction in the 1960s, between Elkhorn Tavern and the visitor center (MB: DSC\_0689.jpg).

Telegraph Road varies from poor to fair condition depending on the segment.

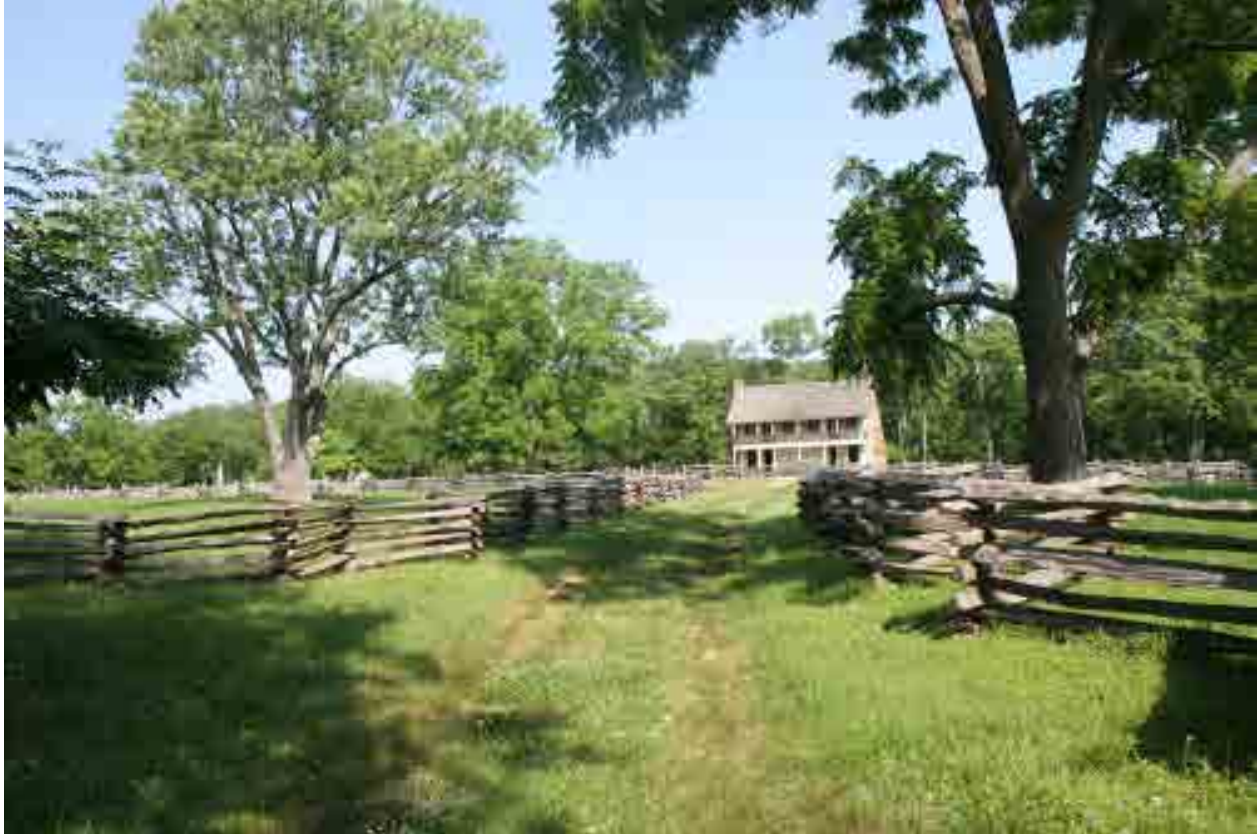
Figure 3-39. Huntsville Road: the view towards Elkhorn Tavern along the current-day alignment (MB: IMG\_5752.jpg).

Huntsville Road extends from Elkhorn Tavern east to the edge of Clemens' Field, at which point it turns to the north to follow the west edge and then the north edge of the field. From Clemens' Field it extends to the east to the park boundary. The road is a mown grass-covered road trace, approximately eight-feet wide. Near Elkhorn Tavern, the road alignment is lined with fences. Beyond this area, to the east, the road trace visible in some locations, particularly along Clemens' Field. The road trace is in fair to good condition.

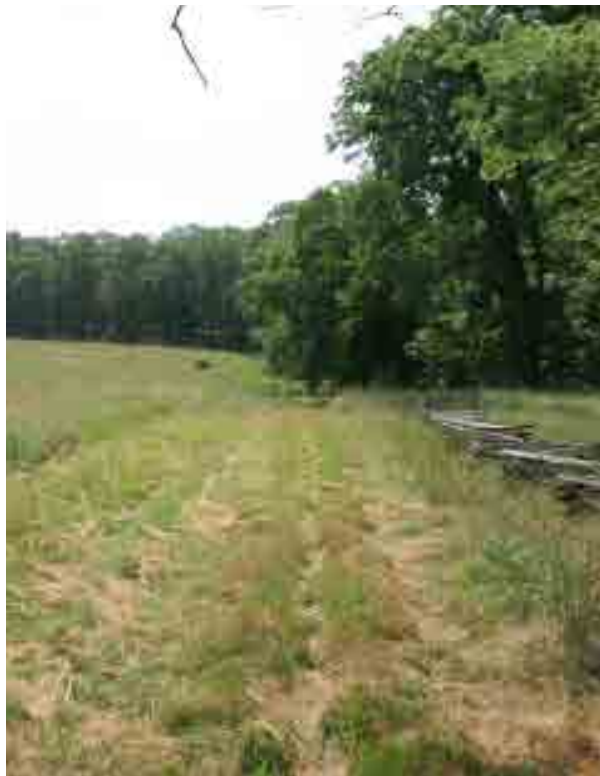
This route extends from Old Leetown Road near the intersection of the Tour Road and Telegraph Road to Huntsville Road at Clemens' Field. More than half of the road is south of U.S. Highway 62, outside the study area. The segment within the park, north of U.S. Highway 62, was reviewed during the June 2013 field investigations. This segment, near Ruddick's Field and along the north edge of Clemens' Field, is a maintained grass-covered road trace,

Figure 3-41. South Road near Clemens' Field  
(MB: img\_5803.jpg).

approximately eight-feet wide. From Clemens' Field to Ruddick's Field the road is part of the park's loop trail.

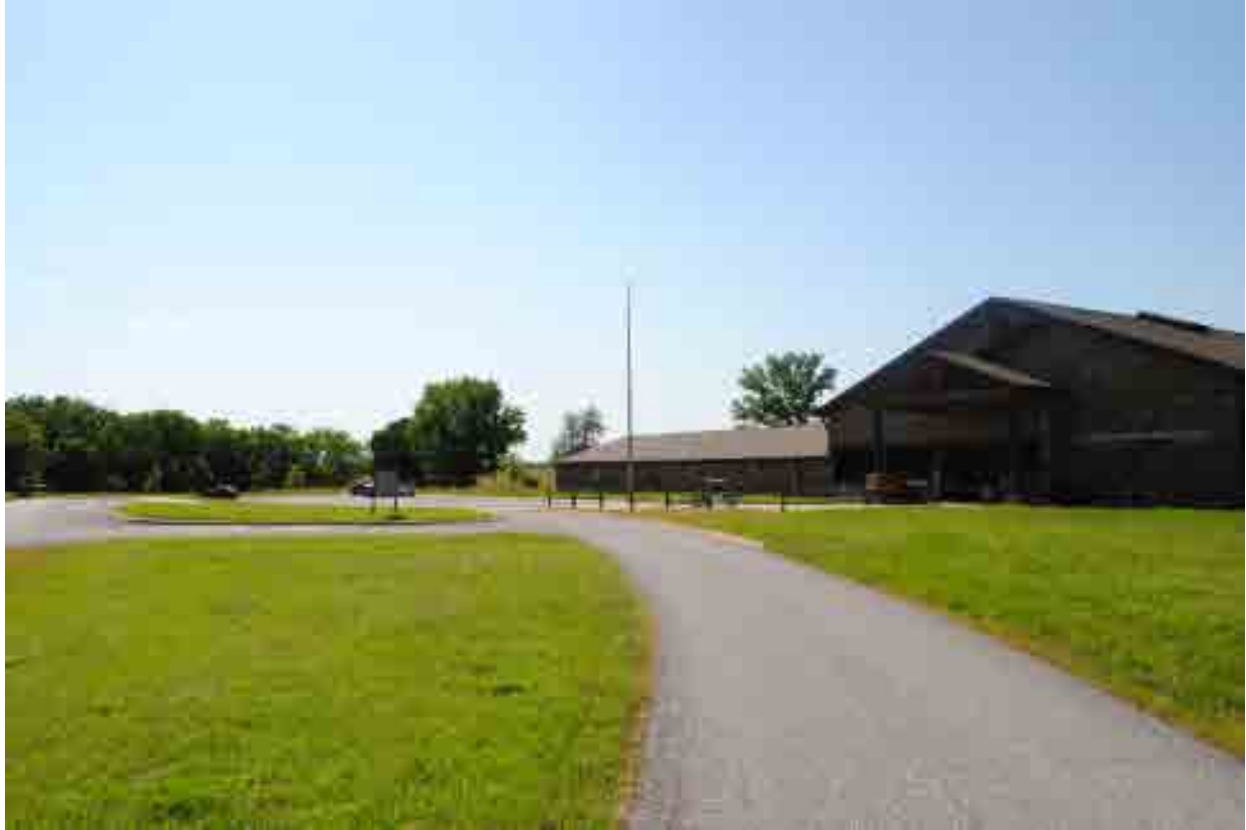
Figure 3-42. The visitor center was modified in 2000. A peaked roof was added and additional space was built for administrative functions and museum exhibits (MB: DSC\_0570.jpg).

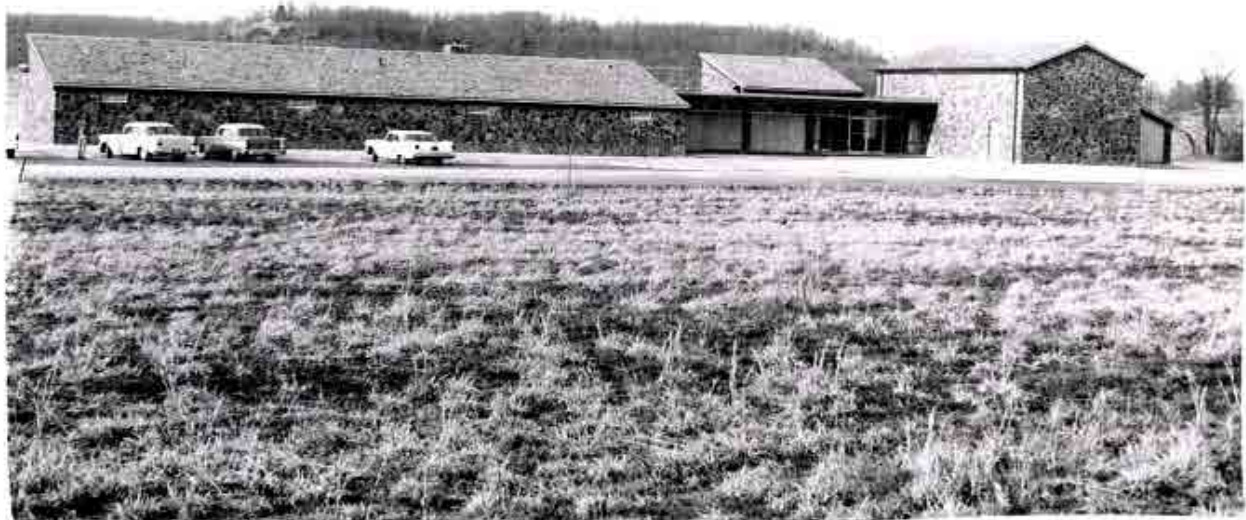
Figure 3-43. The visitor center was originally a single-story museum, office and maintenance space designed and built as part of the NPS Mission 66 program (1960s view of VC only.tif).

The building has been modified several times since its original construction. Early changes included a new roof in 1970, a boiler room in 1984, and new walls, interior spaces and electric panel in 1989. The most extensive modifications occurred in 2000, with the addition of a new south façade and a pitched roof that extended over the original flat roofs. New interior space was created for the gift shop and exhibit spaces. The visitor center is in good condition.

The 1984 NRHP noted the building as historic, likely due to its design and construction as part of the Mission 66 program. Since that time, the building has undergone several modifications that have significantly altered its exterior façade, roof line and footprint.

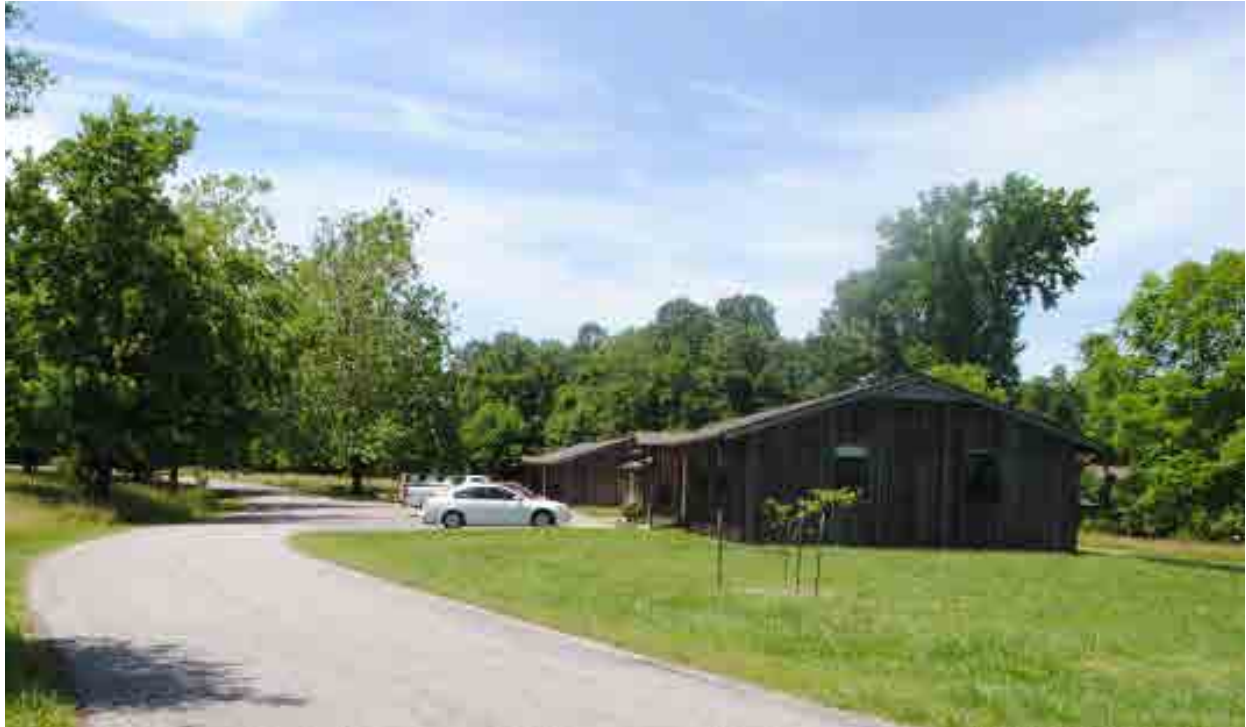
Figure 3-44. These twin buildings were originally designed for staff housing as part of the NPS Mission 66 program in the early 1960s. They are now used as administrative space (MB: DSC\_0557.jpg).

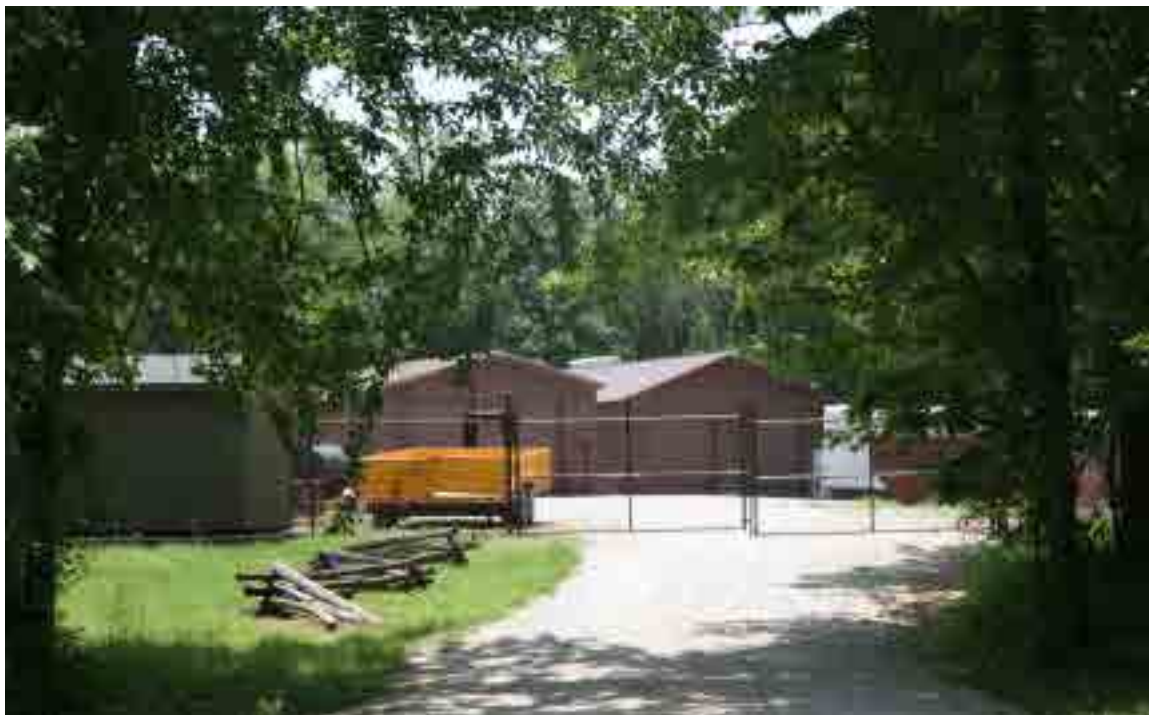
Figure 3-45. The maintenance structures and yard is gated and screened with vegetation (MB: IMG\_5819.jpg).

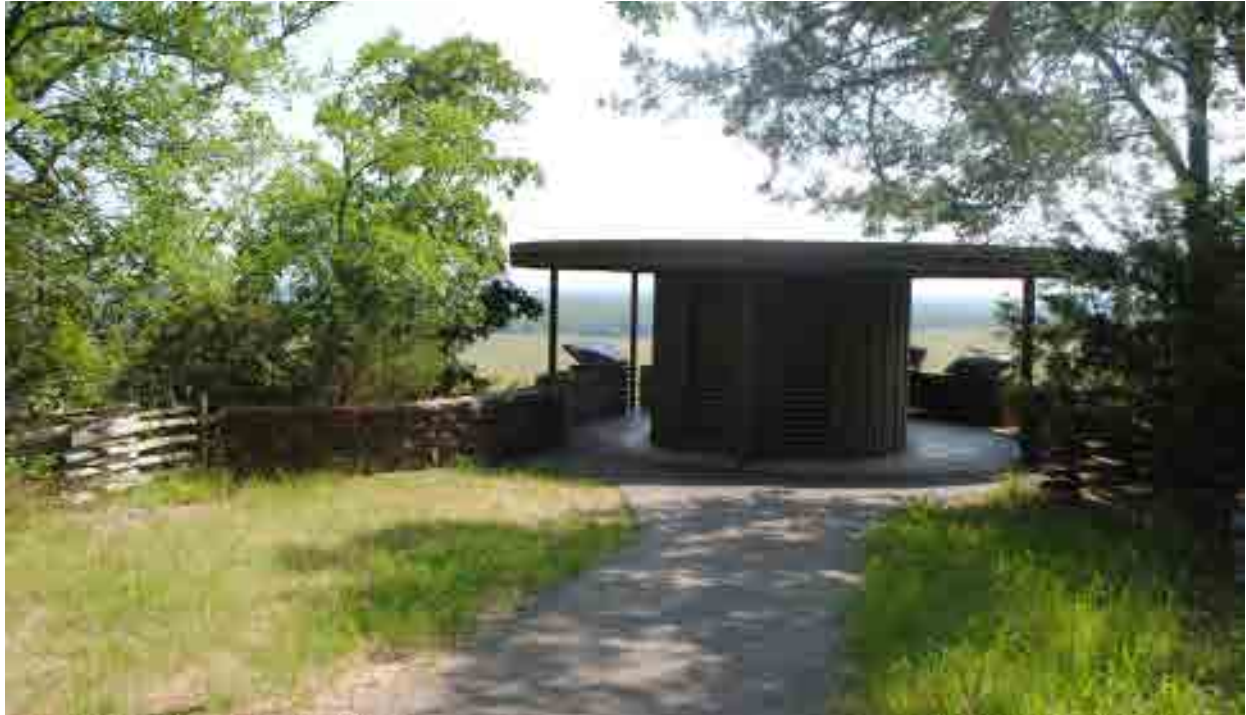
Figure 3-46. Today the east overlook shelter is very similar to its 1960s design. The interior space is occasionally used by interpretive staff. The interior was rehabilitated in 2011. Interpretive panels are mounted on the edges of the original stone wall (MB:DSC\_0622.jpg).

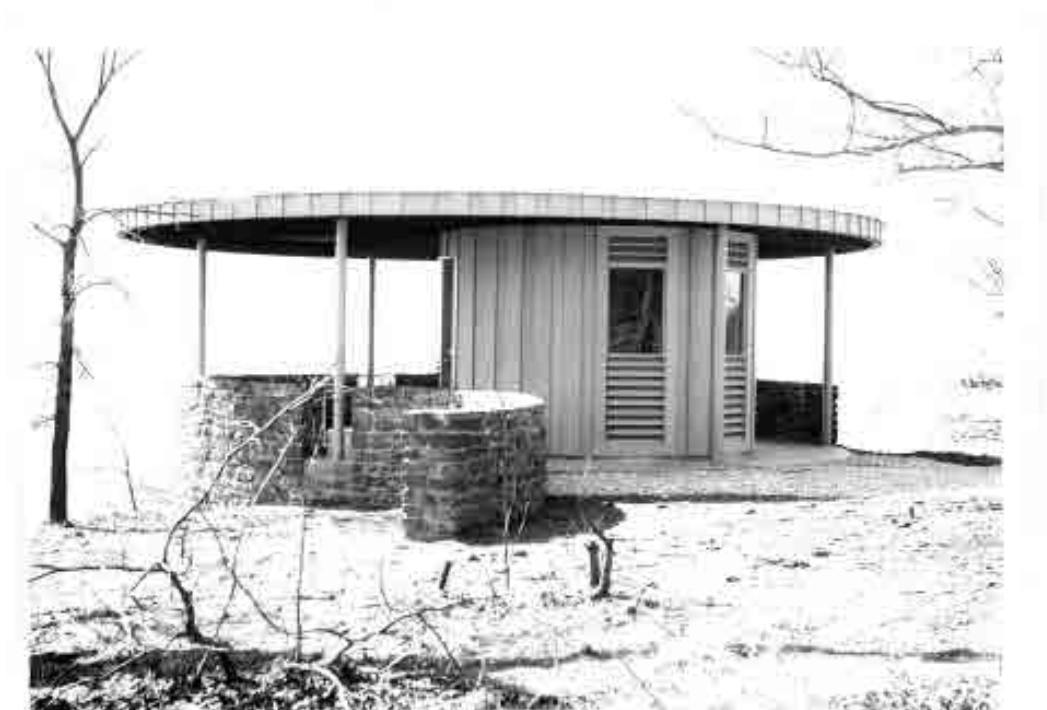
Figure 3-47. The shelter at the east overlook was built in 1963 as part of the NPS Mission 66 program, to provide a panoramic view of the battlefield. The interior of the structure has a small room used by park staff for interpretation. (Interpretive shelter east overlook 1960s.tif)

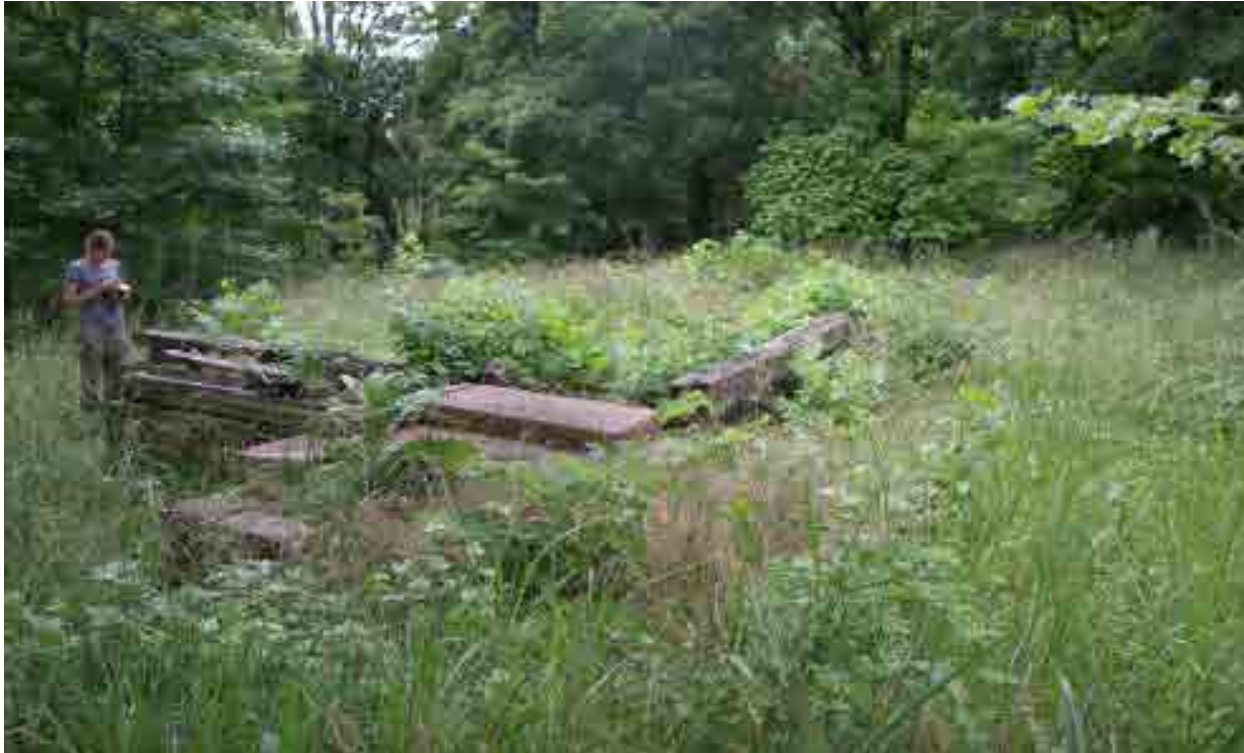
Figure 3-50. In 2013, the Winton Springs House foundation was covered with vegetation, obscuring most of the foundation (MB: IMG\_5823).

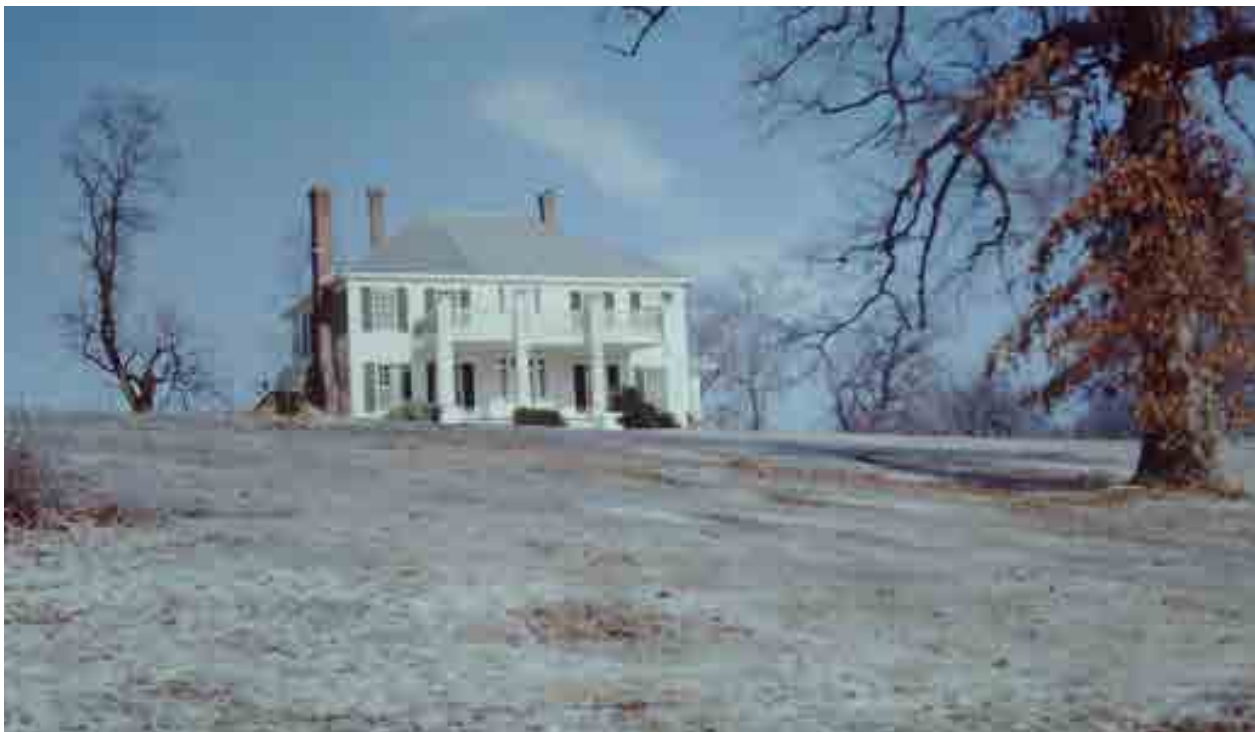
Figure 3-51. The Winton Springs House, c.1970 (PICT0020.jpg).

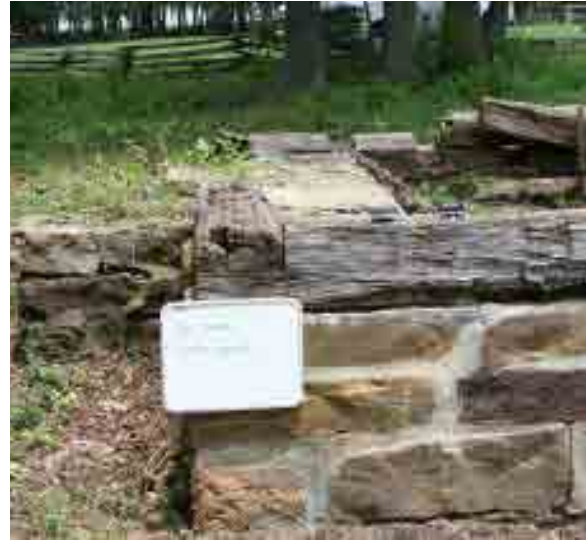
Figure 3-52. The Winton Springs House was demolished in the 1990s after recommendations for its removal were made. The foundation remains, including hand-hewn timbers set on a flagstone base (MB: IMG\_4237.jpg).
