## Chapter 3. Existing Condition Assessment and Landscape Analysis

The evaluation of the existing condition of Pea Ridge NMP's cultural landscape is presented in this chapter, accompanied by the analysis of its integrity. The existing condition assessment provides an overview of the current physical condition of the cultural landscape. The analysis evaluates the significance and integrity of the cultural landscape by assessing each characteristic within the context of the landscape as a whole. This is accomplished by evaluating the 2013 physical conditions against the condition of the 1862 to 1865 landscape.

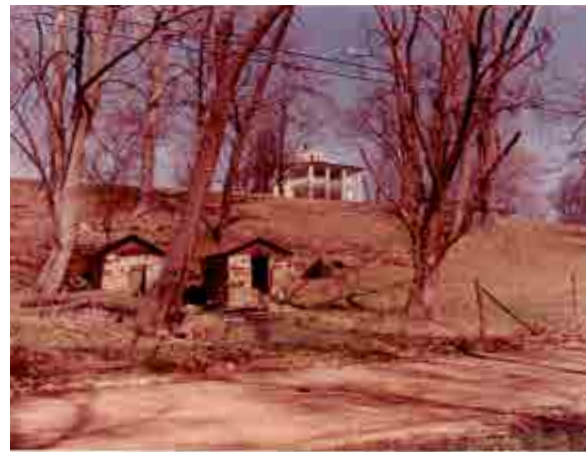
Figure 3-53. Two small identical structures flanked the source of Winton Spring. It is unknown when they were built or removed (Winton Springs spring houses#1.tif).

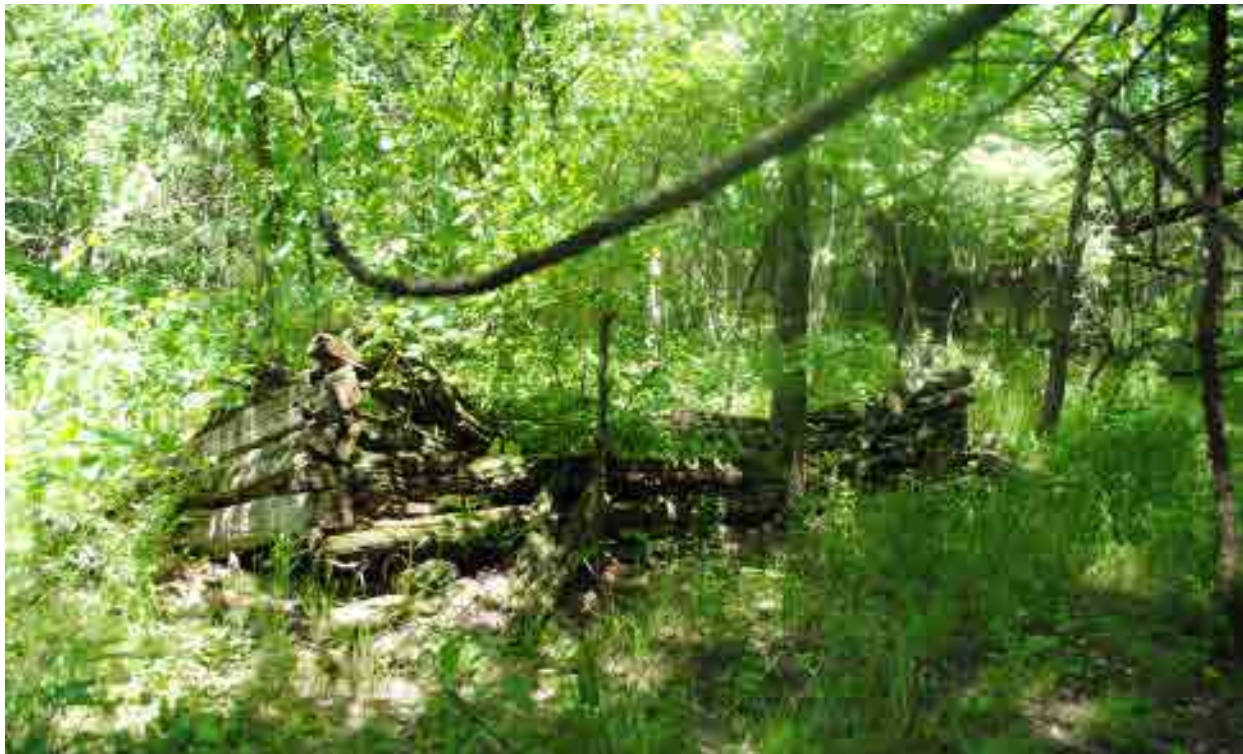
**Figure 3-54.** The remnant log cabin in Morgan's Woods to the west of Lee Creek is a brick foundation with hand-hewn, squared log timbers with dove-tail joints. The cabin measures twenty-feet by sixteen-feet (MB: DSC\_0273.jpg).

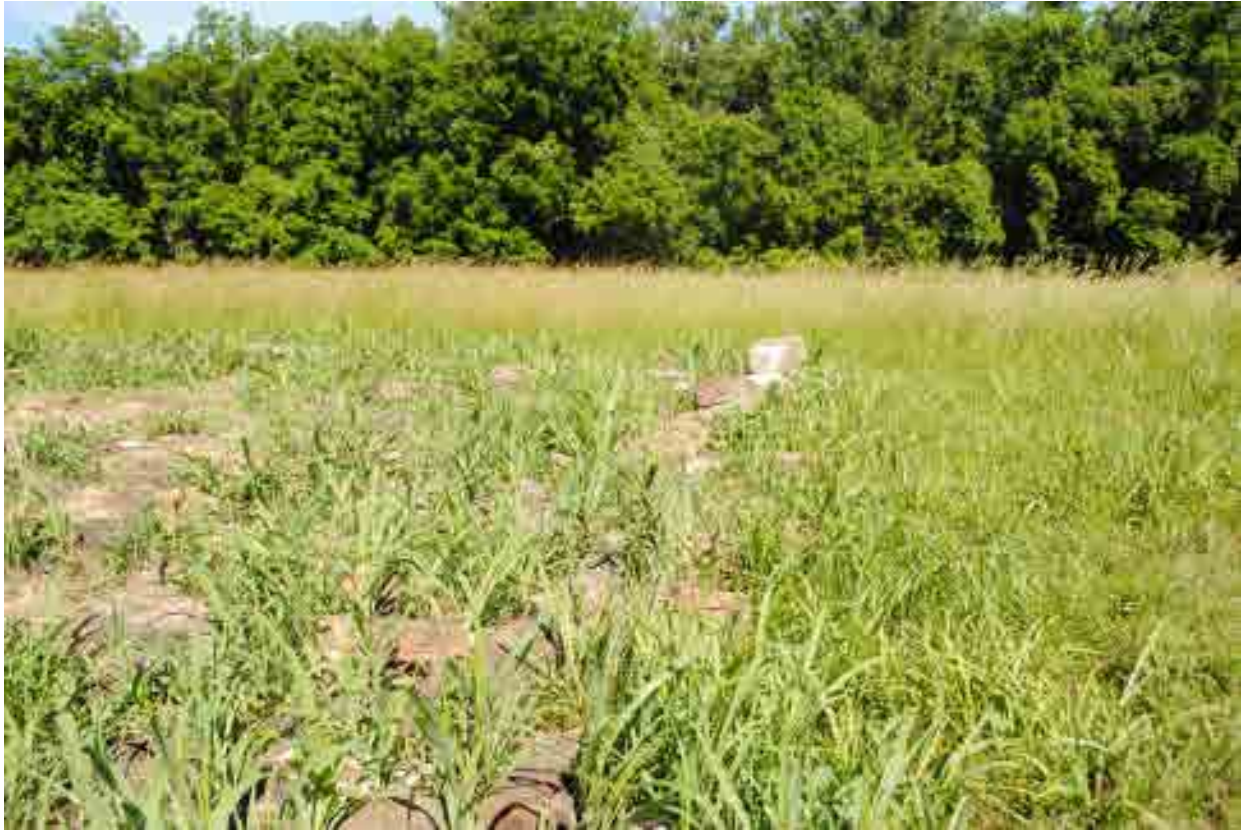
**Figure 3-55.** A house foundation near tour stop 2 consists of stone blocks, and measures approximately twenty-feet square. The foundation is covered with grasses and is in good condition (MB: DSC\_0089.jpg).

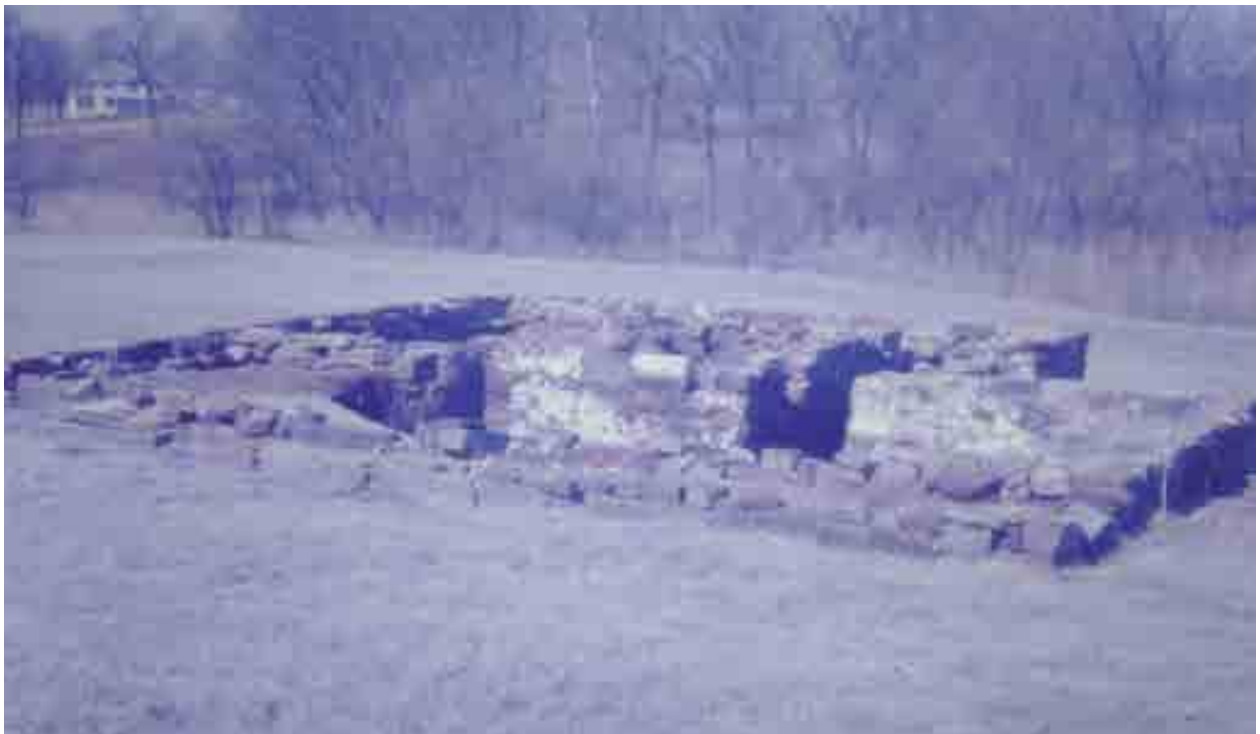
**Figure 3-56.** It is unknown when the house located near tour stop 2 was built, although it was not present in the 1970s. Winton Springs House is in the background (PICT0030.jpg).

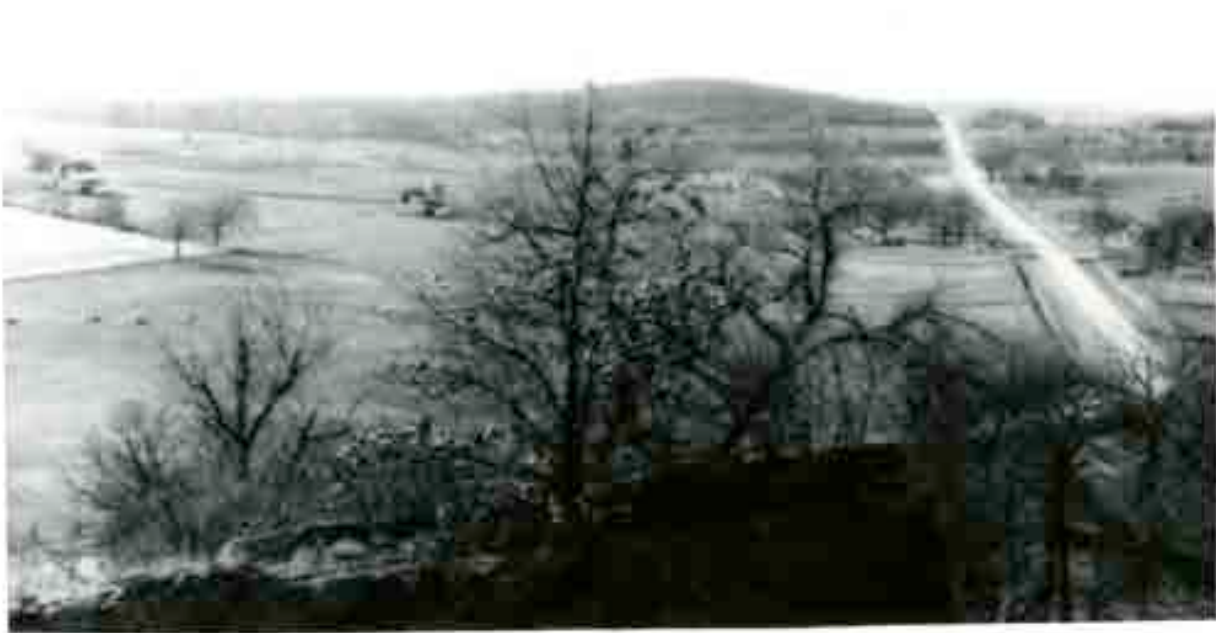
Figure 3-58. The Ruddick (Ford) House was built after the battle of Pea Ridge but was extant in the 1940s. It is unknown when the house and barn were removed (1940\_East\_Overlook\_W.jpg).

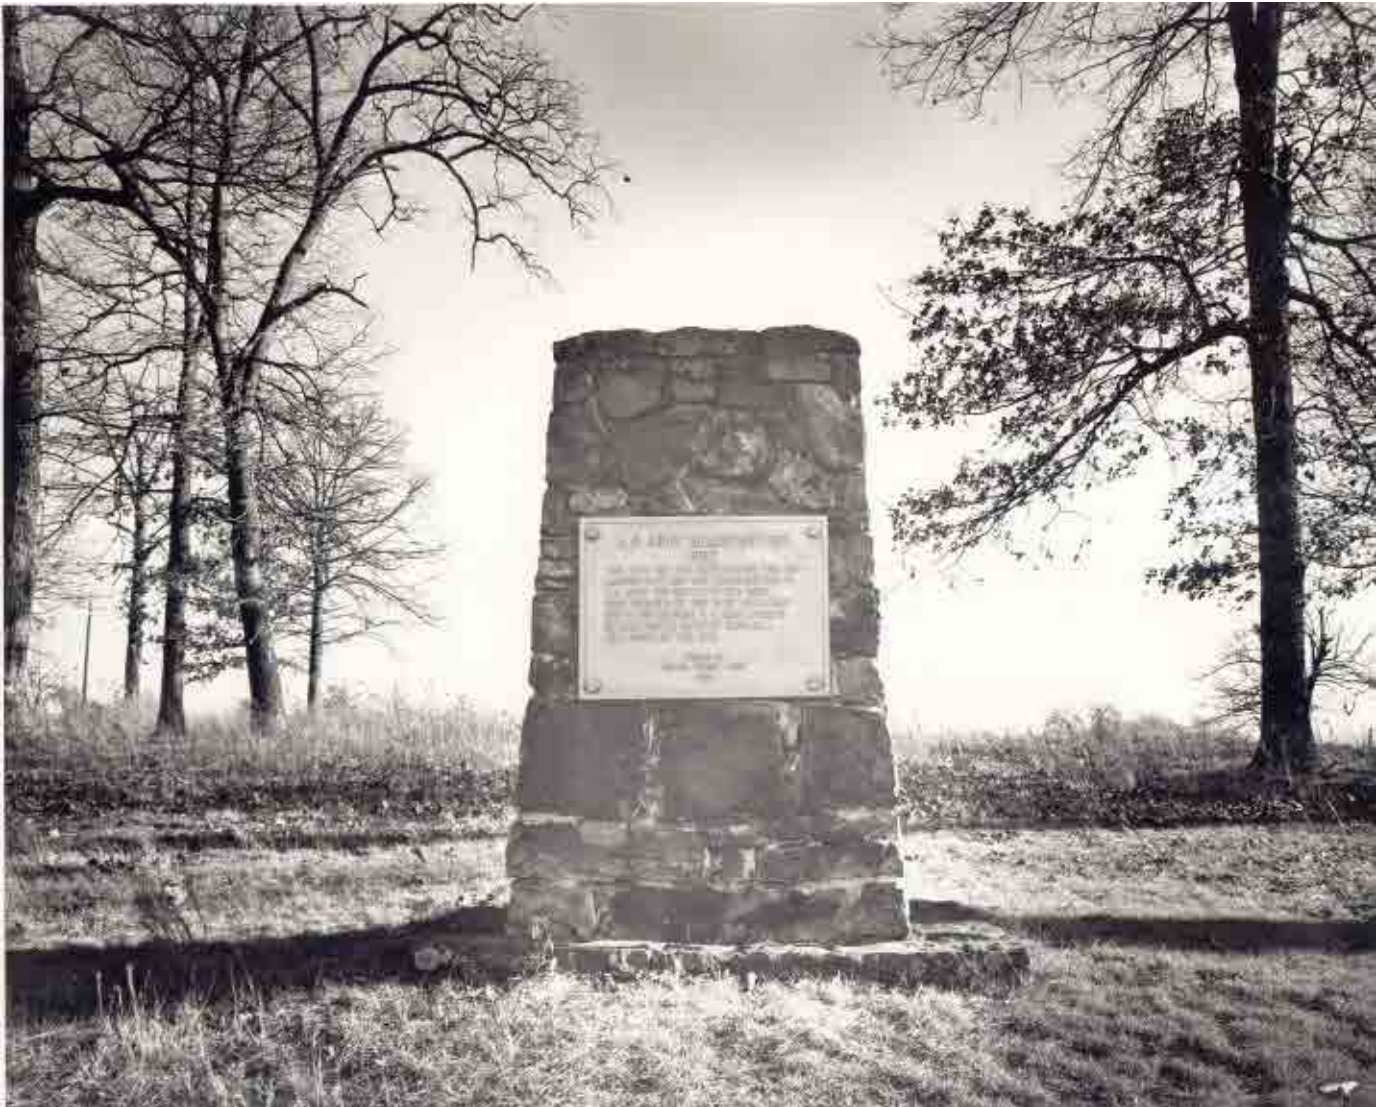
Figure 3-62. The U.S. Army Headquarters Monument is located along U.S. Highway 62, and was built in 1935 (B&W U.S. jpg).

This feature is located along U.S. Highway 62. The monument marks the site of the headquarters of the Union army and the location where the commanding officers camped during the Battle of Pea Ridge. The stone monument is a rough masonry fieldstone pillar approximately five-feet square. The monument is in good condition.

The U.S. Army Headquarters Monument was built in 1935, to commemorate the site of the headquarters of General Curtis. Although the monument was built outside the period of significance, it is a contributing feature as it assists in commemorating the battle. The monument has been determined eligible for listing on the NRHP by the SHPO.

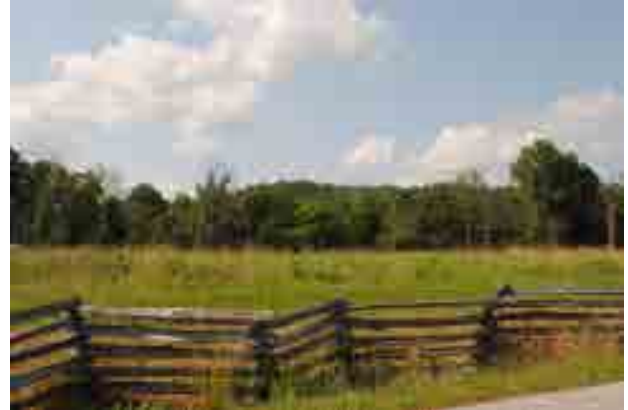
Figure 3-63. The worm fence is the most common fence within Pea Ridge NMP. It is used to define historic fields and roadways (MB: DSC\_0676.jpg).

To determine the placement of fences to delineate historic fence lines, park staff consulted Bearss 1965 map and Weih's 2006 historic land use map. They verified the fence lines from these documents by reviewing the 1899 Fayetteville quadrangle and photographs from the 1940s and 1960s. When placing fence lines they investigated the site for evidence of grade change. In some cases, linear mounds or lines were identifiable. This enabled park staff to construct extant worm fence lines.<sup>3.41</sup>

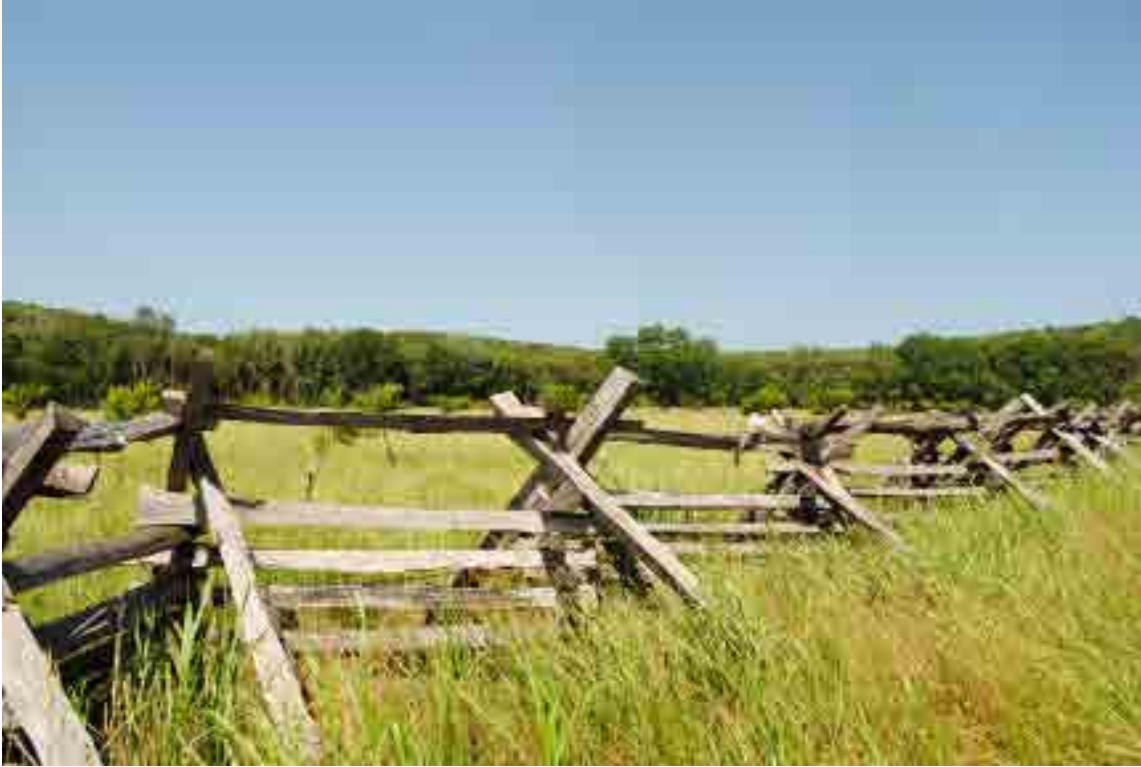
Figure 3-64. A worm fence with a top rail surrounds the peach orchard at Ford's Farm (MB:DSC\_0326.jpg).

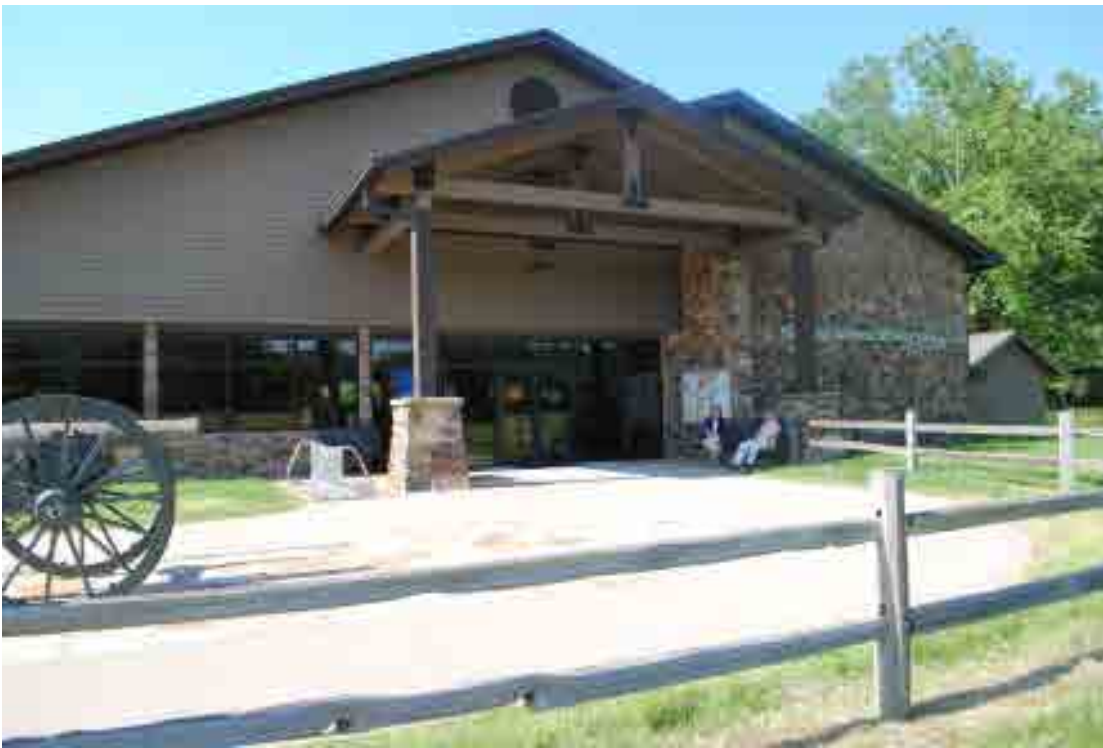
Figure 3-65. A post/rail fence is used at the visitor center (MB:DSC\_03579.jpg).

A wood post and rail fence lines U.S. Highway 62 at the park entrance. At the entrance road, the fence connects to an entry sign / monument. The fence is in good condition.

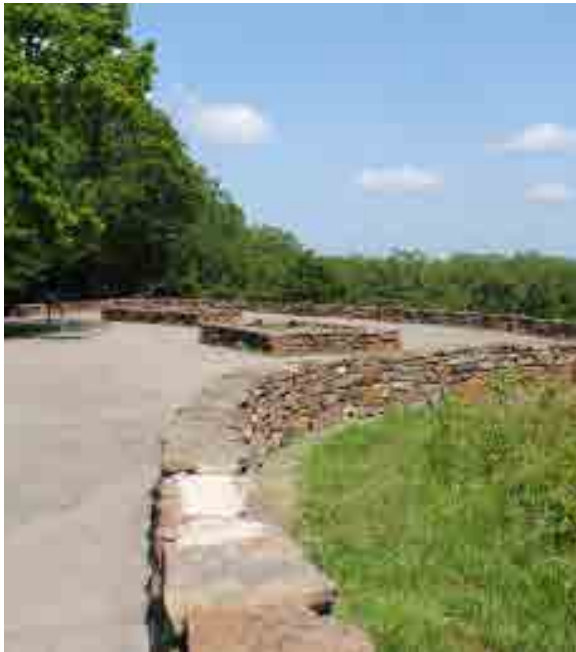
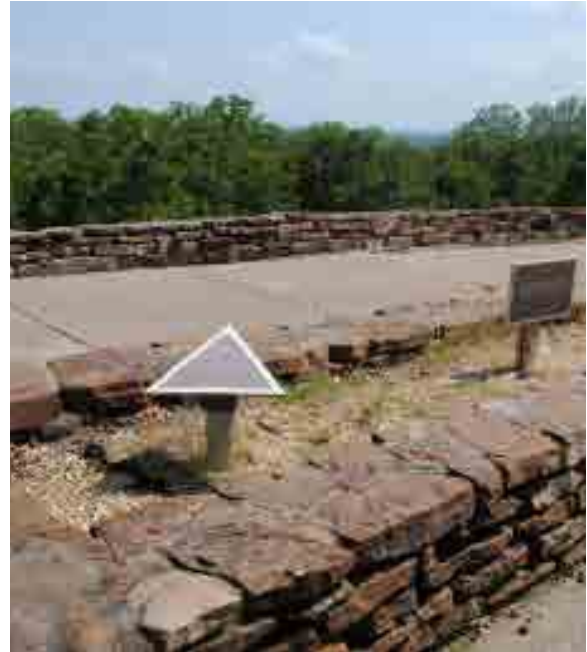
Three of the Tour Road's interpretive stops include stone walls. These were originally built to define overlooks and tour stops, and in the case of the east and west overlooks, as railings for safety. The walls were built in the 1960s as part of the Mission 66 program for the interpretation of the battlefield landscape. The stone walls are in fair to good condition.

Figure 3-66. Stone walls, built as part of NPS Mission 66 program in the 1960s, define the east and west overlooks. These walls are at the west overlook (MB:DSC\_0600.jpg, left and MB:DSC\_0597.jpg, right).

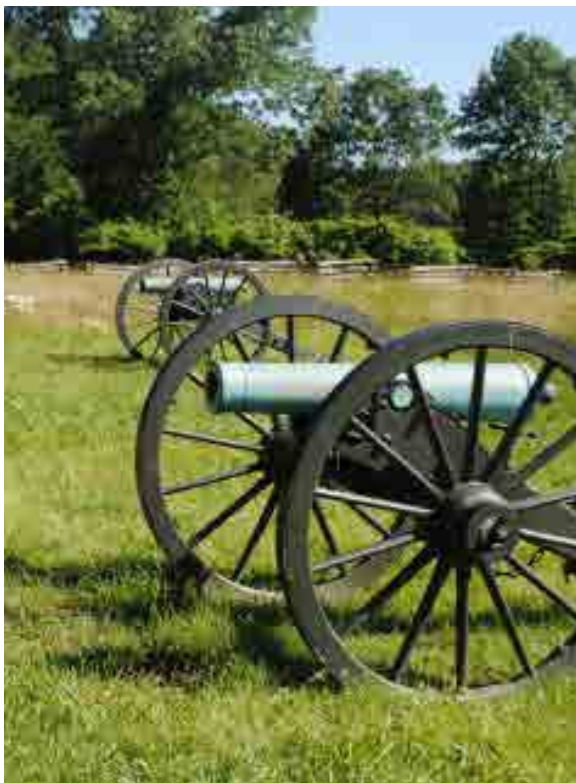
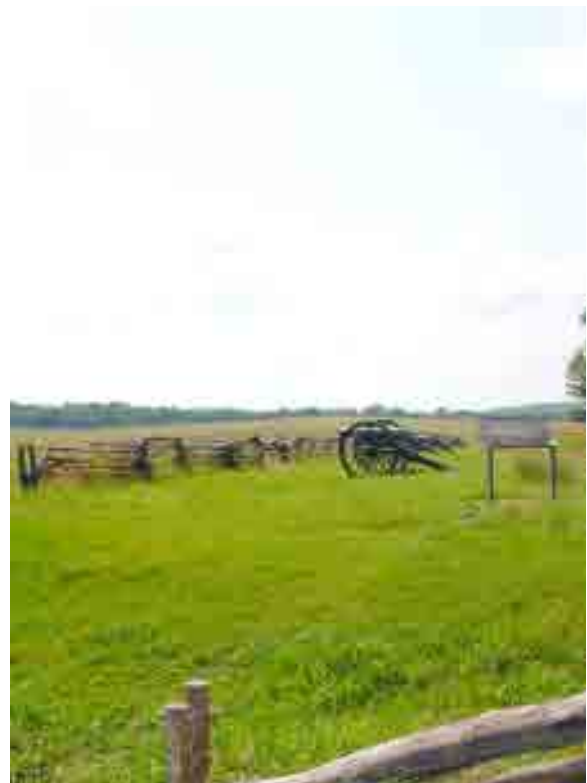
Figure 3-67. Lines of artillery are emplaced within the study area. The replica artillery are moved occasionally by park staff to depict battle segments (MB:DSC\_131.jpg, left and MB:DSC\_0678.jpg, right).

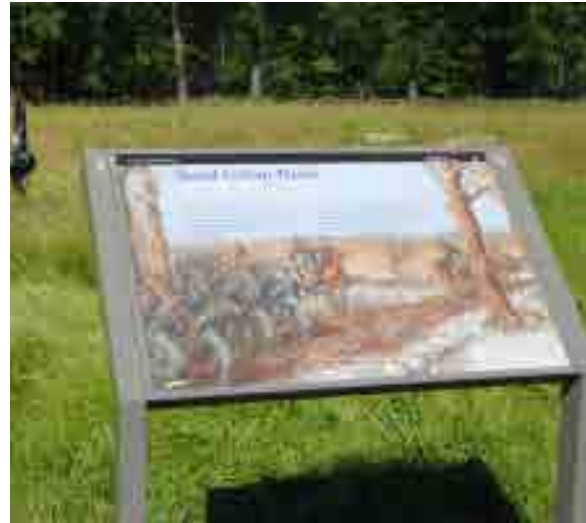
The tour stops and locations for interpretive signs were first installed with the construction of the Tour Road in 1963. The signs were replaced in 2010, and are in fair to good condition. The interpretive signs are non-contributing features.

Figure 3-68. The standard interpretive signage at Pea Ridge NMP (MB:DSC\_03579.jpg).

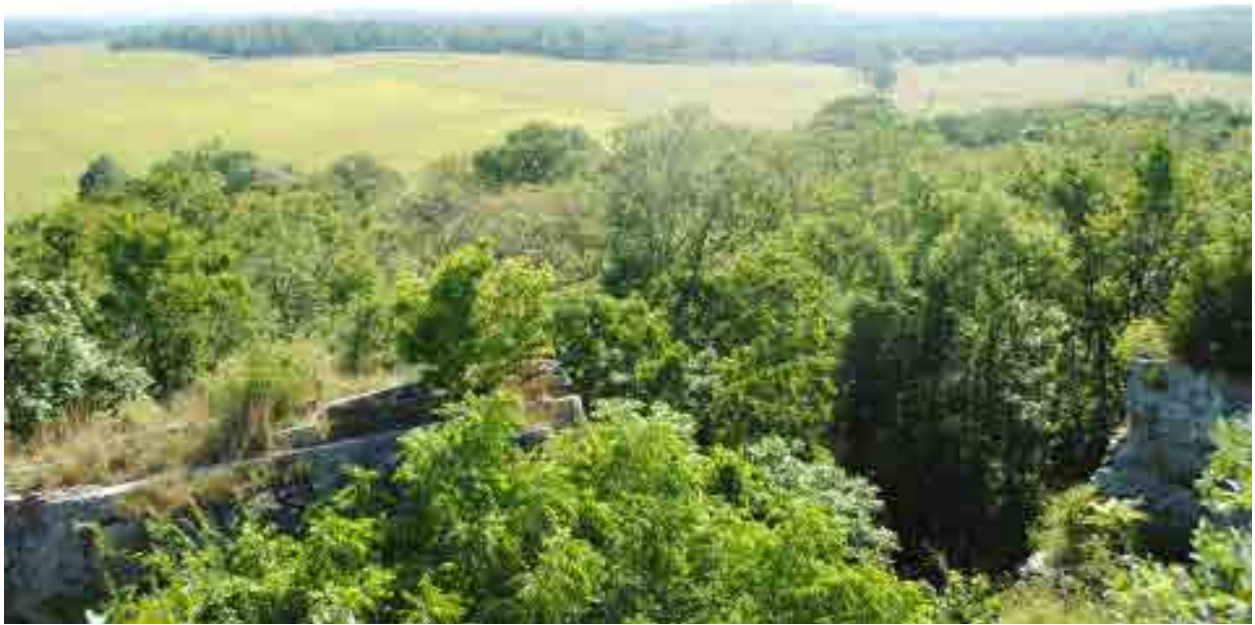
Figure 3-69. The view from Elkhorn Mountain indicates the stark contrast between forest and field, and the vegetation in the fields appears less diverse than what had occurred in the 1940s, and likely in the 1860s as well (MB: DSC\_0172.jpg).

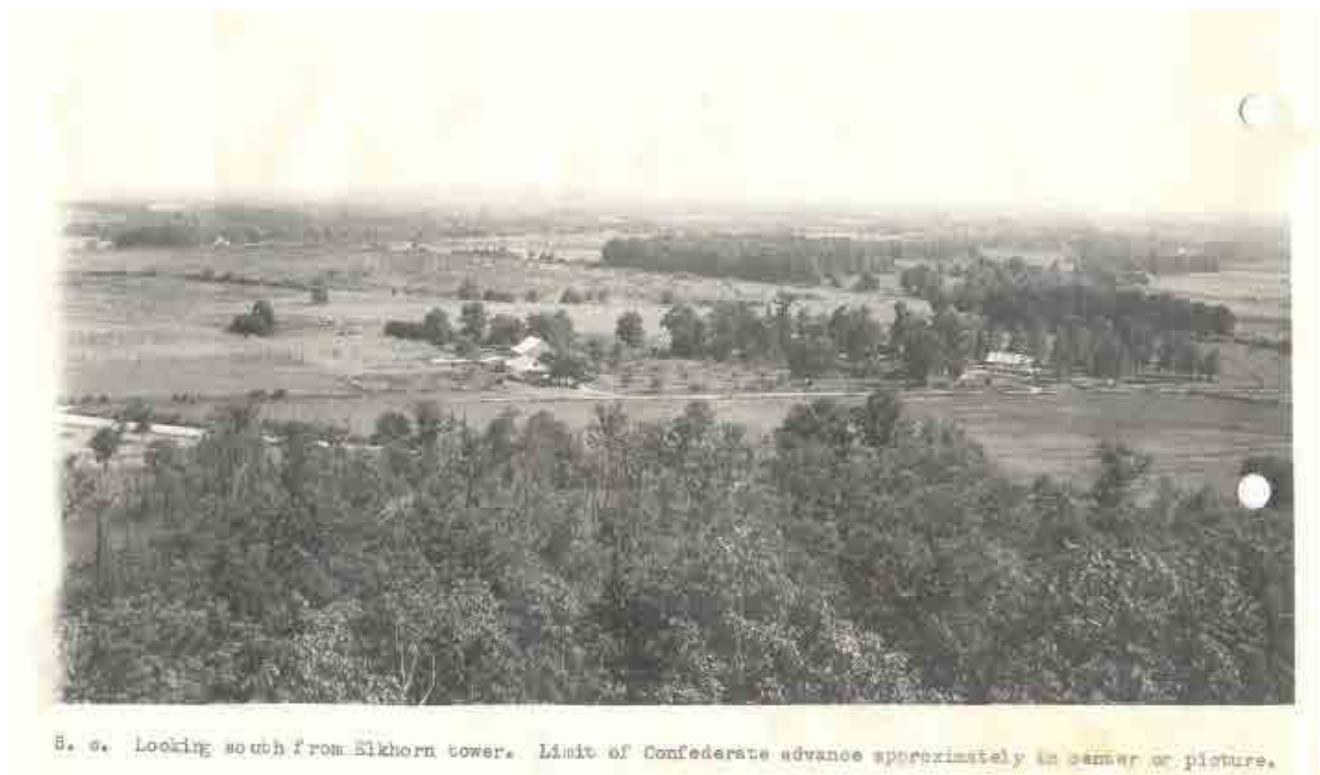
Figure 3-70. In 1940, as seen from Elkhorn Mountain, the vegetation appeared to be more diverse than today. The transition from cropland to woodland was not as abrupt, and different stages of forest regrowth occurred (Looking S from Elkhorn Tower. Limit of Confederate advance in center of photo-1940.jpg).

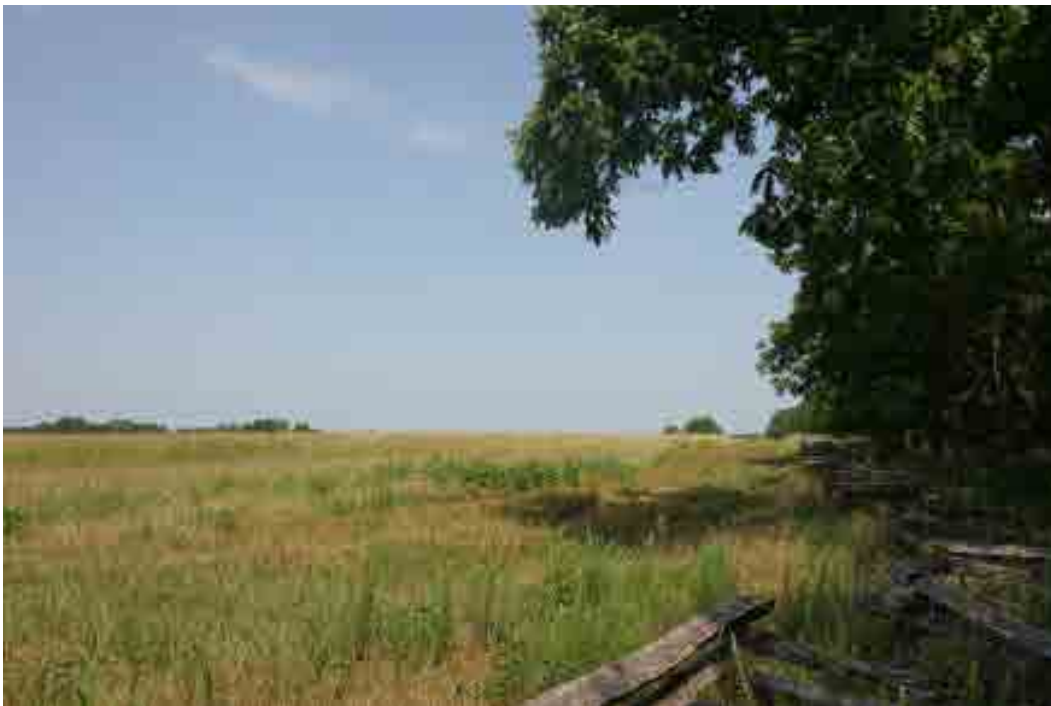
Figure 3-72. Tall grasses in the fields contrast with the dense deciduous woodland in most locations. (MB: IMG\_5798.jpg)

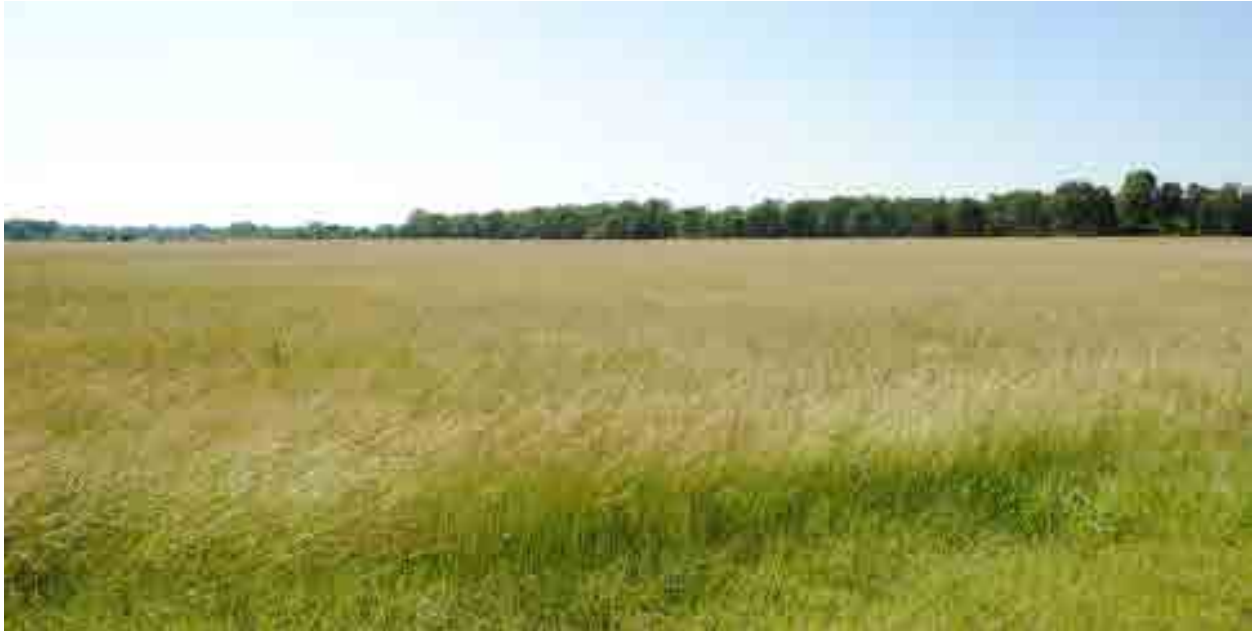
**Figure 3-73.** Unmown pasture grasses are used to indicate former agricultural fields (MB:DSC\_0141.jpg).

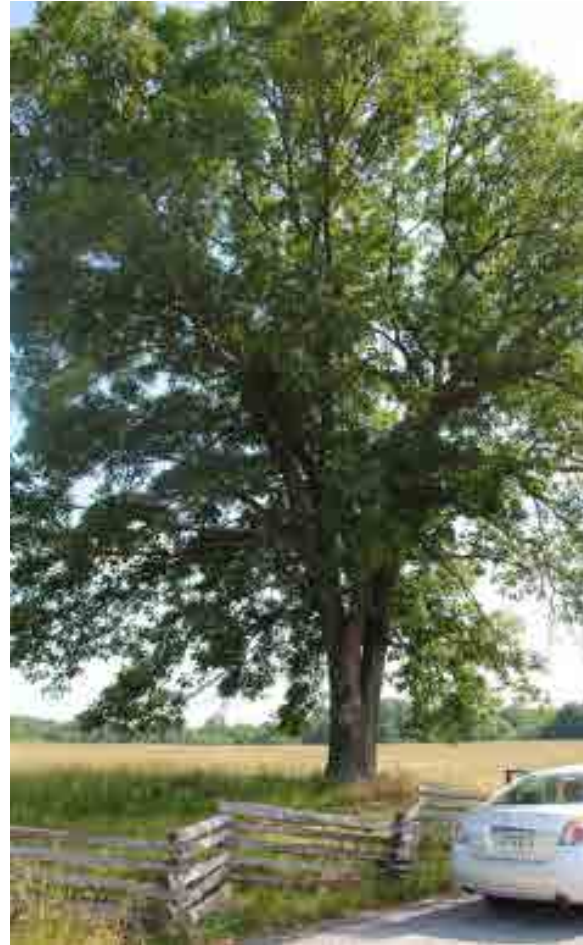
Figure 3-74. Vegetation includes mature trees that edge fence lines and roadways. While likely not from the period of significance, they reflect a pattern of tree planting established in the area in the 1800s (MB: DSC\_0677.jpg).

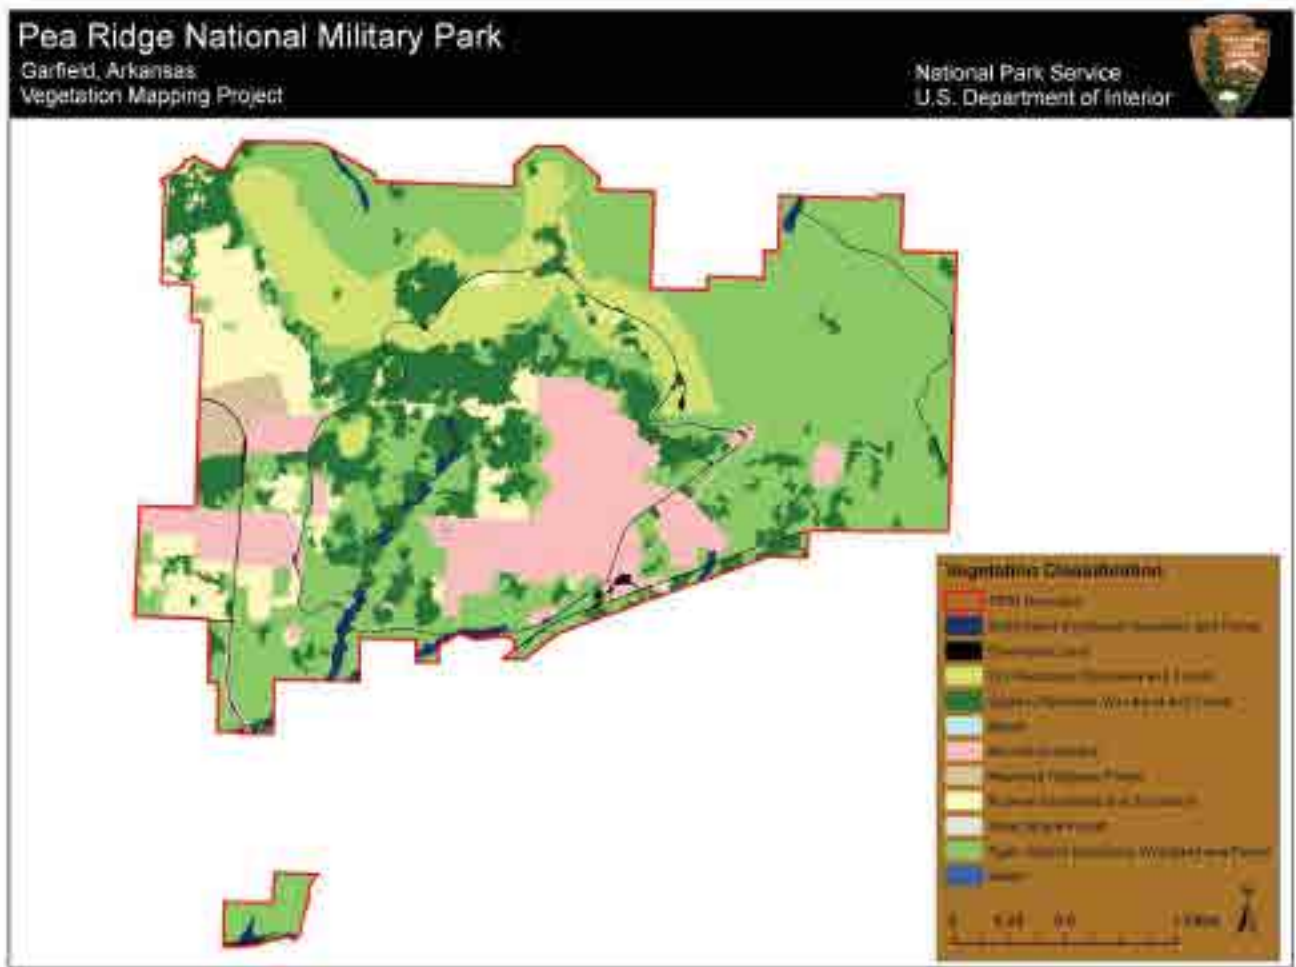
Figure 3-75. Existing Vegetation, DMP 2014 (PERI\_Veg\_Mapping\_DRAFT\_Oct2012).

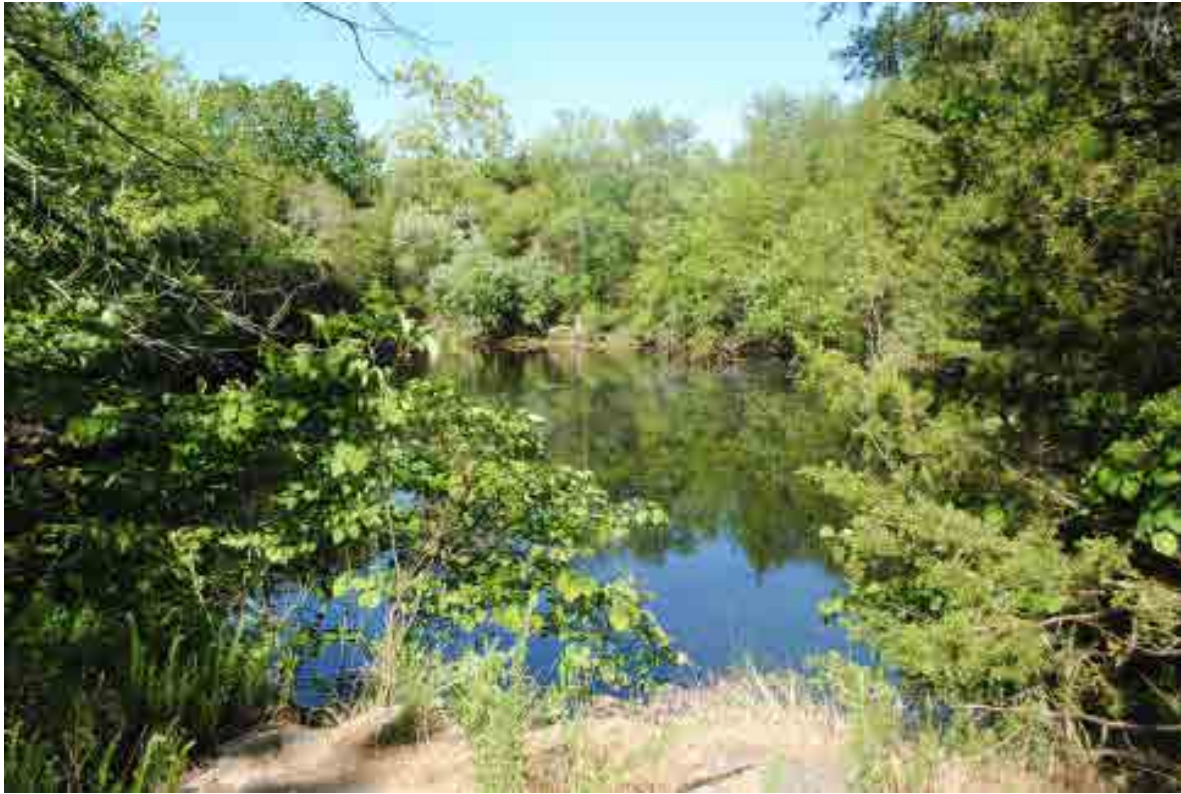
Figure 3-76. The quarry is located near the intersection of the tour road and Ford Road. It is oval shaped, approximately fifty-feet at the longest width, and is filled with water (MB: DSC\_0154.jpg).

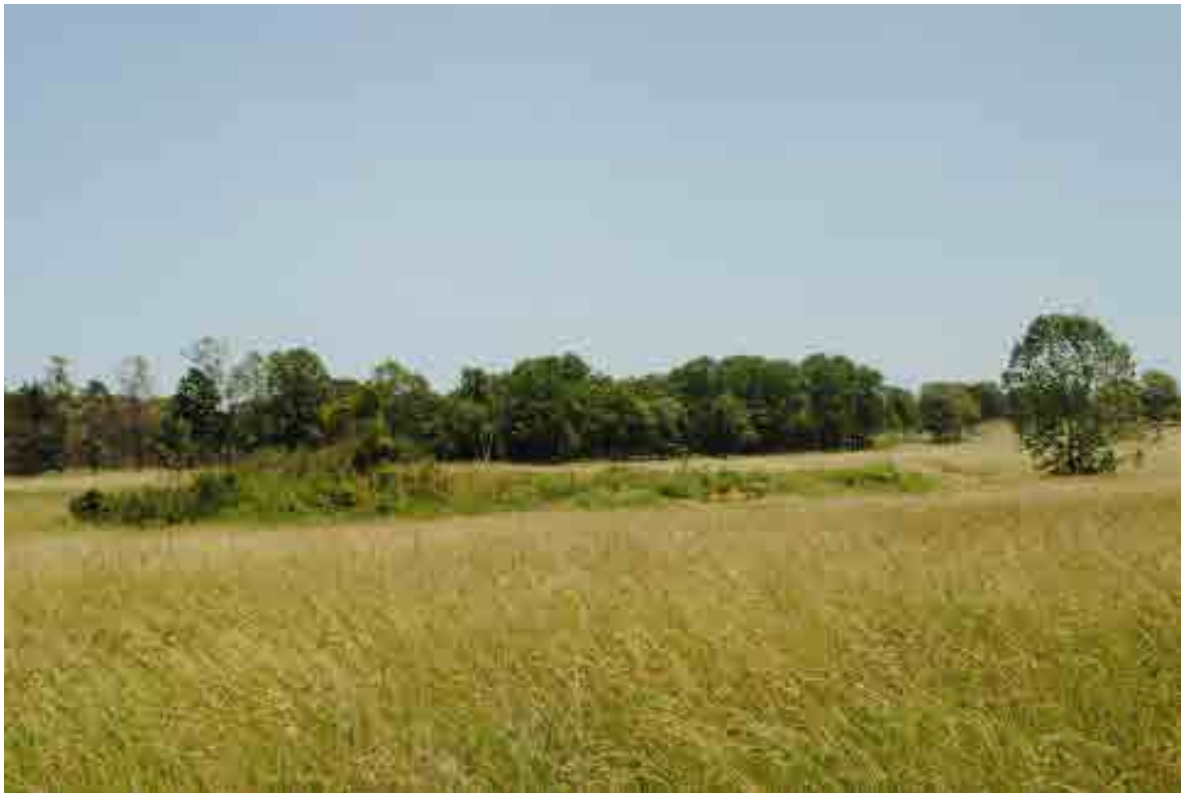
Figure 3-77. The stock pond is located on the west plot of Pratt's field. It was likely built to hold water for animals and irrigation (MB: DSC\_0285.jpg).
