Categorical Exclusion Determination

X1414-04 CAMP ZOE SHANNON COUNTY, MISSOURI

SCI No. 2014-7007.20

Enclosed is the Categorical Exclusion Determination for the new approximate 13,300-lineal-foot access road for a new 407-acre state park located in Shannon County, Missouri.

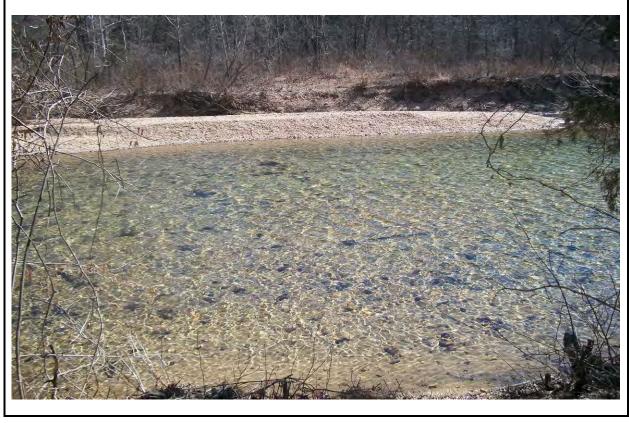
Photo 2. Sinking Creek at potential Crossing 1, facing southeast

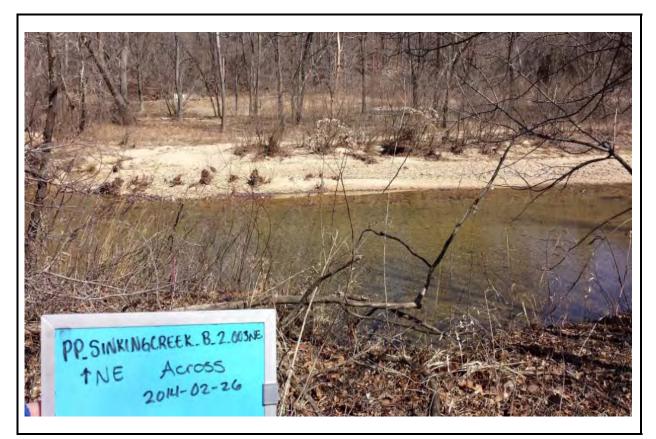
Photo 5. Sinking Creek at potential Crossing 3, facing northeast

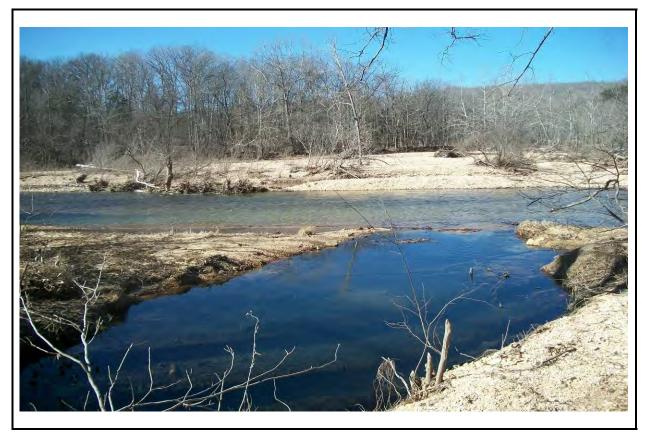
Photo 7. Burnt House Hollow at its confluence with Sinking Creek, facing southwest

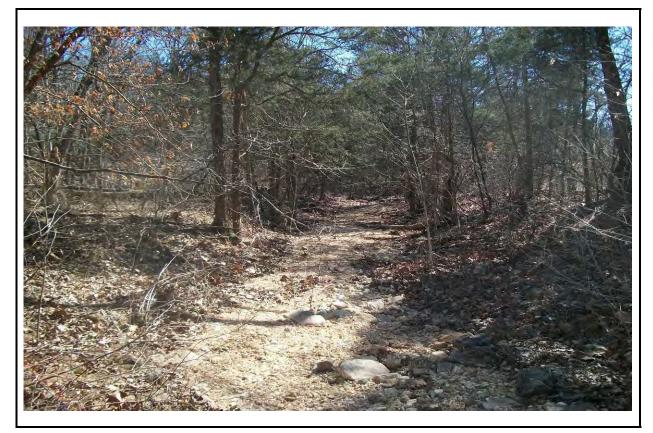
Photo 8. Burnt House Hollow northern upstream section, facing south

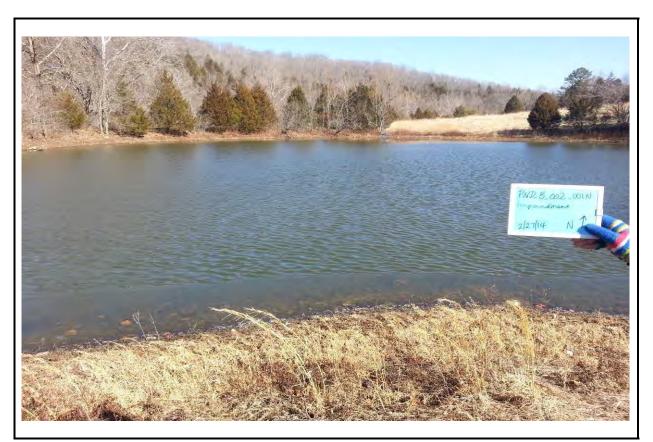
Photo 17. Pond A, facing north

Based on SCI's understanding of Section 328.3 of the Code of Federal Regulations (33 CFR), several of the identified features on site have the potential to not meet the definition of a jurisdictional waters of the United States. Ponds A, B and C, Lagoon A, and the approximate 0.04 acre suspect waterbody located in the northern boundary of site all appeared to lack a direct hydrologic connection to any waters of the United States, and as such, these features may not be regulated by the USACE. Similarly, a man-made closed depression identified in the northwest corner of the site contains hydrophytic vegetation. The depression is located adjacent to County Road 19-B, and appears to be the result of repeated activity in the power line right-of-way, creating a depression suitable for such vegetation to grow but lacks other jurisdictional wetland characteristics (photo 38). There is also a ravine in the north central area of the site, leading down to Sinking Creek that exhibits bed and bank at the gentler slope at the top of the hill, however the feature is predominantly an erosional gully that lacks jurisdictional characteristics such as a consistent bed and bank and OWHM indicators.

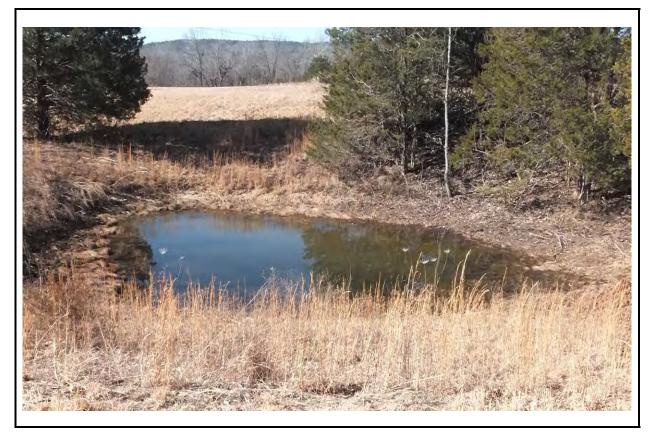
Photo 18. Pond B, facing southwest

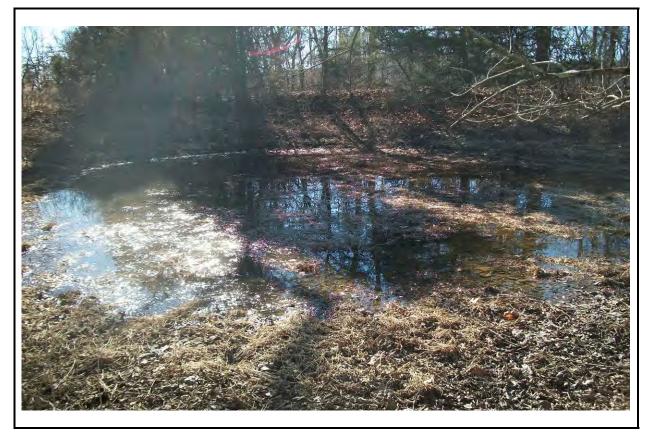
Photo 19. Pond C, facing west

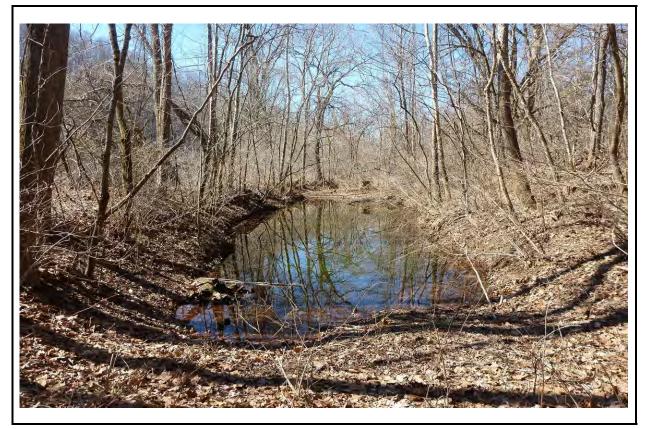
Photo 20. Pond D, facing southwest

Pond D is approximately 0.10 acres and is adjacent to Sinking Creek on the southern end of the site (Photo 20). The pond's source of hydrology is likely overflow discharge from Sinking Creek. Pond D appears to be made by excavating (possibly gravel) near the western bank of Sinking Creek. Dominant bank vegetation includes coastal plains willow (*Salix caroliniana*), sycamore (*Platanus occidentalis*), scarlet and black oaks (*Quercus coccinea* and *Quercus velutina*), and silver maple (*Acer saccharinum*).

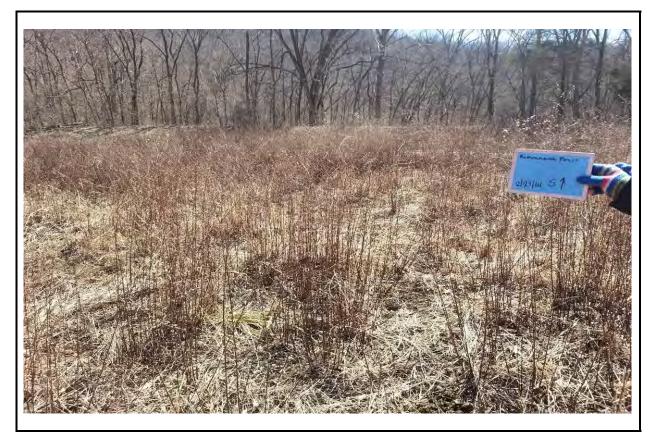
Photo 21. Dry Lagoon A, facing south

Lagoon A is a dry, remnant sewage lagoon approximately 0.44 acres in size and an NWI PUBGh mapped feature (Photo 21). It is located on the east side of Sinking Creek and south of the previous camp facilities in the center of the site. SCI understands the lagoon was the former site of a sewage treatment facility, and appears to have been drained. The source of hydrology is unknown, and the lagoon was not observed to be holding water at the time of inspection. Weedy vegetation has established within the lagoon, and the dominant vegetation observed was: Eastern red cedar (*Juniperus virginiana*), aster species, and little bluestem (*Schizachyrium scoparium*).

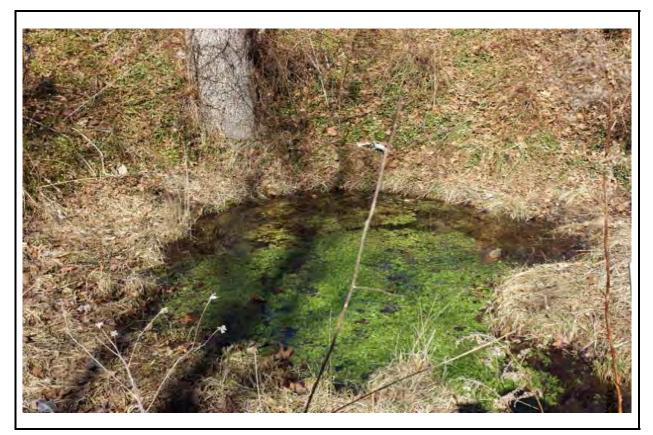
Photo 22. Spring A, facing northeast

Spring A is located on the eastern side of Sinking Creek and south of the previous camp facilities in the center of the site (Photo 22). Water from the spring has channelized and drains into Sinking Creek. The surface of the spring was observed to be dominated by lesser duckweed (*Lemna minor*).

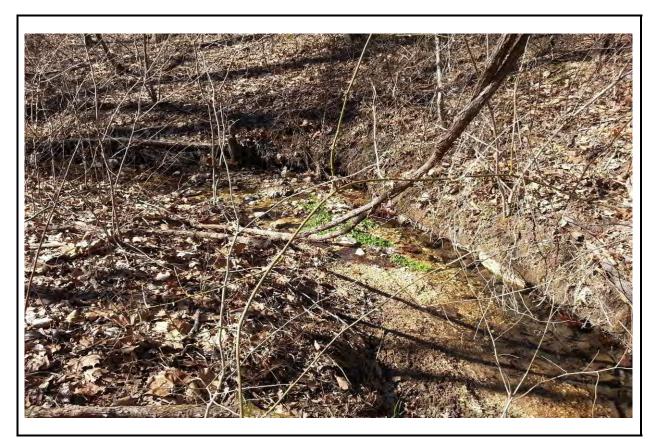
Photo 23. Spring B, facing northwest

Spring B is located on the western side of Sinking Creek and north of caves SHN546 and SHN547 (Photo 23). The spring appears to flow from underneath dolomite rock outcrop, and subsequently channelizes and drains into Sinking Creek.

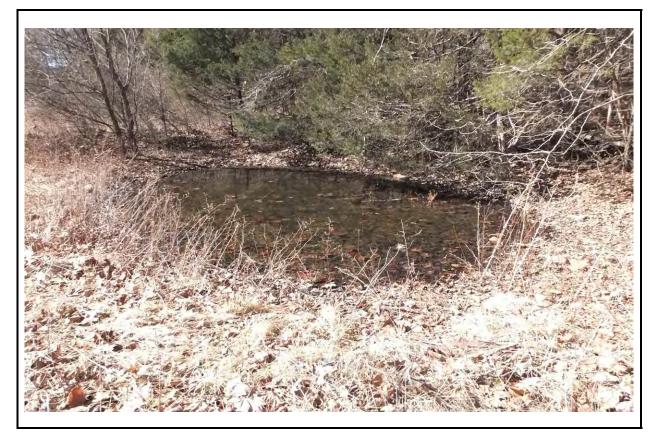
Photo 38. Spring C, facing southwest

Spring C is located to the west of Burnt House Hollow, adjacent to a dolomite glade area (Photo 38). Adjacent vegetation consisted of Eastern red cedar (*Juniperus virginia*), Queen Anne's lace (*Daucus carota*), and Aster species (*Symphyotrichum spp.*).

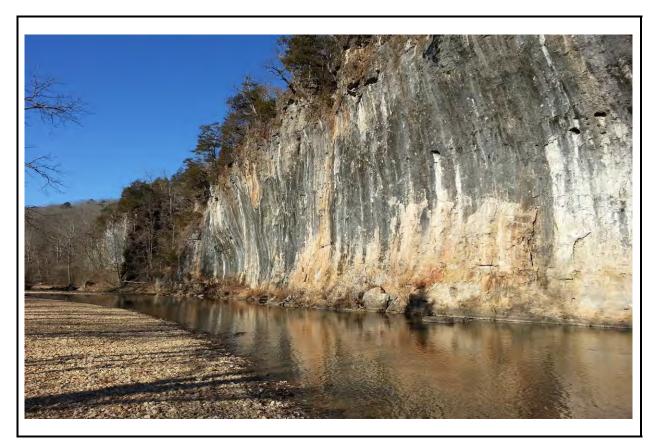
Photo 24. Typical dolomite cliff, facing northwest

The limestone and dolomite cliffs are found throughout the property, and are inhabited primarily by Eastern red cedar (*Juniperus virginiana*), chinkapin oak (*Quercus muehlenbergii*), and briar species (*Smilax* spp) (Photo 24). The taller cliffs that line Sinking Creek also contain caves that serve as winter bat hibernacula. Five caves were identified on our site visit: SHN527, SHN528, SHN529, SHN546, and SHN547 (Photos 25 through 28). An additional cave, SHN090, was reported to exist, however it was not located during our site visit. SCI has been contracted to perform acoustics and mist net surveys for the presence of any Threatened and Endangered bat species such as the Indiana Bat.

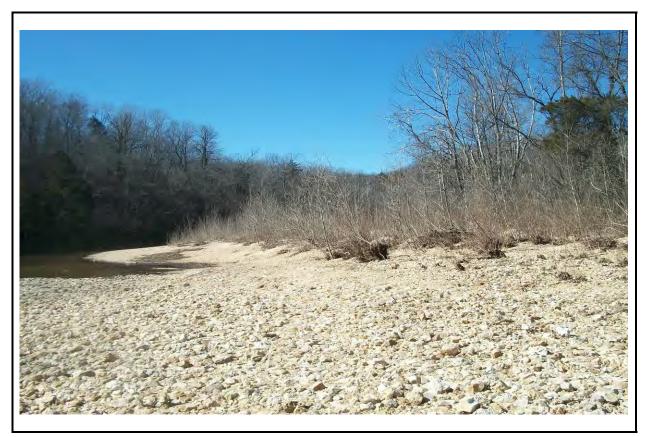
Photo 29. Typical gravel bar with sycamore, sand bar willow, and buttonbush, facing northwest

Due to the meandering nature of Sinking Creek, gravel and sand bar areas frequently line the banks of the channel. Sugar Tree Hollow also has mid-channel gravel bars in the southeast corner of the site. These areas are dominated by rocky gravel and sand substrates, but some vegetation is also present, including sycamore (*Platanus occidentalis*), sandbar willow (*Salix exugua*), buttonbush (*Cephalanthus occidentalis*), swamp dogwood (*Cornus amomum ssp. oblique*), and eastern witch hazel (*Hamamelis virginiana*) (Photo 29).

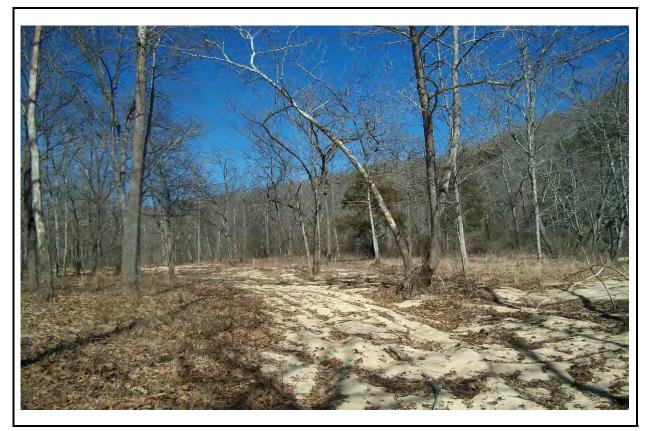
Photo 30. Typical riverfront forest, facing north

The lowland areas along Sinking Creek also contain riverfront forests (Photo 30). Since they are frequently inundated with water, the species in these areas tend to be hydrophytic, and associated with identified wetland areas. The dominant species in the riverfront forests are woodland sedge (*Carex blanda*), hackberry (Celtis occidentalis), box elder (*Acer negundo*), American elm (*Ulmus americana*), Eastern cottonwood (*Populus deltoides*), sycamore (*Platanus occidentalis*), and buttonbush (*Cephalanthus occidentalis*).

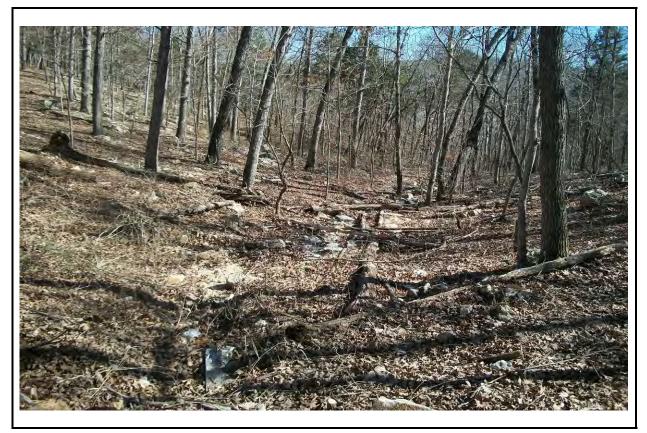
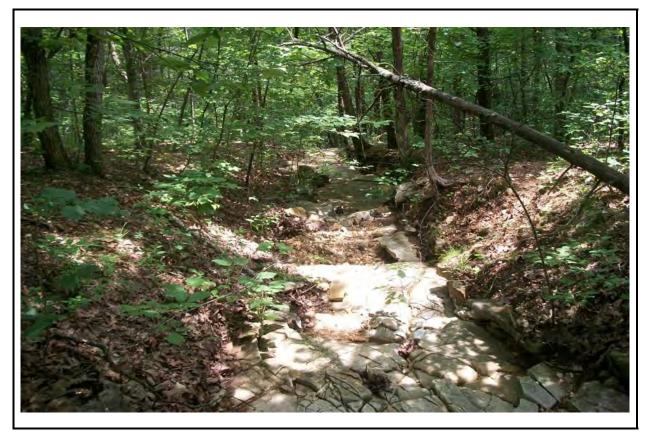
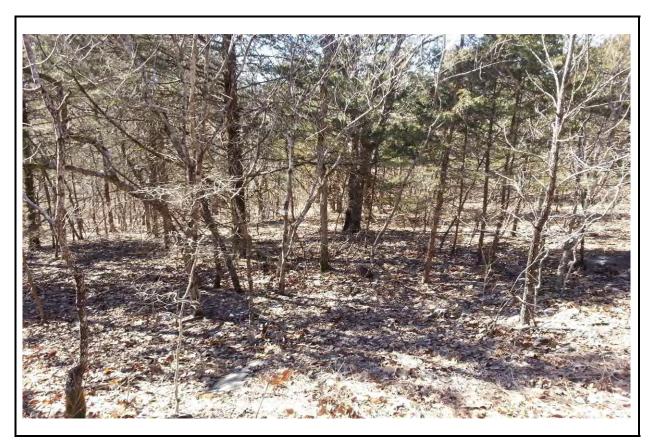
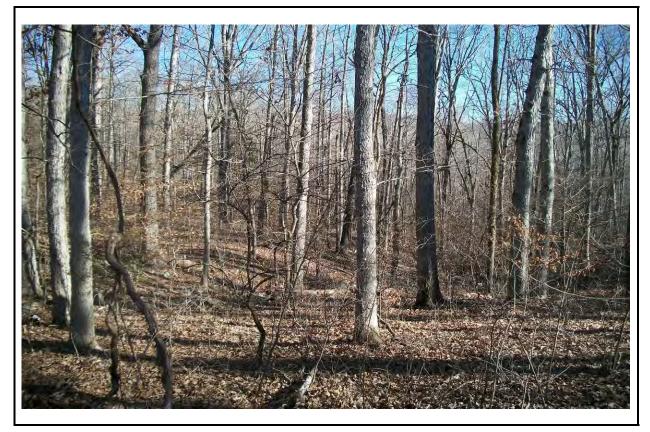
The majority of the site on either side of Sinking Creek is dominated by various types of highly sloping upland forest areas, which include the dry to dry-mesic dolomite woodland, dry-mesic chert woodland and dry-mesic and mesic bottomland (Photos 31 through 34). Rocky outcroppings of dolomite and limestone can be seen protruding from hill slopes throughout the site (Photo 35). These areas are dominated by Eastern red cedar (*Juniperus virginiana*), chinkapin oak (*Quercus muehlenbergii*), black oak (*Quercus velutina*), hackberry (*Celtis occidentalis*), white ash (*Fraxinus americana*), black gum

Photo 31. Upland forest in northwest corner of Camp Zoe, with ravine in center, facing southeast

Photo 32. Drainageway in the northwest corner of the site, facing southeast

Photo 33. Upland forest in southeast corner of Camp Zoe, facing southeast

Photo 34. Wooded area in the southwest area of the site, south of existing residence, facing southeast

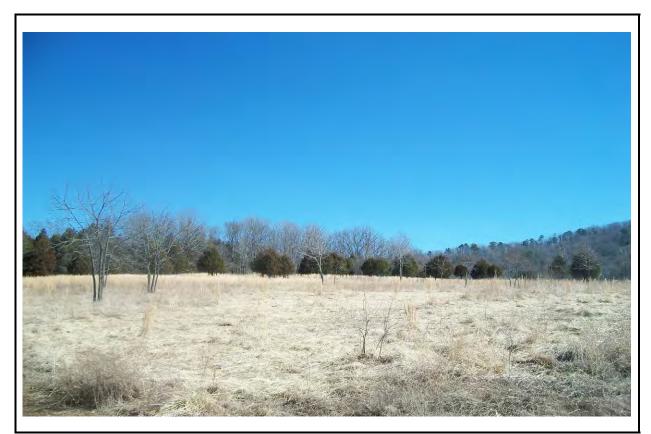
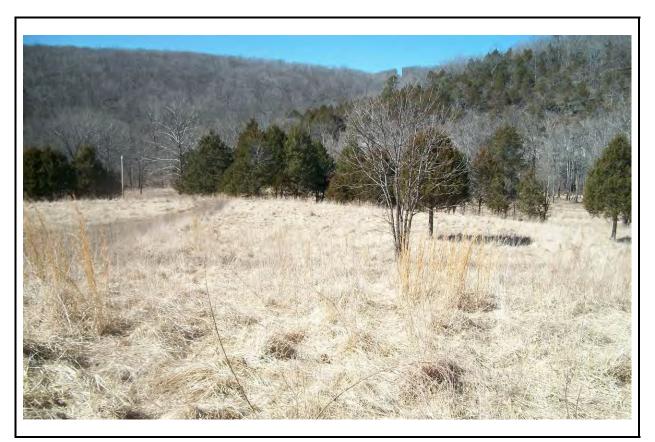
Another terrestrial environment unique to the Ozark area is the dolomite glade (Photos 36 and 37). These areas were identified in the northern section of the site on south-facing slopes that capture abundant sunlight and are free of canopy cover. The dominant vegetation included little bluestem (*Schizachyrium scoparium*), big bluestem (*Andropogon gerardii*), orchard grass (*Dactylis glomerata*), Indian grass (*Sorghastrum nutans*), switch grass (*Panicum virgatum*), sideoats grama (*Bouteloua curtipendula*), and glade coneflower (*Echinacea simulata*).

Photo 36. Typical dolomite glade in northeastern section of Camp Zoe, facing northeast

Photo 37. Dolomite glade in former parking area, facing north

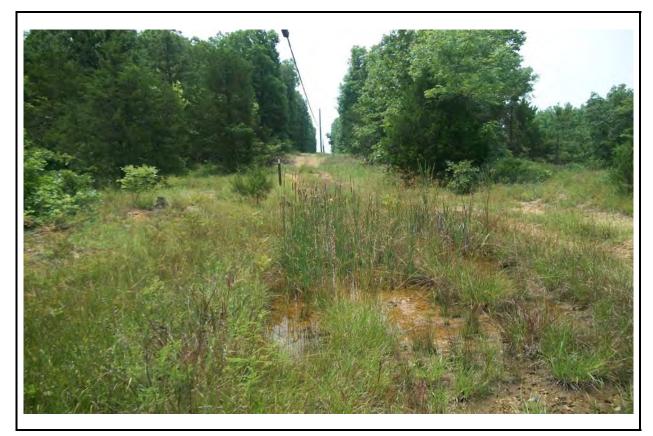
Photo 39. Man-made closed depression, facing south

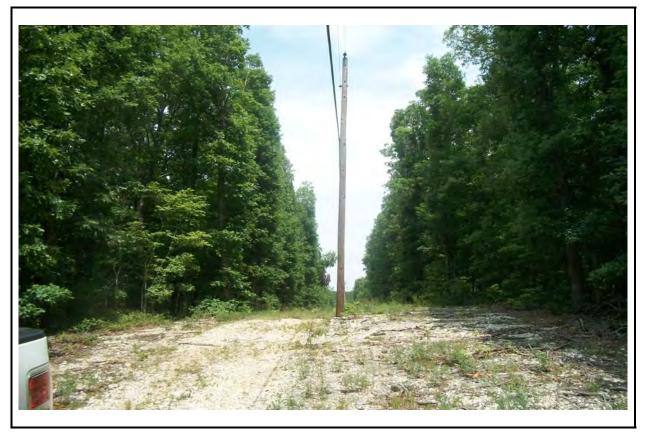
Photo 40. Existing overhead power line right-of-way in NPS property, facing north

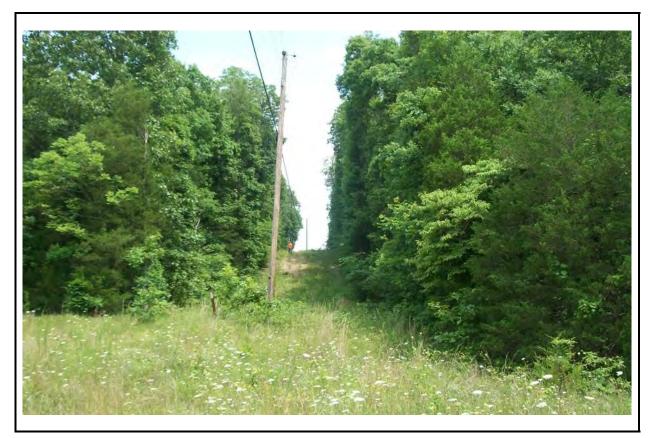
Photo 41. Existing overhead power line right-of-way north of Sinking Creek, facing north

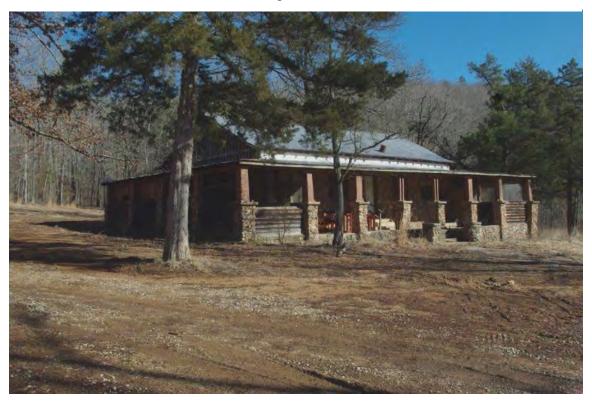
Photo 2: Building 1 Facing Southeast

It is not known when these changes were made, but a 1966 photograph of the building indicates that the porches had been enclosed by that time (Figure 13). Patty Allen, a 1964 Camp Zoe camper, stated that the enclosed porches were utilized as bunks for the campers (Personal Communication Patty Allen). The bunks could be accessed by the entrances on the porch or doorways from inside the building. The modern doors, window, and plywood steps were most likely added in the 1990s or 2000s during Jimmy Tebeau's ownership of the property.

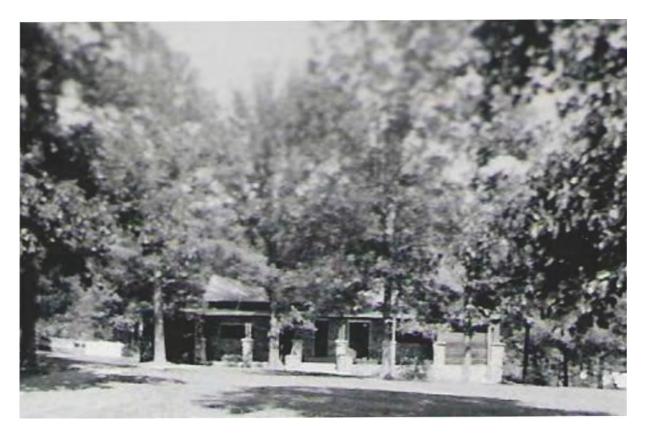
Photo 6: Building 2, Stable, Facing Southeast

Building 2 is the stable which is located southwest of Building 1 (Figure 11, Page 26). It has a board-formed concrete foundation, vertical wood siding, and a corrugated metal gambrel roof (Photos 6-9). A corrugated metal shed roof addition, is on the south wall of the building. The addition also has a board-formed concrete foundation and vertical wood siding. The west gable end has a hinged, double door that is off-center and a hinged double loft door (Photos 6 and 9). A sign stating "Camp Zoe Riding Stable" is above the loft door and a brass light fixture is located just north of the door. Three openings covered with chicken wire are on the north and south walls of the stable and another opening covered with chicken wire is on the west gable end of the addition. The east gable end has sliding double doors and two openings above the double doors (Photos 7-8). The openings possibly had chicken wire and might have been used for vents and/or sunlight similar to the other openings on the building. A frontgable roof that aligns with the shed roof of the addition existed along this gable end. The roof most likely went with a building that had been attached to the west wall of Building 2, as seen in a 2013 photograph (Figure 14). This building was most likely removed due to its dilapidated state. Currently, only a gravel pad and impressions of the foundation on the berm wall are still present (Photo 10). In addition to the removal of this building, the double doors and frame on the west gable end of the building have been replaced along with some of the siding above the doors (Photo 11). The building also has missing and rotting siding and portions of the roof on the addition are coming off.

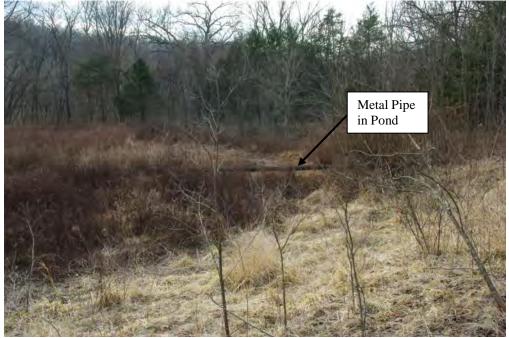
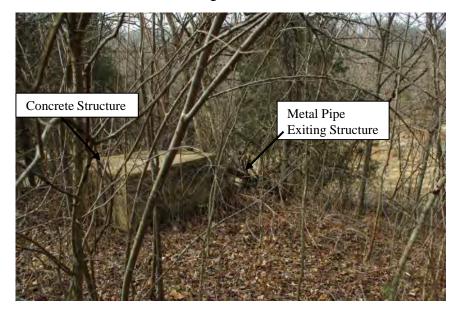
Photo 12: Remains of a Pond, and Portion of Pipe and Pump Facing Southwest Photo 13: Pipe and Pump Facing Northwest

Other features identified in Area B include a drained pond just south of Building 2. The pond has a berm between it and the building. A pipe ran from the pond towards a board formed concrete structure that likely held a pump. A second pipe exited the structure on the opposite side of the pond. (Photos 12 and 13). On top of the berm, south of the pump and southwest of Building 1, was a wood loading chute for horses that appears to be movable (Photo 14). A concrete pad is located to the northeast of the stable, likely used in connection with this building (Figure 11, Page 26).

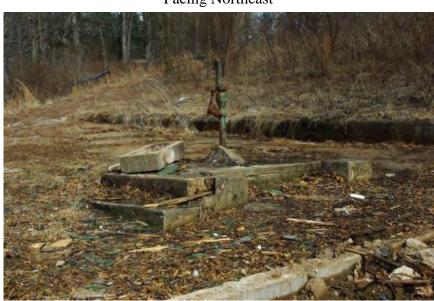
Photo 15: Pump Facing Northeast

A hand pump (Photo 15) was located next to R10 identified as a cistern during the State Park Survey (Missouri State Parks 2013). A small stone bridge, by R10, spans a drainage ditch (Photo 16). There are 2 concrete pads with concentric circle designs, likely used for games (Photo 17). In addition, a series of stone and concrete sidewalks and stairways connect the camp buildings throughout Area B (Photo 18). Two concrete culverts with metal rails are present to span drainages. No other cultural resources were located in Area B (Photo 19).

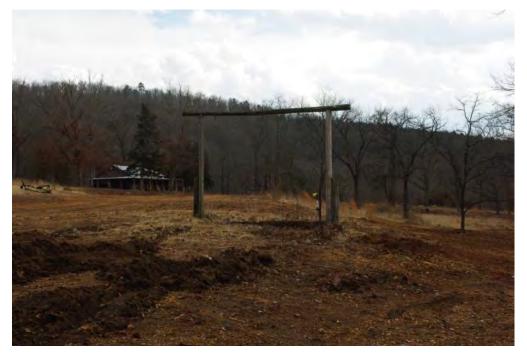
Photo 22: Wooden Sign Post Facing

Two structures were located in Area C. These include a wooden entrance way to the youth camp that at one time held a sign (Photo 22; Figure 11, Page 26). A metal structure was identified, which likely served as an entryway to the main stage area (Photo 23; Figure 11, Page 26). No additional cultural resources were located in Area C.

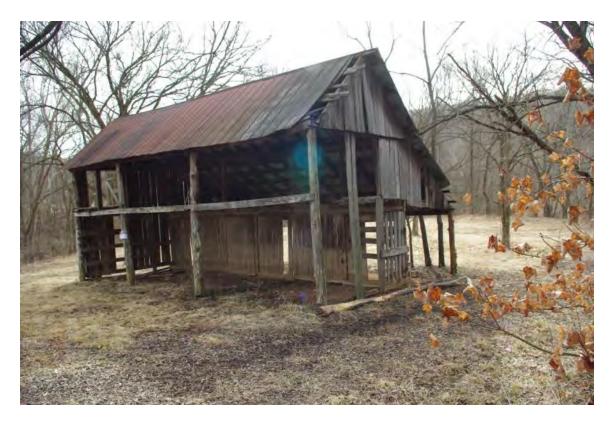
Photo 33: Building 4, Pole Barn Facing Southeast

Also present was one barn (Building 4) and two pole shed (Buildings 5 & 6). (Bldgs. 4-6, Figure 15). Building 4 is a wood pole barn located north of Sinking Creek and west of site 23SH1550. This building was documented by Missouri State Parks, designated as building CZOE124, during their survey of the area (Missouri State Parks 2013). It has vertical wood siding and a gabled, corrugated metal roof (Photos 33-36). A drive-through machine shed is located on the south side of the barn. The west wall has a wood door and the east wall has a loft door (Photos 34-37). The barn is in extremely poor condition. The siding on the north wall is no longer present and much of the siding on the other three walls is missing or rotten. Also, small portions on the western side of the roof are missing. It is not known when this building was constructed and Missouri State Parks has decided to demolish it (Photo38).

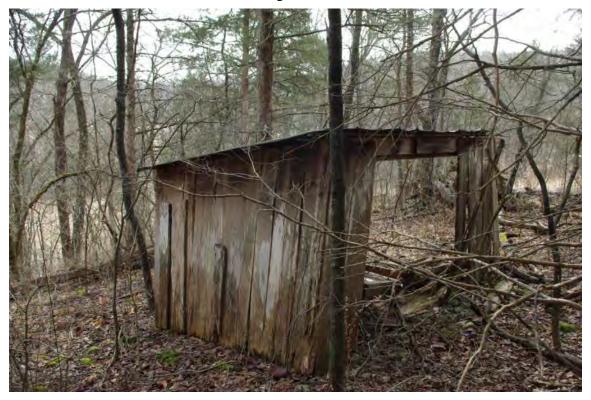
Photo 39: Building 5, Pole Shed Facing Northwest Photo 40: Building 5, Pole Shed Facing Southeast

Two pole sheds were identified during the survey (Bldg. 5 & 6, Figure 15, Page 47). Building 5 is located immediately northwest of Building 4. It is a small, dilapidated shed with vertical wood siding, corrugated metal roof, and may or may not have had a southern wall (Photos 39-40). A portion of the west wall also is gone. A window frame covered with a metal bed frame is located on the east wall (Photo 41). The siding below the window frame is missing. A large concrete block is present in the center of the shed, but it is unclear if was used in the shed or dumped there. Like Building 4, the date of construction and purpose of this building is unknown, but it is in existence by 1945 when it appears on that topographic map. It is likely that the most recent landowner, Tebeau, used this building to construct and/or store the portable bridges used to cross Sinking Creek during the music festivals (Personal Communication, Jim Newberry Feb. 14, 2014). At least one completed bridge and three partially completed bridges were identified around Building 5 (Photo 42).

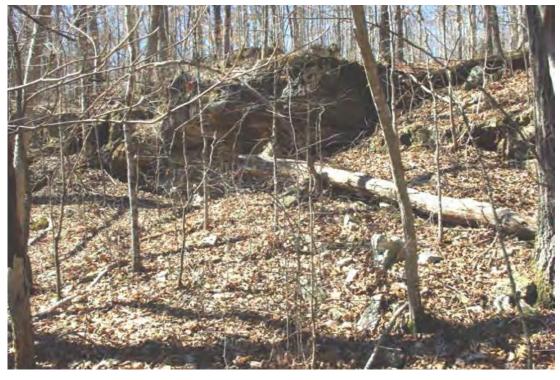
Photo 51: Rockshelter About 4 feet High Facing Northwest

Some potential rock shelters were identified within Area 1 along the natural drainage that passes through the northern portion of Area 1 (Photos 51-52). The leaf debris was swept away just below these shelters and the bare areas below the rock overhangs were examined for cultural remains. No artifacts, however, were found. A spring was identified issuing from one of the rock formations (Photo 53). The area around this small spring was examined but no cultural remains were identified.

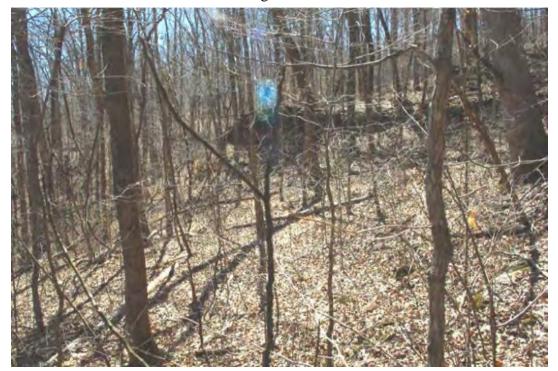
Photo 52: Rockshelter About 7 Feet High Facing Southwest

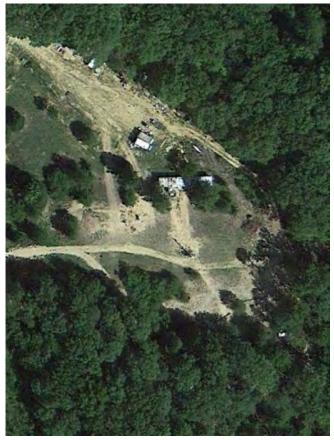
Figure 19: Aerial View of Little Camp Zoe Showing Disturbance

The southern portion of Area 1 was located within Little Camp Zoe. Much of this area had been cleared of vegetation and the soils appear to have been eroded due to the use of this area as a campground (Figure 19). Surface visibility was better at this location at 60-70%. The rocky ground was directly examined for remains, but other than some modern debris, no artifacts were identified.

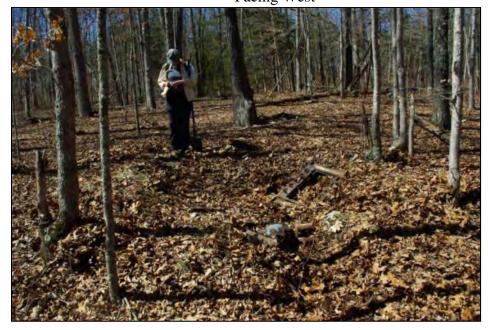
were identified near the base of a ridge slope (Figure 20: Pits 1 and 2). Pit 1 was circular, with diameter of 3 meters, and a depth of 1.5 to 2 meters (Figure 21). Back dirt was placed on the upslope side to the north, south, and west (Photo 54). This pit was filled with a number of tin cans, a graniteware bowl, and a piece of a glass bowl (Photo 55). Two unknown metal objects also were left in this pit (Photo 56). There is a depression, likely an erosion gully, about 1 meter wide leading out of the east side of the pit and ending at Pit 2, about 2

meters down slope (Photo 57). The second pit is rectangular shaped, measuring 3.5 meters long and 1.5 meters wide, and it is about 50 cm deep. Cans also were found in this pit, but fewer than in the circular depression. Photo 54: Circular Mining Pit 1 Filled with Artifacts, Site 23SH1552, Facing West

It's possible that these materials were deposited into these pits from a nearby field kitchen. The site was utilized for historic pit mining activities, probably during the early 20th century, based on the presence of numerous cans and the graniteware bowl. During the survey, it was observed that even more pits existed on the ridge top within Area 2, where the crew did not have access during the present survey. The site boundary was expanded to include this ridge top until the site can be properly surveyed and the mining activities more accurately determined on the western portion of the site.

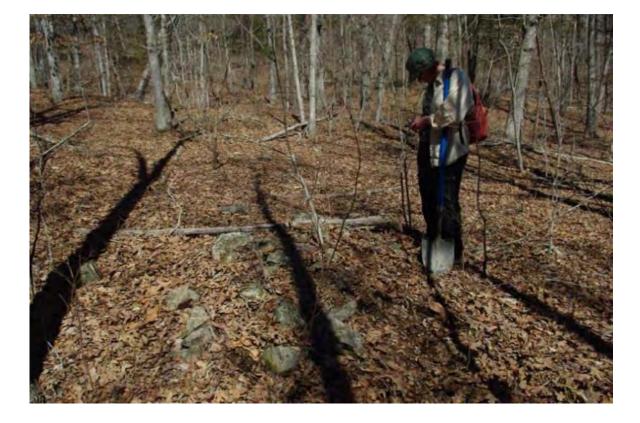
Photo 58: Rock Pile Identified within Site 23SH1552 Facing North

North of these three pits near the natural drainage was found a pile of stones (Figure 20). This pile measured at least 2 meters in diameter and was about 40 cm high (Photo 58). This feature most likely was the result of mining activities, but there is a slight possibility that this it represents a small prehistoric burial cairn.

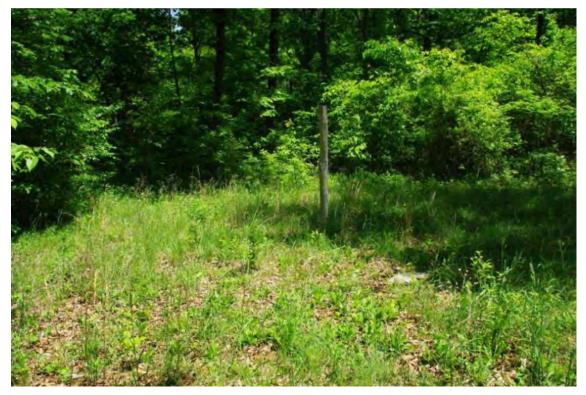
Photo 65: Location of Post in Cleared Area Northeast of Residence and Cement Block Placed Just in Front of Post Facing Northeast

Also discovered was a wooden pole in very good condition that was likely associated with one of the more recent landowners, possibly erected during Tebeau's tenure on the property. The post is located in a clearing northeast of where the residence once stood (Photo 65). This pole stood about 3 meters above the surface and had hewing marks from an axe having been used to remove the bark and branches (Photo 66). It is not clear how this pole was utilized by the owner. There was a concrete rectangle about 2.5 meters northwest of the pole that may have been associated with it.

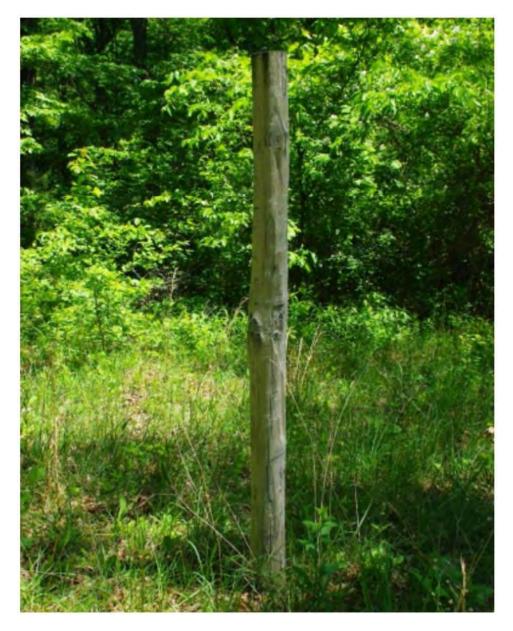
Photo 66: Close-up of Post, Notice Hewing Marks from an Axe, Facing Northeast

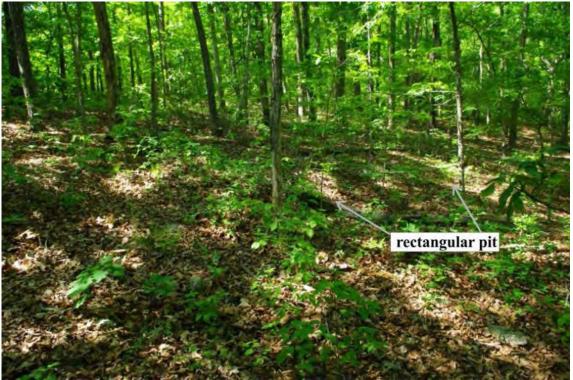
Photo 72: Rectangular Pit within Site 23SH1552 in Area 2W Facing East

The middle section of this tract represented the apex of two ridge tops. These areas were forested with moderate undergrowth and leaf cover, affording 20-50% visibility (Photo 70), however, visibility was better on the southern part of the ridge top at 60-70%. During the survey of Area 1, mining pits were observed across the northern ridge apex, identified as site 23SH1552. At least 38 pits were documented within this area during the present survey. Most of these were circular pits measuring about 2 by 1 meters, but some pits were nearly 3 meters in diameter. These pits varied from 50 to 100 cm deep (Photo 71). At least one pit was rectangular shape measuring 3.5 meters by 2 meters (Photo 72).

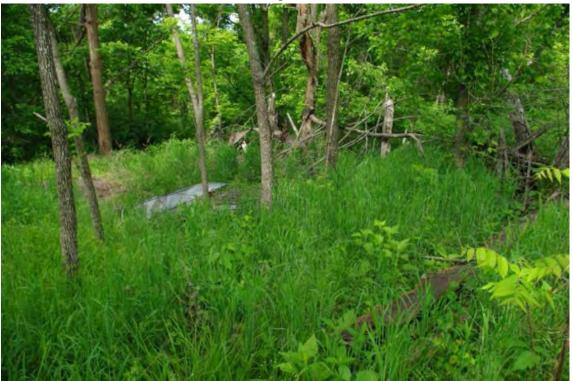
Photo 80: Ruins of Outbuilding, Area 2W Facing Southwest

The recent and 1945 topographic quadrangles suggested that there were two buildings on the southwestern portion of Area 2W (see Figures 5 and 6, Pages 17 and 18). Visibility was very poor at this location as weeds were over 5 feet high and very dense with a number of thorn bushes and honey locust trees (Photo 78). Other areas contained piles of cut trees and brush further limiting the survey of this portion of the tract (Photo 79). Shovel testing in this area also was difficult as the rocky subsoil was exposed at the surface. However, the ruins of the southernmost building were identified (Photo 80). The ruins suggested that this building measured approximately 12 by 12 meters. It was constructed of logs whose bark had been removed. The logs were notched and nailed with large wire nails to support the joists (Photo 81). Remaining portions of the roof showed that it was made of sheet metal (Photo 82). These remains would have served as an outbuilding.

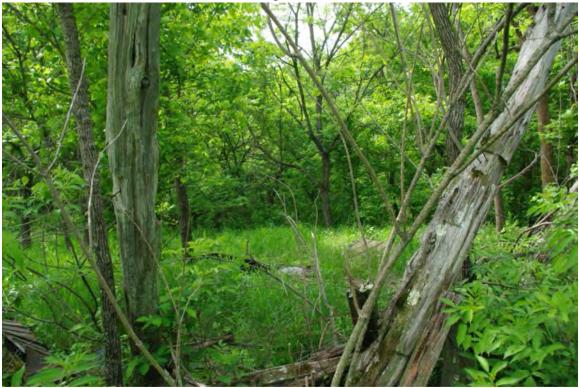
Photo 81: Notched Logs Used in Outbuilding Discovered within Area 2W Facing Southeast

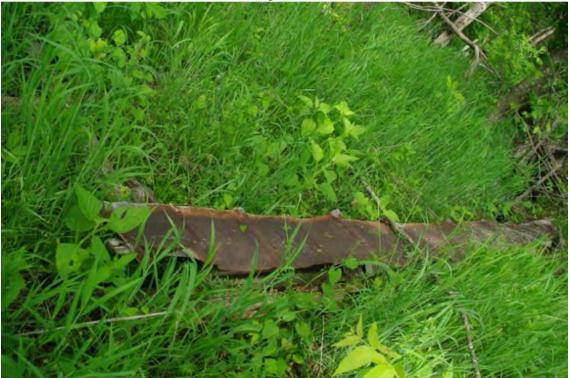
Photo 82: Remains of Metal Roof on Outbuilding in Area 2W Facing Southwest

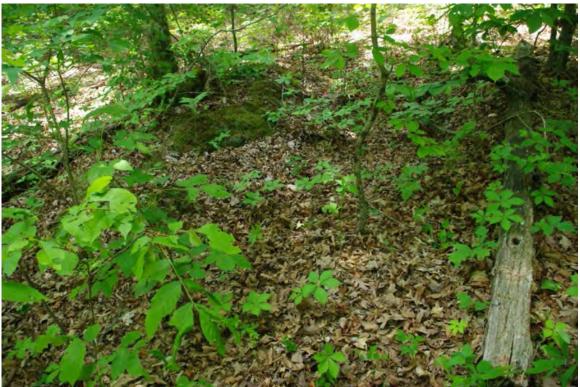
Photo 86: Oval Shaped Pit within Area 2E Facing East

No artifacts were discovered, but two pits were identified near the southeastern edge of the tract (Figure 27). One of the pits was oval shaped, measuring approximately 3 by 2 meters (Photo 86). The second pit was rectangular shape, measuring 5 by 2 meters (Photo 87). These could represent isolated mining pits, but it is possible that they were tree falls or were pushed over during past lumbering activities forming the pits.

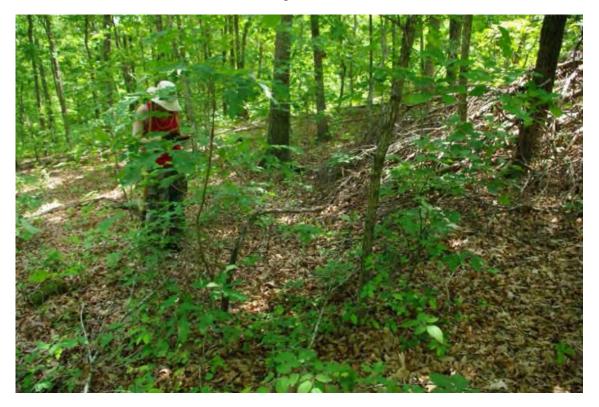
Photo 87: Rectangular Pit within Area 2E Facing Northeast

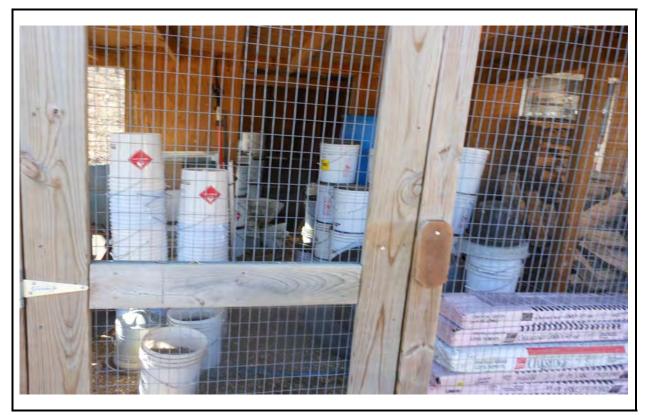
Photo 6. Example of stored hazardous waste located on the northern vicinity near the on-site residential structure.

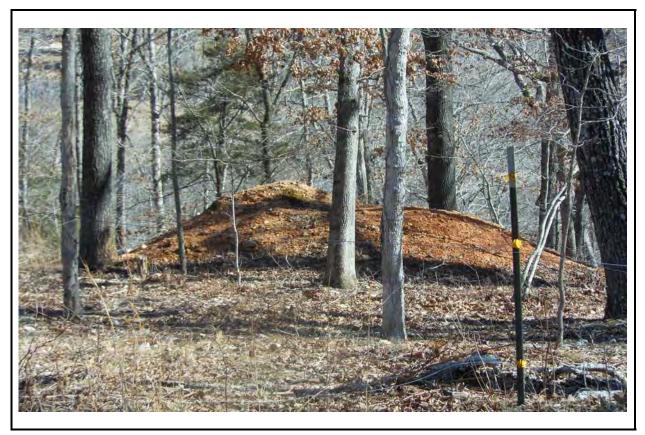
Photo 7. Example of stockpile located on the northern vicinity near the on-site residential structure.
