Preliminary Assessment Prepared for:

Preliminary Assessment for Keane Wonder Mine Death Valley National Park Inyo and San Bernardino Counties, California

March 2014

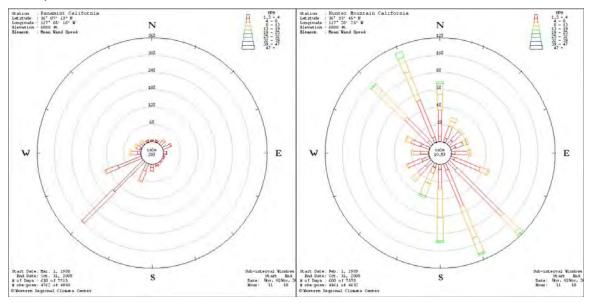
per day." Prevalent wind direction is from the south; however, conditions vary greatly in specific locations (NPS, 2002). The weather station at Park Village indicates wind directions 0 to 360 degrees (i.e., north and south) and scalar wind speeds up to 16 meters per second (2.24 miles per hour) (NPS, 2002). The Panamint, California, and Hunter Mountain, California, weather stations are located south and west of Keane Wonder Mine, respectively. The station wind rose from Panamint indicates prevalent southwesterly wind origins⁷. The station wind rose from Hunter Mountain indicates wind from north-northwest and south-southeast⁸. See the two excerpted wind roses below.

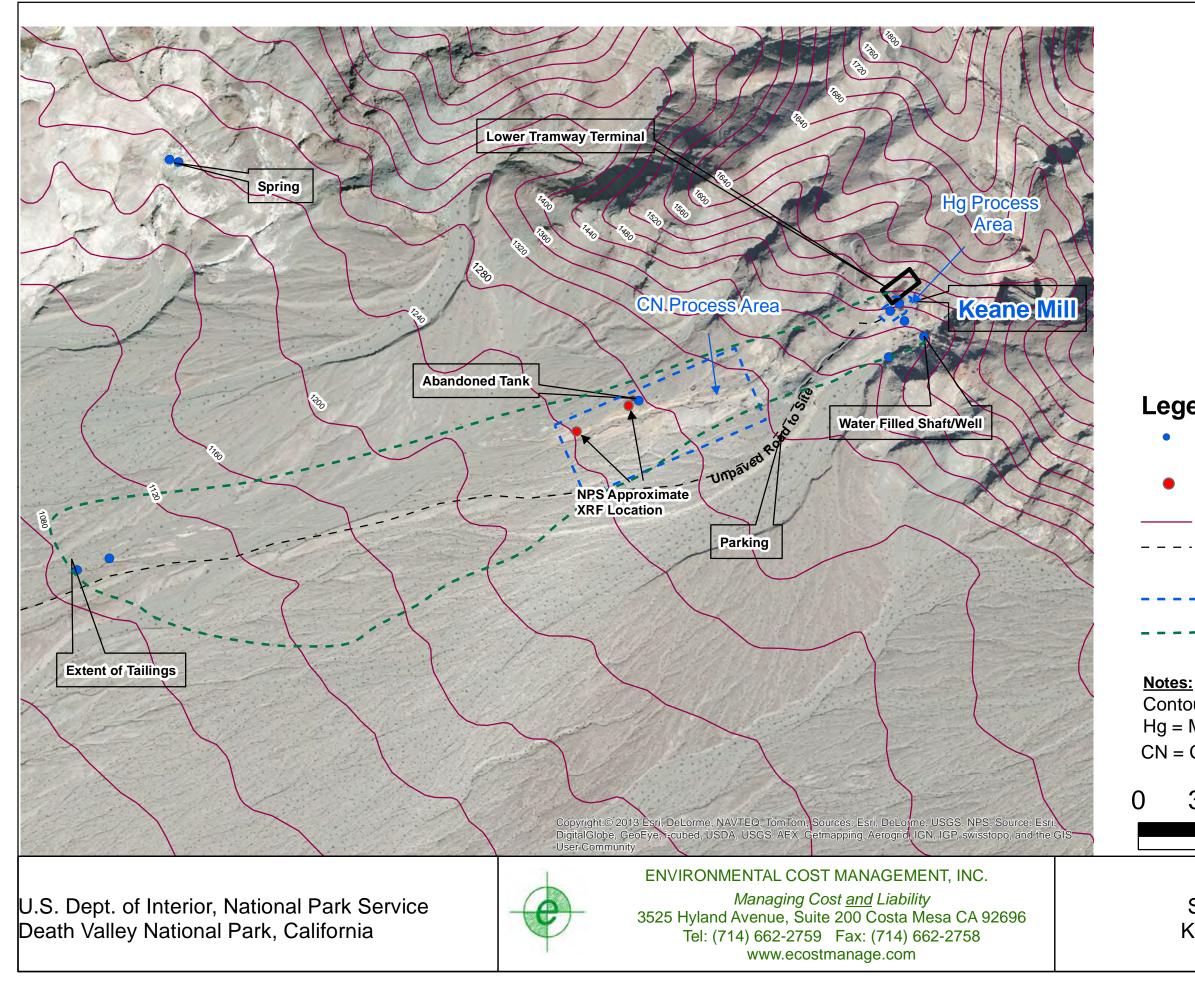
Legend Keane Wonder Mine Stie Features Location of NPS Previous **XRF** Samples **Elevation Contour** Trail into Keane Wonder Mine From Parking Lot Out line of Process Areas **Extend of Mill Tailings** Contour Interval is 40 Feet Hg = Mercury CN = Cyanide 750 1,500 375 Feet Figure Site Features Map Keane Wonder Mine 3

Photographs showing site features and current environmental conditions are presented in **Appendix C**. **Figure 3** shows the locations of the former stamp mill, mercury and cyanide processing areas, tailing stockpile area, and present extent of tailings. Additional details for the mercury processing area and cyanide processing area are depicted on **Figure 4** and **Figure 5**. Site features such as springs, water features, access roads, parking area, and remains of mining structures are depicted. The locations where select site photographs were taken are posted on the figures for reference.

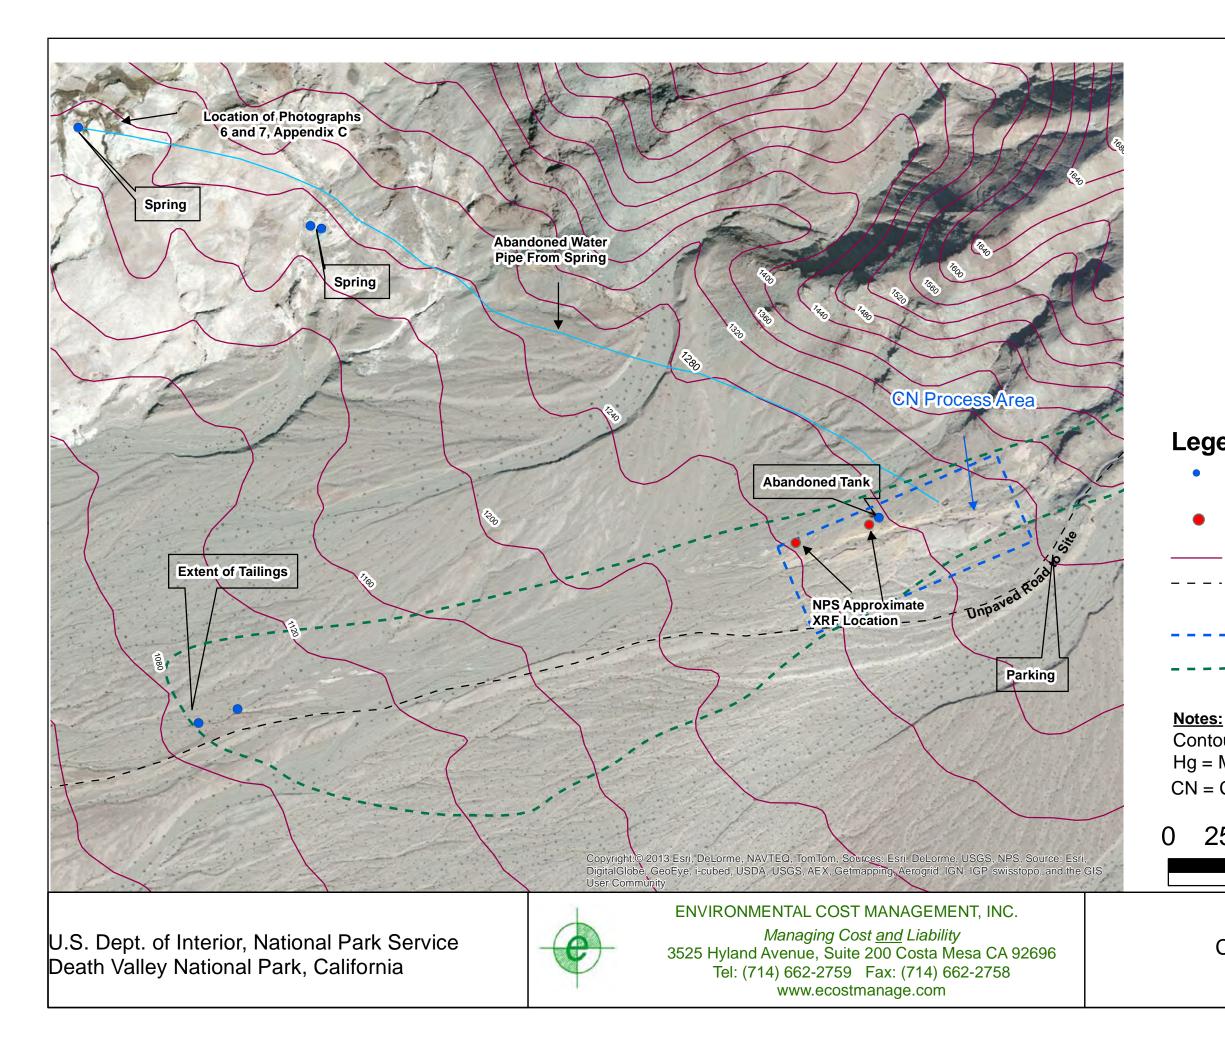
Legend Keane Wonder Mine Stie Features Location of NPS Previous **XRF** Samples **Elevation Contour** Trail into Keane Wonder Mine From Parking Lot Out line of Process Areas **Extend of Mill Tailings** Contour Interval is 40 Feet Hg = Mercury CN = Cyanide 1,000 250 500 Feet Figure Cyanide Process Area 5 Keane Wonder Mine

Mill tailings generated using mercury extraction processes are located to the south of the stamp mill, while the tailings generated from cyanide processing activities are found to the west of the stamp mill. The tailings associated with both processes were placed at the mouth to a canyon over a three-decade period that ended in the 1930s. Stockpiled tailings remain on site and wind and water have scattered the tailings downgradient. The locations of the stamp mill, pipeline, mercury and cyanide processing areas, and extent of tailings are shown on **Figures 4** and **5**.

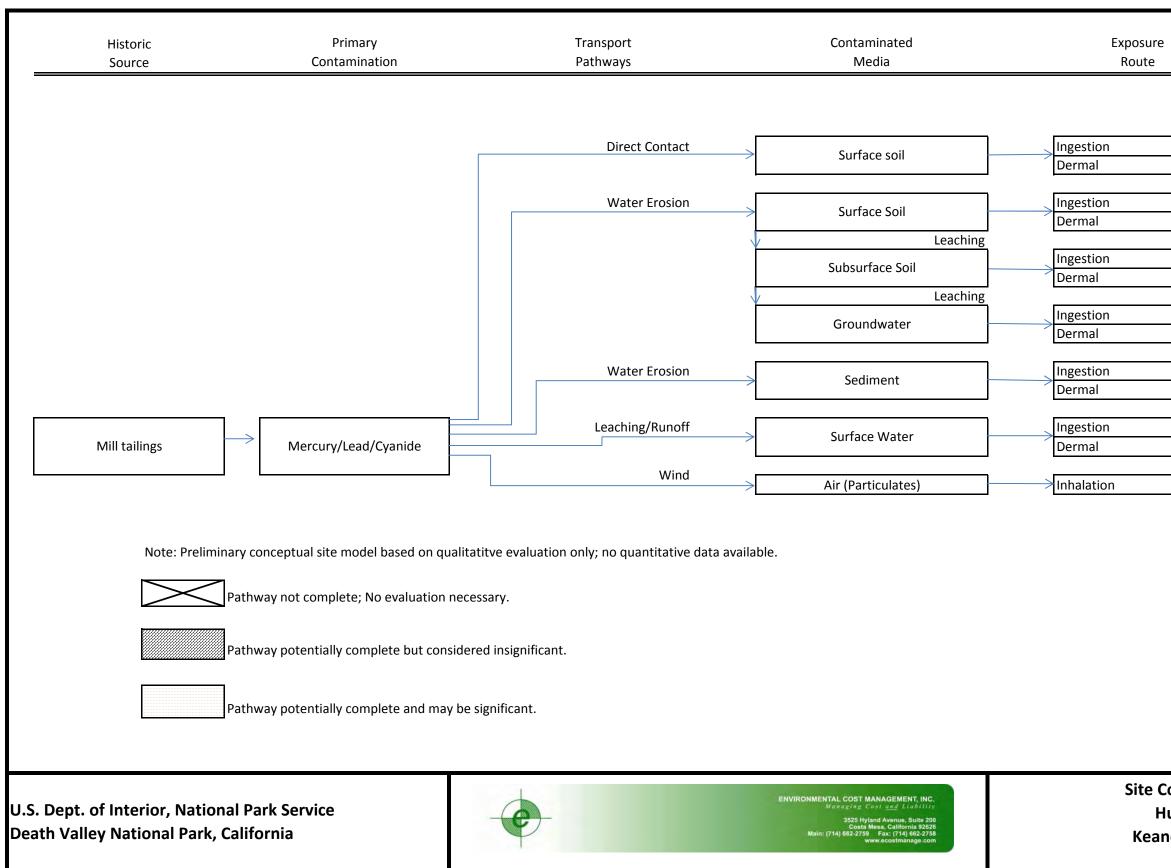
| Conceptual Model uman Targets | Figure | | |
|---|---|--|--|
| ne Wonder Mine | 6 | | |

Exposed Population

The human health and ecological conceptual site models for Keane Wonder Mine are presented on **Figures 6** and **7**. The conceptual site models integrate information about the site to describe potential source areas, release and transport mechanisms, and complete and incomplete exposure pathways. They also identify potentially exposed receptors under the current and reasonably anticipated future land and water uses. The preliminary site conceptual models are used to identify chemical and nonchemical data gaps and guide recommendations for future action at the site. Future data generated can be used to refine the preliminary conceptual site models.

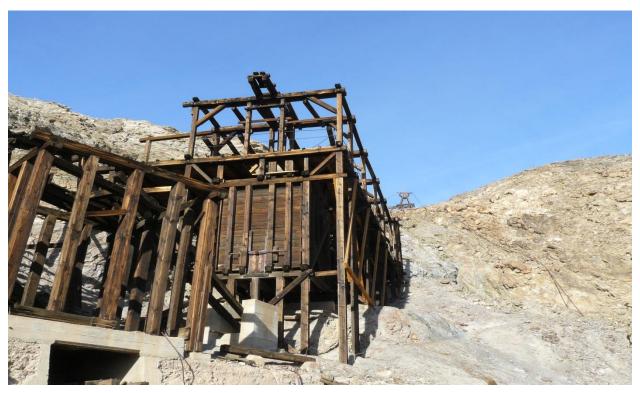
Photo 1: January 8, 2014 Remains of The Tramway That Linked The Mine Development Area With The Mill Processing Area

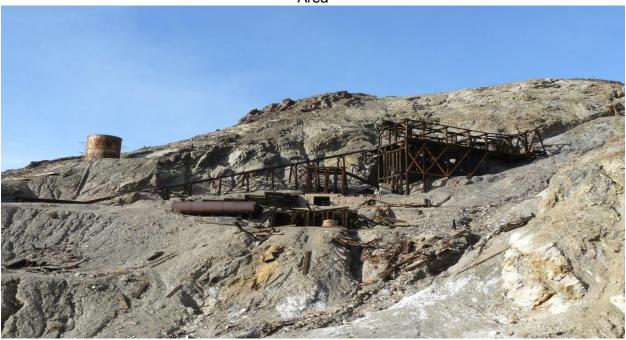
Photo 2: January 8, 2014 Mercury Processing Area

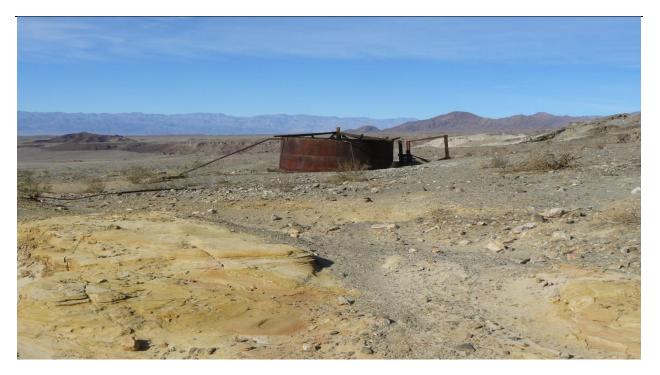
Photo 3: January 8, 2014 Cyanide Process Area

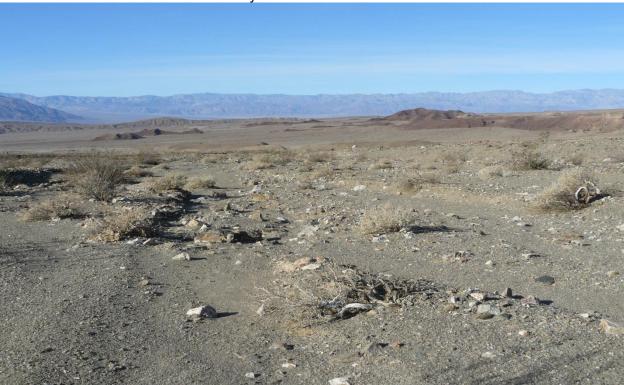
Photo 4: January 8, 2014 Alluvium Deposits Below Mill Tailings Impact Area

Subsurface materials at the site consist of high-grade metamorphic bedrock from the lower member of the Crystal Springs Formation. Alluvial deposits consist of clastic sediments ranging in size from clay to boulders (**Appendix C**, Photo 4). The surface soils in the area are composed of gravelly coarse sands with high infiltration rates (EDR, 2013a). Local groundwater recharge occurs from infrequent but significant storm events. A topographic elevation profile of the site is provided in the EDR Summary Radius Map Report of the Keane Wonder Mine (see EDR, 2013a, **Appendix B**). Based on the elevation profile, the groundwater flow direction is to the southwest from the upper-level mine development area. One water well was identified approximately 200 feet cross-gradient from the mercury processing area (EDR, 2013b, **Figure 3**). The well was converted to a mineshaft due to discovery of gold, and currently is filled with water and covered by a large metal mesh grate to prevent humans and wildlife from entering (**Appendix C**, Photo 5). Water level in the mineshaft is approximately 30 feet below ground surface. No groundwater samples have been collected from the well/mineshaft.

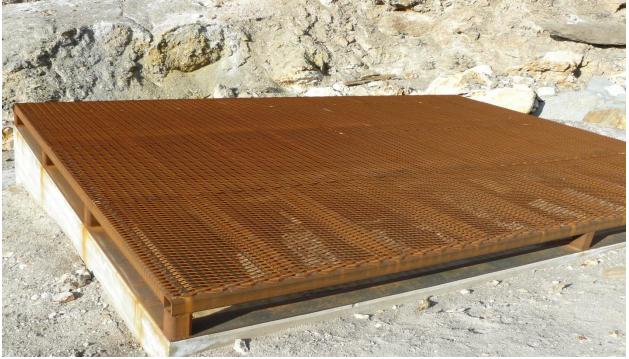
Photo 5: January 8, 2014 Onsite Well (Shaft)

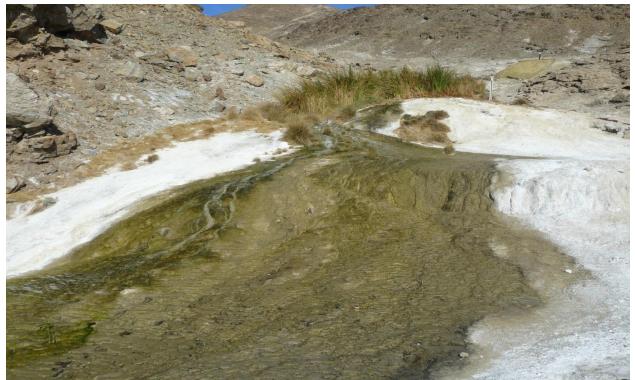
Photo 6: January 8, 2014 Spring Runoff at Keane Wonder Mine

During the site inspection on January 8, 2014, the ECM geologist observed evidence of minor pooling and runoff from the Keane Wonder Spring and secondary spring located approximately 3,500 feet northwest from the cyanide processing area (**Appendix C**, Photos 6 and 7). These springs are located cross- and upgradient of the site near the Cyty Mine area. Historically, a pipeline conveyed water from the spring to the cyanide processing area to support ore extraction activities, and so the spring could be a former source for elevated metals in soil and tailings in the ore processing area. The waters in the spring have characteristic hydrogen sulfide odor and the water is not considered potable. However, wildlife is attracted to the spring area.

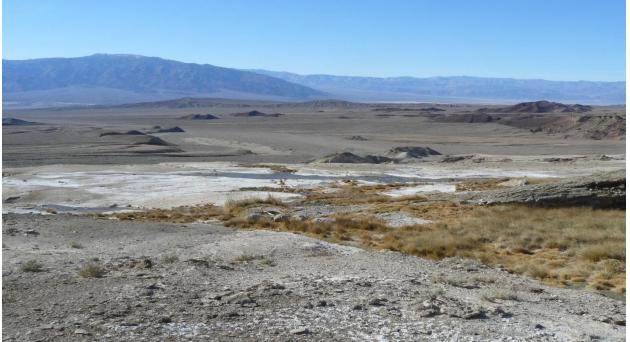
Photo 7: January 8, 2014 Pools From Spring Runoff Downgradient form Keane Wonder Mine

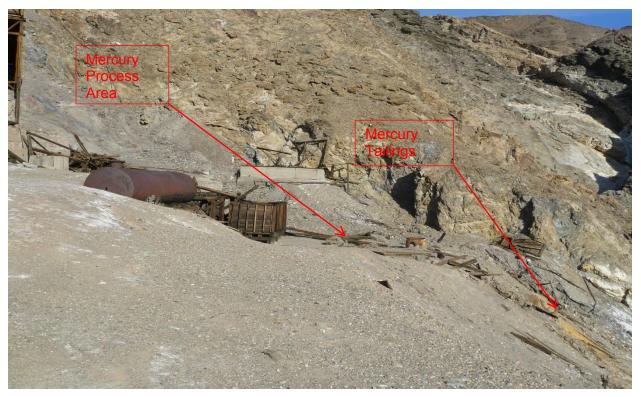
Photo 8: January 8, 2014 Mercury Processing Area Mill Tailings

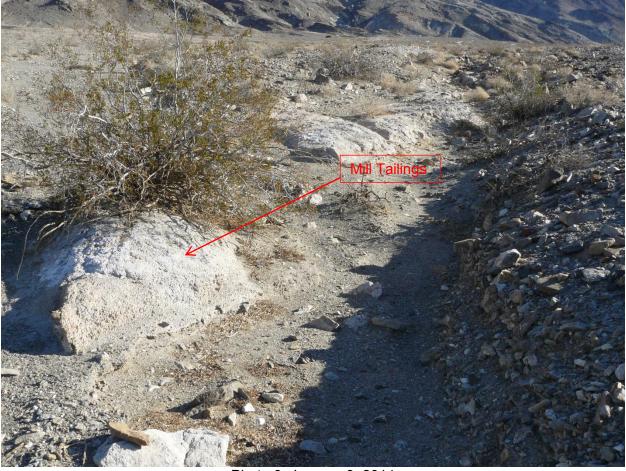
Photo 9: January 8, 2014 Mill Tailings Below the Cyanide Process Area

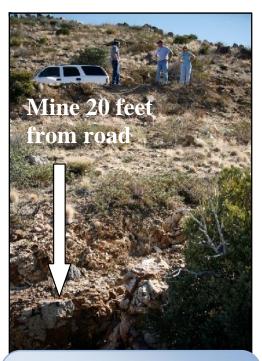
Dangerous mine shaft next to BLMmaintained road near Kingman, AZ. This shaft was a short distance from a similar hazard where a young girl died in September 2007. (OIG Photo)

After our visit, a BLM official told us the shaft where the young girl was killed had since been fenced using materials provided by BLM, and warning signs had been erected.
