AUG 2015
DRAFT

Accessibility Self-Evaluation and Transition Plan

LAVA BEDS

NATIONAL MONUMENT | CA

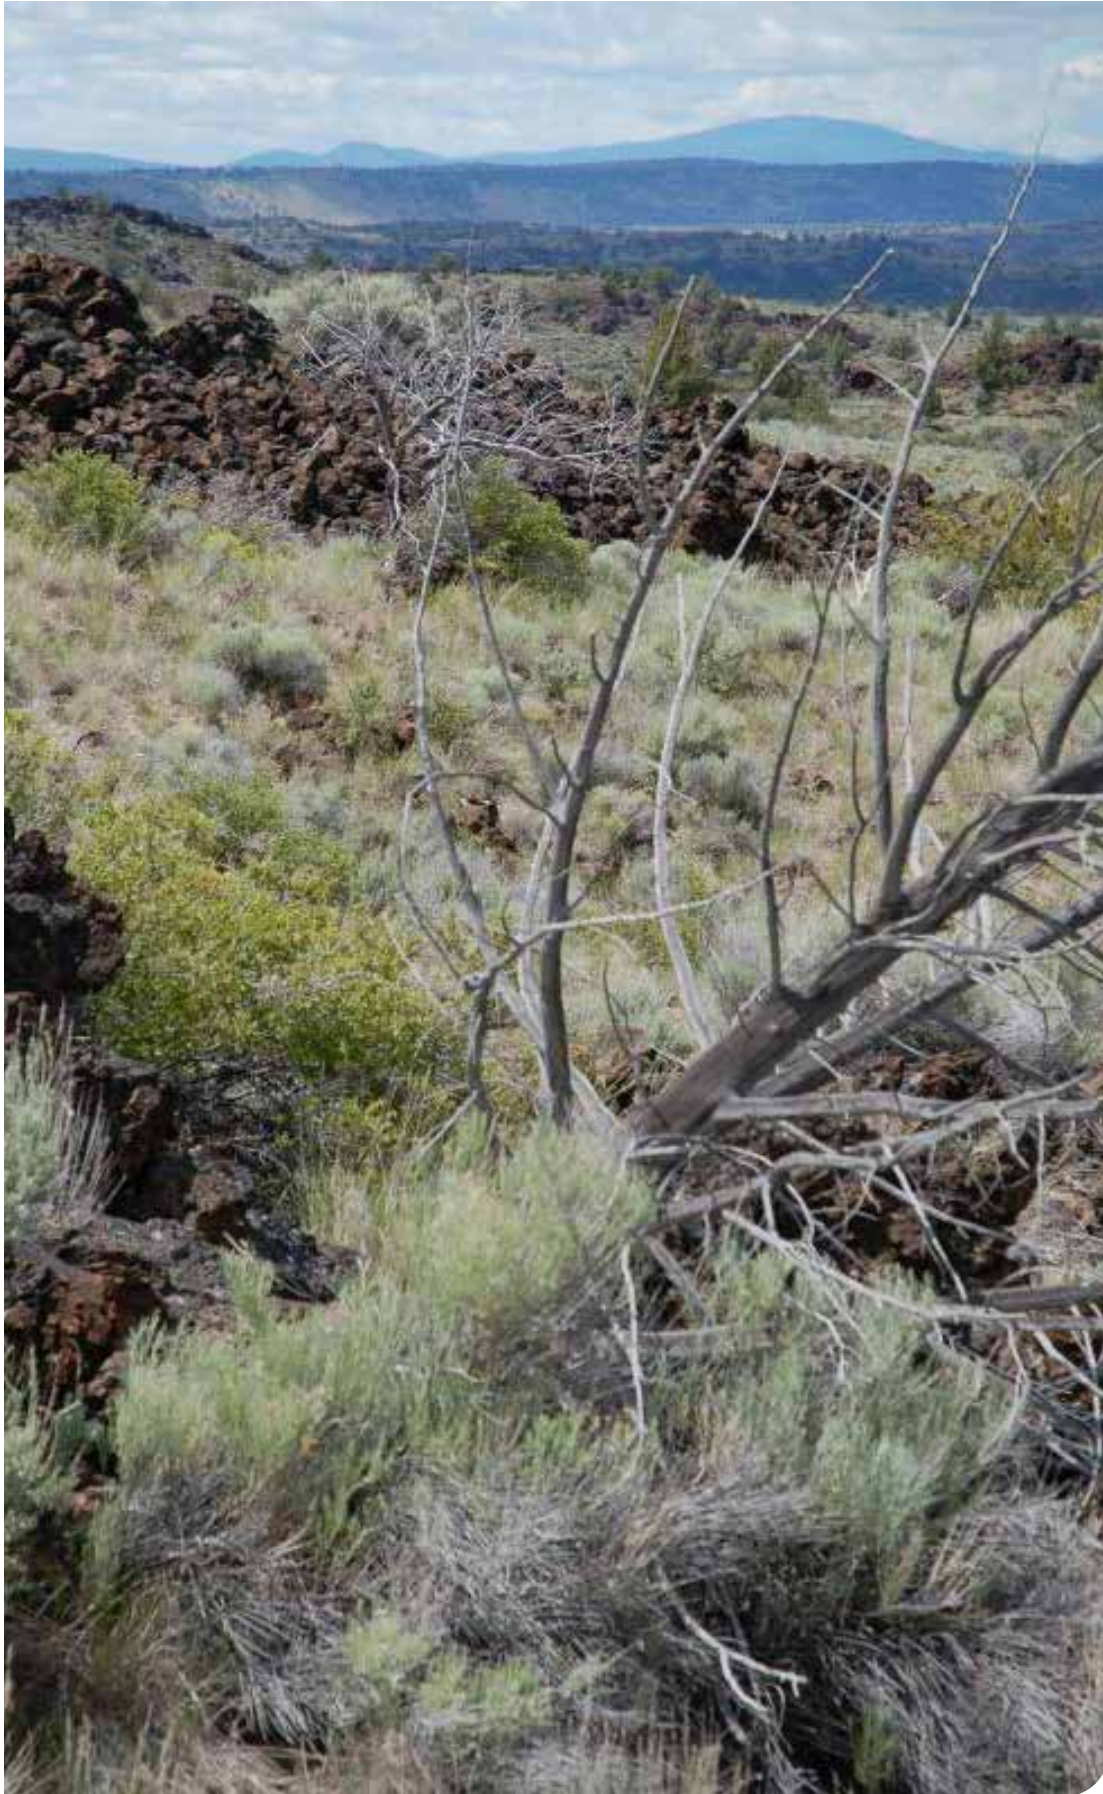
Site Map

- 2 Outdoor Recreation Access Route and Walking Surfaces.** 1) Provide a curb cut from "van accessible" parking stall to sidewalk. 2) Provide firm and stable surface at stall and trash and recycling, interpretive wayside / trailhead kiosk, and trailhead, etc. No cracks or changes in level greater than 1/2".
short-term

- 5 Hiking Trail.** 1) Provide trailhead information signage on trail and cave conditions (length of the trail or trail segment, surface type, typical and maximum tread width, typical and maximum running slope, and typical and maximum cross slope) per Architectural Barriers Act Accessibility Standards section 1017.10. 2) Regrade trail to have 2% or less cross slopes and a 36" wide minimum tread width. 3) Make sure entire trail provides a firm and stable surface with decomposed granite and binders (maintenance will be needed on a regular basis). Consider providing alternative format experiences of cave, such as a GoPro tour of the cave or tactile, 3-dimensional human experience of caves in the visitor center.

- 2 Outdoor Recreation Access Route and Walking Surfaces.** 1) Repair asphalt surface so that there are no gaps greater than 1/2" and regrade so the surface has a maximum 2% cross slope.

- 3 Interpretive Wayside.** 1) Replace panel and ensure that all font size on panels is 24 point (16 point for labeling photos) and that there is a 70% or greater contrast between photos and background so text is easily read.

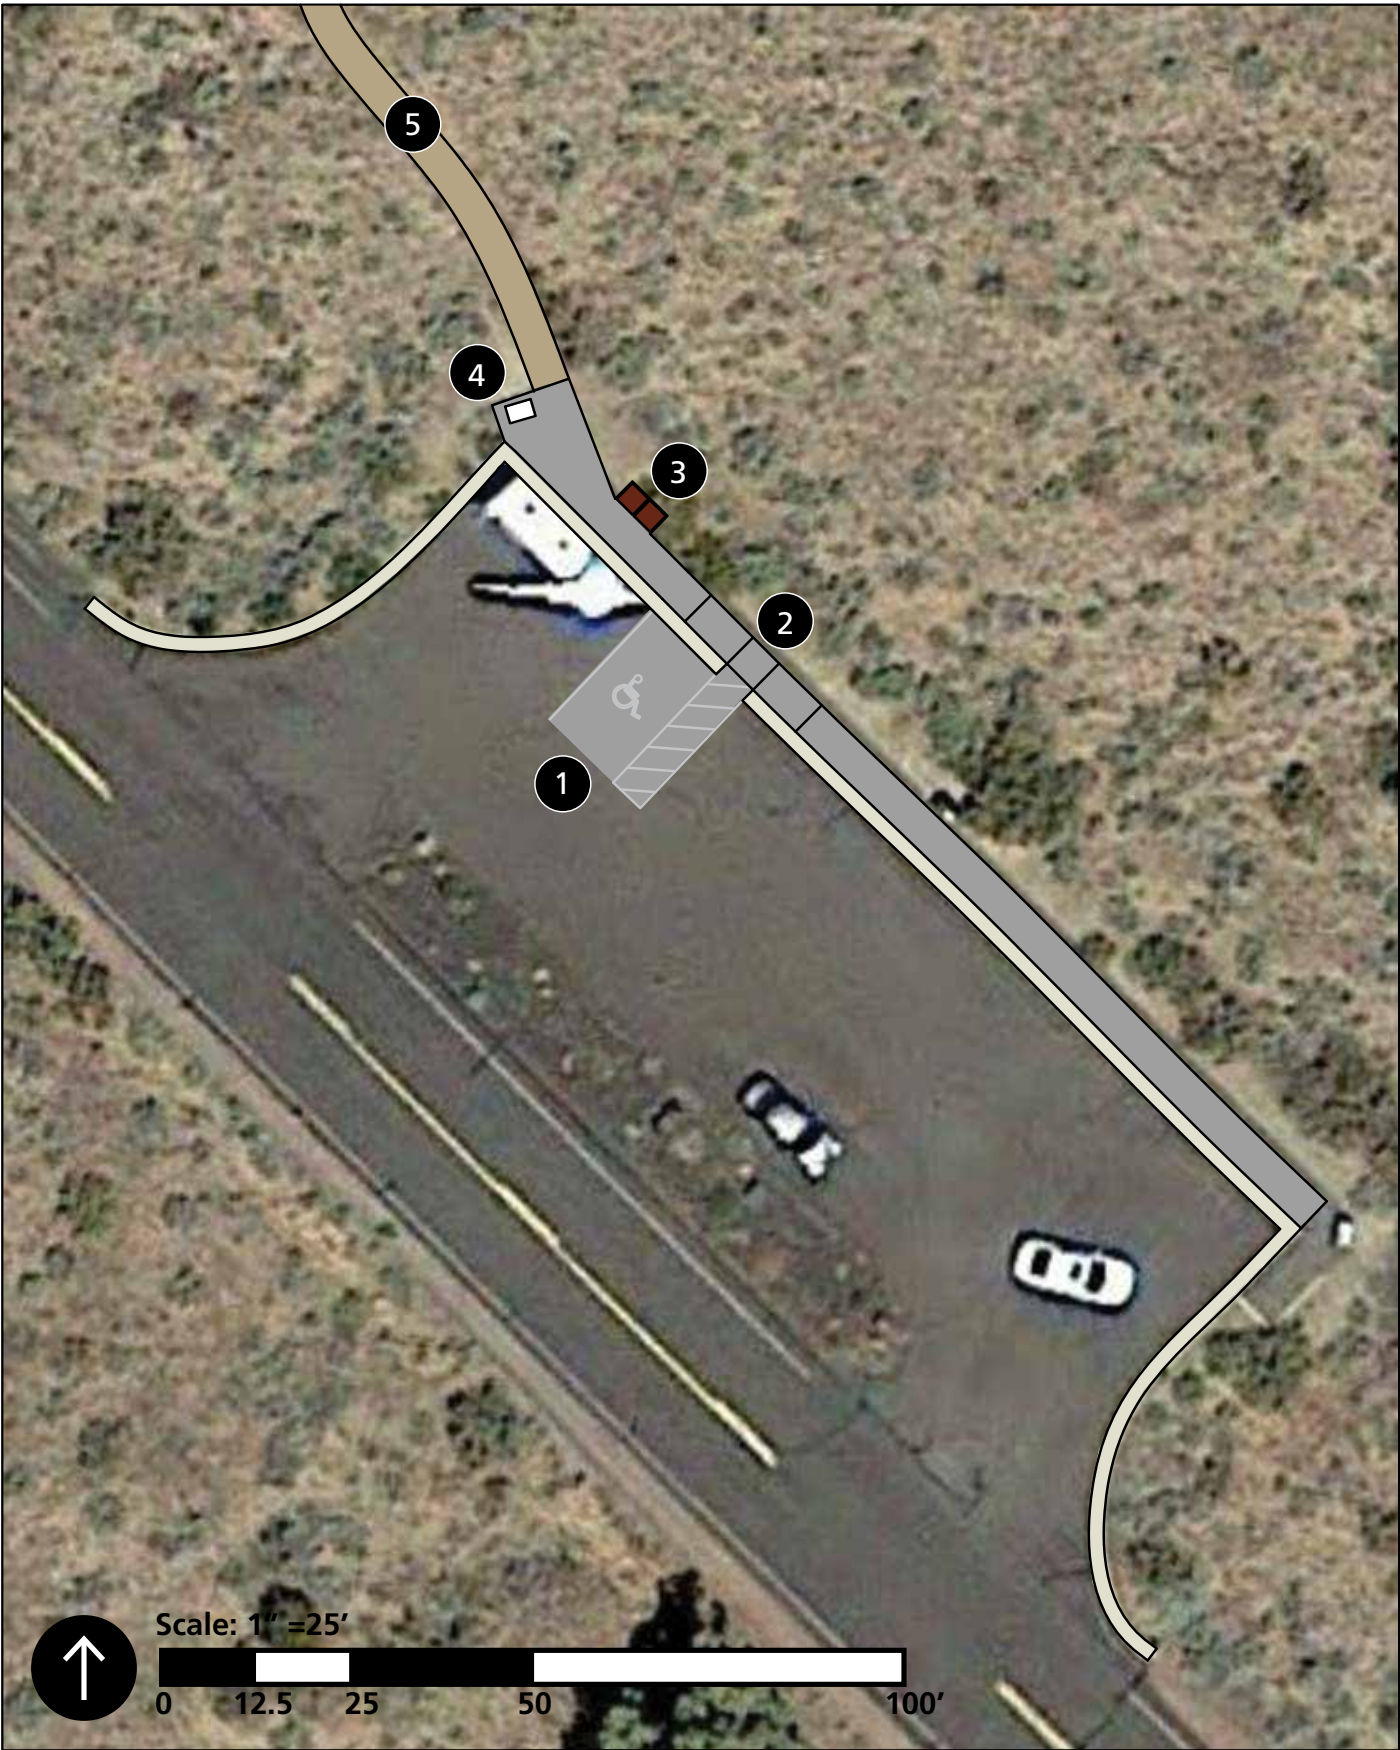
Service, Activity, or Program	Level of Access				PAMP Optimizer Band ±	Barrier	Solution	Proximity to Other Recommended Solutions ∞
	Cognitive	Mobility	Vision	Hearing				
Car Parking	1	2	2	1	3	No accessible parking space provided.	1) Provide one signed and marked "van accessible" parking stall. Stall should be maximum 2% running and cross slopes, 5' marked access aisle, and 11' wide van accessible stall. Provide access aisle on the passenger side of the van. 2) Provide "van accessible" signage with bottom of sign at 60" minimum height.	Balcony and Boulevard Caves Pullout
Outdoor Recreation Access Route and Walking Surfaces	1	2	1	1	3	There is no curb cut to get from parking stall to trailhead elements. There are gaps in asphalt greater than 1/2".	1) Provide a curb cut from van accessible parking stall to sidewalk. 2) Provide firm and stable surface at stall and trash and recycling, interpretive wayside / trailhead kiosk, and trailhead, etc. No cracks or changes in level greater than 1/2".	Balcony and Boulevard Caves Pullout

Service, Activity, or Program	Level of Access				PAMP Optimizer Band ±	Barrier	Solution	Proximity to Other Recommended Solutions ∞
	Cognitive	Mobility	Vision	Hearing				
Interpretive Wayside	2	1	2	1	3	Interpretive panel contains font that is too small.	1) Remove italicized text. Contrast should be 70% or greater. 2) Provide a firm and stable surface (paved) up to interpretive wayside and regrade to have 2% cross and running slopes.	Balcony and Boulevard Caves Pullout; all interpretation signage throughout park
Hiking Trail and Cave	1	2	2	1	3	No information provided at trailhead or cave entrance on trail conditions (running and cross slopes, length, and surface). Some sections of the trail are over 2% cross slope and the allowable hiking trail maximum running slopes at specific lengths (e.g., for 200 feet the trail can be 5%–8.33%, for 30 feet the trail can be 8.33%–10%, and for 10 feet the trail can be 10%–12%). Some sections do not have the vertical clearance for protruding objects (80" maximum). There are stairs to enter the cave.	1) Provide trailhead information signage on trail and cave conditions (length of the trail or trail segment, surface type, typical and maximum tread width, typical and maximum running slope, and typical and maximum cross slope) per Architectural Barriers Act Accessibility Standards section 1017.10. 2) Regrade trail to have 2% or less cross slopes and a 36" wide minimum tread width. 3) Make sure entire trail provides a firm and stable surface with decomposed granite and binders (maintenance will be needed on a regular basis). Consider providing alternative format experiences of cave, such as a GoPro tour of the cave or tactile, 3-dimensional human experience of caves in the visitor center.	Balcony and Boulevard Caves Pullout

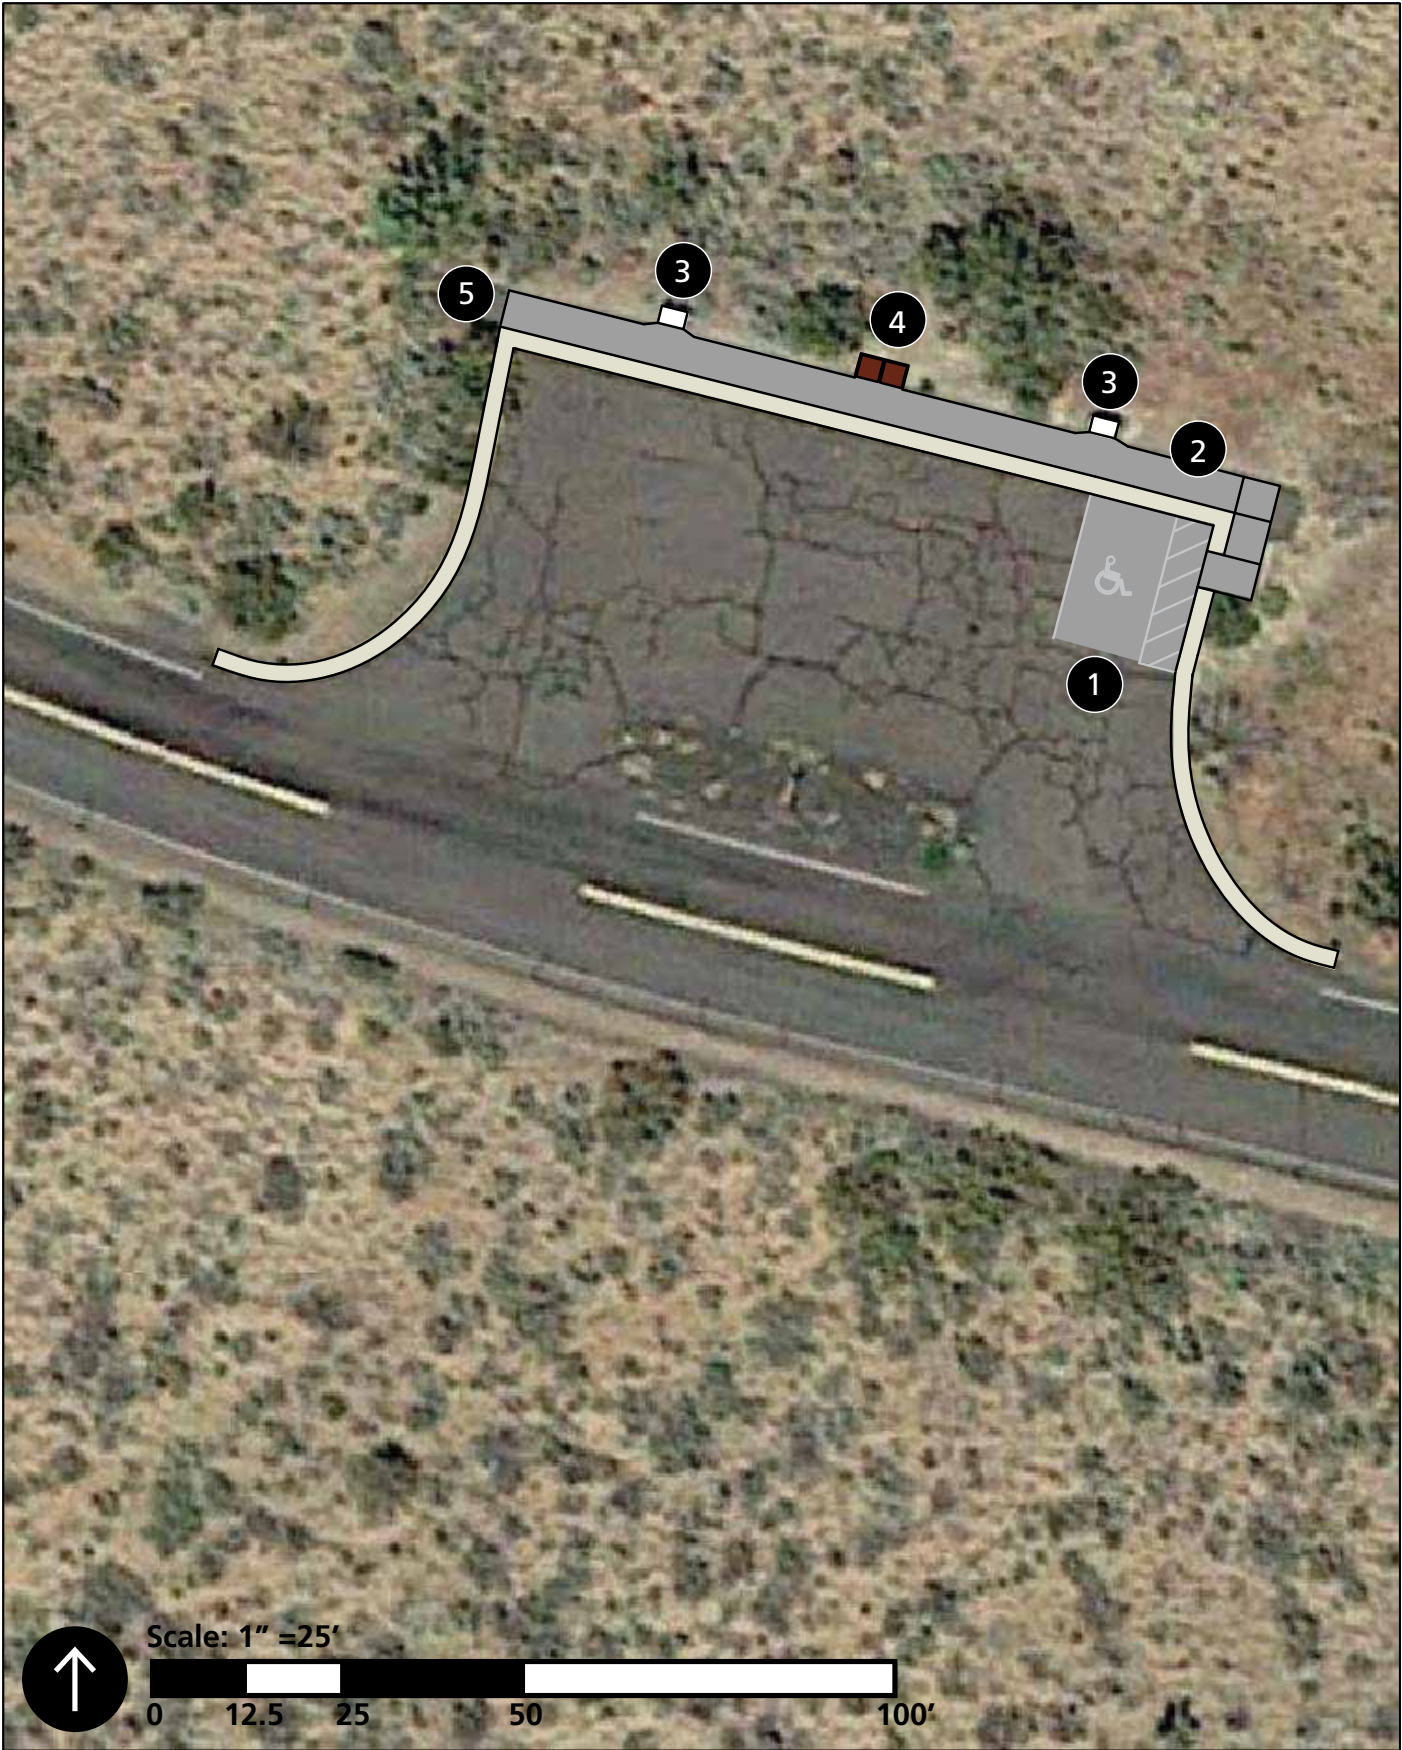
Site Map

Service, Activity, or Program	Level of Access				PAMP Optimizer Band ±	Barrier	Solution	Proximity to Other Recommended Solutions ∞
	Cognitive	Mobility	Vision	Hearing				
Car Parking	1	2	2	1	2	No accessible parking space provided. The existing curb cut is too high.	1) Provide one signed and marked "van accessible" parking stall. Stall should be maximum 2% running and cross slopes, 5' marked access aisle, and 11' wide van accessible stall. Provide access aisle on the passenger side of the van. 2) Provide "van accessible" signage with bottom of sign at 60" minimum height.	Bunchgrass Pullout
Outdoor Recreation Access Route and Walking Surfaces	1	2	1	1	2	Gaps in the asphalt exceed 1/2" and occasionally the cross slope exceeds 2%.	1) Repair asphalt surface so that there are no gaps greater than 1/2" and regrade so the surface has a maximum 2% cross slope.	Bunchgrass Pullout
Trailhead Kiosk	2	1	2	2	2	Does not provide trailhead information signage on conditions of trail.	1) Provide trailhead information signage on trail conditions (length of the trail or trail segment, surface type, typical and maximum tread width, typical and maximum running slope, and typical and maximum cross slope) per Architectural Barriers Act Accessibility Standards section 1017.10.	Bunchgrass Pullout

Service, Activity, or Program	Level of Access				PAMP Optimizer Band ±	Barrier	Solution	Proximity to Other Recommended Solutions ∞
	Cognitive	Mobility	Vision	Hearing				
Trash Receptacle	1	2	1	1	2	Weight to lift the trash receptacle is more than five pounds, and latch is not operable with a closed fist.	1) Replace trash and recycling receptacle with unit that requires no lifting or can be opened with a closed fist and less than five pounds of pressure.	Bunchgrass Pullout
Interpretive Waysides	2	1	2	2	2	The font size is too small and the pictures are faded.		Bunchgrass Pullout; all interpretation signage throughout park

- 4 Trash and Recycling.** 1) Replace trash and recycling receptacle with unit that requires no lifting or can be opened with a closed fist and less than five pounds of pressure.

- 5 Trailhead Kiosk.** 1) Provide trailhead information signage on trail conditions (length of the trail or trail segment, surface type, typical and maximum tread width, typical and maximum running slope, and typical and maximum cross slope) per Architectural Barriers Act Accessibility Standards section 1017.10.

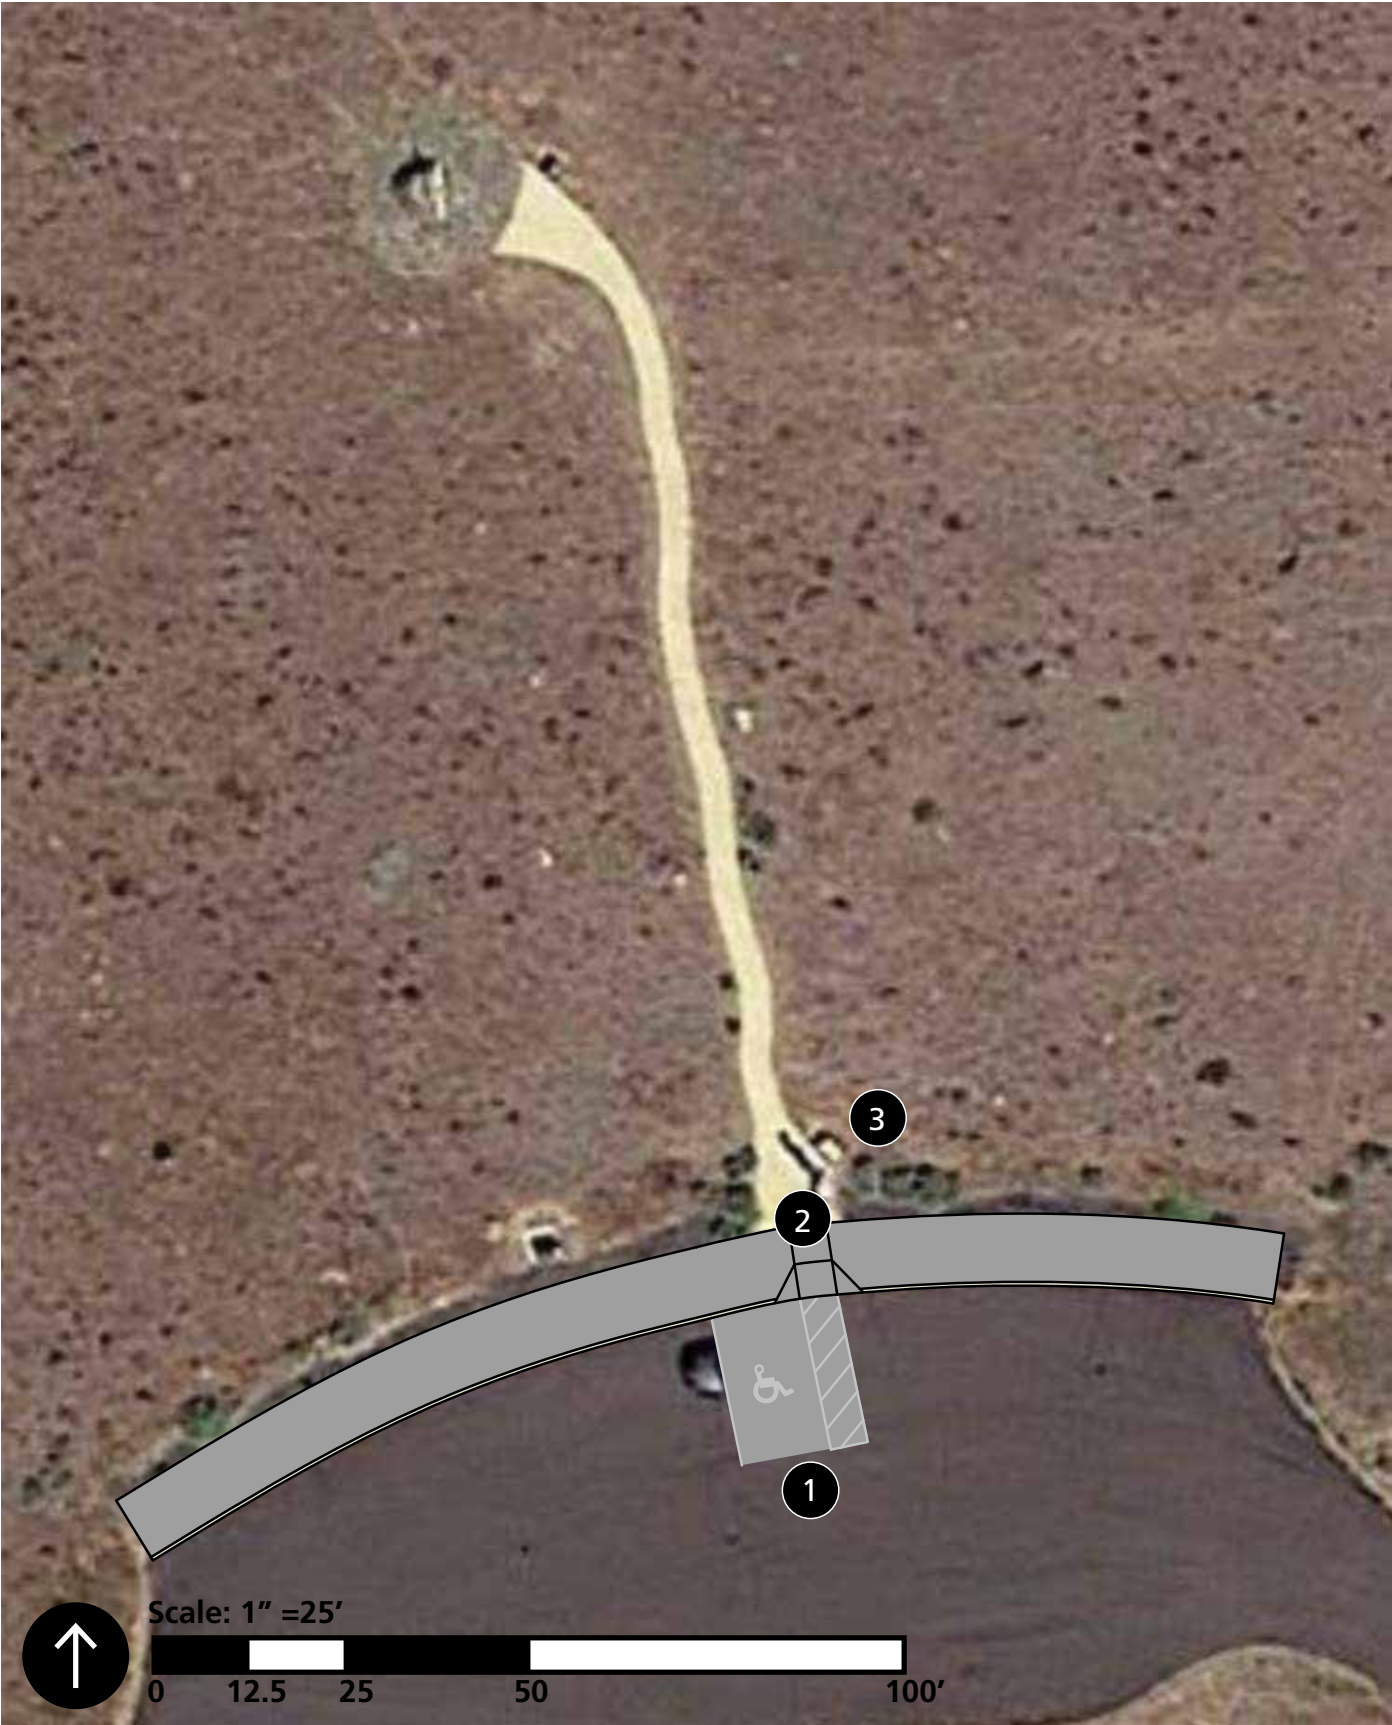
Site Map

Service, Activity, or Program	Level of Access				PAMP Optimizer Band ±	Barrier	Solution	Proximity to Other Recommended Solutions ∞
	Cognitive	Mobility	Vision	Hearing				
Car Parking	1	2	2	1	3	No accessible parking space is provided.	1) Provide one signed and marked "van accessible" parking stall. Stall should be maximum 2% running and cross slopes, 5' marked access aisle, and 11' wide van accessible stall. Provide access aisle on the passenger side of the van. 2) Provide "van accessible" signage with bottom of sign at 60" minimum above the finish ground.	Canby's Cross
Outdoor Recreation Access Route and Walking Surfaces	1	2	1	1	3	No curb cut provided from parking stall to trailhead elements. There are cracks along asphalt path greater than 1/2" width.	1) Provide a curb cut from van accessible parking stall to sidewalk. 2) Provide firm and stable surface to all elements at trailhead. Ensure there are no cracks greater than 1/2" or vertical changes greater than 1/2".	Canby's Cross

Interpretive Waysides	2	1	2	2	3	Interpretive panel contains all caps text and drawings or photos do not provide enough contrast.	1) Removed all caps in panel text when panel is replaced and ensure that future graphics are clear with a 70% minimum contrast with background color of panel.	Canby's Cross; all interpretation signage throughout park

- 2 Outdoor Recreation Access Route and Walking Surfaces.** 1) Provide a curb cut from van accessible parking stall to sidewalk. 2) Provide firm and stable surface to all elements at trailhead. Ensure there are no cracks greater than 1/2" or vertical changes greater than 1/2".

- 3 Interpretive Waysides.** 1) Replace all caps in panel text when panel is replaced and ensure that future graphics are clear with a 70% minimum contrast with background color of panel.

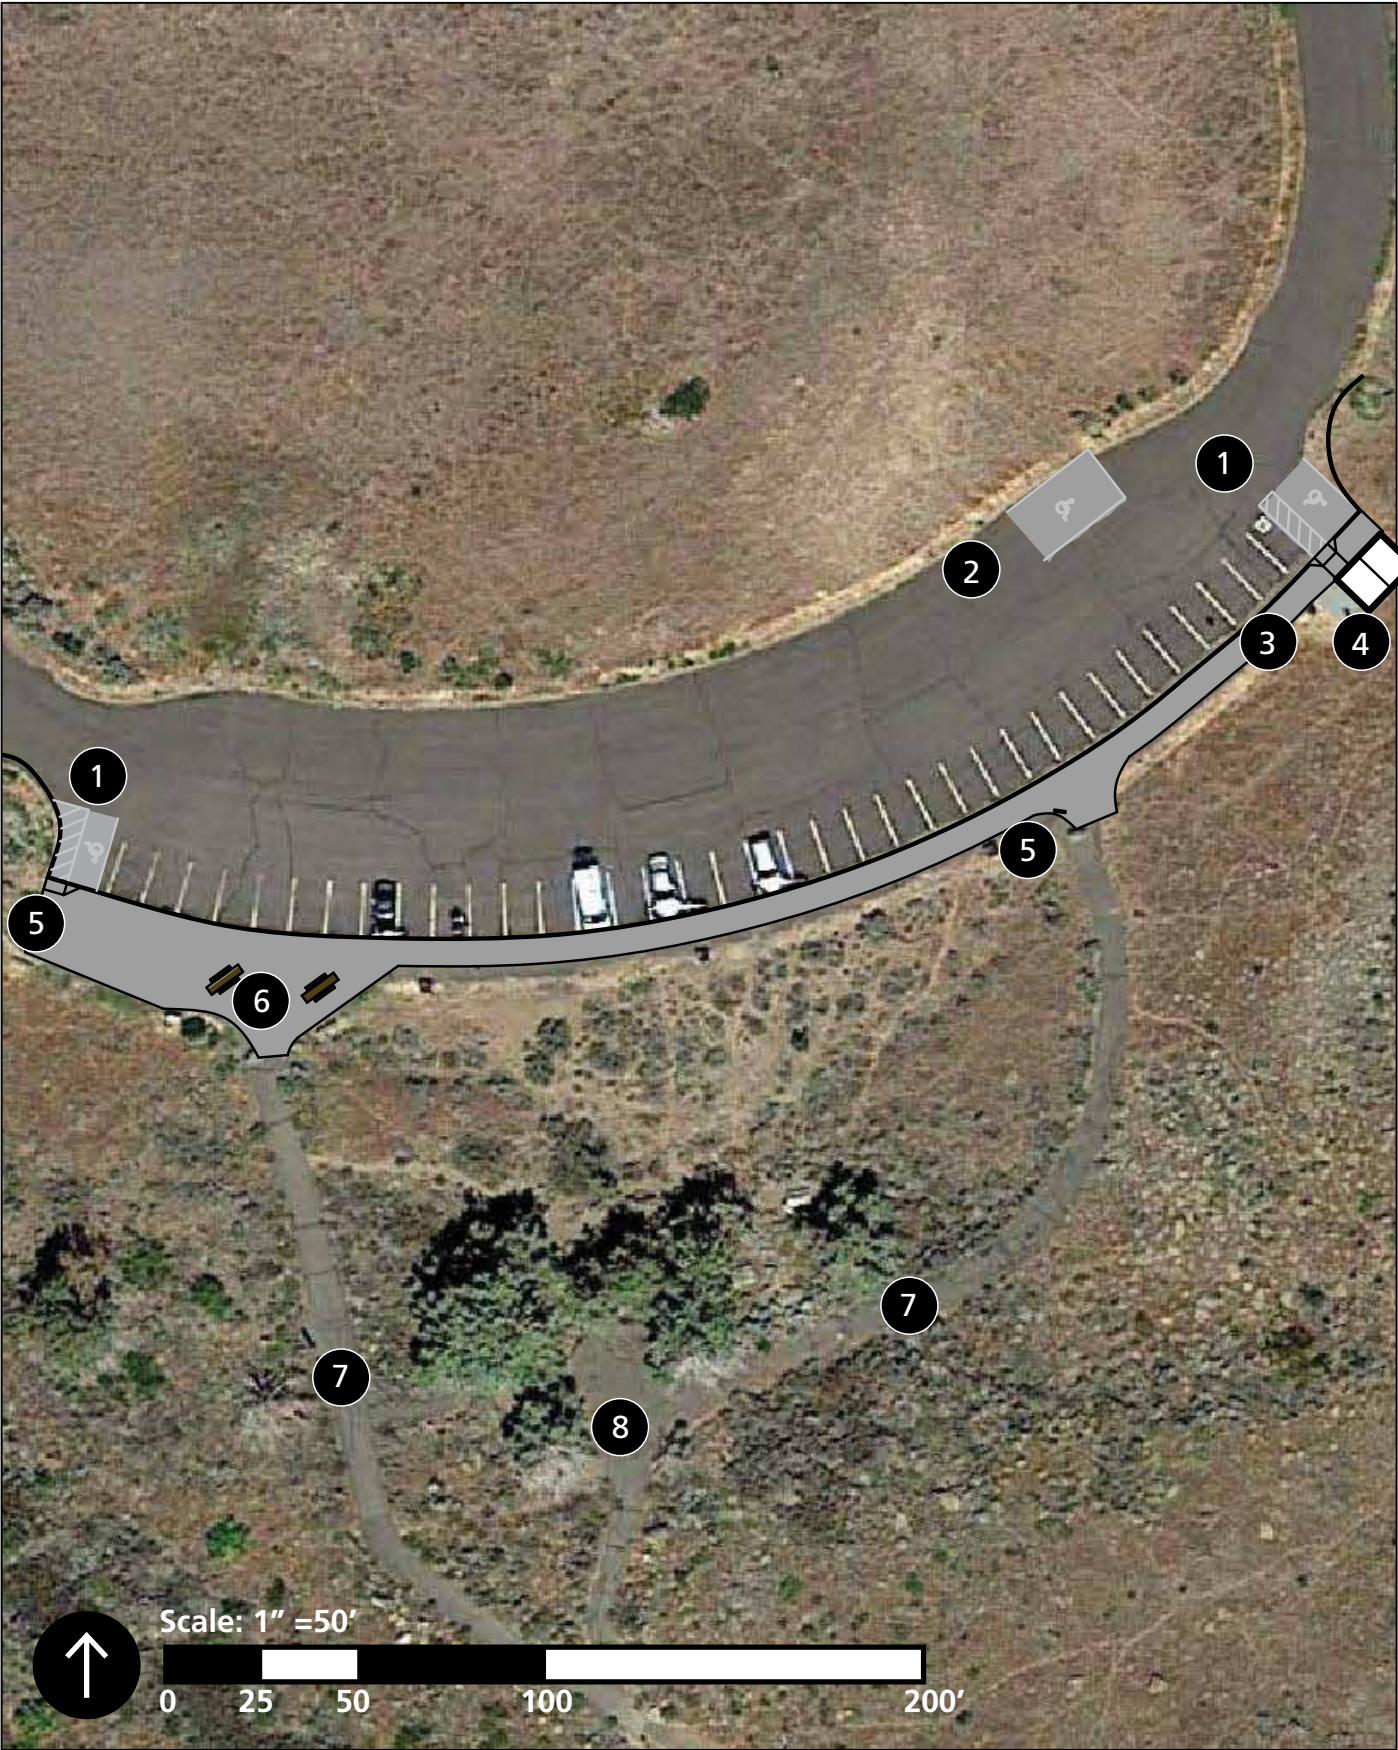
Site Map

Service, Activity, or Program	Level of Access				PAMP Optimizer Band ±	Barrier	Solution	Proximity to Other Recommended Solutions ∞
	Cognitive	Mobility	Vision	Hearing				
Car Parking	1	2	2	1	3	No accessible parking space and no van accessible parking space provided.	1) Provide one signed and marked "van accessible" parking stall and one signed and marked standard accessible parking stall near restroom. 2) Pave an additional van accessible stall on the western end of the parking lot. Stalls should be maximum 2% running and cross slopes, 5' marked access aisle, and 11' wide van accessible stall, and 8' wide for vehicle stall. Provide access aisle on the passenger side of the van and driver side of the vehicle. 3) Provide firm and stable surface at stall and restrooms. 4) Provide "van accessible" signage with bottom of sign at 60" minimum at van accessible stalls and another accessible sign at the standard accessible stall.	Captain Jack's Stronghold

Service, Activity, or Program	Level of Access				PAMP Optimizer Band ±	Barrier	Solution	Proximity to Other Recommended Solutions ∞
	Cognitive	Mobility	Vision	Hearing				
Oversized Vehicle Parking	1	2	2	1	3	No recreational vehicle (RV) or bus parking spaces striped.	1) Provide striping for RV or bus parking spaces. Accessible space should be 16' wide measured to centerline of striping or face of curb and a maximum slope of 2% in all directions. 2) The curb ramp between parking and sidewalk should have a running slope of 8.33% maximum and a cross slope of 2%. The curb ramp should have a 36" minimum landing at the top with a running slope and cross slope of 2% maximum. Curb ramp flared side slopes should be 10% or less. 3) Install parking space signs to be 60" minimum above the finished ground surface to the bottom of the sign.	Captain Jack's Stronghold

Service, Activity, or Program	Level of Access				PAMP Optimizer Band ±	Barrier	Solution	Proximity to Other Recommended Solutions ∞
	Cognitive	Mobility	Vision	Hearing				
Hiking Trail	1	3	2	1	2	The current route is very steep and is not accessible.	Due to steep grades and cultural resource sensitivity (ABAAS 1019.1 and 1017.1 Exception 1), the hiking trail is not accessible. Subsequent planning and design is needed to provide an understanding of potential alternate routes for an accessible trail to the upper part of the site. 1) Create a firm and stable trail surface where possible. 2) Provide trailhead information signage on trail conditions (length of the trail or trail segment, surface type, typical and maximum tread width, typical and maximum running slope, and typical and maximum cross slope) per Architectural Barriers Act Accessibility Standards section 1017.10.	Captain Jack's Stronghold

Service, Activity, or Program	Level of Access				PAMP Optimizer Band ±	Barrier	Solution	Proximity to Other Recommended Solutions ∞
	Cognitive	Mobility	Vision	Hearing				
Picnic Facilities	1	2	2	1	2	The trail to the tables is too steep and is not accessible.	1) Due to steep grades and cultural resource sensitivity (ABAAS 1019.1 and 1011.2 Exception), the existing viewing area cannot be made accessible. Subsequent planning and design is needed to provide an appropriate location for the picnic facility. Subsequent planning and design is needed to provide an appropriate location for the picnic facility. 1) Add two accessible tables near the trailhead that have integrated seating spaces on the ends or middles with 36" clear space and firm and stable surfaces around each table. 2) Provide shade for one of the two tables.	Captain Jack's Stronghold
Men's Restroom	1	2	2	1	3	The door to the restroom is too heavy, and the sign is not in the correct location.	1) Replace signage to the left side of the doors between 48" and 60" above the finish floor. 2) Add braille identification to signage.	Captain Jack's Stronghold

Women's Restroom	1	2	2	1	3	The door to the restroom is too heavy.	1) Replace signage to the left side of the doors between 48" and 60" above the finish floor. 2) Add braille identification to signage.	Captain Jack's Stronghold

Service, Activity, or Program	Level of Access				PAMP Optimizer Band ±	Barrier	Solution	Proximity to Other Recommended Solutions ∞
	Cognitive	Mobility	Vision	Hearing				
Outdoor Recreation Access Route and Walking Surfaces	1	2	1	1	3	No access to sidewalk from parking stall.	1) Provide curb cuts from proposed parking stall access aisles to sidewalk. Curb cuts to meet requirements in ABAAS section 406.	Captain Jack's Stronghold
Interpretive Waysides and Trailhead Kiosk	2	2	2	2	3	Text is difficult to read, and there is not a 70% contrast between all text and images in the background. Some italicized text on the panel, and not all fonts maintain 24 point (with the exception of 16 point font for labeling photos). The clear space in front of the panel exceeds the maximum 2% slope. Route to the signage is also not accessible.	1) Due to steep grades and cultural resource sensitivity (ABAAS 1019.1 and 1017.1 Exception 1), the existing location of interpretive signage and trailhead kiosk cannot be made accessible. Provide alternate locations for installation of new signage adjacent to parking lot where grades are flatter. Avoid all caps in panel text when panel is replaced and ensure that future graphics are clear and contrast with background color of panel. 2) Add braille identification to entrance signage.	Captain Jack's Stronghold; all interpretation signage throughout park

- 4 **Restrooms.** 1) Replace signage to the left side of the doors between 48" and 60" above the finish floor. 2) Add braille identification to signage.

- 5 **Interpretive Waysides and Trailhead Kiosk.** 1) Due to steep grades and cultural resource sensitivity (ABAAS 1019.1 and 1017.1 Exception 1), the existing location of interpretive signage and trailhead kiosk cannot be made accessible. Provide alternate locations for installation of new signage adjacent to parking lot where grades are flatter. Avoid all caps in panel text when panel is replaced and ensure that future graphics are clear and contrast with background color of panel. 2) Add braille identification to entrance signage.

- 7 **Hiking Trail (continues off map to the south).** Due to steep grades and cultural resource sensitivity (ABAAS 1019.1 and 1017.1 Exception 1), the hiking trail is not accessible. Subsequent planning and design is needed to provide an understanding of potential alternate routes for an accessible trail to the upper part of the site. 1) Create a firm and stable trail surface where possible. 2) Provide trailhead information signage on trail conditions (length of the trail or trail segment, surface type, typical and maximum tread width, typical and maximum running slope, and typical and maximum cross slope) per Architectural Barriers Act Accessibility Standards section 1017.10.

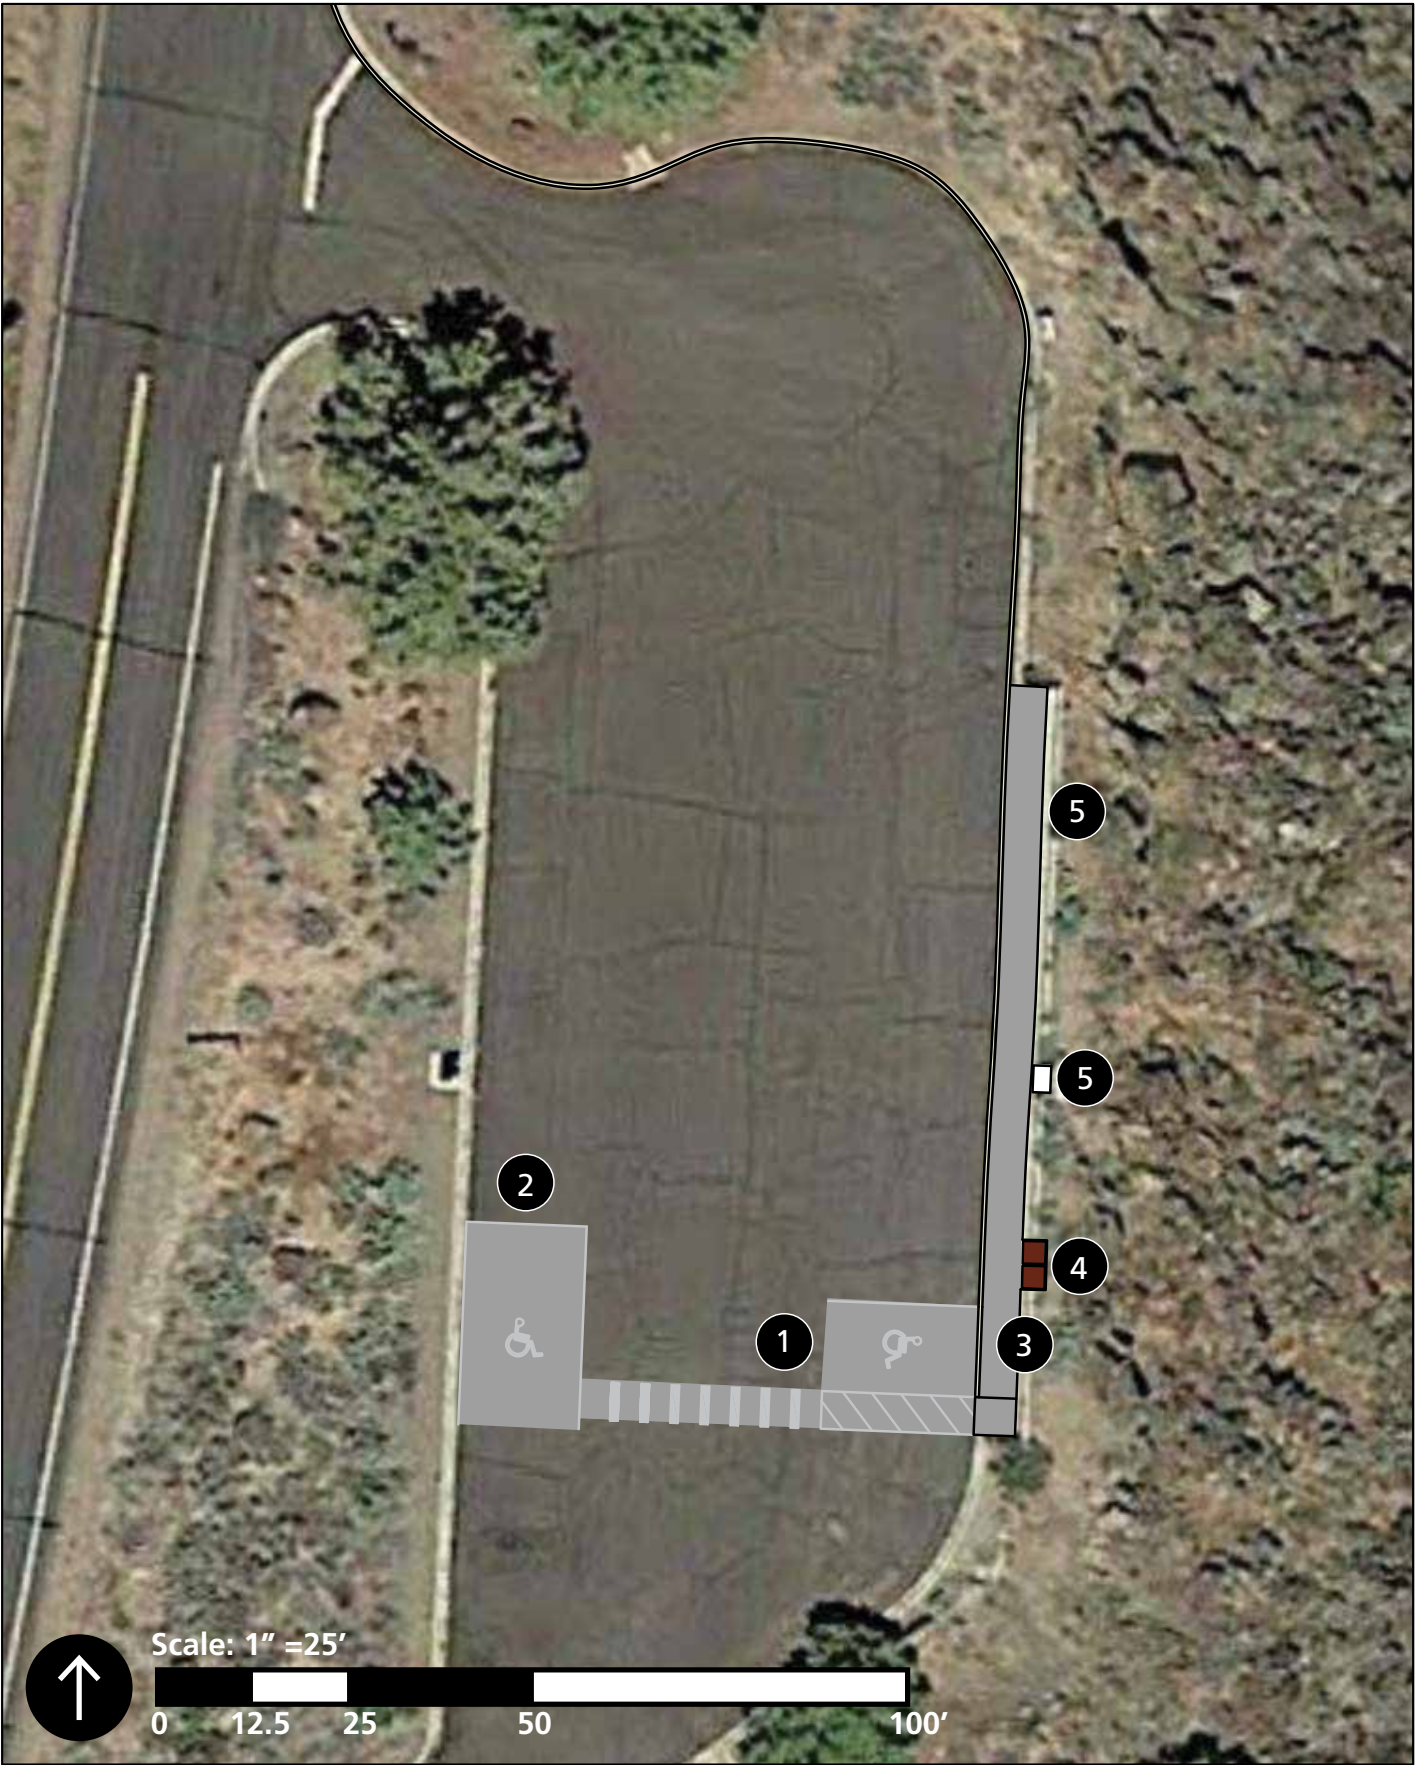
Site Map

Service, Activity, or Program	Level of Access				PAMP Optimizer Band ±	Barrier	Solution	Proximity to Other Recommended Solutions ∞
	Cognitive	Mobility	Vision	Hearing				
Car Parking	1	2	2	1	3	No van accessible parking space provided.	1) Provide one signed and marked "van accessible" parking stall. Stalls should be maximum 2% running and cross slopes, 5' marked access aisle on the passenger side of the stall, and 11' wide. 2) Also provide "van accessible" signage at the stall with the bottom of the sign 60" minimum above the ground.	Devils Homestead Pullout
Oversized Vehicle Parking	1	2	2	1	3	RV and/or bus parking accessible spaces are not striped and signed.	1) Stripe one oversized vehicle accessible parking stall at 16' wide. 2) Provide accessible parking signage 60" minimum above finish ground measured to bottom of the sign.	Devils Homestead Pullout

Service, Activity, or Program	Level of Access				PAMP Optimizer Band ±	Barrier	Solution	Proximity to Other Recommended Solutions ∞
	Cognitive	Mobility	Vision	Hearing				
Outdoor Recreation Access Route and Walking Surfaces	1	2	1	1	3	No curb cut or outdoor recreation access route to trash and recycling and interpretive waysides.	<p>1) Cut curb adjacent to accessible parking to provide access to the sidewalk. Ensure curb ramp running slope is 8.33% maximum and cross slope 2% maximum. The curb ramp should be flared, and the side slopes should be 10% maximum. The curb ramp should have a landing at the top that is 36" minimum in depth with no more than 2% slope in all directions.</p> <p>1) Replace trash receptacle with one that requires five pounds or less force to open and is operable with a closed fist. 2) Relocate trash receptacle to be on the main walking surface or install a second trash receptacle along the main path. 3) Install receptacle to have reach range of 48" maximum height.</p>	Devils Homestead Pullout

Service, Activity, or Program	Level of Access				PAMP Optimizer Band ±	Barrier	Solution	Proximity to Other Recommended Solutions ∞
	Cognitive	Mobility	Vision	Hearing				
Trash and Recycling	1	2	1	1	3	Trash receptacle is too high.	1) Ensure that all text is 24 point (with the exception of 16 point for titles and credits of photographs) and ensure that future graphics are clear and contrast 70% or greater with the background color of panel. 2) Provide a clear space in front of interpretive waysides that is 36" by 48" and has a maximum slope of 2% in all directions. 3) Relocate interpretive panels found to the north onto the accessible walking surface. 4) Provide a tactile model of landscape on interpretive wayside. 5) Provide audio description and accessible electronic PDF of wayside content on website and at visitor center.	Devils Homestead Pullout
Interpretive Waysides	2	1	2	2	3	Interpretive panel font sizes smaller than 24 point (16 point allowed for photograph titles and credits) and drawings or photos do not provide enough contrast. Clear space is not provided in front of one panel.		Devils Homestead Pullout; all interpretation signage throughout park

- 4 Trash and Recycling.** 1) Replace trash receptacle with one that requires five pounds or less force to open and is operable with a closed fist. 2) Relocate trash receptacle to be on the main walking surface or install a second trash receptacle along the main path. 3) Install receptacle to have a maximum reach range of 48" maximum height.
short-term

- 5 Interpretive Wayside.** 1) Ensure that all text is 24 point (with the exception of 16 point for titles and credits of photographs) and ensure that future graphics are clear and contrast 70% or greater with the background color of panel. 2) Provide a clear space in front of interpretive waysides that is 36" by 48" and has a maximum slope of 2% in all directions. 3) Relocate interpretive panels found to the north onto the accessible walking surface. 4) Provide a tactile model of landscape on interpretive wayside. 5) Provide audio description and accessible electronic PDF of wayside content on website and at visitor center.
