Oakleigh: Main house at left; kitchen—proposed for rehabilitation—at right. Looking southeast.

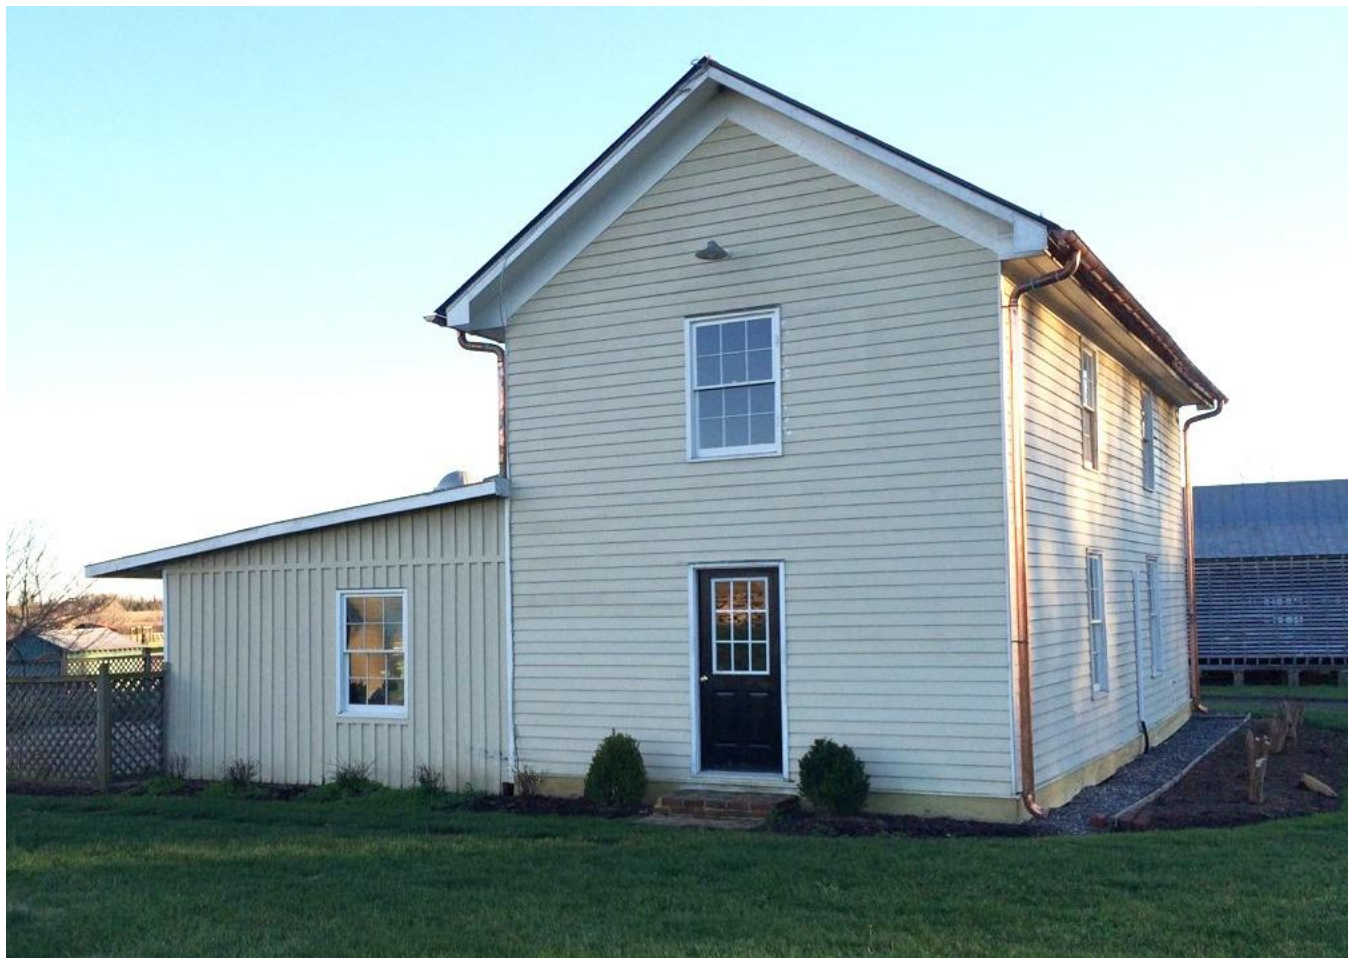
Oakleigh Kitchen: north and (at right) west facades. One-story shed-addition, remodeled 1984-c.2002, is proposed for removal. One-story porch proposed for door at center.

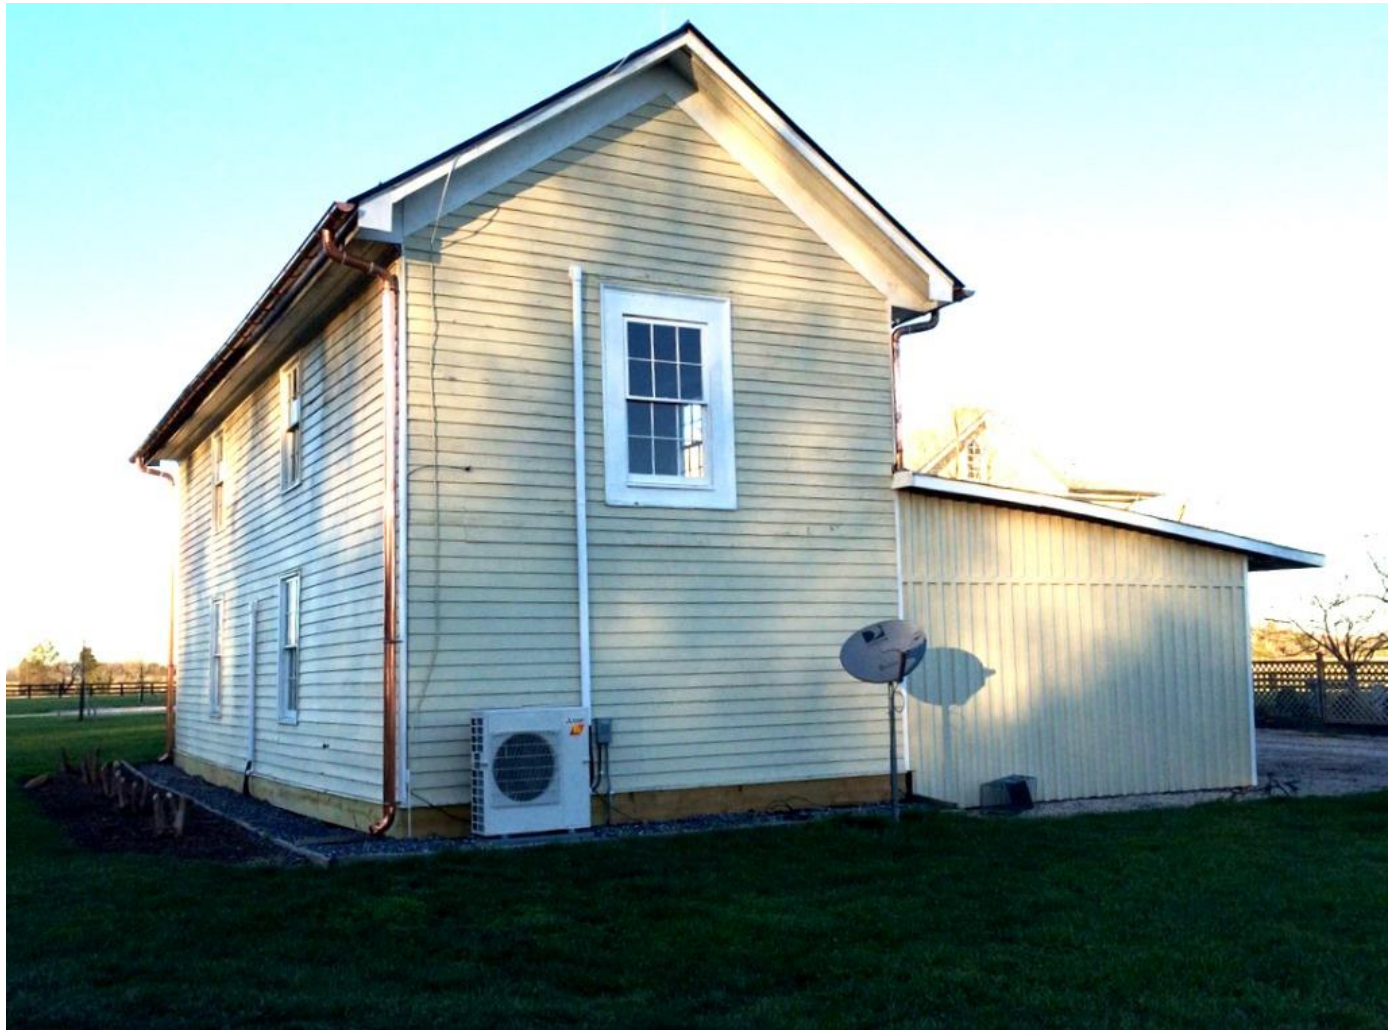
Oakleigh Kitchen: south and (at left) west facades. Note gable-end of main house above roof of Kitchen's shed addition. Second window proposed for area under existing window.

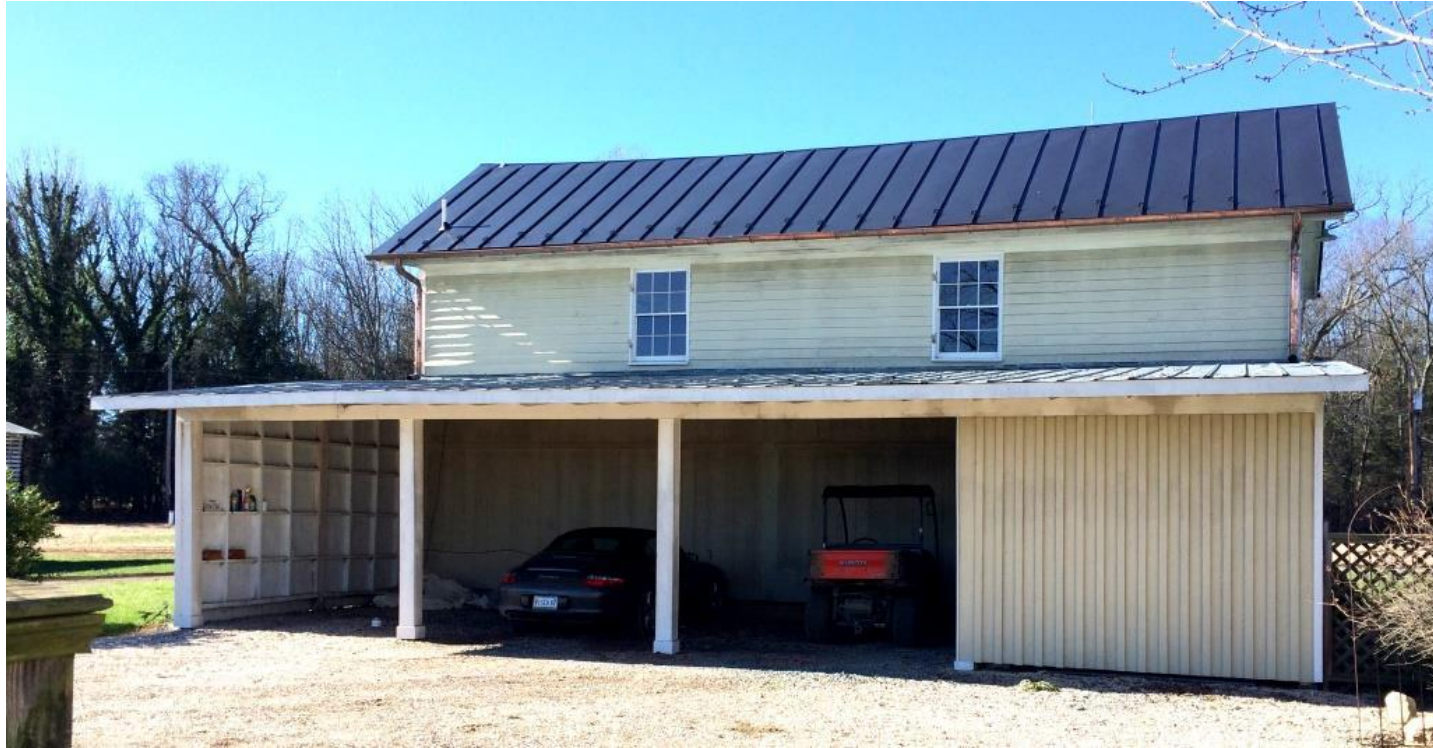
Oakleigh kitchen: east façade. One-story shed addition is proposed for removal; existing door—hidden by garage-wall at right—to be shifted to area behind parked car. Pea gravel to be removed.

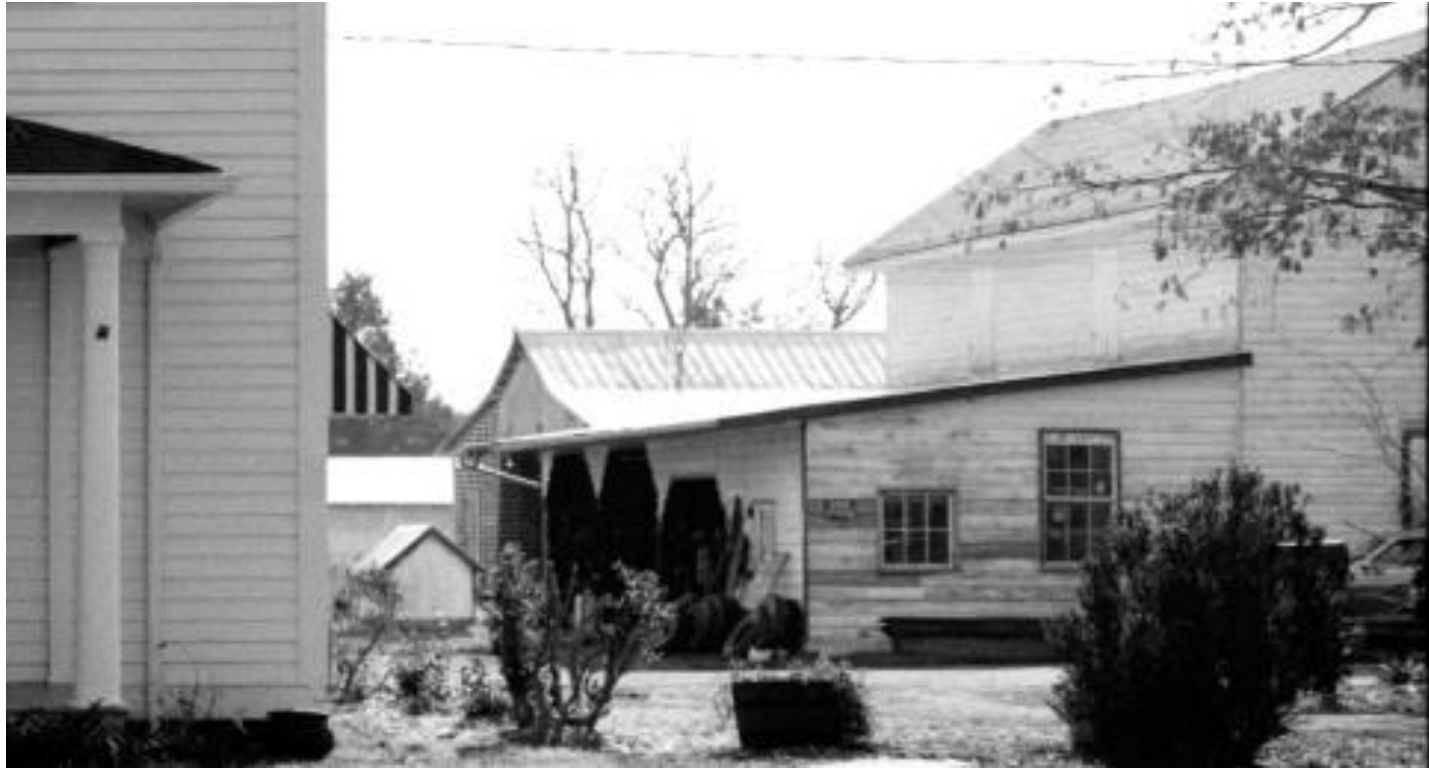
Oakleigh Kitchen, east and north facades (right), from detail of HABS photo of main house (left) in 1984. One-story shed additon on east façade of kitchen was later replaced or extensively remodeled. Note solid-wood door at far right, on north façade of kitchen, likewise changed—through replacement by with door with lights and stoop—sometime after 1984.
