3.0 AFFECTED ENVIRONMENT

3.1 Cultural Resources

Table 3- 3: Significant Surviving Landscape Characteristics and Features within Elkmont Historic District

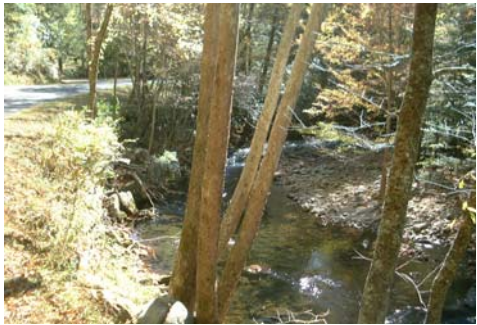
Type and Description of Characteristic or Feature	Representative Photo of Examples Found in Elkmont Historic District	Type and Description of Characteristic or Feature	Representative Photo of Examples Found in Elkmont Historic District
Spatial organization Pattern of watercourses, landforms, circulation routes, topography, vegetation, nodes of development, buildings and structures, and smaller features <i>Photo Descriptions:</i> View of Little River adjacent to Elkmont Road between the Wonderland Club and the Appalachian Club

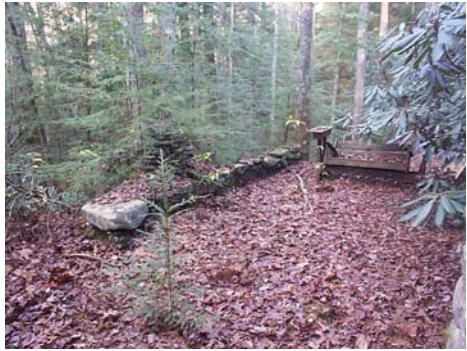
Small- scale features Wonderland Hotel steps, fountain, and side paths; remnants of Camp Le Conte dam and power plant; Bearwallow Branch footbridge; CCC culverts and erosion control walls; remnants of CCC walkway at swimming hole; stone fireplace or possible still between Cabins 46 & 47 <i>Photo Descriptions:</i> Remnants of stone wall in the Wonderland Club

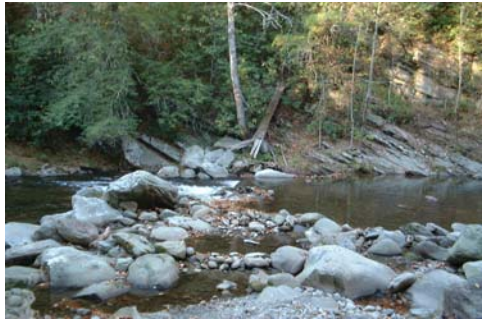
Water features Spring head at Bearwallow Branch; power plant base at Jakes Creek; Camp Le Conte lakebed, dam remnants, and base of power plant; Appalachian Club swimming hole; underground cistern near Elkmont Town (current campground) <i>Photo Description:</i> View of Little River “swimming hole”.

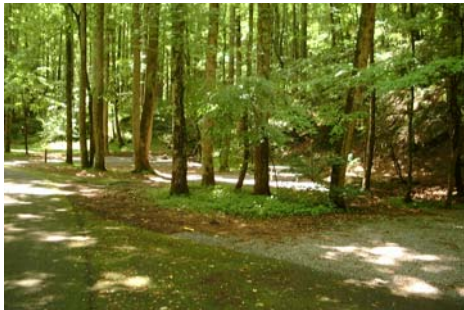
Buildings and structures Wonderland Club area (hotel, annex, and cabins), Appalachian Club area (clubhouse and cabins in Daisy Town, Society Hill, and Millionaire’s Row), and infrastructure (water tanks, utility lines, etc.) <i>Photo Description:</i> “Adamless Eden” playhouse in Daisy Town

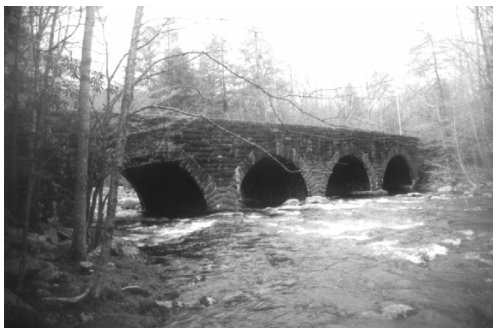
Circulation Old road to Gatlinburg via Fighting Creek Gap, roads into and throughout the District following removal of railroad tracks, and CCC stone bridge over Little River <i>Photo Description:</i> Little River stone bridge; view of east side

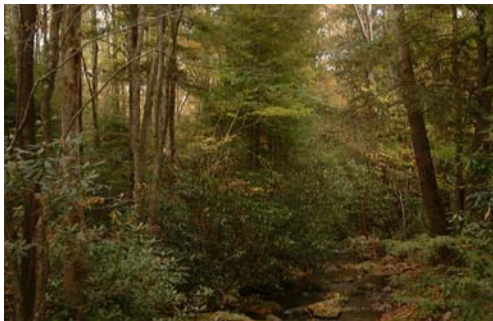
Topography and vegetation Flat land adjacent to watercourses, sloped areas and ridges, native trees and plants (successional forest), and non- native species planted by club residents <i>Photo Description:</i> Hemlock forest at Elkmont

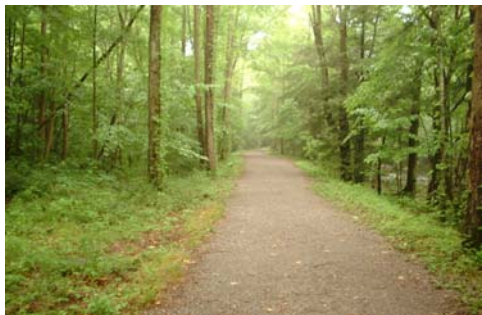
<i>Photo Description:</i> Axial view along Little River Trail; view facing east from Millionaire’s Row. Trail follows former bed of the Little River Railroad.
