*Fort Snelling 1938*

## Design Guidelines For Minneapolis Park and Recreation Board Development at Fort Snelling

Including Parade Ground, Quartermaster Area,  
Artillery Complex, and Cavalry Drill Hall

April 20, 1999

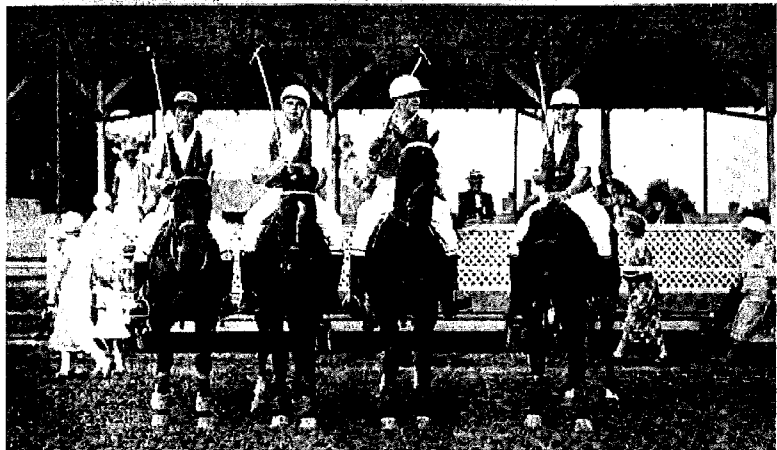
After World War I, the parade ground was transformed into a sports complex. A 1927 map shows an oval polo field stretching along Bloomington Road, with a polo practice field adjacent to the southeast. A single-story viewing or concession stand was apparently erected along Bloomington Road opposite Building 211. Assuming that this is the structure visible in photographs in a program for a 1925 polo tournament, the stand

had lattice railings instead of walls and was topped by a gable roof with exposed rafters. A smaller oval track occupied the south corner of the parade ground. Northeast of the track along Taylor Avenue was a baseball diamond. Baseball diamonds also appeared on the east and north corners of the parade ground. A periodical published in 1919 shows the back corner of tall, wood-frame bleachers, perhaps situated in front of the gymnasium (53) at what is now the northeastern end of Taylor Avenue. It was in this location that a federal relief program built a substantial concrete stadium, which was dedicated in June 1939. The V-shaped stadium was oriented to the north. Some of the outfield, along with the entire northeastern edge of the parade ground, were consumed by Highway 55 in the 1950s. This project demolished two large, early twentieth-century artillery barracks fronting on the parade ground. The stadium was torn down in about 1979.

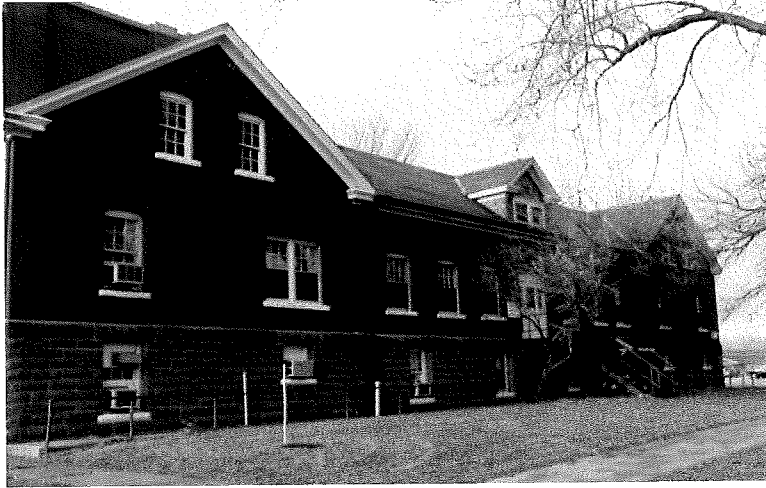
Walls of the early twentieth-century structures are red face brick. Brick walls of the 1894 forage house (218) are buff colored. Limestone ashlar foundations edge low to relatively high basements. Most of these buildings have gable roofs; in some cases, the original slate sheathing has been replaced by asphalt shingles. Building 201 had a tile roof, and Building 218 wood shingles. The gable roofs of the former barns (211, 214) are topped by monitors;

the monitors originally held pairs of louvered shutters alternating with pairs of windows, perhaps casements. Parapet walls with a semicircular apex trim the gable ends of the drill hall (201).

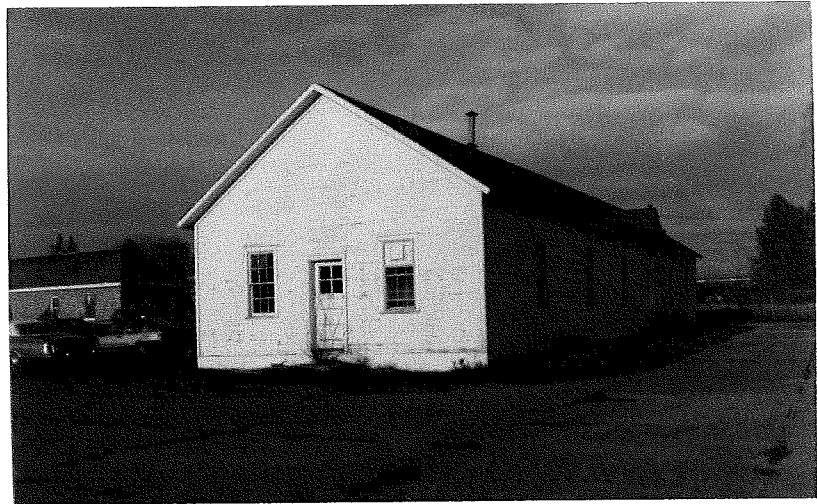
Wood was used to construct a complex of stables and gun sheds for the artillery in 1903. Only two of these buildings survive (207, 209), but structures that replaced 1903-vintage buildings in 1914 (202) and 1940 (T-203) are similar in character to the earlier structures. Another construction campaign in 1916-1917 produced several one- and two-story

utilitarian service buildings in the quartermaster area, including two garages (216, T-228), an office building (221), and a paint shop (225). Of this cohort, only the paint shop, now a storehouse, and one of the garages (T-228) survive. These buildings look very similar to a wood-frame storehouse (217), which property records claim was built in 1879. Wood also framed and clad a group of houses moved from an unknown location to the periphery of the quartermaster area between 1910 and 1913. These modest structures, which were used to lodge civilian workers, stand in contrast to the more substantial and prominent brick military quarters along Bloomington Road. Even more humble is the 1933 garage (T-213, demolished), a simple rectangle with a nearly flat, single-slope roof. The powder magazine (237), with walls and a roof of corrugated metal, matches the scale and form of the other wood-frame buildings but is otherwise an anomaly.

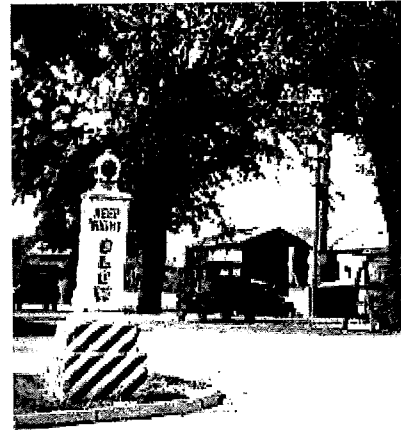
Signage at the fort was minimal. Buildings were identified by numbers painted on the walls. Photographs from around 1940 show street signs similar to those typically found on street corners in Minneapolis and St. Paul. A circa 1930s photograph includes a traffic monument at the west corner of Minnehaha Avenue and Bloomington Road. The cast-concrete structure has a stepped base painted with white and dark (black?) diagonal stripes. This supports a square-section post with the admonition "Keep Right—Slow" painted on its sides. A signal, perhaps a blinking light, caps the post.
