Fort Snelling State Park "Upper Bluff" Reuse Study

Prepared by
the Fort Snelling State Park Upper Bluff Consultation Team
and Thomas R. Zahn & Associates

2006 Update by Miller Dunwiddie Architecture

June 2006

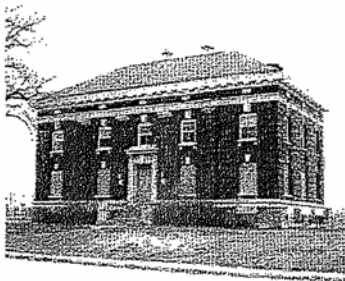
Gymnasium: Building #53

Date of Construction: 1903

Foundation: stone Walls: brick Roof: slate

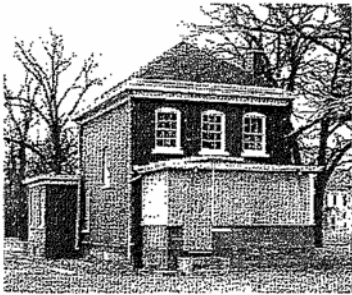
Hospital Steward's Quarters: Building #56

Date of Construction: 1900

Foundation: stone Walls: brick Roof: slate *Asphalt Shingles*

This two-story, red brick, Colonial Revival building next to the hospital was initially constructed to house the hospital's principal non-commissioned officer, the chief steward and his family. The structure has a hipped roof with one chimney on the south roof slope. The original full-width wooden porch has since been replaced by a brick one with a rusticated concrete block foundation. The asymmetrically placed front door is common on the Colonial Revival structures building around the turn of the century. The windows have segmental – arch lintels and have a 6/6 pattern of glazing. There is a small, single story addition off the eastern rear corner of the house.

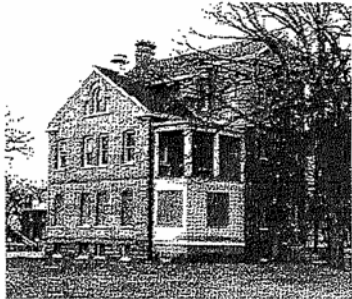
Band Barracks: Building #57

Date of Construction: 1903

Foundation: stone Walls: brick Roof: slate *Asphalt Shingles*

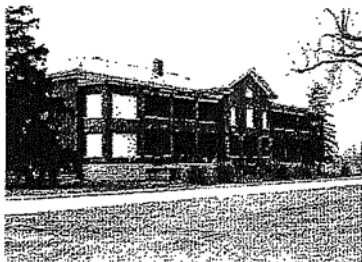
Bachelor Officers' Quarters: Building

#151 Date of Construction: 1904

Foundation: stone Walls: brick Roof: slate

This red brick Colonial Revival building has a hipped roof with a gable roofed bay projecting out from the center of the facade. The bay is supported by four columns on the first story. The structure originally had two 2-story wood porches with flat roofs on either side of the central bay. The main entrance to the building is located under the second story bay. The windows of the structure have flat-arch lintels and sills made of stone. In 1929, two 12'-x12' 6", two-story additions were made to each side of the back to house a total of four kitchens for these living quarters. It had a cement block foundation, brick walls, and a tin roof. Sometime after 1929, brick additions were made to either side of the facade and the wood porches were replaced in brick. In 1936, a concrete addition was made to install a new boiler. This building also served as the Officers' Country Club in the 1920s.

The BOQ (#151) is generally representative of the Colonial Revival style with its overall hipped roof; full-height, gable-roofed entry porch projection at the center of the facade; and full-width, flat roofed, wood porches. The central facade projection also exhibits influences of the Neoclassical style with its prominent square support columns and semi-circular fanlight at the front gable. This style, which is in turn made up of elaborations found in Early Classical Revival and Greek Revival styles, were very popular for domestic buildings in the United States during the first half of the 20th century. Interest in classical styles was rekindled by the World's Columbian Exposition held in Chicago in 1893.

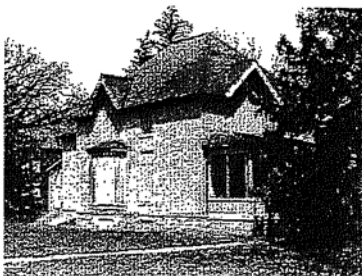
Officer's Quarters: Building

#152 Date of Construction: 1879-80

Foundation: stone Walls: brick Roof: shingle

When Officers' Row was constructed, this was one of five houses built to this particular plan. However, this is the only remaining example of that plan at Fort Snelling. It is of the Queen Anne style and has a cross-hipped roof. As was common in the Queen Anne style, the roof also has lower cross gables on the north, south, and east sides, which have a decorative cornice. The single story full width wood porch is decorated with modest spindlework. However, the original porch was replaced by a smaller brick porch. There is a bay window on the south side of house. A decorative balustrade sits on the roof of the porch outside a pair of windows on the facade. A pair of windows have a hipped pent roof on the north side of the building. Its asymmetrical plan is typical of the Queen Anne style of architecture, which aimed to avoid flat-walled surfaces.

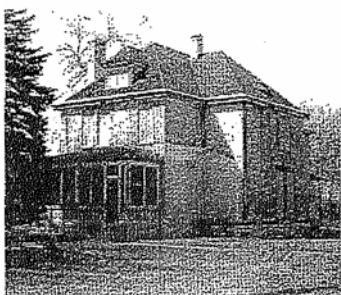
Officer's Quarters: Building #153

Date of Construction: 1892

Foundation: stone Walls: brick Roof: shingle

When Officers' Row was constructed, this was one of seven houses built to this particular plan. Currently, four houses of that plan remain at Fort Snelling. This yellow brick house is of the Queen Anne style with a cross hipped roof with hipped dormers on east and south sides and eyebrow dormer on north side. A single-story full-width decorated wood porch existed on the facade. This was later replaced by a smaller brick porch. A single-story bay projects from the house on the south side. The windows have stone lintels and sills. The structure originally had patterned-masonry chimneys on the roof slope, but these were replaced by simpler chimneys. Its asymmetrical plan is typical of the Queen Anne style of architecture, which aimed to avoid flat-walled surfaces. This particular style of Queen Anne is starting to show Colonial Revival influences.

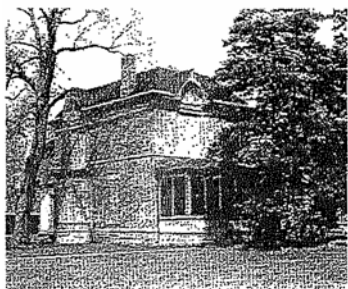
Officer's Quarters: Building #154

Date of Construction: 1879-80

Foundation: stone Walls: brick Roof: shingle

This yellow brick house is of the Queen Anne style with some characteristics of the Second Empire Style, such as the mansard-like deck-on-hip roof and brackets below the eaves. As was common in the Queen Anne style, the roof also has lower cross gables. These gables have decorated bargeboards. The gable on the facade originally had a finial. A single-story full-width decorated wood porch existed on the facade. This was later replaced by a smaller brick porch. Single-story bays projected from the house on the north and south sides. The bay on the north side of the house was topped with a decorative balustrade. A decorative band of stone breaks the first from the second stories on the exterior of the house. The structure originally had a patterned-masonry chimney on the roof slope, but this was replaced by a simpler chimney. Its asymmetrical plan is typical of the Queen Anne style of architecture, which aimed to avoid flat walled surfaces.

Buildings #154, #156, #158 and #160 display many of the characteristics noted above for the Queen Anne style; however, they also have distinct characteristics of the French Second Empire, and its related Italianate, style. Such characteristics include mansard roofs; tall, narrow windows with elaborate crowns which are often curved; and decorative brackets under the eaves. Both the French Second Empire and the Italianate styling dominated urban housing in America between 1860 and 1880.

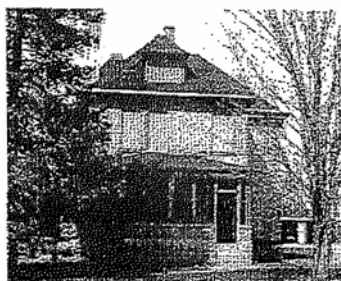
Officer's Quarters: Building #155

Date of Construction: 1892

Foundation: stone Walls: brick Roof: shingle

When Officers' Row was constructed, this was one of seven houses built to this particular plan. Currently, four houses of that plan remain at Fort Snelling. This yellow brick house is of the Queen Anne style with a cross hipped roof with hipped dormers on east and south sides and eyebrow dormer on north side. A single-story full-width decorated wood porch existed on the facade. This was later replaced by a smaller brick porch. A single-story bay projects from the house on the south side. The windows have stone lintels and sills. The structure originally had patterned-masonry chimneys on the roof slope, but these were replaced by simpler chimneys. Its asymmetrical plan is typical of the Queen Anne style of architecture, which aimed to avoid flat-walled surfaces. This particular style of Queen Anne is starting to show Colonial Revival influences.

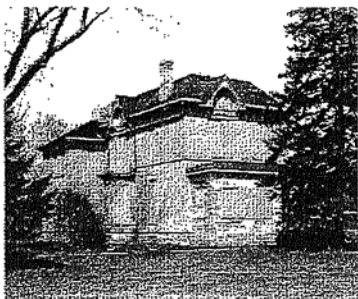
Officer's Quarters: Building #156

Date of Construction: 1879-80

Foundation: stone Walls: brick Roof: shingle

This yellow brick house is of the Queen Anne style with some characteristics of the Second Empire Style, such as the mansard-like deck-on-hip roof and brackets below the eaves. As was common in the Queen Anne style, the roof also has lower cross gables. These gables have decorated bargeboards. The gable on the facade originally had a finial. A single-story full-width decorated wood porch existed on the facade. This was later replaced by a smaller brick porch. Single-story bays projected from the house on the north and south sides. The bay on the north side of the house was topped with a decorative balustrade. A decorative band of stone breaks the first from the second stories on the exterior of the house. The structure originally had a patterned-masonry chimney on the roof slope, but this was replaced by a simpler chimney. Its asymmetrical plan is typical of the Queen Anne style of architecture, which aimed to avoid flat-walled surfaces. Unlike the other houses of this style, this house has had a two-story hipped roof addition made on the southwest corner of the back.

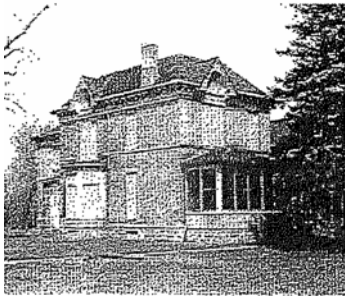
Field Officer's Quarters: Building #158

Date of Construction: 1879-80

Foundation: stone Walls: brick Roof: shingle

This yellow brick house is of the Queen Anne style with some characteristics of the Second Empire Style, such as the mansard-like deck-on-hip roof and brackets below the eaves. As was common in the Queen Anne style, the roof also has lower cross gables. These gables have decorated bargeboards. The gable on the facade originally had a finial. A single-story full-width decorated wood porch existed on the facade. This was later replaced by a smaller brick porch. Single-story bays projected from the house on the north and south sides. The bay on the north side of the house was topped with a decorative balustrade. A decorative band of stone breaks the first from the second stories on the exterior of the house. The structure originally had a patterned-masonry chimney on the roof slope, but this was replaced by a simpler chimney. Its asymmetrical plan is typical of the Queen Anne style of architecture, which aimed to avoid flat walled surfaces.

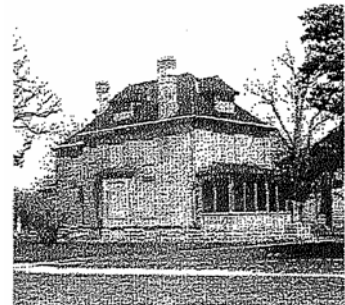
Officer's Quarters: Building #159

Date of Construction: 1892

Foundation: stone Walls: brick Roof: shingle

When Officers' Row was constructed, this was one of seven houses built to this particular plan. Currently, four houses of that plan remain at Fort Snelling. This yellow brick house is of the Queen Anne style with a cross hipped roof with hipped dormers on east and south sides and eyebrow dormer on north side. A single-story full-width decorated wood porch existed on the facade. This was later replaced by a smaller brick porch. A single-story bay projects from the house on the south side. The windows have stone lintels and sills. The structure originally had patterned-masonry chimneys on the roof slope, but these were replaced by simpler chimneys. Its asymmetrical plan is typical of the Queen Anne style of architecture, which aimed to avoid flat-walled surfaces. This particular style of Queen Anne is starting to show Colonial Revival influences.

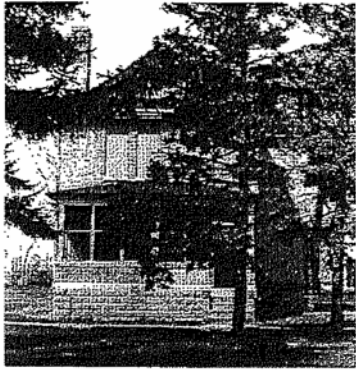
Officer's Quarters: Building #161

Date of Construction: 1892

Foundation: stone Walls: brick Roof: shingle

When Officers' Row was constructed, this was one of seven houses built to this particular plan. Currently, four houses of that plan remain at Fort Snelling. This yellow brick house is of the Queen Anne style with a cross hipped roof with hipped dormers on east and south sides and eyebrow dormer on north side. A single-story full-width decorated wood porch existed on the facade. This was later replaced by a smaller brick porch. A single-story bay projects from the house on the south side. The windows have stone lintels and sills. The structure originally had patterned-masonry chimneys on the roof slope, but these were replaced by simpler chimneys. Its asymmetrical plan is typical of the Queen Anne style of architecture, which aimed to avoid flat-walled surfaces. This particular style of Queen Anne is starting to show Colonial Revival influences.
