STATEMENT OF FINDINGS FOR EXECUTIVE ORDER 11988:
FLOODPLAIN MANAGEMENT; EXECUTIVE ORDER 13690: ESTABLISHING A
FEDERAL FLOOD RISK MANAGEMENT STANDARD AND A PROCESS FOR
FURTHER SOLICITING AND CONSIDERING STAKEHOLDER INPUT;
AND EXECUTIVE ORDER 11990: WETLANDS PROTECTION,
Chickasaw Heritage Center Access Road

Natchez Trace Parkway
Lee County, MS

Wetland Delineation Report for the Natchez Trace Parkway

Chickasaw Heritage Center Access

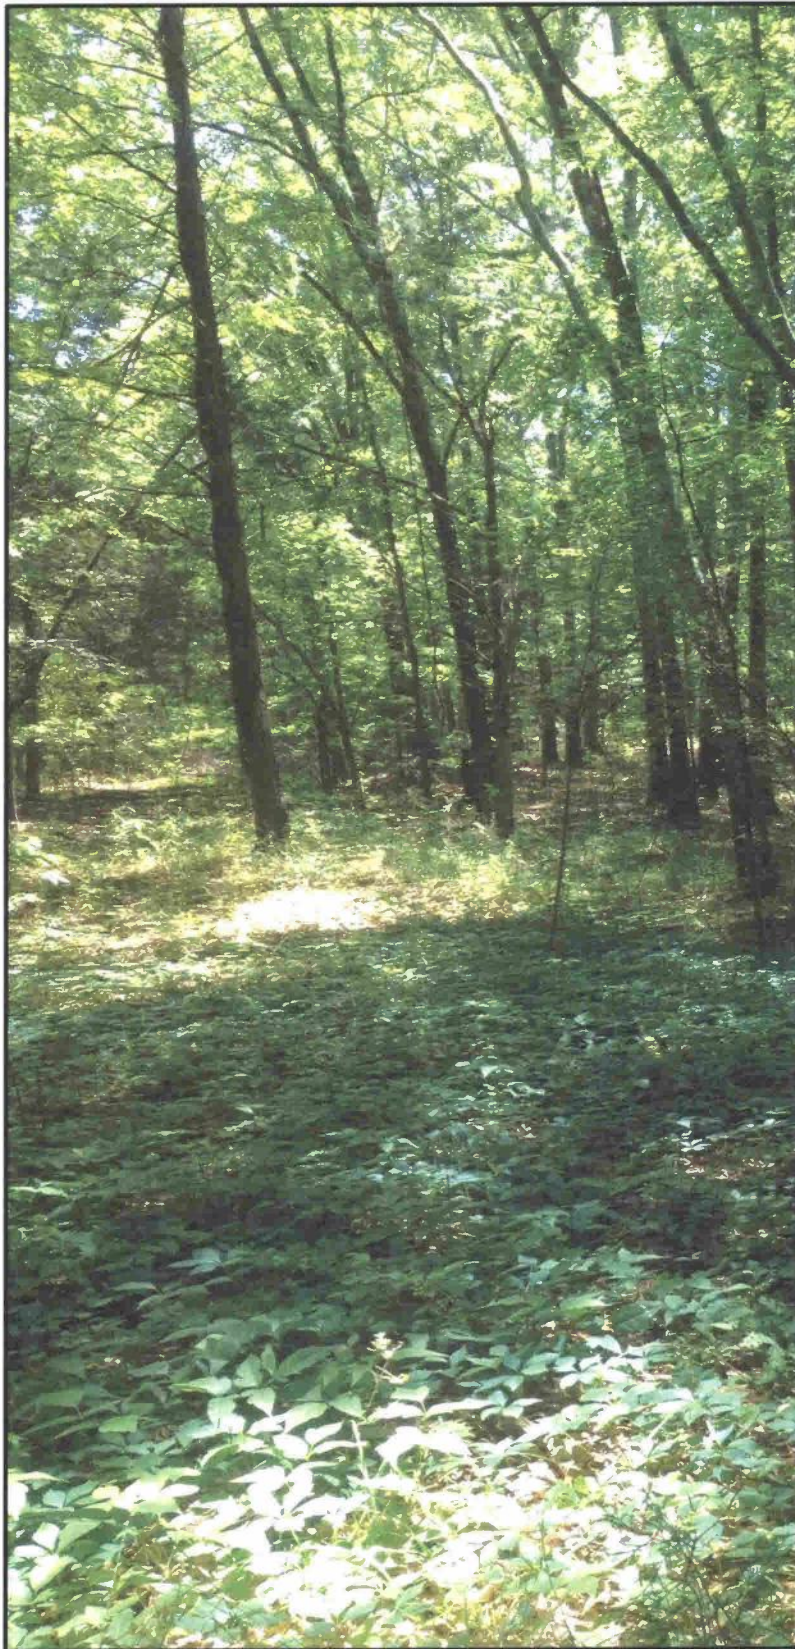
Figure 2. Project area looking east from in the forest back toward the Parkway.

The general habitat of the project site is composed of deciduous forest on a minor grade. The overstory is dominated by water oak (*Quercus nigra*), hackberry (*Celtis occidentalis*) and eastern redcedar (*Juniperus virginiana*). The midstory is dominated by honey locust (*Gleditsia triacanthos*), black cherry (*Prunus serotina*), sparkleberry (*Vaccinium arboreum*), and non-native privet (*Ligustrum* species). The understory herbaceous cover is dominated by poison ivy (*Toxicodendron radicans*) and sedges (*Carex* species, Figure 2). The surrounding area has been previously disturbed by construction of the Parkway and Gun Club Road. Other previous disturbance includes the Natchez Trace National Scenic Trail, which runs through the project area in two locations (Figure 3).

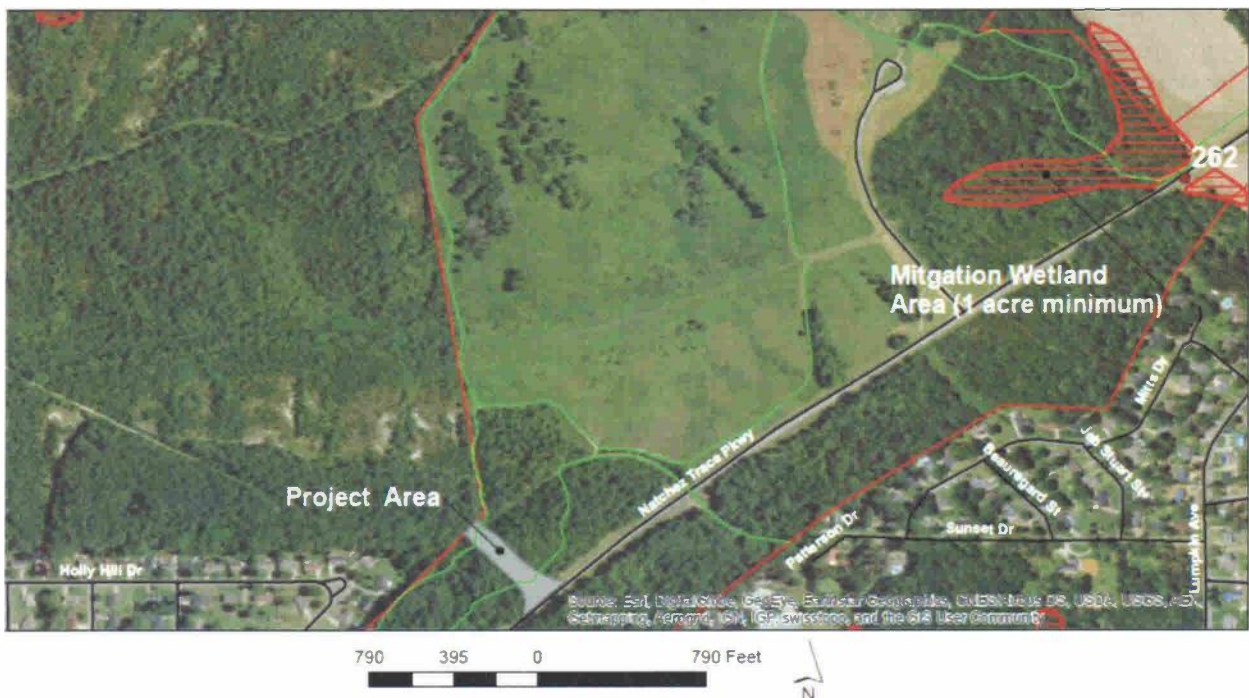
Figure 6. Wetland mitigation area (red hatched area). Mitigation will consist of eradication of Chinese privet within the nearby palustrine forested wetland. This wetland is 5.69 acres in size, and contains approximately 1 acre of Chinese privet in scattered locations. At least 1 acre of Chinese privet will be treated in this area over a 3-year timeframe in order to enhance wetland function.

Although the acreage of wetlands affected by the project is below the 0.10 acres threshold requiring mitigation, the Parkway will compensate for the impacts of the preferred alternative by enhancing adjacent palustrine forested wetlands. This will be accomplished by non-native Chinese privet (*Ligustrum sinense*) eradication in adjacent palustrine forested wetlands at a minimum mitigation to impact ratio of 10:1 (Figure 6). This will result in at least one acre of Chinese privet treatment in a nearby in-kind wetland.

Chinese privet is known to reduce wetland function by decreasing diversity and habitat quality. Eradication will consist of cutting and stump treatment, with follow-up treatments at from 1-3 years post-treatment. Cut privet will be piled and burned or broadcast on site. Mitigation will be funded by existing contracts in 2017 and by base operating funds in out years.

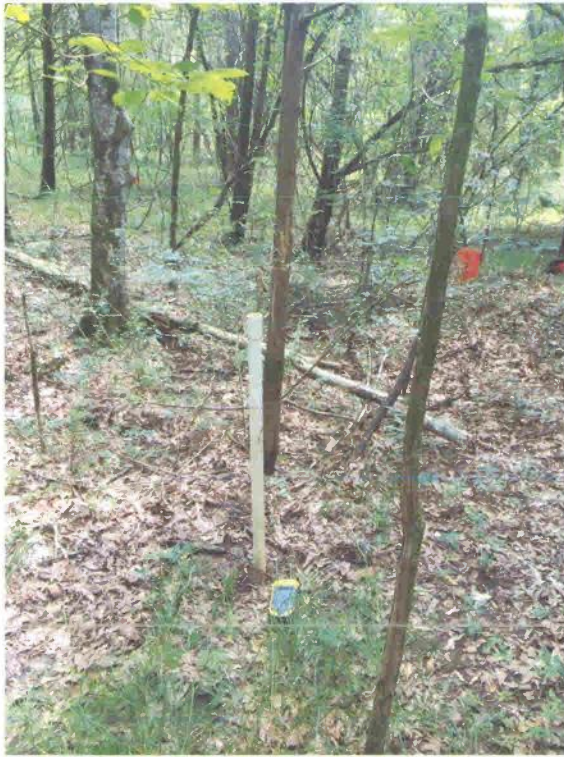
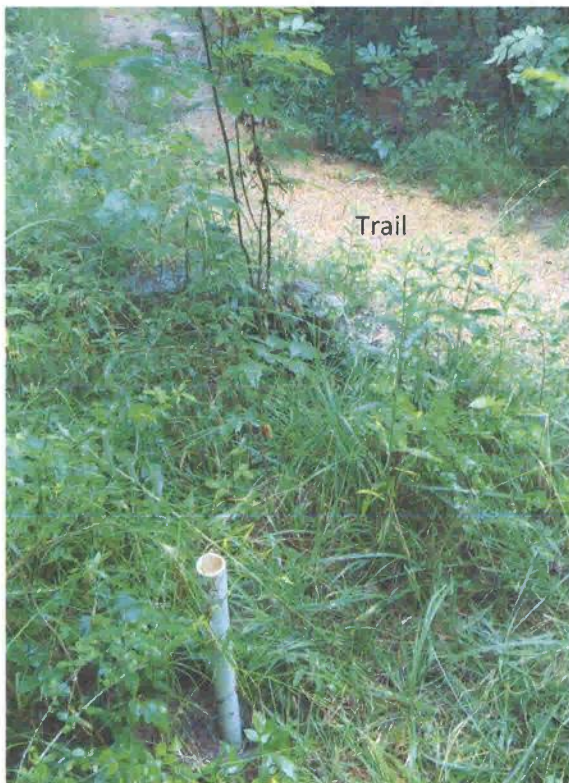
Figure 3. Views of wetland near sample site 1 (top) and sample site 6 (bottom).

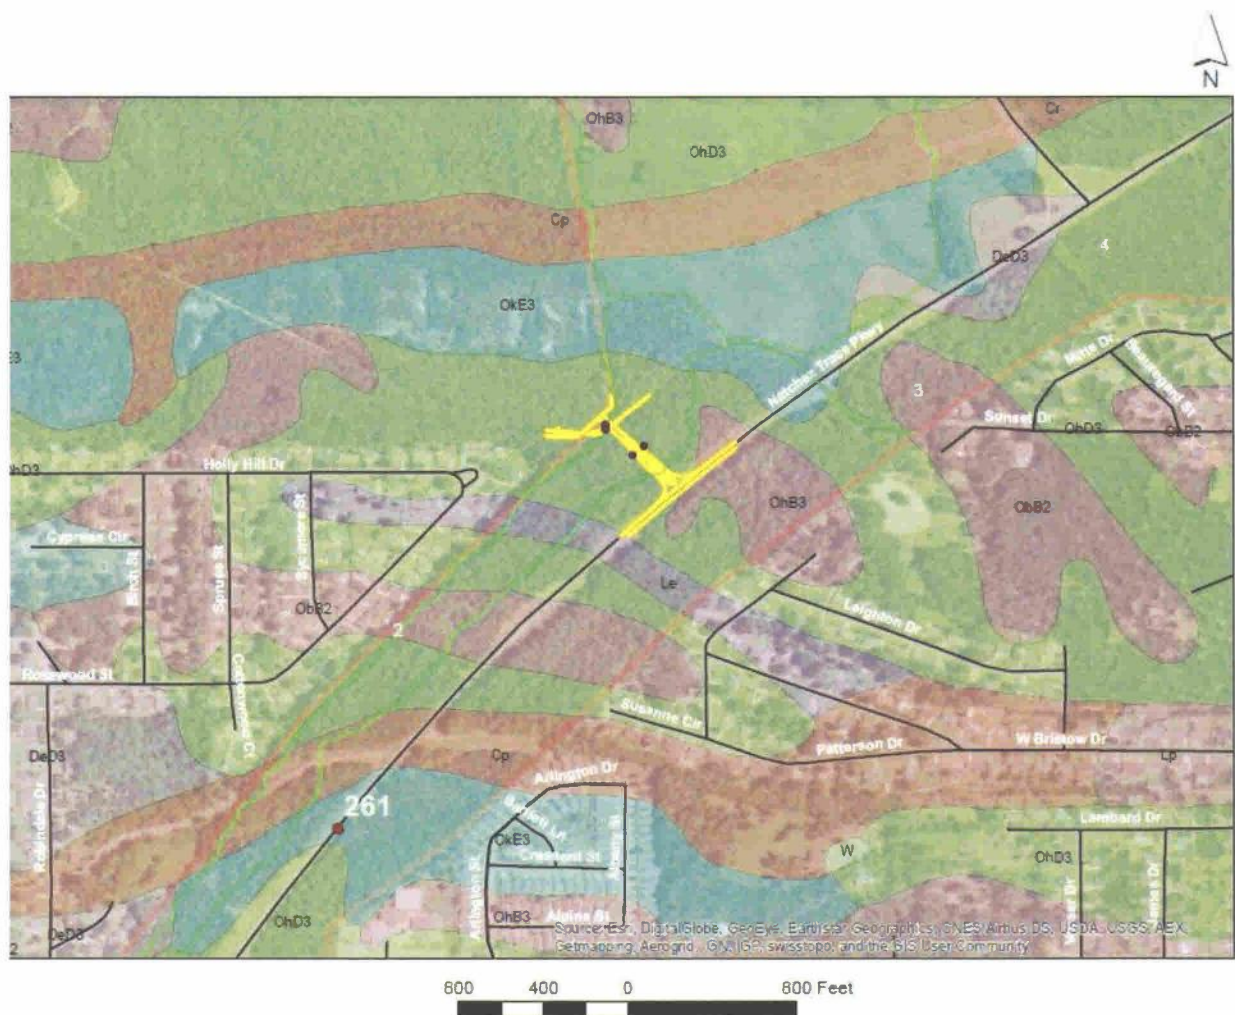
Figure 4. Natural Resource Conservation Service soil types within the project area (denoted as the roadway in yellow). Soils were delineated as OhD3, Oktibbeha silty clay, 5-12% severely eroded slopes (non- hydric).

Wetland 2 consisted of a drainage crossing the Natchez Trace National Scenic Trail. The immediately adjacent land was populated by pines with no visual evidence of wetland hydrology or wetland plants. The vegetation was dominated by eastern redcedar and hydrophytes including black willow (*Salix nigra*), green ash (*Fraxinus pennsylvannica*), sedges (*Caryx* species), and lamp rush (*Juncus effuses*). Soil characteristics and color for sampling sites 5-6 were determined to be hydric, with signs of mottling and redox indicators. Natural Resource Conservation Service soil types within the project area can be found in Figure 4.

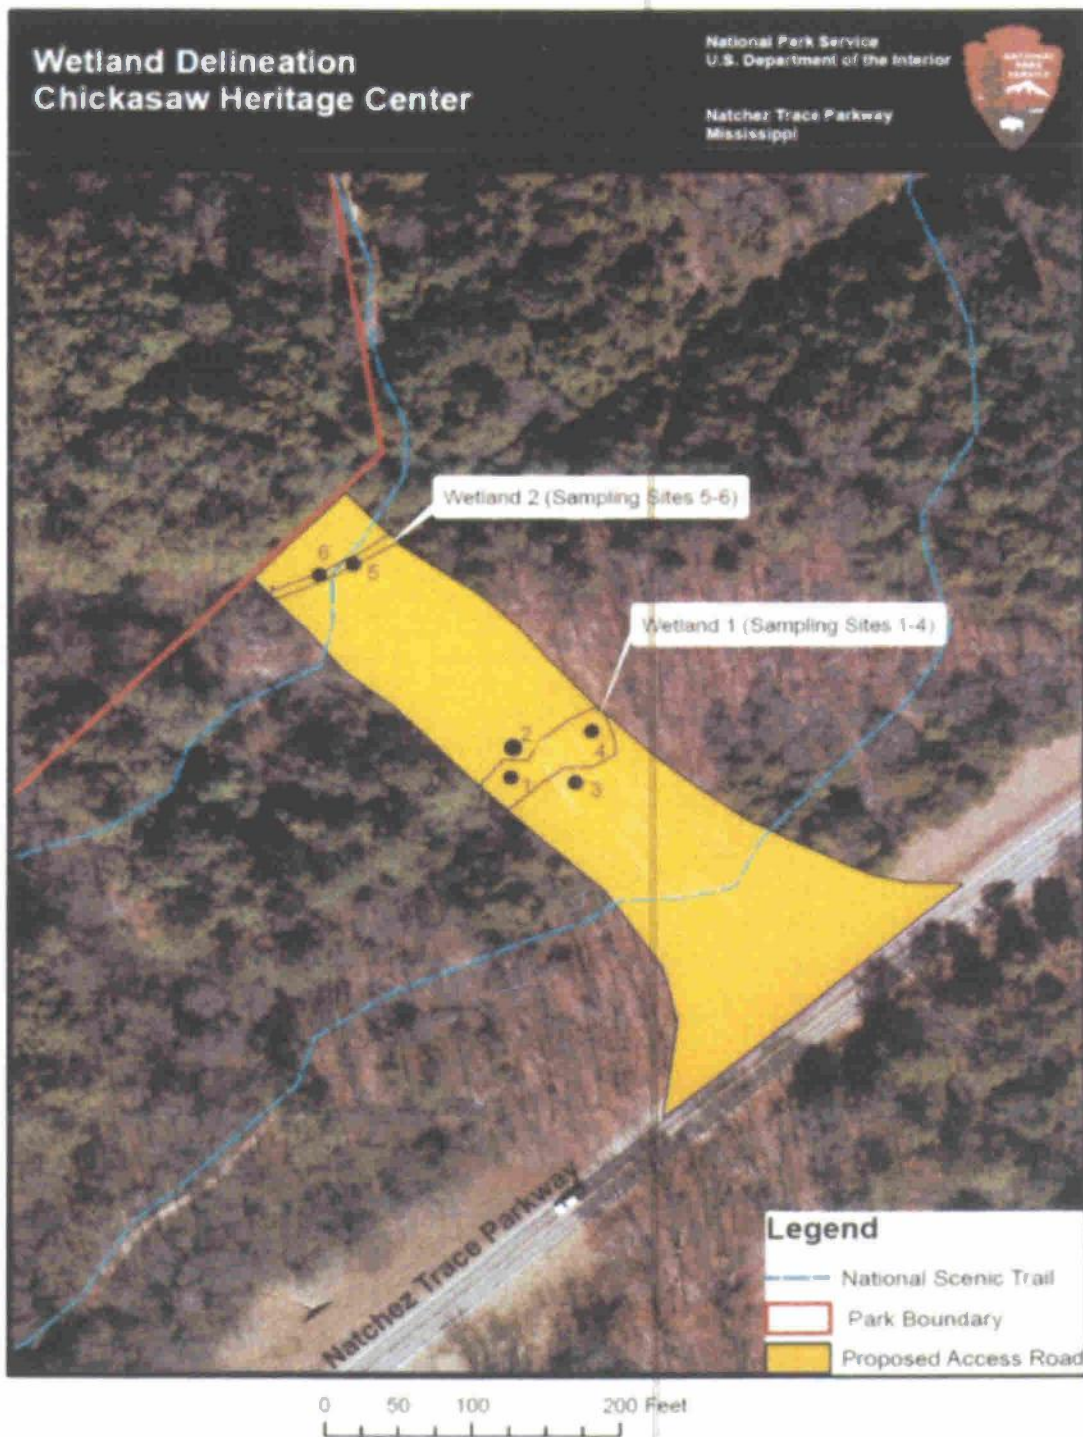
Figure 2. Wetland and sampling site locations (1-6) within the project area. Wetland 1 is 0.05 acres, and Wetland 2 is 0.02 acres,

Site number	Latitude	Longitude	Cowardin Class	Estimated amount of aquatic resource in review area	Class of aquatic resource
1	34.2719	-88.7466	PFO	0.05	Section 404
2	34.2720	-88.7472	PFO	0.02	Section 404
