Matrix 3-10. Big Spring Character Area

Affected Environment

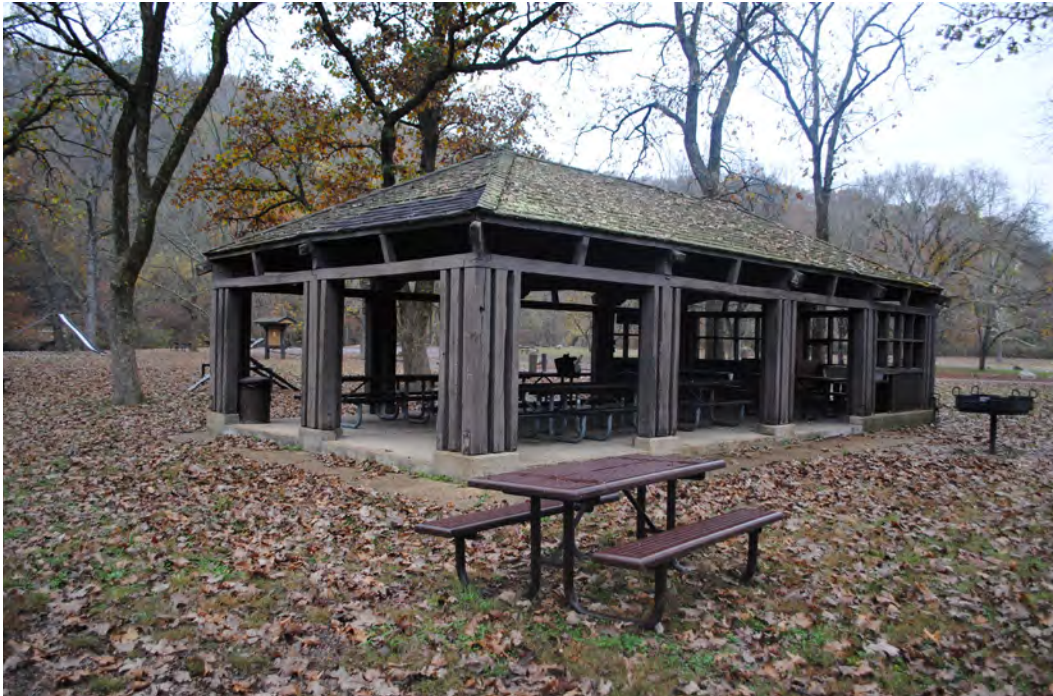
Figure 3-142. Big Spring Pavilion (HS-425). (Mundus Bishop 2015)

| BUILDINGS AND STRUCTURES | | | |
|--|---|---|---|
| "Big Spring Pavilion (HS-425) (1947)" | Big Spring Pavilion was built in 1947. It is a 41'-6"x21'-6" one-room, open-sided picnic shelter with a wood shingled hip roof supported by square wood columns. A brick oven and fireplace are located at the center of the north wall and the floor is poured concrete. | Fair | Contributing |

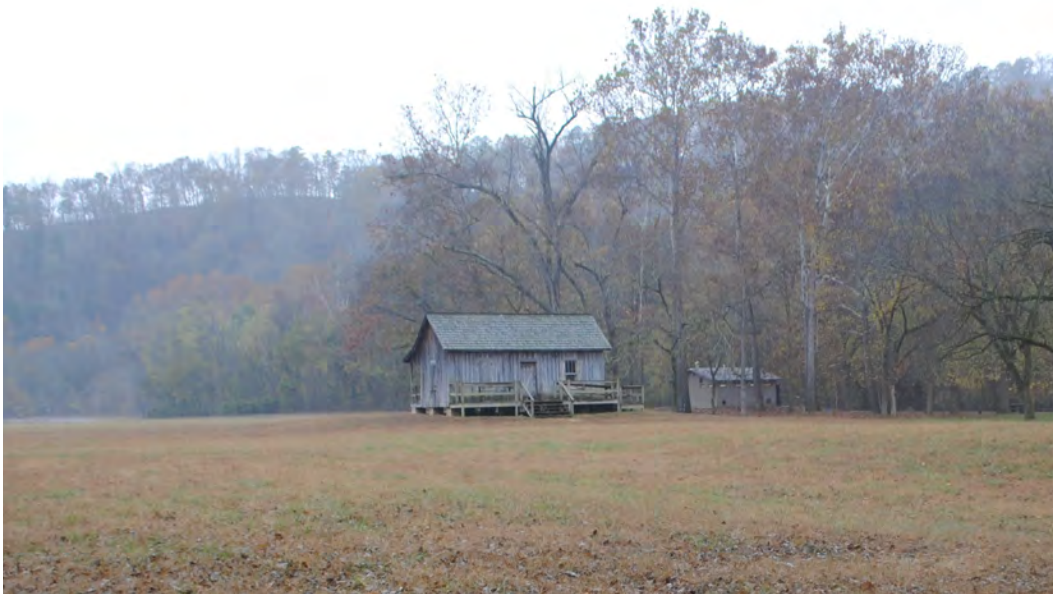
Figure 3-143. Big Spring Craft Cabin (458) center, and Big Spring Latrine (476) at right. (Mundus Bishop 2015)

| BUILDINGS AND STRUCTURES | | | |
|--|---|---|---|
| Big Spring Craft Cabin (458) (1972) | Wood construction, rustic cabin. | Fair | Non-contributing |
| Big Spring Latrine (476) (2010) | New prefabricated, precast concrete restrooms. Replacing restrooms originally established in 1977. | Good | Non-contributing |

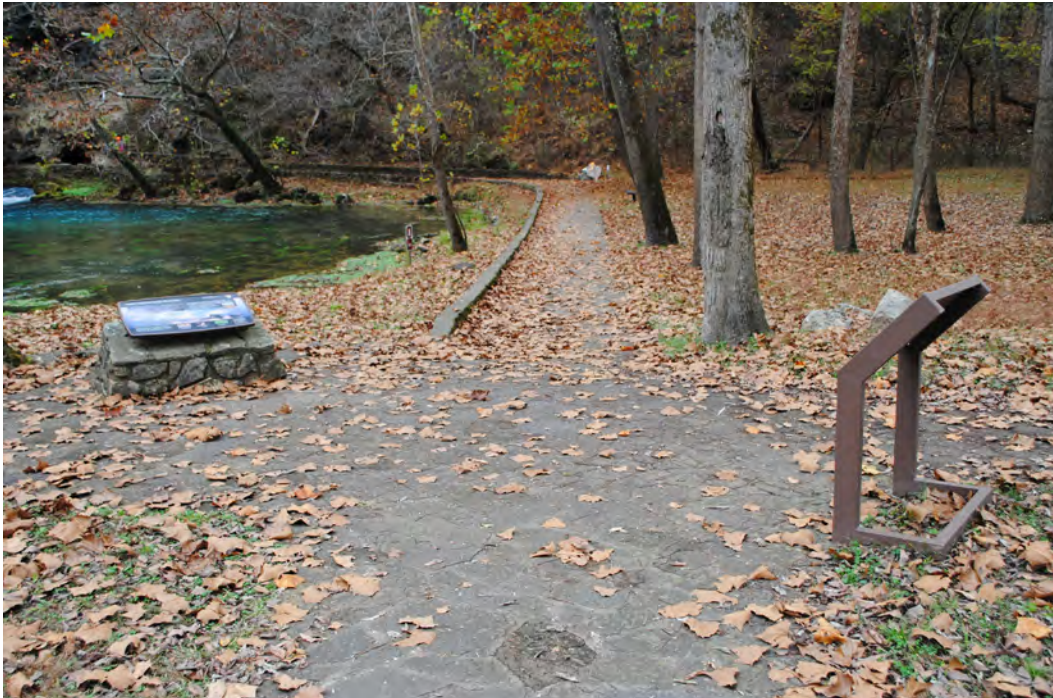
Figure 3-144. The stone interpretive pedestal at left, circa 1970s, is still in use with its contemporary interpretive panel. Interpretive panels, at right, occur throughout the area. The low stone wall and flagstone walk were added circa 1970. (Mundus Bishop 2015)

| SMALL SCALE FEATURES | | | |
|---|--|---|---|
| Stone Wall (after 1950) | Mortared native stone retaining wall and guard rail wall, with flat stone cap, Rustic style. Height of walls vary from 12" to 36". Drain blockouts allow storm water to flow off of trail into Big Spring. Areas along the water side of the wall are being undermined by erosion. | Fair | Contributing |
| Stone Interpretive Pedestal (after 1950) | Small, mortared native stone interpretive pedestal, with sloping top. Contemporary interpretive panel mounted to top of pedestal. Size is approximately 48" x 28" x 12'-18". There are two identical pedestals, one located at 'circle' area of Big Spring Trail and one located at 'elbow' of Big Spring Trail. | Good | Contributing |

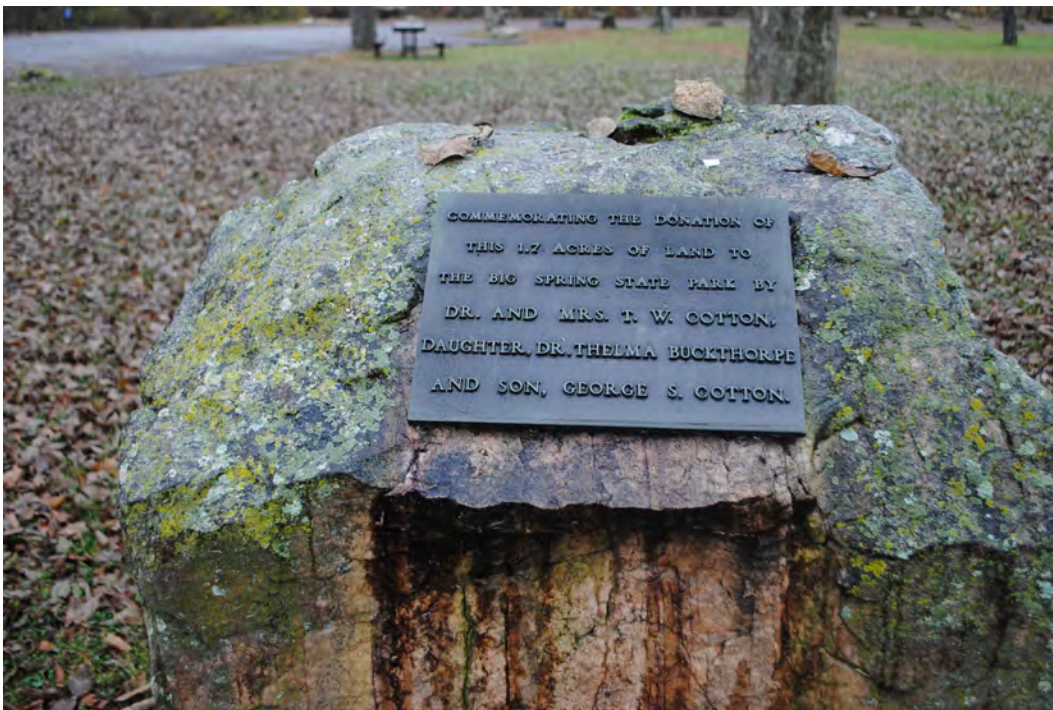
Figure 3-145. The Cotton Plaque (HS-472) honors the donation of land by the Dr. T. W. Cotton family. (Mundus Bishop 2015)

| SMALL SCALE FEATURES | | | |
|---|---|---|---|
| Cotton Plaque (HS-472) | Large native stone boulder with bronze plaque, reads as follows: 'COMMEMORATING THE DONATION OF THIS 1.7 ACRES OF LAND TO THE BIG SPRING STATE PARK BY DR. AND MRS. T.W. COTTON, DAUGHTER, DR. THELMA BUCKTHORPE AND SON, GEORGE S. COTTON' | Good | Contributing |

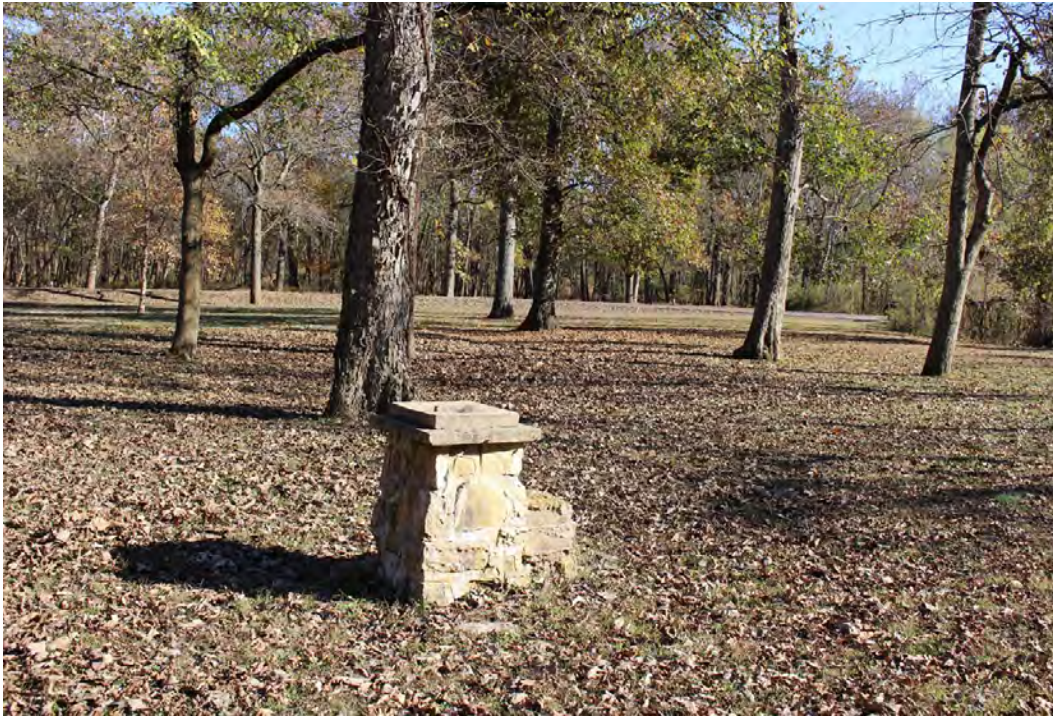
Figure 3-146. Stone drinking Fountain #1 (HS-712) near the Big Spring Pavilion (HS-425). (Mundus Bishop 2015)

| SMALL SCALE FEATURES | | | |
|---|---|---|---|
| Fountain #1 (HS-712) (1934-1937) | CCC built drinking fountains are rough cut stones of a heavy design in the Rustic style, each with a stone step attached and a concrete basin set on a stone pad. Fountain #1 is near the Big Spring Pavilion (HS-425). | Good | Contributing |

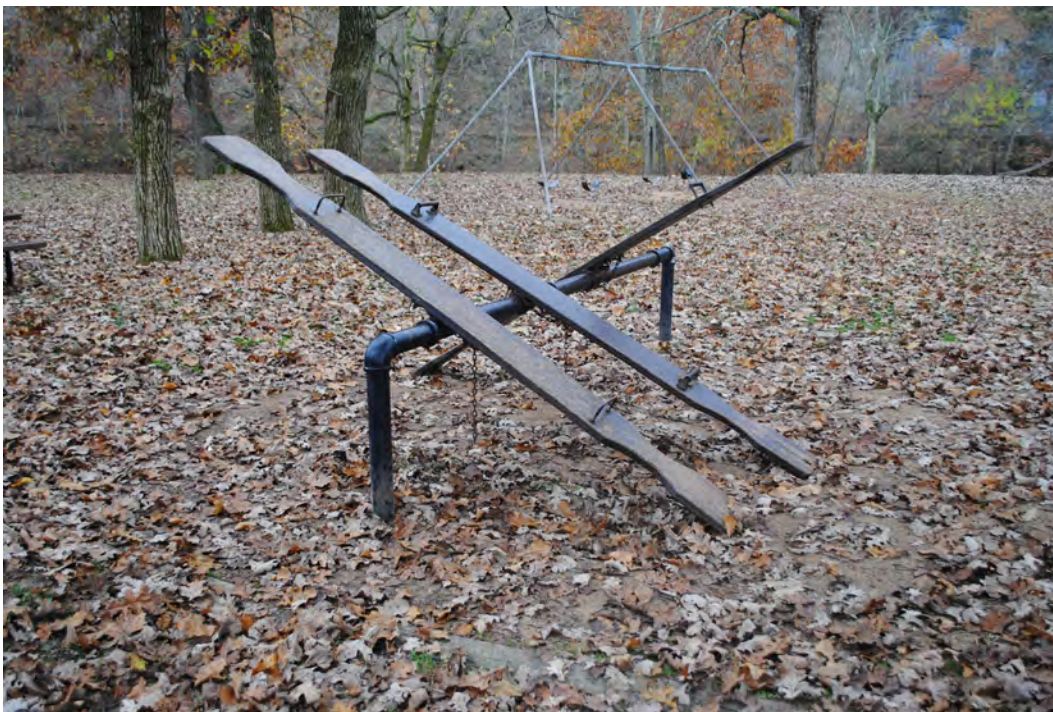
Figure 3-147. The playground equipment dates from the 1960s, and while in good condition, it does not meet contemporary safety standards. (Mundus Bishop 2015)

| SMALL SCALE FEATURES | | | |
|---|--|---|---|
| Play Equipment (1960s) | Galvanized play equipment - slides, swings and jungle gym | Fair | Non-contributing |

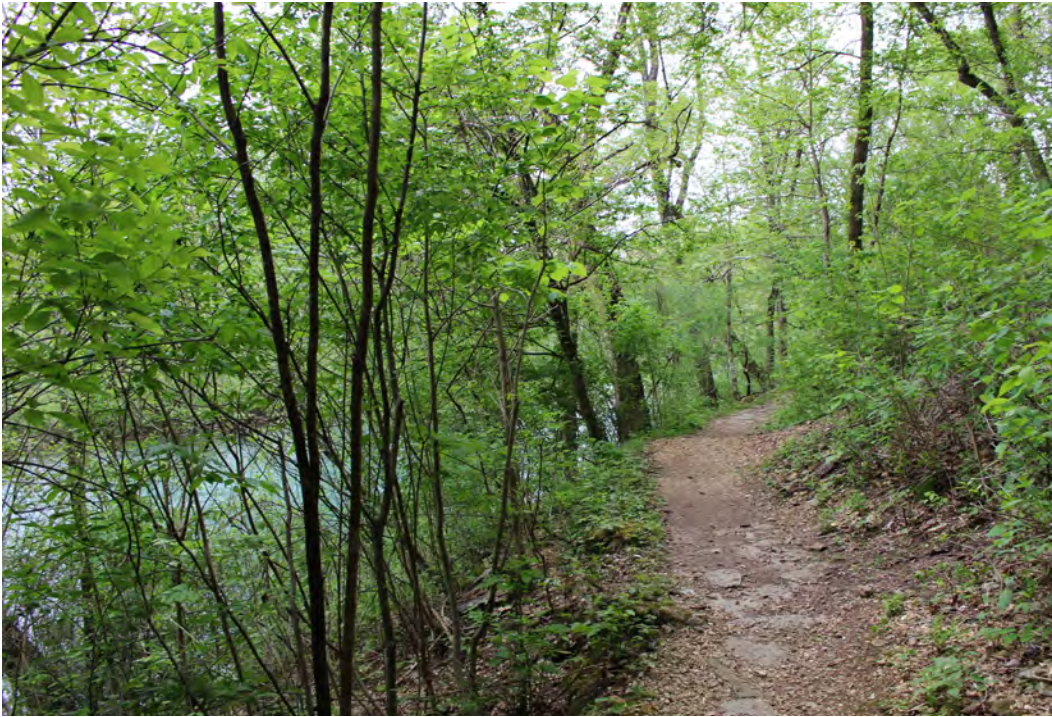
Figure 3-148. The vegetation in the Big Spring character area includes riparian shrubs along the bank of Big Spring branch. Historically, the CCC had cleared much of this vegetation to provide a view of the water from the trail. (Mundus Bishop 2016)

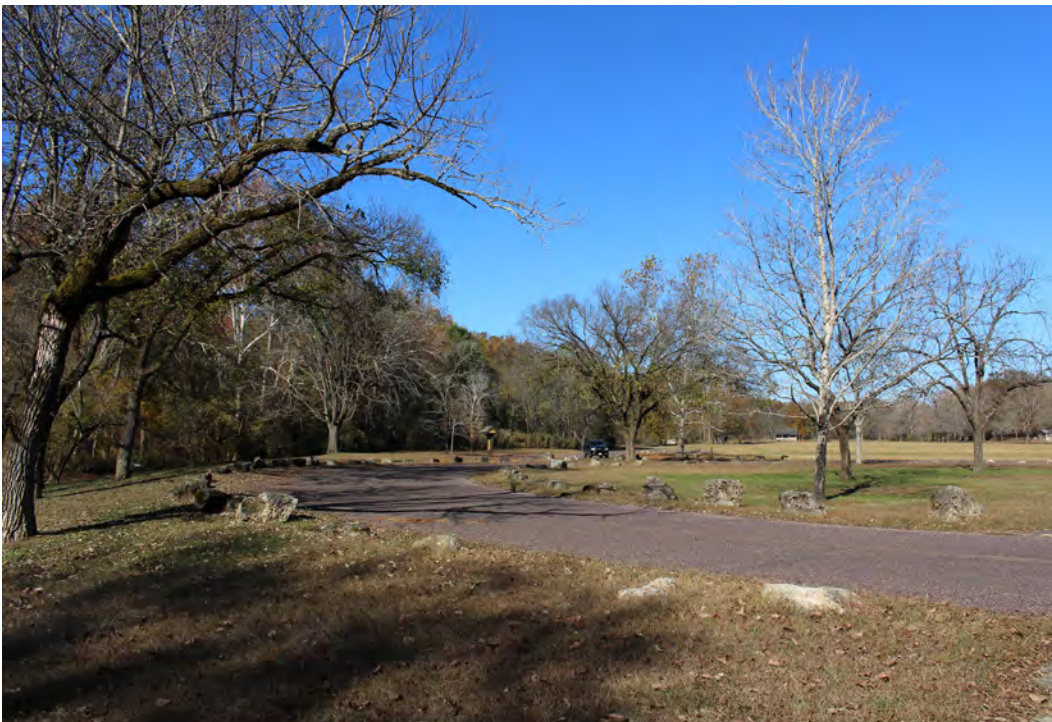
Figure 3-149. Big Spring has a park-like setting, characterized by a maintained lawn with groupings of mature shade trees. (Mundus Bishop 2015)

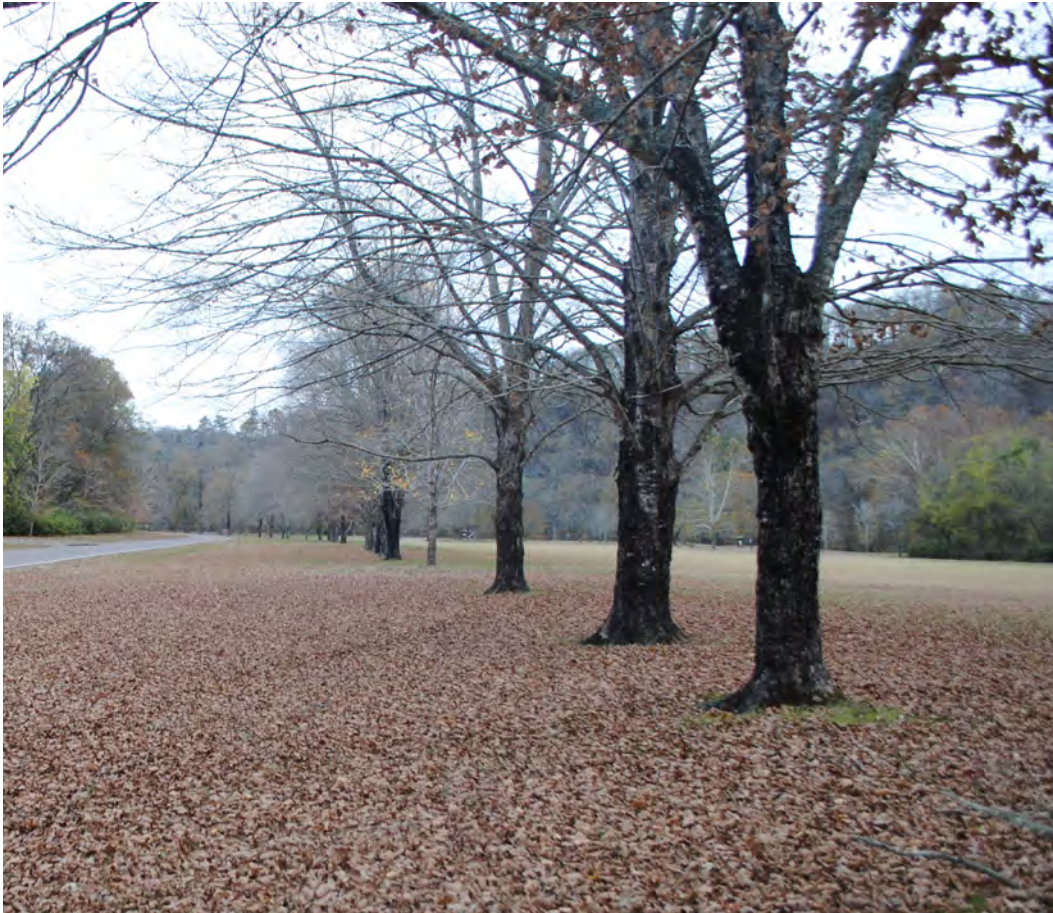
Figure 3-150. A single row of maples lines Peavine Road on the eastern edge of the field.
(Mundus Bishop 2015)

| VEGETATION | | | |
|---|---|---|---|
| Maple Trees (c 1970) | Single row of maple trees planted 20'-25' on center, 30' off edge of road, lining the playfield area, and defining the eastern edge of the playfield. | Good | Non-contributing |
