Core Development Character Area

1 Introduction

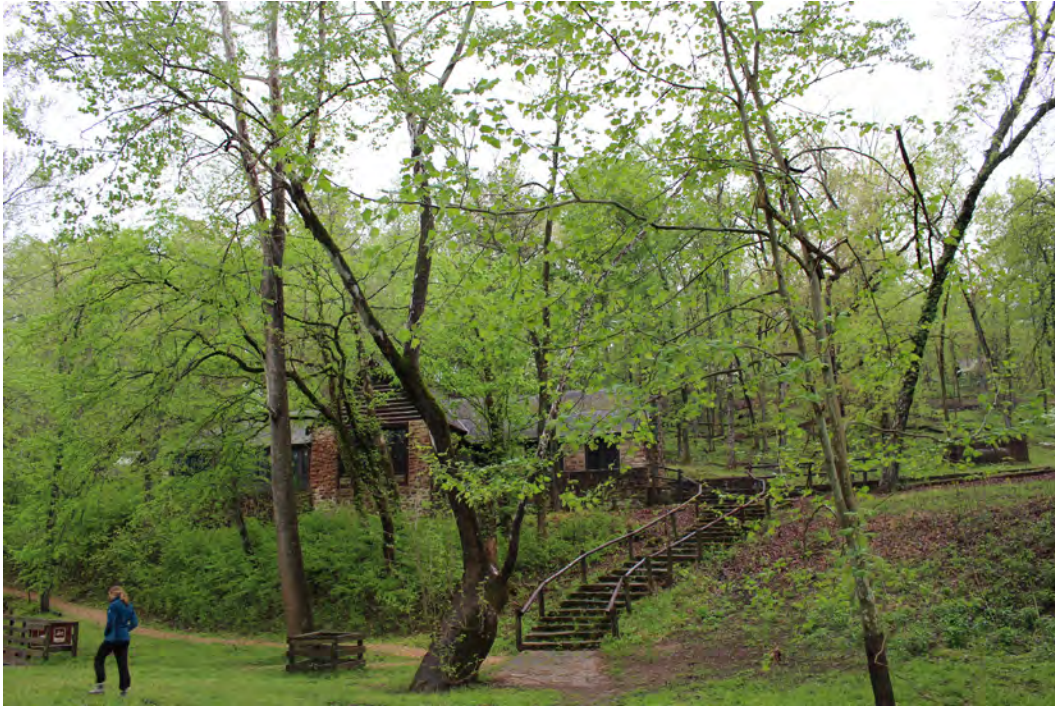
Figure 3-36. The Dining Lodge (HS-422) was sited to be prominent and visible from the river below. (Mundus Bishop 2016)

1 relationship to the playfield, and the cluster
 2 of cabins set into the steeply sloping hillside.
 3 The main visitor facilities, the Museum and
 4 Dining Lodge and structures were sited to be
 5 prominent and visible—from the entrance
 6 drive for the Museum, and from the Current
 7 River for the Dining Lodge. Clustering the
 8 cabins on the southern hillside created a
 9 distinct separation between uses and afforded
 10 views, while providing privacy.

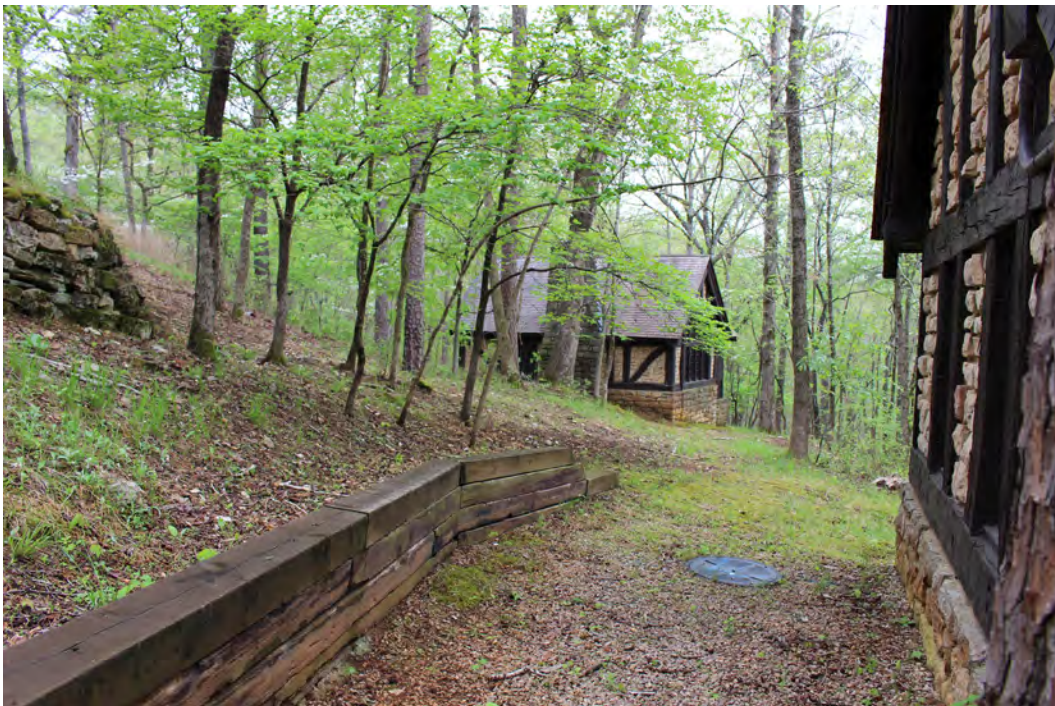
Figure 3-37. The cabins are clustered on the southern hillside, creating a separation between private and public spaces, while also providing views. (Mundus Bishop 2016)

1 (HS-422) at the far eastern end, overlooking
 2 the Current River, completes the arrival
 3 experience. Fifteen cabins are nestled into
 4 the southern hillside overlooking the valley,
 5 the playfield and the Current River. All were
 6 sited and designed to purposefully to blend
 7 with the natural landscape and afford views
 8 into the forest. Thirteen are set into the north
 9 facing hillside or along the ridge line, with
 10 two on the southern facing hillside. Chubb
 11 Hollow sits at the bottom of this southern
 12 hillside on a low ridge within Chubb Hollow.

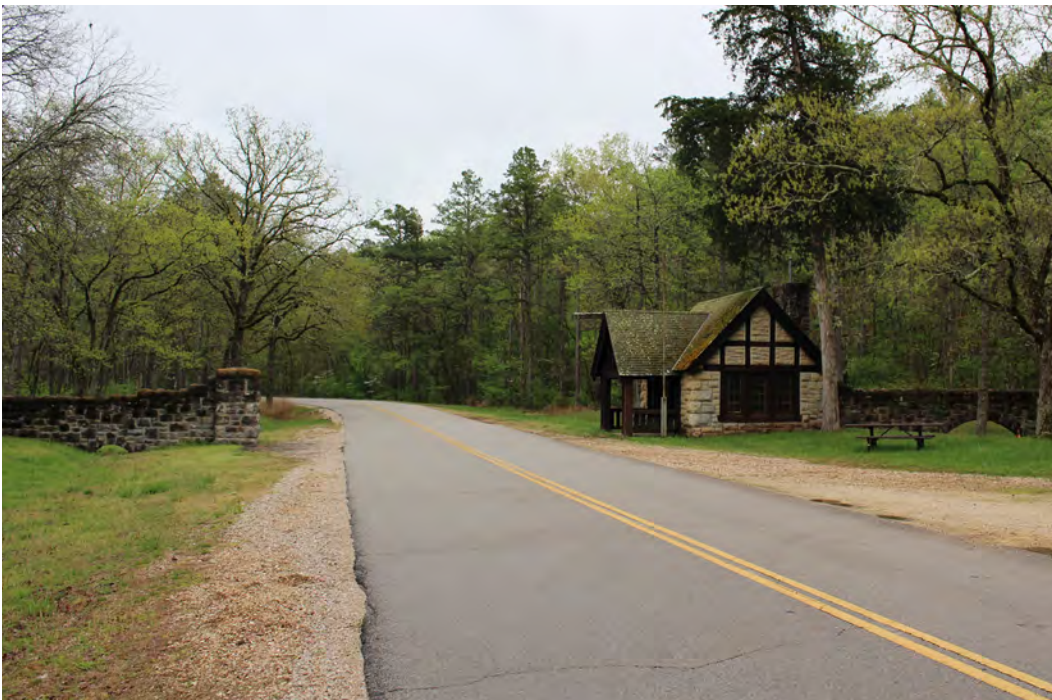
Figure 3-39. The Entrance Building (HS-432) is set at the center of a level open space that creates a stunning threshold and arrival experience into the study area. (Mundus Bishop 2016)

13
14 At the west edge, the siting of the Entrance
15 Building (HS-432) and Entrance Portal Walls
16 (HS-432A) at the center of a level open space
17 creates a stunning threshold and arrival
18 experience into the study area. From this
19 point, the open space begins to broaden
20 slightly outward, affording a long view
21 towards the Museum (HS-420) to the east
22 with the Dining Lodge (HS-422) in the far
23 background. To the south, the Maintenance
24 Area is tucked into a sloping forested hillside,
25 sited and organized to minimize views
26 into maintenance operations. This broad,
27 level open space continues, extending to
28 the Current River where its eastern end
29 it becomes a mown grass playfield. The
30 Latrine (HS-423) anchors the northeastern
31 corner, set on a low hillside overlooking the
32 Current River and the playfield. Two clusters
33 of buildings define the southern edge, one
34 consisting of visitor facilities and the cabins
