## Chapter 3. Existing Condition and Landscape Analysis

1 This chapter presents the existing condition  
2 and analysis of integrity for the Big Spring  
3 Historic District cultural landscape.  
4 Photographs, existing condition matrices  
5 and plans, and illustrative analysis diagrams  
6 describe the BSHD through an assessment of  
7 landscape characteristics.

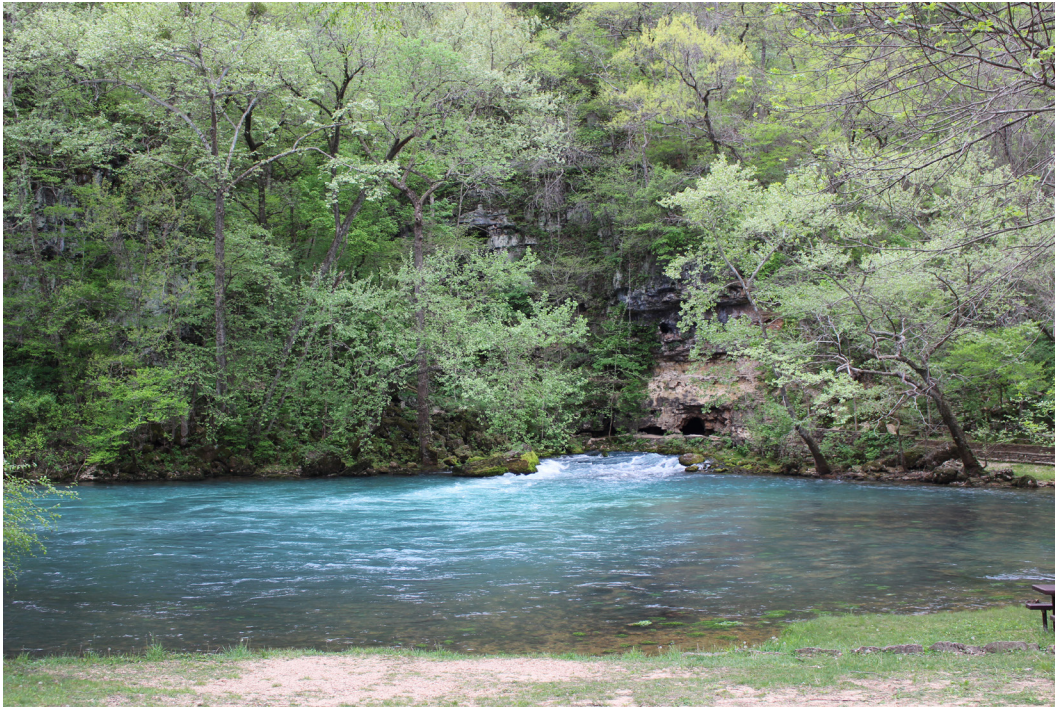
Figure 3-3. Big Spring is one of the largest single-conduit springs in the United States and one of the largest in the world. (Mundus Bishop 2016)

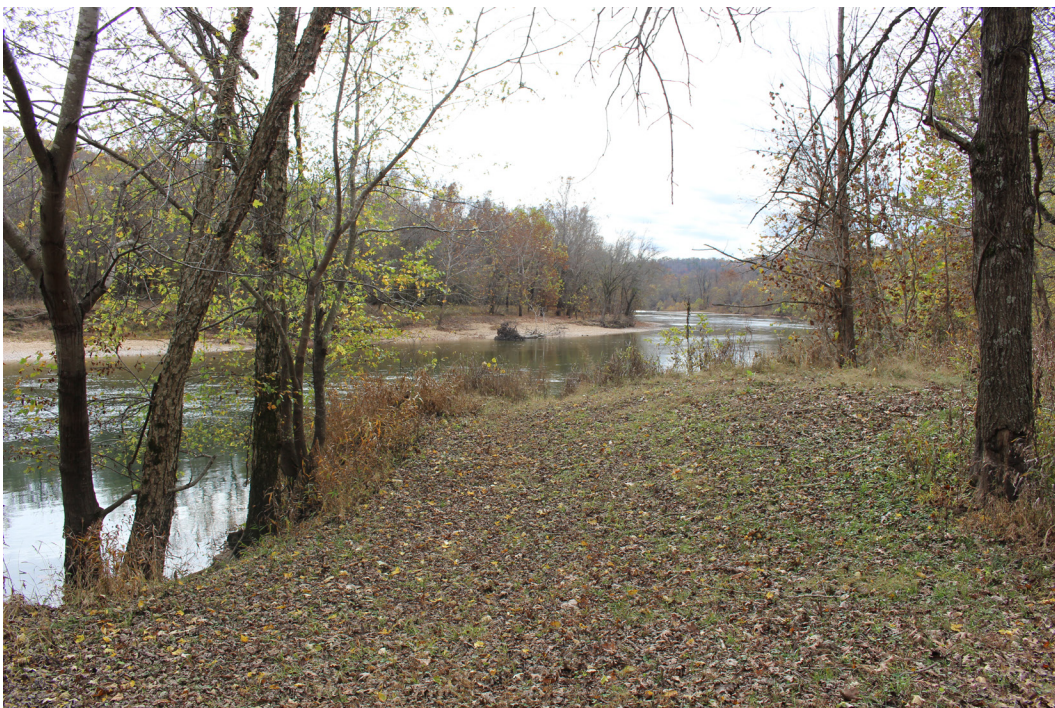
Figure 3-4. The Current River's floodplain is a diverse and dynamic environment due to the high frequency of flooding. (Mundus Bishop 2016)

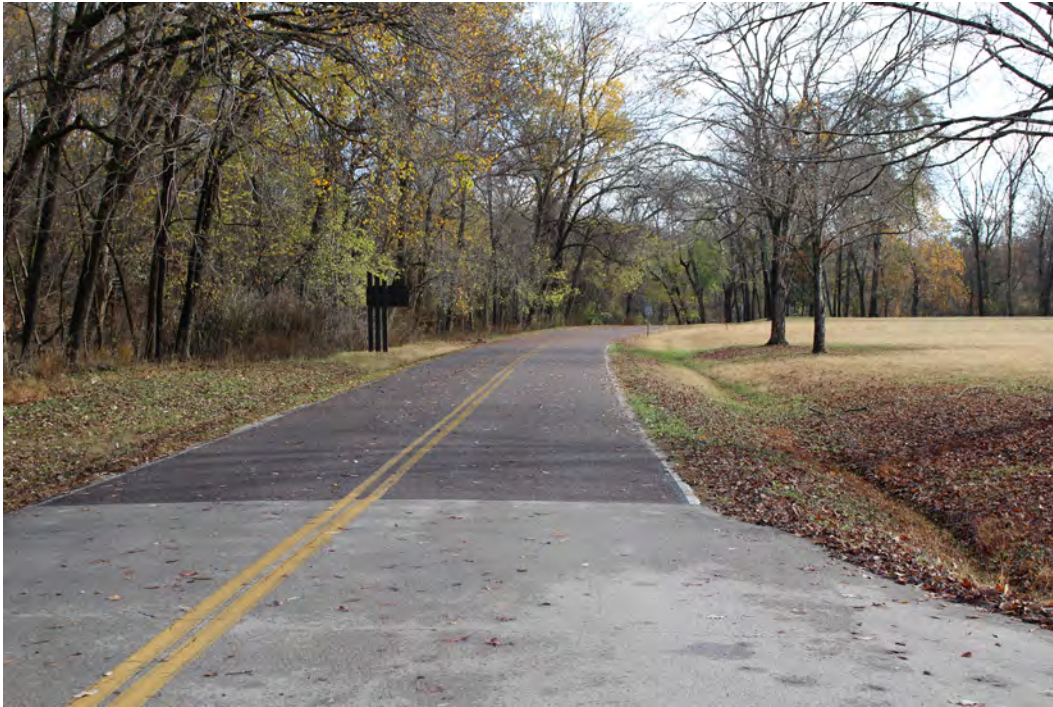
Figure 3-11. Peavine Road / Highway 103 is the main vehicular route and entrance to Big Spring State Historic District. It connects the core development area with Big Spring. (Mundus Bishop 2015)

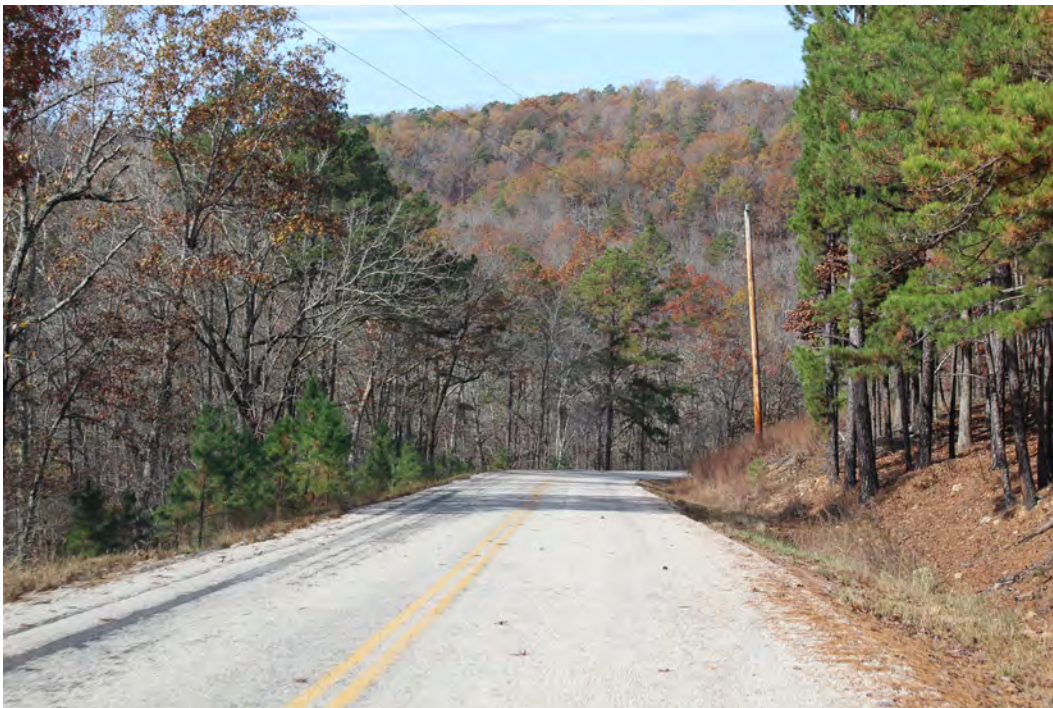
Figure 3-12. State Highway Z is the primary north south route through the study area, connecting the cabins to Chubb Hollow, the May / Winters Quarters (HS-444), and CCC Rock Quarry (HS-700). (Mundus Bishop 2015)

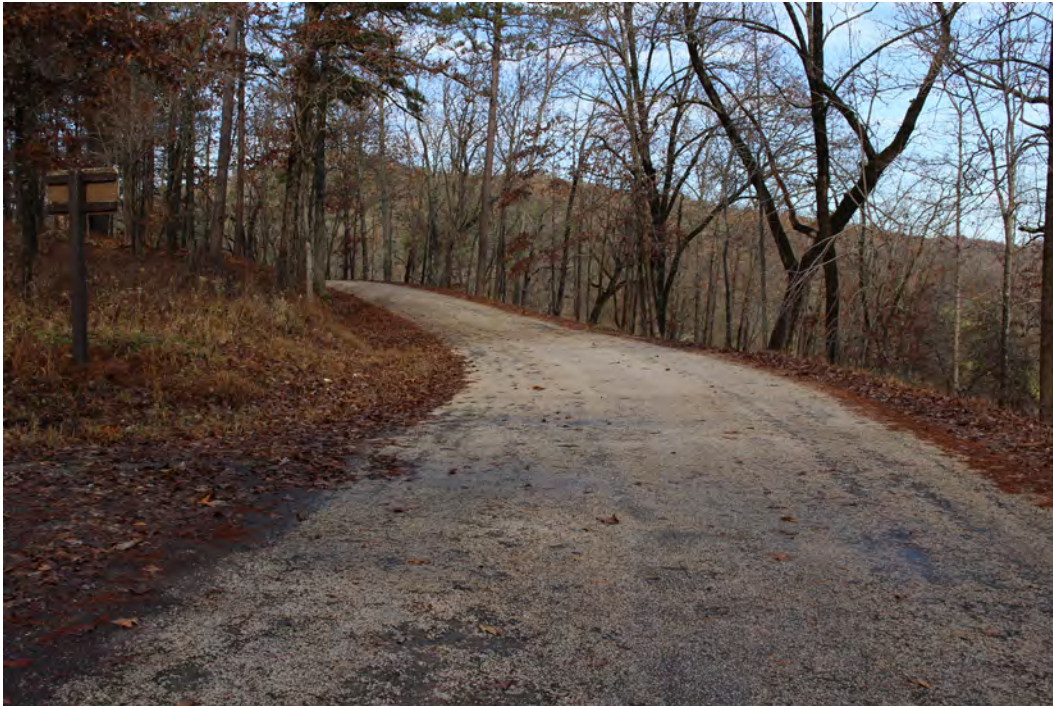
Figure 3-13. State Highway Z follows the natural topography of the rolling hillsides. (Mundus Bishop 2015)

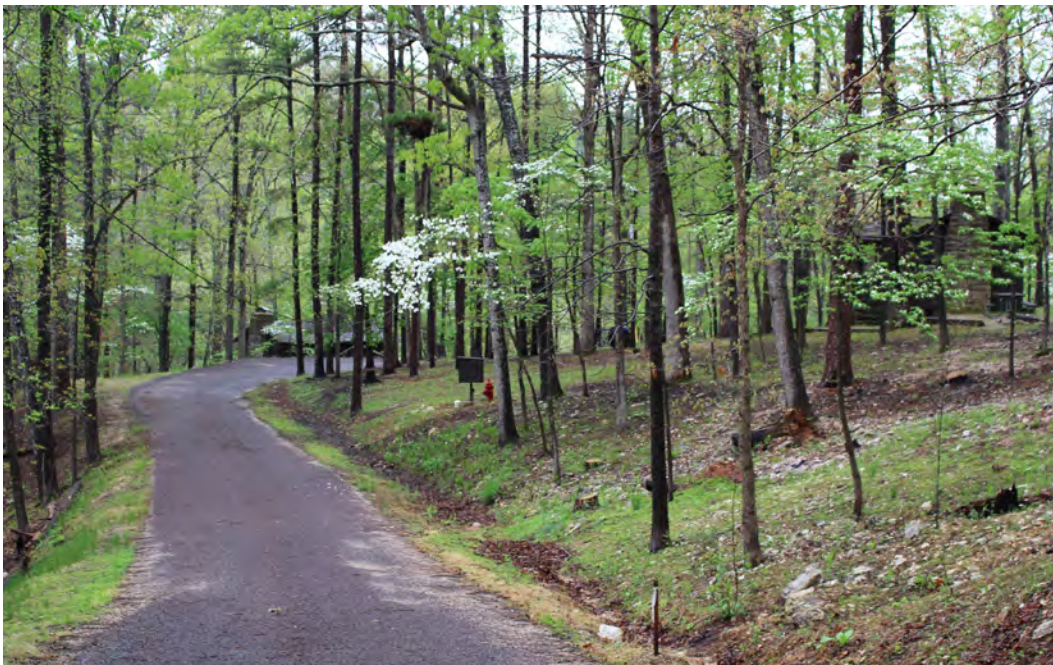
Figure 3-14. Most existing roads follow 1930s configurations and alignments. The road is adjacent to the cabins, above, has been modified with new parking pull-outs. (Mundus Bishop 2016)
