This Cultural Landscape Report (CLR) identifies characteristics and features that convey the historic significance and character of The Pictured Rocks National Lakeshore Historic District and provides a plan for the long-term preservation and stewardship of the landscape. The report provides park management with a comprehensive understanding of the physical evolution of the park's buildings, structures, roads, trails, and vegetation, and provides managers with guidance for care of these features. Treatment recommendations include repair of vegetation and views, improvements to trails and trailheads, provision of accessibility to key buildings and structures, and repair of small scale landscape features.

SAND POINT/MUNISING USCG LIFE SAVING STATION,  
PICTURED ROCKS NATIONAL LAKESHORE  
Cultural Landscape Report and Environmental Assessment

2017

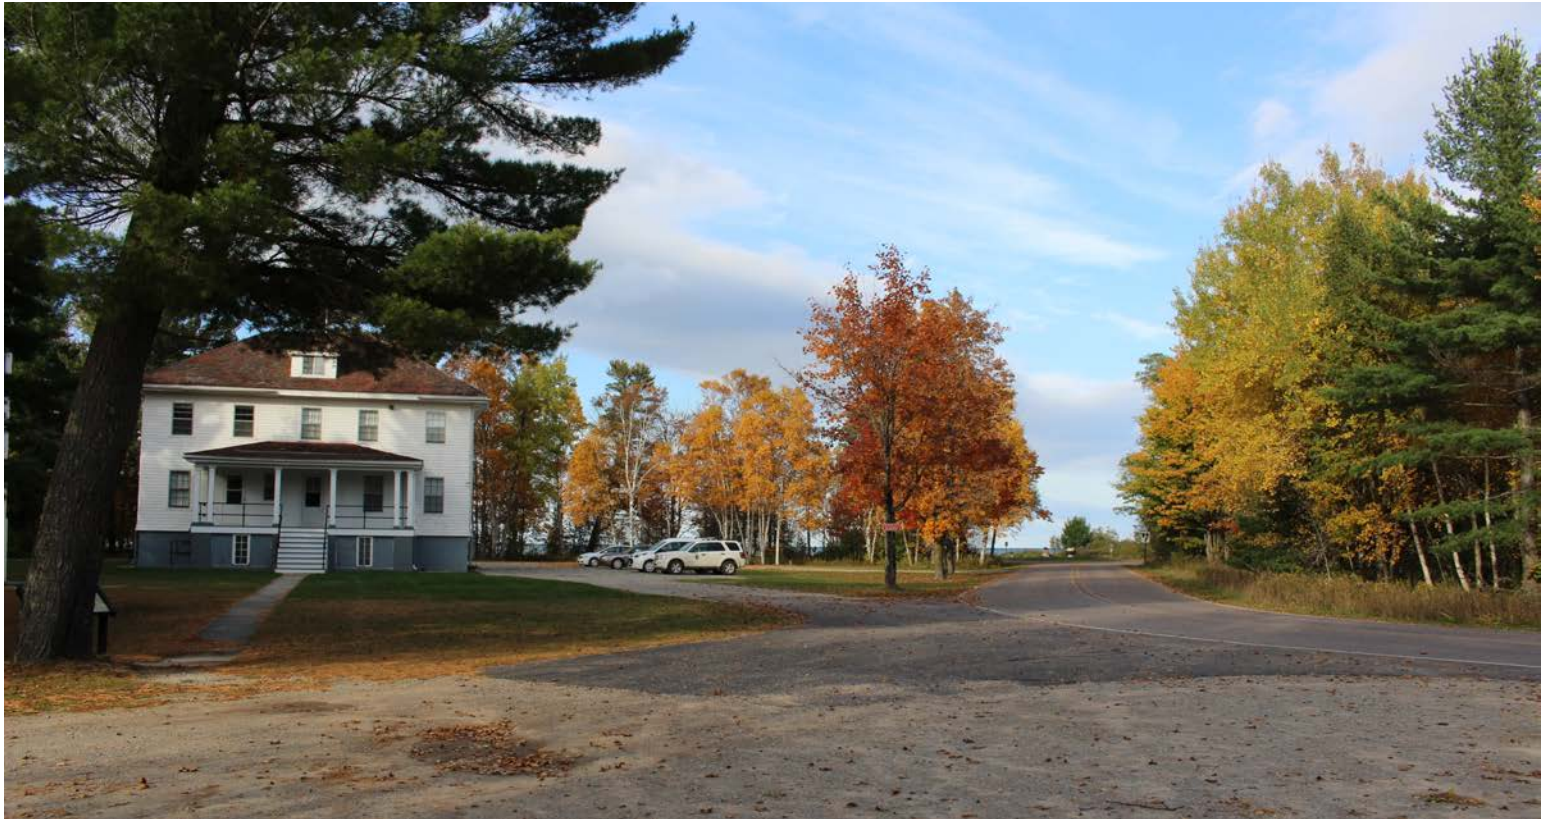
Figure 6-2. Existing Life Saving Station setting. (source: Mundus Bishop 2016)

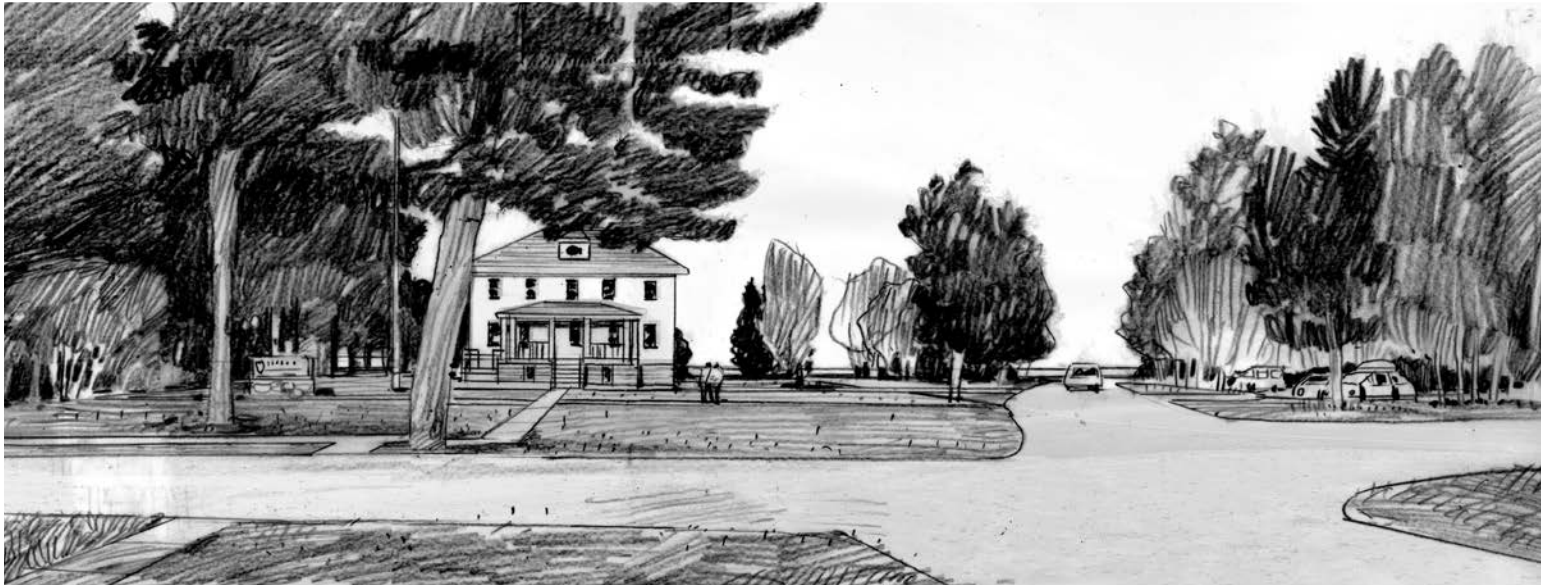
Figure 6-3. The formal military setting of the Life Saving Station will be rehabilitated, with short mown lawn, orthogonal walks, and raised plinth surrounded by a concrete curb that frames the building. Walks will be added or modified to meet access needs to the building and will connect to an expanded visitor parking area. (source: Mundus Bishop 2016)

- Contributing small scale features consist of a concrete edge and flagpole that date from the period of significance. The continuous curb that originally framed the rectangular space around the building may still be intact below grade. The restoration of this feature will reestablish the formal space around the building.

3. Repair the concrete curb around the Life Saving Station. Reveal the full extent and form of the curb to create the defined formal setting around the building.

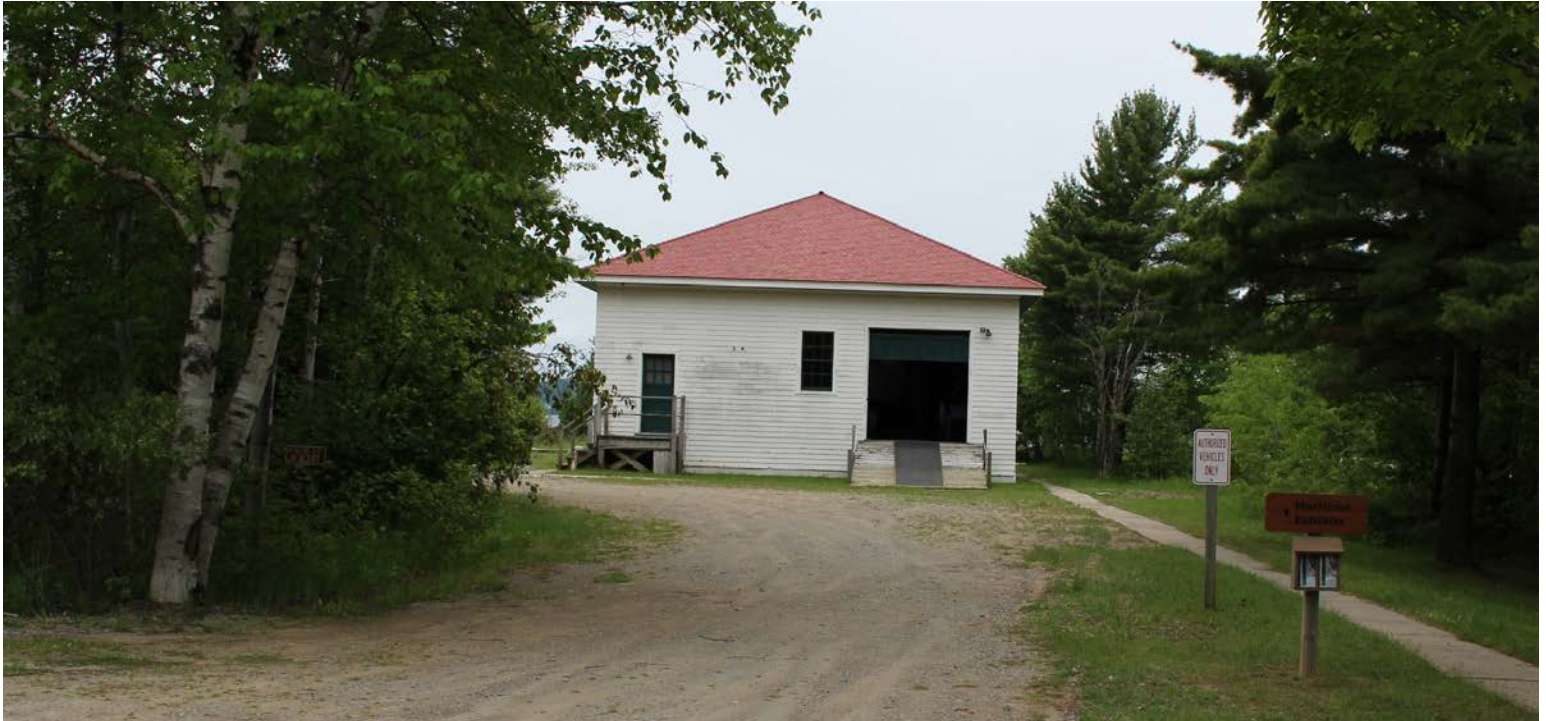
Figure 6-4. The Existing Boathouse setting. (source: Mundus Bishop 2016)

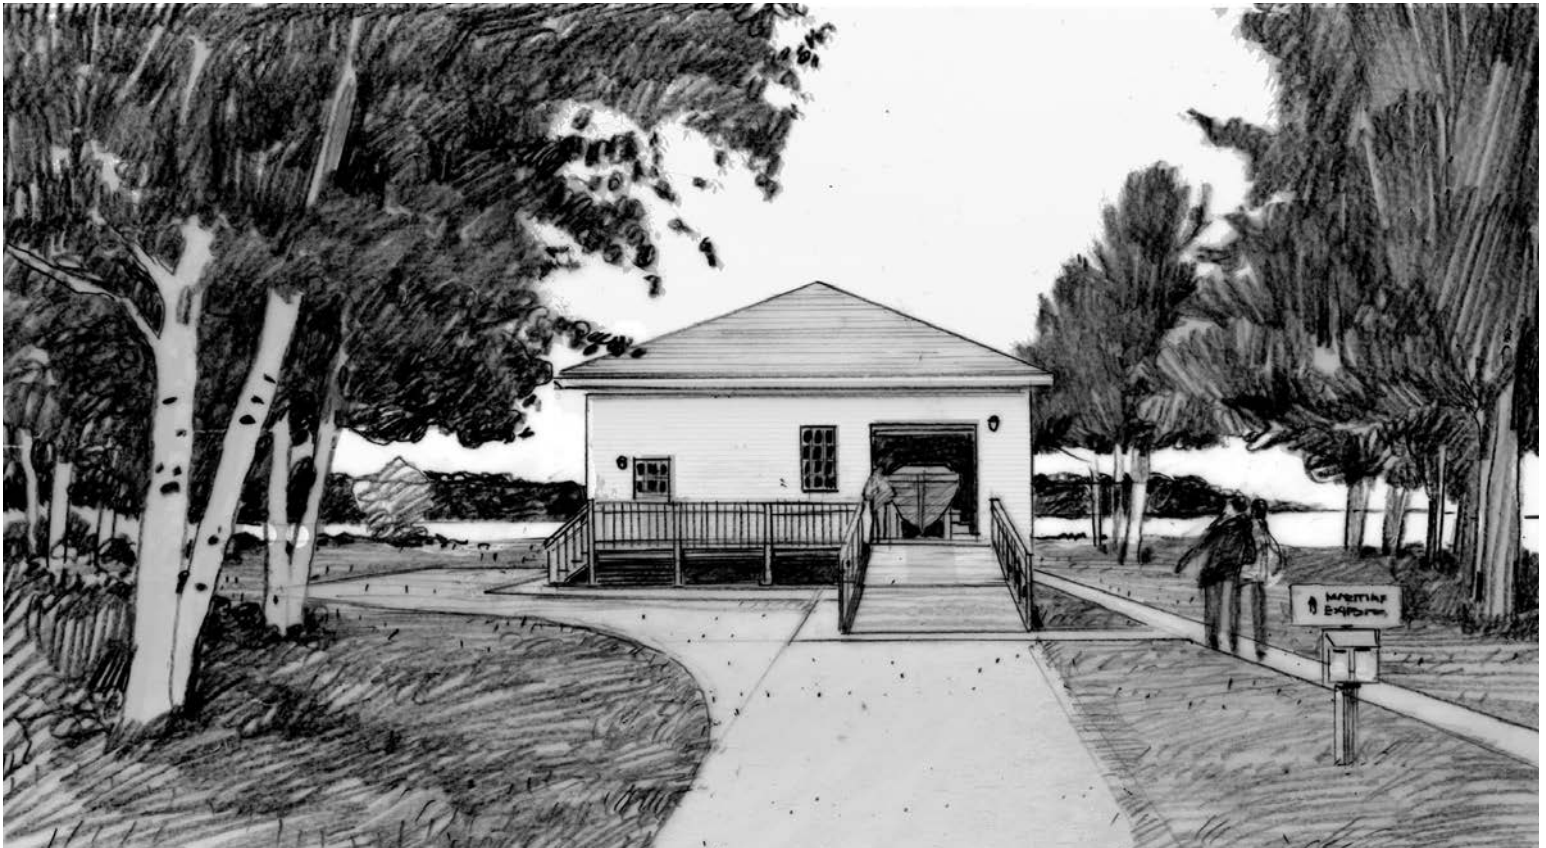
Figure 6-5. The Boathouse will be rehabilitated to provide universal access and interior restrooms. The adjacent setting will be repaired by thinning trees and establishing low growing native shrubs to maintain the visual connection to Lake Superior. (source: Mundus Bishop 2016)

4. Rehabilitate the Boathouse to provide ABA compliant and interior restrooms (Refer to HSR recommendations).
  - a. Provide a new ramp on the east side of the Boathouse for universal access.

- b. Add a landing and exterior connection to the man door to the south. This will also provide accessible access when the overhead door is closed by
