Figure 2  
 Study Areas  
 Catoclin  
 NPS/NCR Wetland Restoration Action Plan  
 Maryland

Figure 6a  
 CATO-01  
 Catocin  
 NPS/NCR Wetland Restoration Action Plan  
 Frederick, Maryland

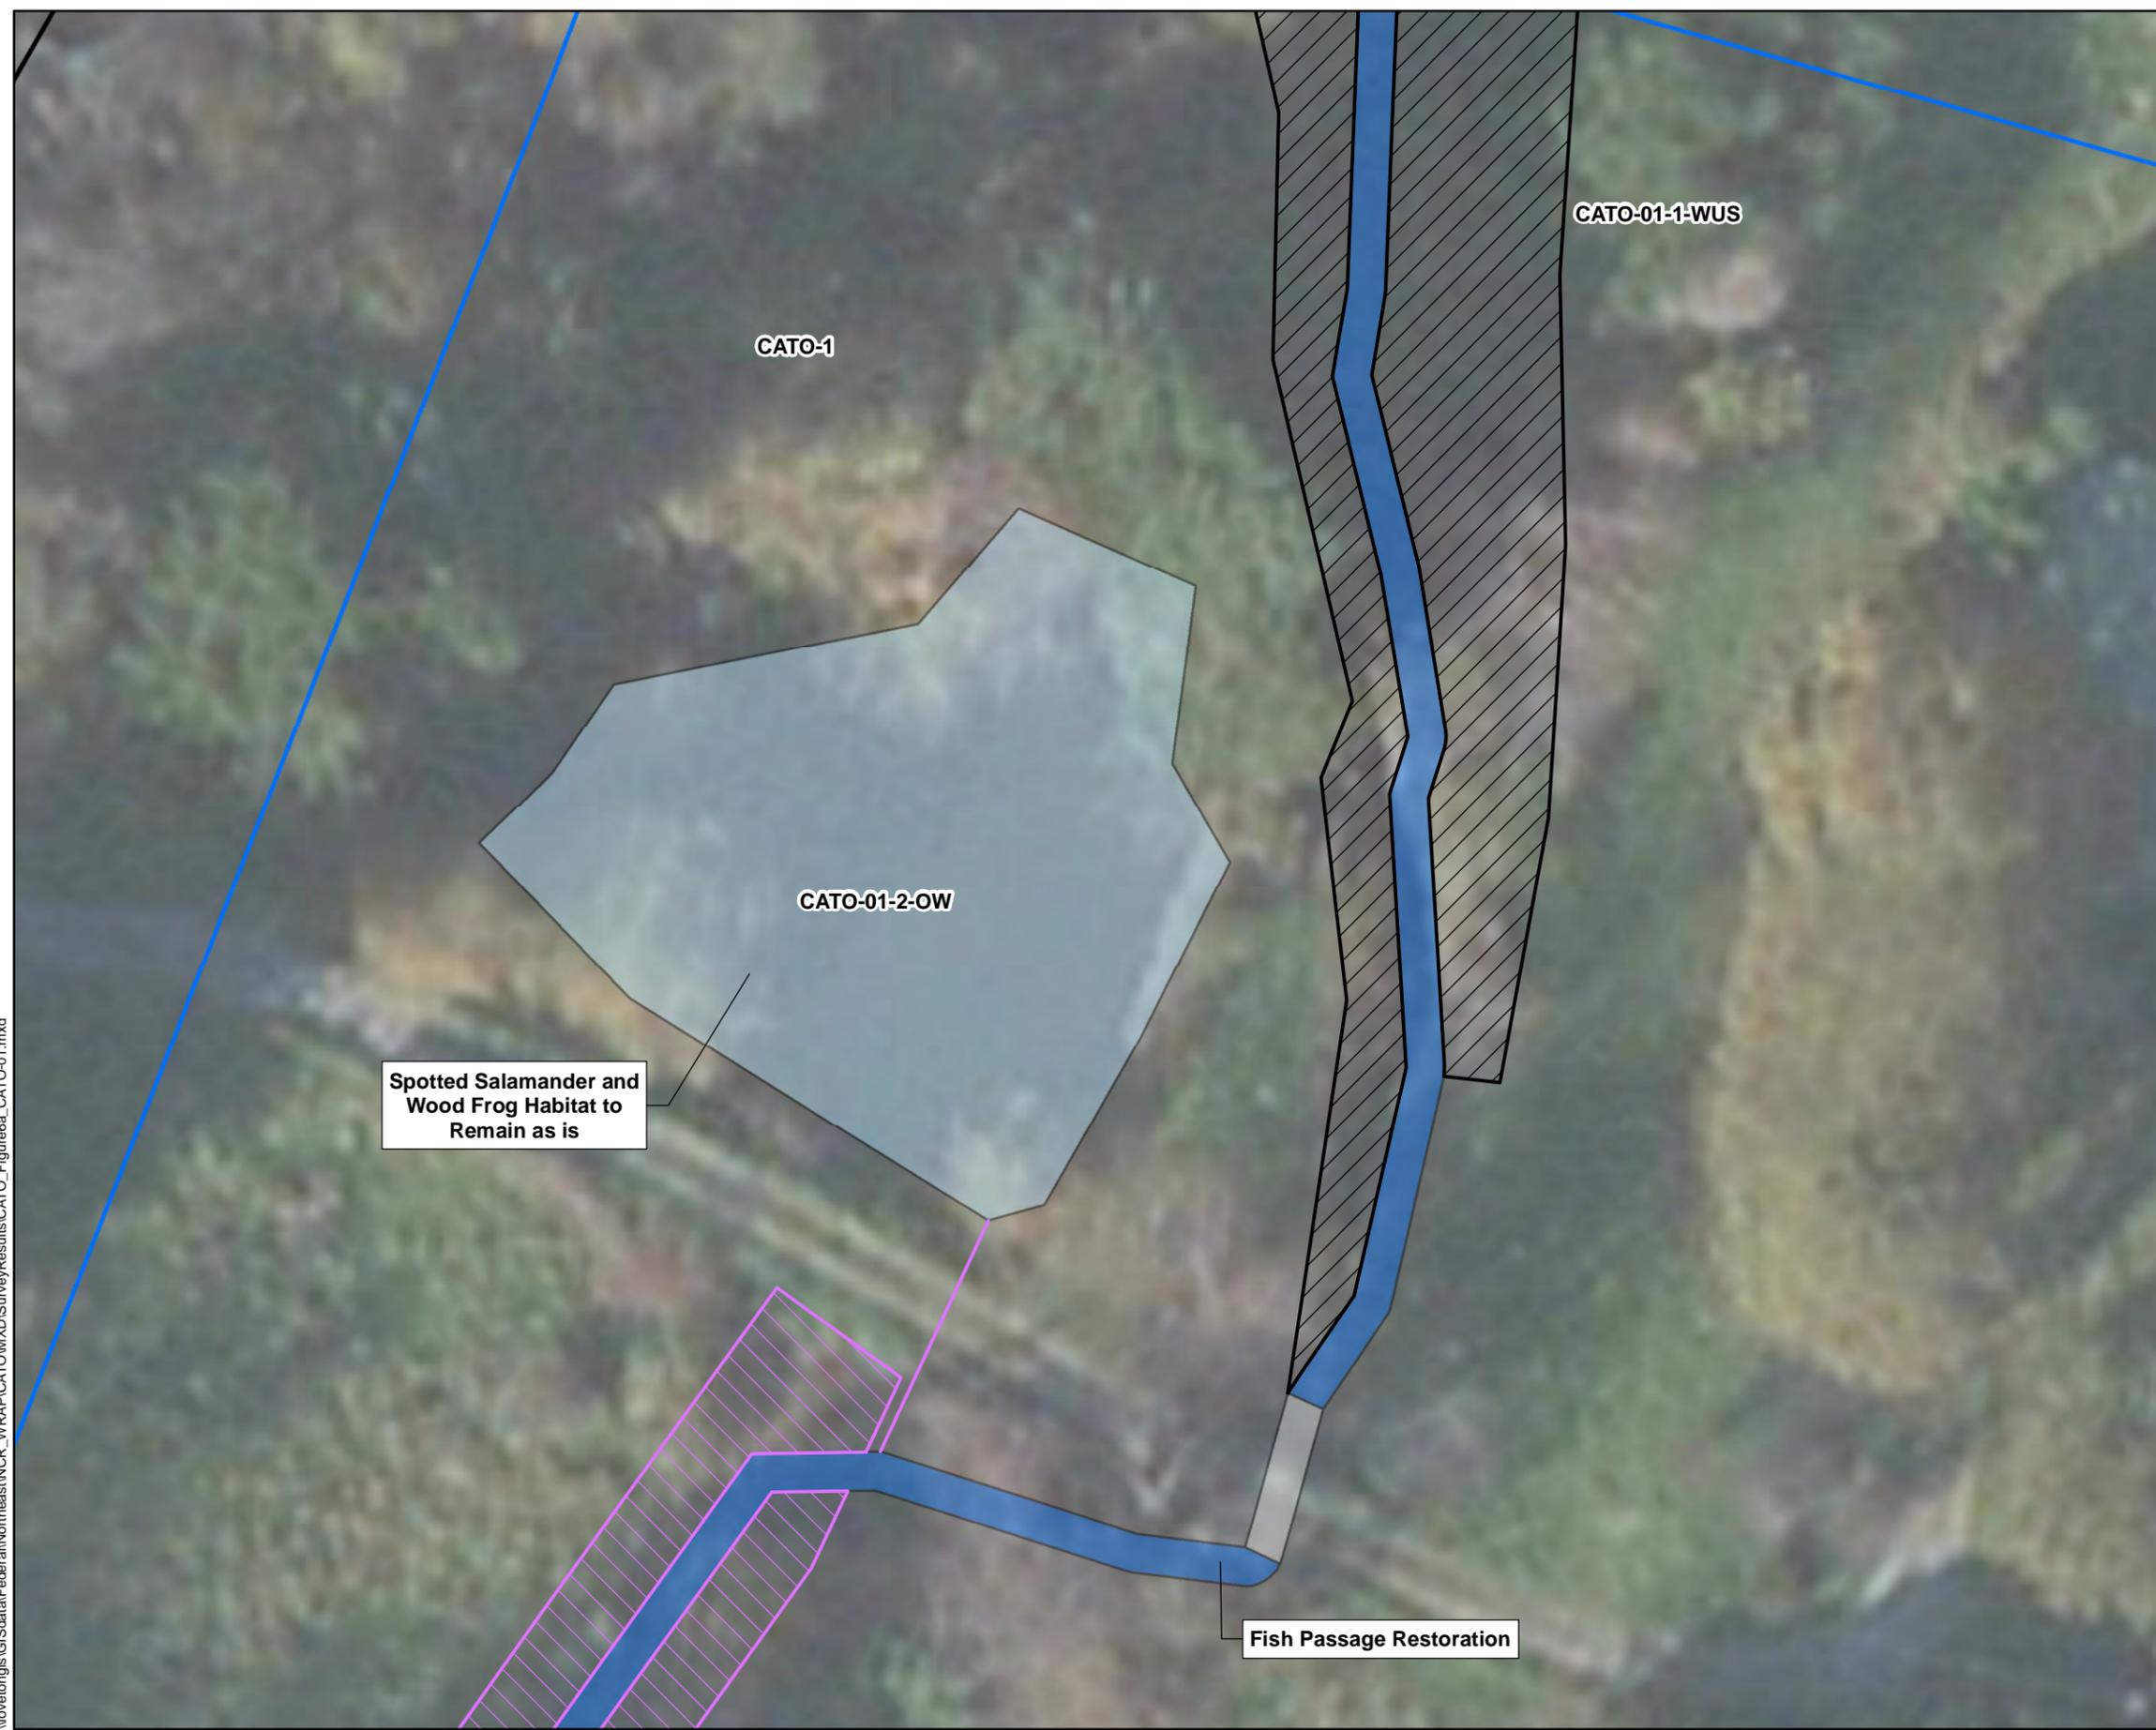
Small channel appears to have been diverted from natural flow around the pond embankment and through a culvert beneath the driveway causing minor bank erosion and fish passage issues. Lack of riparian buffer below the existing driveway.

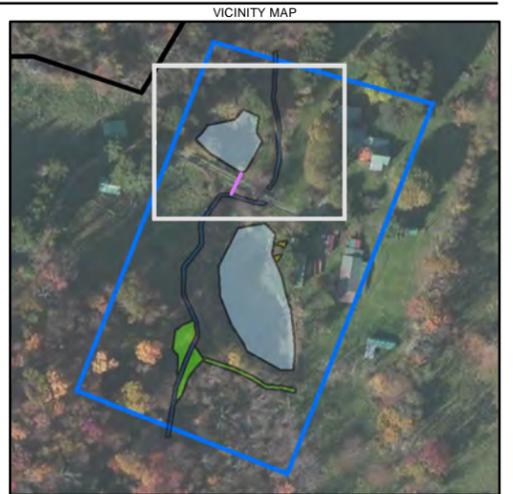
<b><u>Site ID</u></b>	<b>CATO-1</b>
<u>Potential Restoration Area (Acres)</u>	0.00
<u>Date of Field Assessment</u>	3/21/16
<u>Existing Land Use</u>	old field/home stead
 <u>Adjacent Land Use</u>	 old field/home stead/park
 <u>Distance to Nearest Road</u>	 adjacent
<u>RTE Species Present?</u>	No
<u>Known Cultural Concern?</u>	Yes
<u>Stream Restoration Opportunity?</u>	Yes
<u>Site Currently Wetland?</u>	Yes
<u>Site Formerly Wetland?</u>	Yes
<u>Evidence of Disturbance</u>	Yes
<u>Soils Score</u>	9
<u>Hydrology Score</u>	9
<u>Existing Vegetation Score</u>	8
<u>Geomorphic Score</u>	9
<u>Surrounding Land Use Score</u>	7
<u>Function and Value Score</u>	7
<u>Presence of Invasive Species Score</u>	7
<u>Site Disturbance Score</u>	6
<u>Ease of Access Score</u>	9
<u>Stormwater Influence Score</u>	9
<u>Total Score</u>	80
<u>Invasive Species Control?</u>	Yes
<u>Native Plantings?</u>	Yes
<u>Restore Hydrology?</u>	Yes
<u>Increase Diversity?</u>	Yes

<u>Convert Open Water to Vegetated?</u>	Yes
<u>Convert Emergent to Shrub/Forested</u>	No
<u>Increase Asthetic or Educational Value</u>	No
<u>Other</u>	No
 <u>Notes</u>	 Groundwater seep feeding pond, berm separates from stream hydric soils within seep groundwater seep on NE edge. Pond overflows to stream through verticle pipe open water, trees and shrubs along border. Water level could be lowered and planted to increase habitat and diversity, improve connection to stream. Barberry and multiflora rose along edge culvert and berm continue to alter stream flow, however no new alteration gravel road off main road crosses stream.

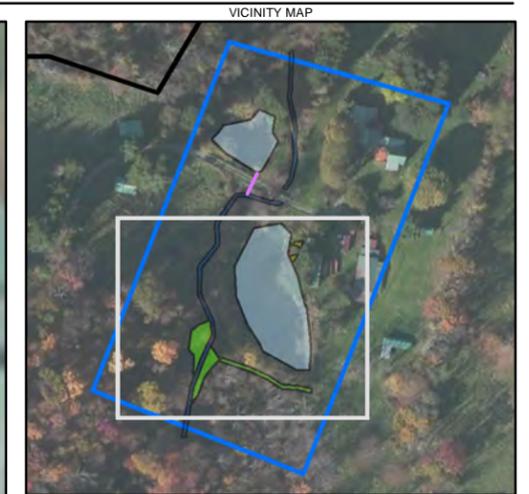
Figure 6b  
 CATO-01  
 Catoctin  
 NPS/NCR Wetland Restoration Action Plan  
 Frederick, Maryland

<u>Site ID</u>	<u>CATO-1</u>
<u>Potential Restoration (linear feet)</u>	100
<u>Date</u>	3/21/16
<u>Existing Land Use</u>	old field
<u>Adjacent Land Use</u>	open field/forested
<u>Distance to Nearest Road</u>	0ft
<u>Stream Hydrology</u>	Perennial
<u>RTE Species Present?</u>	No
<u>Known Cultural Concern?</u>	Yes
<u>Wetland Restoration Opportunity?</u>	Yes
<u>Existing Wetlands Present</u>	Yes
<u>Evidence of Disturbance</u>	Yes
<u>Can Restoration be Completed in NPS Area?</u>	Yes
<u>Estimated Bank Erosion Score</u>	3
<u>Degree of Channel Incision Score</u>	1
<u>Existing Floodplain Access Score</u>	3
<u>Opportunity for Floodplain Development Score</u>	8
<u>Threat of Impact to Resources Score</u>	3
<u>Surrounding Vegetation Score</u>	5
<u>Land Use Score</u>	1
<u>Opportunity for Ecological Lift Score</u>	5
<u>Ease of Access</u>	10
<u>Surrounding Land Use Score</u>	5
<u>Total Score</u>	44
<u>Invasives Species Control?</u>	Yes

<u>Riparian Buffer Enhancement?</u>	Yes
<u>Restore Natural Hydrology?</u>	Yes
<u>Livestock Agricultural Exclusion</u>	No
<u>Fish Passage?</u>	Yes
<u>Channel Restoration?</u>	Yes

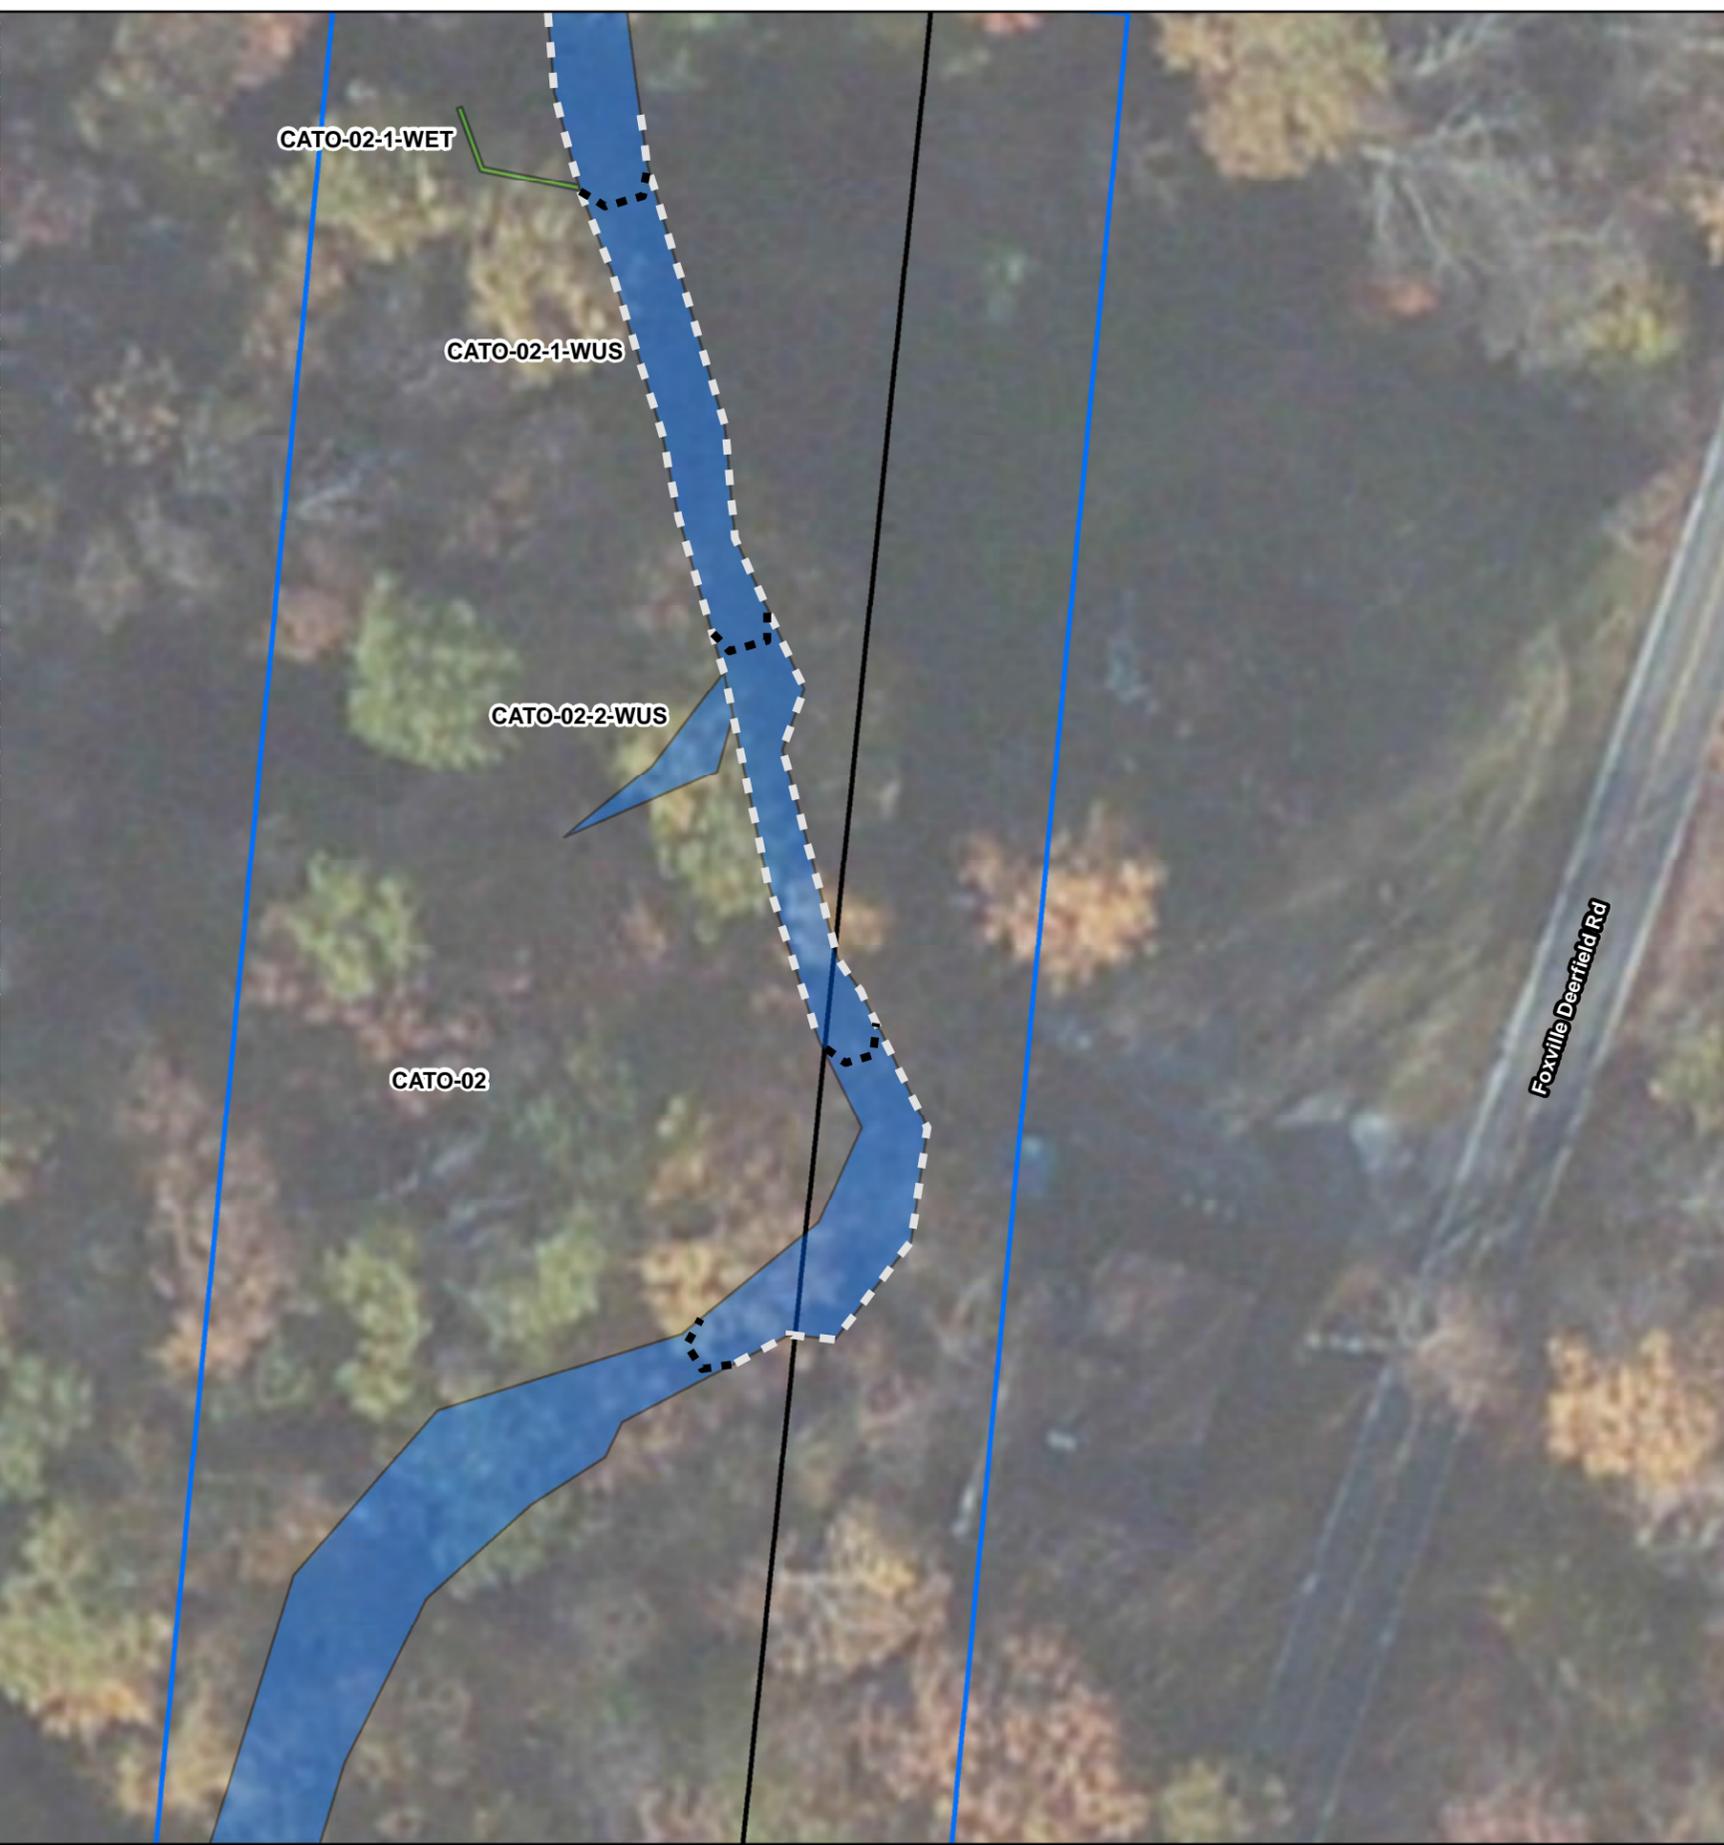
Figure 7  
CATO-02  
Catoctin  
NPS/NCR Wetland Restoration Action Plan  
Frederick, Maryland

<b>Other</b>	No
	Residential yard on right bank is eroded and lacking riparian buffer, needs stabilization. May be able to use existing boulders and rock for bank protection. Invasive control needed on banks.
<b>Notes</b>	Increased erosion on banks may impact stream quality and habitat. Mostly forested but some residential yard. Forest clearing or private property access required. Microstegium and barberry along right bank.

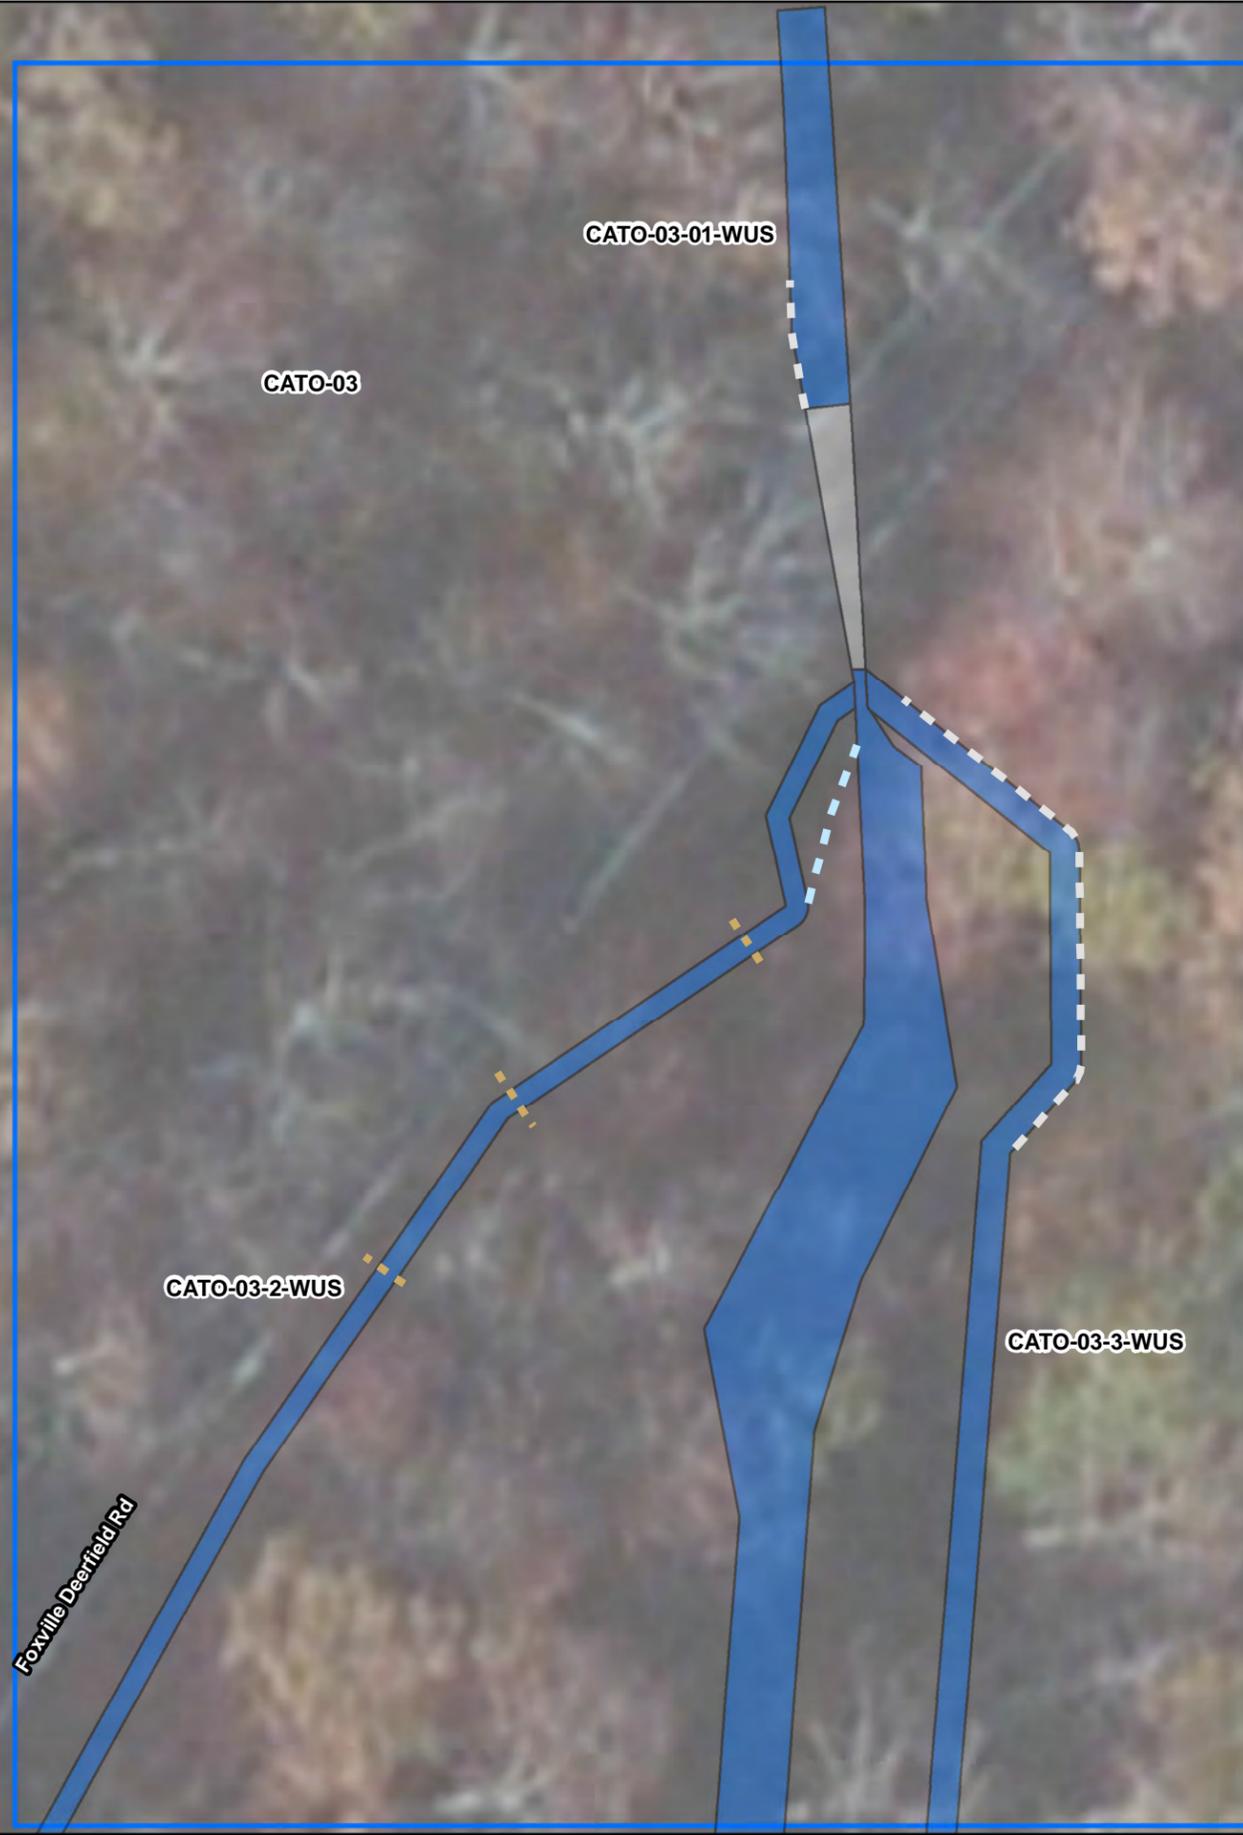
Figure 8  
 CATO-03  
 Catoctin  
 NPS/NCR Wetland Restoration Action Plan  
 Frederick, Maryland

<b>Other</b>	Yes
<b>Notes</b>	Stream at road crossing near Owens campground. Issues with stream alignment to culvert wing wall and eroding bank downstream. Protection of existing left stream bank downstream of culvert with Boulder placement. Also opportunity for larger rock check damn along roadside drainage to reduce gravel wash entering stream. Also opportunity to protect existing wing wall on left bank.

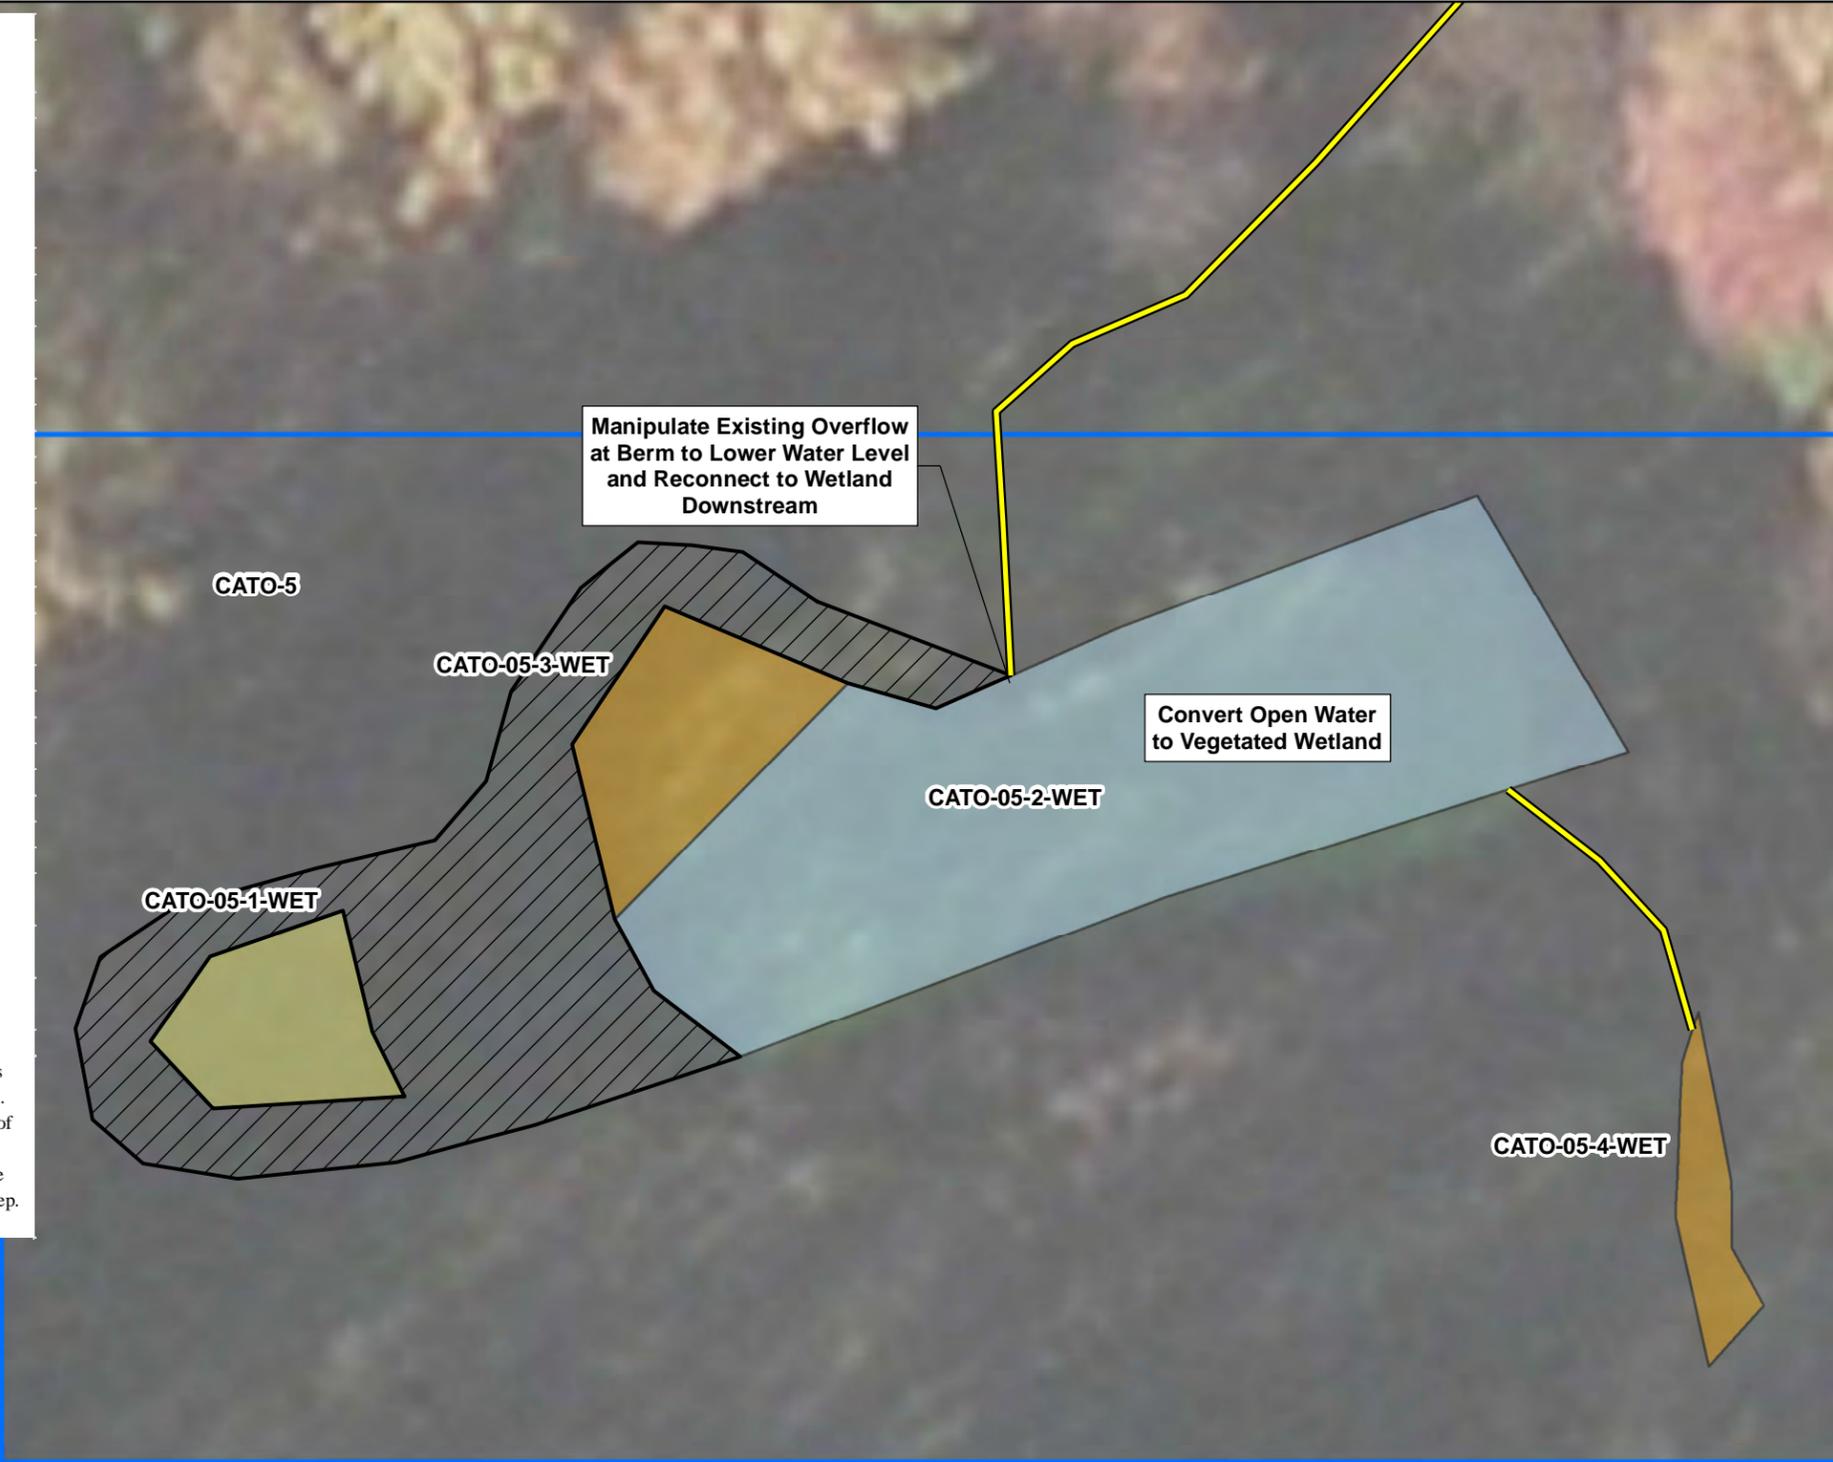
Figure 9  
 CATO-05  
 Catoctin  
 NPS/NCR Wetland Restoration Action Plan  
 Frederick, Maryland

<b>Site ID</b>	<b>CATO-5</b>
Potential Restoration Area (Acres)	0.01
Date of Field Assessment	3/21/16
Existing Land Use	old field/pond
Adjacent Land Use	forested
Distance to Nearest Road	50 ft
RTE Species Present?	No
Known Cultural Concern?	No
Stream Restoration Opportunity?	No
Site Currently Wetland?	Yes
Site Formerly Wetland?	Yes
Evidence of Disturbance	Yes
Soils Score	9
Hydrology Score	9
Existing Vegetation Score	7
Geomorphic Score	8
Surrounding Land Use Score	7
Function and Value Score	7
Presence of Invasive Species Score	6
Site Disturbance Score	6
Ease of Access Score	7
Stormwater Influence Score	7
Total Score	73
Invasive Species Control?	Yes
Native Plantings?	Yes
Restore Hydrology?	Yes
Increase Diversity?	Yes
Convert Open Water to Vegetated?	Yes
Convert Emergent to Shrub/Forested	No
Increase Aesthetic or Educational Value	Yes
Other	No
<b>Notes</b>	Groundwater seep feeding pond, berm separates from large forested wetland complex downslope. Water level could be lowered by deep notching of existing berm and reconnected downstream and planted to increase habitat and diversity, improve hydrological connection including the upslope seep. Some invasive species along the pond edge.

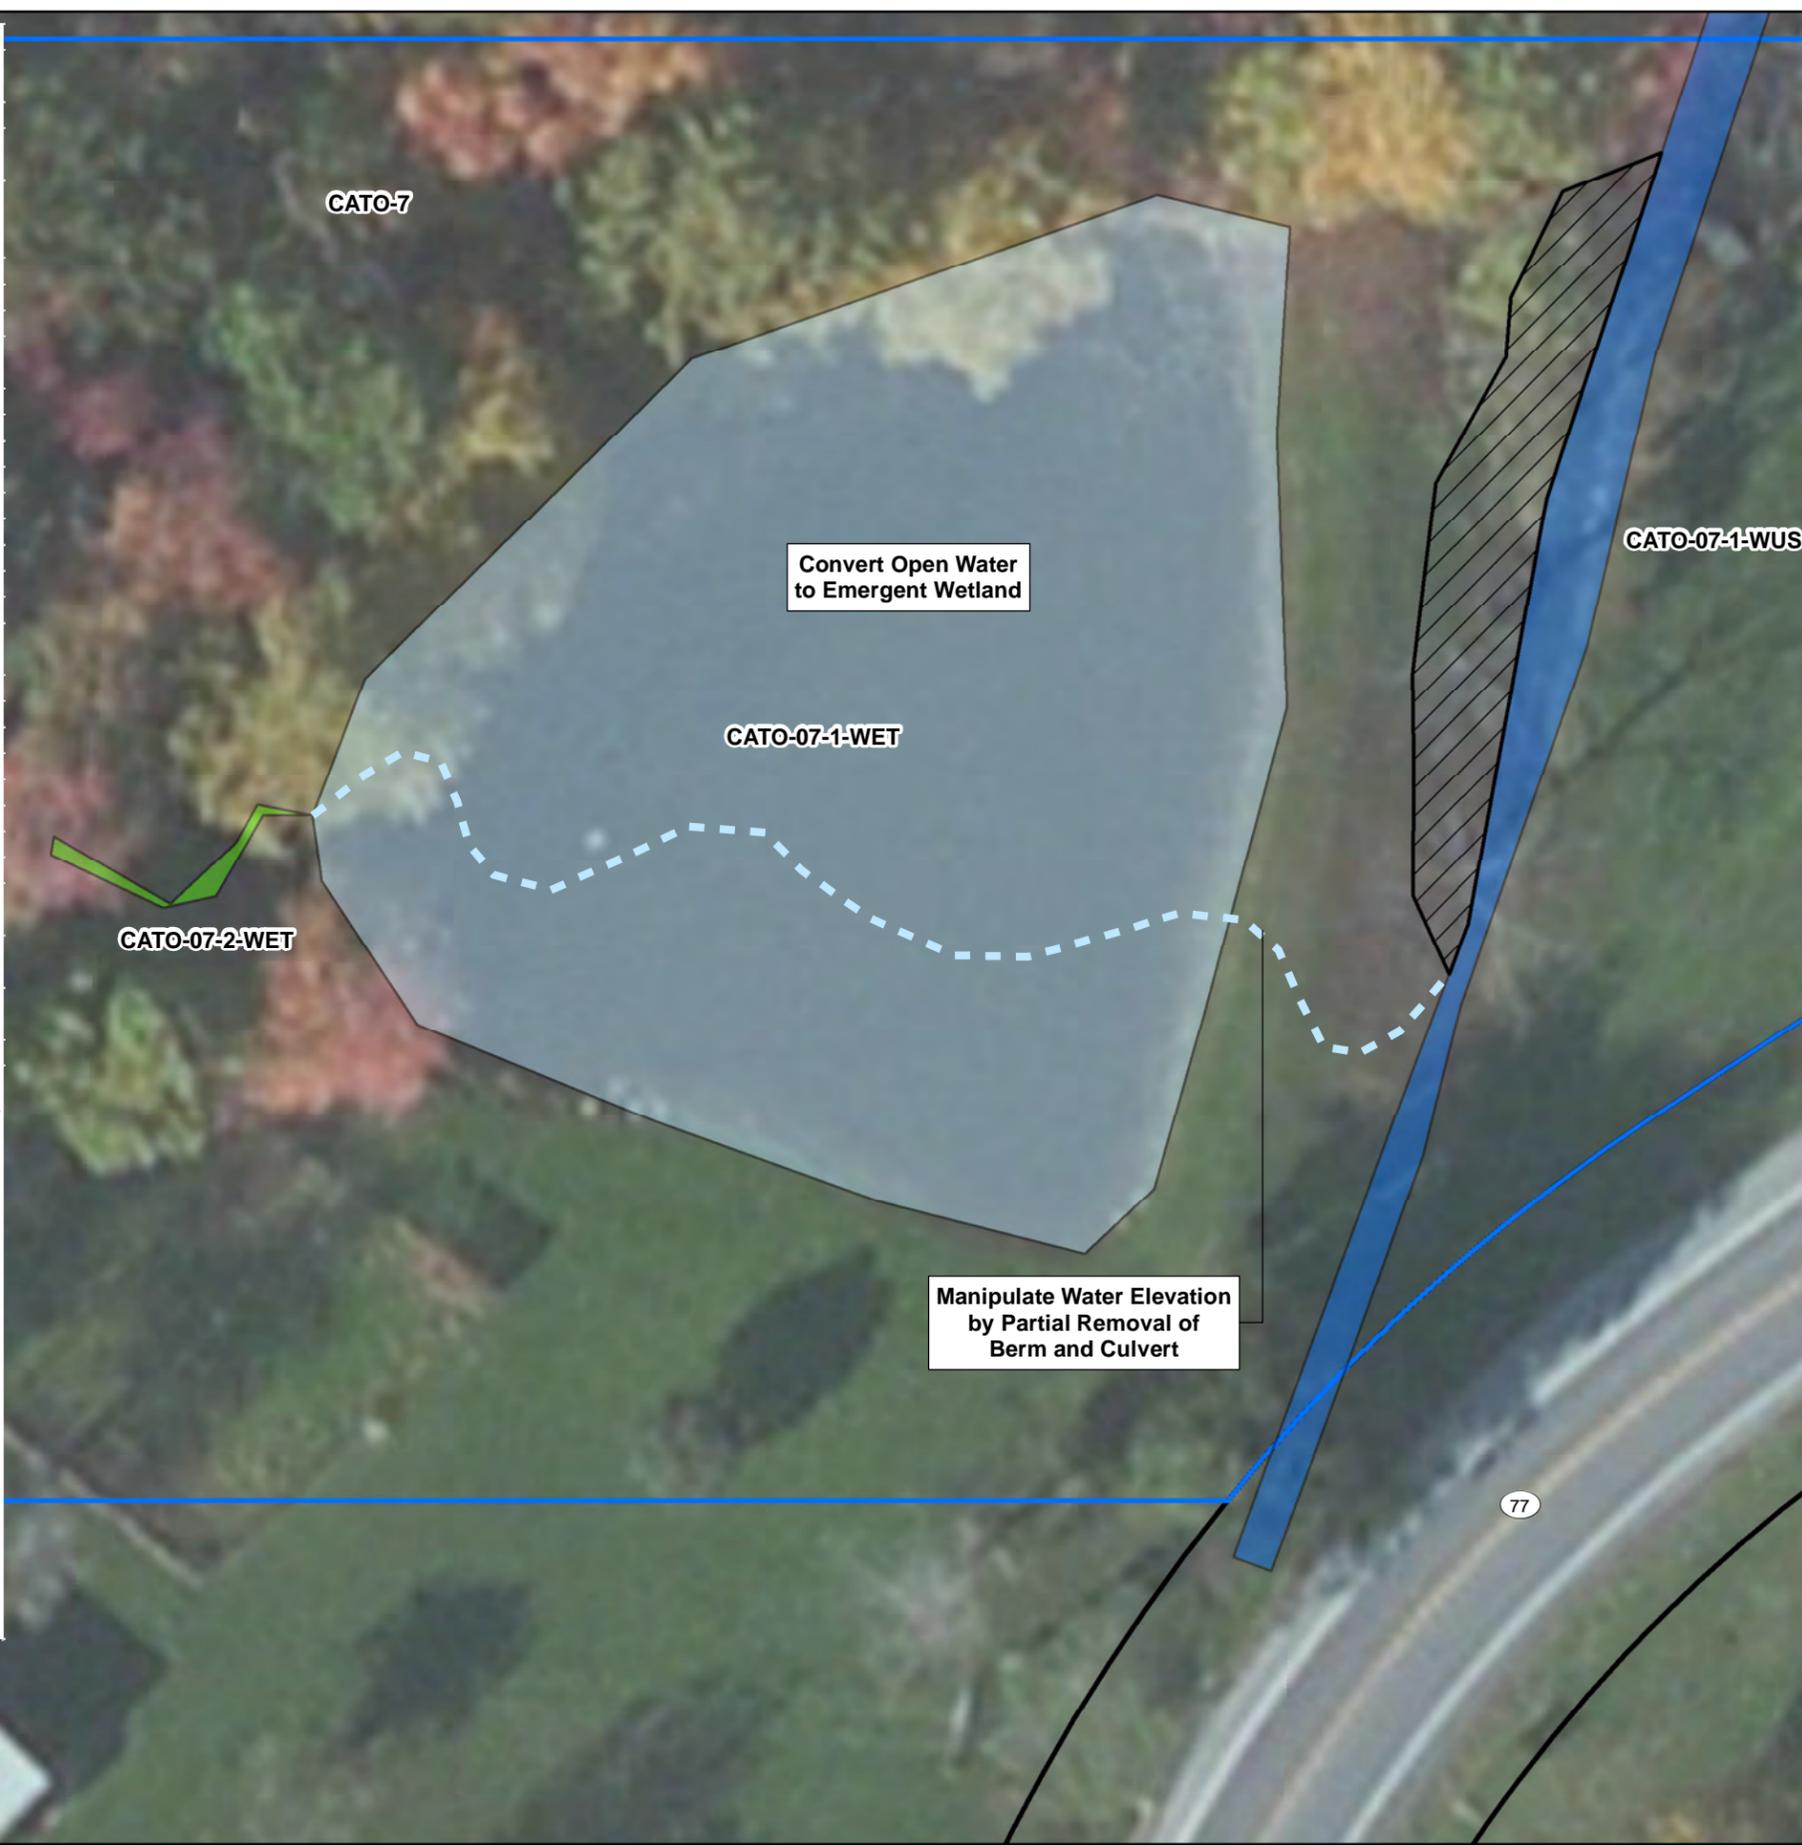
Figure 10  
 CATO-07  
 Catoclin  
 NPS/NCR Wetland Restoration Action Plan  
 Frederick, Maryland

**Notes**  
 Open pond previously used for fishing and picnicking. Site near roadway with good access and visitor opportunities. Cultural resources present - spring has historic rock and foundations. Spring provides hydrology to pond. Currently submerged under open water. Direct runoff from forested slope adjacent to pond. Open water surrounded by turf grass and some recent tree plantings. Pond adjacent to a steep forested slope. Berm around pond very high and steep. Restoring area would require reworking topography at site. NPS forested land, private homeowner, and existing road. Site not currently functioning as a wetland. Invasive species not an issue but mowed and maintained turf throughout site. Site still maintained as open water and turf. Some planted trees present and portions of site are a little steep. Overland flow from adjacent forested and maintained areas. Entire open water area could be converted to open wet meadow with a small defined channel in meadow from spring to channel. Remove portions of berm.

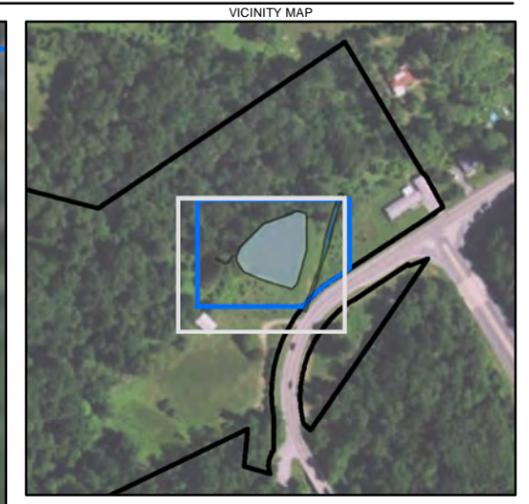
<b>Site ID</b>	CATO-7
<b>Potential Restoration Area (Acres)</b>	0.50
<b>Date of Field Assessment</b>	3/24/16
<b>Existing Land Use</b>	Open parkland and recreation
<b>Adjacent Land Use</b>	Parkland and private homeowner
<b>Distance to Nearest Road</b>	15 ft
<b>RTE Species Present?</b>	No
<b>Known Cultural Concern?</b>	Yes
<b>Stream Restoration Opportunity?</b>	Yes
<b>Site Currently Wetland?</b>	Yes
<b>Site Formerly Wetland?</b>	Yes
<b>Evidence of Disturbance</b>	Yes
<b>Soils Score</b>	8
<b>Hydrology Score</b>	8
<b>Existing Vegetation Score</b>	10
<b>Geomorphic Score</b>	5
<b>Surrounding Land Use Score</b>	8
<b>Function and Value Score</b>	8
<b>Presence of Invasive Species Score</b>	4
<b>Site Disturbance Score</b>	8
<b>Ease of Access Score</b>	9
<b>Stormwater Influence Score</b>	5
<b>Total Score</b>	73
<b>Invasive Species Control?</b>	No
<b>Native Plantings?</b>	Yes
<b>Restore Hydrology?</b>	Yes
<b>Increase Diversity?</b>	Yes
