Figure 33
CHOH-12
C&O Canal
NPS/NCR Wetland Restoration Action Plan
Washington, D.C.

Figure 34
CHOH-13
C&O Canal
NPS/NCR Wetland Restoration Action Plan
Montgomery, Maryland

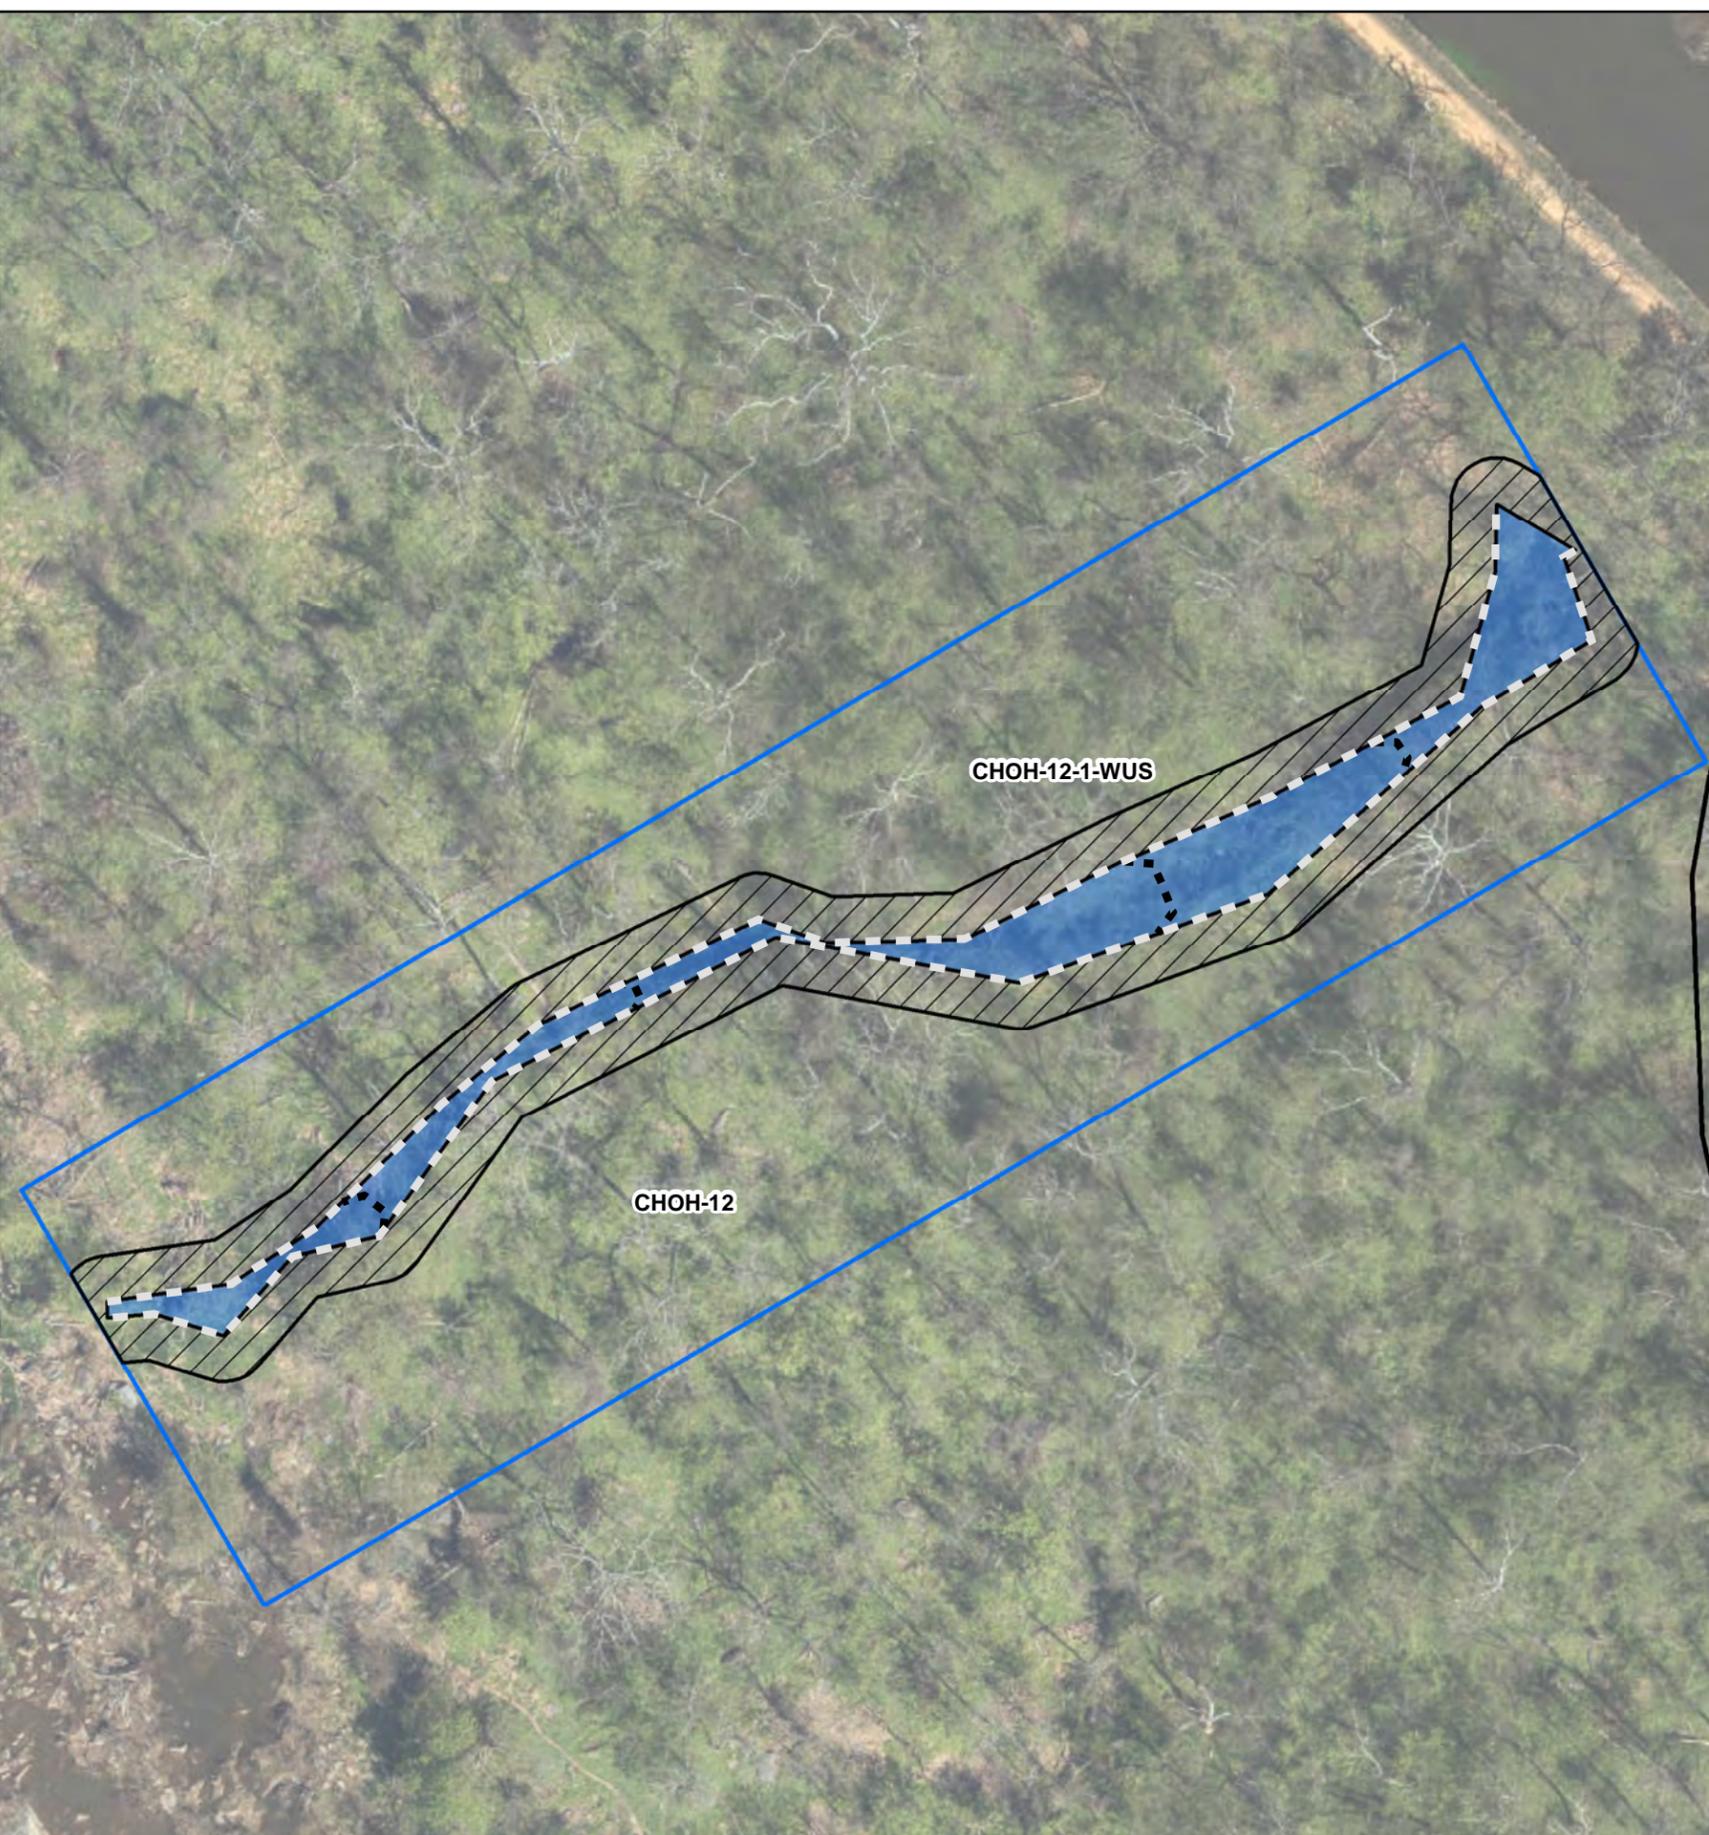
Banks are steep and high but not severely eroding, vegetated with Ficaria which is likely reducing erosion. At upstream portion of reach, erosion is extreme at over 20 feet; at downstream portion of reach, channel has recovered and is completely connected to the floodplain. Out of bank flooding does not occur at upstream portion of reach due to bank height. Channel disconnected to floodplain. Forest is young in age and dominated by Chinese wisteris, pawpaw, silver maple, elm, and box elder (new mature trees). No immediate threat but potential future threat of erosion continues. Could reconnect floodplain to improve habitat. May require equipment under pedestrian bridge; would have to cross canal. Stream appears straightened. Surrounding area is upland and dominated by invasive species at upstream end. Downstream most portion of the reach is stable, connected to floodplain but with Japanese knotweed. Stream and floodplain restoration proposed at upstream portion of reach to reconnect stream to floodplain and treat for invasives. Tie in to downstream point and do not disturb wetland at downstream end. Add meander bends and in stream habitat.

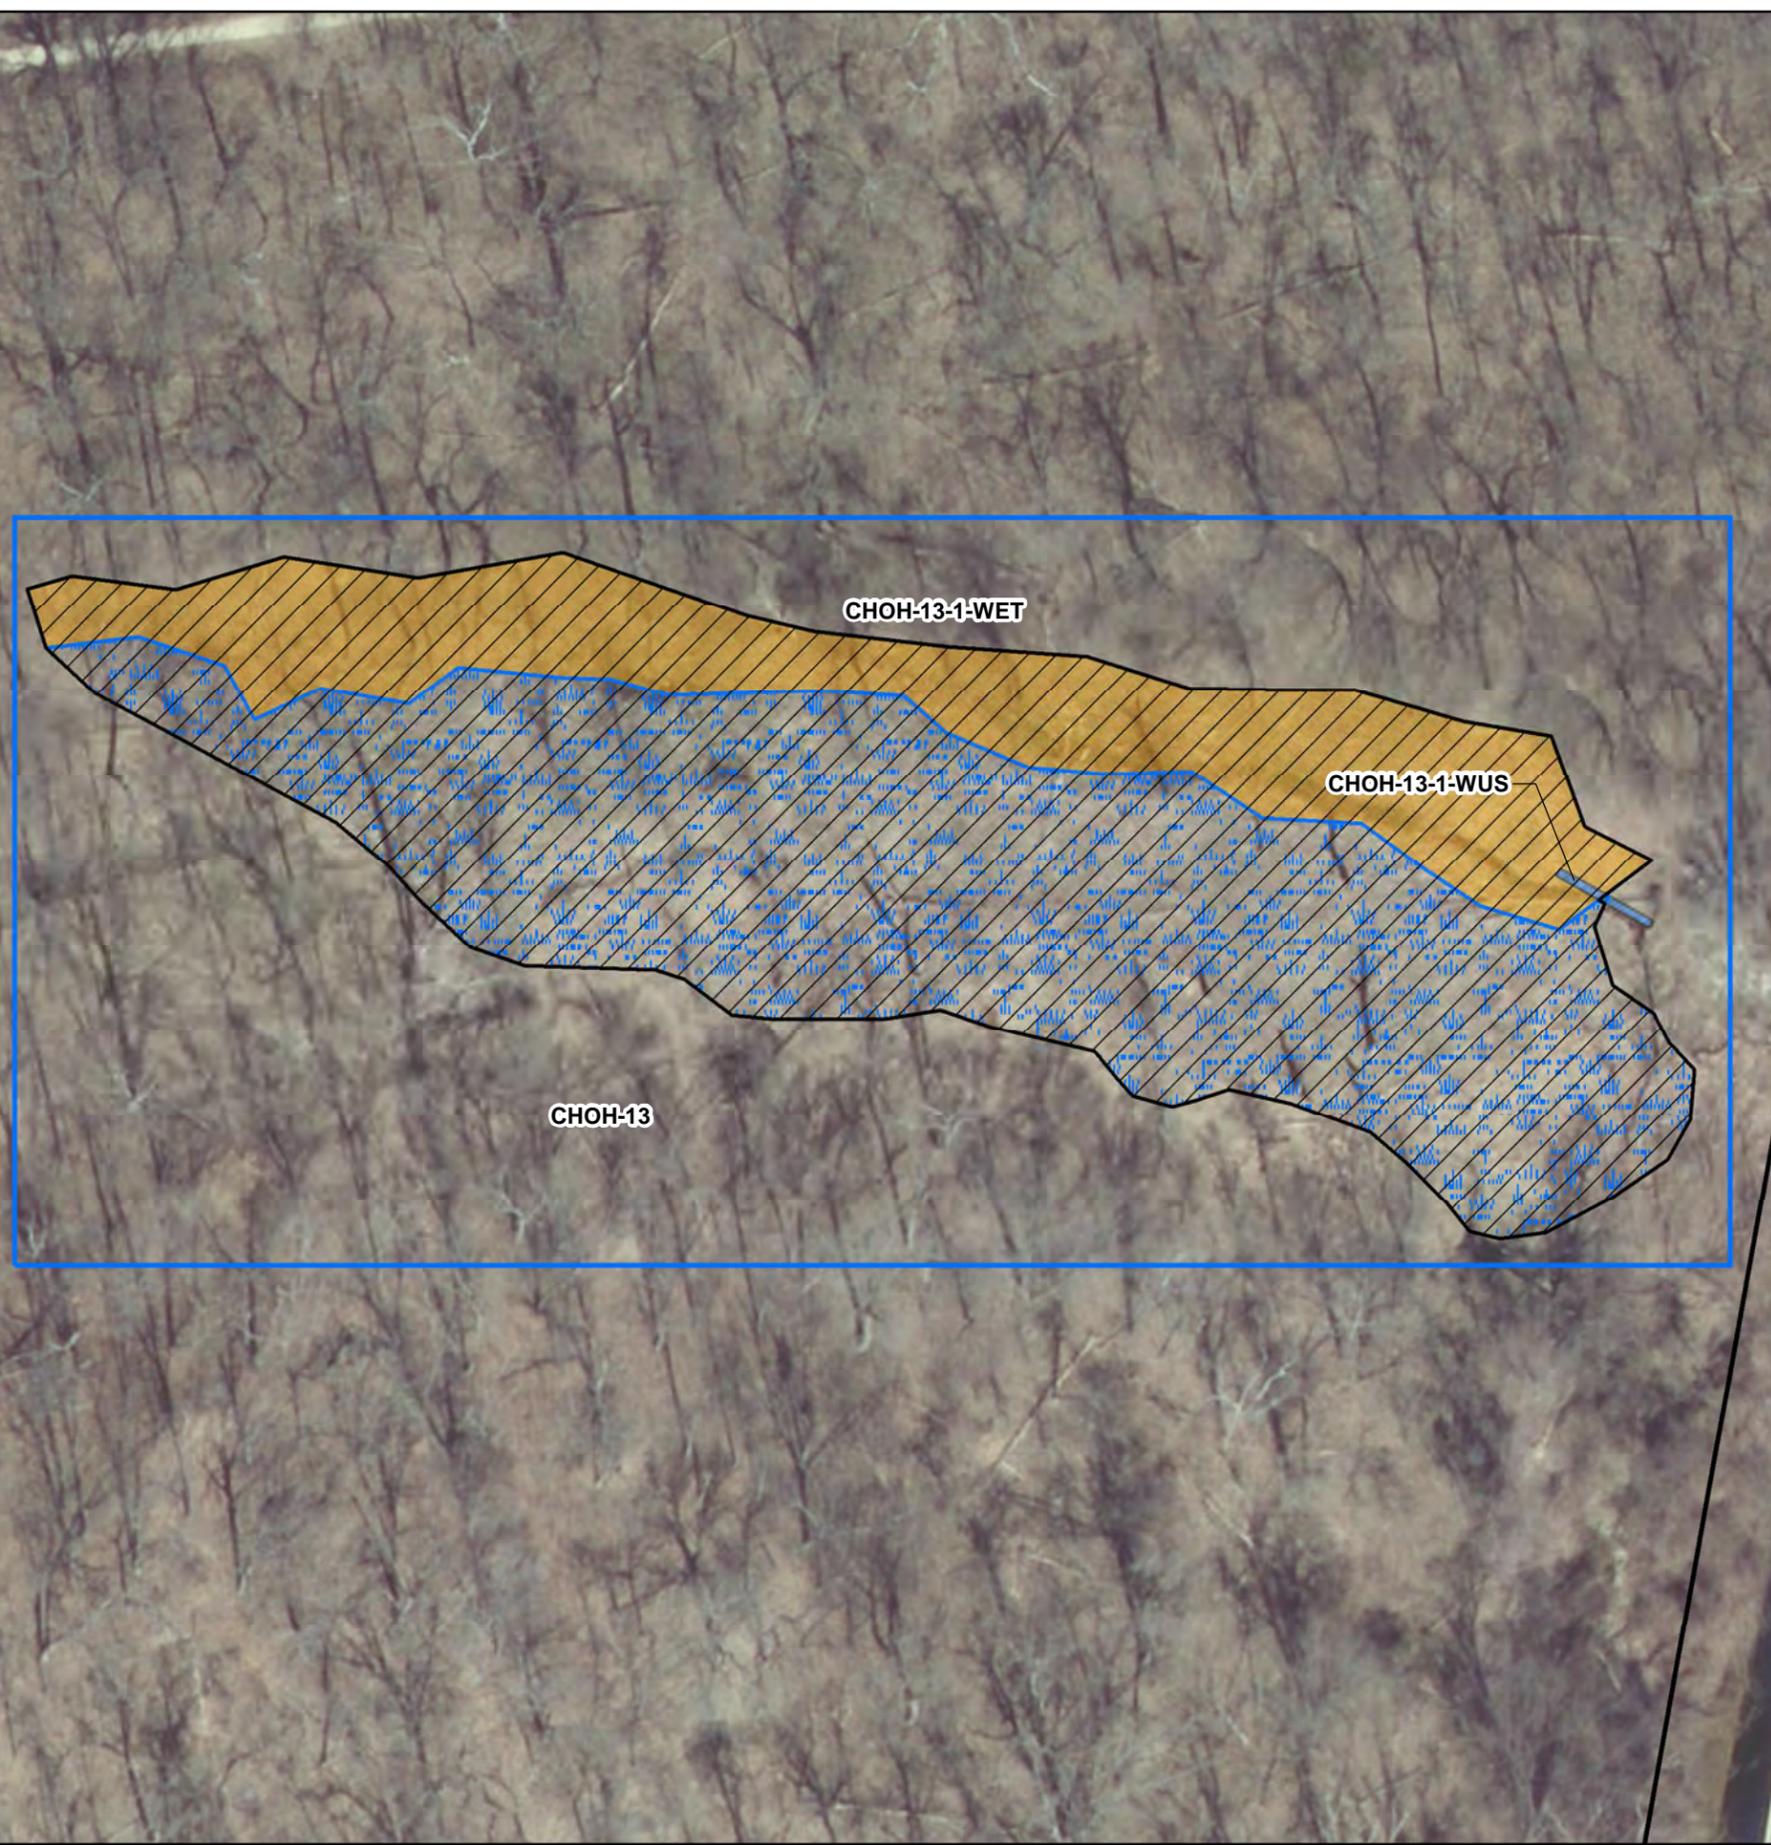
Site ID	CHOH-13
Potential Restoration Area (Acres)	1.00
Date of Field Assessment	4/27/2016
Existing Land Use	Open meadow and forested parkland
Adjacent Land Use	I 495 and Forest
Distance to Nearest Road	75 feet from towpath
RTE Species Present?	No
Known Cultural Concern?	No
Stream Restoration Opportunity?	No
Site Currently Wetland?	No
Site Formerly Wetland?	Yes
Evidence of Disturbance	Yes
Soils Score	4
Hydrology Score	4
Existing Vegetation Score	6
Geomorphic Score	8
Surrounding Land Use Score	8
Function and Value Score	5
Presence of Invasive Species	9
Score	
Site Disturbance Score	5
Ease of Access Score	4
Stormwater Influence Score	6
Total Score	59
Invasive Species Control?	Yes
Native Plantings?	Yes
Restore Hydrology?	Yes
Increase Diversity?	Yes
Convert Open Water to Vegetated?	No
Convert Emergent to Shrub/Forested	No
Increase Aesthetic or Educational Value	Yes
Other	Yes
Notes	Portion of site identified as wetland and remaining open area identified as previous wetland that appears to have been historically drained. Old abandoned channels that are dry were observed. Dominated by reed canary grass jewelweed smartweed. Some standing live and some standing dead sycamores were also observed scattered. Potential to remove invasive species from existing wetlands and improve hydrology to previously drained area.

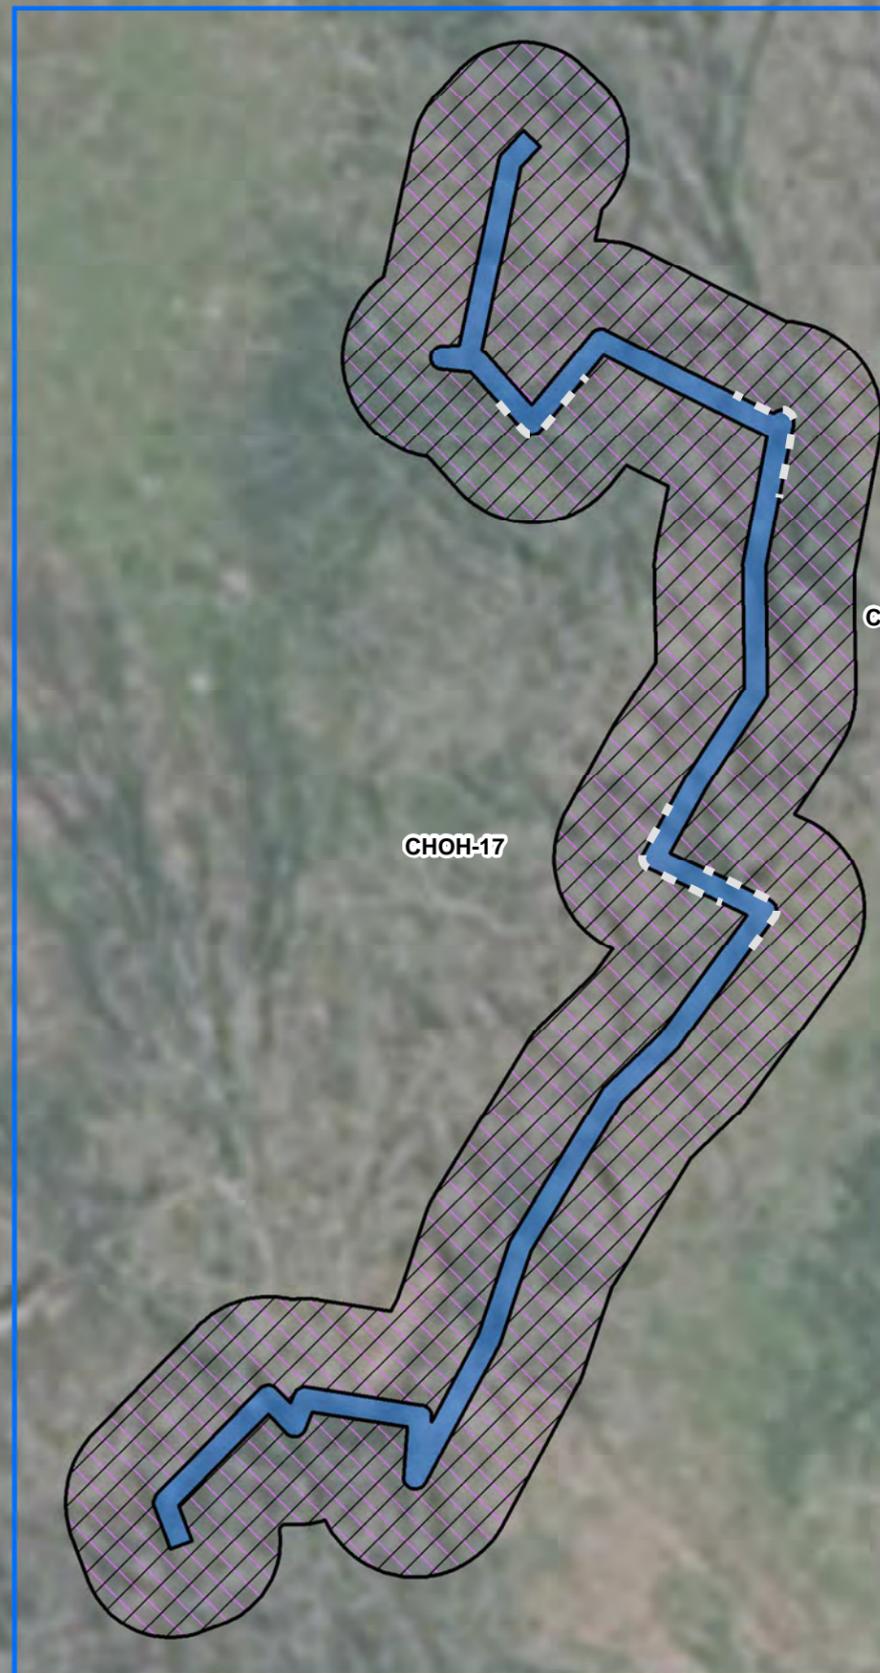
Figure 35
CHOH-17
C&O Canal
NPS/NCR Wetland Restoration Action Plan
Frederick, Maryland

Site ID	CHOH-17
Potential Restoration (linear feet)	320
Date	4/21/16
Existing Land Use	Old field
Adjacent Land Use	Forested
Distance to Nearest Road	150 ft
Stream Hydrology	Perennial
RTE Species Present?	No
Known Cultural Concern?	No
Wetland Restoration Opportunity?	No
Existing Wetlands Present	No
Evidence of Disturbance	No
Can Restoration be Completed in NPS Area?	Yes
Estimated Bank Erosion Score	4
Degree of Channel Incision Score	4
Existing Floodplain Access Score	5
Opportunity for Floodplain Development Score	7
Threat of Impact to Resources Score	4
Surrounding Vegetation Score	4
Land Use Score	4
Opportunity for Ecological Lift Score	5
Ease of Access	5
Surrounding Land Use Score	5
Total Score	47
Invasives Species Control?	Yes
Riparian Buffer Enhancement?	Yes
Restore Natural Hydrology?	No
Livestock Agricultural Exclusion	No
Fish Passage?	No
Channel Restoration?	Yes
Increase Aesthetic or Educational Value?	No
Other	No
Notes	Channel lacking riparian buffer for approx 150 feet has small patchy areas of bank erosion and invasives on banks. Small bank armoring in patches and enhance riparian area and treat garlic mustard on banks.

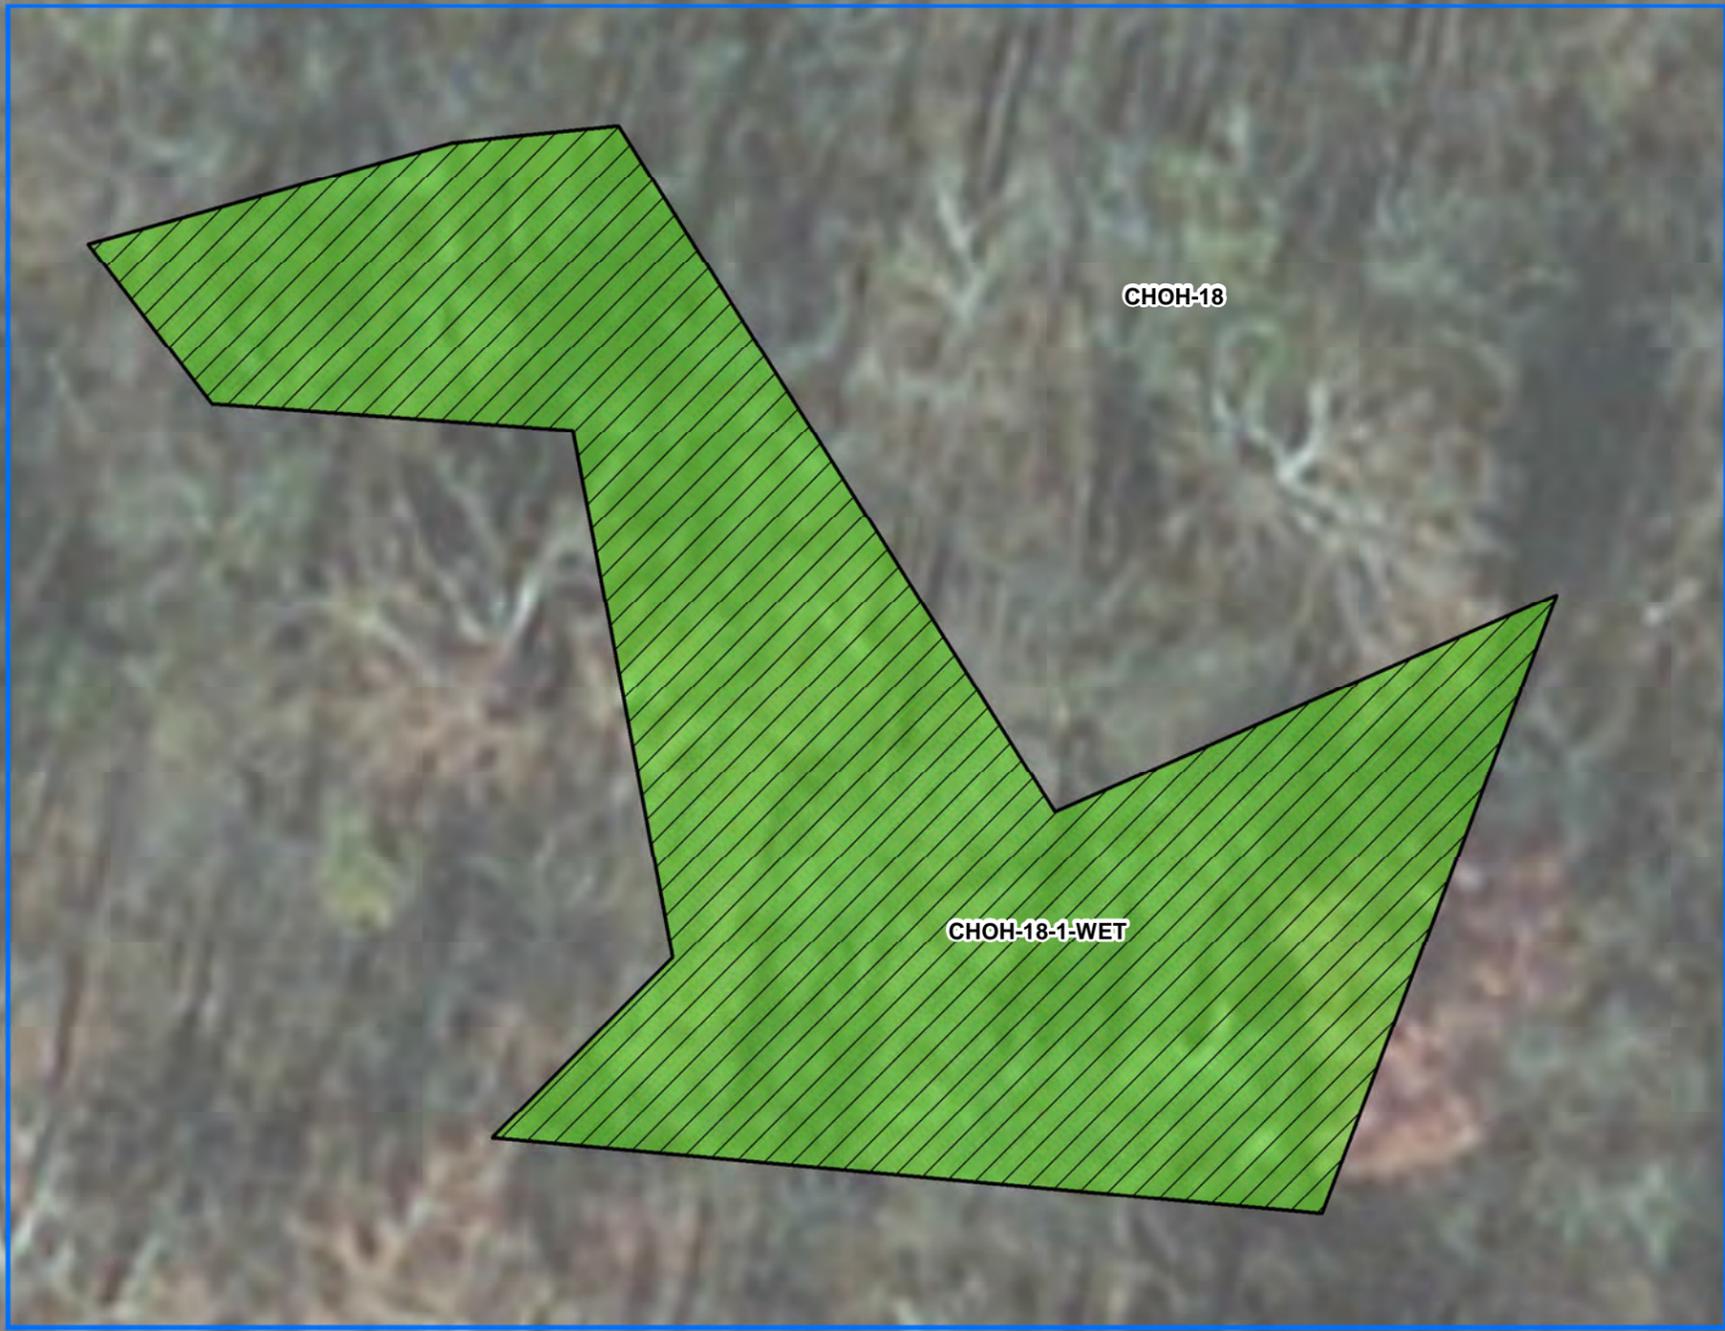
Figure 36
CHOH-18
C&O Canal
NPS/NCR Wetland Restoration Action Plan
Washington, Maryland

Site ID	CHOH-18
Potential Restoration Area (Acres)	1.00
Date of Field Assessment	4/20/16
Existing Land Use	Forested
Adjacent Land Use	Canal and old field
Distance to Nearest Road	75 feet to path
RTE Species Present?	No
Known Cultural Concern?	No
Stream Restoration Opportunity?	No
Site Currently Wetland?	Yes
Site Formerly Wetland?	No
Evidence of Disturbance	No
Soils Score	10
Hydrology Score	10
Existing Vegetation Score	4
Geomorphic Score	8
Surrounding Land Use Score	6
Function and Value Score	4
Presence of Invasive Species Score	9
Site Disturbance Score	3
Ease of Access Score	4
Stormwater Influence Score	8
Total Score	66
Invasive Species Control?	Yes
Native Plantings?	Yes
Restore Hydrology?	No
Increase Diversity?	No
Convert Open Water to Vegetated?	No
Convert Emergent to Shrub/Forested	No
Increase Aesthetic or Educational Value	No
Other	No
Notes	Forested wetland with large multi flora stand. Requires invasive species control.

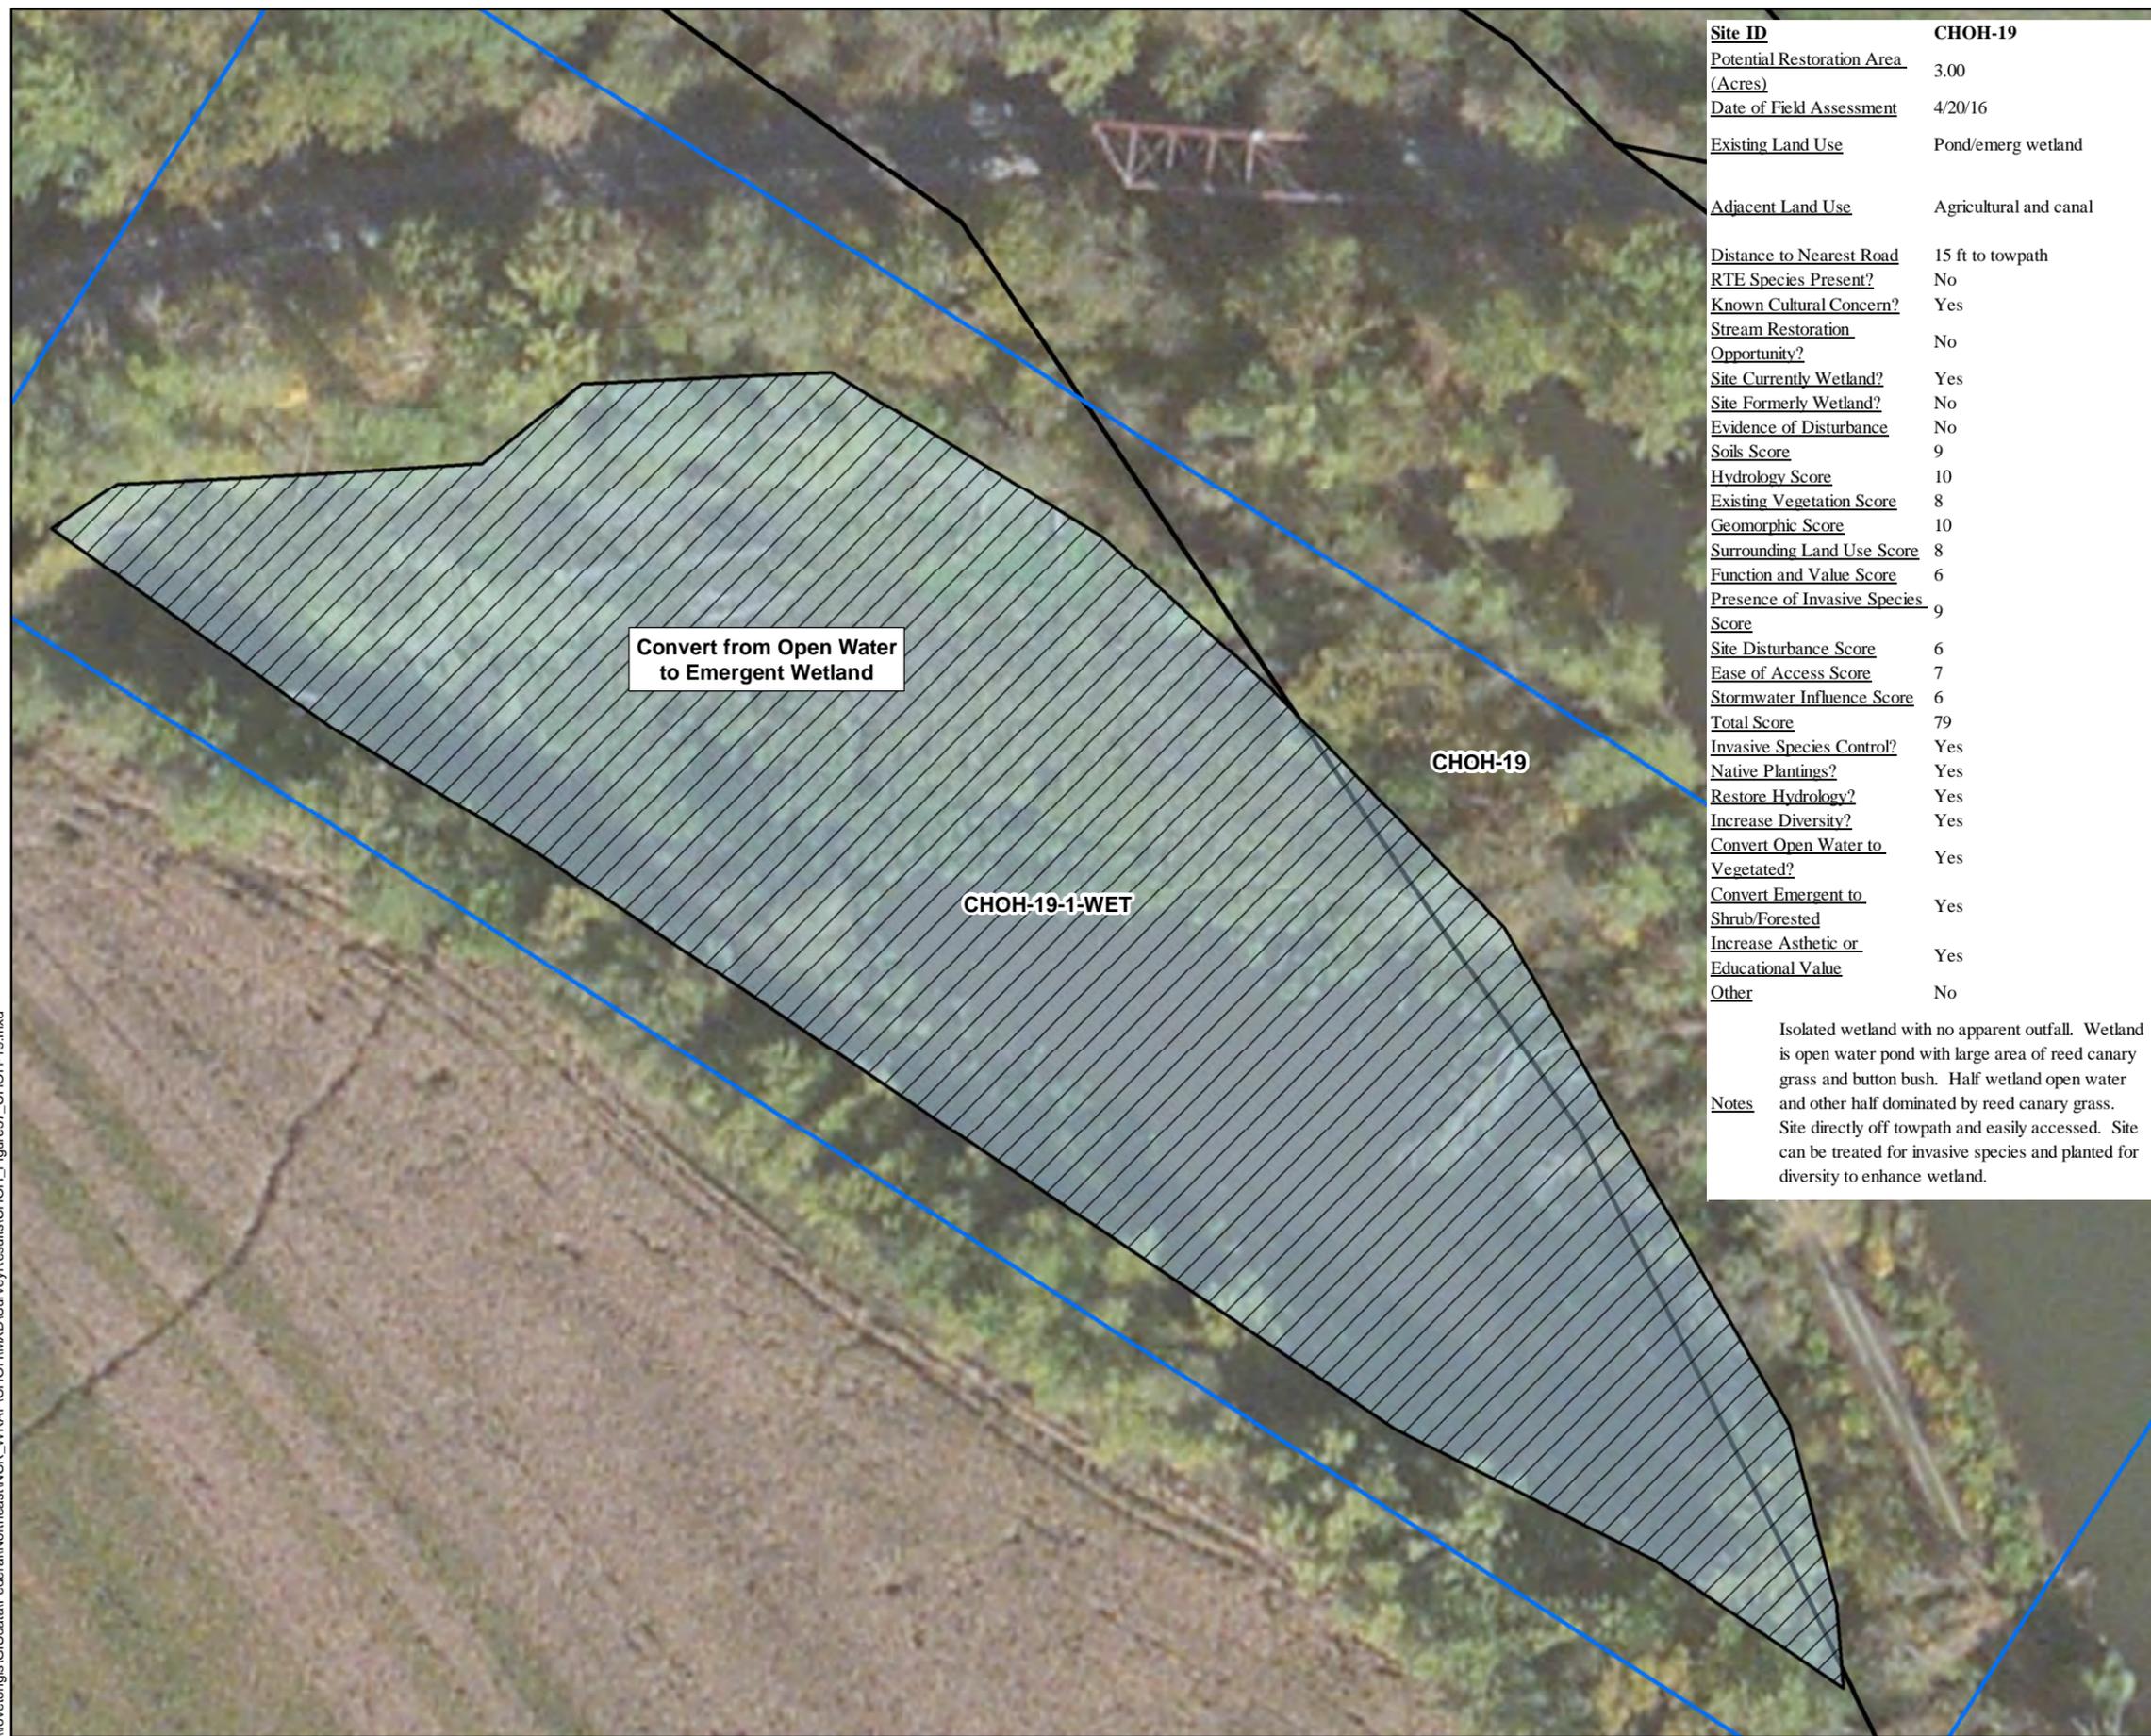
Figure 37
 CHOH-19
 C&O Canal
 NPS/NCR Wetland Restoration Action Plan
 Washington, Maryland

Notes
 Isolated wetland with no apparent outfall. Wetland is open water pond with large area of reed canary grass and button bush. Half wetland open water and other half dominated by reed canary grass. Site directly off towpath and easily accessed. Site can be treated for invasive species and planted for diversity to enhance wetland.

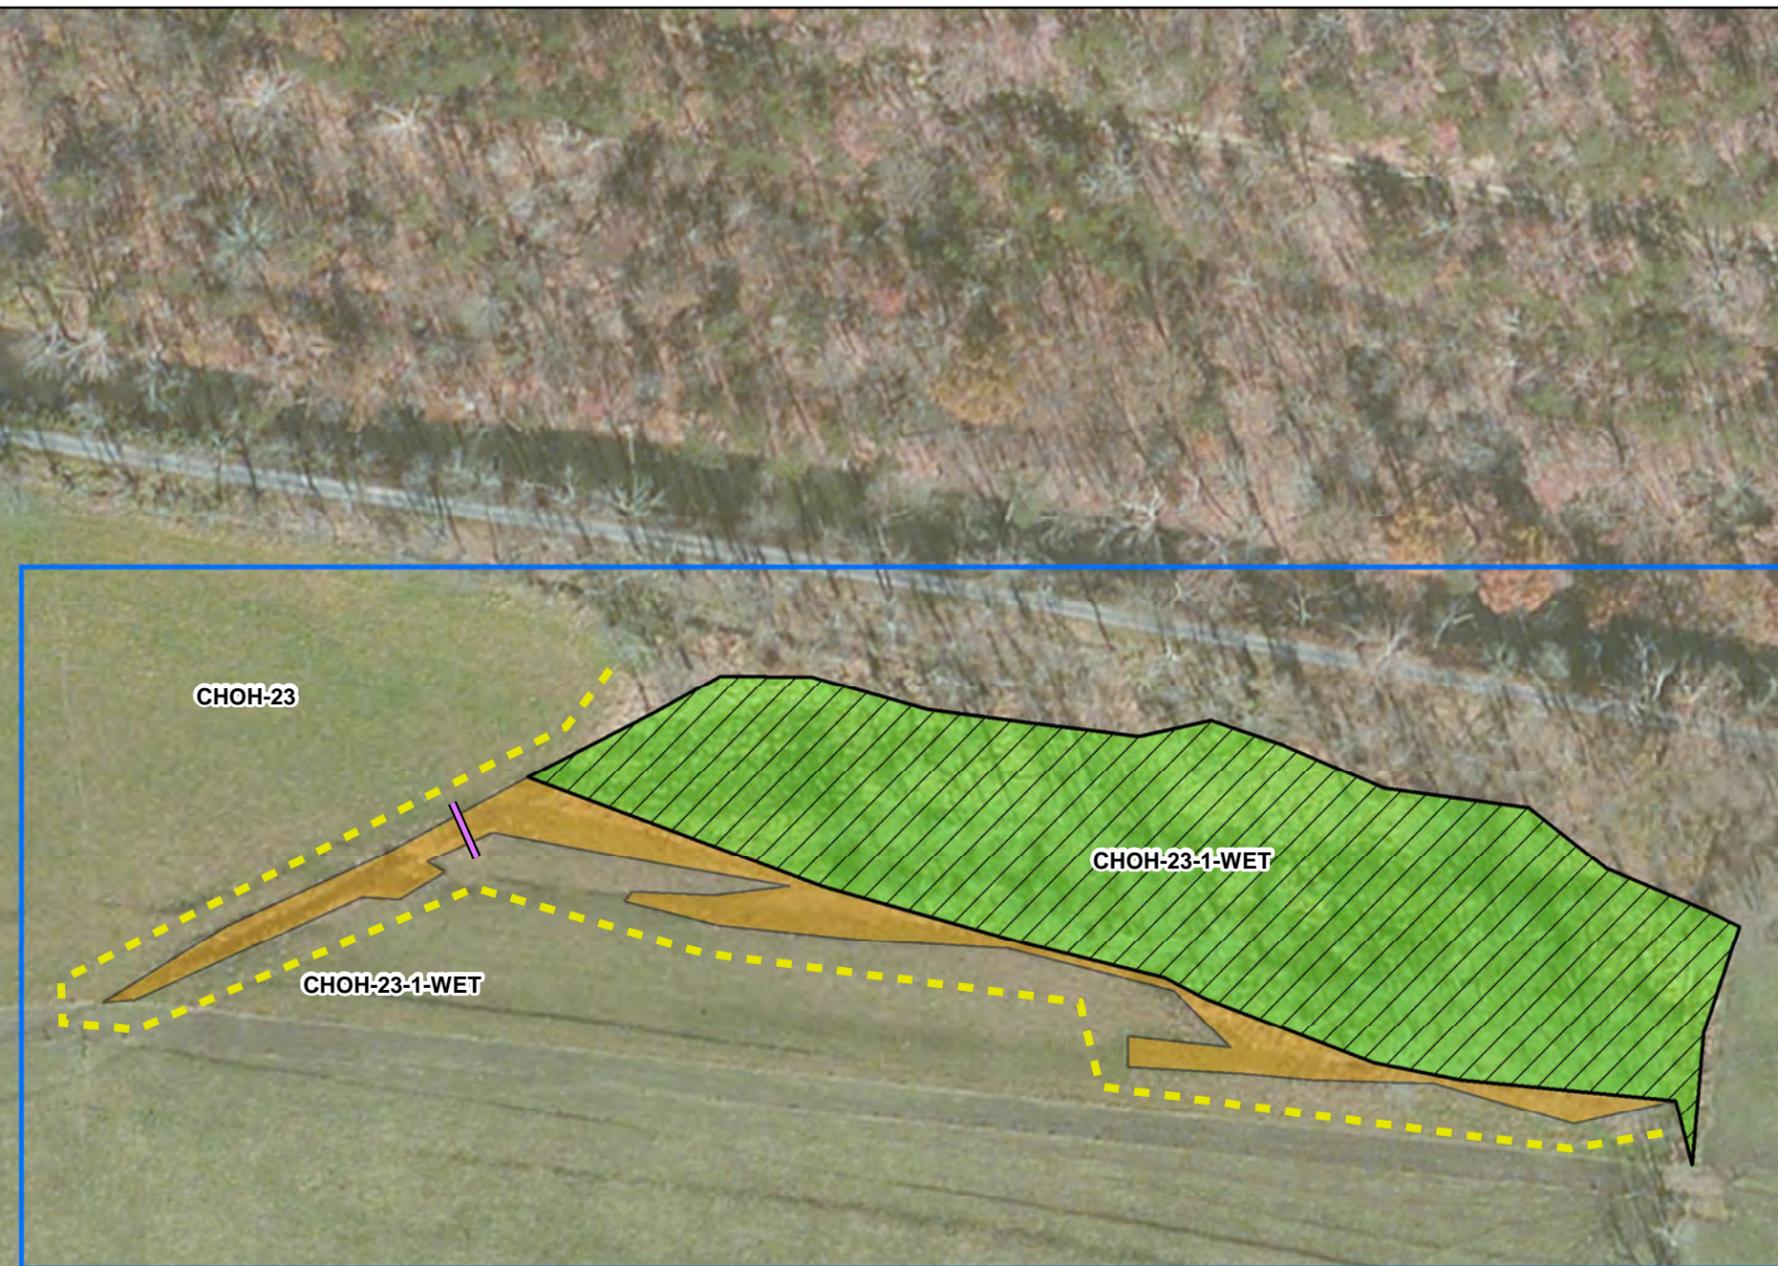
Figure 38
CHOH-23
C&O Canal
NPS/NCR Wetland Restoration Action Plan
Allegany, Maryland

Site ID	CHOH-23
Potential Restoration Area (Acres)	5.00
Date of Field Assessment	4/20/16
Existing Land Use	Agricultural/forested
Adjacent Land Use	Agricultural
Distance to Nearest Road	200 feet from tow path
RTE Species Present?	No
Known Cultural Concern?	No
Stream Restoration Opportunity?	No
Site Currently Wetland?	Yes
Site Formerly Wetland?	Yes
Evidence of Disturbance	Yes
Soils Score	10
Hydrology Score	10
Existing Vegetation Score	5
Geomorphic Score	5
Surrounding Land Use Score	7
Function and Value Score	6
Presence of Invasive Species Score	6
Site Disturbance Score	6
Ease of Access Score	6
Stormwater Influence Score	9
Total Score	70
Invasive Species Control?	Yes
Native Plantings?	Yes
Restore Hydrology?	Yes
Increase Diversity?	Yes
Convert Open Water to Vegetated?	No
Convert Emergent to Shrub/Forested	No
Increase Aesthetic or Educational Value	No
Other	No
Notes	Wetland partially drained by ditch. Many invasives species identified within forested shrub area of wetland and outer edge of wetland disturbed by agricultural practices. Drained wetland still functioning and delineated as wetland but reduced hydrology and some veg changing over to invasive upland species.

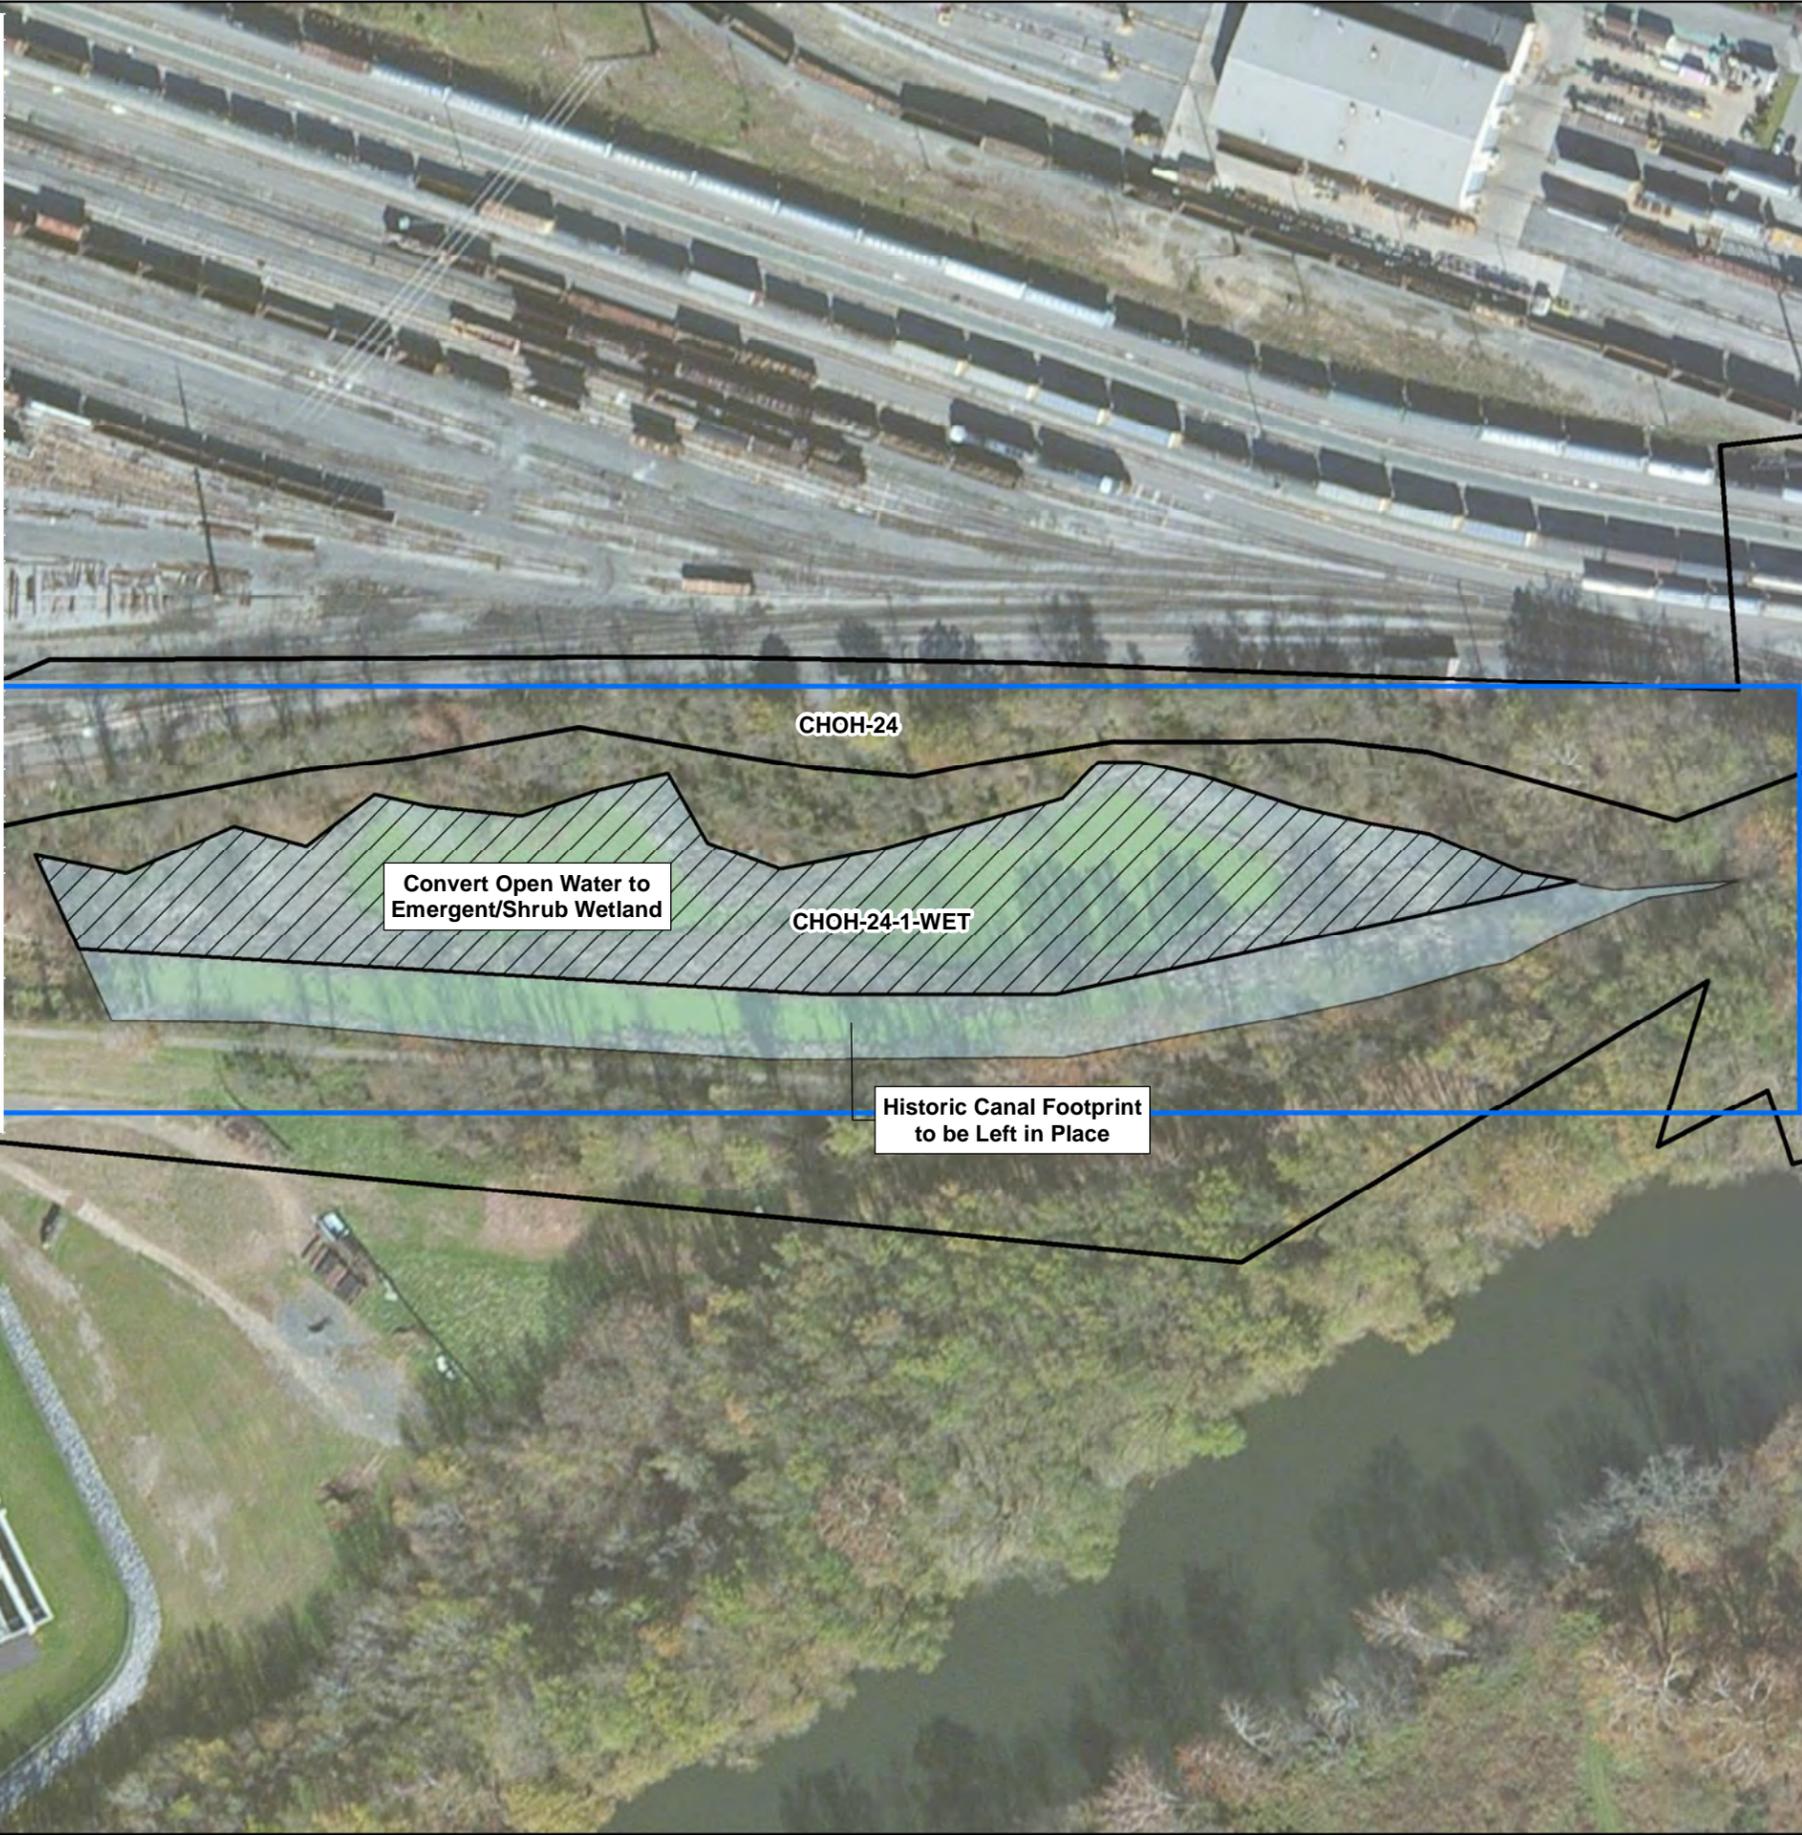
Figure 39
CHOH-24
C&O Canal
NPS/NCR Wetland Restoration Action Plan
Allegany, Maryland

Site ID	CHOH-24
Potential Restoration Area (Acres)	3.00
Date of Field Assessment	4/19/16
Existing Land Use	Open water pond
Adjacent Land Use	Train yard and riparian forest to potomac
Distance to Nearest Road	Directly adjacent
RTE Species Present?	No
Known Cultural Concern?	Yes
Stream Restoration Opportunity?	No
Site Currently Wetland?	Yes
Site Formerly Wetland?	Yes
Evidence of Disturbance	Yes
Soils Score	9
Hydrology Score	10
Existing Vegetation Score	8
Geomorphic Score	8
Surrounding Land Use Score	5
Function and Value Score	6
Presence of Invasive Species Score	2
Site Disturbance Score	4
Ease of Access Score	5
Stormwater Influence Score	5
Total Score	62
Invasive Species Control?	No
Native Plantings?	Yes
Restore Hydrology?	Yes
Increase Diversity?	Yes
Convert Open Water to Vegetated?	Yes
Convert Emergent to Shrub/Forested	Yes
Increase Aesthetic or Educational Value	Yes
Other	No
Notes	Large emergent wetland/open water complex north of historic canal footprint. Not dominated by invasive but large monotypic stand of cat tails.
