Figure 33
CHOH-12
C&O Canal
NPS/NCR Wetland Restoration Action Plan
Washington, D.C.

Figure 34
CHOH-13
C&O Canal
NPS/NCR Wetland Restoration Action Plan
Montgomery, Maryland

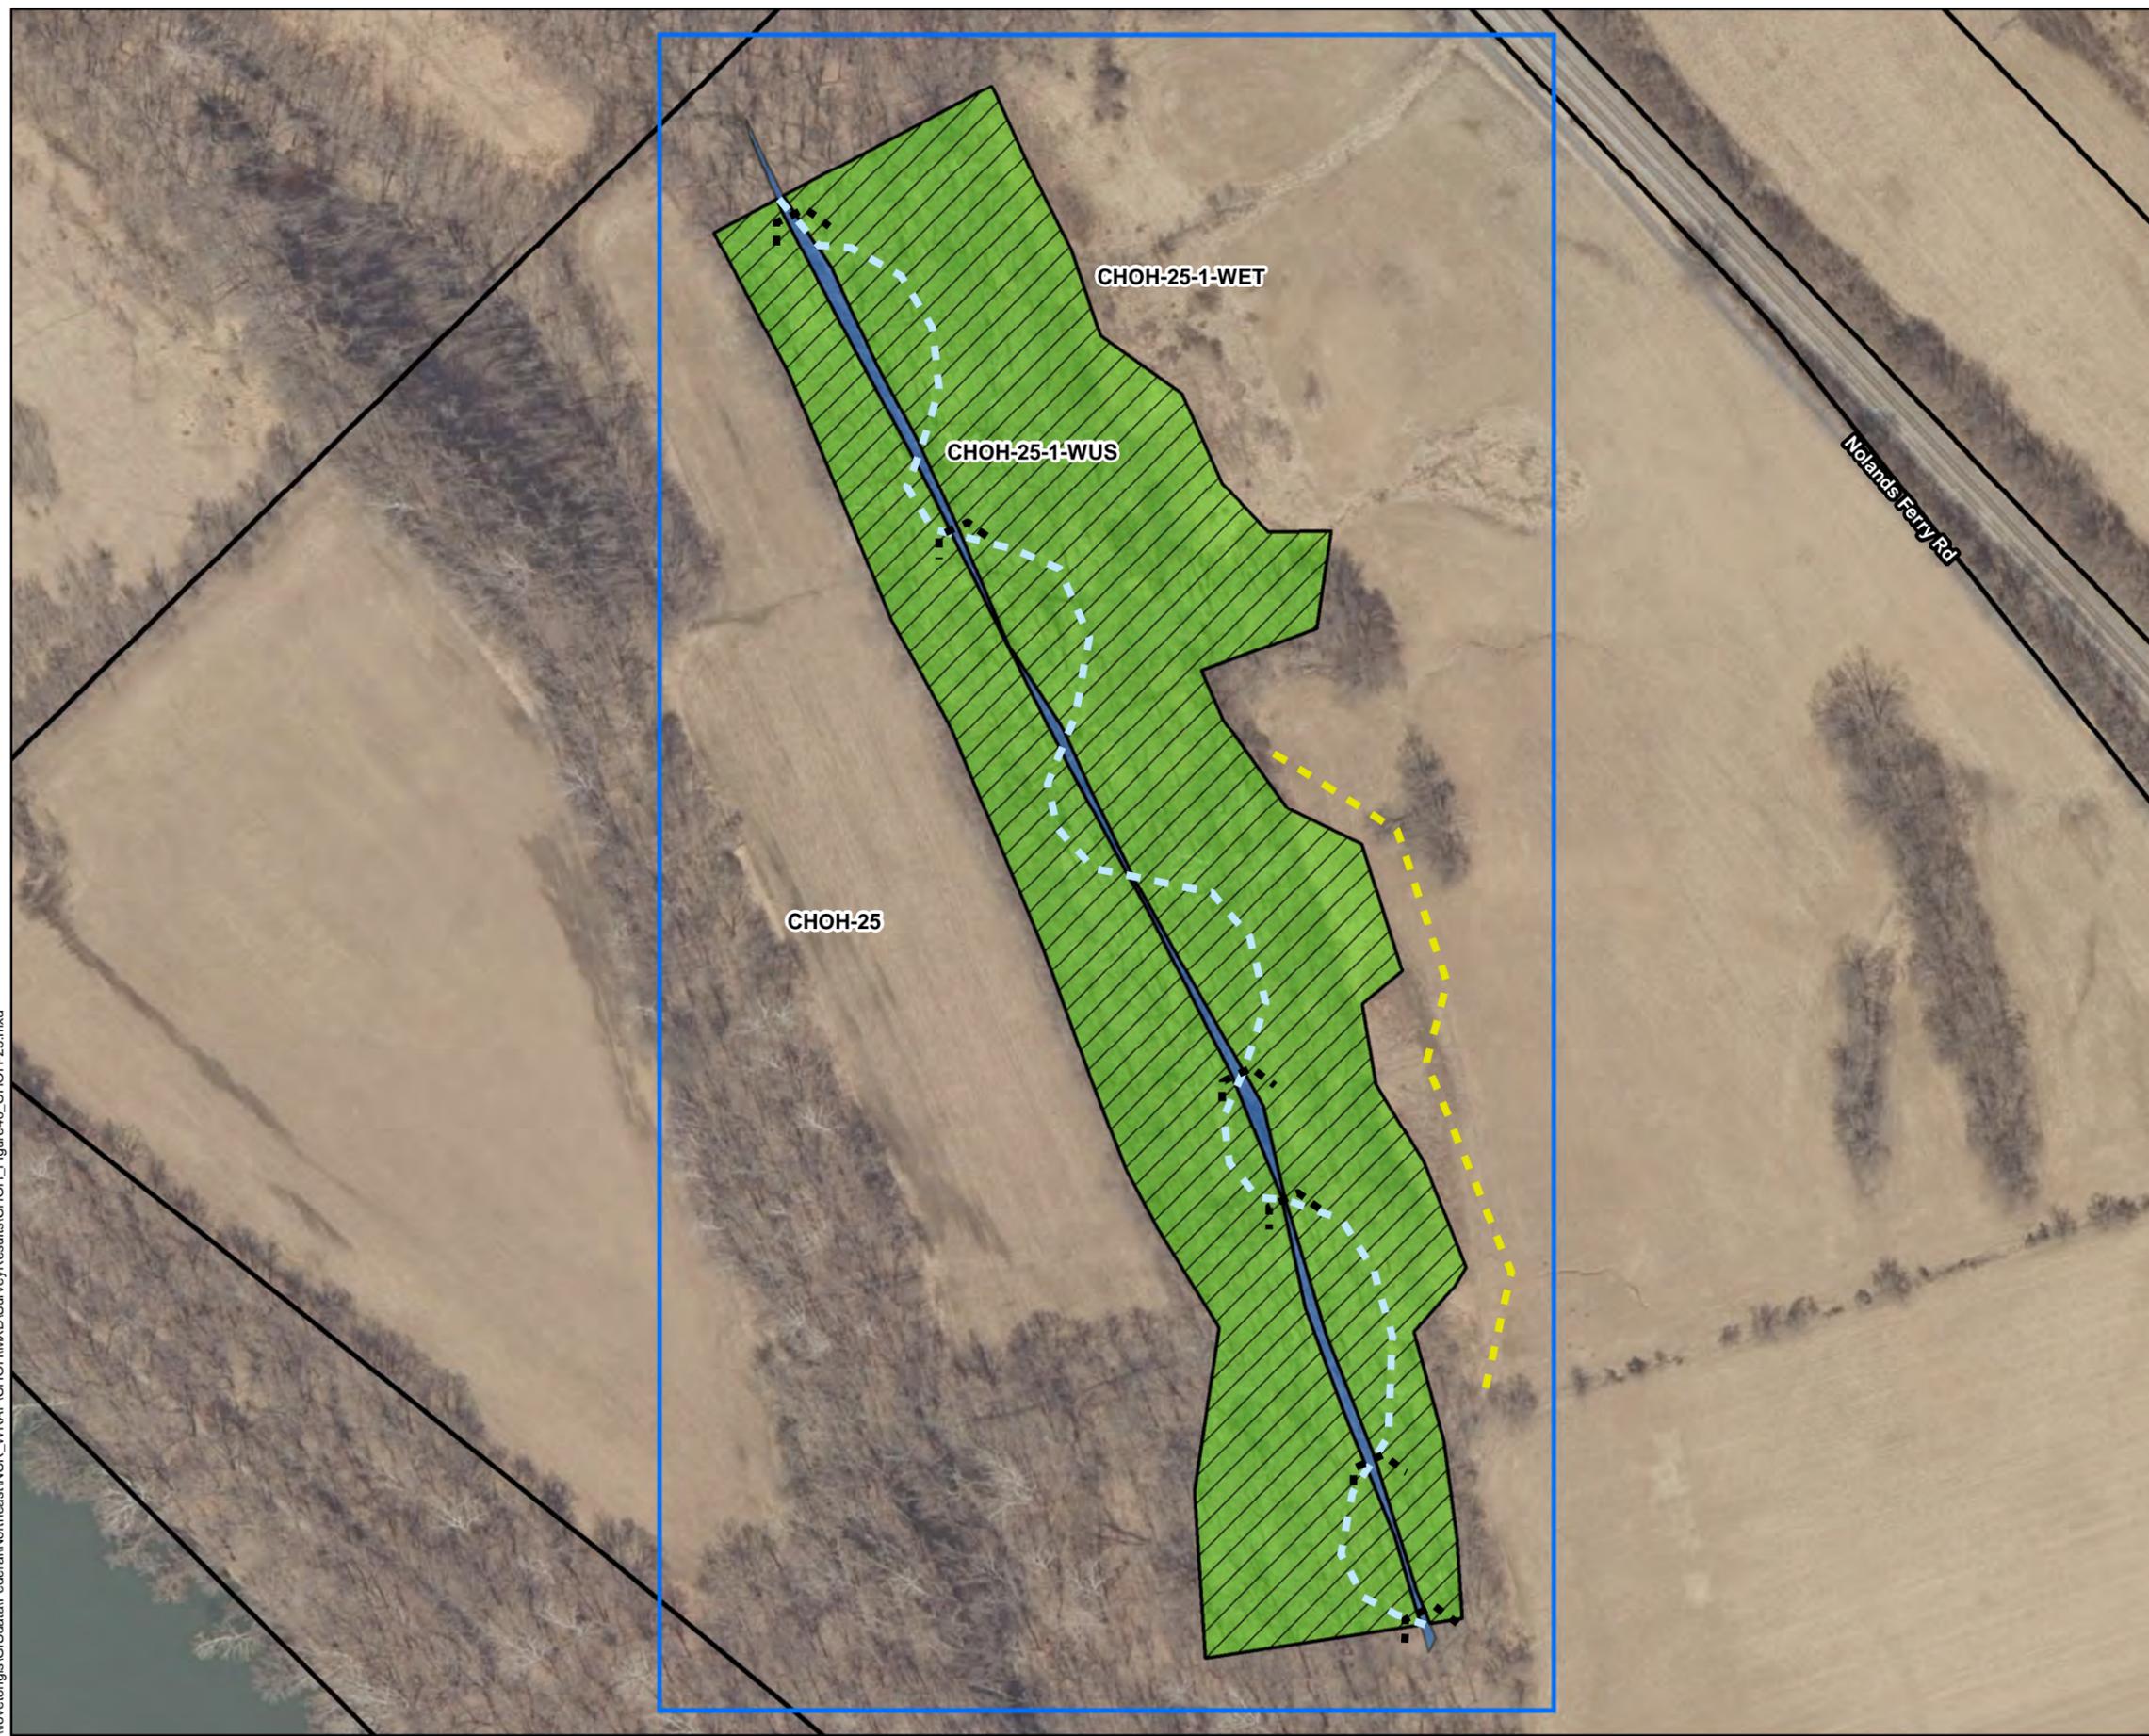
Figure 40
CHOH-25
C&O Canal
NPS/NCR Wetland Restoration Action Plan
Frederick, Maryland

<u>Restore Hydrology?</u>	Yes	No
<u>Increase Diversity?</u>	Yes	Yes
<u>Convert Open Water to Vegetated?</u>	No	No
<u>Convert Emergent to Shrub/Forested</u>	No	Yes
<u>Increase Asthetic or Educational Value</u>	No	No
<u>Other</u>	No	Yes
<u>Notes</u>	Wetland partially drained by ditch. Tree of heaven Drained wetland still functioning and delineated as wetland but reduced hydrology and some veg changing over to upland.	Wetland disturbed in agricultural field. Agricultural exclusion with signs or fence.

<u>Restore Natural Hydrology?</u>	Yes
<u>Livestock Agricultural Exclusion</u>	No
<u>Fish Passage?</u>	No
<u>Channel Restoration?</u>	Yes
<u>Increase Aesthetic or Educational Value?</u>	No
<u>Other</u>	No
<u>Notes</u>	Partially drained wetland by ditching stream channel. Recommend lifting ditch elevation or completely plugging to restore wetland hydrology.

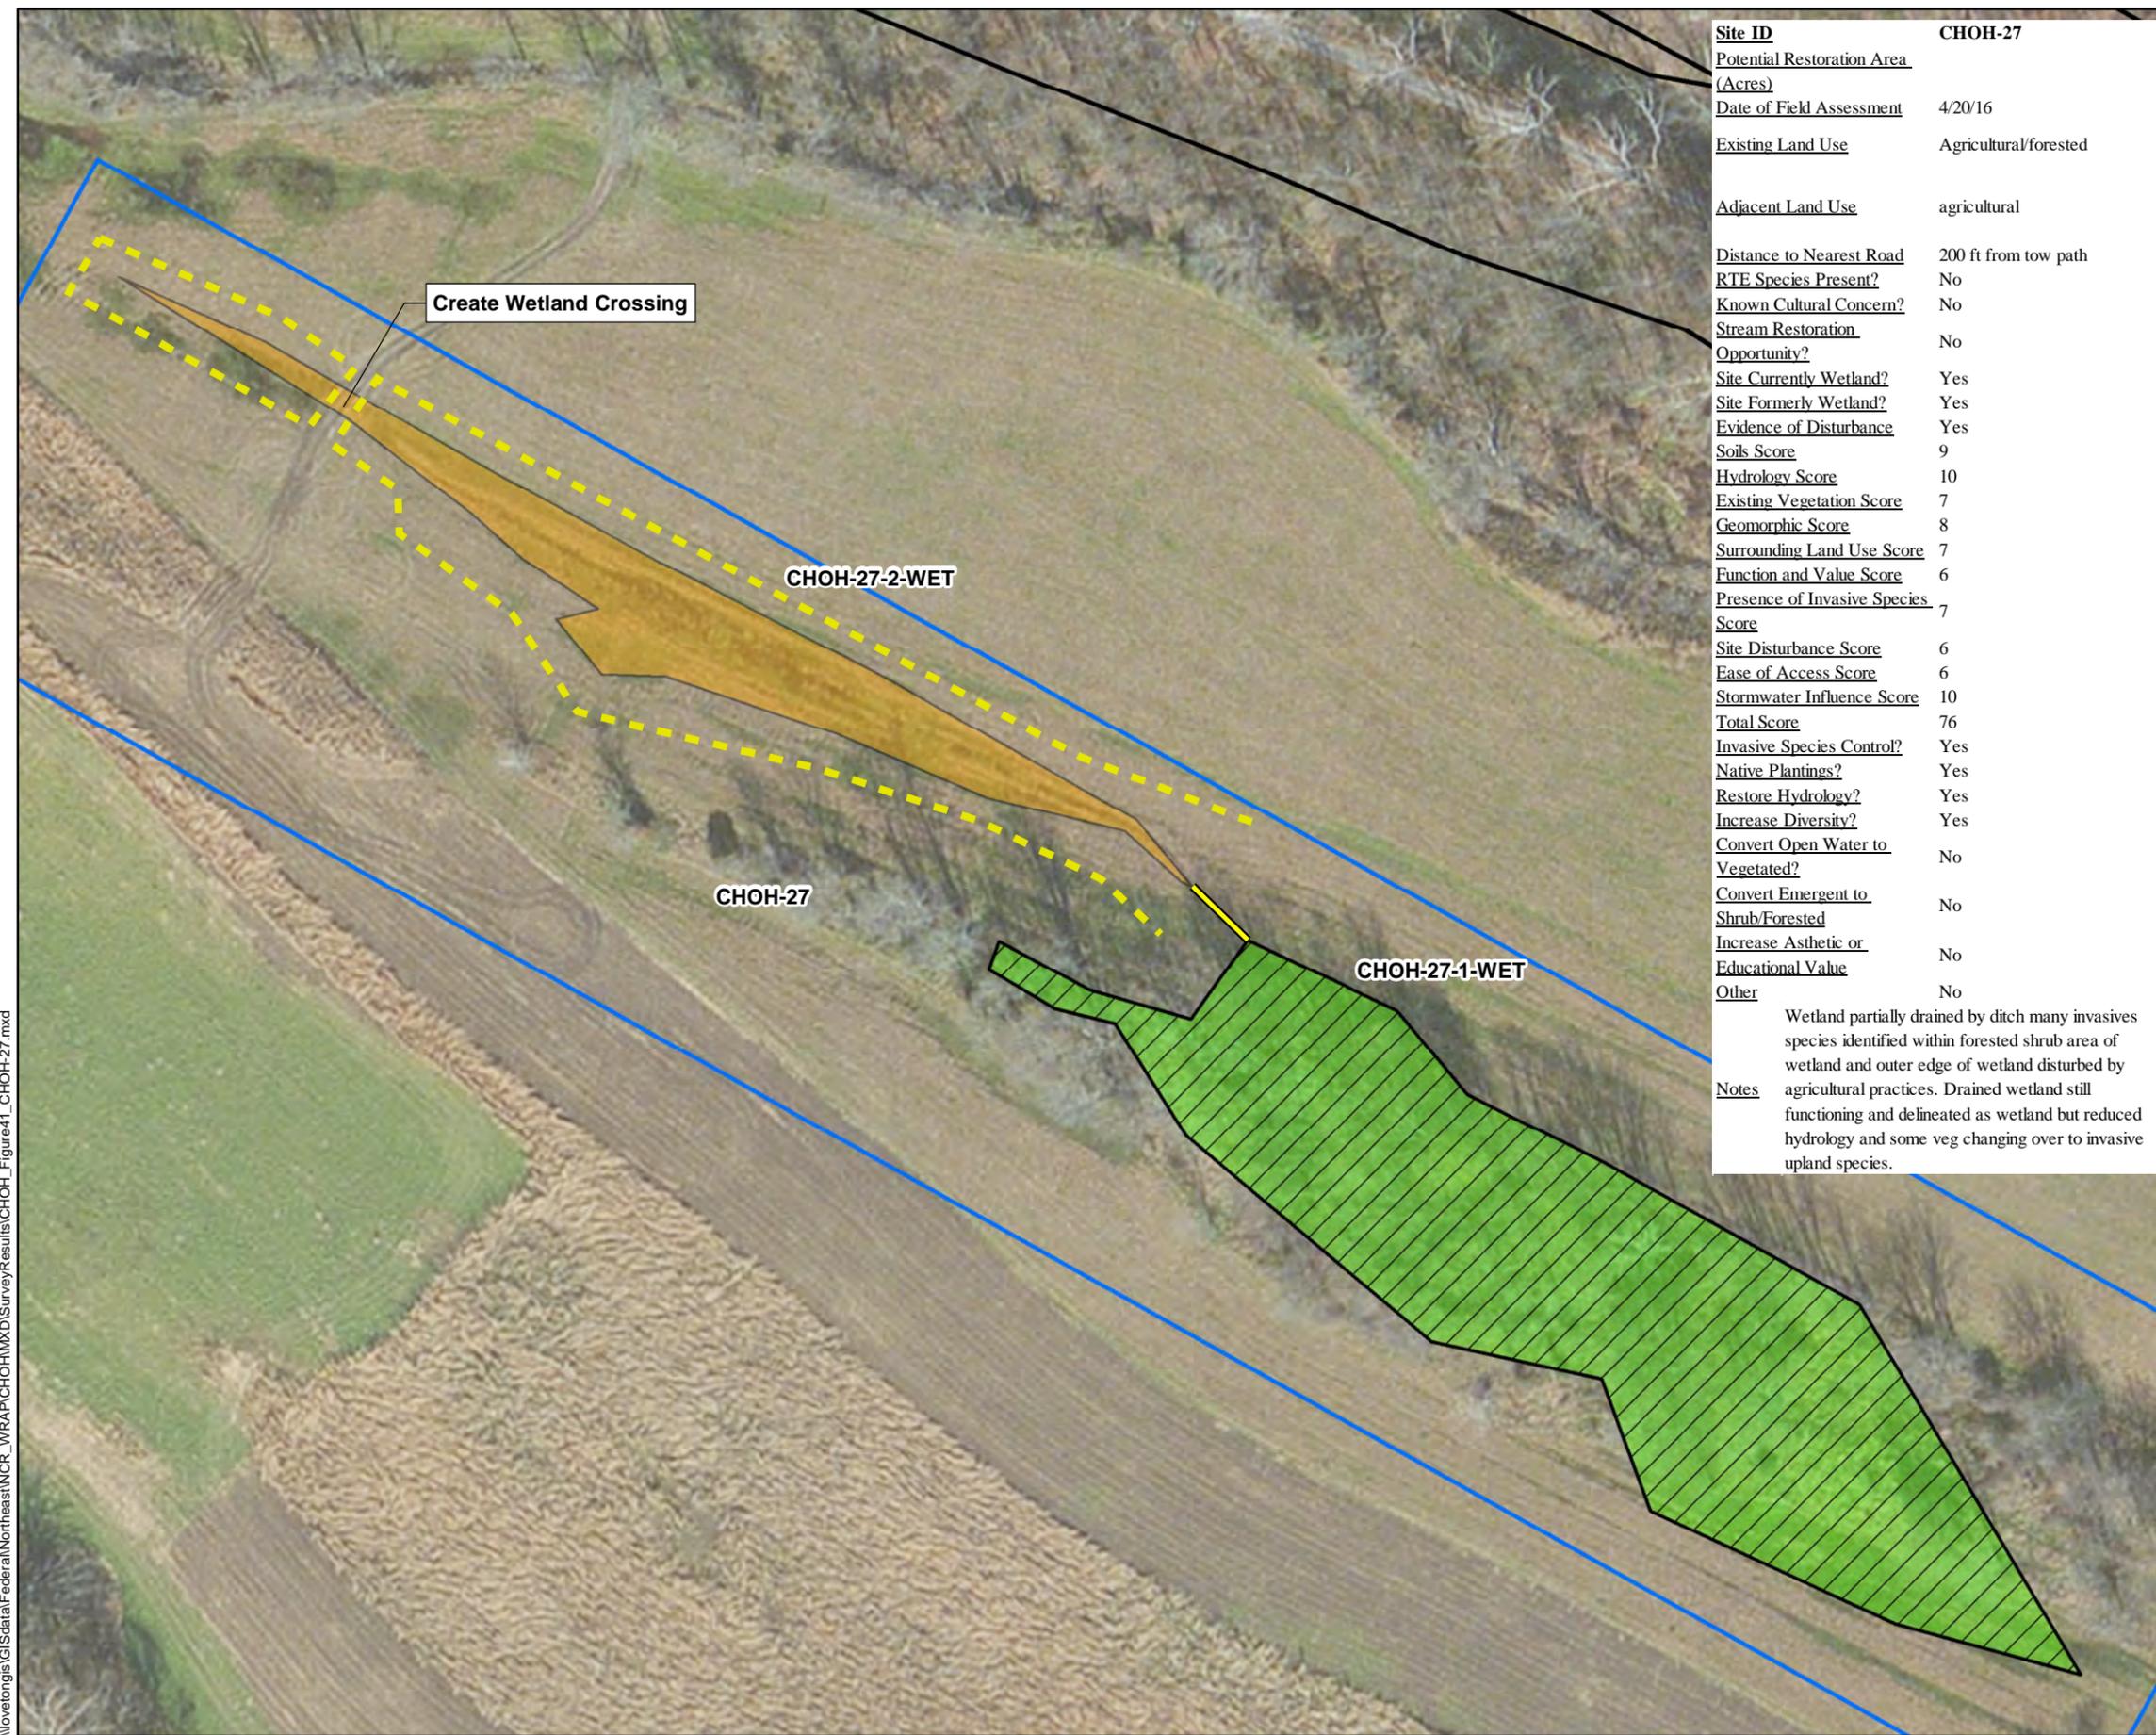
Figure 41
CHOH-27
C&O Canal
NPS/NCR Wetland Restoration Action Plan
Allegany, Maryland

<u>Convert Emergent to Shrub/Forested</u>	No
<u>Increase Aesthetic or Educational Value</u>	No
<u>Other</u>	No
<u>Notes</u>	Wetland partially drained by ditch many invasive species identified within forested shrub area of wetland and outer edge of wetland disturbed by agricultural practices. Drained wetland still functioning and delineated as wetland but reduced hydrology and some veg changing over to invasive upland species.

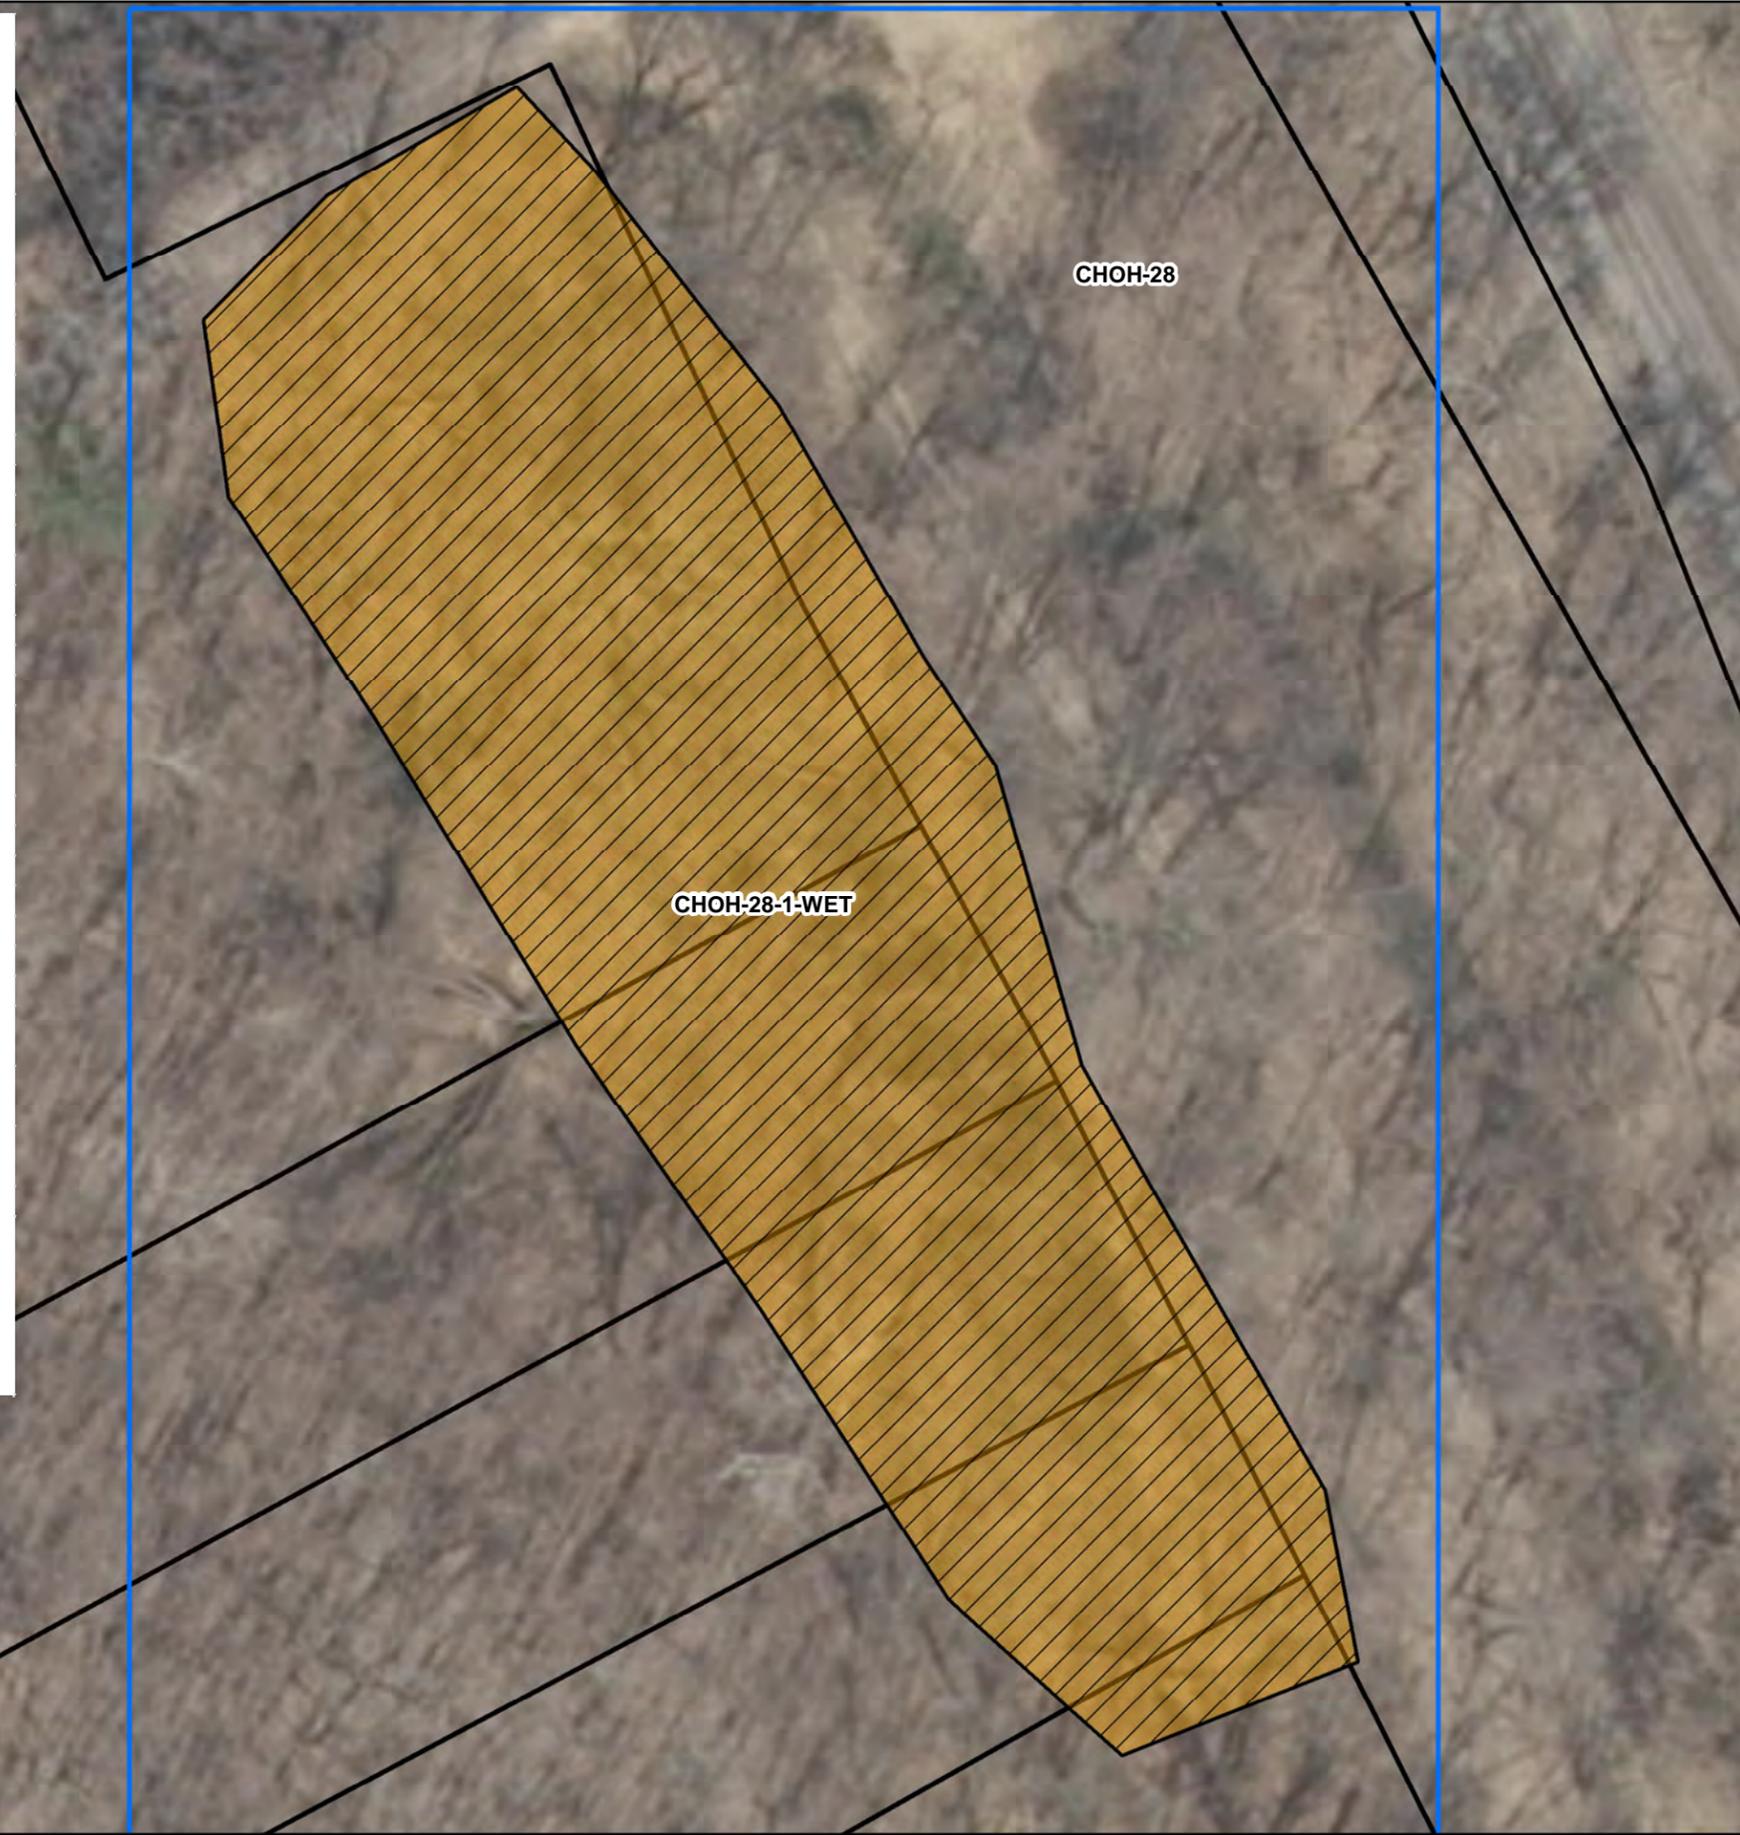
Figure 42
 CHOH-28
 C&O Canal
 NPS/NCR Wetland Restoration Action Plan
 Frederick, Maryland

Notes
 Forested wetland between towpath berm and old road bed. Large amount of multiflora and garlic mustard as well as old concrete walkway/foundation and concrete posts. Removal of concrete as well as debris and invasives.

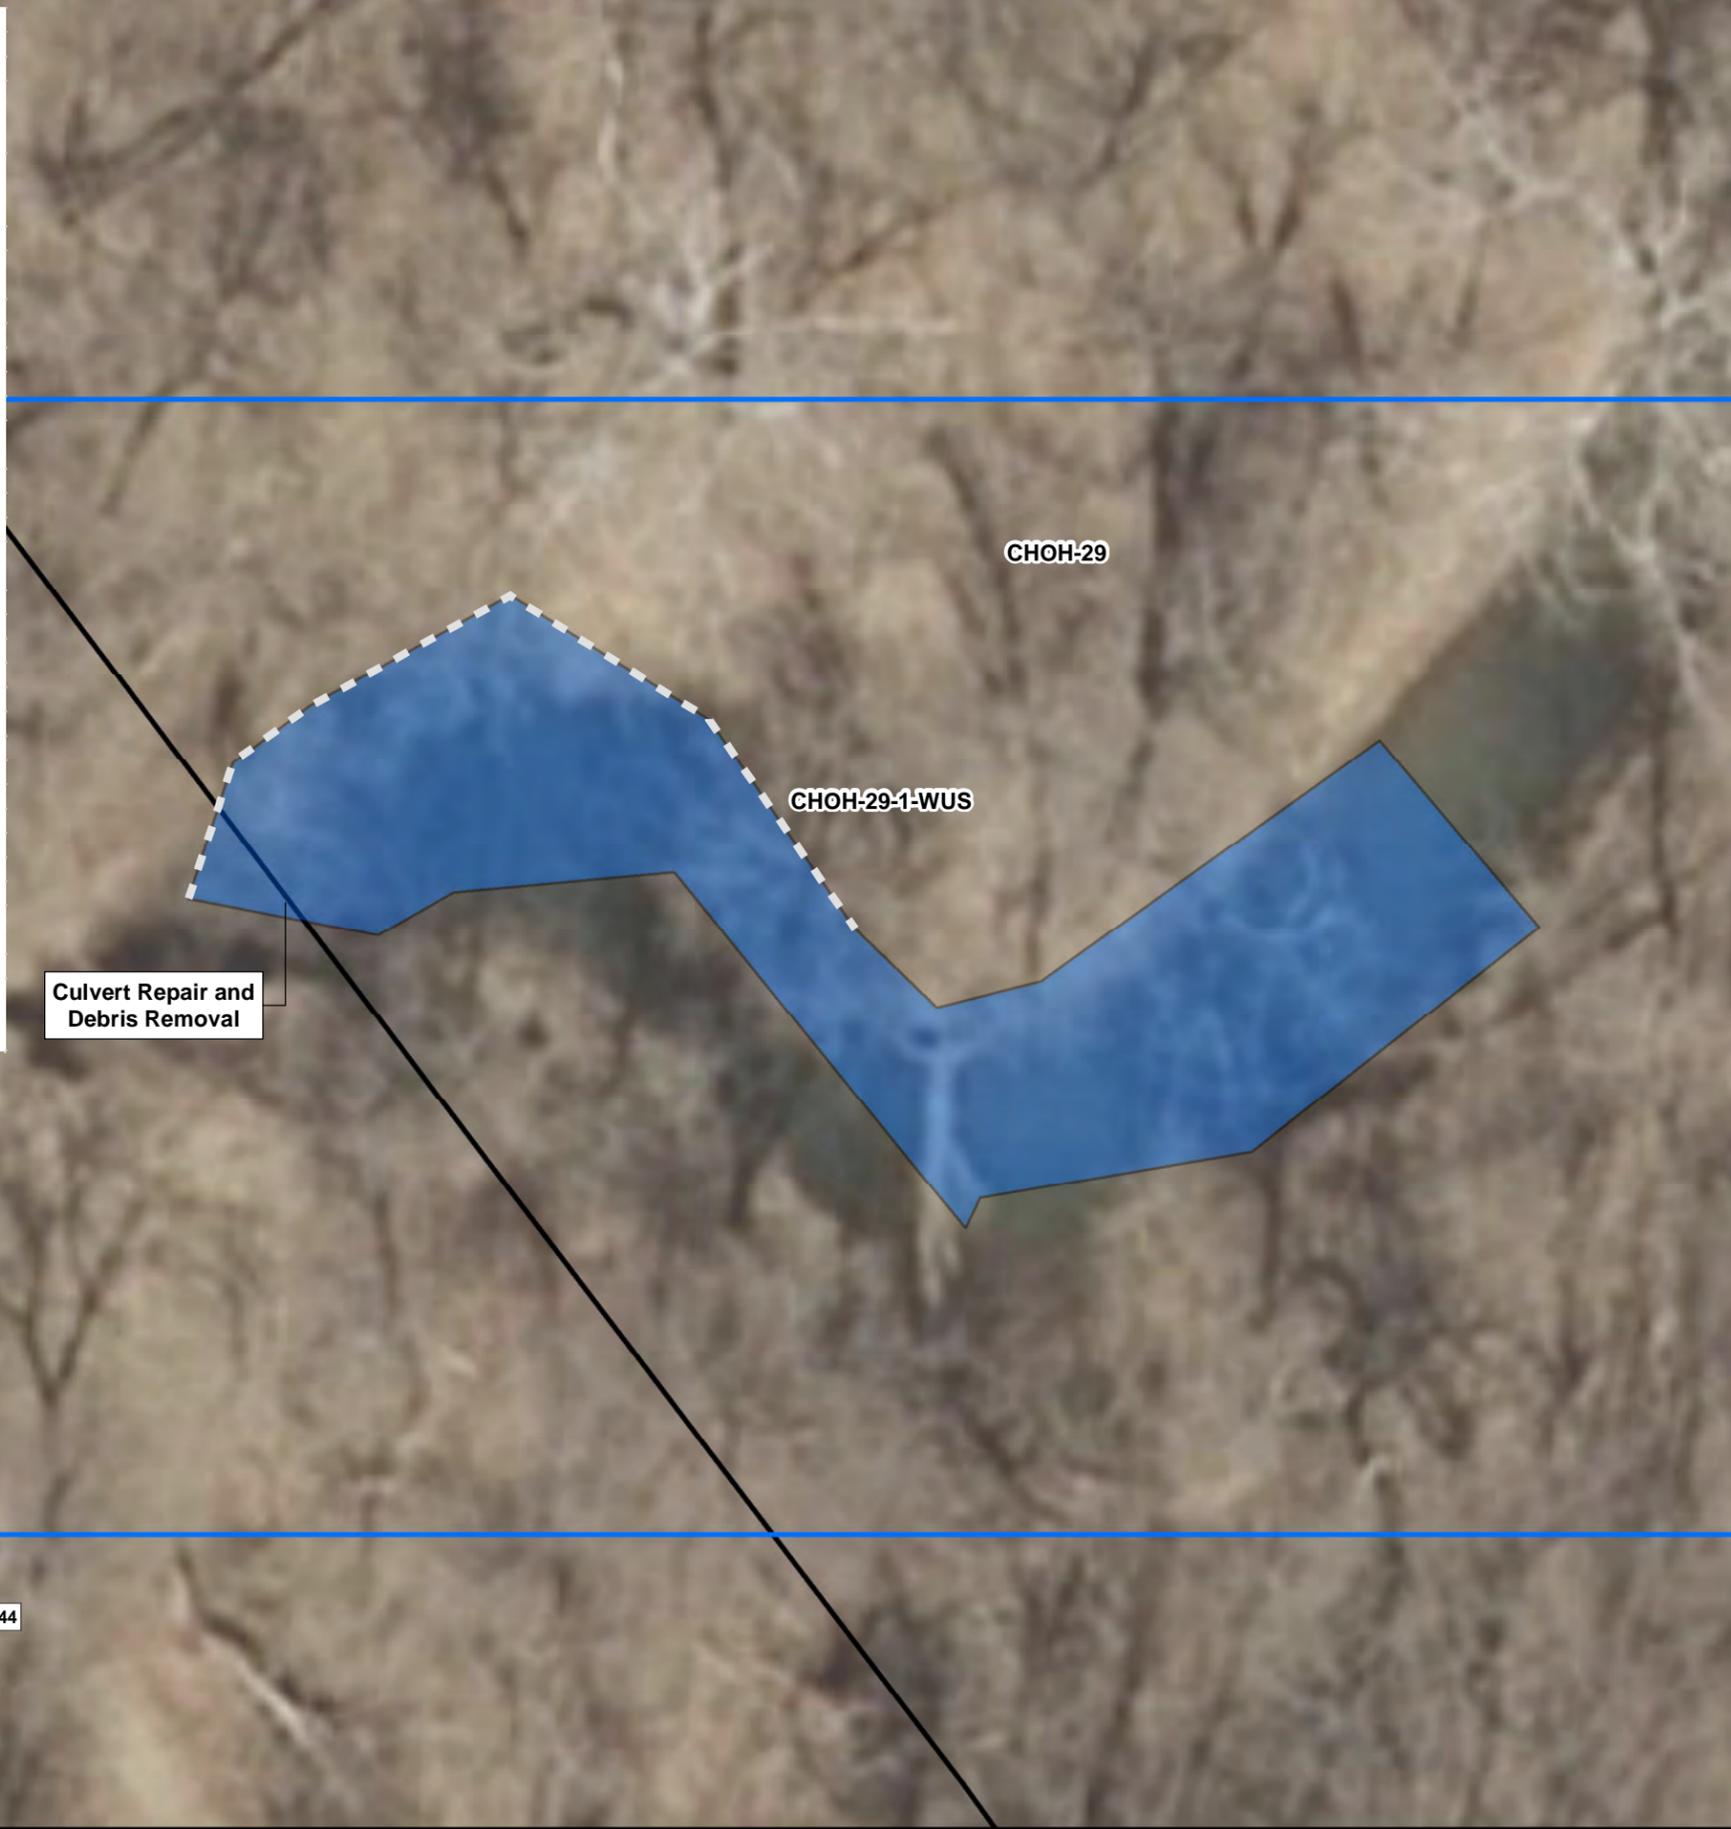
Figure 43
 CHOH-29
 C&O Canal
 NPS/NCR Wetland Restoration Action Plan
 Frederick, Maryland

Site ID	CHOH-29
Potential Restoration (linear feet)	200
Date	4/21/16
Existing Land Use	Forested
Adjacent Land Use	Towpath
Distance to Nearest Road	10ft
Stream Hydrology	Perennial
RTE Species Present?	No
Known Cultural Concern?	Yes
Wetland Restoration Opportunity?	No
Existing Wetlands Present	No
Evidence of Disturbance	No
Can Restoration be Completed in NPS Area?	Yes
Estimated Bank Erosion Score	10
Degree of Channel Incision Score	10
Existing Floodplain Access Score	10
Opportunity for Floodplain Development Score	3
Threat of Impact to Resources Score	10
Surrounding Vegetation Score	4
Land Use Score	3
Opportunity for Ecological Lift Score	7
Ease of Access	8
Surrounding Land Use Score	7
Total Score	72
Invasives Species Control?	No
Riparian Buffer Enhancement?	No
Restore Natural Hydrology?	No
Livestock Agricultural Exclusion	No
Fish Passage?	No
Channel Restoration?	Yes
Increase Aesthetic or Educational Value?	Yes
Other	No
Notes	Highly eroded stream channel causing mass bank failure and culvert collapse. Historic canal culvert collapsing into channel and mass erosion near towpath. Bank armoring required

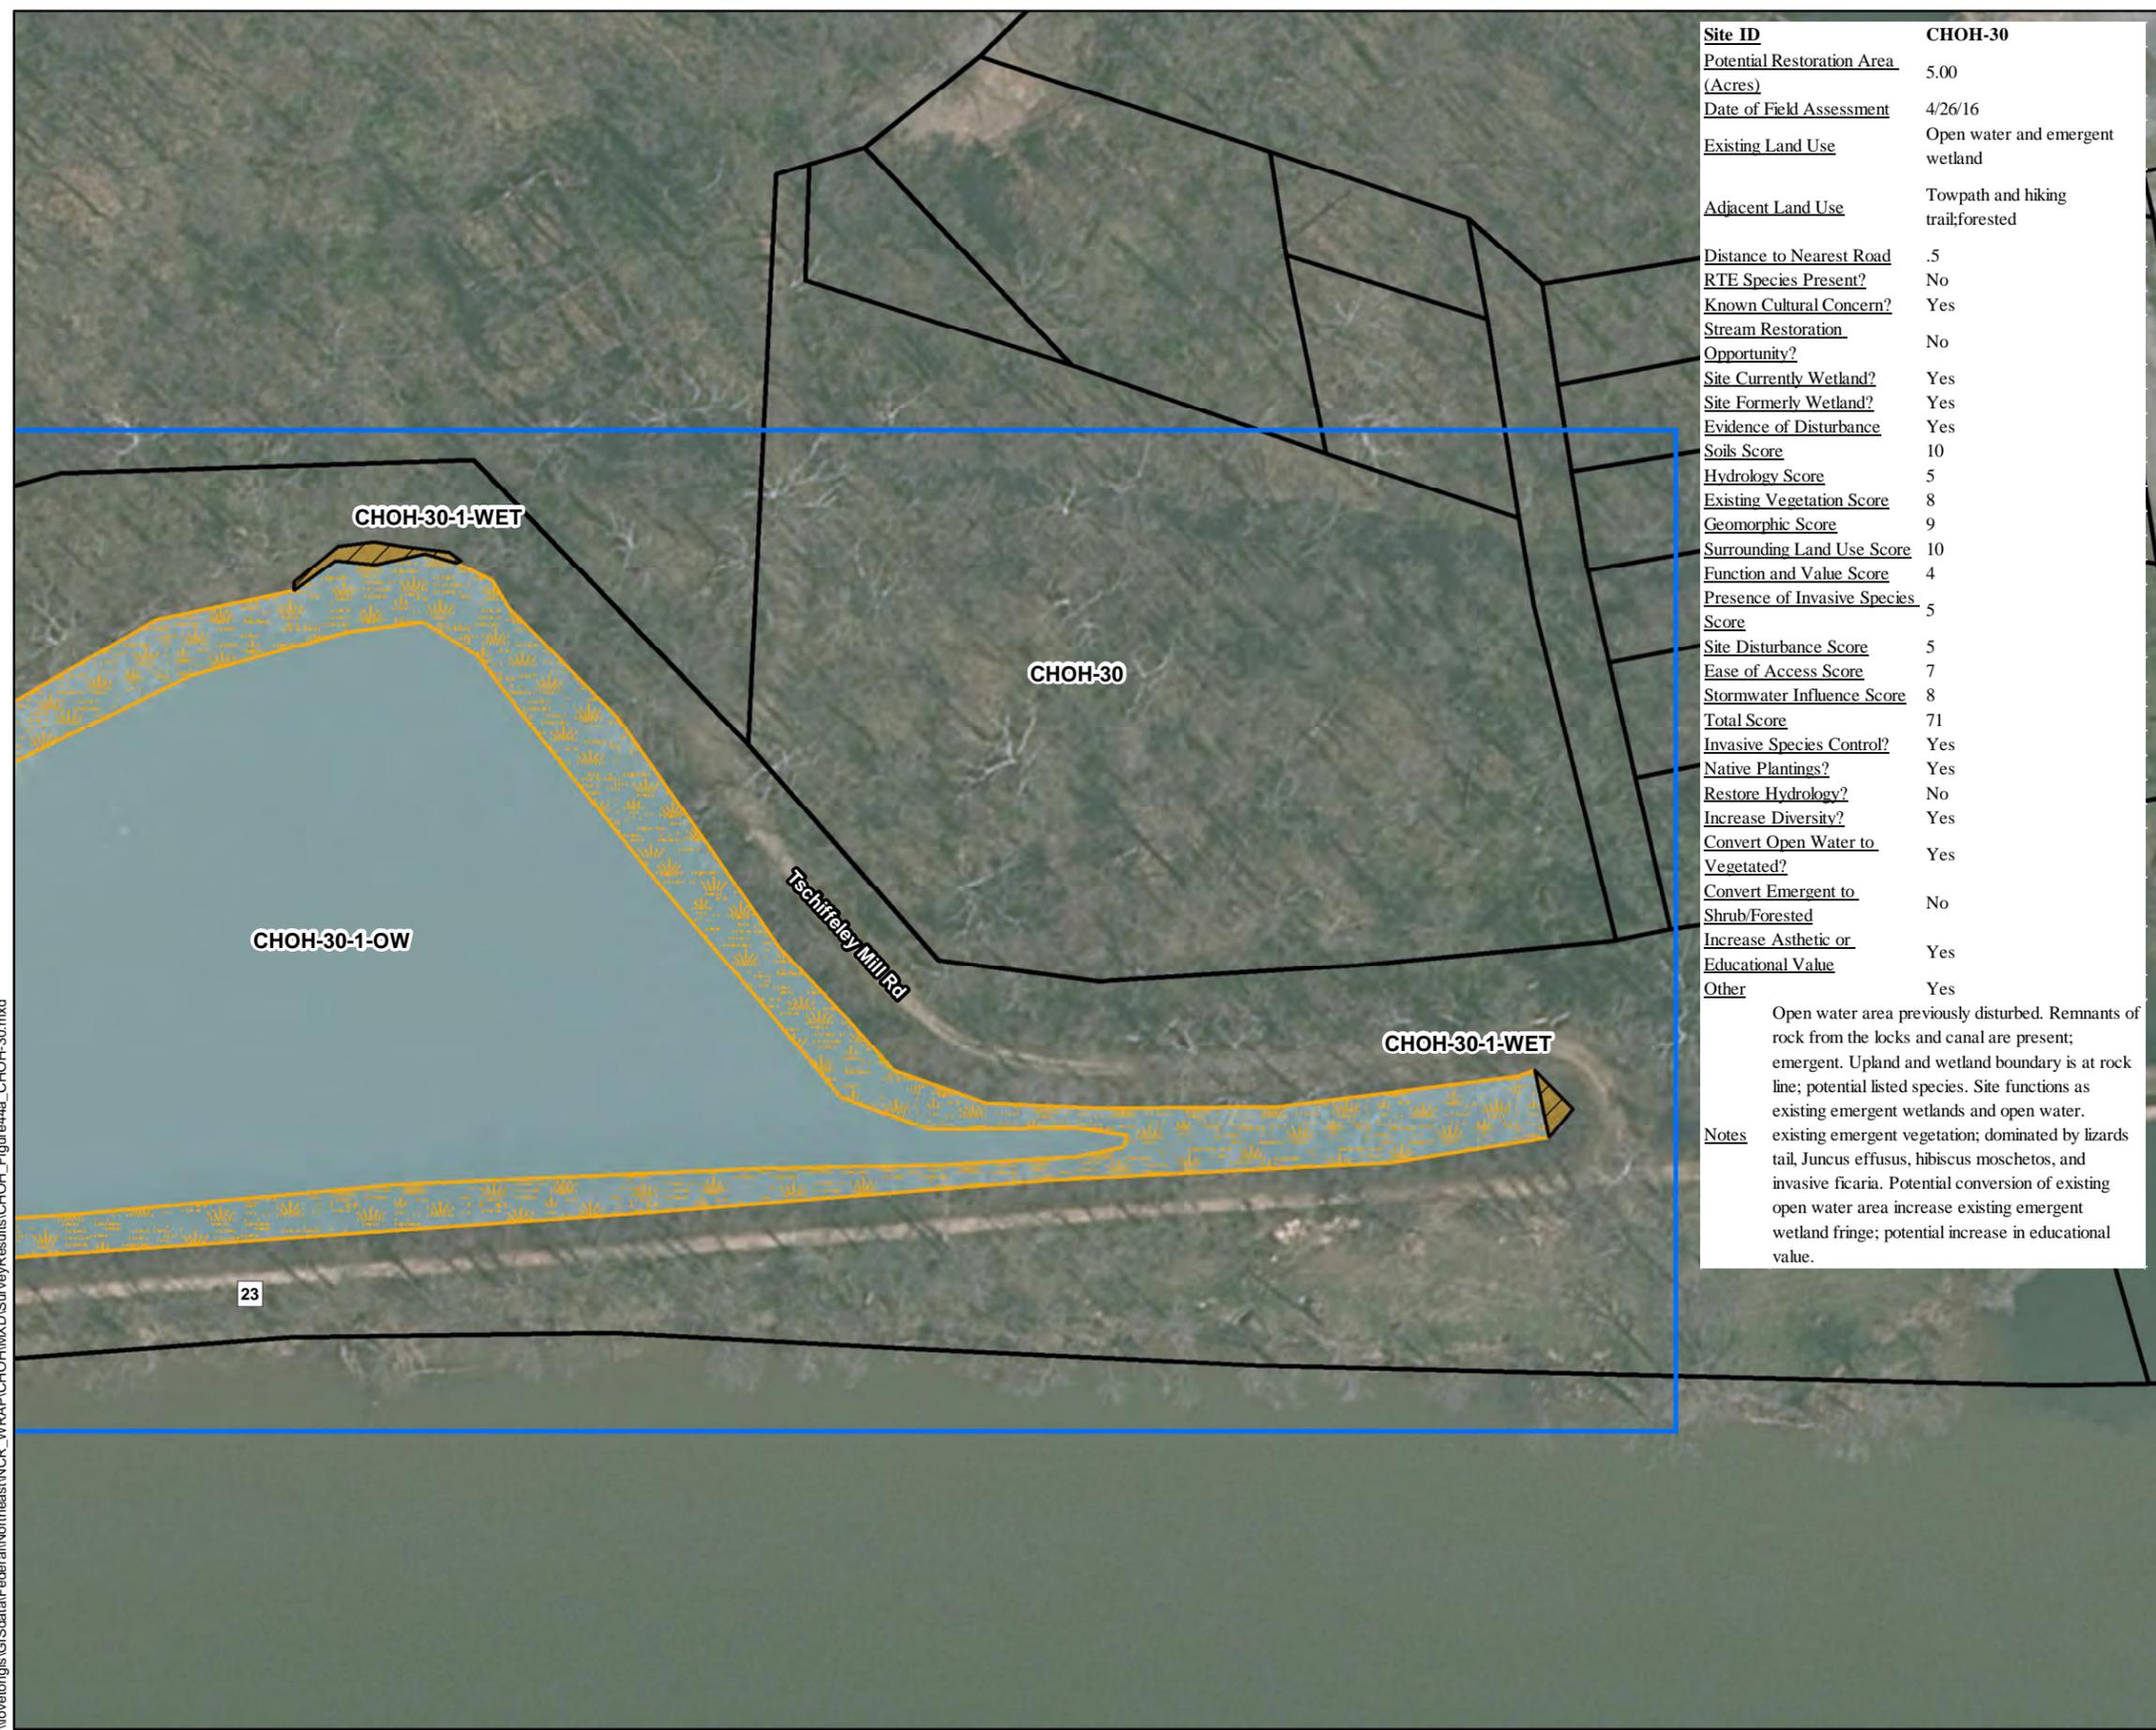
Figure 44a
CHOH-30
C&O Canal
NPS/NCR Wetland Restoration Action Plan
Montgomery, Maryland

<u>Convert Open Water to Vegetated?</u>	Yes
<u>Convert Emergent to Shrub/Forested</u>	No
<u>Increase Aesthetic or Educational Value</u>	Yes
<u>Other</u>	Yes
<u>Notes</u>	Open water area previously disturbed. Remnants of rock from the locks and canal are present; emergent. Upland and wetland boundary is at rock line; potential listed species. Site functions as existing emergent wetlands and open water. existing emergent vegetation; dominated by lizards tail, Juncus effusus, hibiscus moschetos, and invasive ficaria. Potential conversion of existing open water area increase existing emergent wetland fringe; potential increase in educational value.

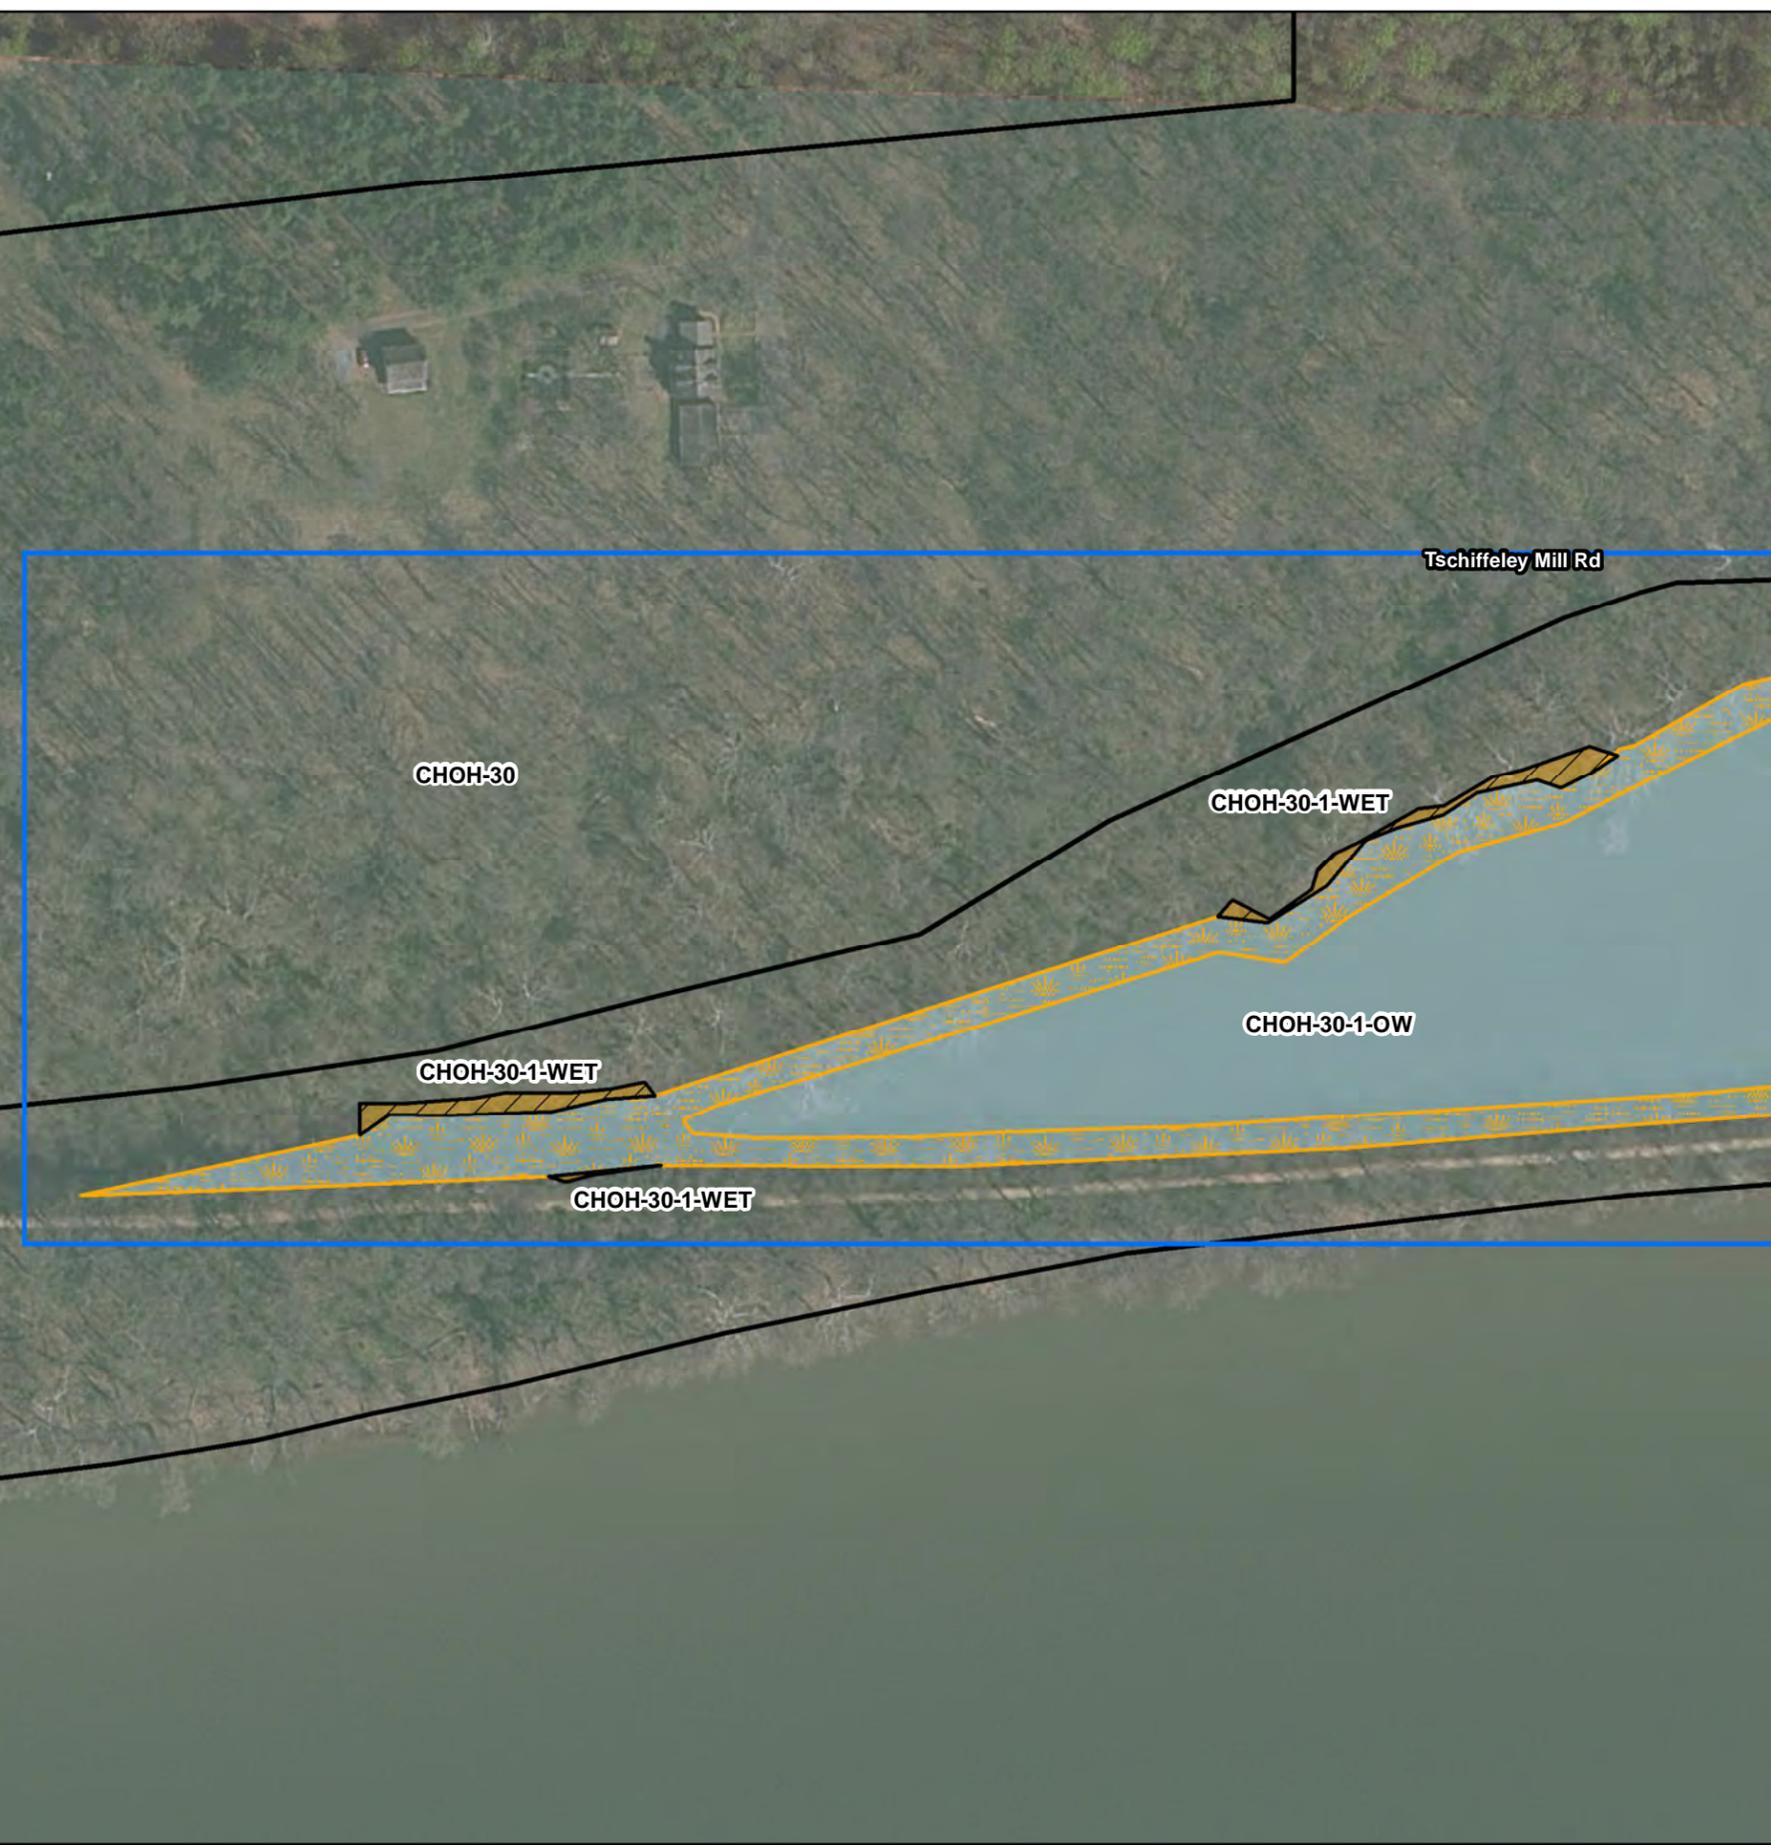
Figure 44b
 CHOH-30
 C&O Canal
 NPS/NCR Wetland Restoration Action Plan
 Montgomery, Maryland

Notes
 Open water area previously disturbed. Remnants of rock from the locks and canal are present; emergent. Upland and wetland boundary is at rock line; potential listed species. Site functions as existing emergent wetlands and open water. existing emergent vegetation; dominated by lizards tail, Juncus effusus, hibiscus moschetos, and invasive ficaria. Potential conversion of existing open water area increase existing emergent wetland fringe; potential increase in educational value.
