Figure 33
CHOH-12
C&O Canal
NPS/NCR Wetland Restoration Action Plan
Washington, D.C.

Figure 34
CHOH-13
C&O Canal
NPS/NCR Wetland Restoration Action Plan
Montgomery, Maryland

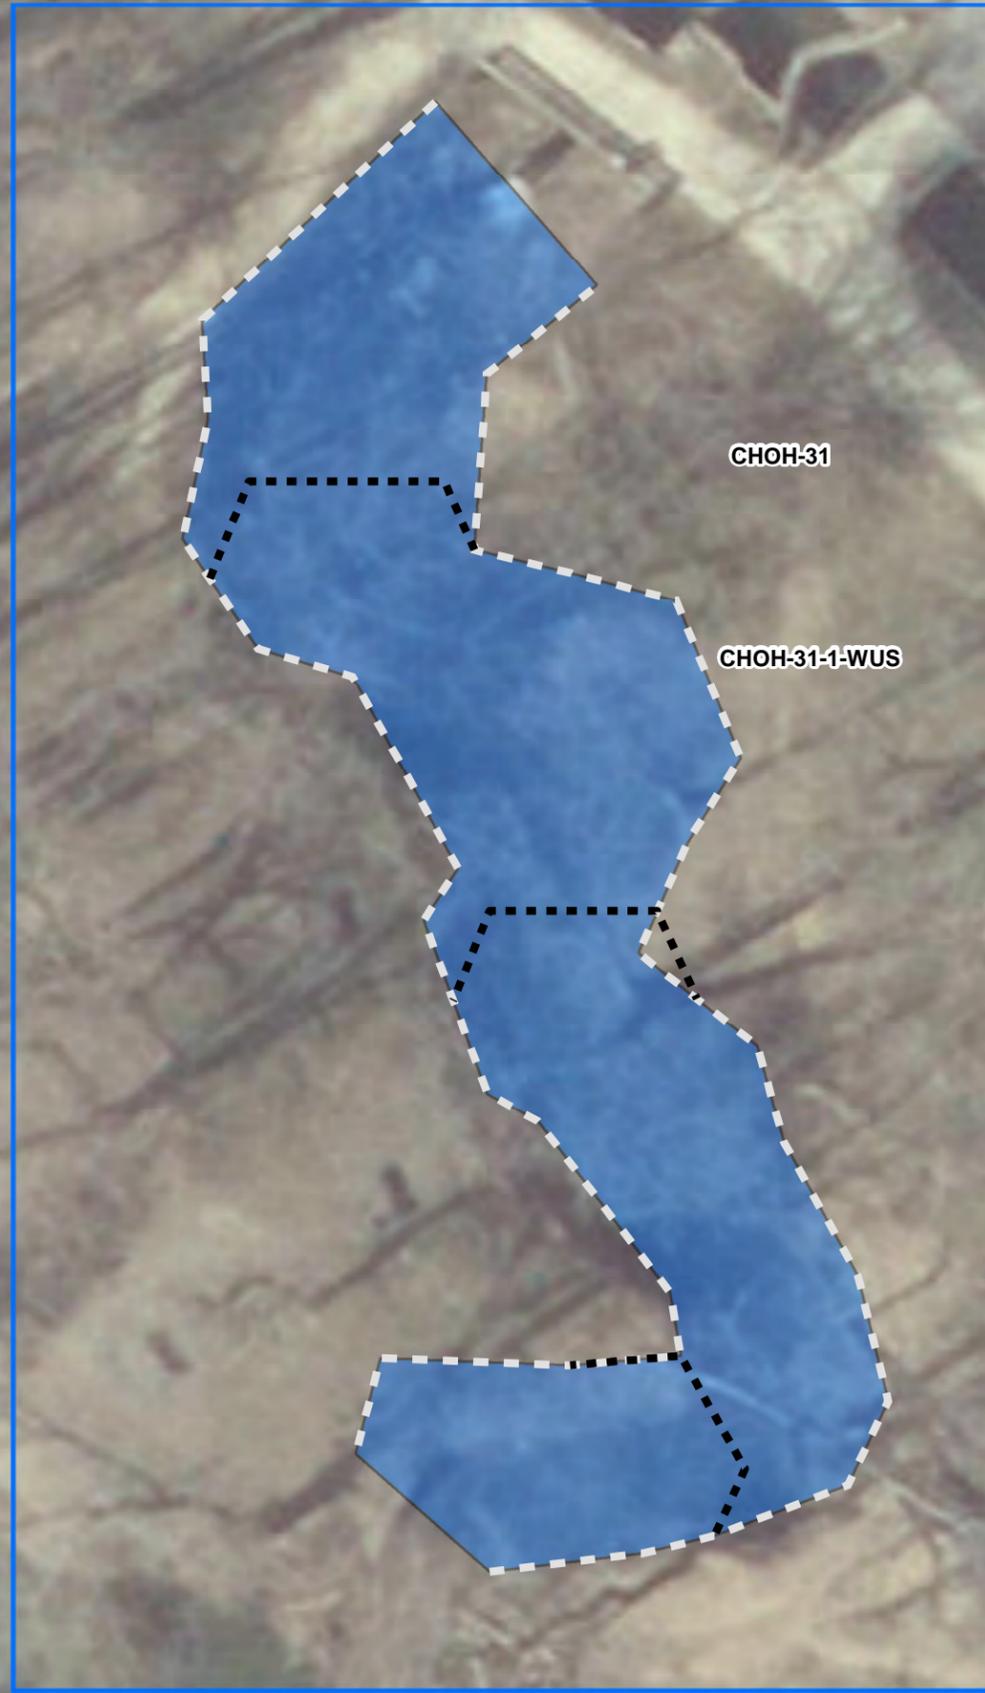
Figure 45
CHOH-31
C&O Canal
NPS/NCR Wetland Restoration Action Plan
Montgomery, Maryland

Potential relocation of stream since flow makes a tight turn or improvement of in stream resources in restoration design to make Channel and stream banks stable. Possible re-connection with Potomac River floodplain that currently does not exist. Extreme erosion on both banks. Most extreme cases 10 or more feet high. Channel likely too wide for out of bank flooding. Potential for floodplain restoration but currently a picnic and camping area.

Notes Grassy picnic area with some large box elders and silver Maples scattered throughout. Could improve surrounding vegetation and in-stream habitat. Excellent access but would have to cross canal; narrow bridge across canal. Recent large tree plantings have just occurred along stream. Construction would require closure of some park resources to the public temporarily. Hydrology not natural because source from canal. Fish passage cannot be improved upon because of canal.

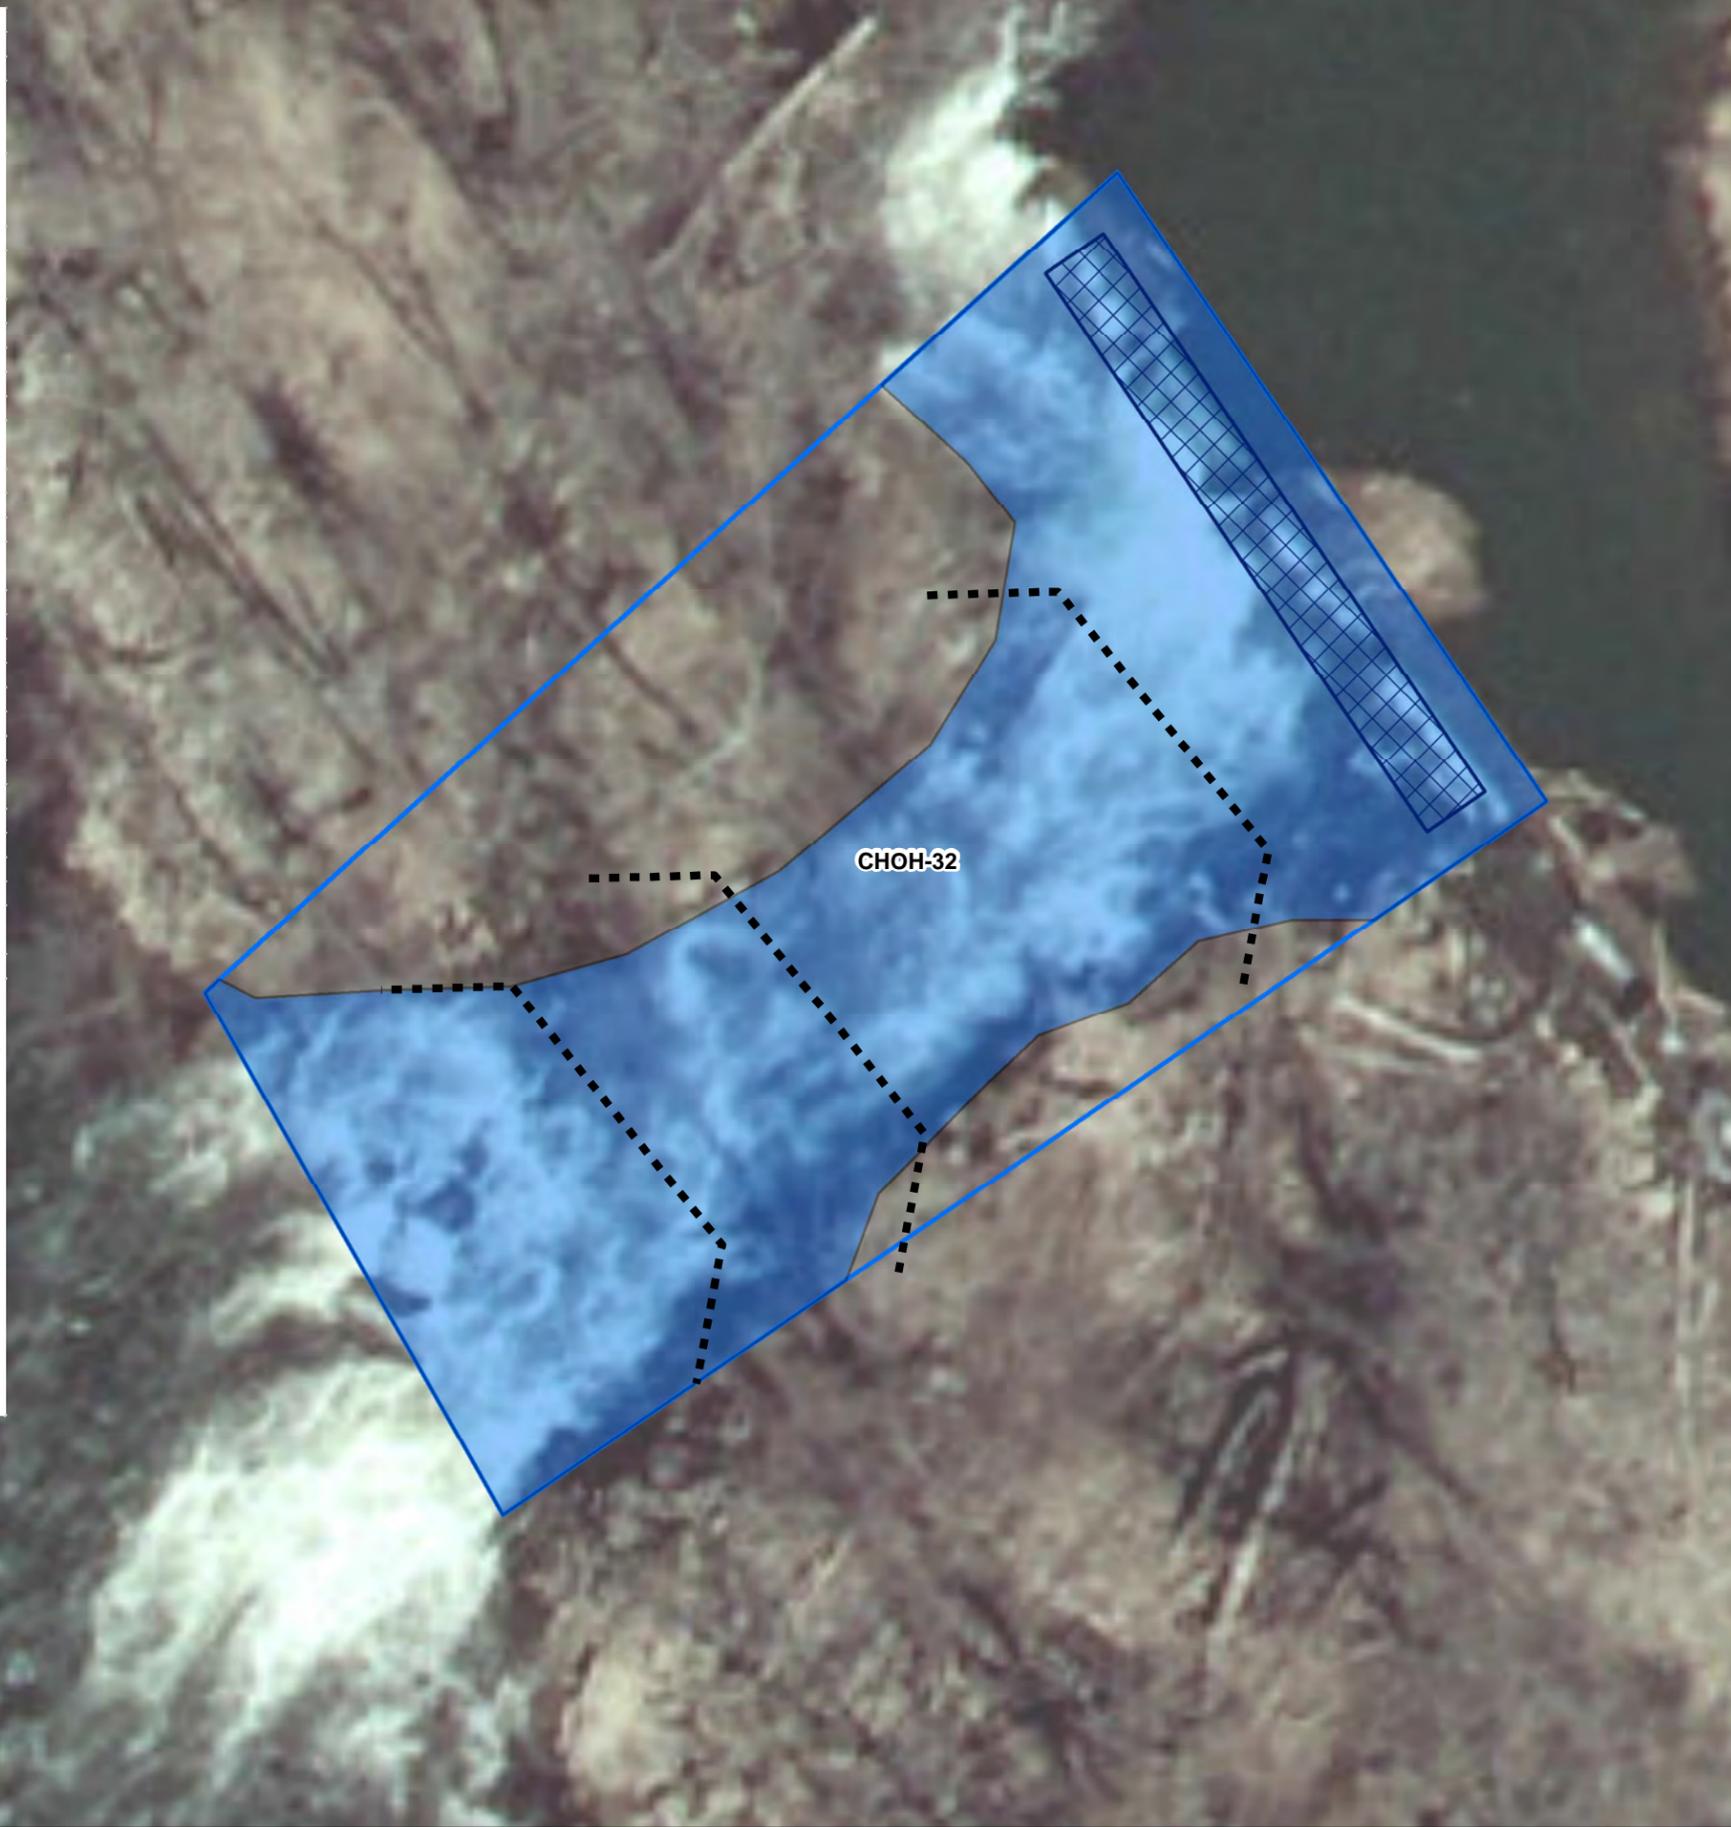
Figure 46
 CHOH-32
 C&O Canal
 NPS/NCR Wetland Restoration Action Plan
 Montgomery, Maryland

Notes
 Breach of canal lock resulted in stream channels, woody debris accumulation, and stream erosion. Restoration could include creating defined channels flowing to the Potomac River. Overflow from canal, especially during storm events which adds to erosion and creation of channels. Minor channelization is present now but has potential to worsen and further incise given time. Channels only exist due to overflow from canal waters. Narrow floodplain width opportunity. Degrading of cultural resources currently occurring. Canal lock has potential to further degrade and lead to destabilization of canal and historic rock. Mature forest and forested riparian buffer along Potomac River. Flow velocities currently too high for sustaining aquatic community. Development of channels and floodplain could improve habitat diversity. Access good but via towpath. Surrounded by NPS land Potential restoration would require rehabilitation of cultural resources associated with canal. Lock is currently degrading and water is flowing out of the lock and canal overland into the Potomac River.

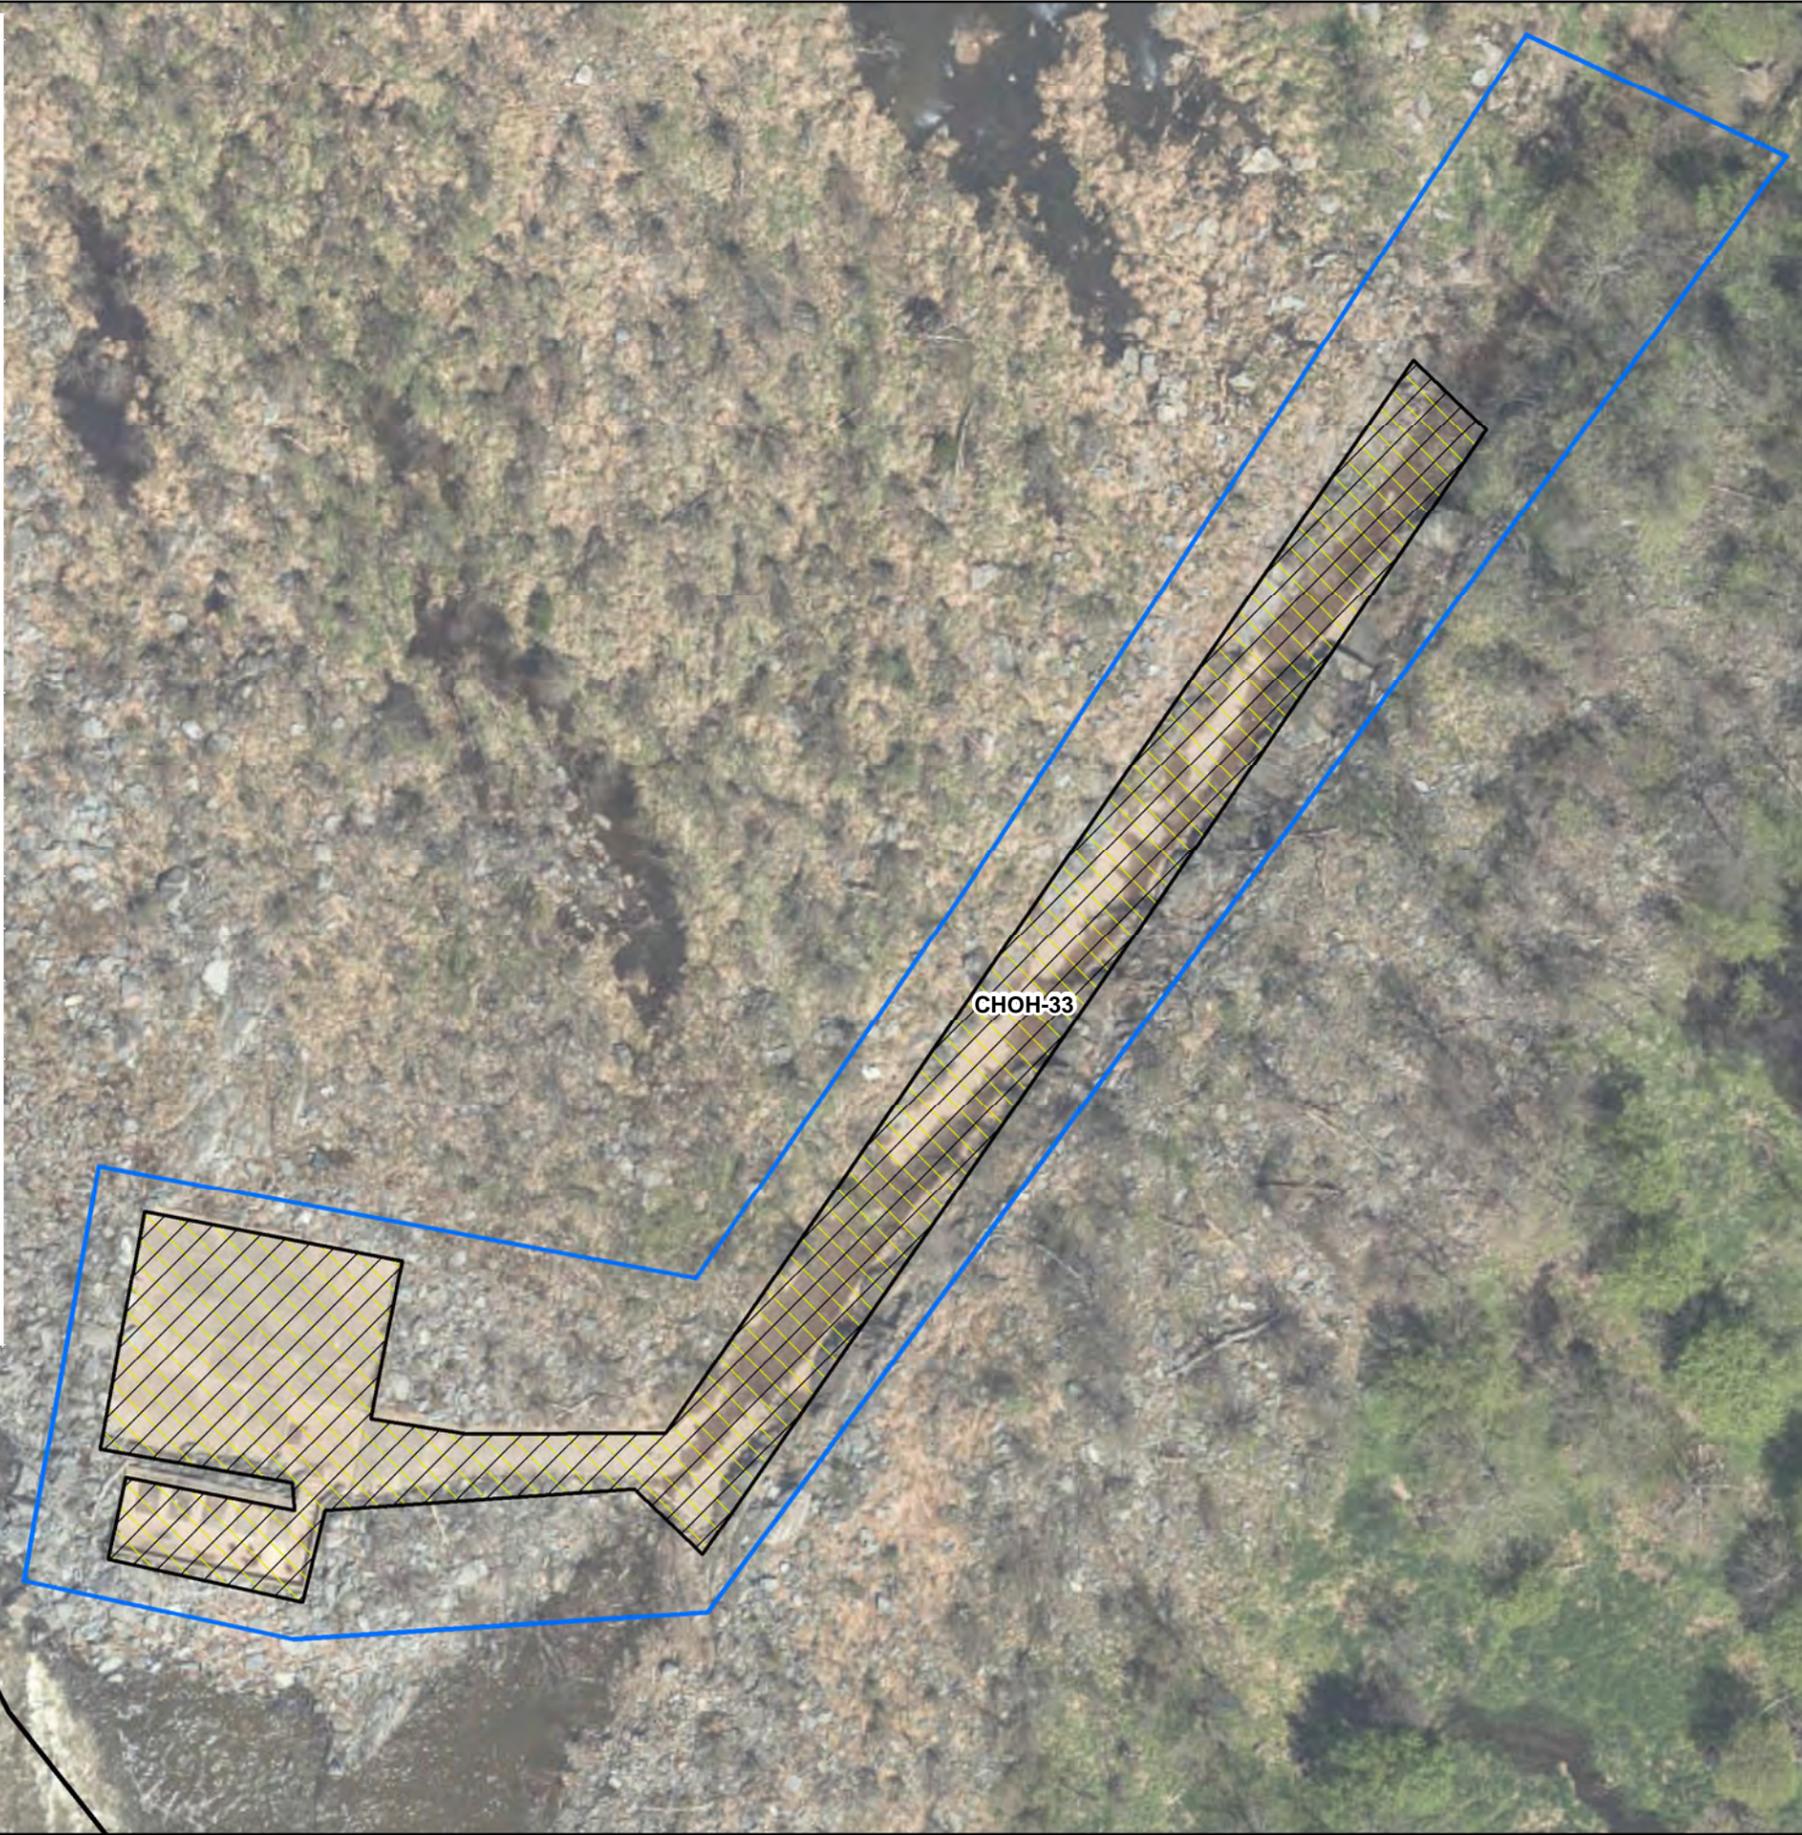
Figure 47
 CHOH-33
 C&O Canal
 NPS/NCR Wetland Restoration Action Plan
 Washington, D.C.

Site ID	CHOH-33
Potential Restoration Area (Acres)	0.50
Date of Field Assessment	4/28/16
Existing Land Use	Abandoned paved
Adjacent Land Use	Forested park land
Distance to Nearest Road	100 feet towpath
RTE Species Present?	No
Known Cultural Concern?	No
Stream Restoration Opportunity?	No
Site Currently Wetland?	No
Site Formerly Wetland?	Yes
Evidence of Disturbance	Yes
Soils Score	0
Hydrology Score	2
Existing Vegetation Score	10
Geomorphic Score	8
Surrounding Land Use Score	10
Function and Value Score	10
Presence of Invasive Species Score	4
Site Disturbance Score	10
Ease of Access Score	7
Stormwater Influence Score	10
Total Score	71
Invasive Species Control?	No
Native Plantings?	Yes
Restore Hydrology?	Yes
Increase Diversity?	Yes
Convert Open Water to Vegetated?	No
Convert Emergent to Shrub/Forested	No
Increase Aesthetic or Educational Value	Yes
Other	No
Notes	Potential for restored RTE species. Completely paved. Historic hydrology may have been Potomac River floodplain and groundwater inflow. No vegetation on paved area but surrounding area is sycamore dominated. Upland forested park land to northeast. No stormwater influence observed. Existing pavement appears abandoned and could be removed. Flood plane and native plantings could be restored. Visitor access could be improved aesthetically. Could create fishing pier and bird viewing area.
