# Technical Synthesis Report for Physical and Ecological Resources at Fire Island National Seashore

Natural Resource Report NPS/FIIS/NRR—2017/1415

March 2017

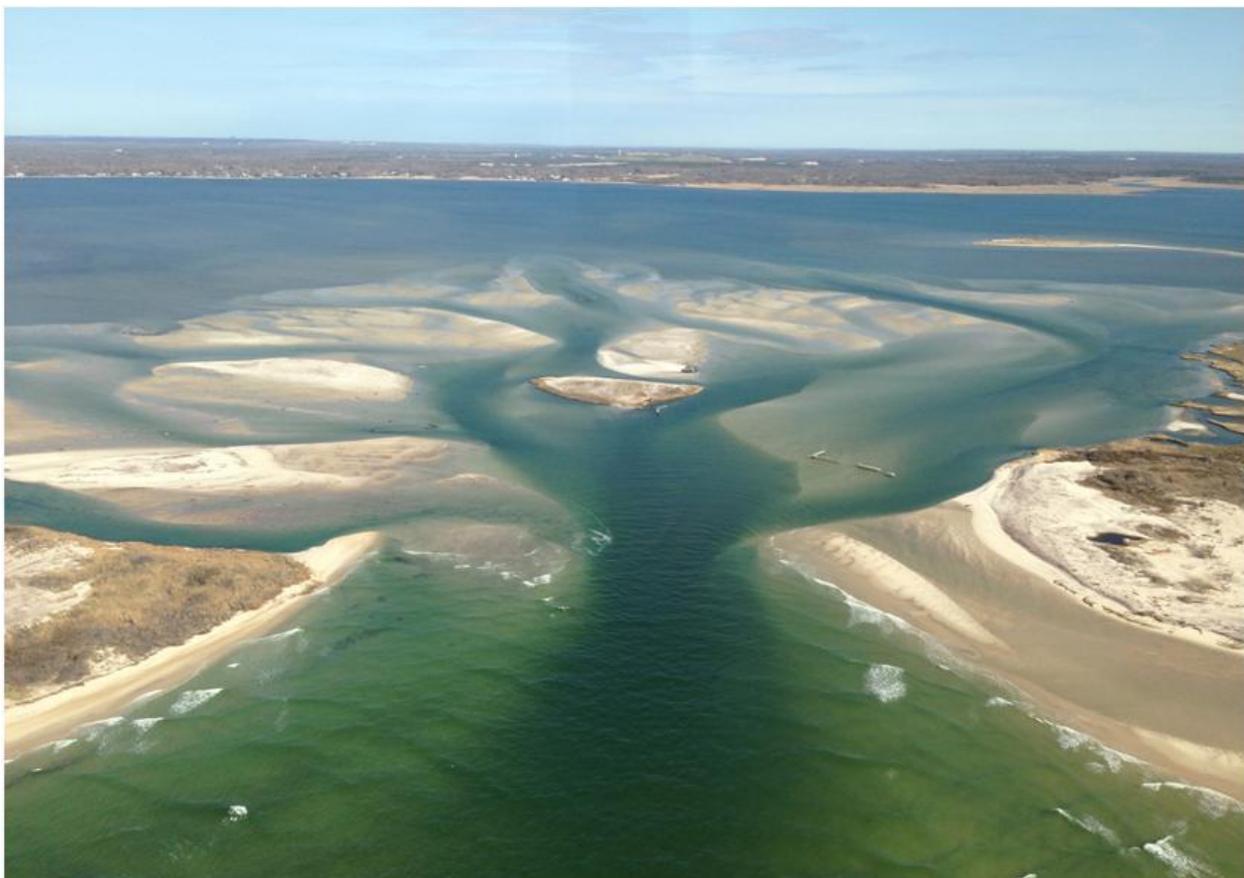
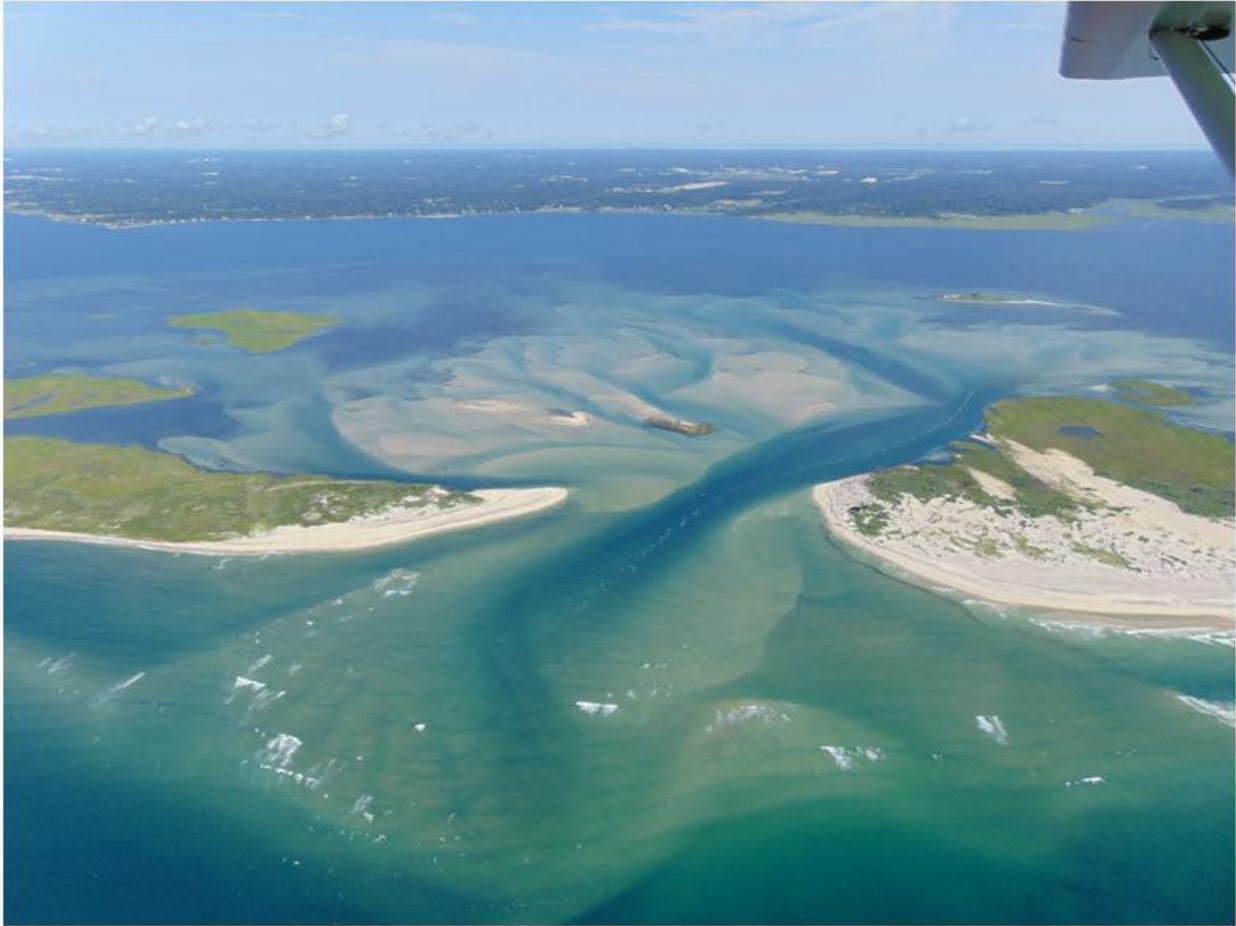
Photograph of the breach at Fire Island National Seashore.  
Photograph courtesy of Charles Flagg, June 24, 2014.

Photograph of the breach at Fire Island National Seashore.  
Photograph courtesy of John Vahey, April 18, 2013.

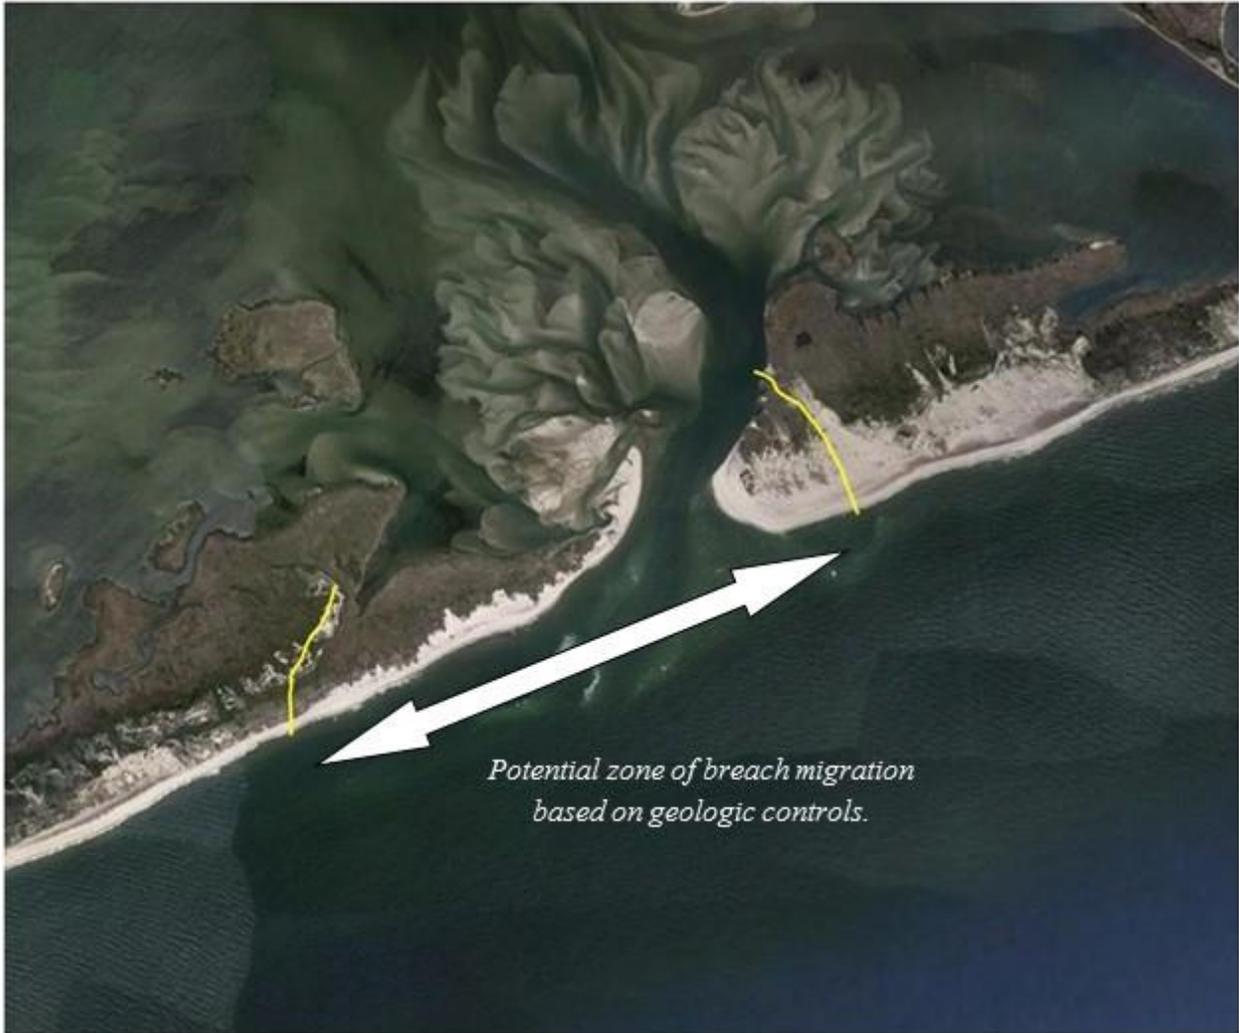
**Figure 25.** Projected zone of breach migration based on geologic controls identified through coring by USGS. Photo from GoogleEarth, May 23, 2015.

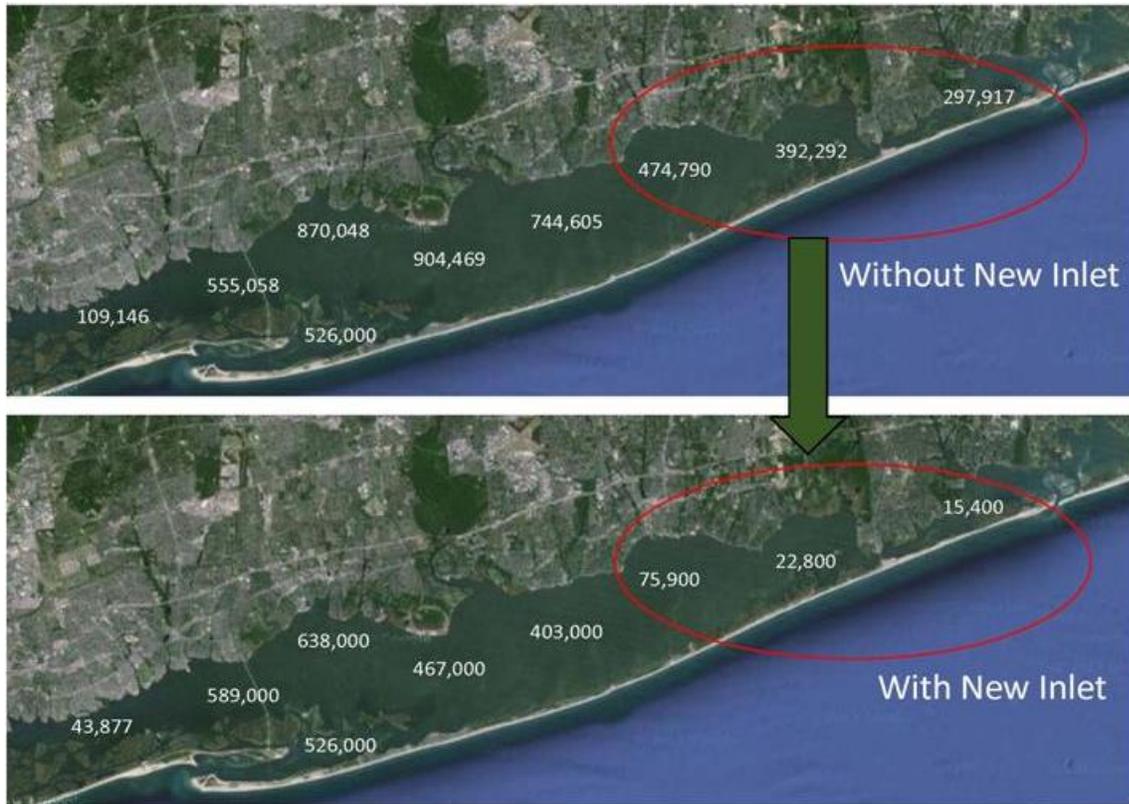
**Figure 37.** Brown tide (cells/mL) in Great South Bay, June 2013 (Gobler, Collier, and Lonsdale 2014)

Since breach formation, there has been a reduction in the intensity of brown tide in eastern Great South Bay, in the areas of Bellport Bay and the Narrow Bay (Gobler, Collier, and Lonsdale 2014). Likewise, an increase in the frequency and intensity of brown tide in central Great South Bay has been documented. This is indicated in 2013 brown tide sampling which showed cell densities averaged ~400,000 cells/mL, with some sampling stations in the central Great South Bay area having densities over 1.2 million cells/mL (Gobler, Collier, and Lonsdale 2014). In the vicinity of the breach (Figure 37), cell densities were lower (ranging from about 22,800–75,900 compared with an average of 400,000) during the 2013 bloom. Figure 38 shows the 2013 brown tide cell densities in both a bar graph, and a sampling station map. The figure shows that cell densities were lower at stations close to inlets and the breach (blue bars on graph), when compared with more distant stations (brown bars on graph). Arrows on the lower figure point to sampling stations located near the inlet and breach, where cell densities are lower. Frequency of brown tide blooms has also increased in Great South Bay overall; Brown tide blooms occurred in 4 of the 13 years preceding the breach (2000–2012) but occurred in each year since the breach: 2013, 2014, and 2015 (Gobler, Collier, and Lonsdale 2014).

More rapid reduction in the cell density of brown tide following the 2013 bloom occurred in areas closer to all inlets and the wilderness breach, with cell densities between 1 and 2 orders of magnitude lower near the inlets. Post-breach cell densities of the 2013 brown tide bloom were substantially lower than those measured during two bloom years (2000 and 2008) that occurred prior to the breach (Figure 39). Plankton community composition also differed spatially during 2013–2014, with large chain-forming diatoms dominant at the inlets, distinct from species found at central bay sites where ciliates and *Thalassioria* species were more common (Figure 40). This is notable because large form phytoplankton are a better food source for filter feeders, relative to small form species. Gobler noted a decline in the toxic dinoflagellate, *Dinophysis acumanata*, and pathogenic strains of bacteria in Great South Bay. Aerial photographs of the breach site (Figure 41) captured in 2014 showed a “flushing out” of brown tide cells resulting from water exchange between the estuarine and oceanic environments.

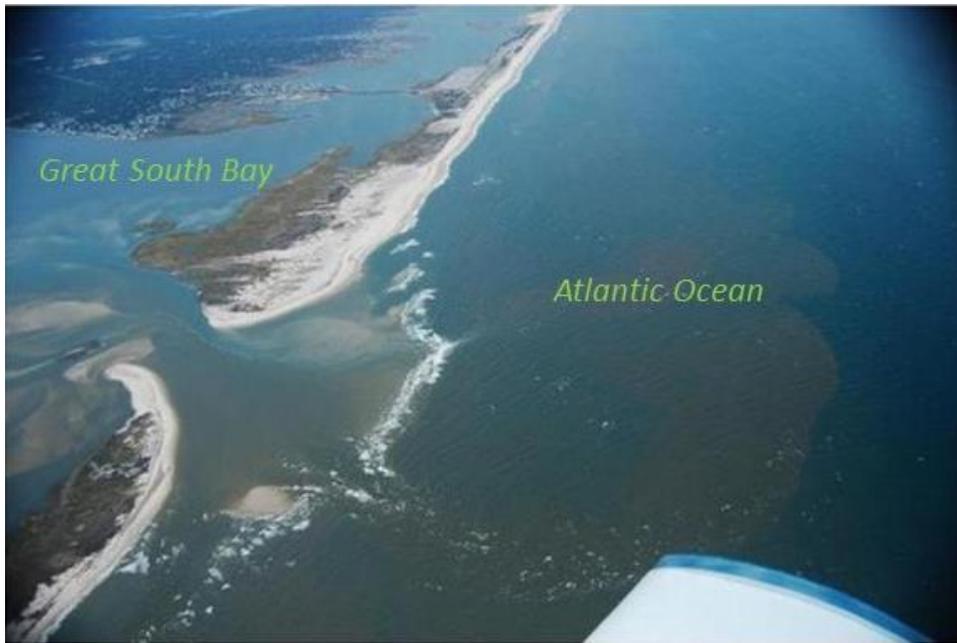
**Figure 41.** Wilderness breach exports brown tide (Fall 2014) (Gobler, Collier, and Lonsdale 2014).

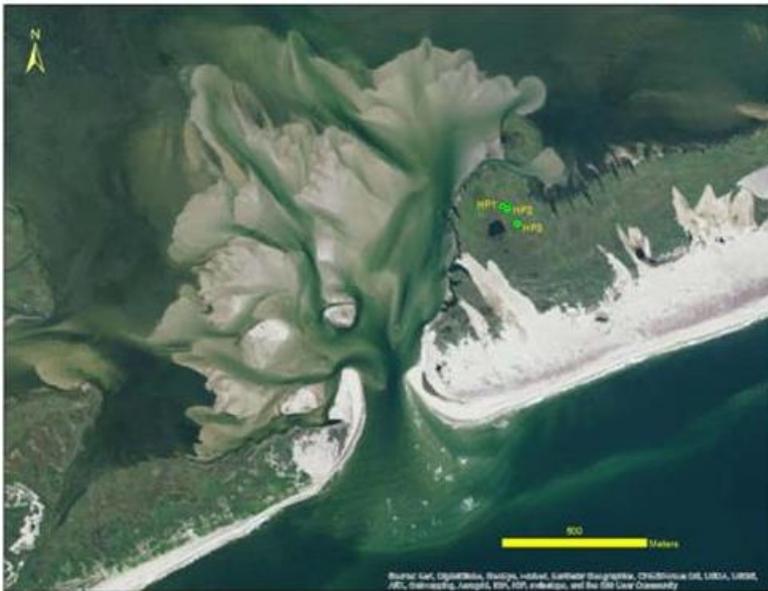
**Figure 42.** Aerial image (June/July 2013) showing location of the Hospital Point Marsh SET monitoring sites. Note the extensive flood-tidal delta associated with the Wilderness Breach and overwash sand deposits on the marsh surface in the vicinity of the SET sites (Roman and Lynch pers. comm. 2016).

and can increase the elevation of the marsh (Figure 42). The areas east of Watch Hill and extending to Moriches Inlet where salt marshes are most common on Fire Island, are known to have had several inlets and overwash events during the past two centuries (Leatherman and Allen 1985). In the area of the current breach and to the east (Great Gun), there is evidence from sediment cores, dating back to the late 1700s, that marsh establishment historically has coincided with the formation of inlets (Roman et al. 2007).

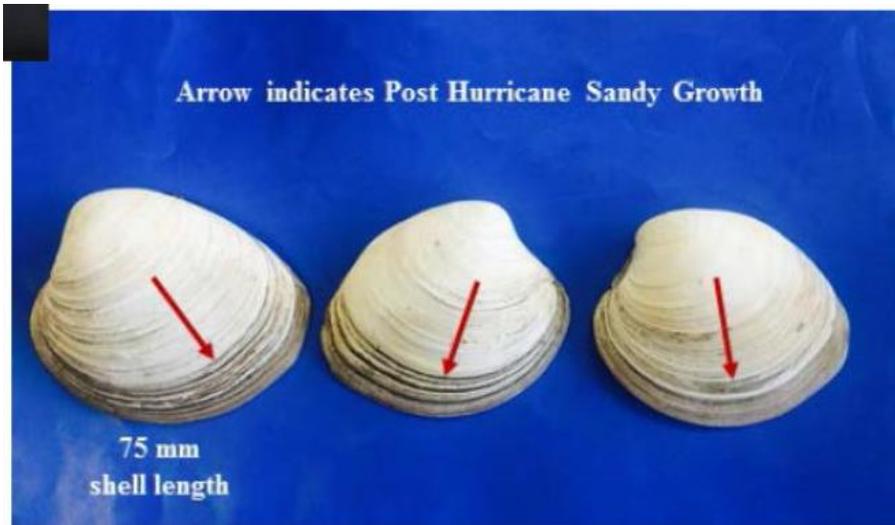
**Figure 60.** Hard clams collected in Bellport Bay after Hurricane Sandy (from Starke and LoBue 2016).

Improved measures of clam success in Bellport Bay after the breach have also been noted by Starke and LoBue (2016). Clams collected before and after the breach in Bellport Bay show marked differences in growth rates (Greene 1978; Starke and LoBue 2016). Whereas prior to Hurricane Sandy, clams in this location had slow growth rates and chalky white shells due to the acidic sediment in which they lived. Clams collected in Bellport Bay after Hurricane Sandy have secreted large and healthier-appearing growth rings in their shells, indicating improved growth rate and sediment habitat condition (Figure 60). Starke and LoBue (2016) also noted improvements in CI values for clams in Bellport Bay. Researchers sampled 20 individuals of naturally occurring clams from the same locations on the same date. The results show a striking improvement in CI from before the breach in 2009 compared to after the breach in 2015 at Bellport Bay, whereas CI for central Great South Bay was relatively unchanged over the same time period (Figure 61) (Starke and LoBue 2016). These improvements in clam growth and CI are attributed to improvements in water quality, as increased rates of flushing are able to locally suppress blooms of brown tide algae and improve food quality in Bellport Bay (Starke and LoBue 2016).
