STREAM HABITAT SURVEYS OF PROPOSED BRIDGE CROSSINGS ON THE BROOKS EAST CORRIDOR

July 2014

In 2013, ABR’s summer field survey efforts focused on stream and riparian habitat assessments at proposed bridge crossings along the corridor. Fish sampling was not conducted in 2013. This report summarizes the 2013 stream habitat surveys and integrates these results with data on known fish assemblages in those waterbodies.

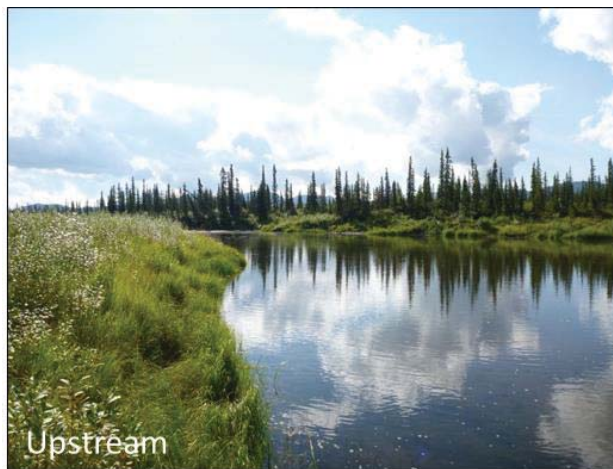
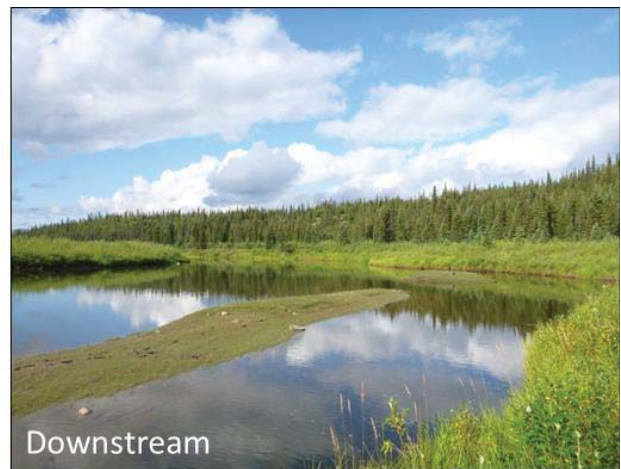
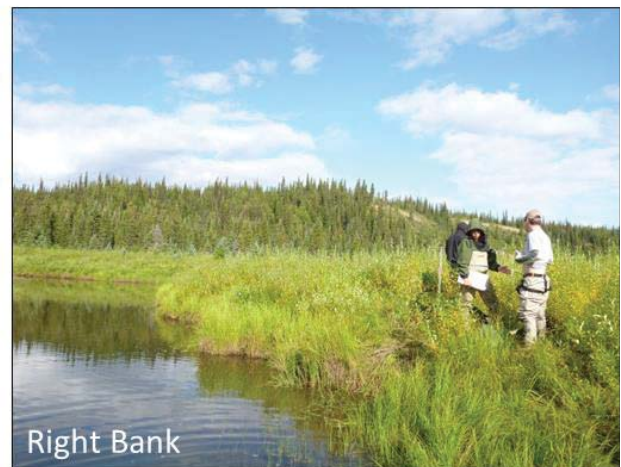
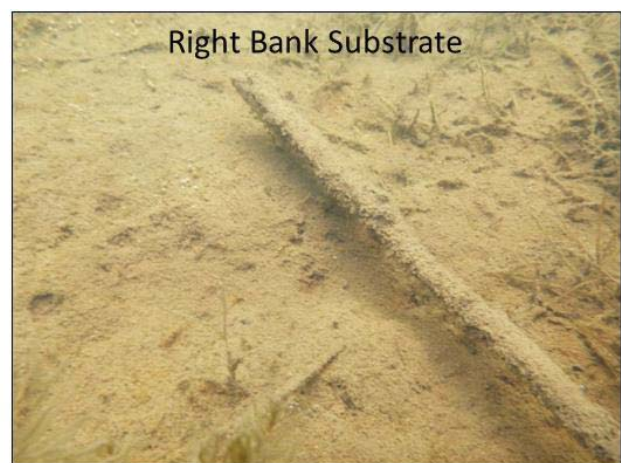
Plate 1. Stream channel characteristics, riparian habitat, and instream substrate composition at transect SH-T1-13, Shungnak River, Brooks East Corridor, Alaska, August 2013.

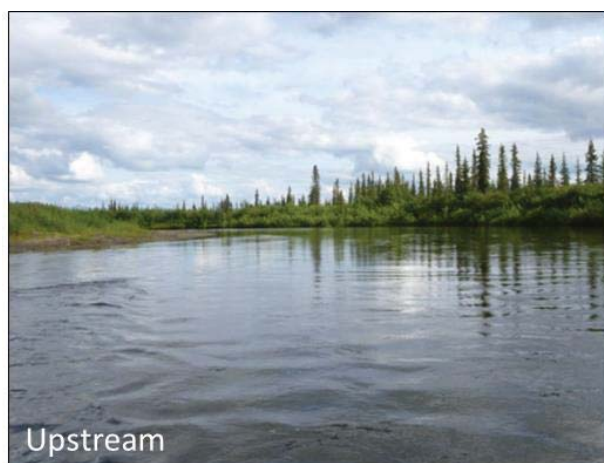
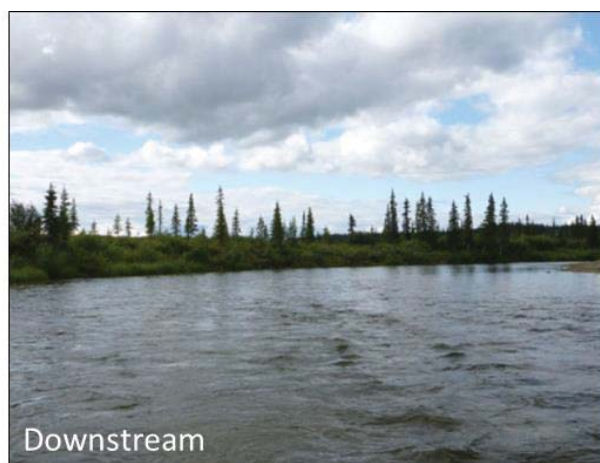
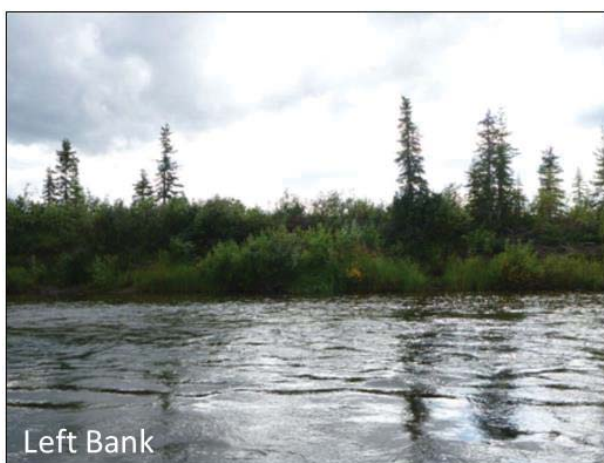
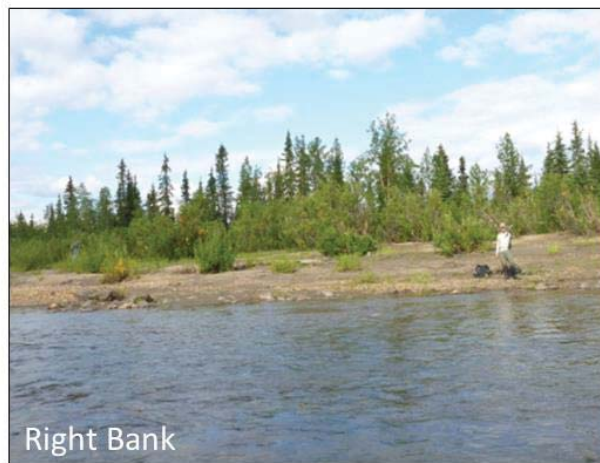
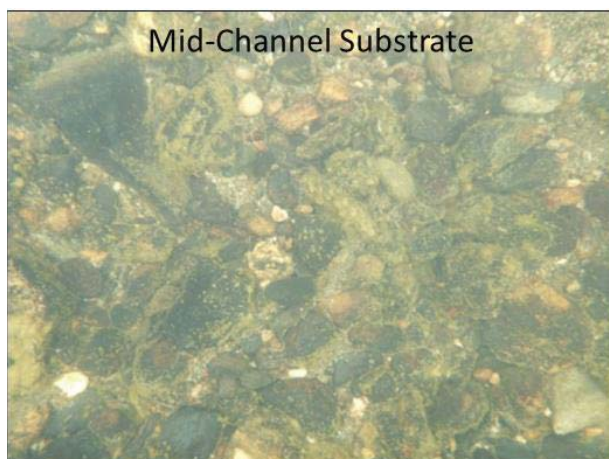
Plate 2. Stream channel characteristics, riparian habitat, and instream substrate composition at transect SH-T2-13, Shungnak River, Brooks East Corridor, Alaska, August 2013.

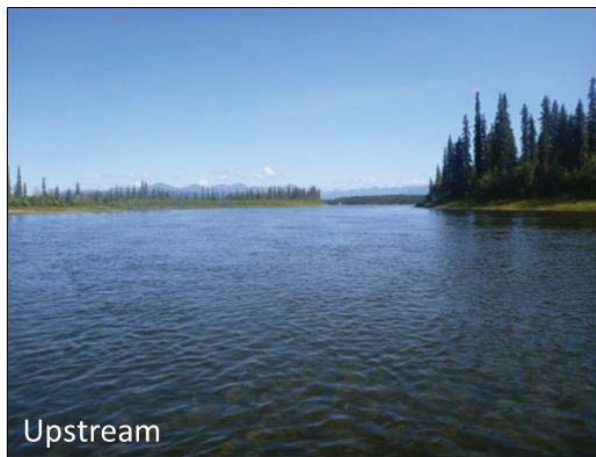
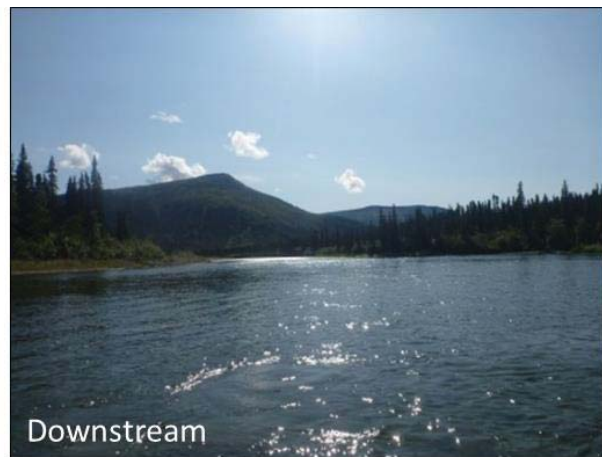
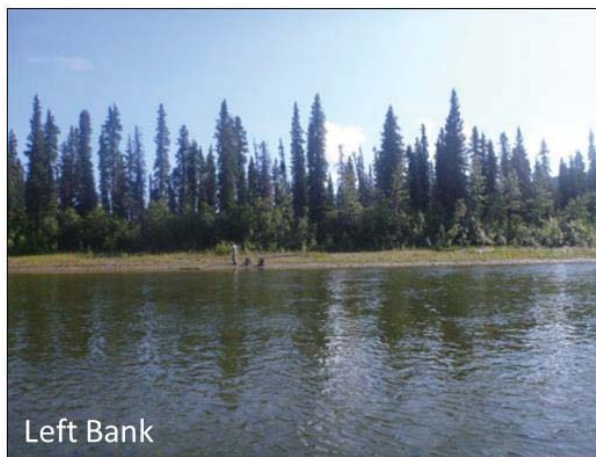
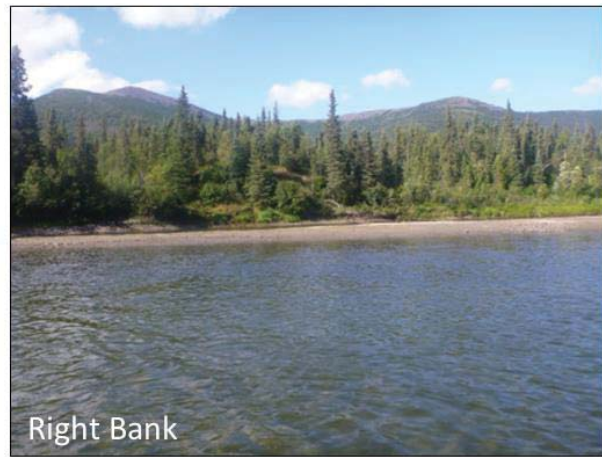
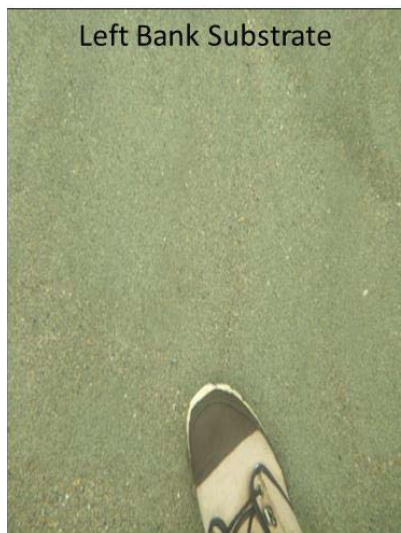
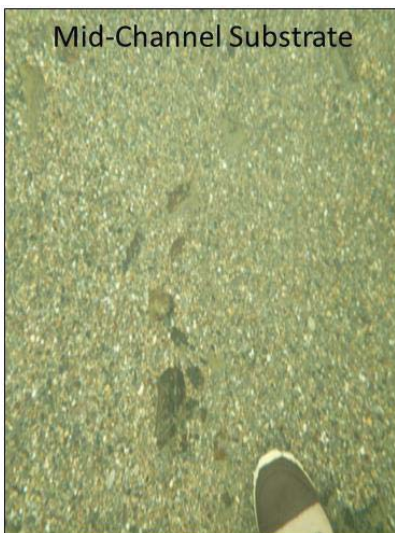
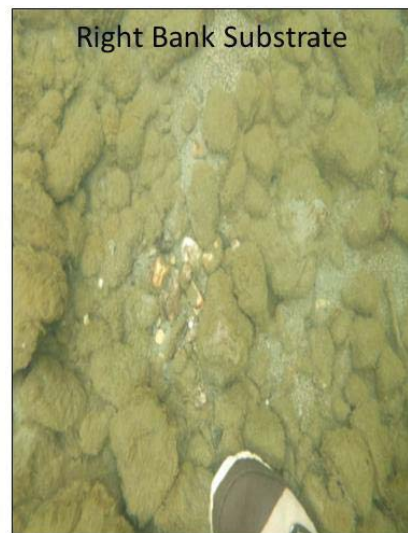
Plate 3. Stream channel characteristics, riparian habitat, and instream substrate composition at transect SH-T3-13, Shungnak River, Brooks East Corridor, Alaska, August 2013.

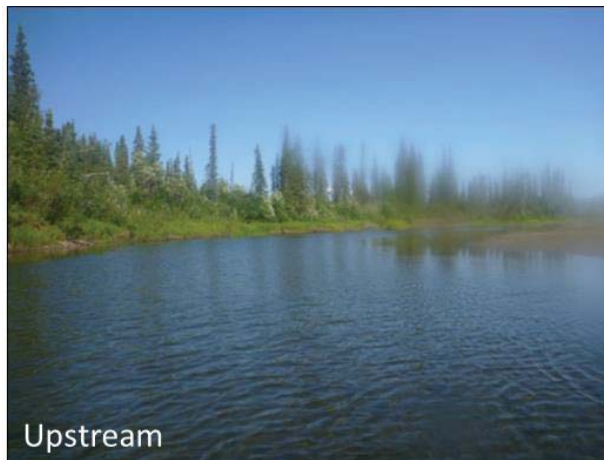
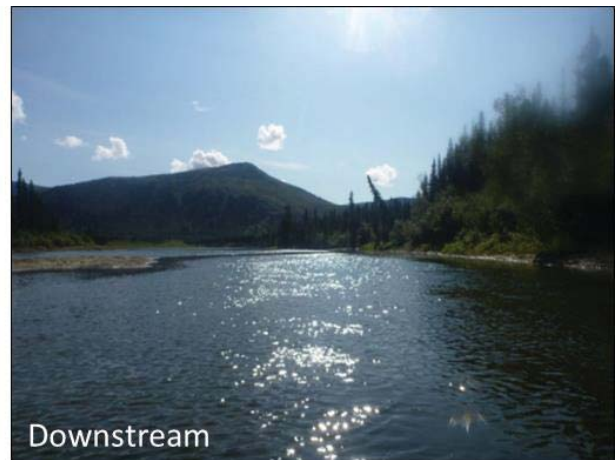
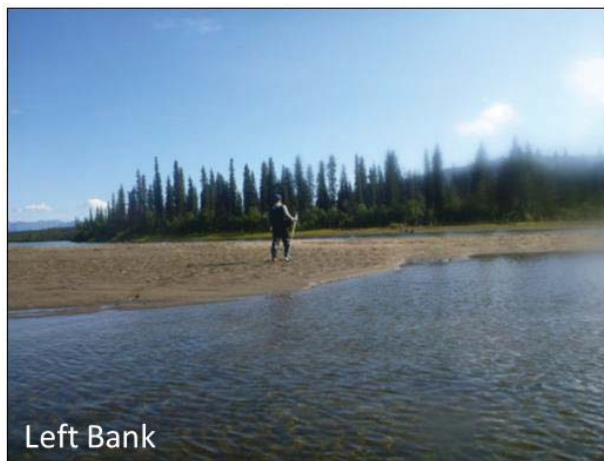
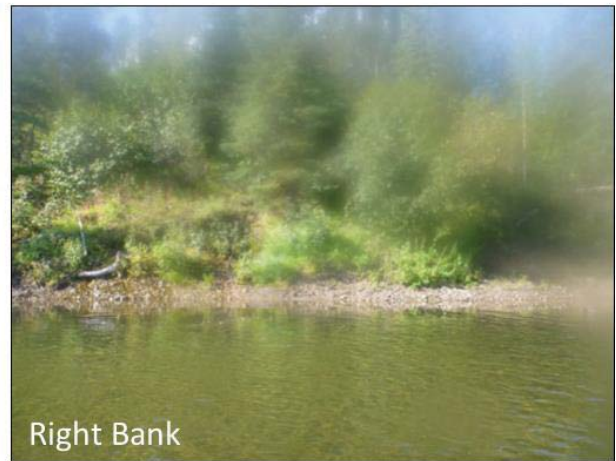
Plate 4. Stream channel characteristics, riparian habitat, and instream substrate composition at transect KG-T1-13, Kogoluktuk River, Brooks East Corridor, Alaska, August 2013.

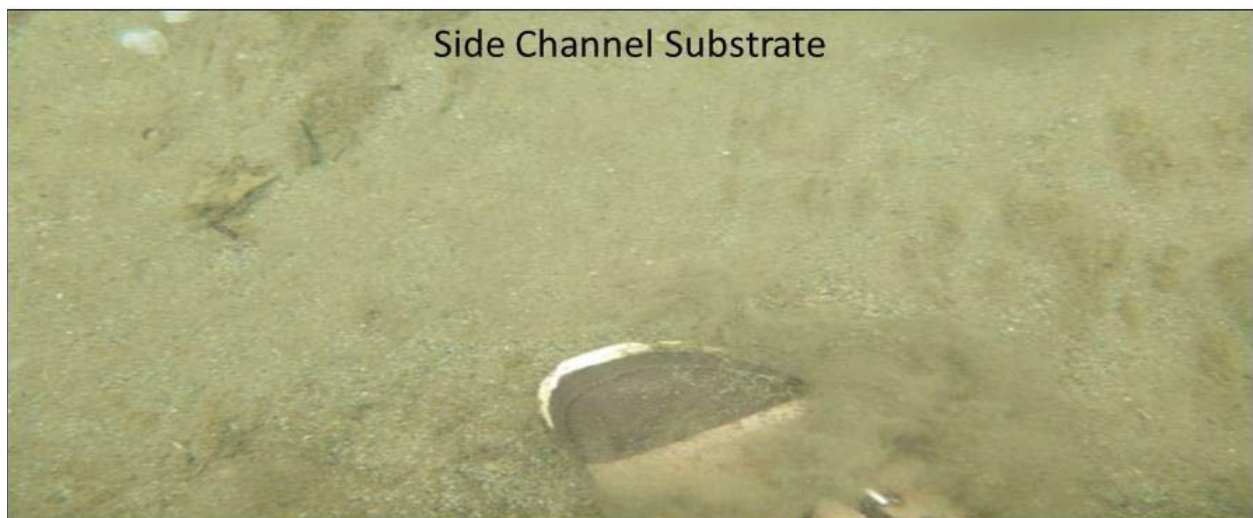
Plate 5. Stream channel characteristics, riparian habitat, and instream substrate composition of side-channel habitat at KG-T1-13, Kogoluktuk River, Brooks East Corridor, Alaska, August 2013.

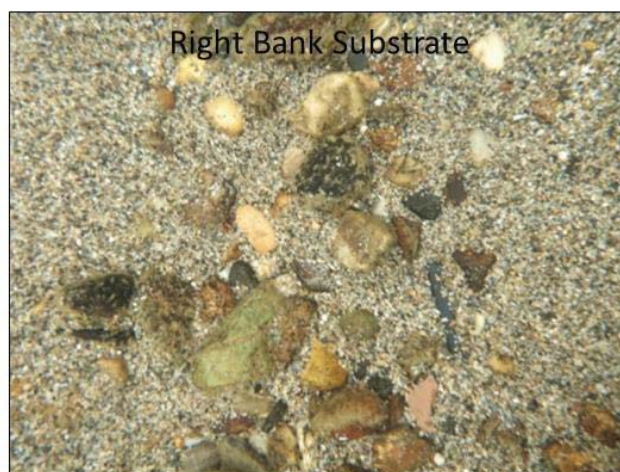
Plate 6. Stream channel characteristics, riparian habitat, and instream substrate composition at transect KG-T2-13, Kogoluktuk River, Brooks East Corridor, Alaska, August 2013.

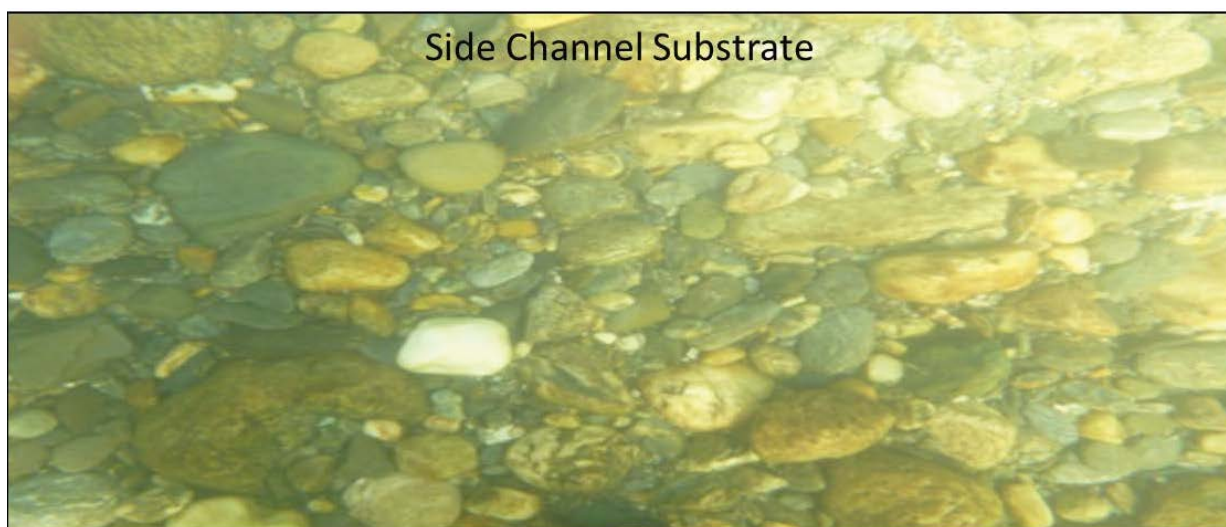
Plate 7. Stream channel characteristics, riparian habitat, and instream substrate composition at partial transect (MN-T1-13) on the Mauneluk River, Brooks East Corridor, Alaska, August 2013.

ABR performed partial habitat surveys at observation points on 13 August 2013 (Figure 5, Appendix B) (Plates 7–8). Transects could not be conducted from bank to bank due to unwadeable conditions on most of the 2,000-ft reach. Efforts to find a suitable crossing in the reach by floating the stream with a packraft were unsuccessful due to a combination of high

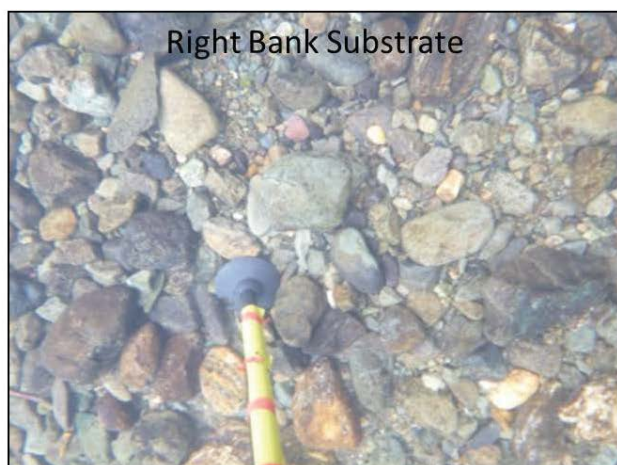
Plate 8. Stream channel characteristics, riparian habitat, and instream substrate composition at partial transect (MN-T2-13) on the Mauneluk River, Brooks East Corridor, Alaska, August 2013.

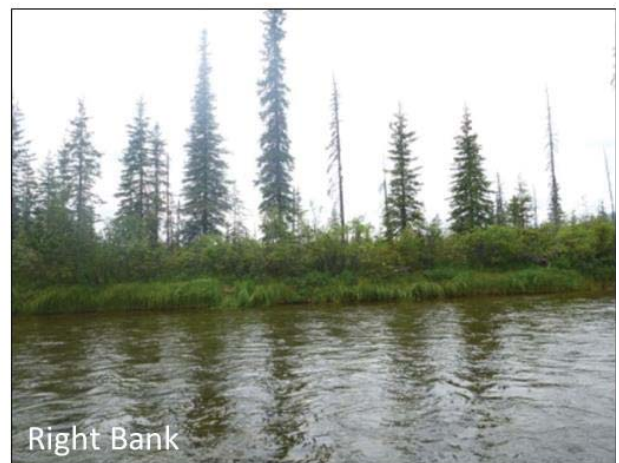
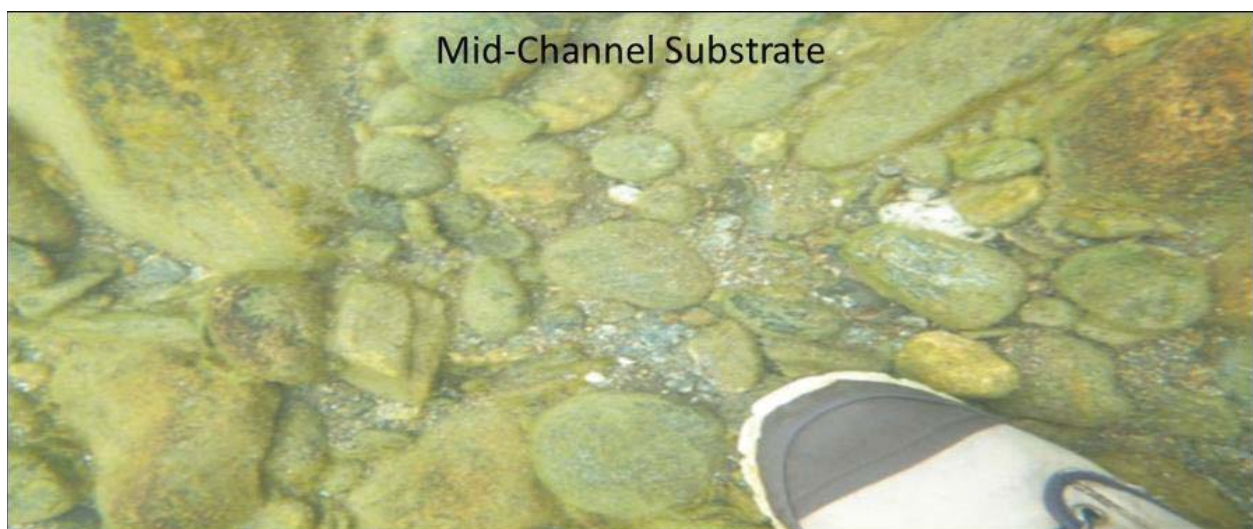
Plate 9. Stream channel characteristics, riparian habitat, and instream substrate composition at transect BV-T1-13, Beaver Creek, Brooks East Corridor, Alaska, August 2013.

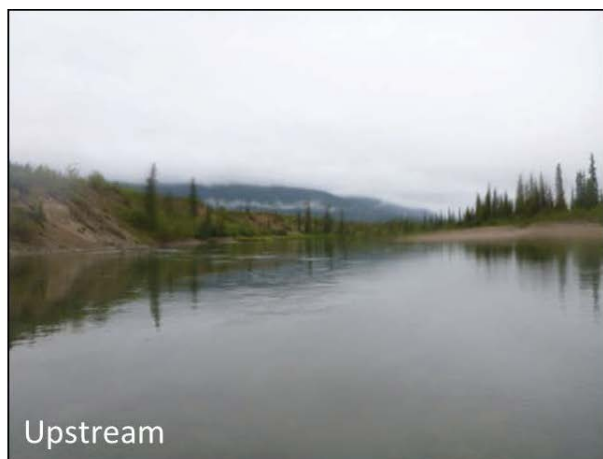
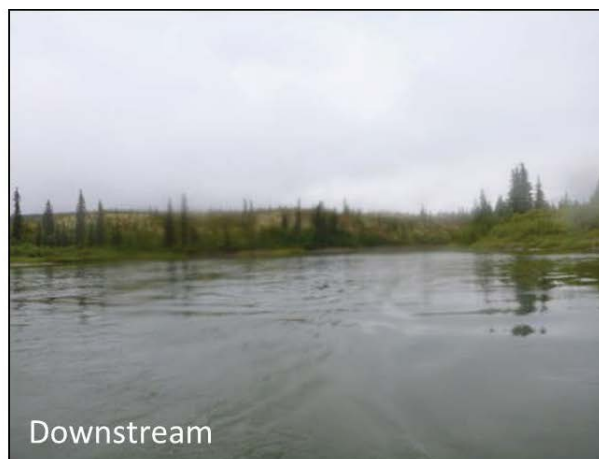
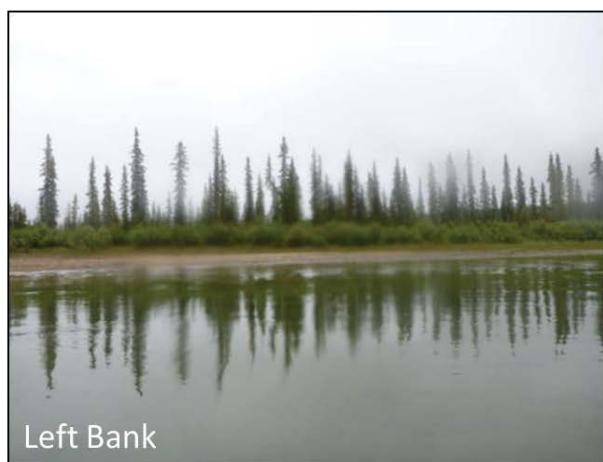
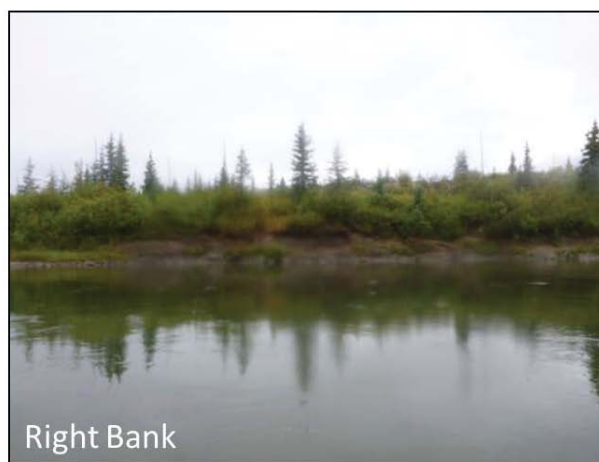
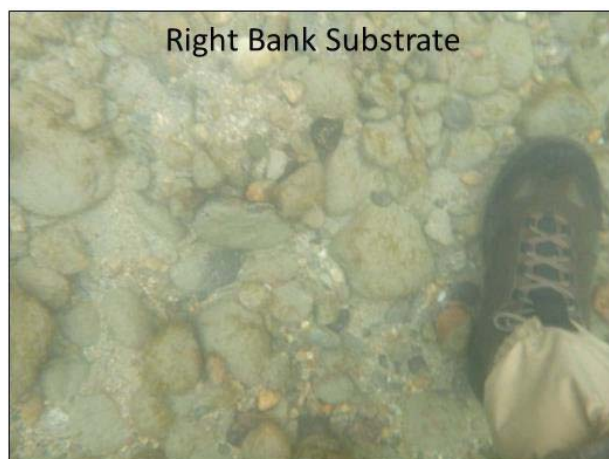
Plate 10. Stream channel characteristics, riparian habitat, and instream substrate composition at transect BV-T2-13, Beaver Creek, Brooks East Corridor, Alaska, August 2013.

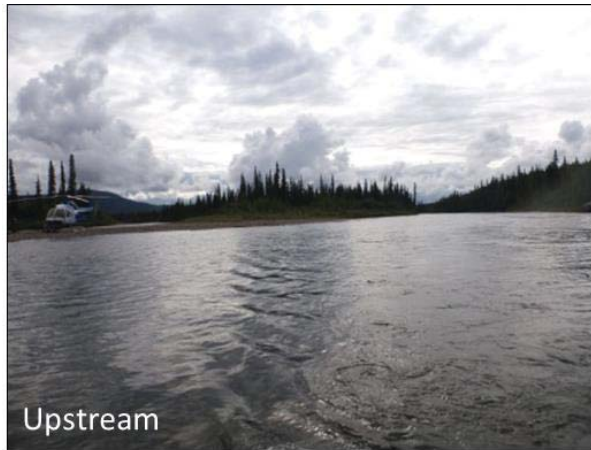
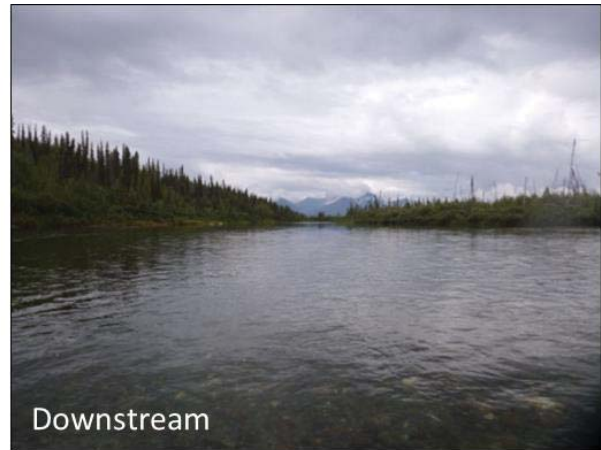
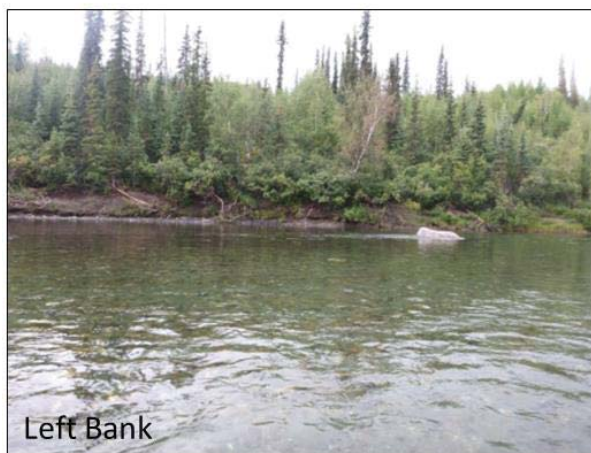
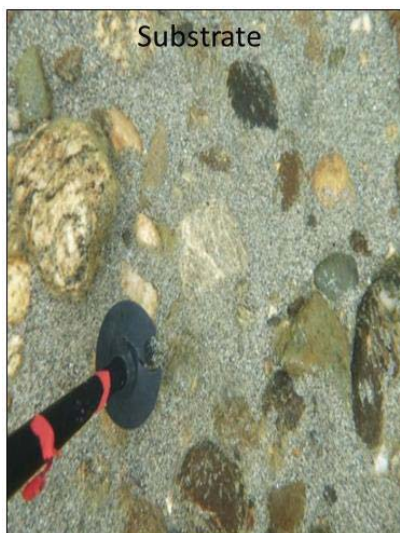
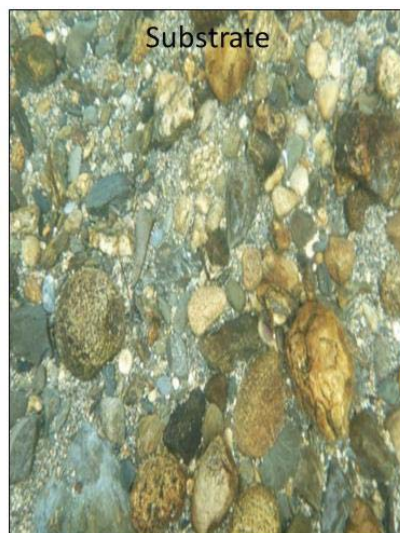
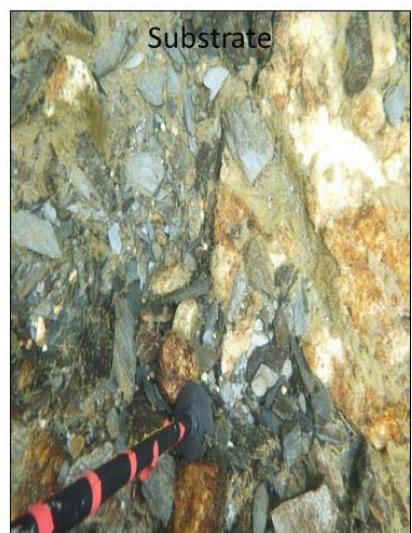
Plate 11. Stream channel characteristics, riparian habitat, and instream substrate composition at transect RD-T1-13, Reed River, Brooks East Corridor, Alaska, August 2013.

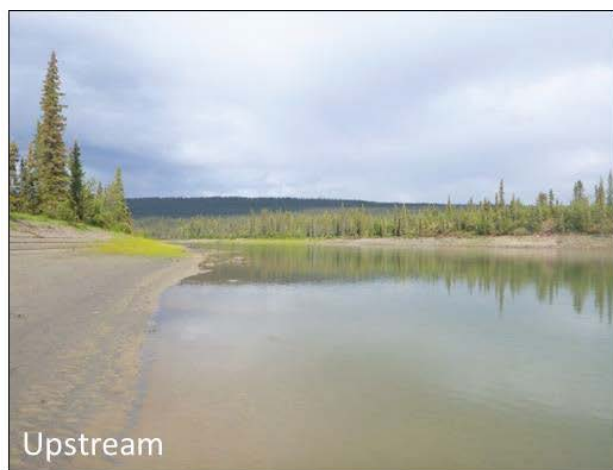
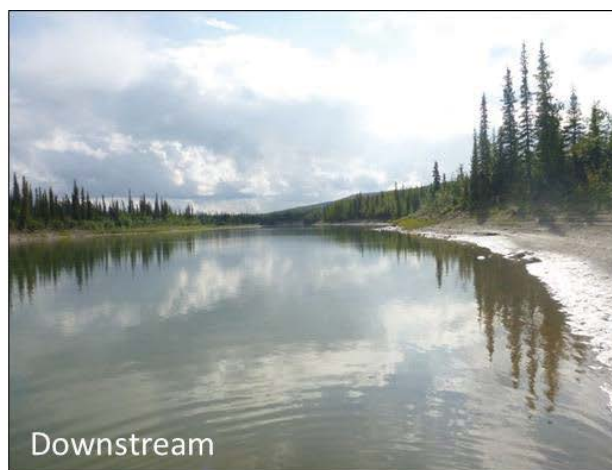
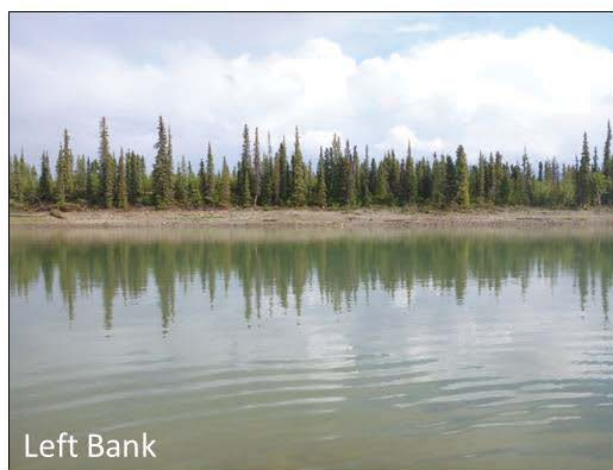
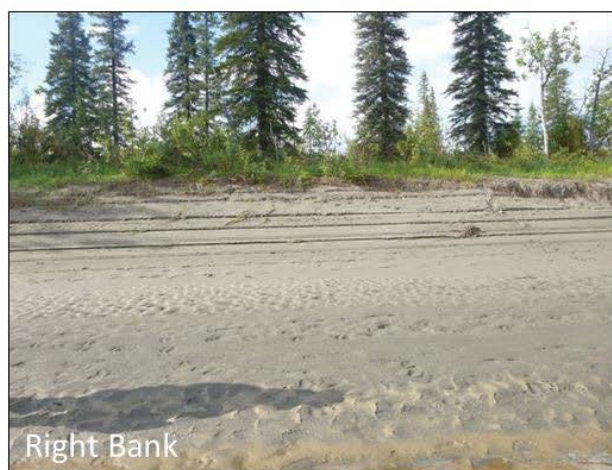
Plate 14. Stream channel characteristics and riparian habitat at observation point AL-T1-13 on the Alatna River, Brooks East Corridor, Alaska, August 2013.

ABR conducted habitat surveys of the crossing reach on the Alatna River on 17 August 2013 but found that waters were unwadeable and too deep to conduct instream surveys. Data were collected during low-level flights over the reach, on the ground at 2 observation points (AL-T1-13 and AL-T1-13) on the right bank of the reach, and observations made from a

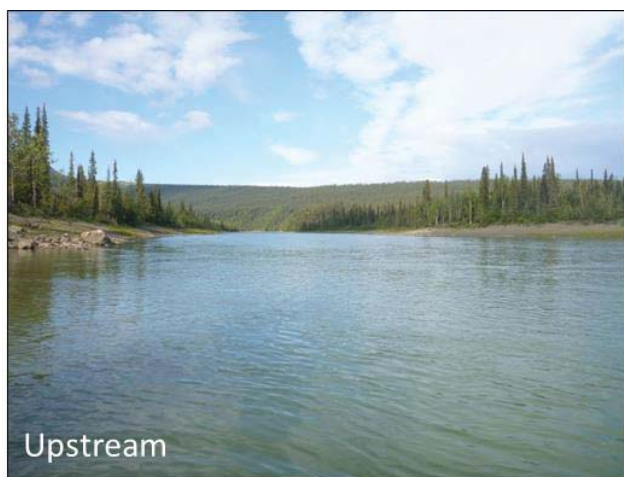
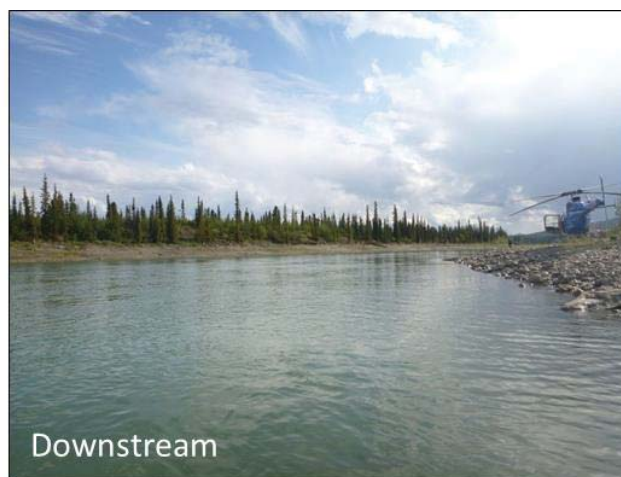
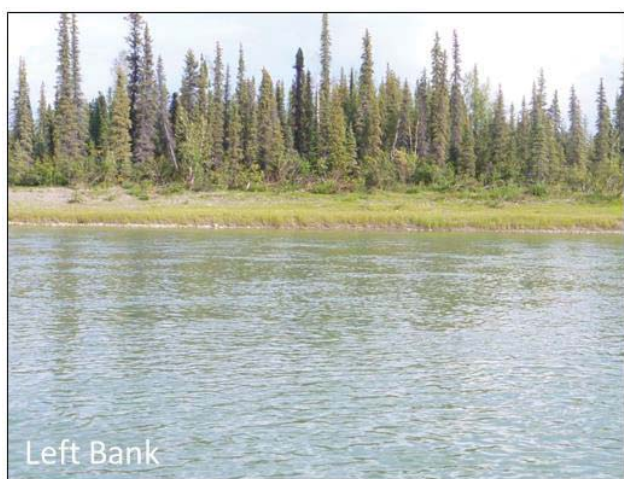
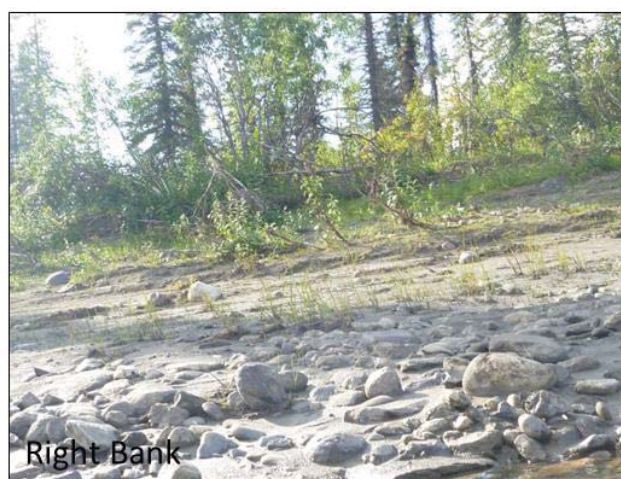
Plate 15. Stream channel characteristics and riparian habitat at observation point AL-T2-13, Alatna River, Brooks East Corridor, Alaska, August 2013.

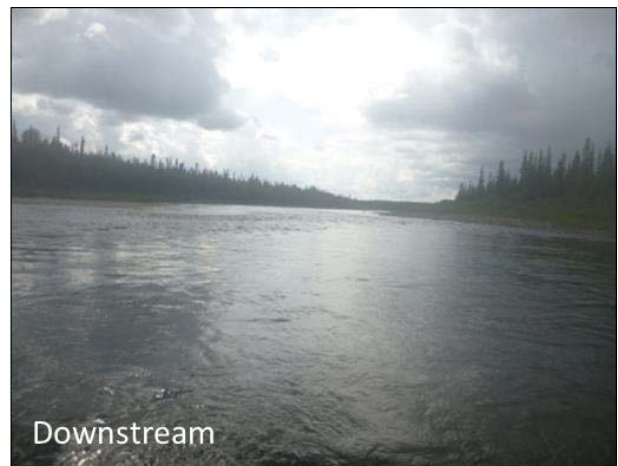
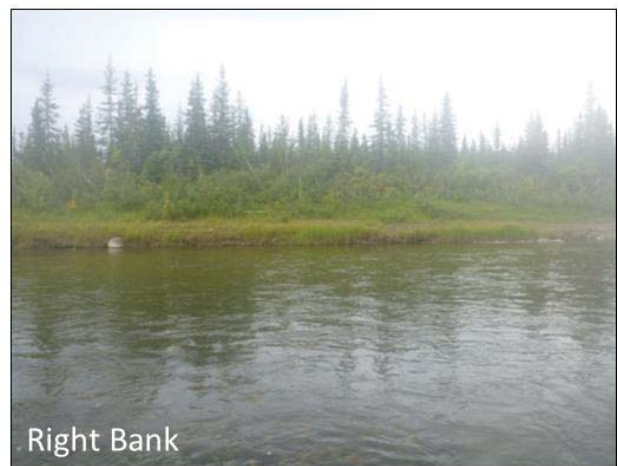
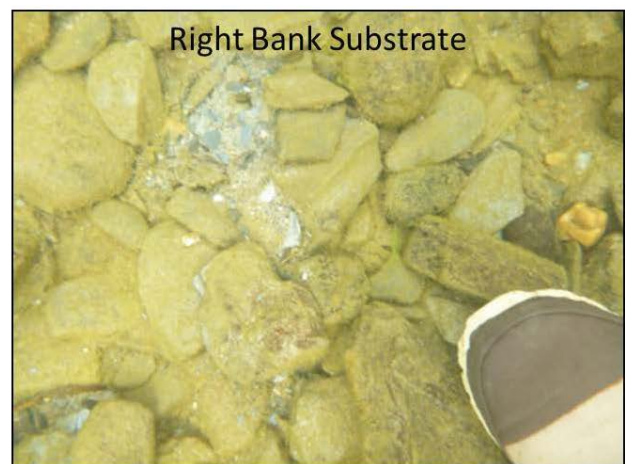
Plate 16. Stream channel characteristics, riparian habitat, and instream substrate composition at transect MF-T1-13, Malamute Fork Alatna River, Brooks East Corridor, Alaska, August 2013.

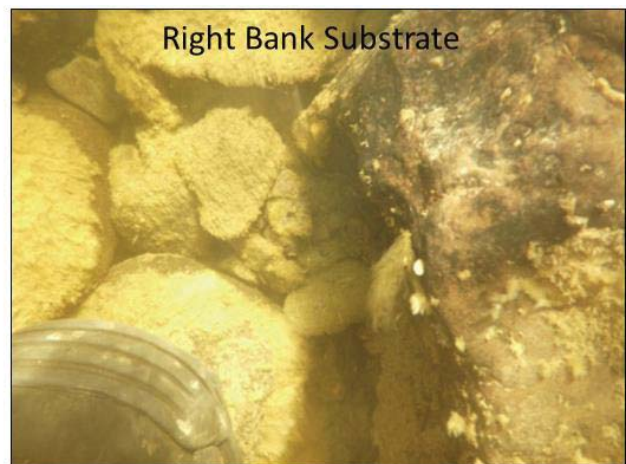
Plate 17. Stream channel characteristics, riparian habitat, and instream substrate composition at transect UN18-T1-13, unnamed tributary to the Malamute Fork Alatna River, Brooks East Corridor, Alaska, August 2013.

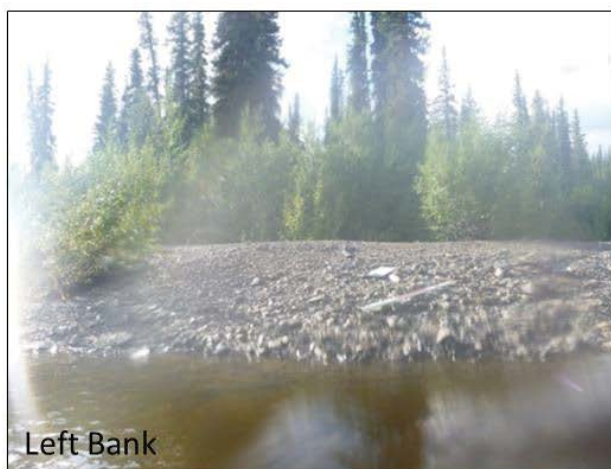
Plate 18. Stream channel characteristics, riparian habitat, and instream substrate composition at transect UN18-T2-13, unnamed tributary to the Malamute Fork Alatna River, Brooks East Corridor, Alaska, August 2013.

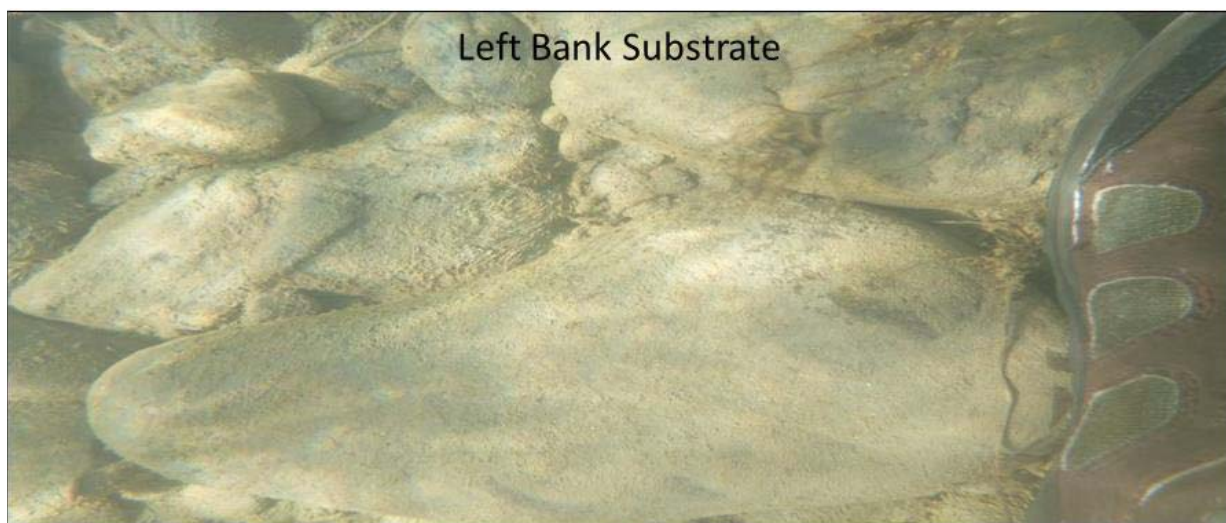
Plate 19. Stream channel characteristics, riparian habitat, and instream substrate composition at observation points on the Koyukuk River, Brooks East Corridor, Alaska, August 2013.

water and strong flow. The entire stream reach was a mix of run and glide flow regime. Instream substrate and riparian habitat were characterized at 3 observations points along the stream's left bank (Figure 12, Appendix B) (Plate 19). ABR floated the reach in a packraft to determine if wadeable transects were present, but none were observed. At the most upstream observation point, at a downstream inside bend in the river, substrate visible from the bank was predominantly sand, as might be expected at such a location where velocity decreases and sand settles out of the water column. Significant gravel and cobble instream substrate could be observed from the left bank along with moderate amounts of large and small woody debris. The left bank in this reach was composed of a large sand bar with little vegetation. Riparian vegetation on the right bank was dense and composed mainly of spruce and willow. The substrate at the second observation point, downstream between 2 proposed bridge crossings was composed of mostly sand, but transitioned to cobble, gravel, and boulder shortly downstream. Between the first and second observations points, the right bank vegetation transitioned from spruce to alder. Substrate composition at the farthest downstream observation point appeared to be composed of primarily of cobble, gravel, and boulder. Overall, this reach likely provides plentiful spawning and refuge habitat to many fishes, including salmon. The channel in this reach appears to have changed slightly between 1981 and 2012, mostly in the form of growing sandbars in upper and lower portions of the stream reach (Appendix C).

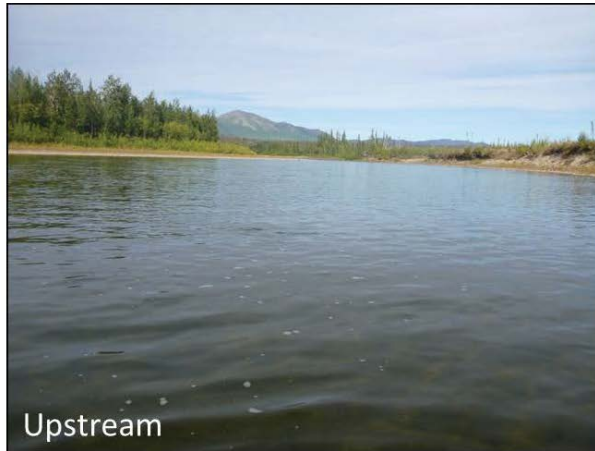
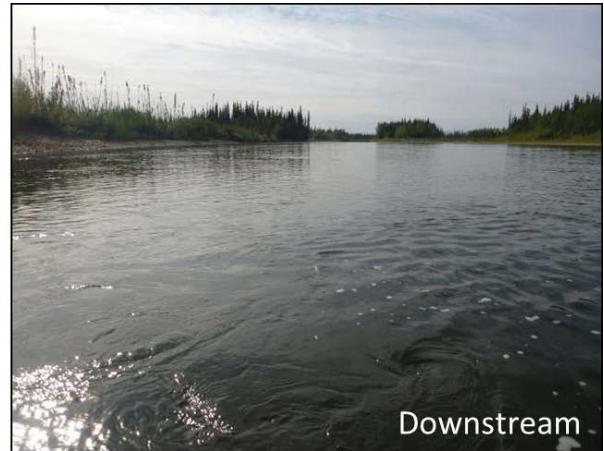
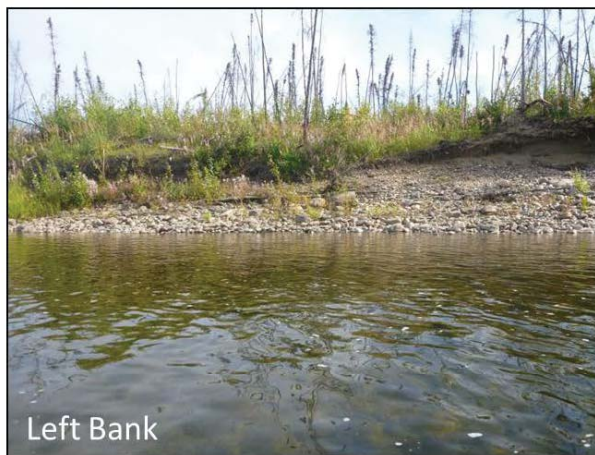
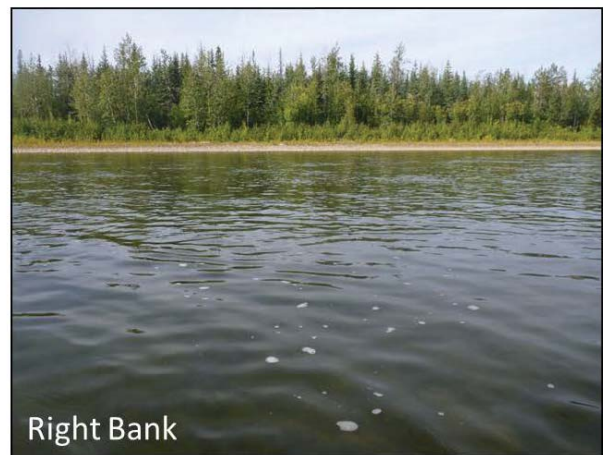
Plate 20. Stream channel characteristics, riparian habitat, and instream substrate composition at transect SF-T1-13, South Fork Koyukuk River, Brooks East Corridor, Alaska, August 2013.

ABR mapped and characterized the stream crossing reach and performed 1 stream habitat transect survey on 22 August 2013 (Figure 13, Appendix B) (Plates 20–21). The flow regime in the stream crossing reach was dominated by a mix of run and pool habitat, with run-riffle habitat in the mid-section of the reach. Flow was estimated to be 13.75 m³/s (Table 2). Transect 1 (SF-

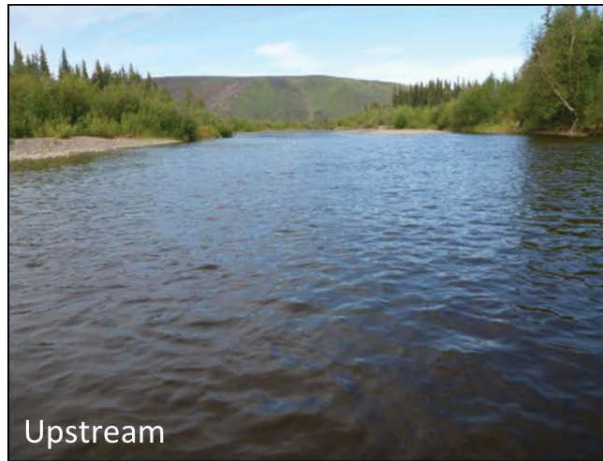
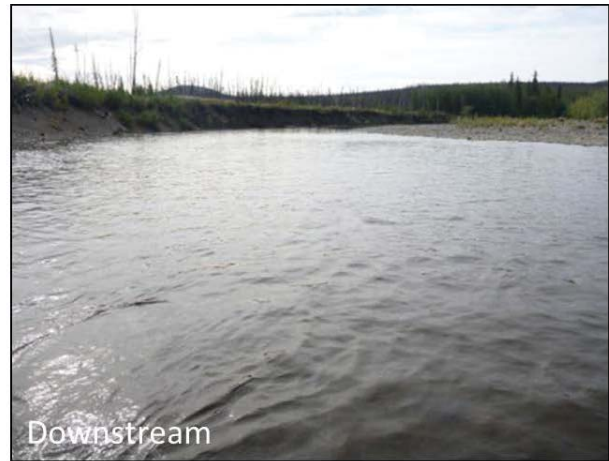
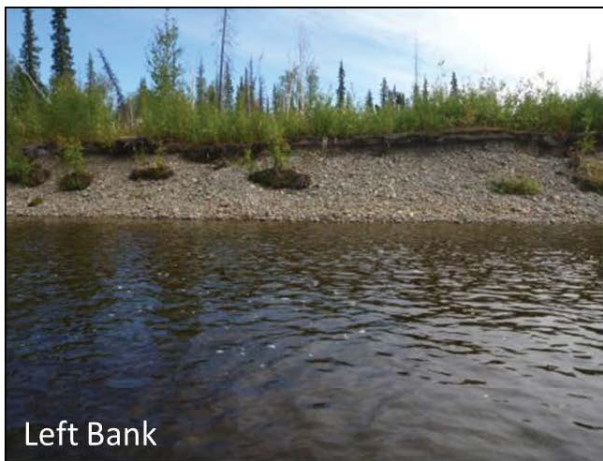
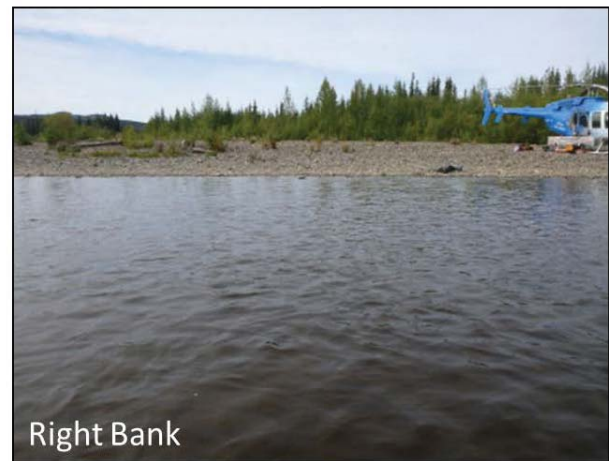
Plate 21. Stream channel characteristics and riparian habitat at observation points on the South Fork Koyukuk River, Brooks East Corridor, Alaska, August 2013.

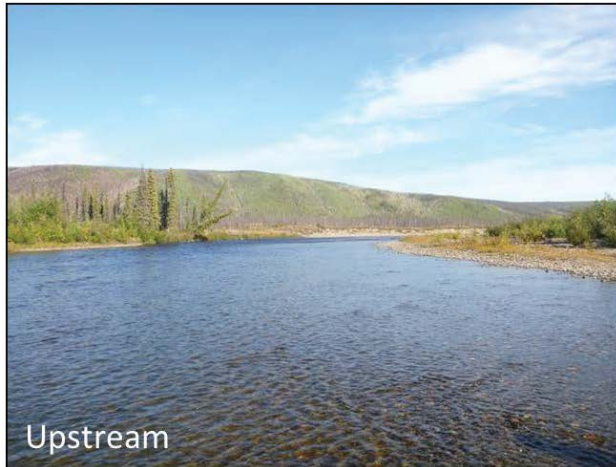
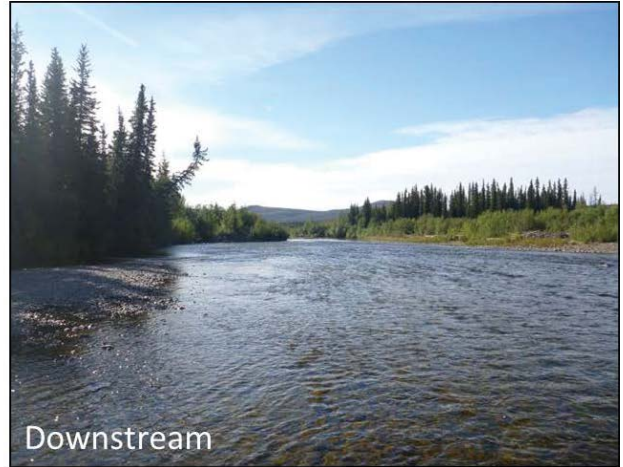
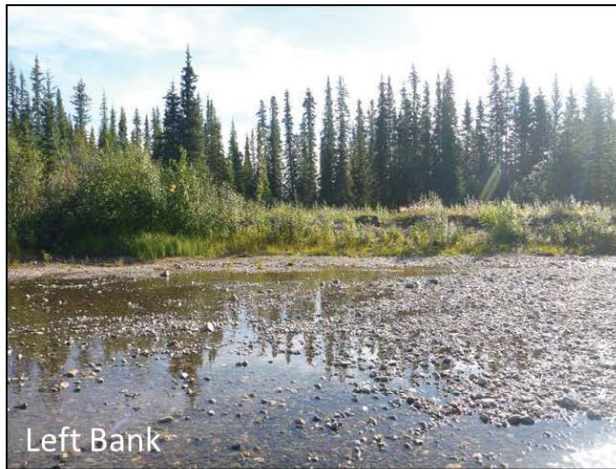
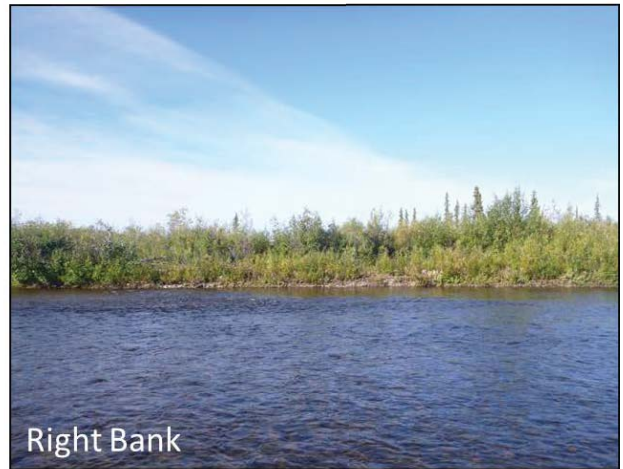
Plate 23. Stream channel characteristics and riparian habitat at upstream observation points on the Jim River, Brooks East Corridor, Alaska, August 2013.

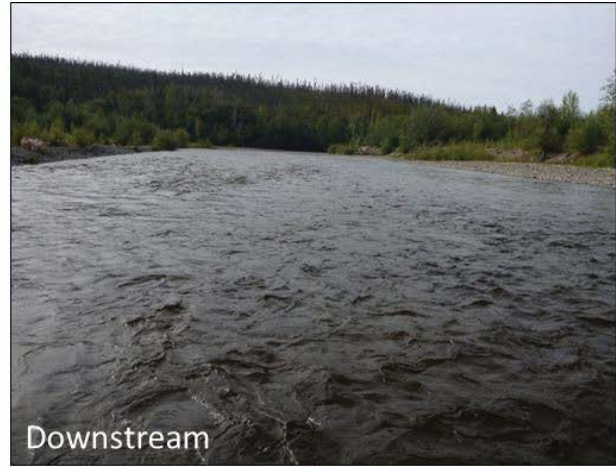
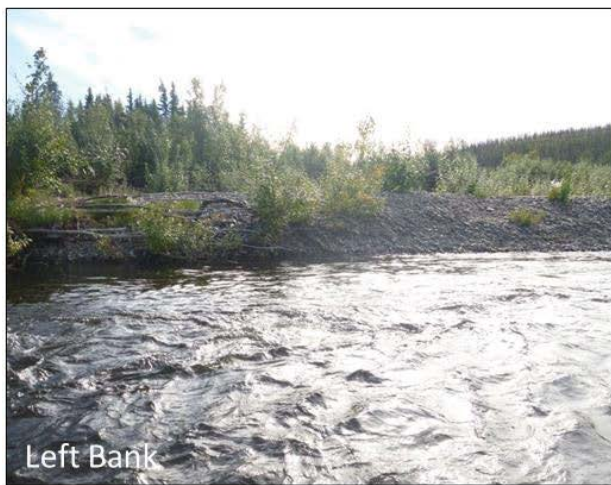
Plate 24. Stream channel characteristics and riparian habitat at downstream observation points on the Jim River, Brooks East Corridor, Alaska, August 2013.

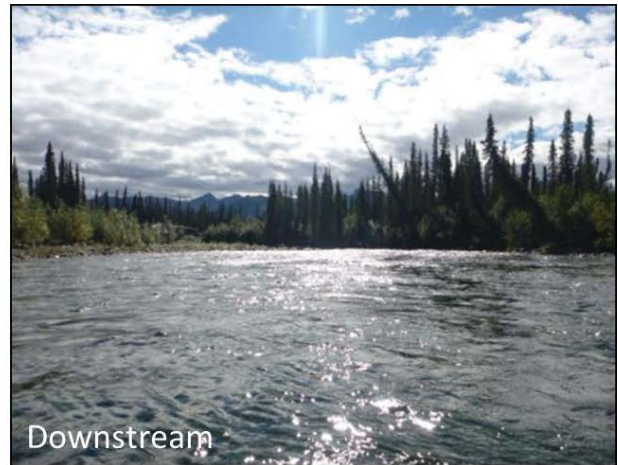
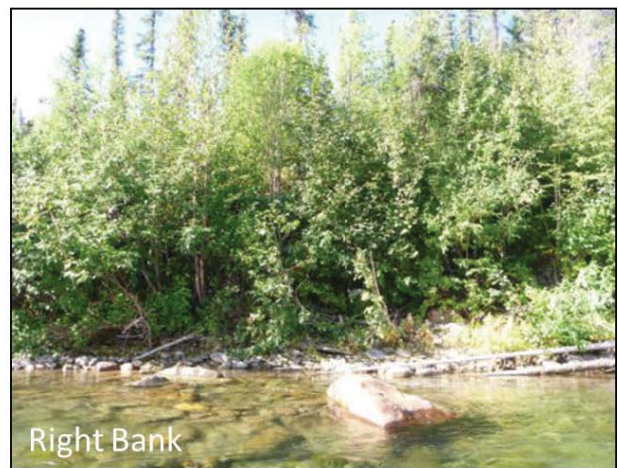
Plate 25. Stream channel characteristics, riparian habitat, and instream substrate composition at transect UN30-T1-13n, unnamed tributary to the Mauneluk River, Brooks East Corridor, Alaska, August 2013.

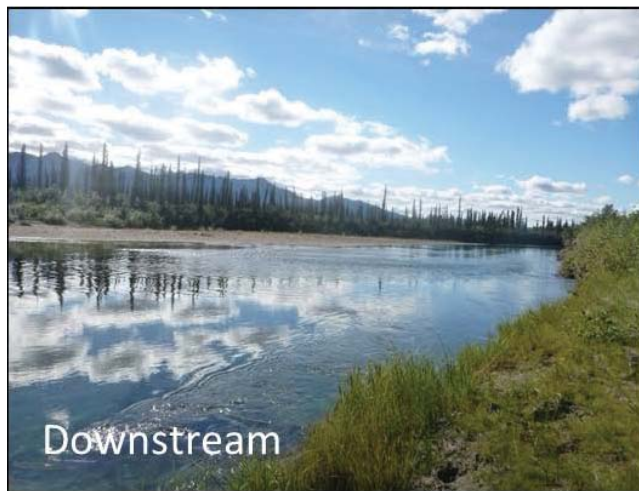
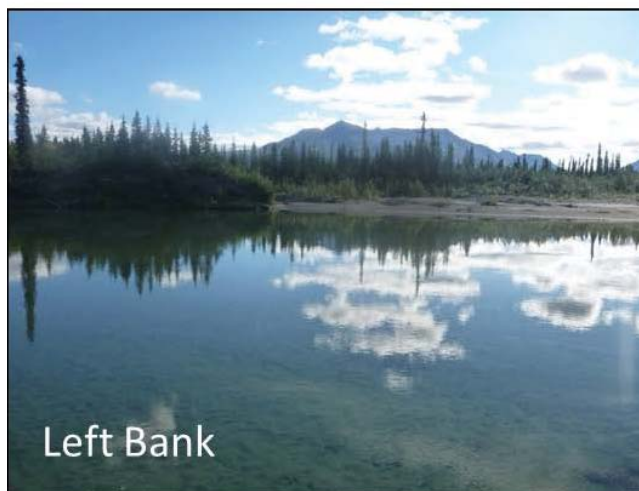
Plate 27. Stream channel characteristics and riparian habitat at observations points on the Mauneluk River (northern option), Brooks East Corridor, Alaska, August 2013.
