STREAM HABITAT SURVEYS OF PROPOSED BRIDGE CROSSINGS ON THE BROOKS EAST CORRIDOR

July 2014

In 2013, ABR’s summer field survey efforts focused on stream and riparian habitat assessments at proposed bridge crossings along the corridor. Fish sampling was not conducted in 2013. This report summarizes the 2013 stream habitat surveys and integrates these results with data on known fish assemblages in those waterbodies.

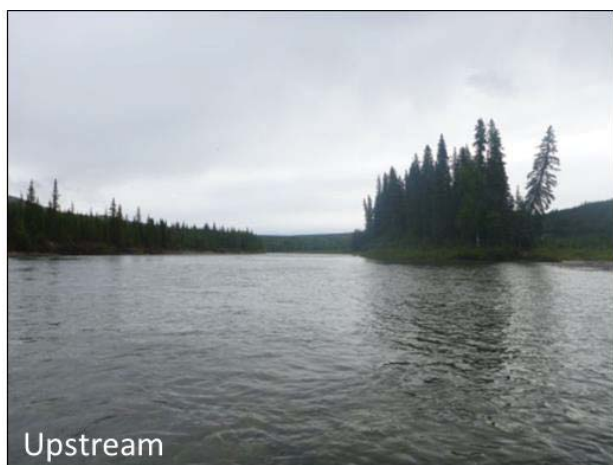
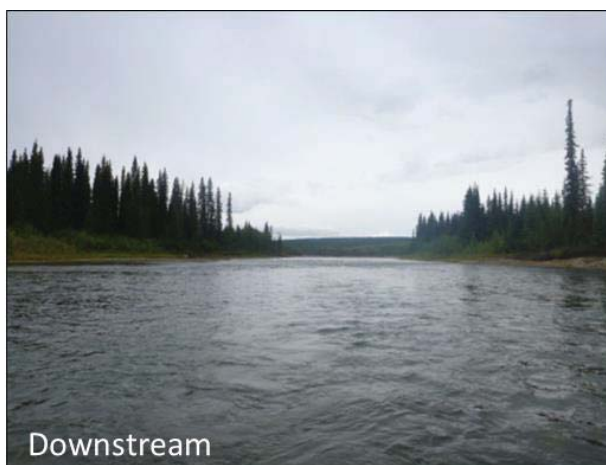
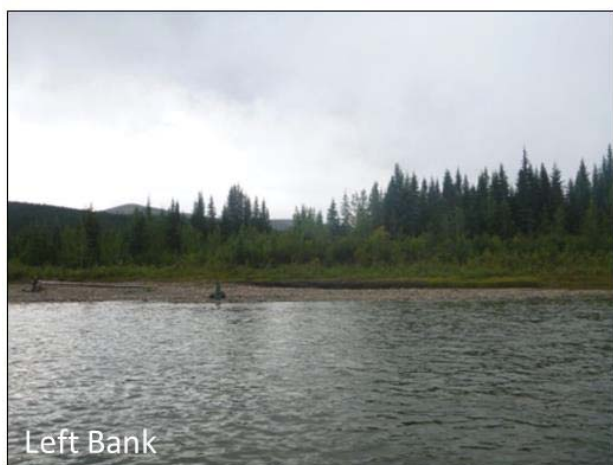
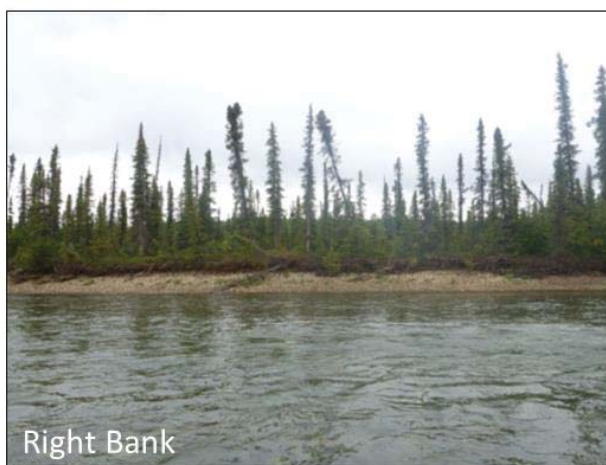
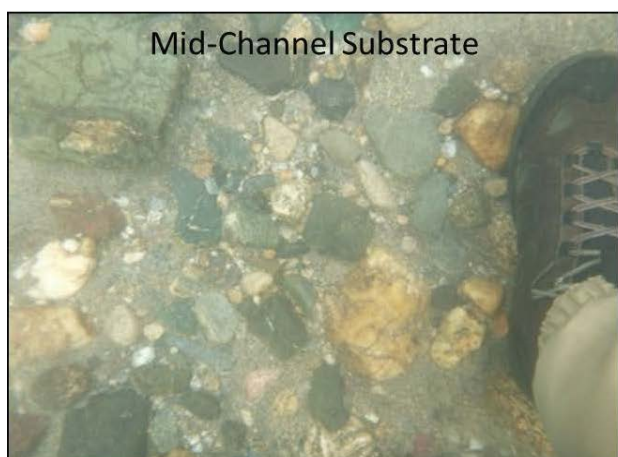
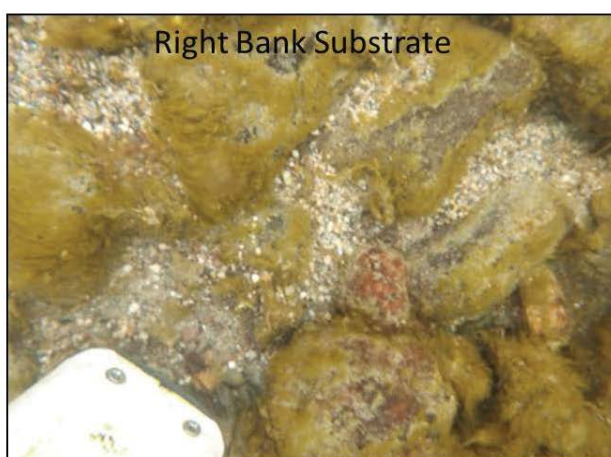
Plate 28. Stream channel characteristics, riparian habitat, and instream substrate composition at transect RD-T1-13s, Reed River (southern option), Brooks East Corridor, Alaska, August 2013.

ABR mapped and characterized the stream crossing reach and performed 2 instream habitat transect surveys on 19 August 2013 (Figure 17, Appendix B) (Plates 28–30). The flow regime of the reach was composed of a long run which transitioned to a riffle at the downstream extent of the reach. Additional riffle and pool habitat were also present upstream in side channel habitat. Both Transects 1 (RD-T1-13s) and 2 (RD-T2-13s) were located in long run habitat. Transect 2 also traversed a small portion of side channel habitat. Instream substrate in Transect 1 was composed of cobble (40%), sand (30%), gravel (20%), and boulder (10%). Substrate in the main channel on Transect 2 was cobble (35%), gravel (30%), sand (30%), and boulder (5%). Side-

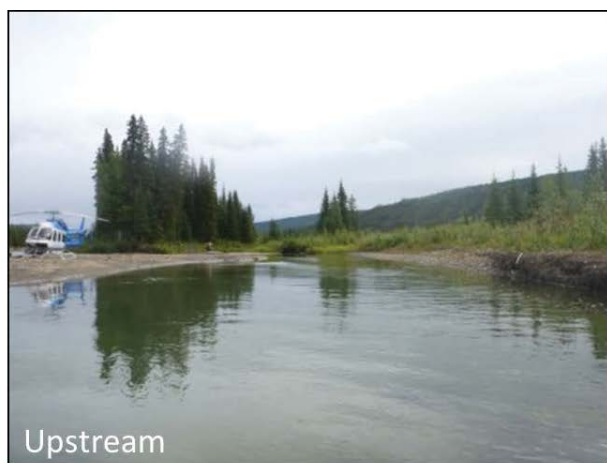
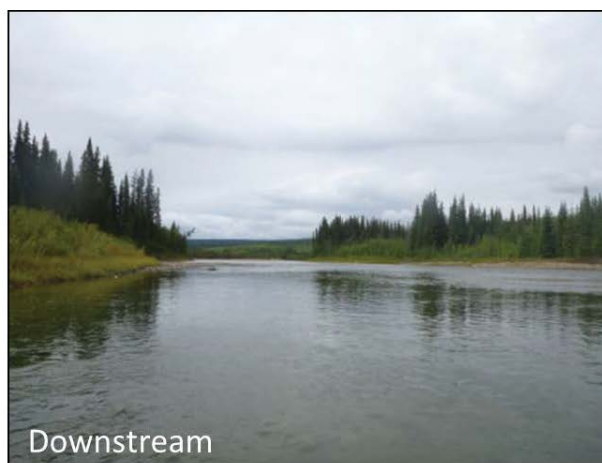
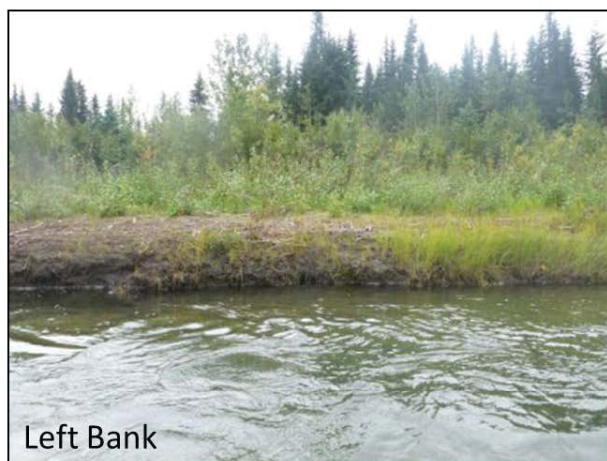
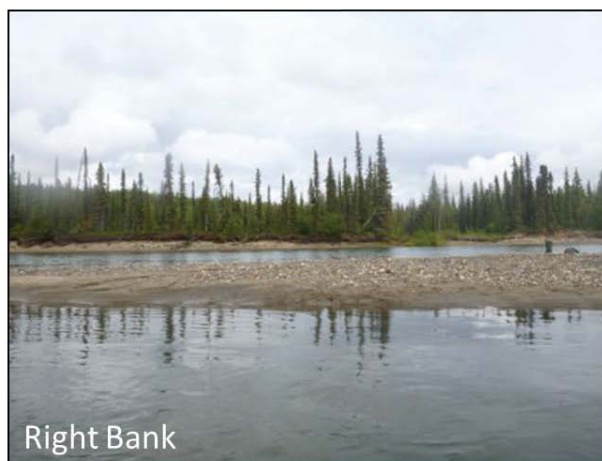
Plate 29. Stream channel characteristics, riparian habitat, and instream substrate composition at transect RD-T2-13s, Reed River (southern option), Brooks East Corridor, Alaska, August 2013.

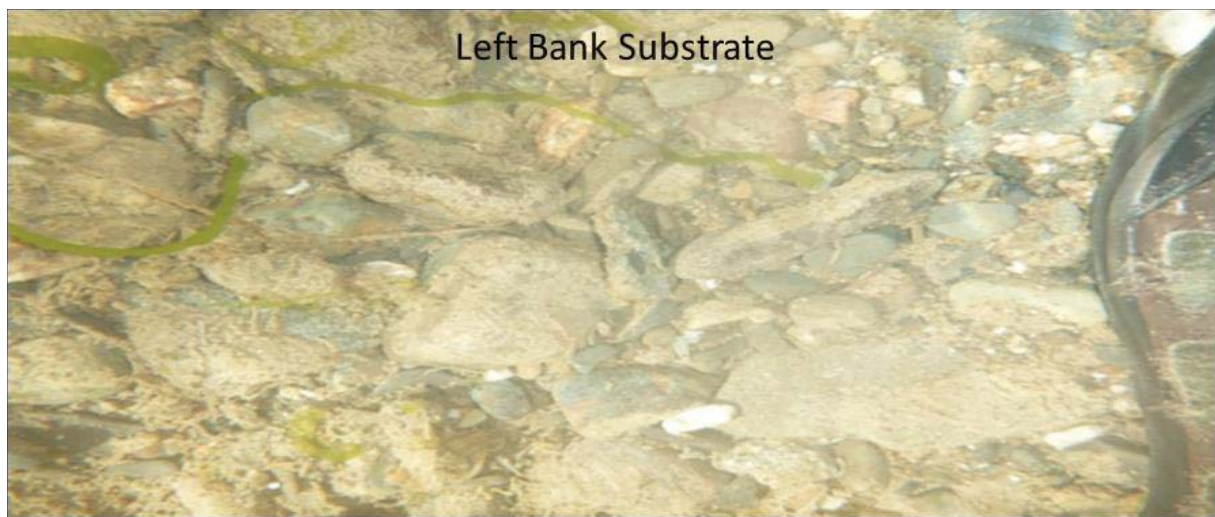
Plate 34. Stream channel characteristics, riparian habitat, and instream substrate composition at transect HG-T2-13SCs, Hogatza River (southern option), Brooks East Corridor, Alaska, August 2013.

Instream cover at both transects included sparse live tree roots, undercut banks, and boulder cover as well as moderately abundant overhanging vegetation, filamentous algae, and small woody debris (Table 2). Sparse large woody debris also was observed at Transect 1. In general, the sample reach would provide good refuge habitat for rearing juvenile fish, as well as sufficient pools for larger fish.

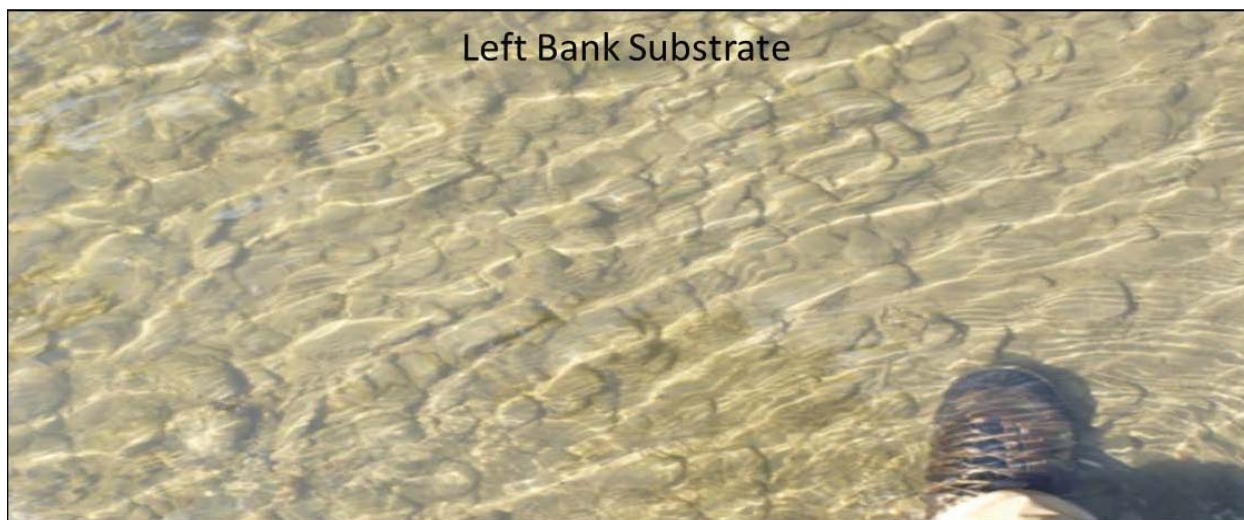
Plate 35. Stream channel characteristics, riparian habitat, and instream substrate composition at transect HJ-T1-13s, Helpmejack Creek (southern option), Brooks East Corridor, Alaska, August 2013.

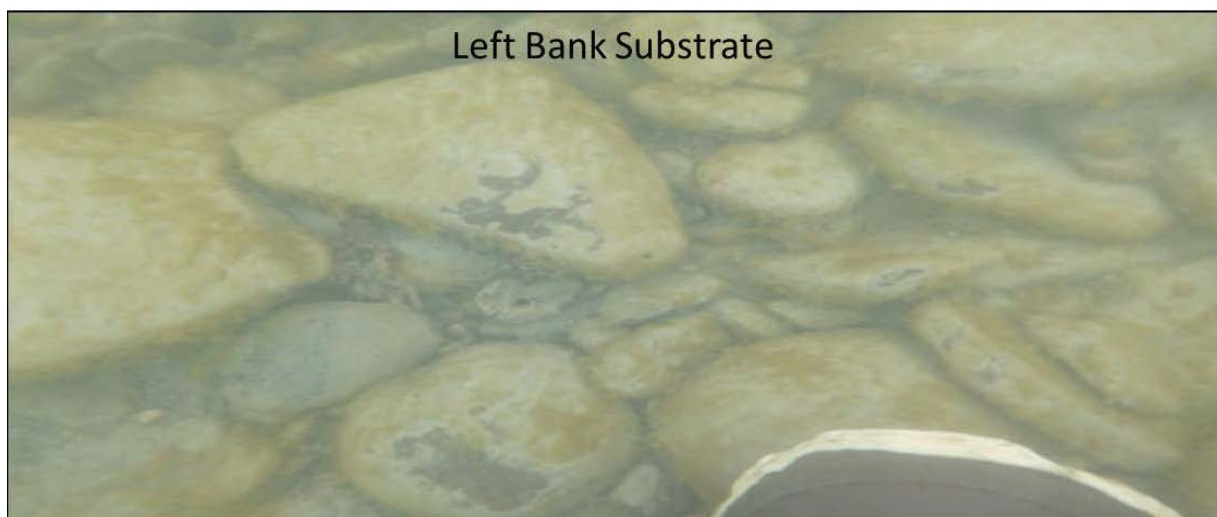
Plate 36. Stream channel characteristics, riparian habitat, and instream substrate composition at transect HJ-T2-13s, Helpmejack Creek (southern option), Brooks East Corridor, Alaska, August 2013.

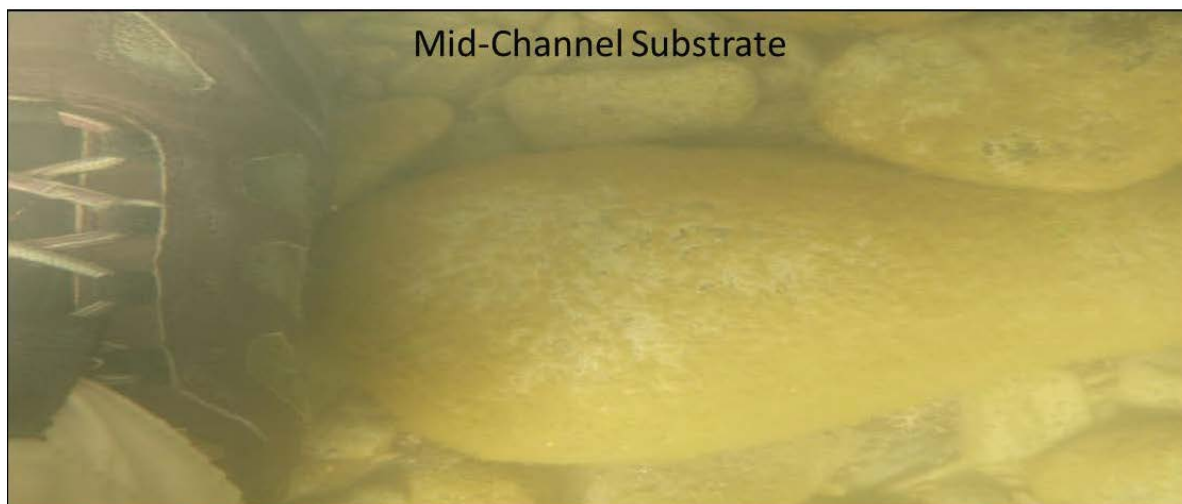
Plate 38. Stream channel characteristics, riparian habitat, and instream substrate composition at 3 observation points on Helpmejack Creek, Brooks East Corridor, Alaska, August 2013.
