Sequoia and Kings Canyon National Parks

Information on the Rehabilitate Halstead Meadow Project (Phase 3)

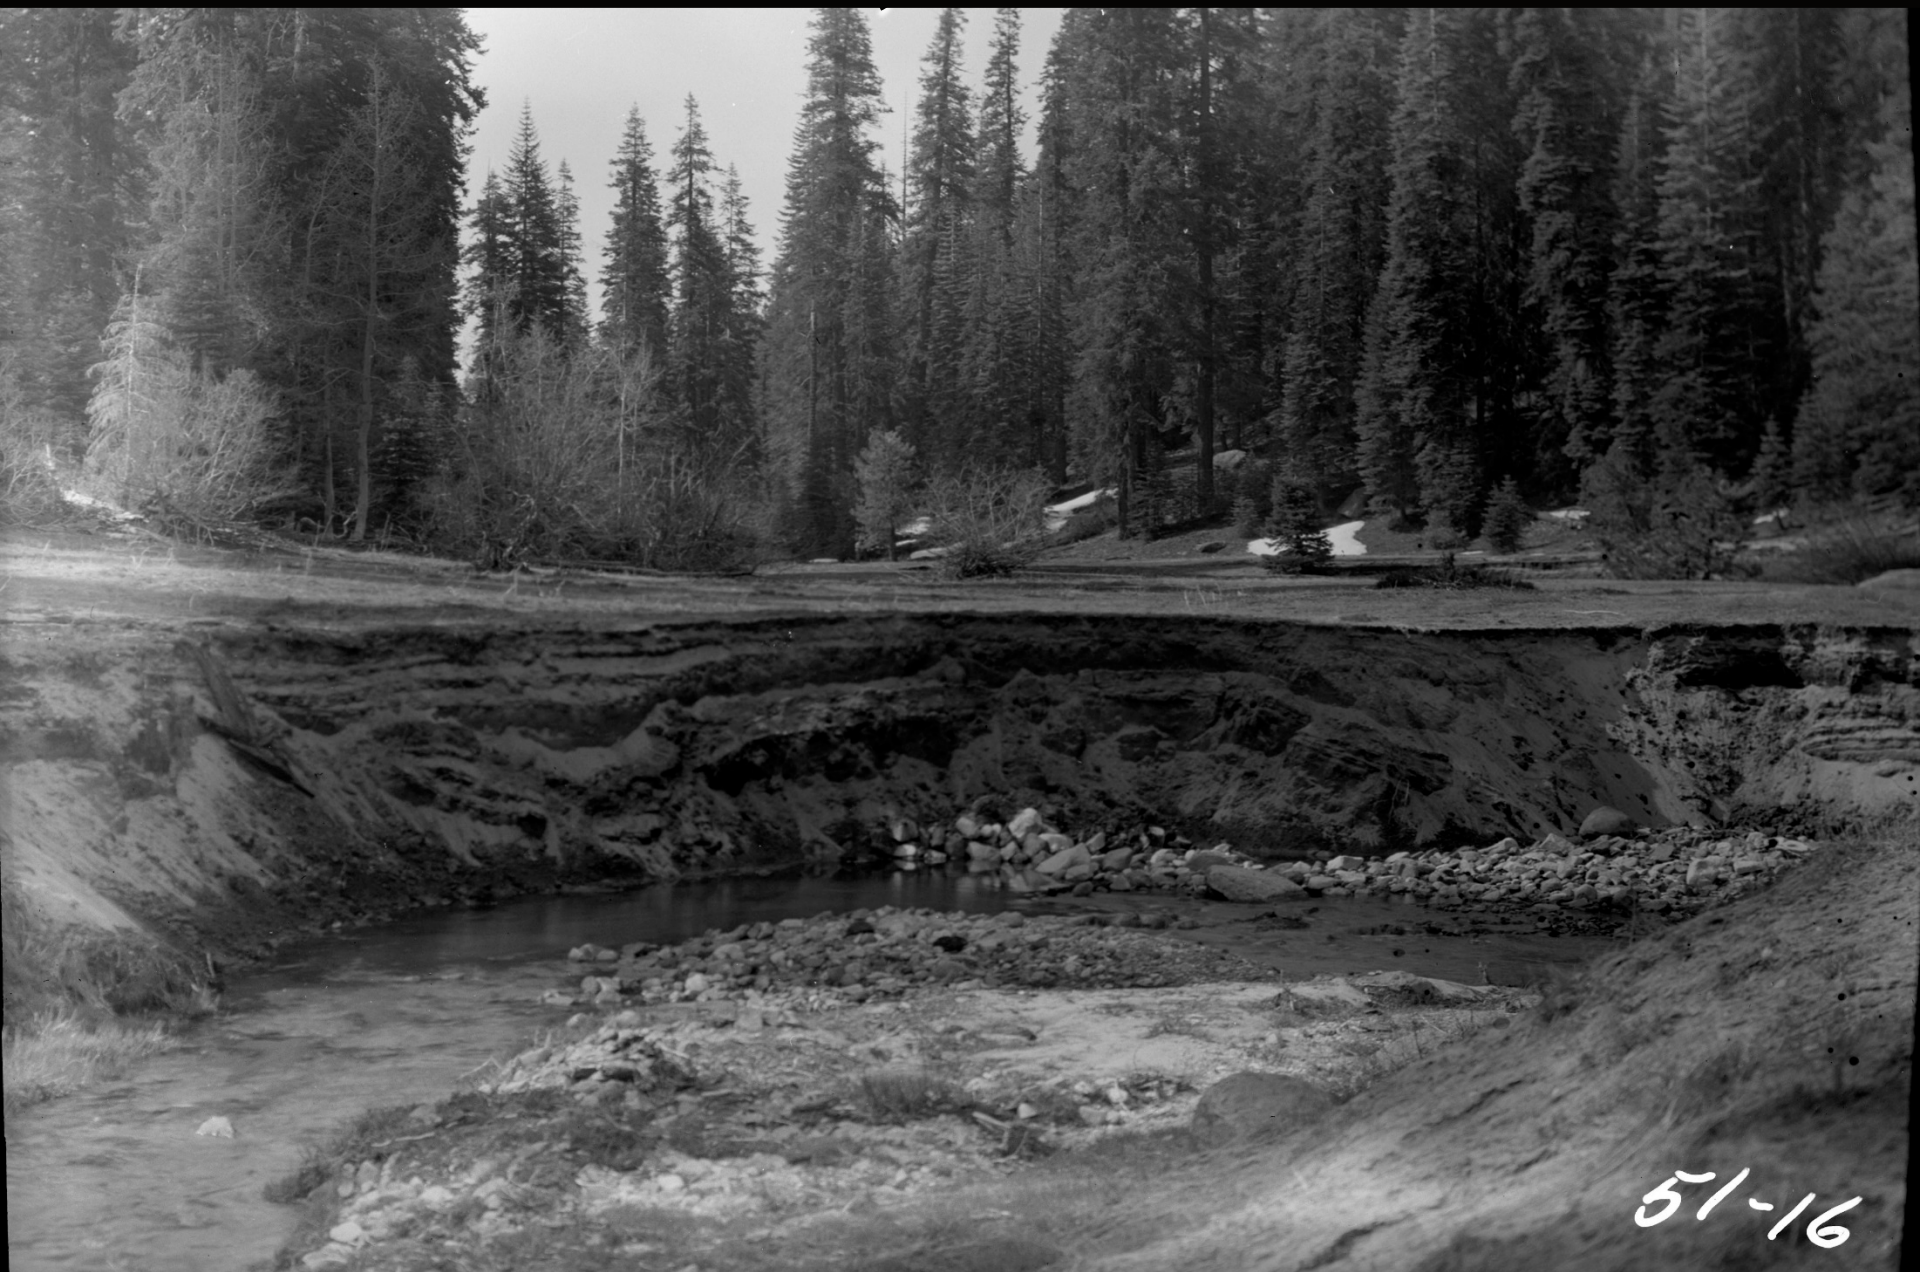
Halstead Meadow, 1951

- Halstead Meadow in Sequoia National Park is a large wet meadow and fen complex that formed by sediment and peat accumulation over thousands of years.
- In the past 150 years, impacts to the meadow, including grazing and culverting water flow, have resulted in severe erosion and gully formation. Tens of thousands of cubic yards of ancient sediment have been eroded, water tables have declined, and vegetation has changed.

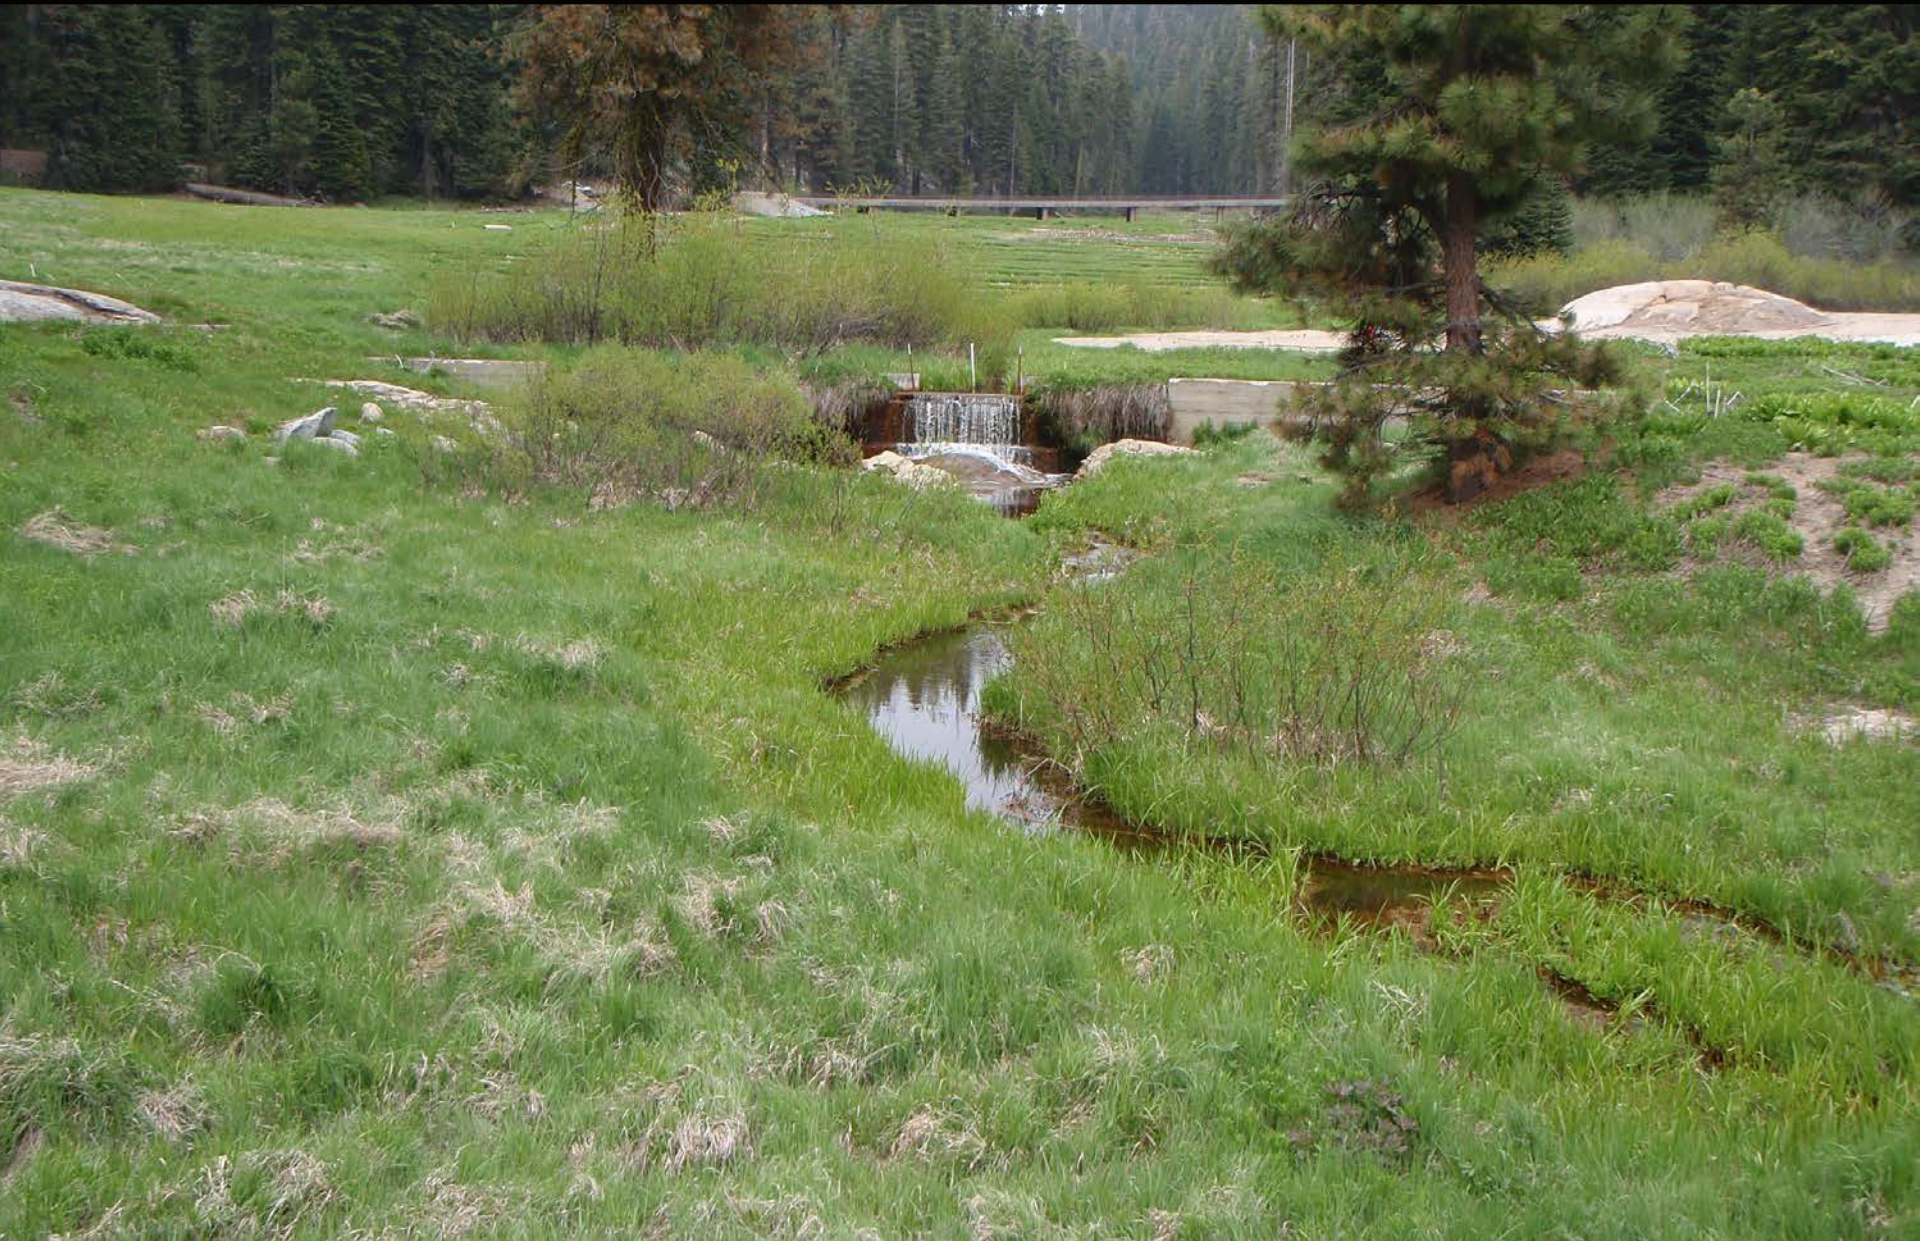
Lower Halstead Meadow – The previous restoration is anchored by 60-year-old structure

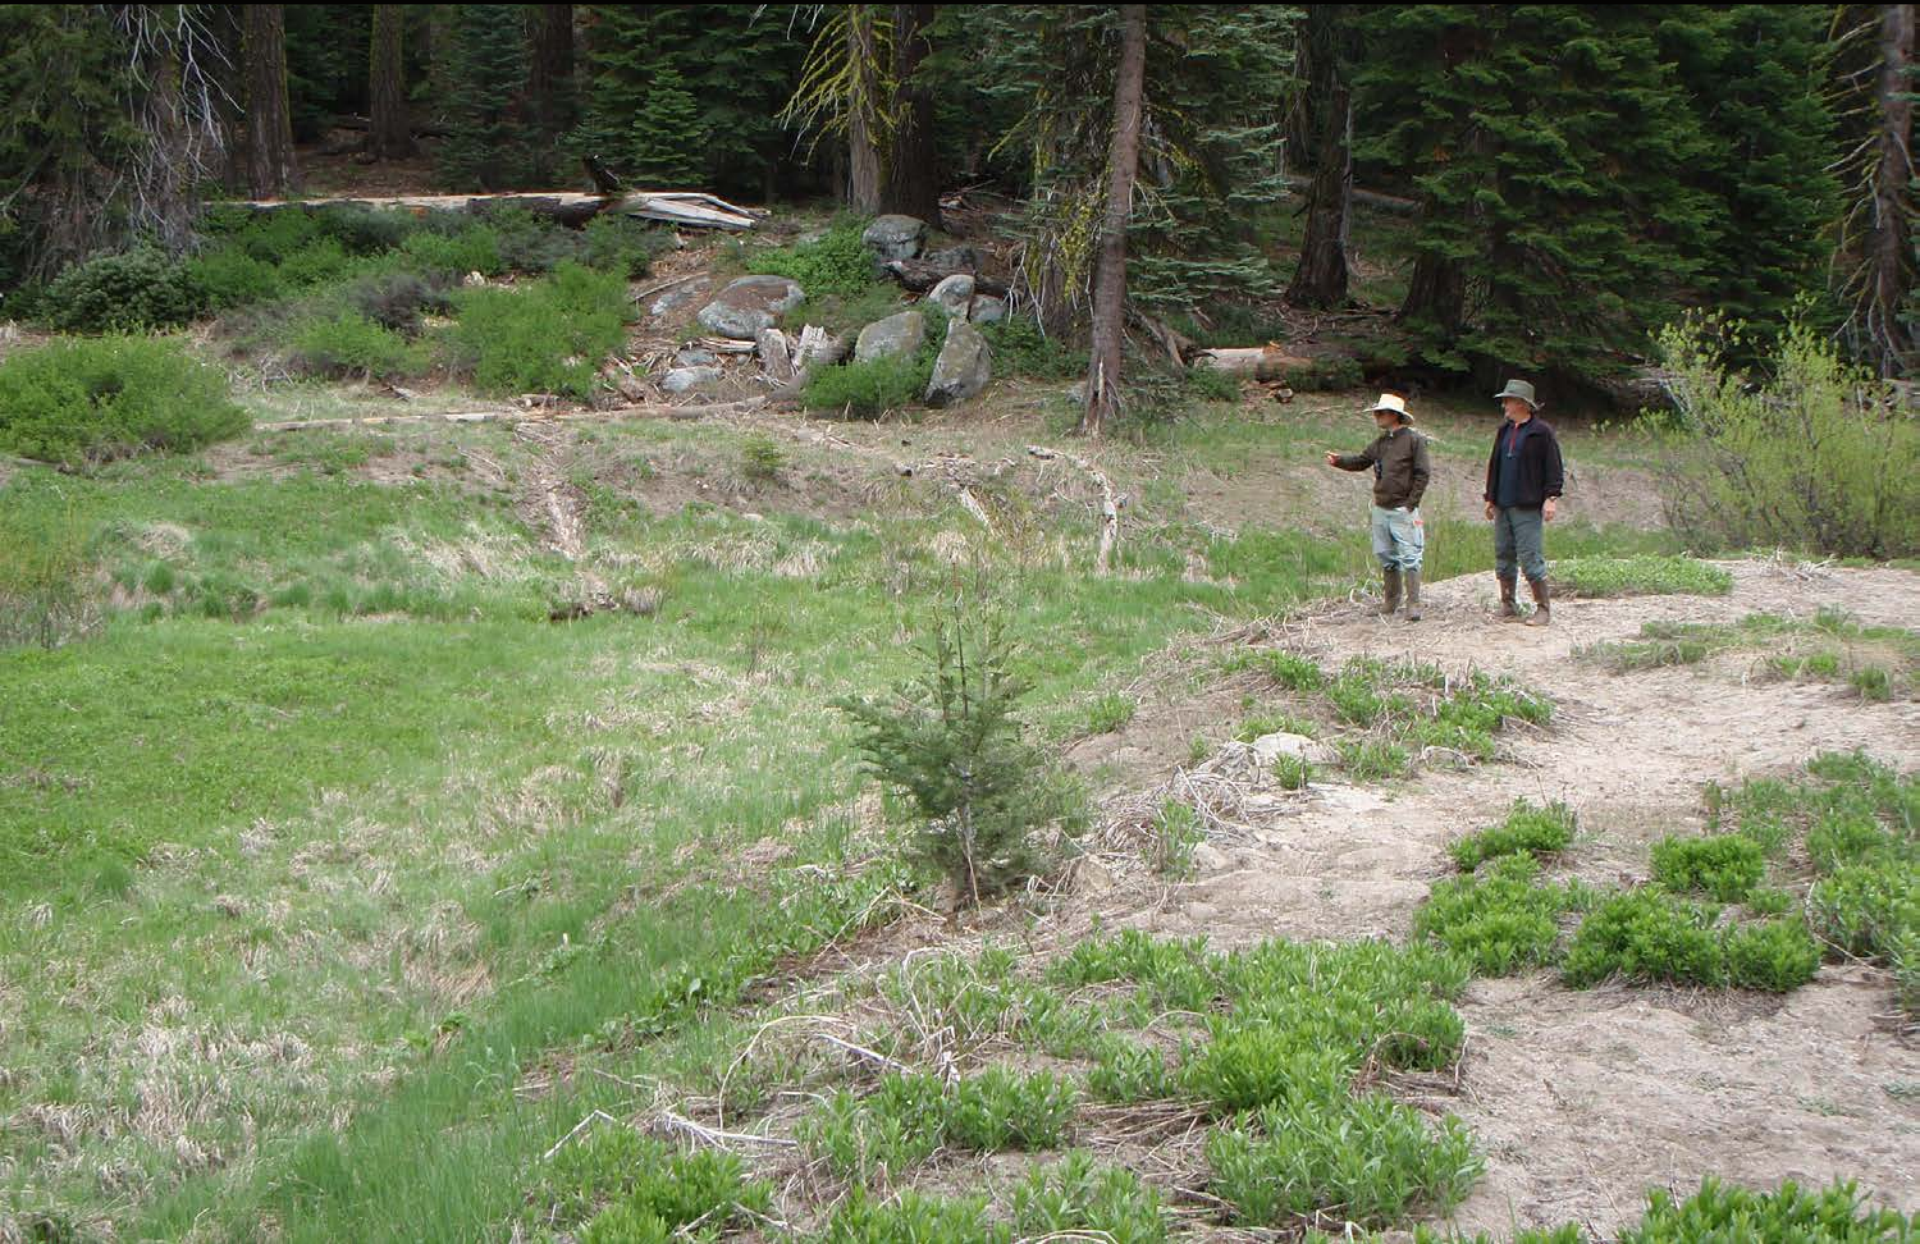
Phase 3: Lower Halstead Meadow, 2016

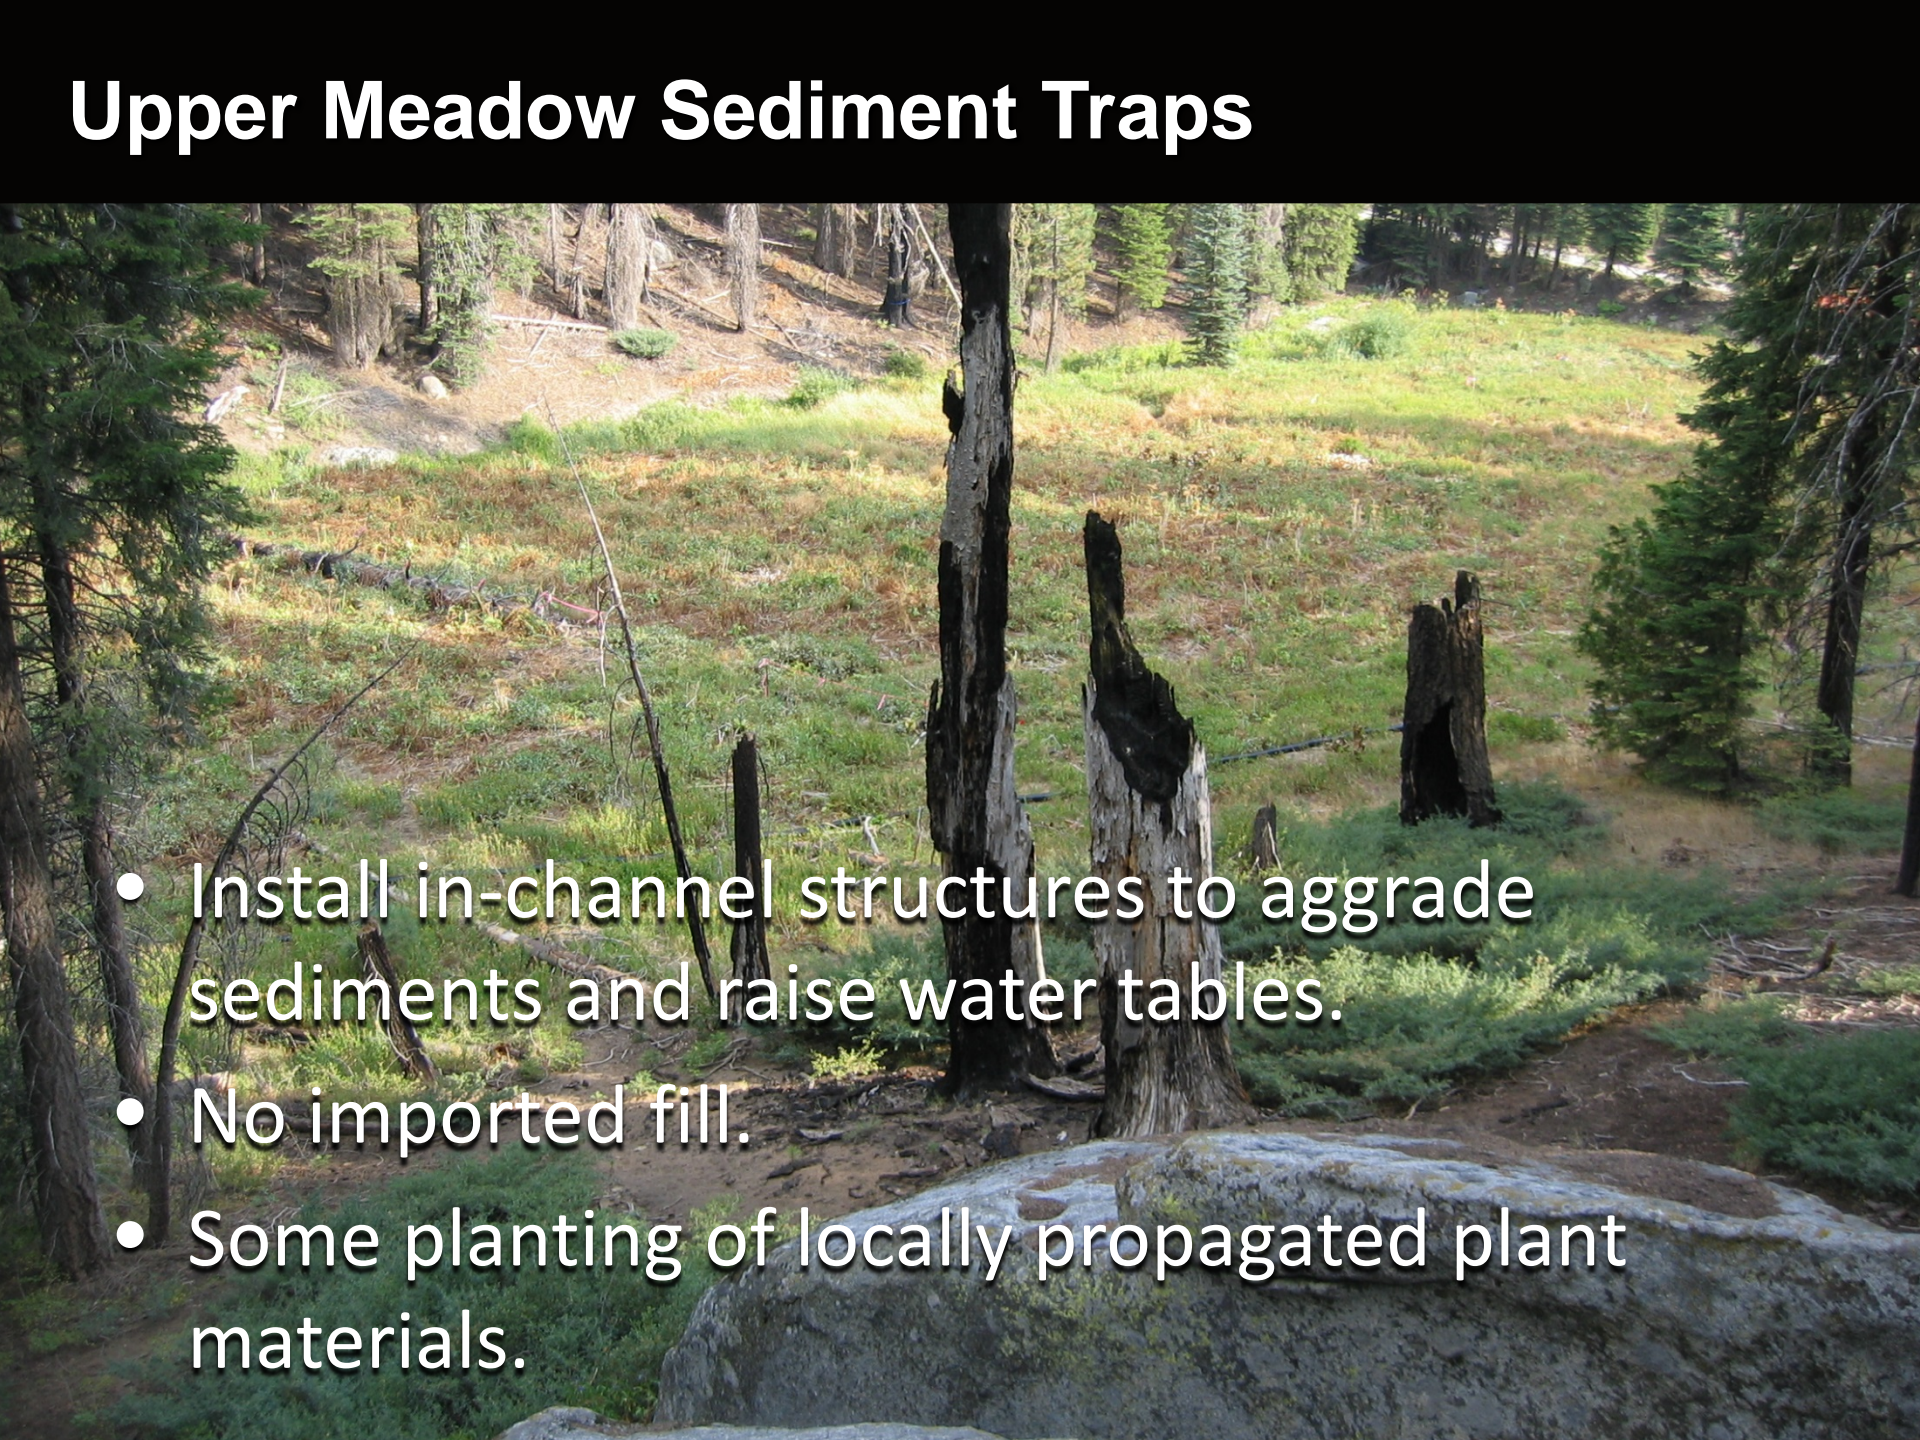
Upper Meadow Sediment Traps

- Install in-channel structures to aggrade sediments and raise water tables.
 - No imported fill.
 - Some planting of locally propagated plant materials.

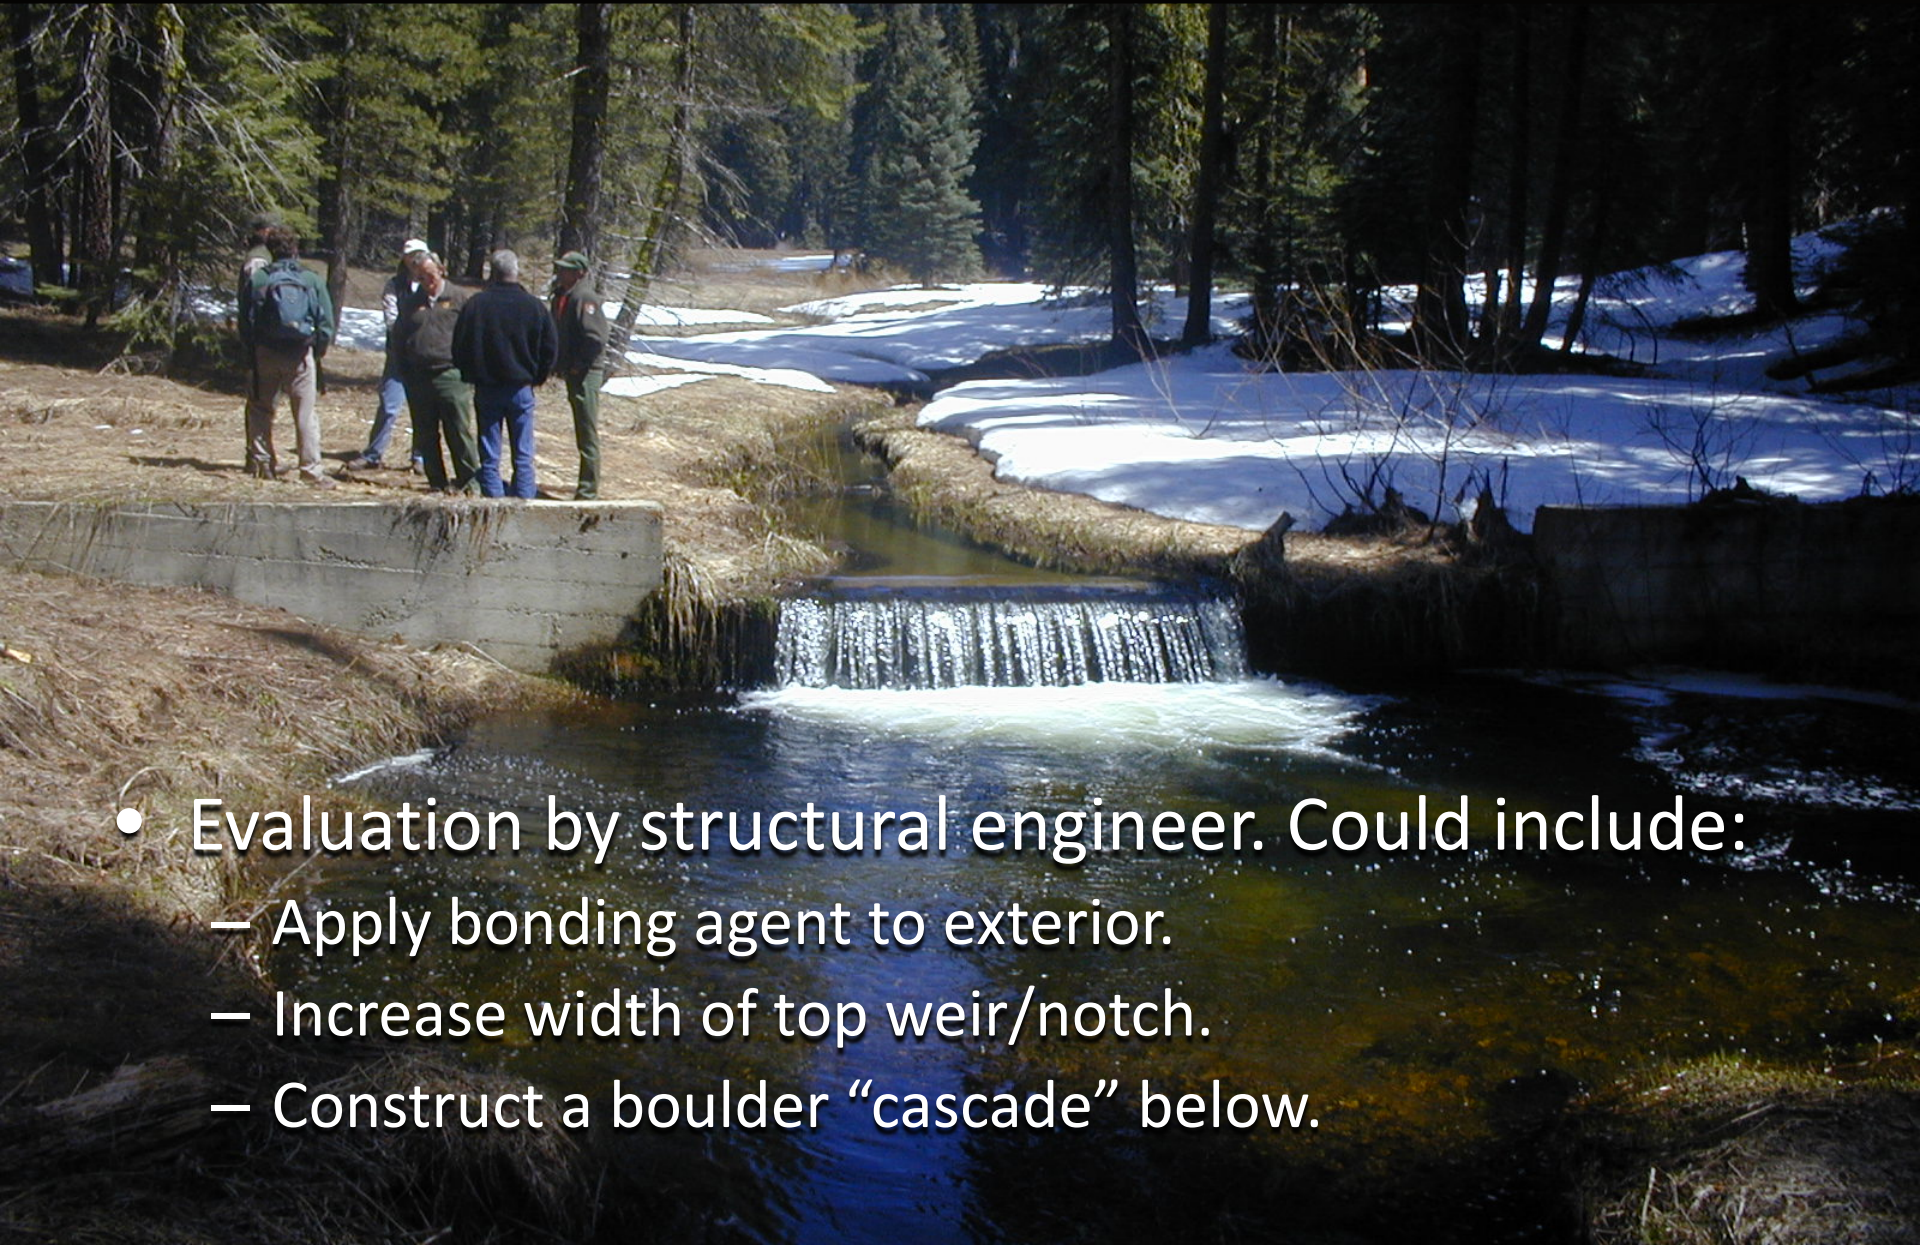
Stabilize Lower Erosion Control Structure

- Evaluation by structural engineer. Could include:
 - Apply bonding agent to exterior.
 - Increase width of top weir/notch.
 - Construct a boulder “cascade” below.

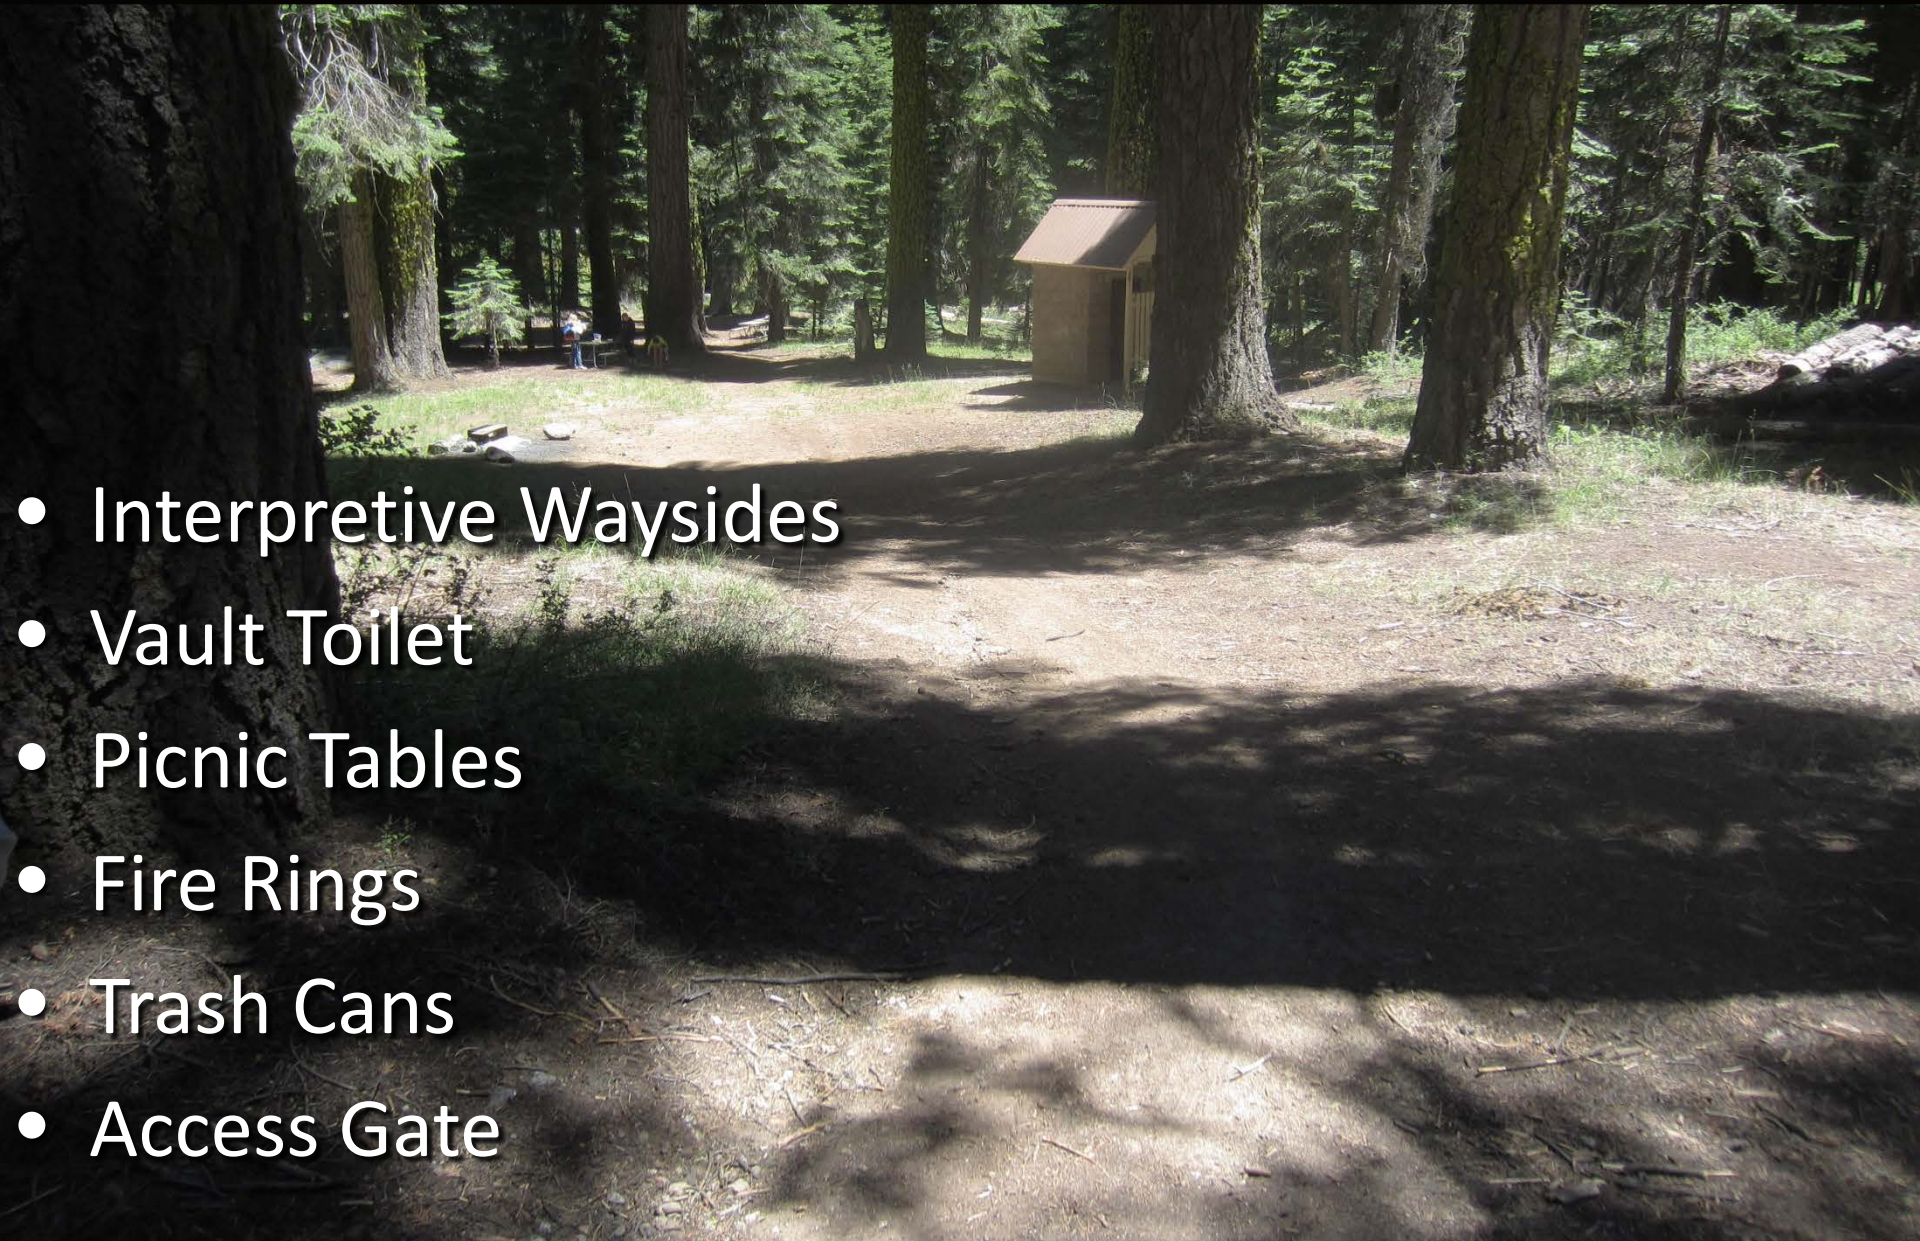
Rehabilitate Picnic Area

- Interpretive Waysides
- Vault Toilet
- Picnic Tables
- Fire Rings
- Trash Cans
- Access Gate
