YOUNGSHOLM: CHARLES YOUNG BUFFALO SOLDIERS NATIONAL MONUMENT

WILBERFORCE, OHIO

CULTURAL LANDSCAPE REPORT / ENVIRONMENTAL ASSESSMENT AND SCHEMATIC DESIGN

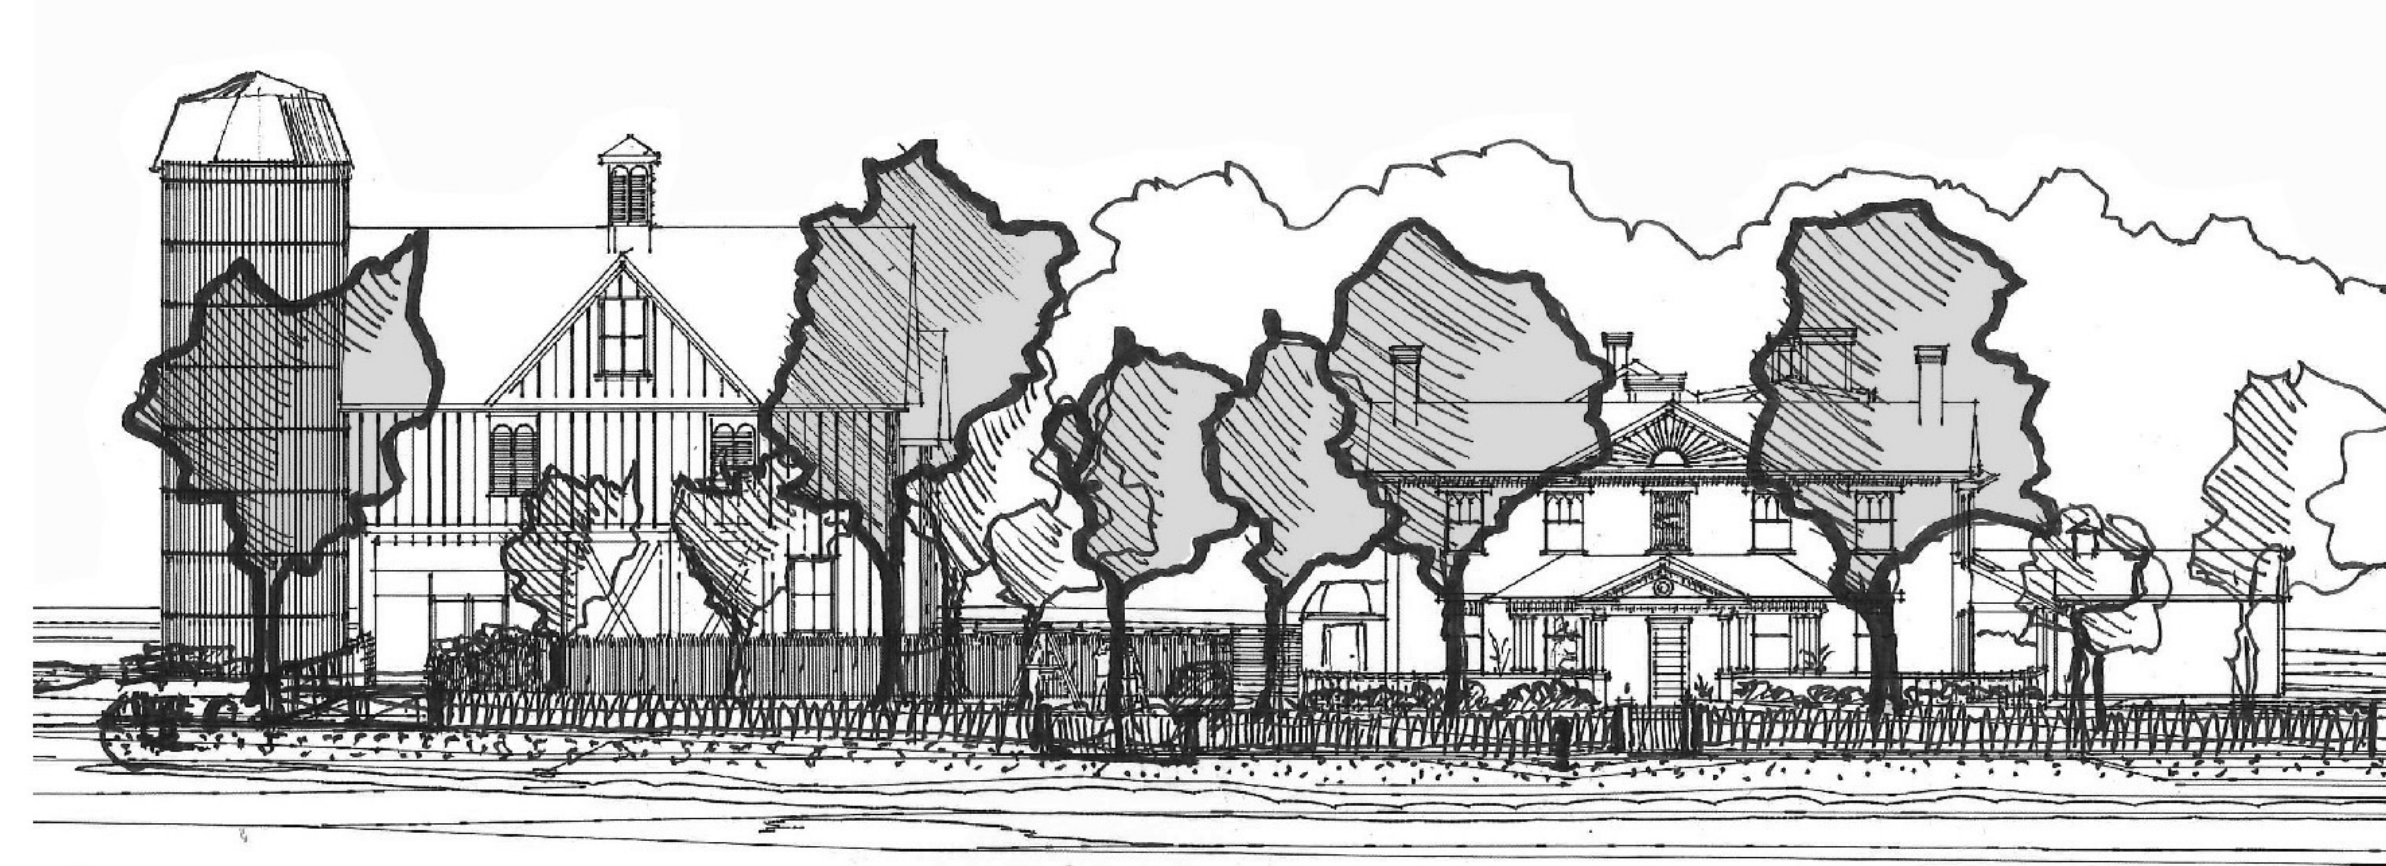
A. The treatment intent is to recapture the spatial rhythm and massing of buildings and canopy trees along the US Route 42 frontage. (source: QEA, 2017)

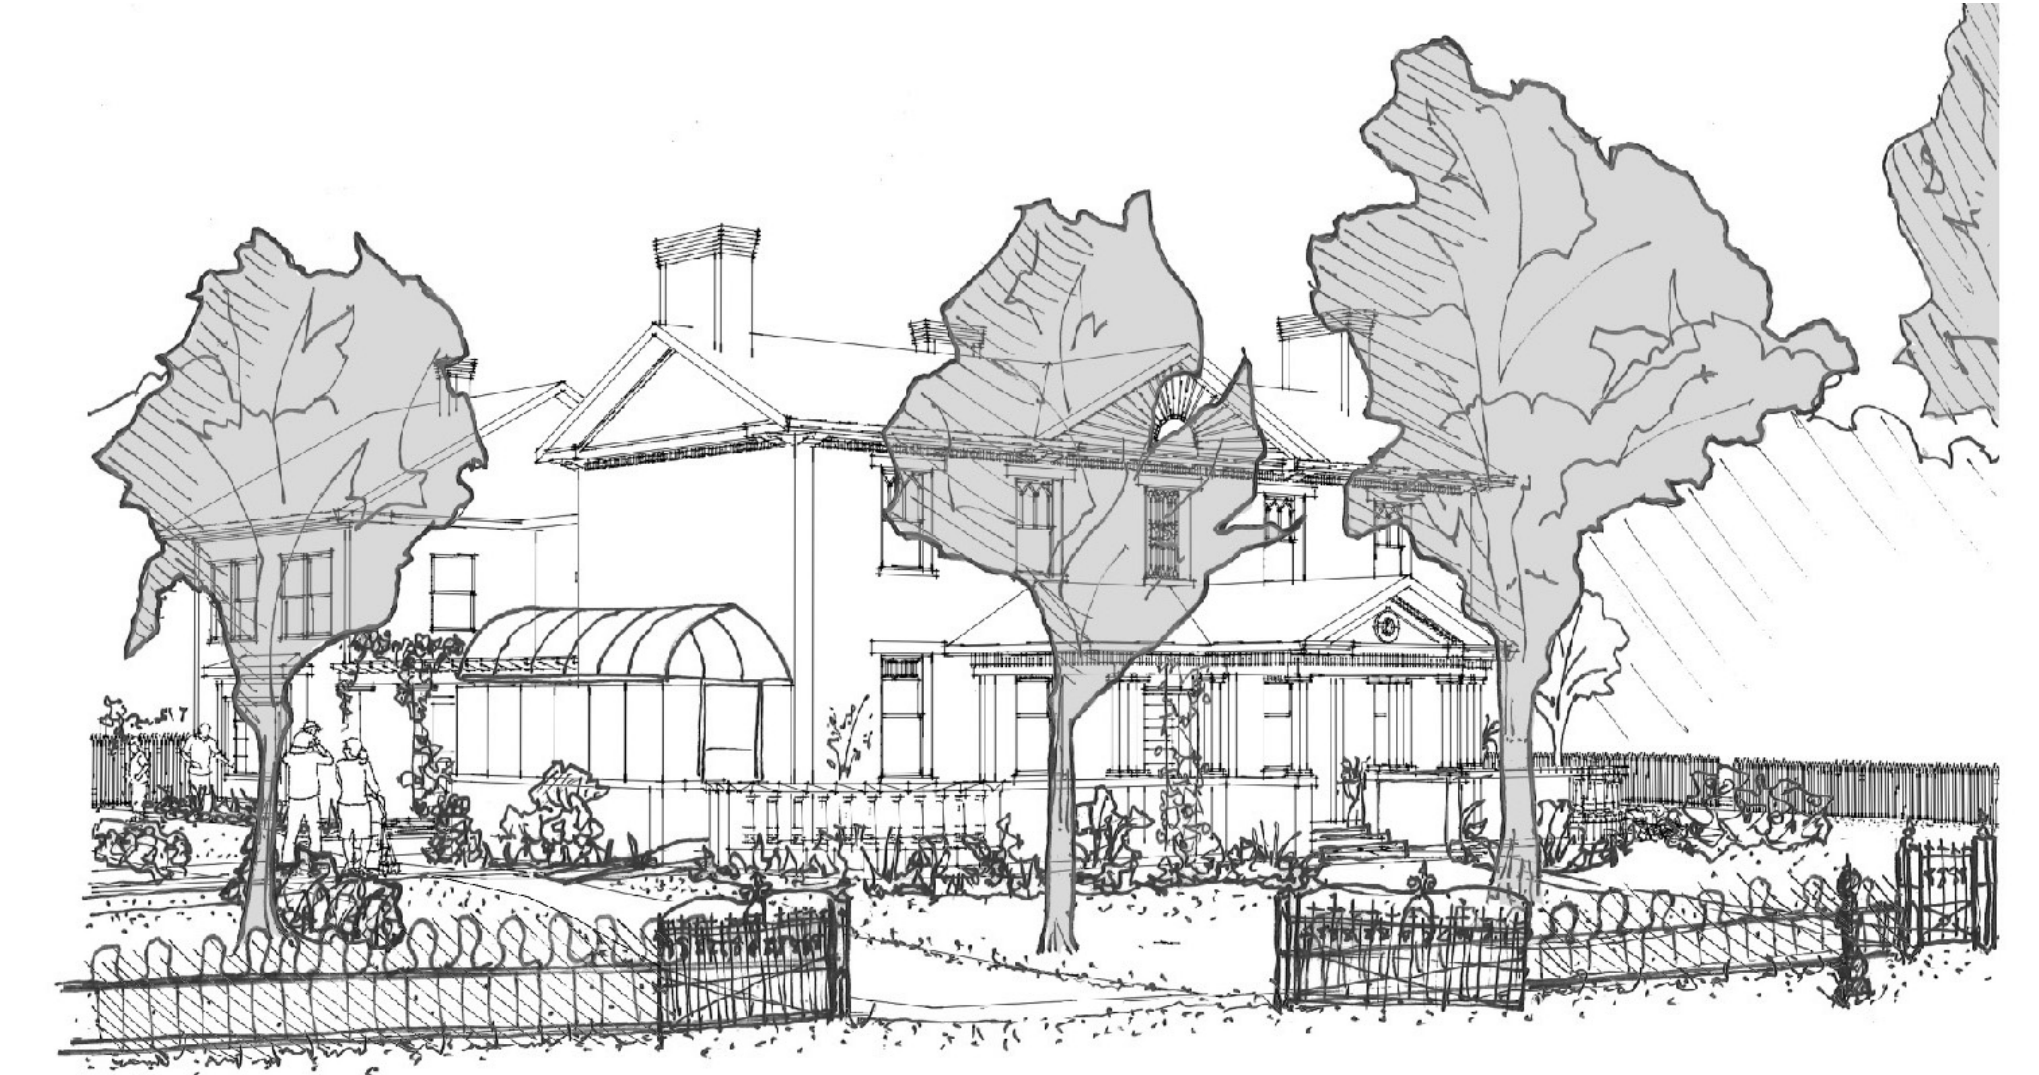
B. Restoration of small-scale elements such as fences, gates, and hitching post will enhance the historic character of the landscape. (source: QEA, 2017)

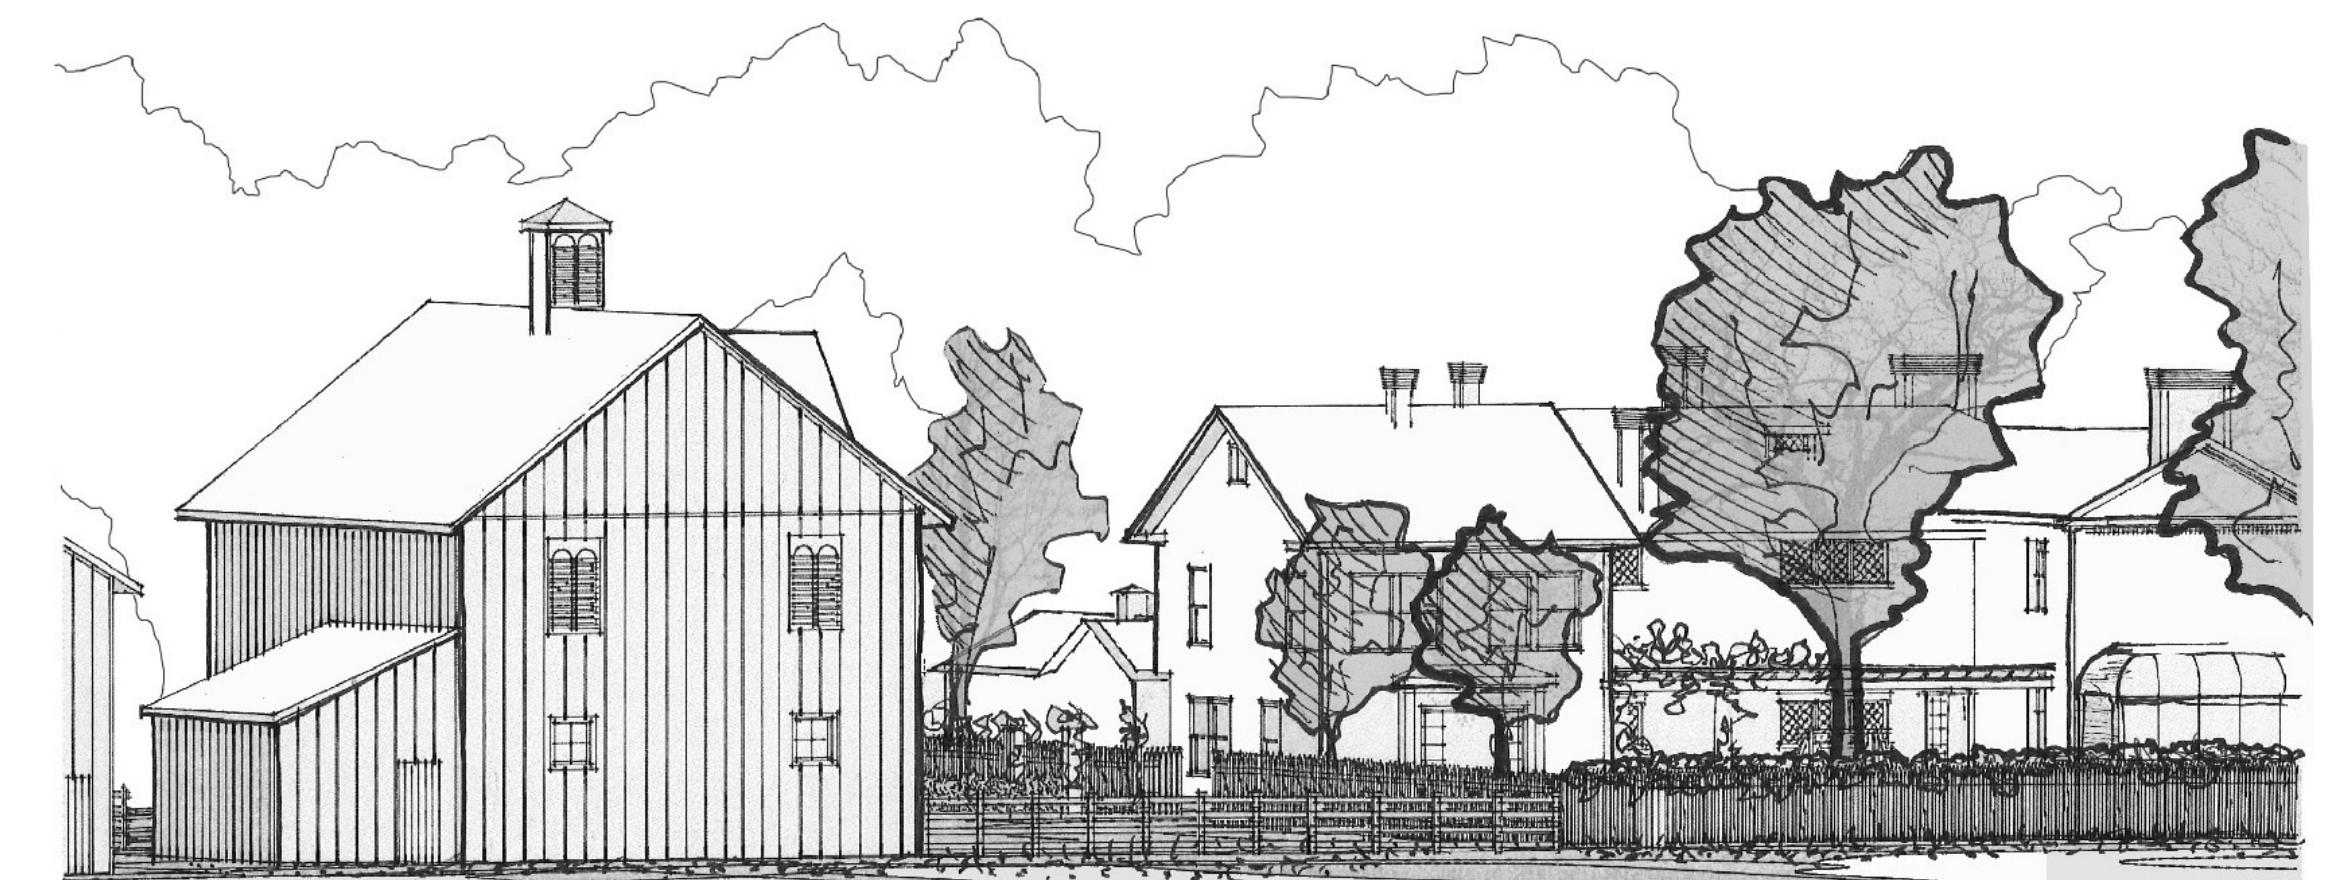
F. Addition of the visitor contact station, canopy trees, and fencing helps to redefine the spatial definition of the Homestead when viewed from the fields. (source: QEA, 2017)
