# Appendix A

## Avalanche Risk Analysis John F. Stevens Canyon Essex, Montana

Burlington Northern/ Santa Fe Railroad Co.  
December 2004

Prepared by:  
David Hamre and Mike Overcast  
Chugach Adventure Guides, LLC

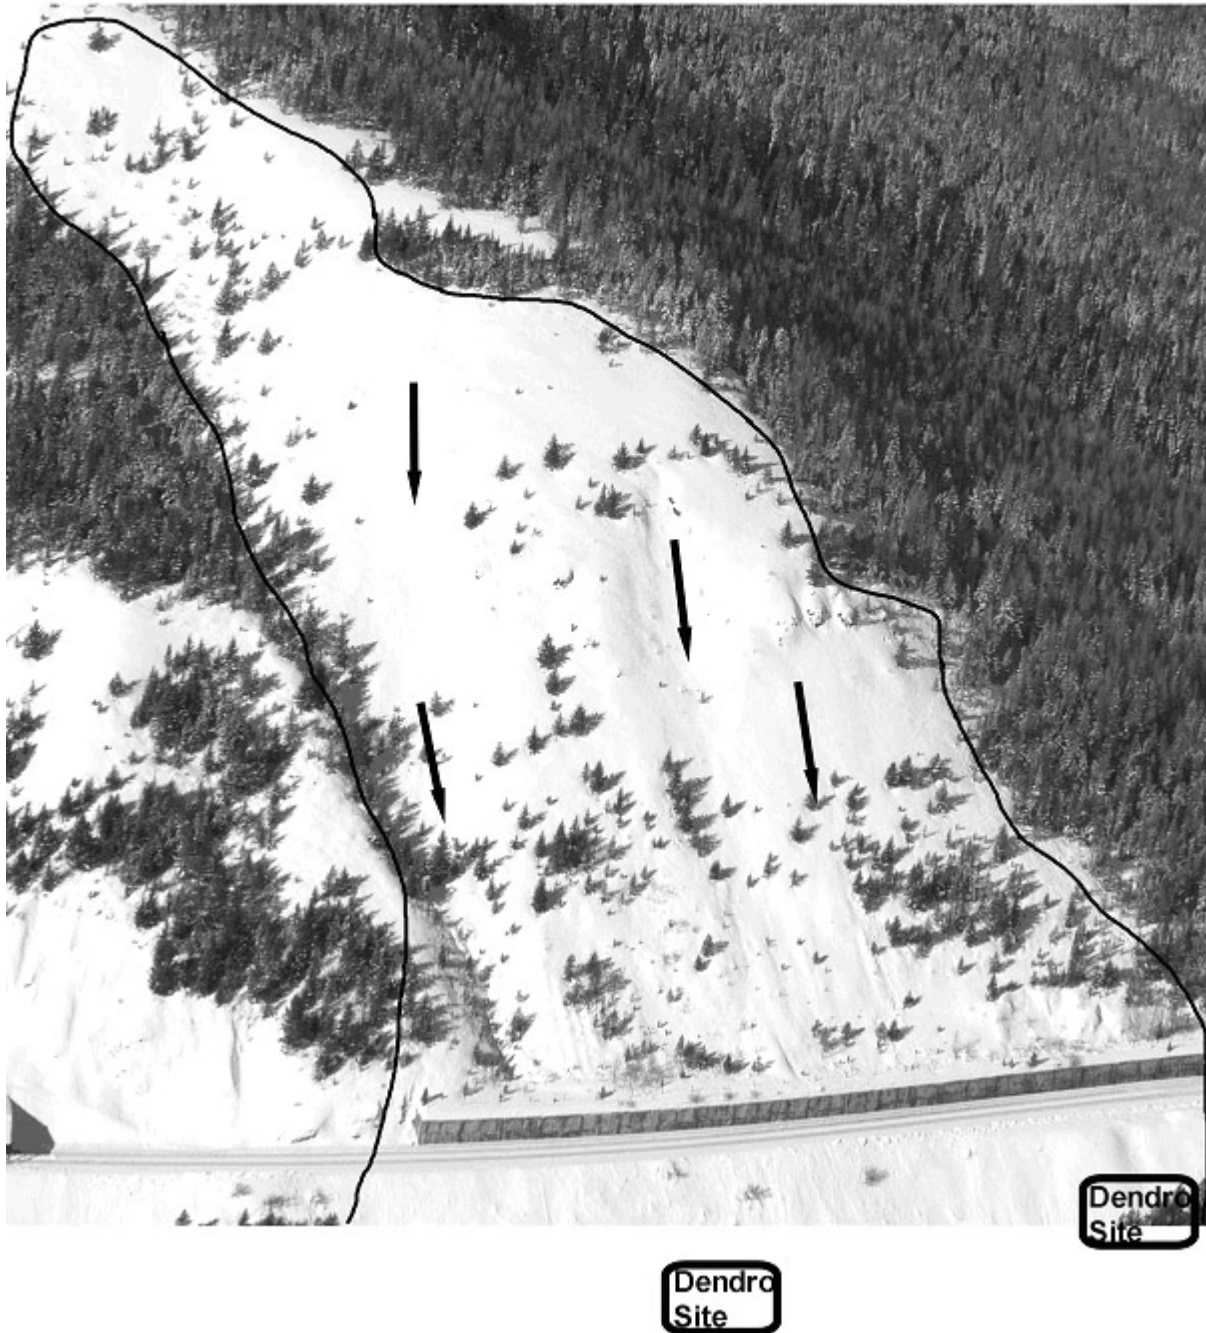
# Burn Out (Shed 4C)

Burn out slide path was equipped with a shed that has been consumed by a fire, destroying the structure. The structure wall remains above the tracks. This path is equipped with signal fence from one end of the wall to the other end. Signal boxes are located at either end. The original structure was well placed and protected traffic from any avalanche potential. Without the structure, there is considerable exposure to avalanches from above. The starting zone is broad, slightly convex, and un-forested with few anchors. The average angle from the beta point is 38 degrees. At the top end of the path, terrain angles are 25-33 degrees. The difference in angle between the upper portion of the path and the lower portion could easily result in an avalanche occurring from the steeper, lower slopes being followed a few hours later by an event from the lower angles above. Some rocky outcrops exist in the starting zone and extend down slope to mid path or track. The track is mostly planer with some shallow swales running down slope to the wall. A flat bench exists above the wall, although it is very narrow at eighty feet on the east end and fifty feet on the west. It offers very little relief to slow an avalanche. The signal fence is maintained on the uphill side of the tracks on top of the wall. A signal fence maintainer is exposed to a thirty-foot fall to the tracks if an avalanche occurred. It would not take a significant sized event for an accident to occur. Burn out is a frequent avalanche producer according to interviews with past and current railroad personnel. It is one of their biggest concerns because of the exposure to a fall and the consequences of landing on the tracks and the burial that could result. Field collections took place near the alpha point and revealed damaged timber, flagged and scarred trees, and considerable signal fence wire assumingly deposited by avalanche activity.

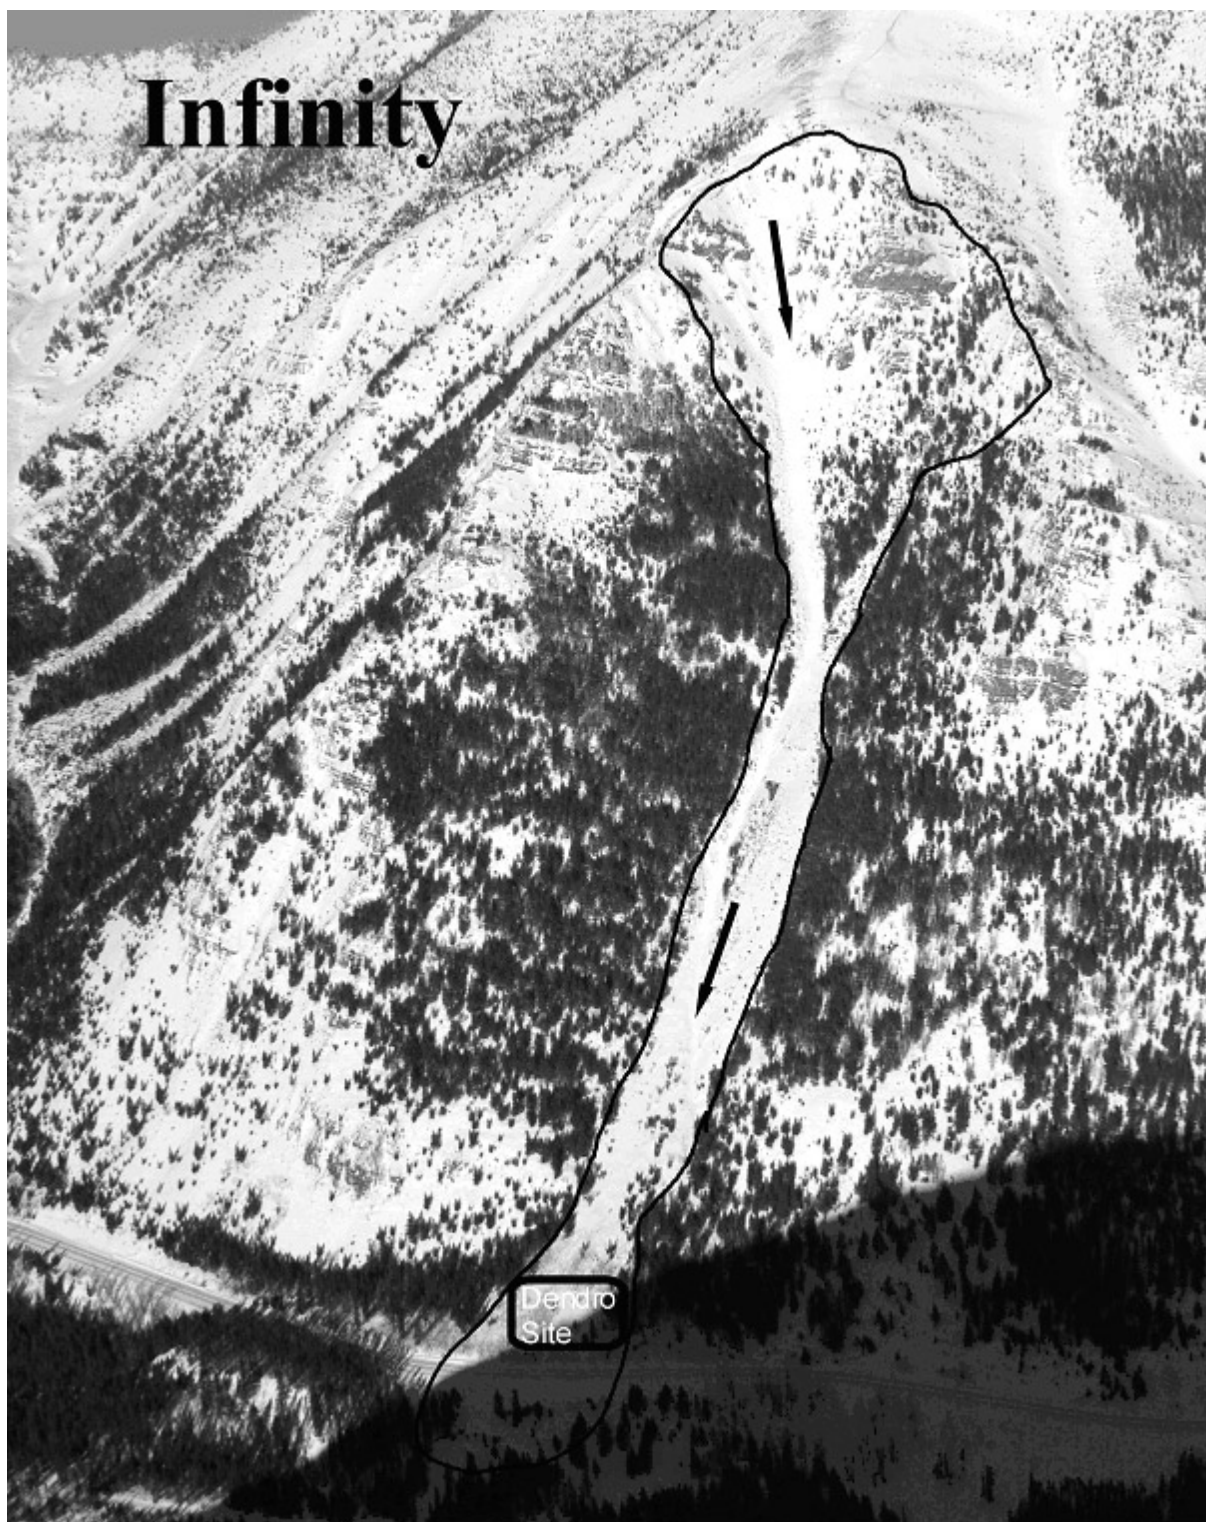
# Infinity

Infinity is a lower elevation slide zone, which has about half the run of the surrounding paths. It has a steep starting zone and retains that pitch for more than half of its length. It is constricted by an incised gully with defined trim lines. The starting zone is erosive, stepped rocks with horizontal benches running east to west. Numerous starting zones exist down the track on both sides of the path. Near the mid point, the angle eases to approximately 25 degrees, and finally eases to the beta point at 1,000 feet above the railroad. The run-out zone is all deciduous trees that show signs of avalanche damage. This path is not a frequent producer in recent times according to maintenance personnel. However, considering its size and potential volume it can definitely affect the tracks below during a large magnitude event. No signal fences are maintained across the path. In the event of an undetected avalanche, it is possible that a train could run in to the resulting debris at full track speed, increasing the possibility of a derailment.
