VI. Affected Environment

CULTURAL RESOURCES

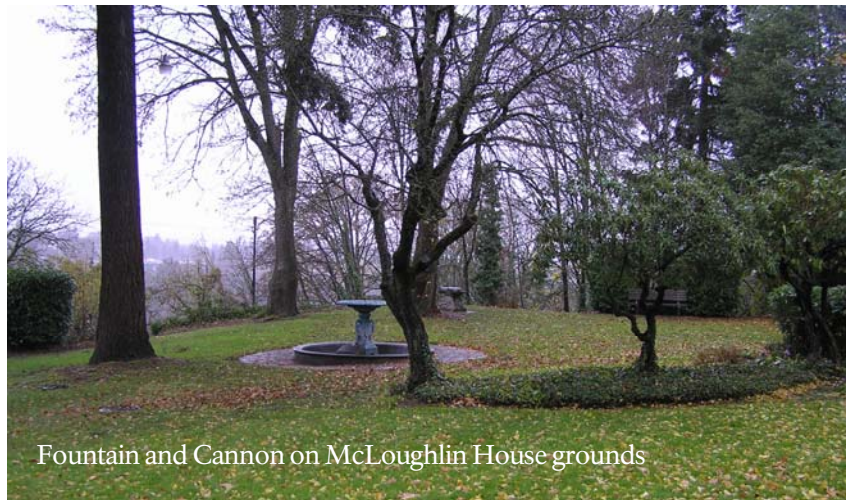
The 1911 cast iron, round fountain stands near the center of the front lawn, facing the river. The fountain is missing the finial, which in early twentieth century photographs, shows a female figure or cherub holding an umbrella. The finial disappeared in 1960. Encircling the fountain is a 10-foot, 6-inch diameter pond.

West of the fountain is a cast iron eighteenth century cannon. Historically, according to oral tradition, the cannon came from a ship that sank in the Willamette River. The cannon was placed in McLoughlin Park in 1958.

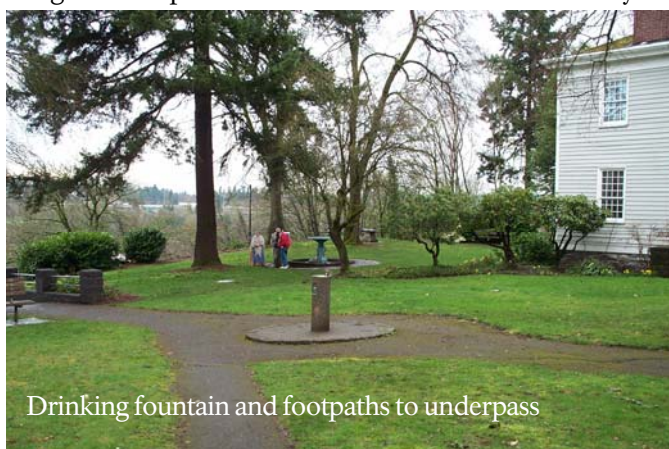
Drinking fountain and footpaths to underpass

Two asphalt footpaths cut through the south lawn on diagonals from the main sidewalk. The paths eventually unite and encircle the drinking fountain and from there continue west ending at a pedestrian underpass. The underpass has cut stone piers and metal tubular railings. Oregon City received a variety of federal funding during the 1930s which resulted in many new improvements to the downtown area. The underpass was constructed in 1936-1937 with Public Works Administration (WPA) funds. The connection steps to the underpass along Singer Creek Falls and down the bluff were also constructed in 1936 using WPA funding.

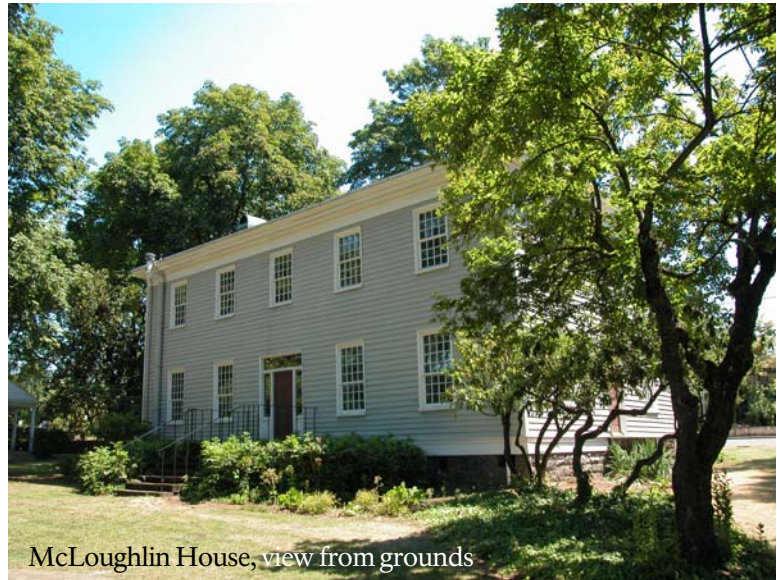
McLoughlin House, view from grounds

drawn from English architectural traditions. In addition, it appears to have influences of French Canadian construction techniques. The house is rectangular in shape with a hipped roof and horizontal clapboard siding. It currently sits on a cut stone foundation. The house has vertical corner boards, window and door trim, overhanging eaves, and a cornice. The house has two interior brick chimneys; one on the north side and one on the south. The east side of the house has five “12 over 12” double hung windows on the second floor and four “16 over 16” double hung windows on the first floor. The west side has the same window arrangement as the east. The north and south sides of the house each have five windows, three on the second floor and two on the first floor. The west side has a central paneled door with a transom and side lights, and the east side has a central paneled door with a transom. There is a paneled door on the south side of the house.
