TIOGA ROAD REHABILITATION

DELINEATION OF WETLANDS AND OTHER WATERS OF THE UNITED STATES
MARCH 2011

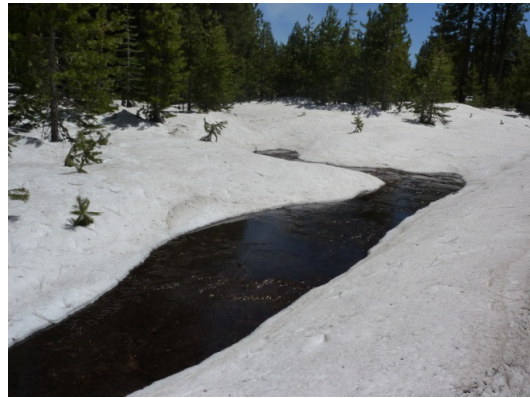
Figure 2-1. Snowmelt Influences Hydrology

In Yosemite National Park, the majority of precipitation falls in the form of snow that accumulates above 6,000 feet during the winter, creating a natural water tower that slowly releases meltwater through the spring and early summer (NPS 2010) (Figure 2-1). The hydrology of the Tioga Road corridor is primarily influenced by meltwater of the Tuolumne River and Merced River watersheds, as the road meanders between both of these watersheds.

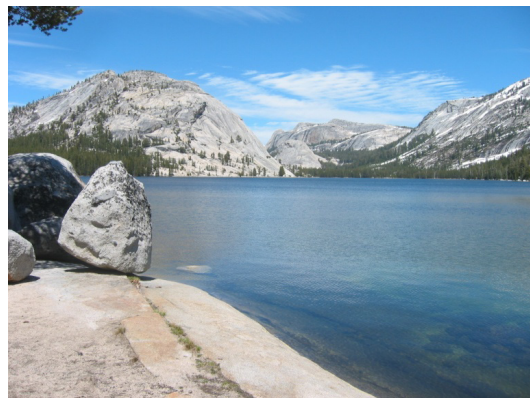
Figure 2-2. Tenaya Lake

Tenaya Lake (Figure 2-2) is the largest surface water feature within the project area. Tenaya Lake, and creeks along portions of the road nearer to Crane Flat, eventually drain to the Merced River in the southern portion of Yosemite National Park. Wetlands and other waters of the United States in the vicinity of Tenaya Lake were previously mapped in 2008 (Herrera Environmental Consultants, Inc. 2009), and thus this area was not surveyed for the purposes of this report.

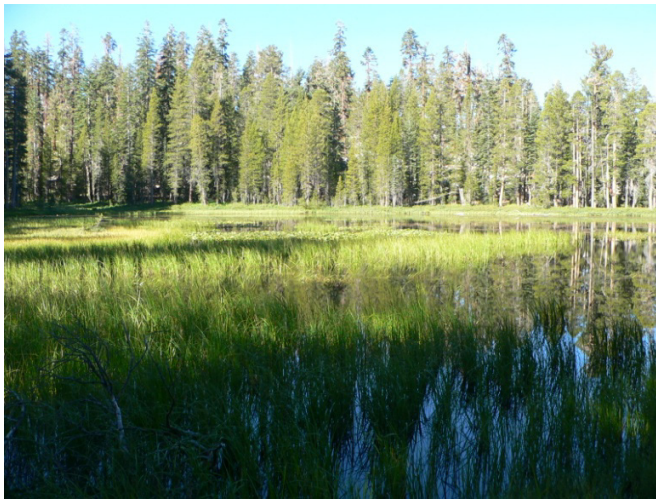
Figure 2-3. Typical Upper Montane Forest (surrounding a ponded wetland)

California red fir and Sierra lodgepole pine are the typical dominant tree species in this forest, and often form pure stands. Jeffrey pine and Sierra juniper are other common component tree species found within the upper montane forest. Around elevations of 8,000 feet, where the growing season is shorter and snowfall is typically higher, subalpine forest replaces the upper montane forest (NPS 2010). Dominant tree species in the subalpine forest are western white pine, mountain hemlock, and Sierra lodgepole pine. Subalpine forest is the dominant vegetation zone in the eastern portion of the Tioga Road corridor. Within these broadly

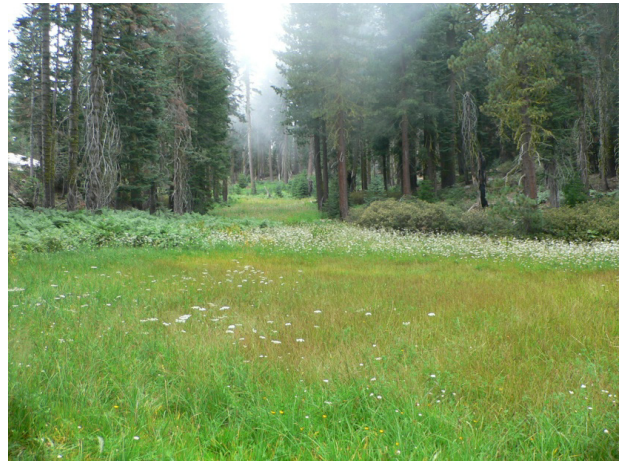
**Figure 2-4. Representative Meadow Community
(surrounded by upper montane forest)**

Meadow communities within Yosemite National Park are highly variable in structure and species composition. Common and dominant herbaceous meadow species observed during field investigations for this report included northwest territory sedge, naked sedge, mountain sedge, American bistort, common rush, Sierra shooting star, tufted hair grass, pullup muhly, plantainleaf buttercup, alpine aster, and subalpine fleabane.

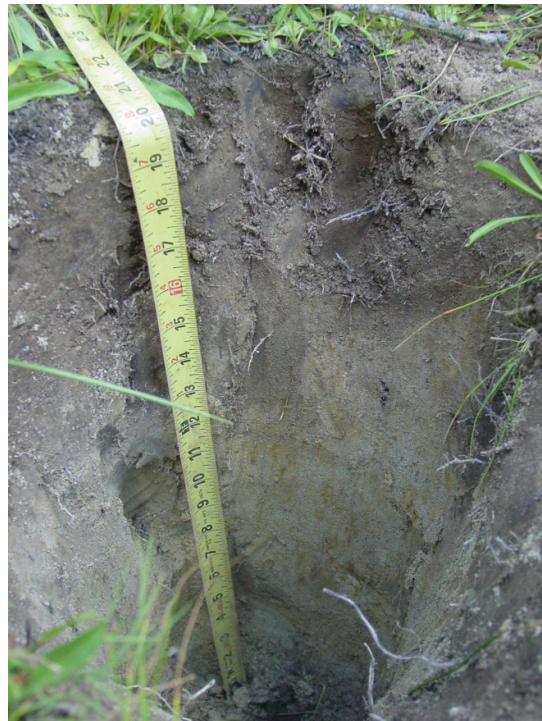
Figure 3-2. Representative Soil Pit

Survey teams evaluated and documented the morphological characteristics of all visible soil horizons observed in excavated soil profiles at each sample plot. Soil pits were excavated to depths of 20 to 24 inches (Figure 3-2), except in instances where positive hydric soil indicators were obtained above that depth or where excavation was met with refusal (e.g., rock or large roots). Soil profile analyses included descriptions of horizon thickness (depth); matrix color; texture; and type, location, abundance, and color of redoximorphic features (if present). These characteristics were used as the basis for determining the presence or absence of hydric soil indicators as set forth in the *Regional Supplement to the Corps of Engineers Wetland Delineation Manual: Western Mountains, Valleys, and Coast Region (Version 2.0)* (USACE 2010).

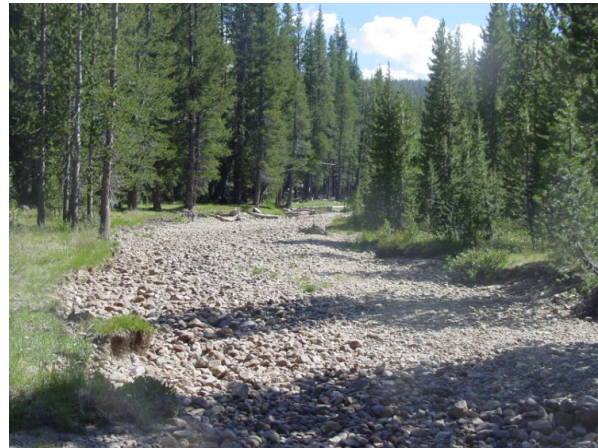
Figure 3-3. Riverine Habitat with Clearly Defined Bed and Banks

Other waters of the United States were mapped and delineated in the field based on the location of ordinary high water marks, as defined by Section 404 of the Clean Water Act and with the guidelines set forth by *Regulatory Guidance Letter No. 05-05* (USACE 2005). The lateral limits of jurisdiction over nontidal water bodies extend to the ordinary high water marks, in the absence of adjacent wetlands. When adjacent wetlands are present, Clean Water Act jurisdiction extends beyond the ordinary high water mark to the limits of the adjacent wetlands. Physical characteristics (as defined by USACE 2005) that were considered when making ordinary high water mark determinations for this report included, but were not limited to, evidence of: a natural line impressed on the bank, scour, shelving, destruction of terrestrial vegetation, bed and banks (Figure 3-3), and deposition.

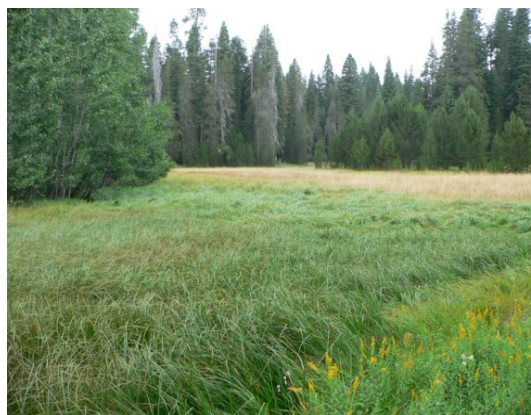
Figure 4-2. Palustrine Emergent Wetland

Palustrine emergent wetlands (PEM) are characterized by erect, rooted, herbaceous hydrophytic vegetation. (Cowardin et al. 1979). The majority of fens, bogs, marshes, and wet meadows found in mountain habitats are classified under this system. These wetlands were the most commonly observed within the project survey area and are the dominant Cowardin habitat in the meadows along Tioga Road. Dominant and/or commonly observed plant species within PEM habitats

along the project corridor included: northwest territory sedge, naked sedge, mountain sedge, American bistort, common rush, Sierra shooting star, tufted hair grass, pullup muhly, plantainleaf buttercup, alpine aster, and subalpine fleabane. A total of 19.14 acres of PEM wetlands were delineated and mapped during surveys for this report. Figure 4-2 shows a typical PEM wetland found within the project survey area.

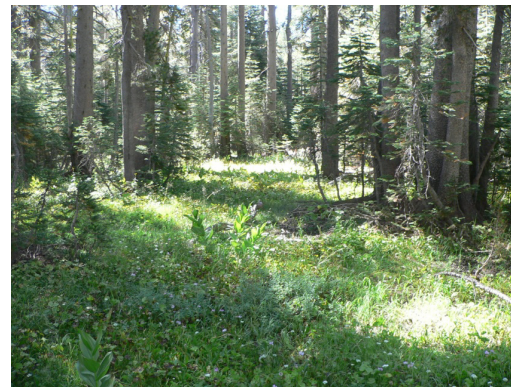
Figure 4-3. Palustrine Forested Wetland

Palustrine forested wetlands (PFO) are dominated by woody vegetation that is at least 20 feet tall, and are most common in the eastern United States and in those sections of the West where moisture is relatively abundant, particularly along rivers and in the mountains (Cowardin et al. 1979). Palustrine forested wetlands occur in floodplains, springs, seeps, adjacent to running waters, and in other areas with high water tables (USACE 2010). Within the Tioga Road project area, these wetlands are dominated by large coniferous species, predominantly lodgepole pine, with herbaceous wetland species occupying the understory. A total of 2.60 acres of PFO wetlands were delineated and mapped during surveys for this report. Figure 4-3 shows a typical PFO wetland found within the project survey area.

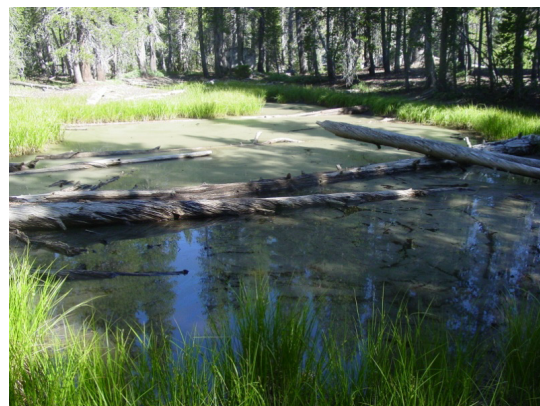
Figure 4-4. Palustrine Unconsolidated Bottom Wetland

Palustrine unconsolidated bottom (PUB) wetlands are characterized as having a vegetative cover less than 30% with at least 25% cover of particles smaller than stones (Cowardin et al. 1979). These wetlands tend to lack large stable surfaces for plant and animal attachment, and their water regimes range from permanently to semipermanently flooded. Palustrine unconsolidated bottom wetlands typically have a strong

association with PEM wetlands, and are often fringed by herbaceous emergent vegetation. Within the project survey area, PUB wetlands often had standing, or ponded, water and were primarily dominated by bladder sedge and/or inflated sedge – two very similar obligate wetland species. A total of 1.11 acres of PUB wetlands were delineated and mapped during surveys for this report. Figure 4-4 shows a typical PUB wetland found within the project survey area.

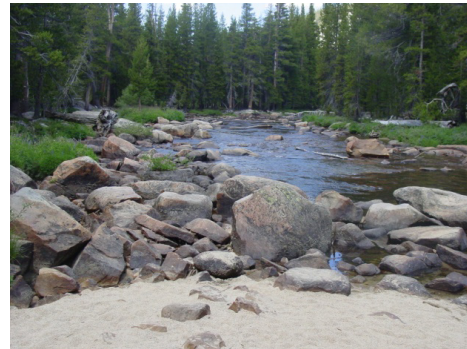
Figure 4-5. Riverine Upper Perennial Rock Bottom

Riverine upper perennial rock bottom (R3RB) habitat includes all riverine upper perennial habitats with substrates having an areal cover of stones, boulders, or bedrock 75% or greater and vegetative cover of less than 30% (Cowardin et al. 1979). These habitats have flowing water year-round, and are generally found in the larger riverine systems within the park. The majority of the portions of Tuolumne River that are within the project study area are classified as this habitat type. A total of 1.77 acres of R3RB habitat were mapped during surveys for this report. Figure 4-5 shows a typical R3RB habitat found within the project survey area.

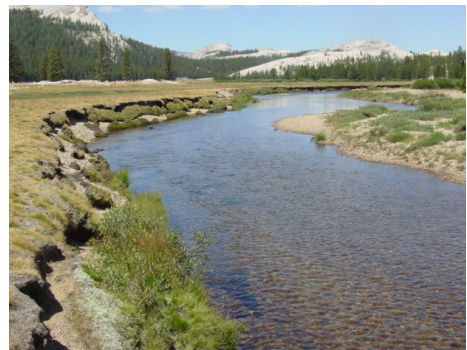
Figure 4-6. Riverine Upper Perennial

Riverine upper perennial unconsolidated bottom (R3UB) habitat includes all riverine upper perennial habitats with at least 25% cover of particles smaller than stones, and a vegetative cover less than 30% (Cowardin et al. 1979). These habitats have bottoms that are characterized by the lack of large stable surfaces, and are usually found in areas with lower energy than rock bottom habitats. Within the project survey area, these riverine habitats are typical of the larger-sized Tuolumne River tributaries that have somewhat lower energy than the main river. Only a small area (0.003 acre) of R3UB habitat was mapped within the study area boundaries, but it is fairly extensive along the Tuolumne River. Figure 4-6 shows a typical R3UB habitat found within the project survey area.

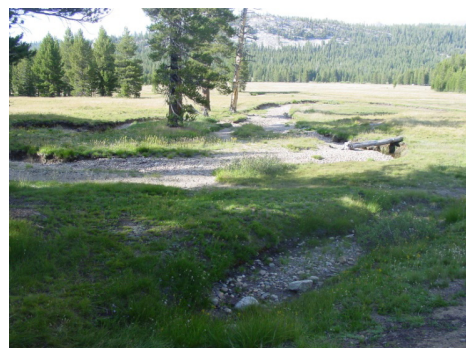
Figure 4-7. Riverine Intermittent Streambed

Riverine intermittent streambed (R4SB) habitat is characterized by the lack of year-round water flow and/or surface water (Cowardin et al. 1979). These systems are typically smaller than perennial riverine systems and can have a variety of bottom substrates. The majority of riverine habitat that was mapped in the project study area is classified as R4SB. Though many of these habitats lacked surface water during field investigations, they often provided evidence of connectivity and drainage between larger wetland habitats. A total of 4.08 acres of R4SB habitat were mapped during surveys for this report. Figure 4-7 shows a typical R4SB habitat found within the project survey area.
