Photos of Existing and Proposed Windows Mammoth Hot Springs Hotel

The following photos are intended to show the character, materials, design, and workmanship of existing wood windows on the Guest Wing of the Mammoth Hot Springs Hotel (Figure 1 through Figure 4). Figure 5 and Figure 6 show examples of the type of window proposed to replace these Guest Wing windows.

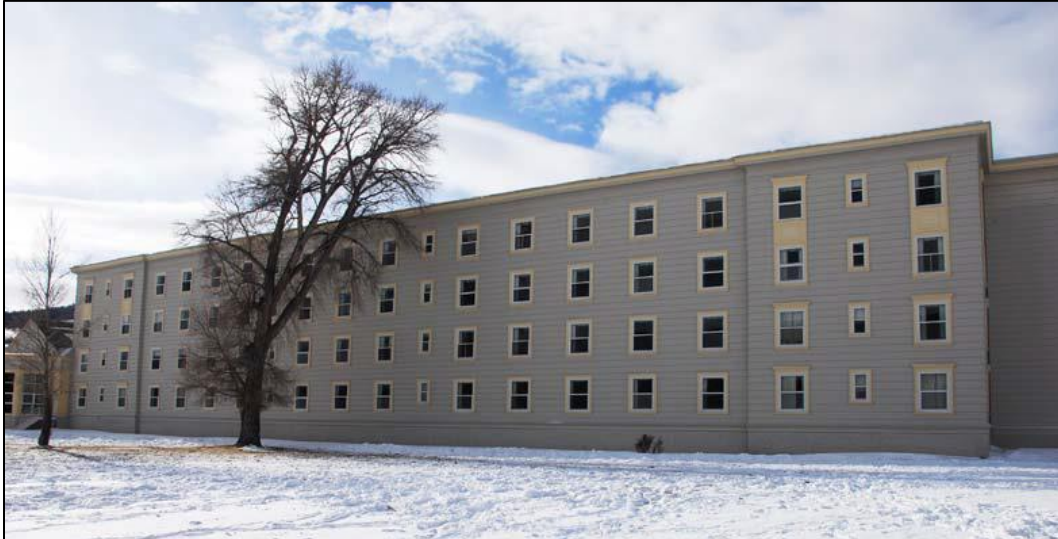
Figure 1: Existing view of east side of the Guest Wing of the Mammoth Hot Springs Hotel that is finished with wide horizontal shiplap siding. Window openings are uniformly spaced on each of the elevations. The windows are one-over-one, double-hung and are finished with projecting cornice with architrave trim. There are decorative panels between the head of the 3rd floor windows and the sill of the 4th floor windows.

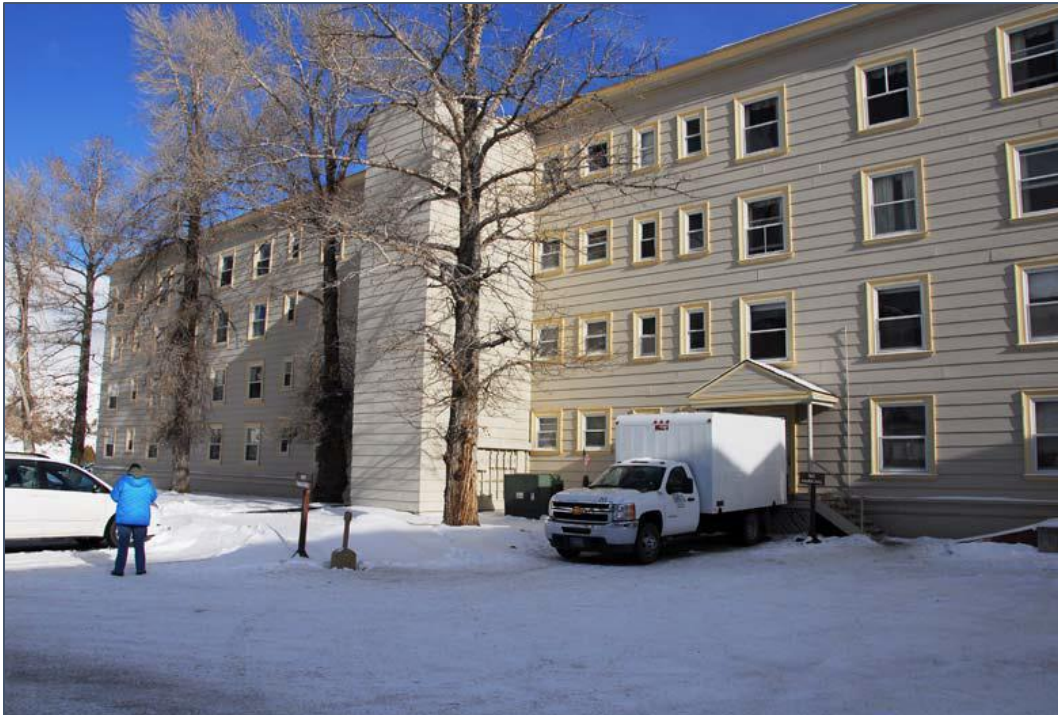
Figure 2: Existing view of west side of the Guest Wing of the Mammoth Hot Springs Hotel.

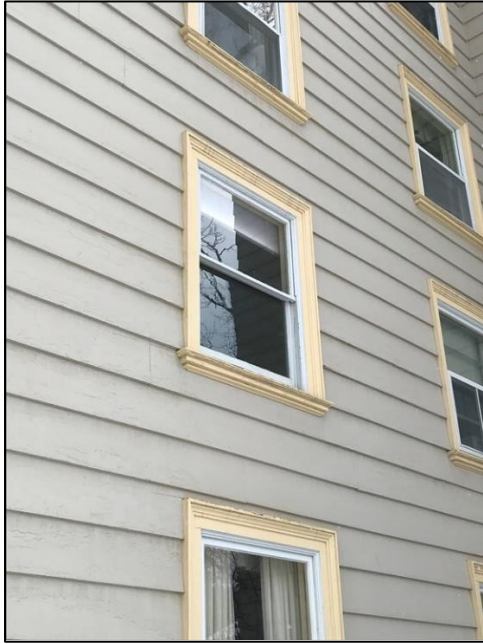
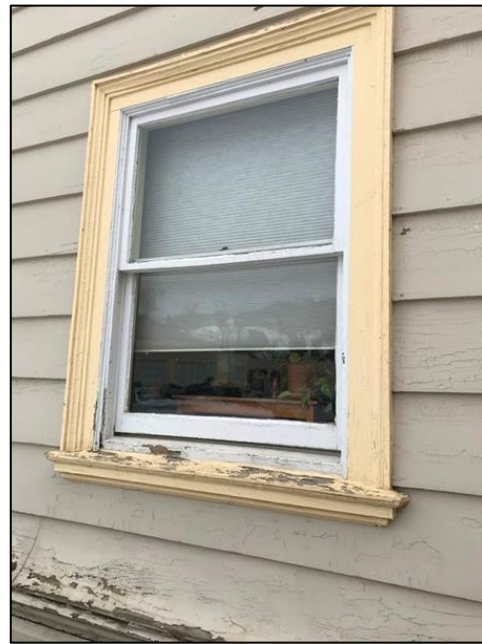
Figure 3: Exterior photos of existing one-over-one, double-hung, wood windows on the Mammoth Hot Springs Hotel Guest Wing (the bottom sash screen has been removed to get a better view of the window). Existing windows on the Guest Wing of the Mammoth Hot Springs Hotel have screens on the bottom sash only. The tops of the double hung windows are painted shut. Photos show the character of the painted trim.

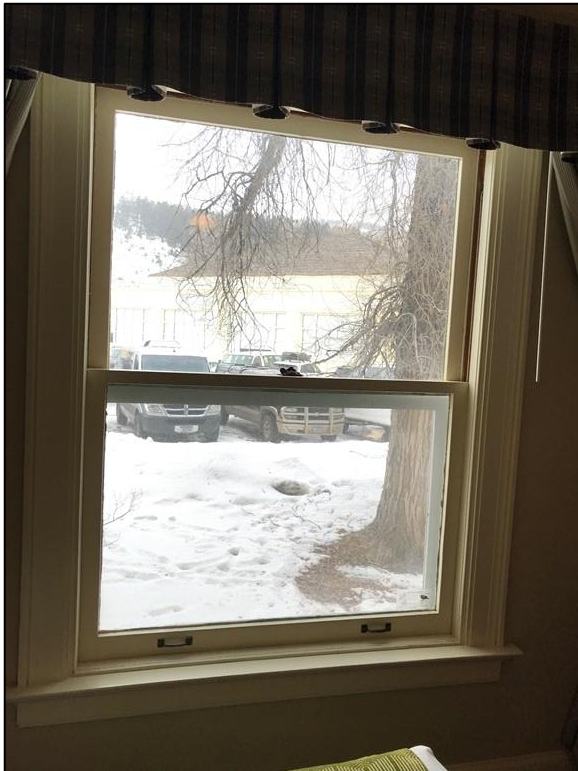
Figure 4: Interior photo of an existing window inside a guest room of the Mammoth Hot Springs Hotel Guest Wing.

Figure 6: Interior photo of the new one-over-one, double-hung, wood window that was used on a recent building addition to the later, 1937 two-story portion of the Mammoth Hot Springs Hotel. Please note the interior trim on this window in this photo has a different style of trim and is unpainted. These new windows would be painted and use trim that matches the interior trim on the existing painted windows as shown in Figure 4 .

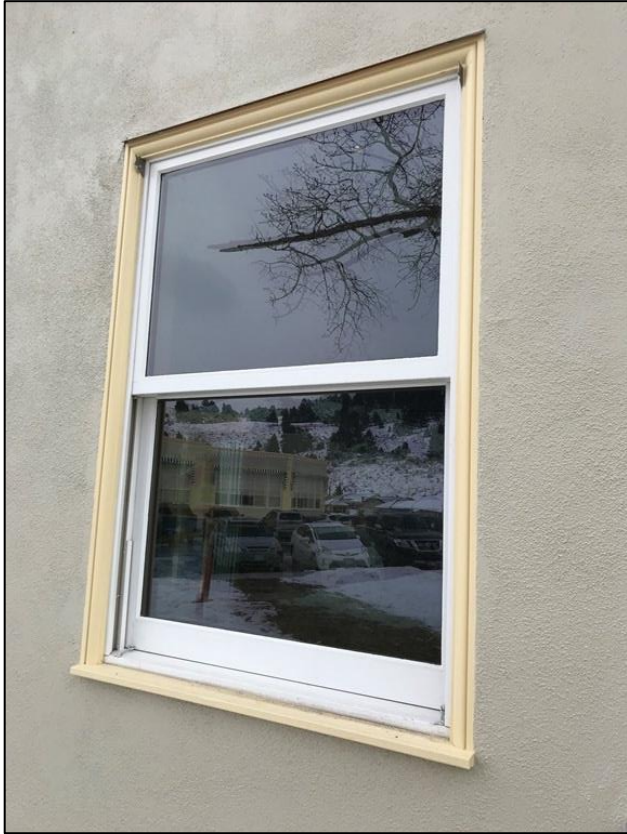
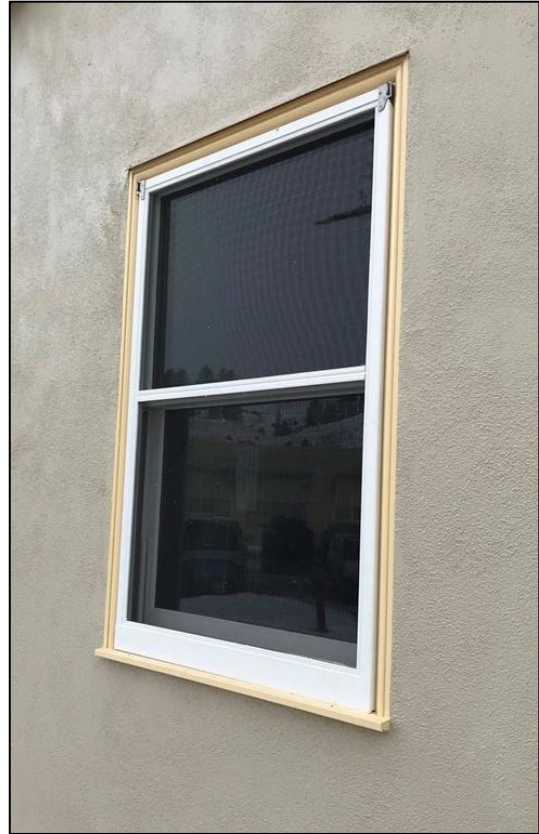
Figure 5: Exterior photos of a new one-over-one, double-hung, wood window that was used on a recent building addition to the 1937 two-story portion of the Mammoth Hot Springs Hotel that has a stucco exterior. Windows on this portion of the hotel have a different style of trim. The park proposes to use this type of window to replace the existing one-over-one, double-hung, wood windows on the Guest Wing, which has a horizontal lapped wood siding exterior. The trim on the new Guest Wing windows would match the exterior trim of existing Guest Wing windows as shown in Figure 1 through Figure 4. These new windows would have full height wood screens that cover both sashes so the upper sash can be lowered to achieve better ventilation in the guest rooms. Photo on the left is without a screen, photo on the right has a screen.
