SECTION 106 REVIEW | 02-13-2018

National World War I Memorial Pershing Park

ASSESSMENT OF EFFECTS

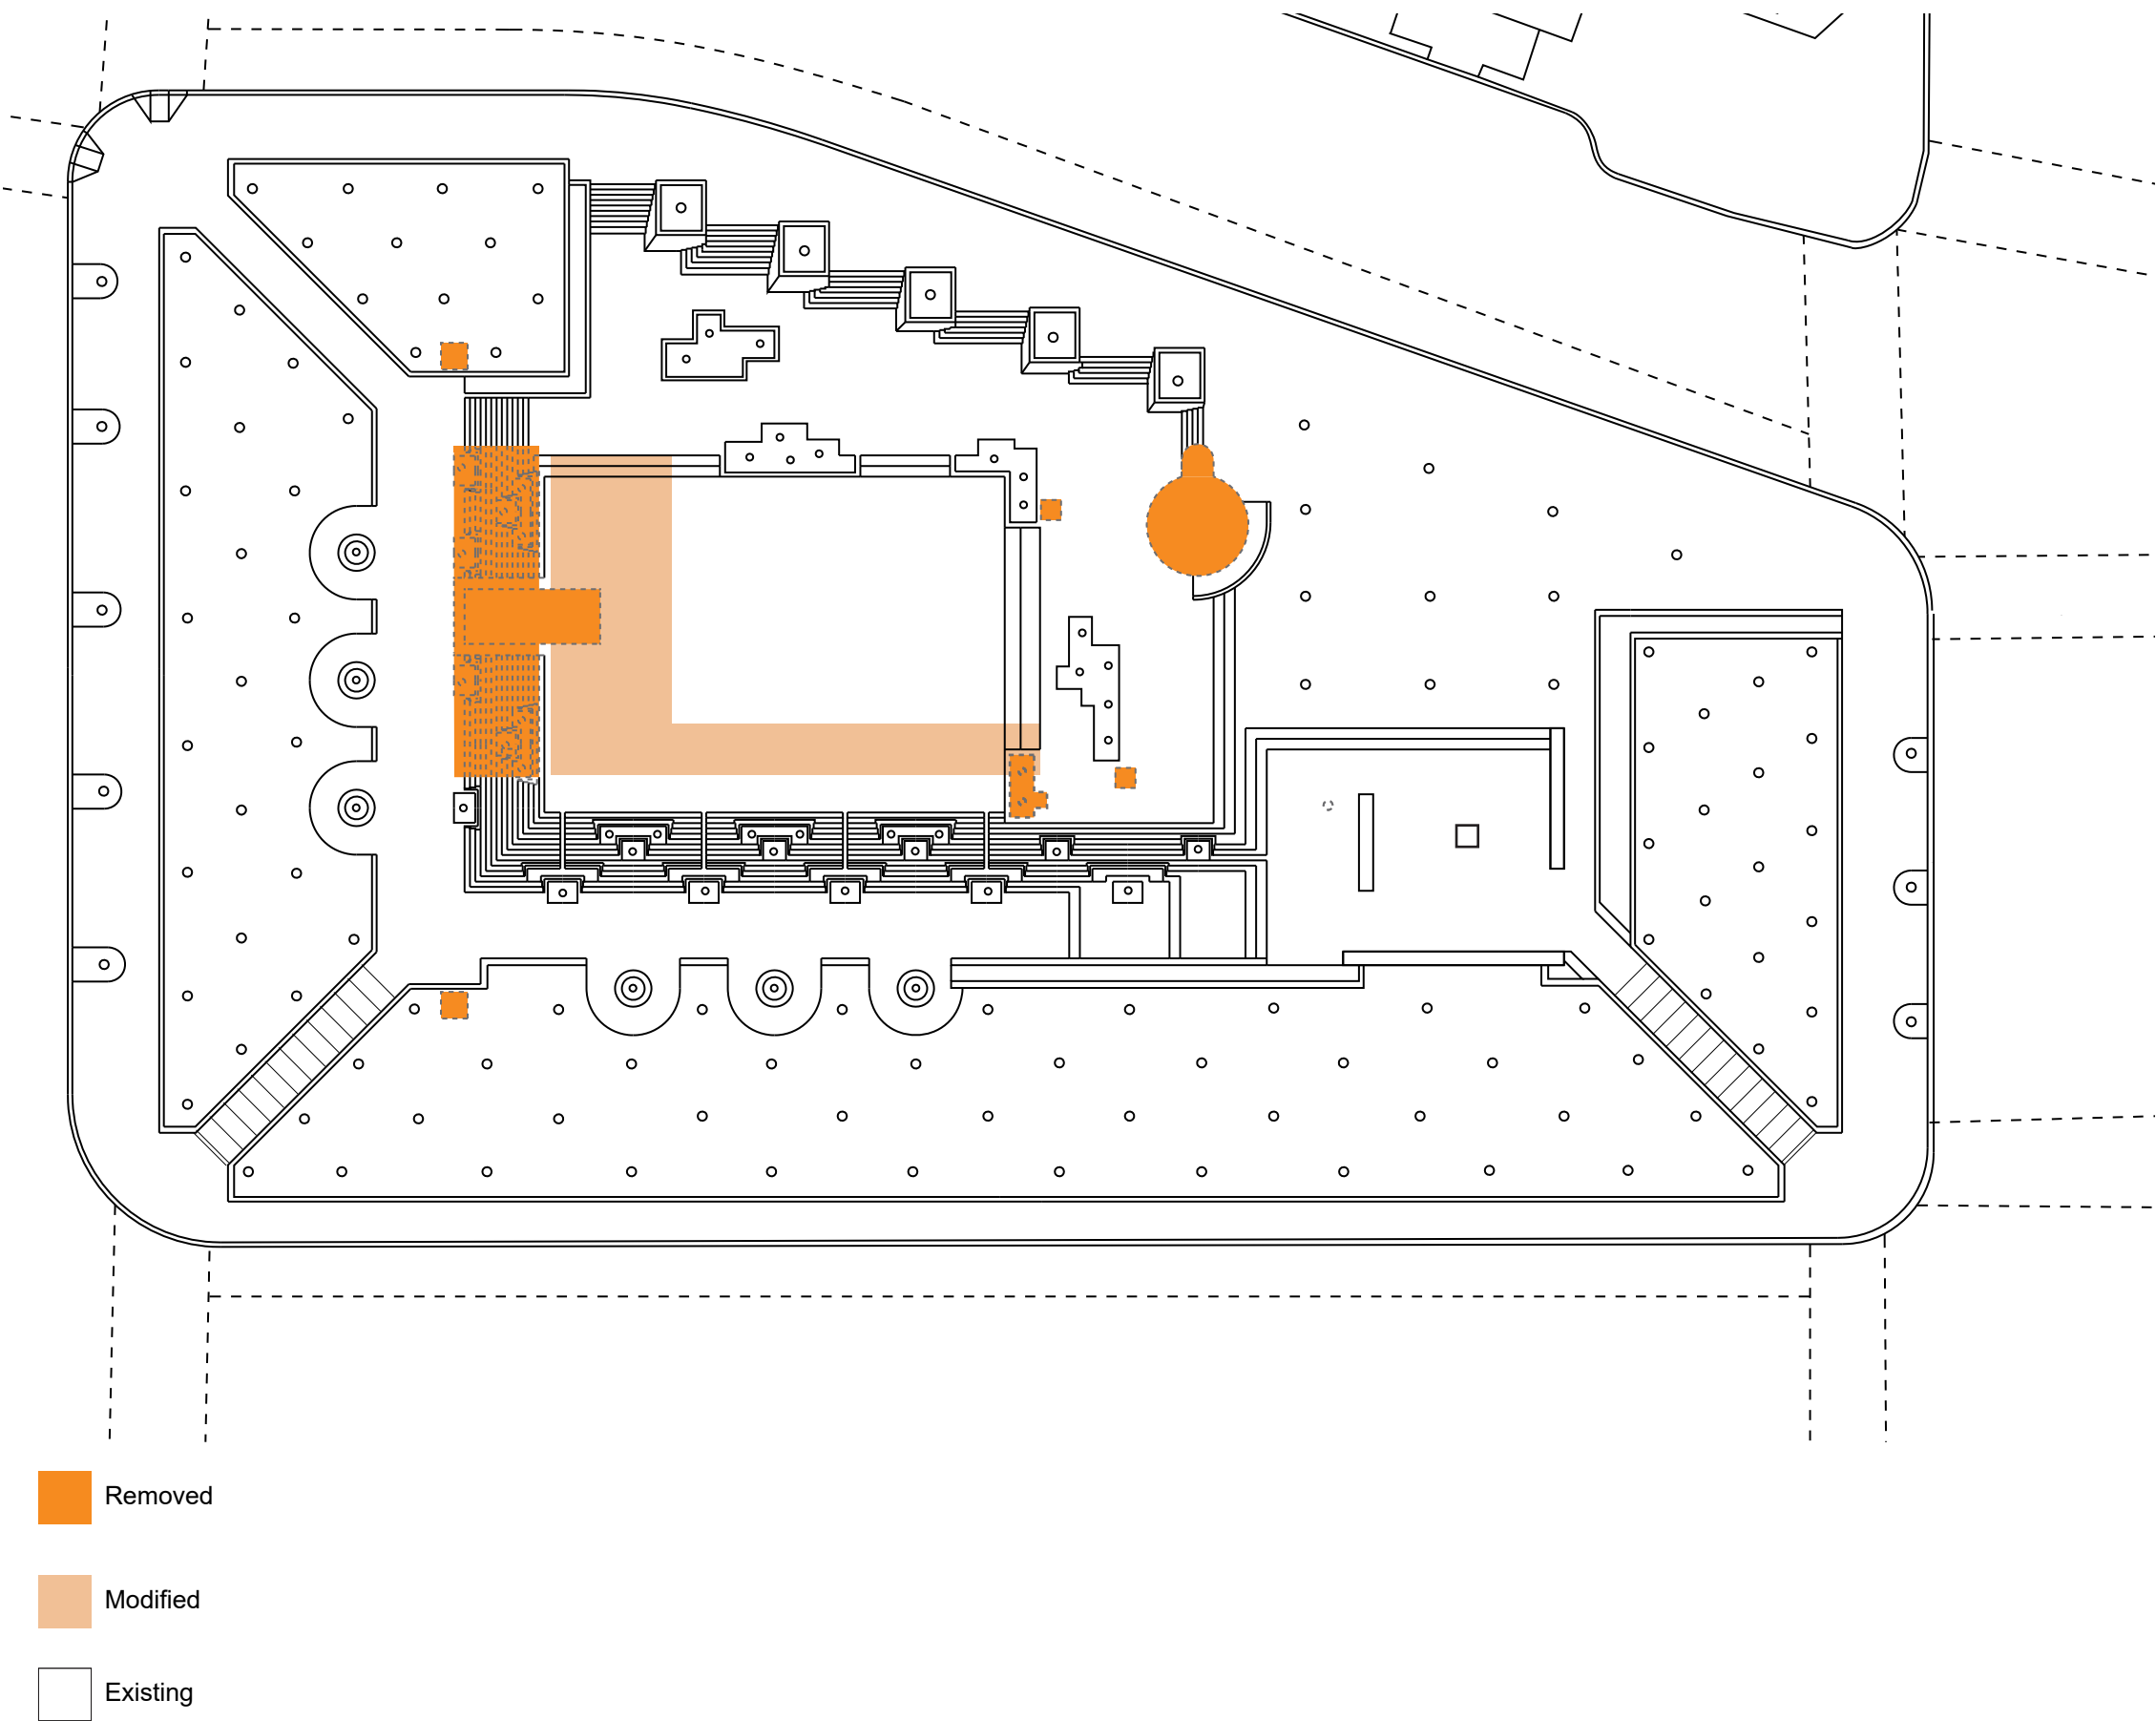
JUNE 2017 RESTORED POOL CONCEPT

The June 2017 concept would result in the following:

No adverse effect on the **L’Enfant Plan of the City of Washington**, the **Pennsylvania Avenue National Historic Site**, and the **Pennsylvania Avenue NW-White House to the U.S. Capitol Cultural Landscape**

Adverse effect on **Pershing Park** due to changes to the spatial organization, views and vistas, built features, water features, and vegetation:

- Loss of the cascade fountain, granite steps and planters along the western edge of the sunken plaza, as well as five specimen trees.
- Alteration of the spatial relationship between the upper and lower sections of the park.
- Insertion of a walkway through the water feature would alter its use and appearance, although the footprint of the pool basin would be retained.
- Replacement of the existing kiosk with a flagpole located on a circular plinth.
- Change of recreation use to no longer include ice skating

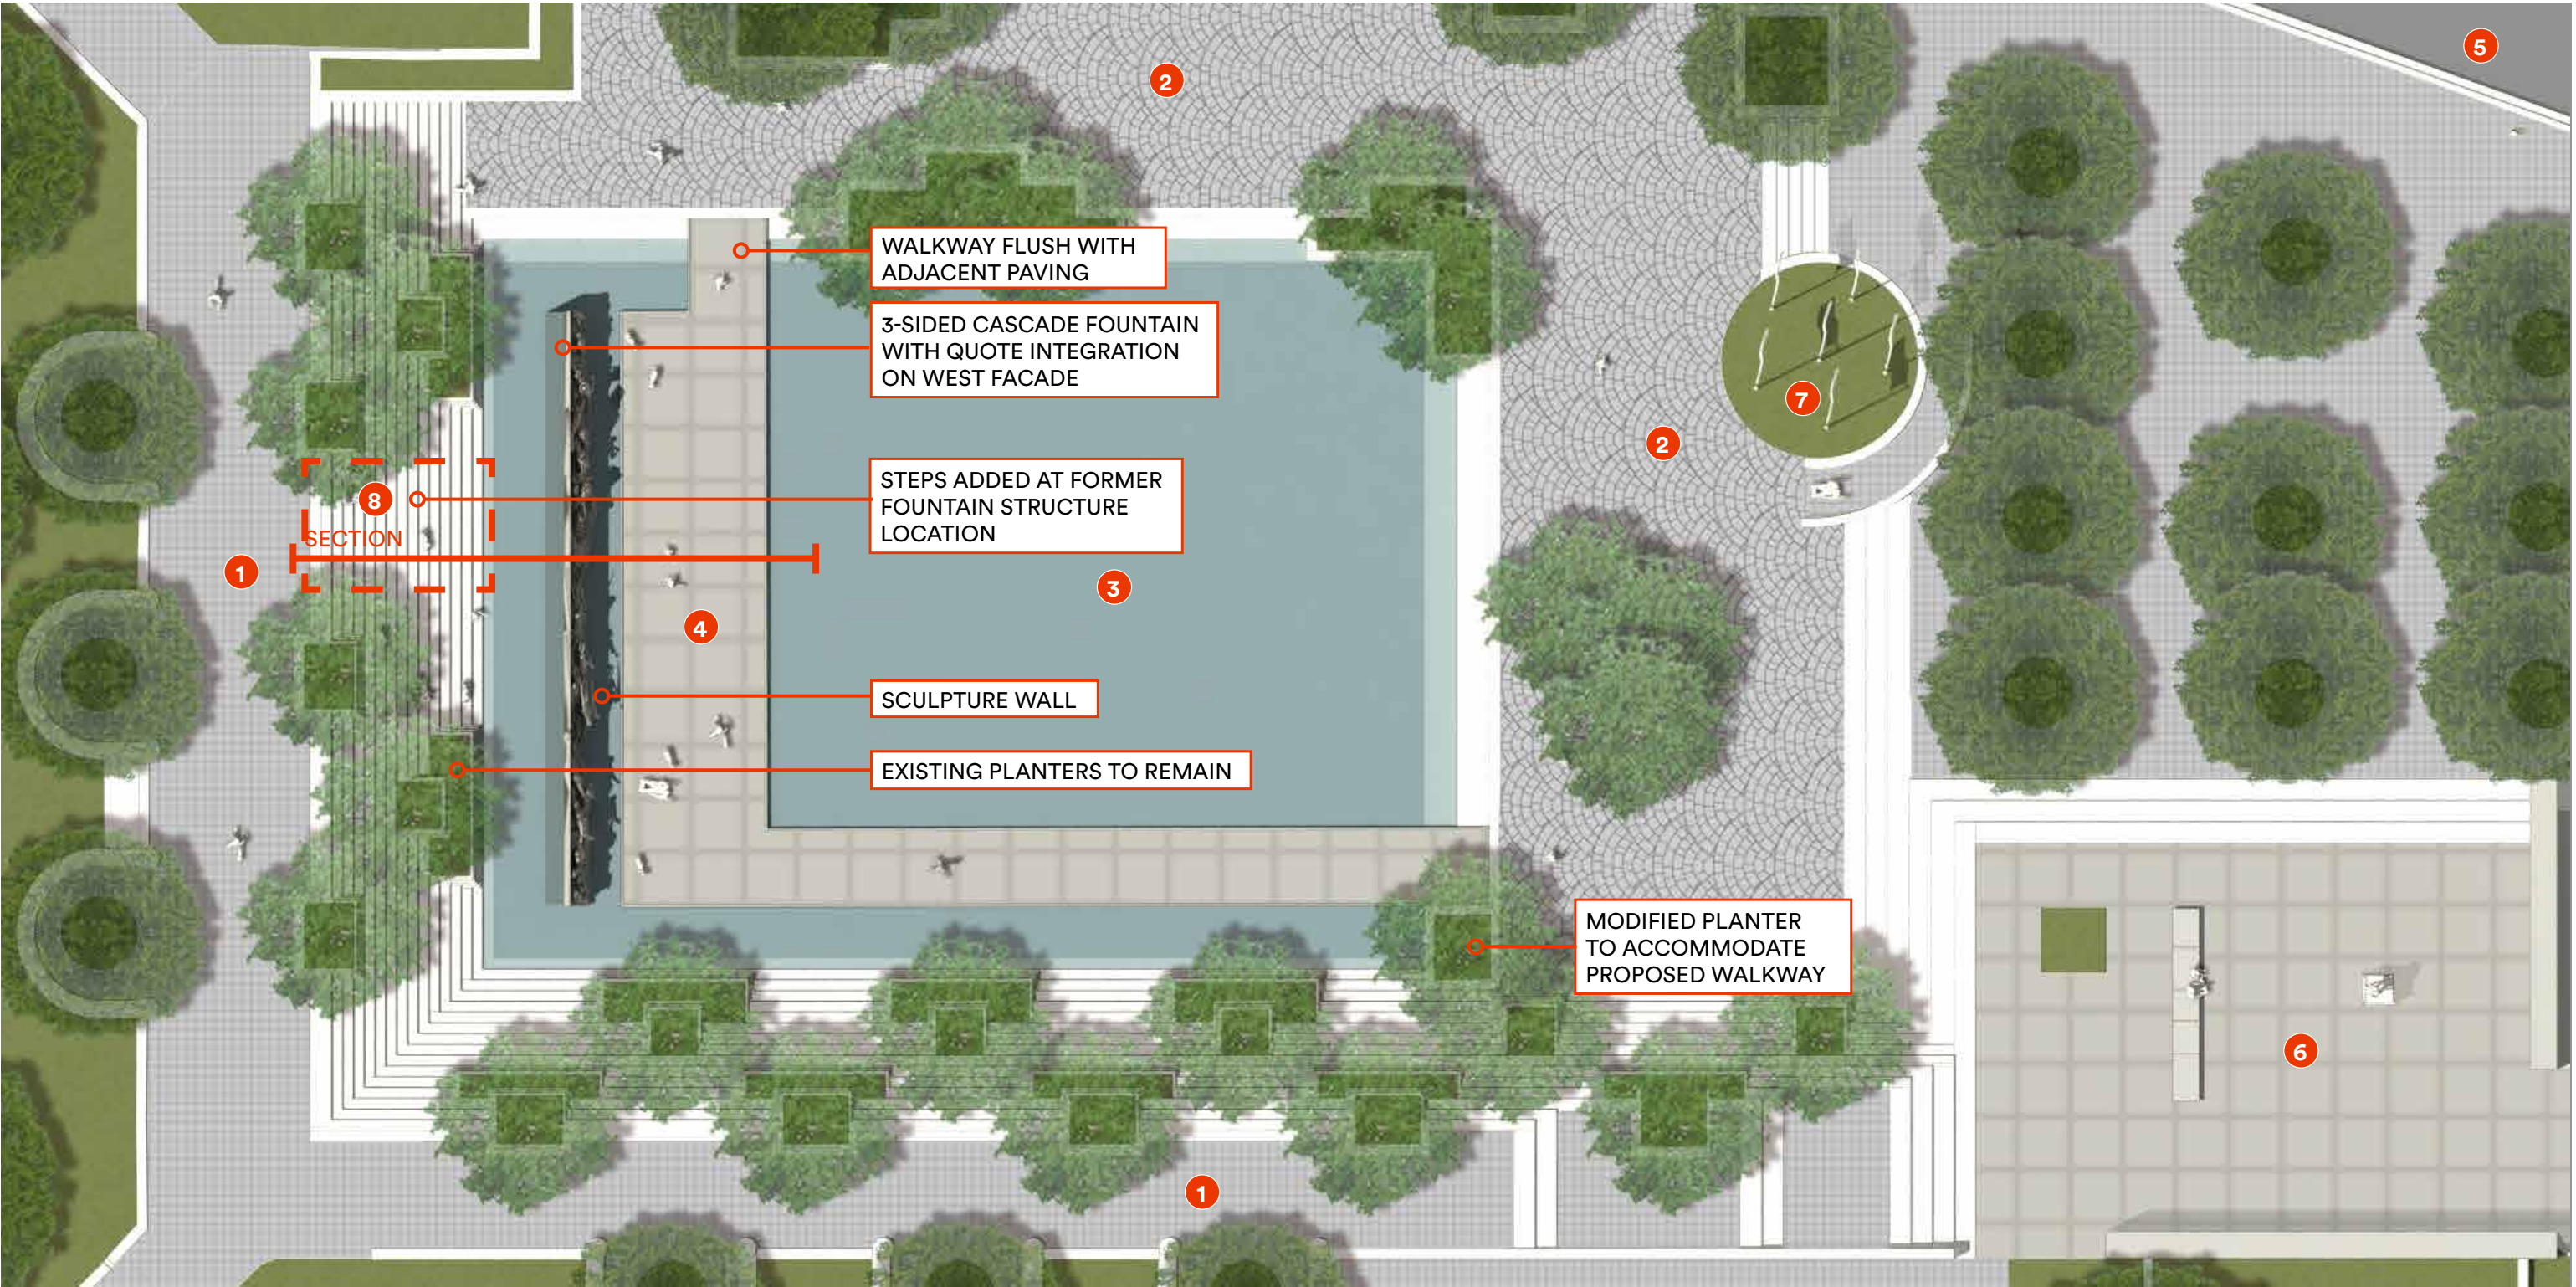
SCULPTURE WALL - OPTION A: FREESTANDING WALL

- 1 EXISTING UPPER WALKWAY
- 2 EXISTING LOWER PLAZA
- 3 FOUNTAIN BASIN
- 4 WALKWAY + VIEWING PLATFORM
- 5 PENNSYLVANIA AVENUE
- 6 EXISTING PERSHING MEMORIAL
- 7 FLAGSTAFF
- 8 CONTEMPLATIVE GATHERING

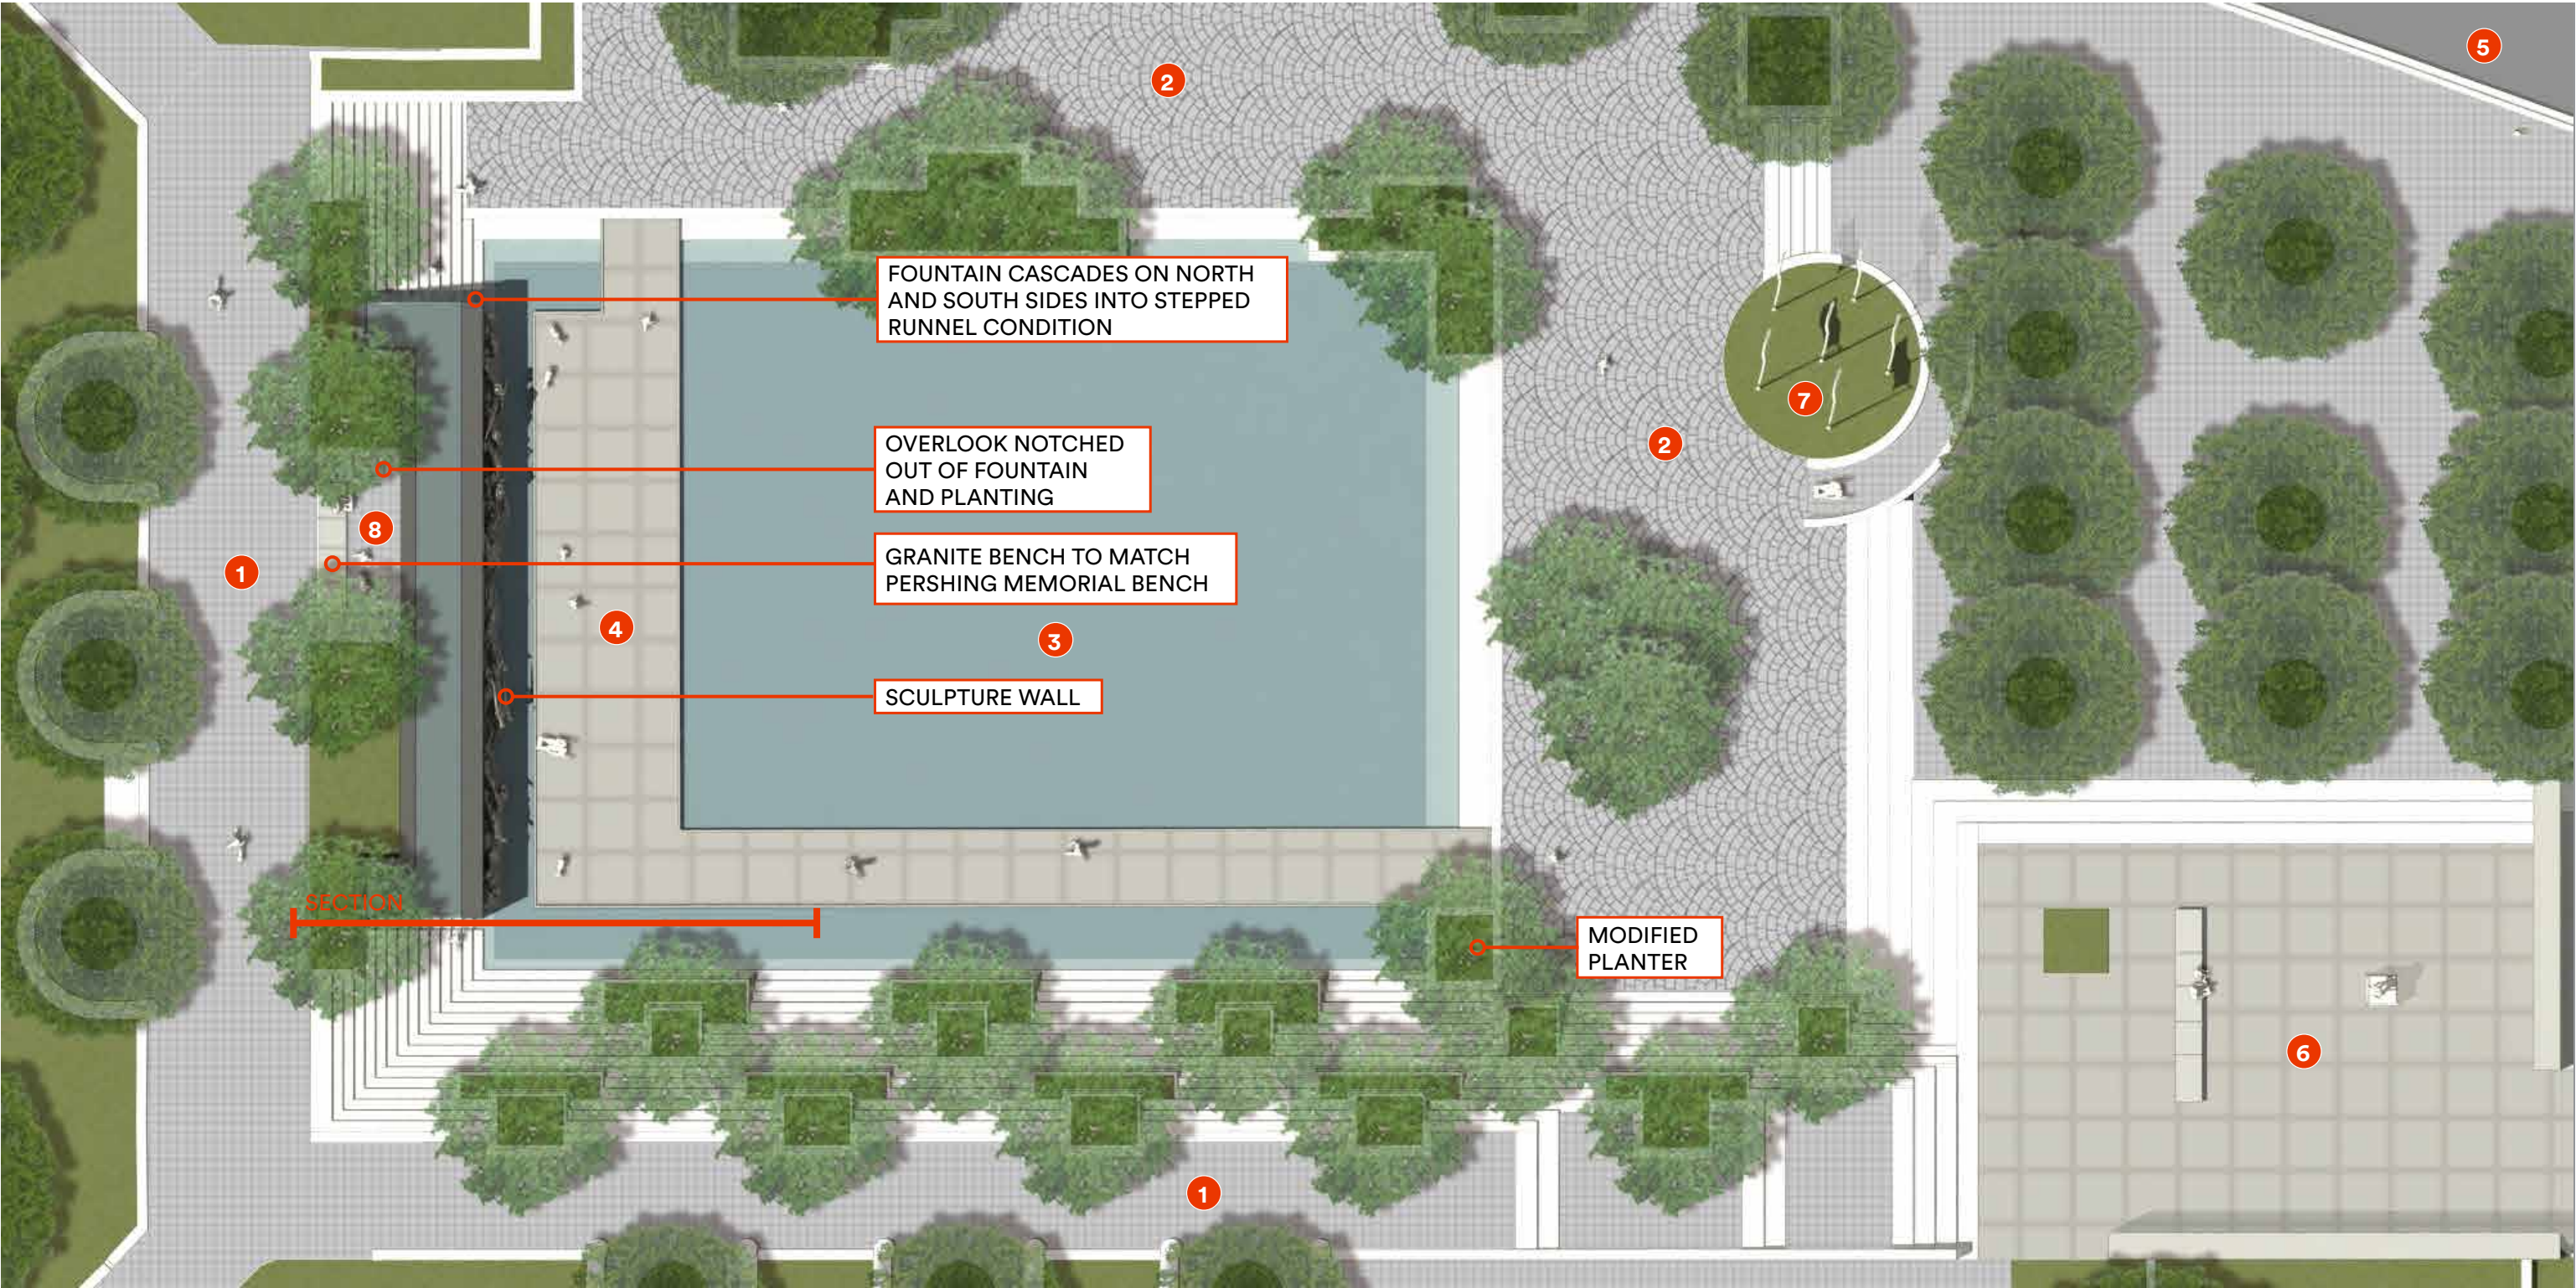
SCULPTURE WALL - OPTION B: INTEGRATED WALL

- | | |

| 1 UPPER WALKWAY | 5 PENNSYLVANIA AVENUE |
| 2 LOWER PLAZA | 6 PERSHING MEMORIAL |
| 3 FOUNTAIN BASIN | 7 FLAGSTAFF |
| 4 WALKWAY + VIEWING PLATFORM | 8 OVERLOOK |

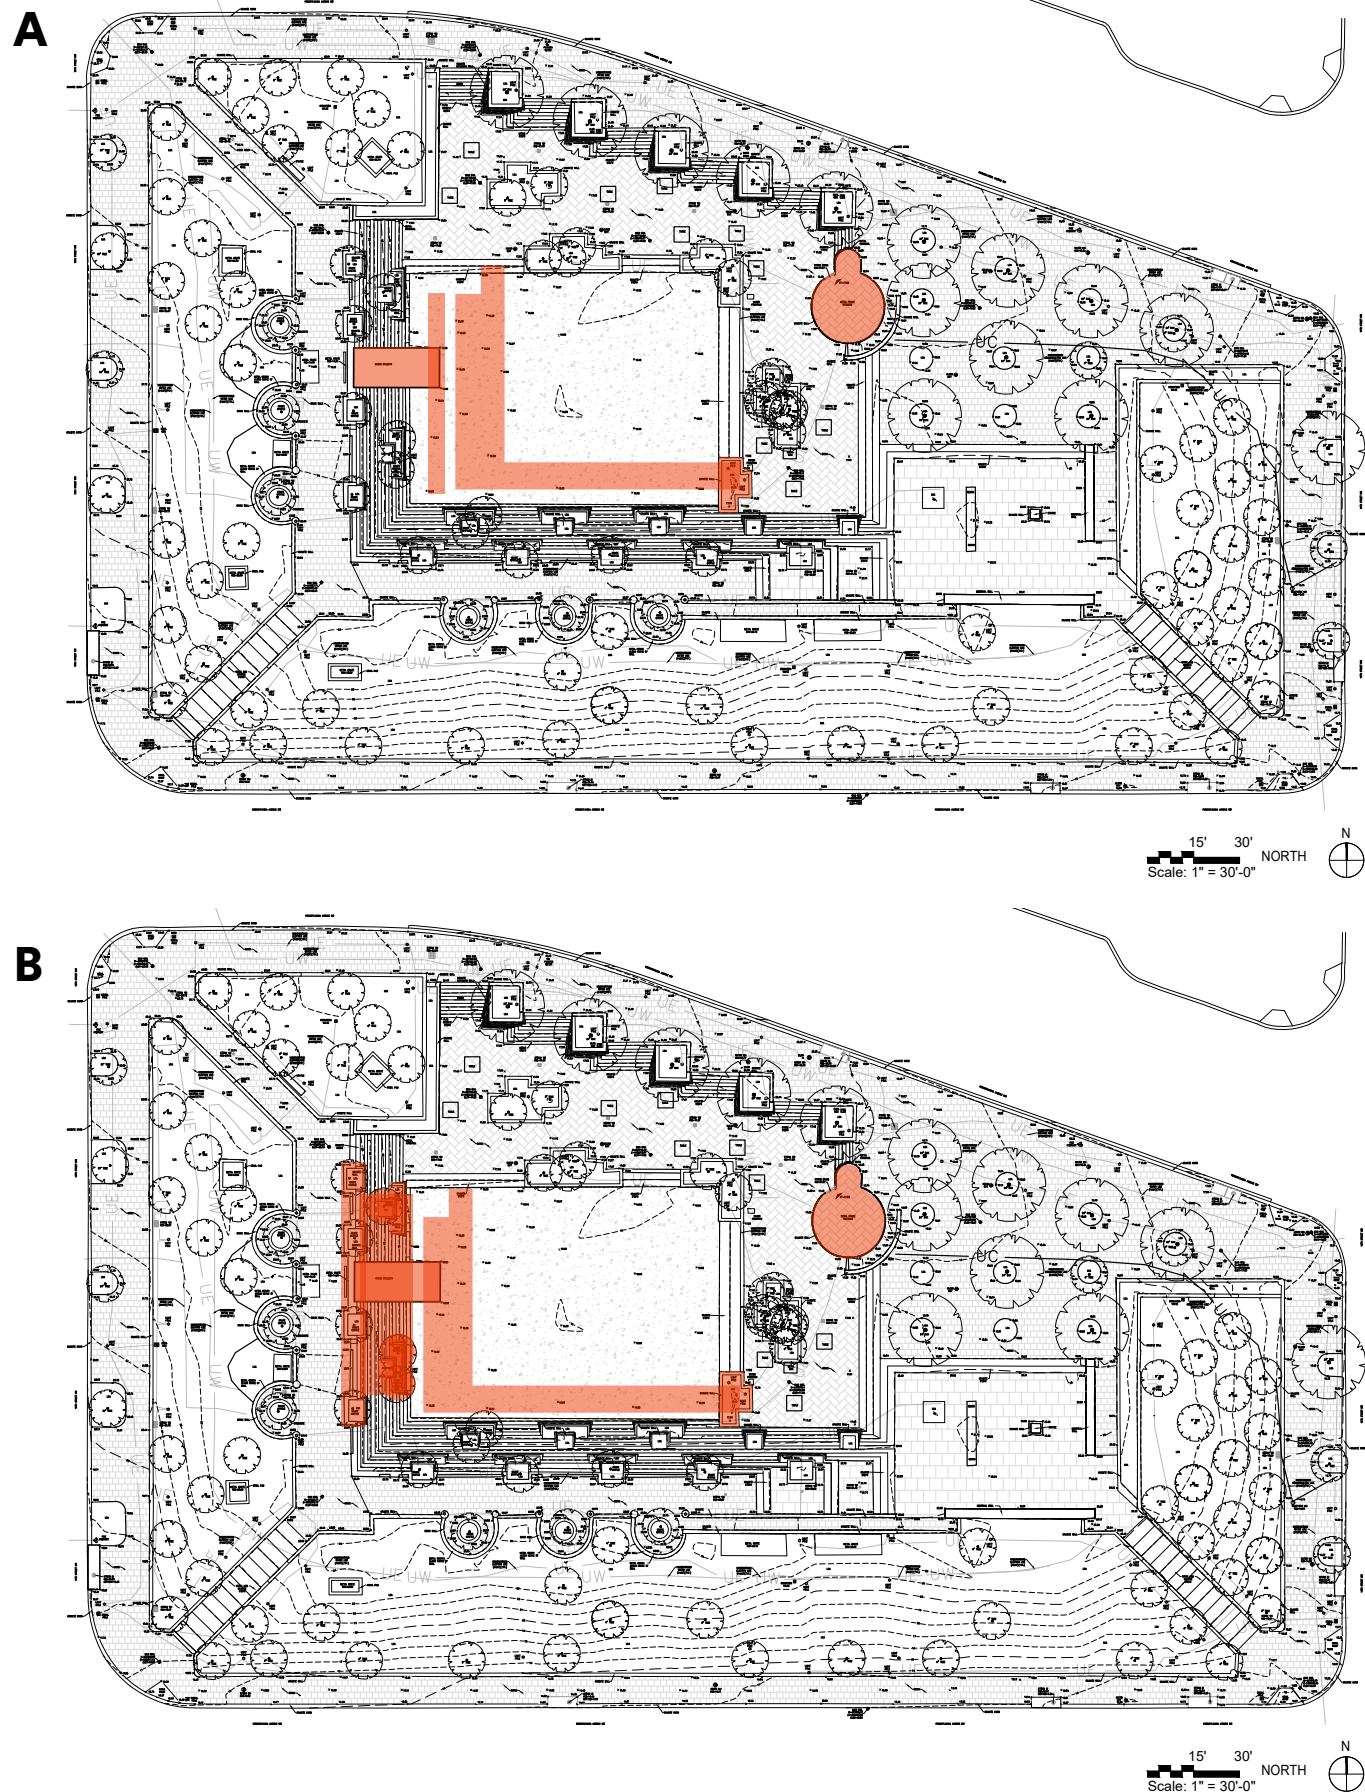
SCULPTURE WALL COMPARISONS - ASSESSMENT OF EFFECTS

Character-Defining Feature	Assessment
Retained	
Pershing Memorial granite walls	No adverse effect
Terra-cotta pavers	No adverse effect
Memorial plaza granite flooring	No adverse effect
Belgian block paving	No adverse effect
Semi-circular alcoves	No adverse effect
Pershing statue and memorial	No adverse effect
PADC lighting	No adverse effect
Removed	
Granite cascade pool structure	Adverse effect
Kiosk	Adverse effect
Cascade fountain	Adverse effect

Character-Defining Feature	Assessment
Modified	
Granite planters	Adverse effect
Granite steps	Adverse effect
Pool basin	Adverse effect
Omnidirectional view	Adverse effect
Honey locust trees over lawn on berms	Likely no adverse effect
Willow oaks above paving at NE corner	Likely no adverse effect
Willow oaks in planters on north side of pool	Likely no adverse effect
Crape myrtle trees in alcoves	Likely no adverse effect
Crape myrtle and birch trees	Likely no adverse effect
Native and naturalized grasses and perennial flowering	Likely no adverse effect
Drinking fountains	Likely no adverse effect
Trash cans	Likely no adverse effect

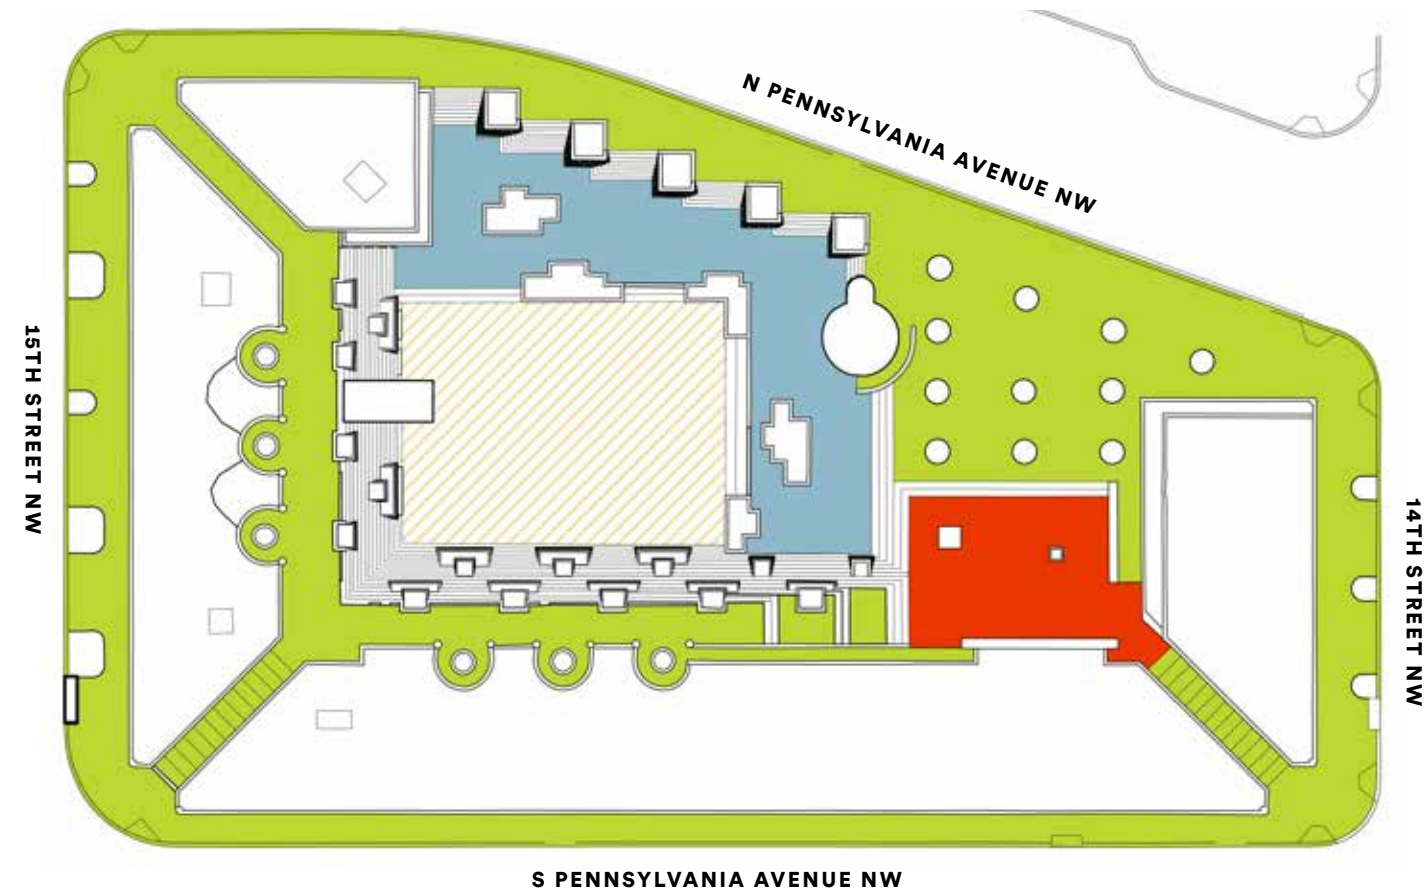
EXISTING PAVING PLAN

EXISTING TO REMAIN AND/OR PROPOSED TO MATCH EXISTING

PENNSYLVANIA AVENUE PAVER:
TERRA COTTA PAVERS AND BRICKS OF
VARYING SIZES

GRANITE SETTS:
COLDSRING CARNELIAN GRANITE
SETTS

PERSHING MEMORIAL PAVING:
(THERMAL FINISH), COLDSRING
CARNELIAN GRANITE

EXISTING TO BE REMOVED

POOL BASIN / ICE RINK FLOOR:
CAST IN PLACE (CIP) CONCRETE

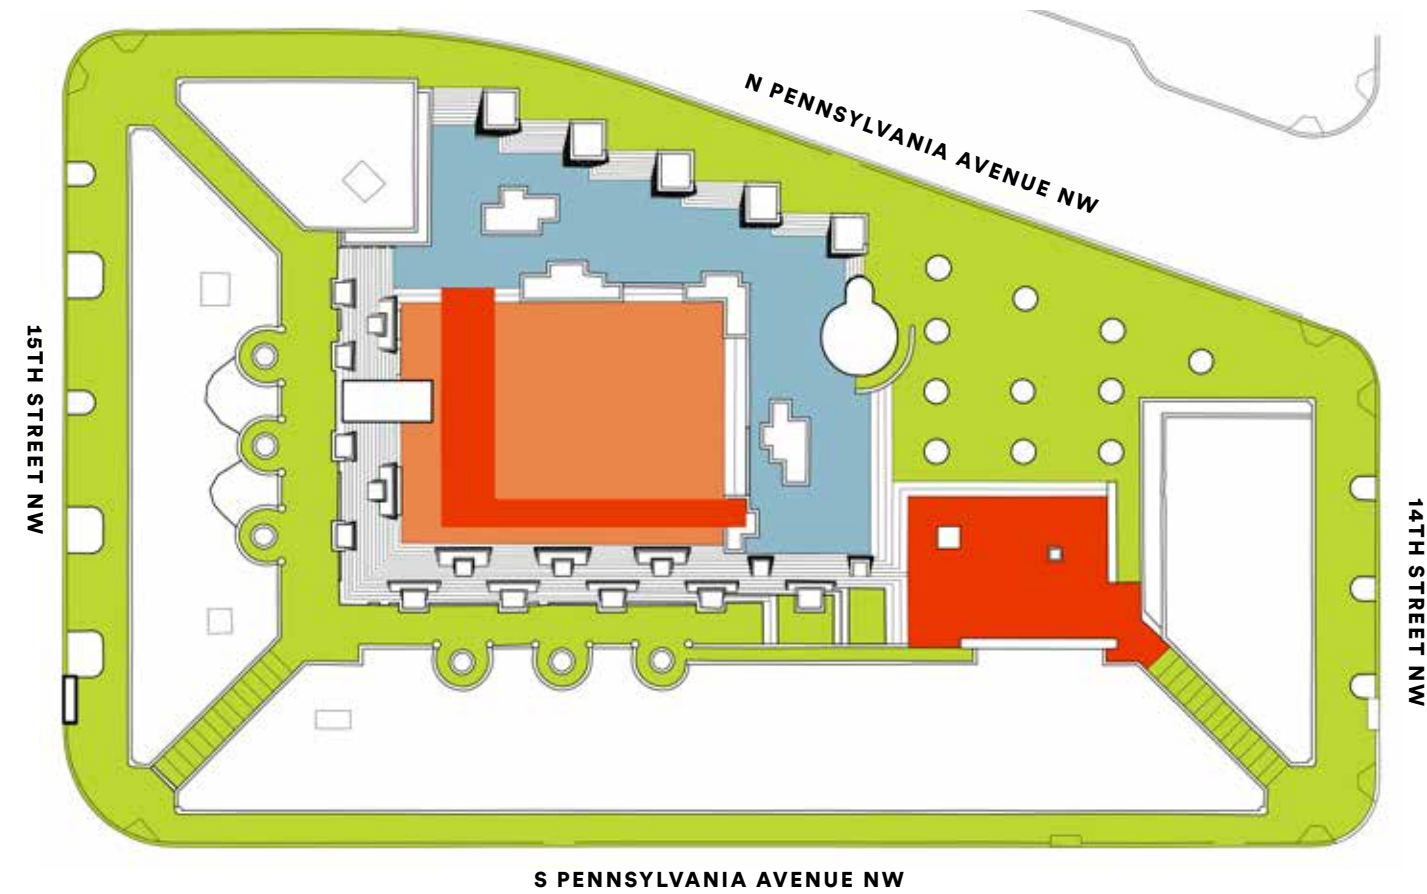
PROPOSED PAVING PLAN

PROPOSED

POOL BASIN /
SCULPTURE SUPPORT WALL:
COLSPRING MESABI BLACK GRANITE
(DIAMOND 100 FINISH FOR BASIN,
DIAMOND 8 HONED FINISH FOR WALL)

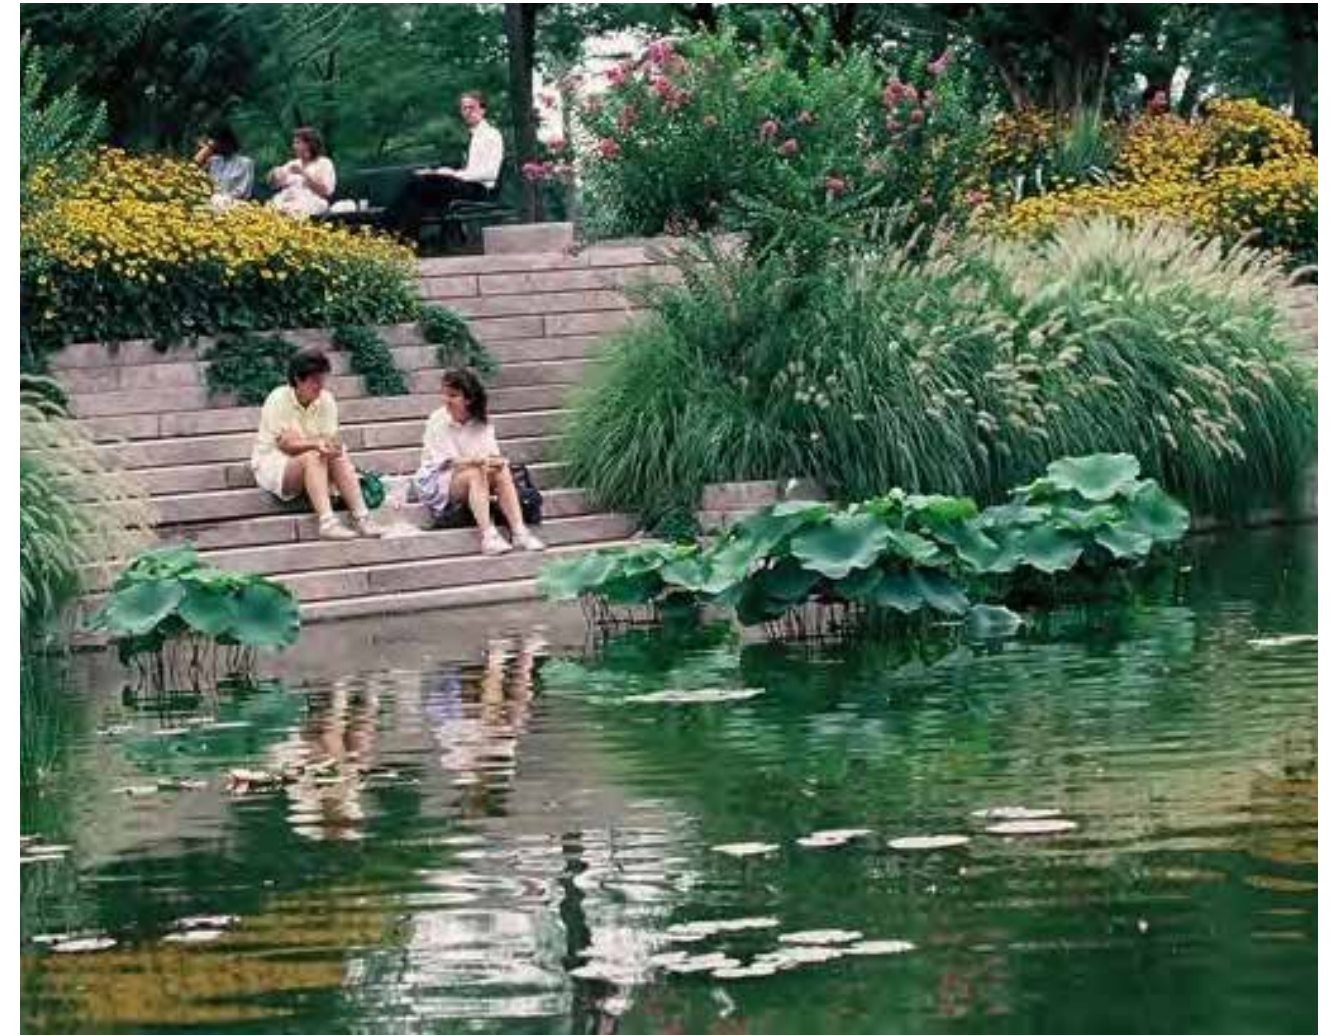
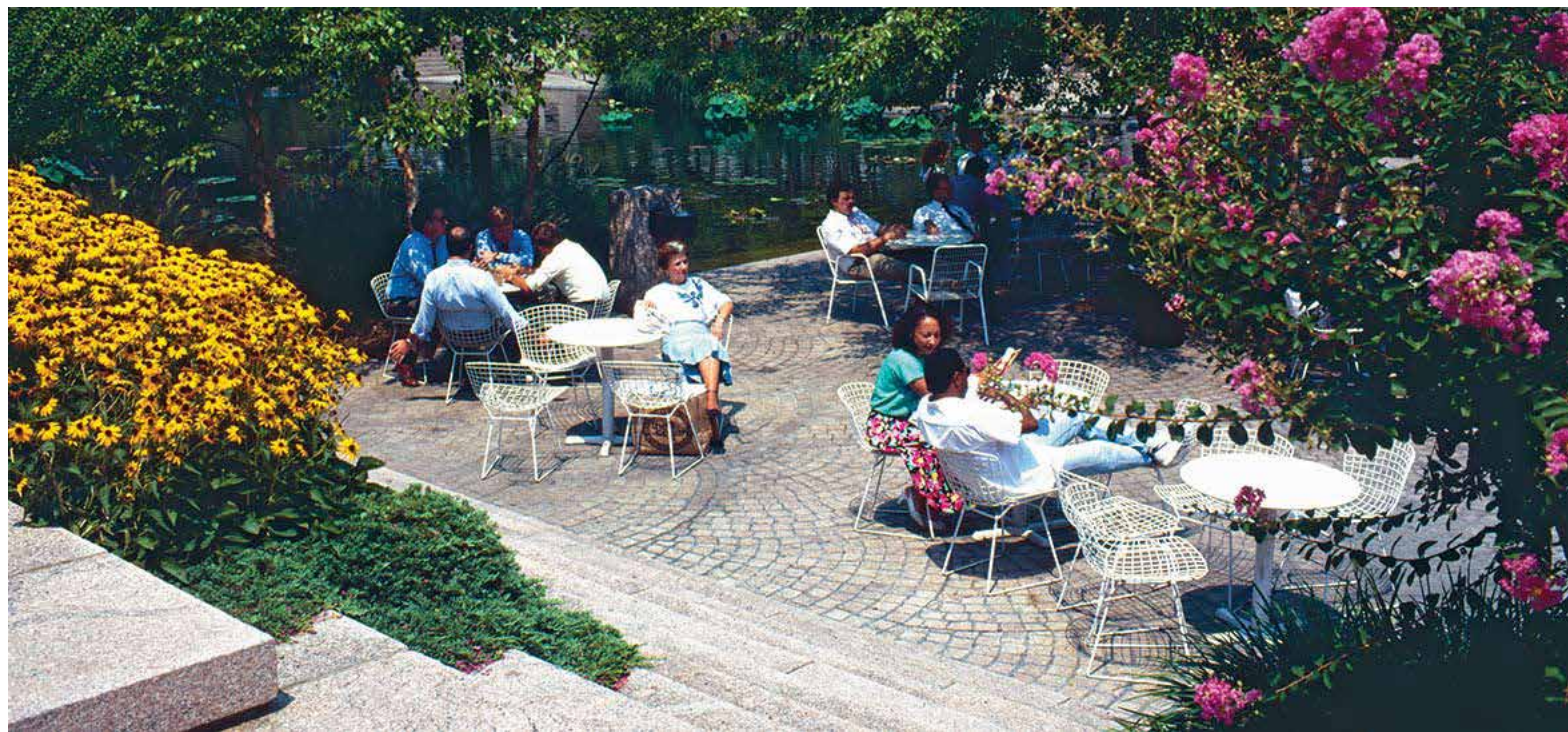
REHABILITATE OEHME VAN SWEDEN PLANTING PLAN

The Oehme van Sweden planting plan for Pershing Park added grasses and perennials near the pool. Water plants, ornamental grasses, and perennials created lush spaces within the design framework.

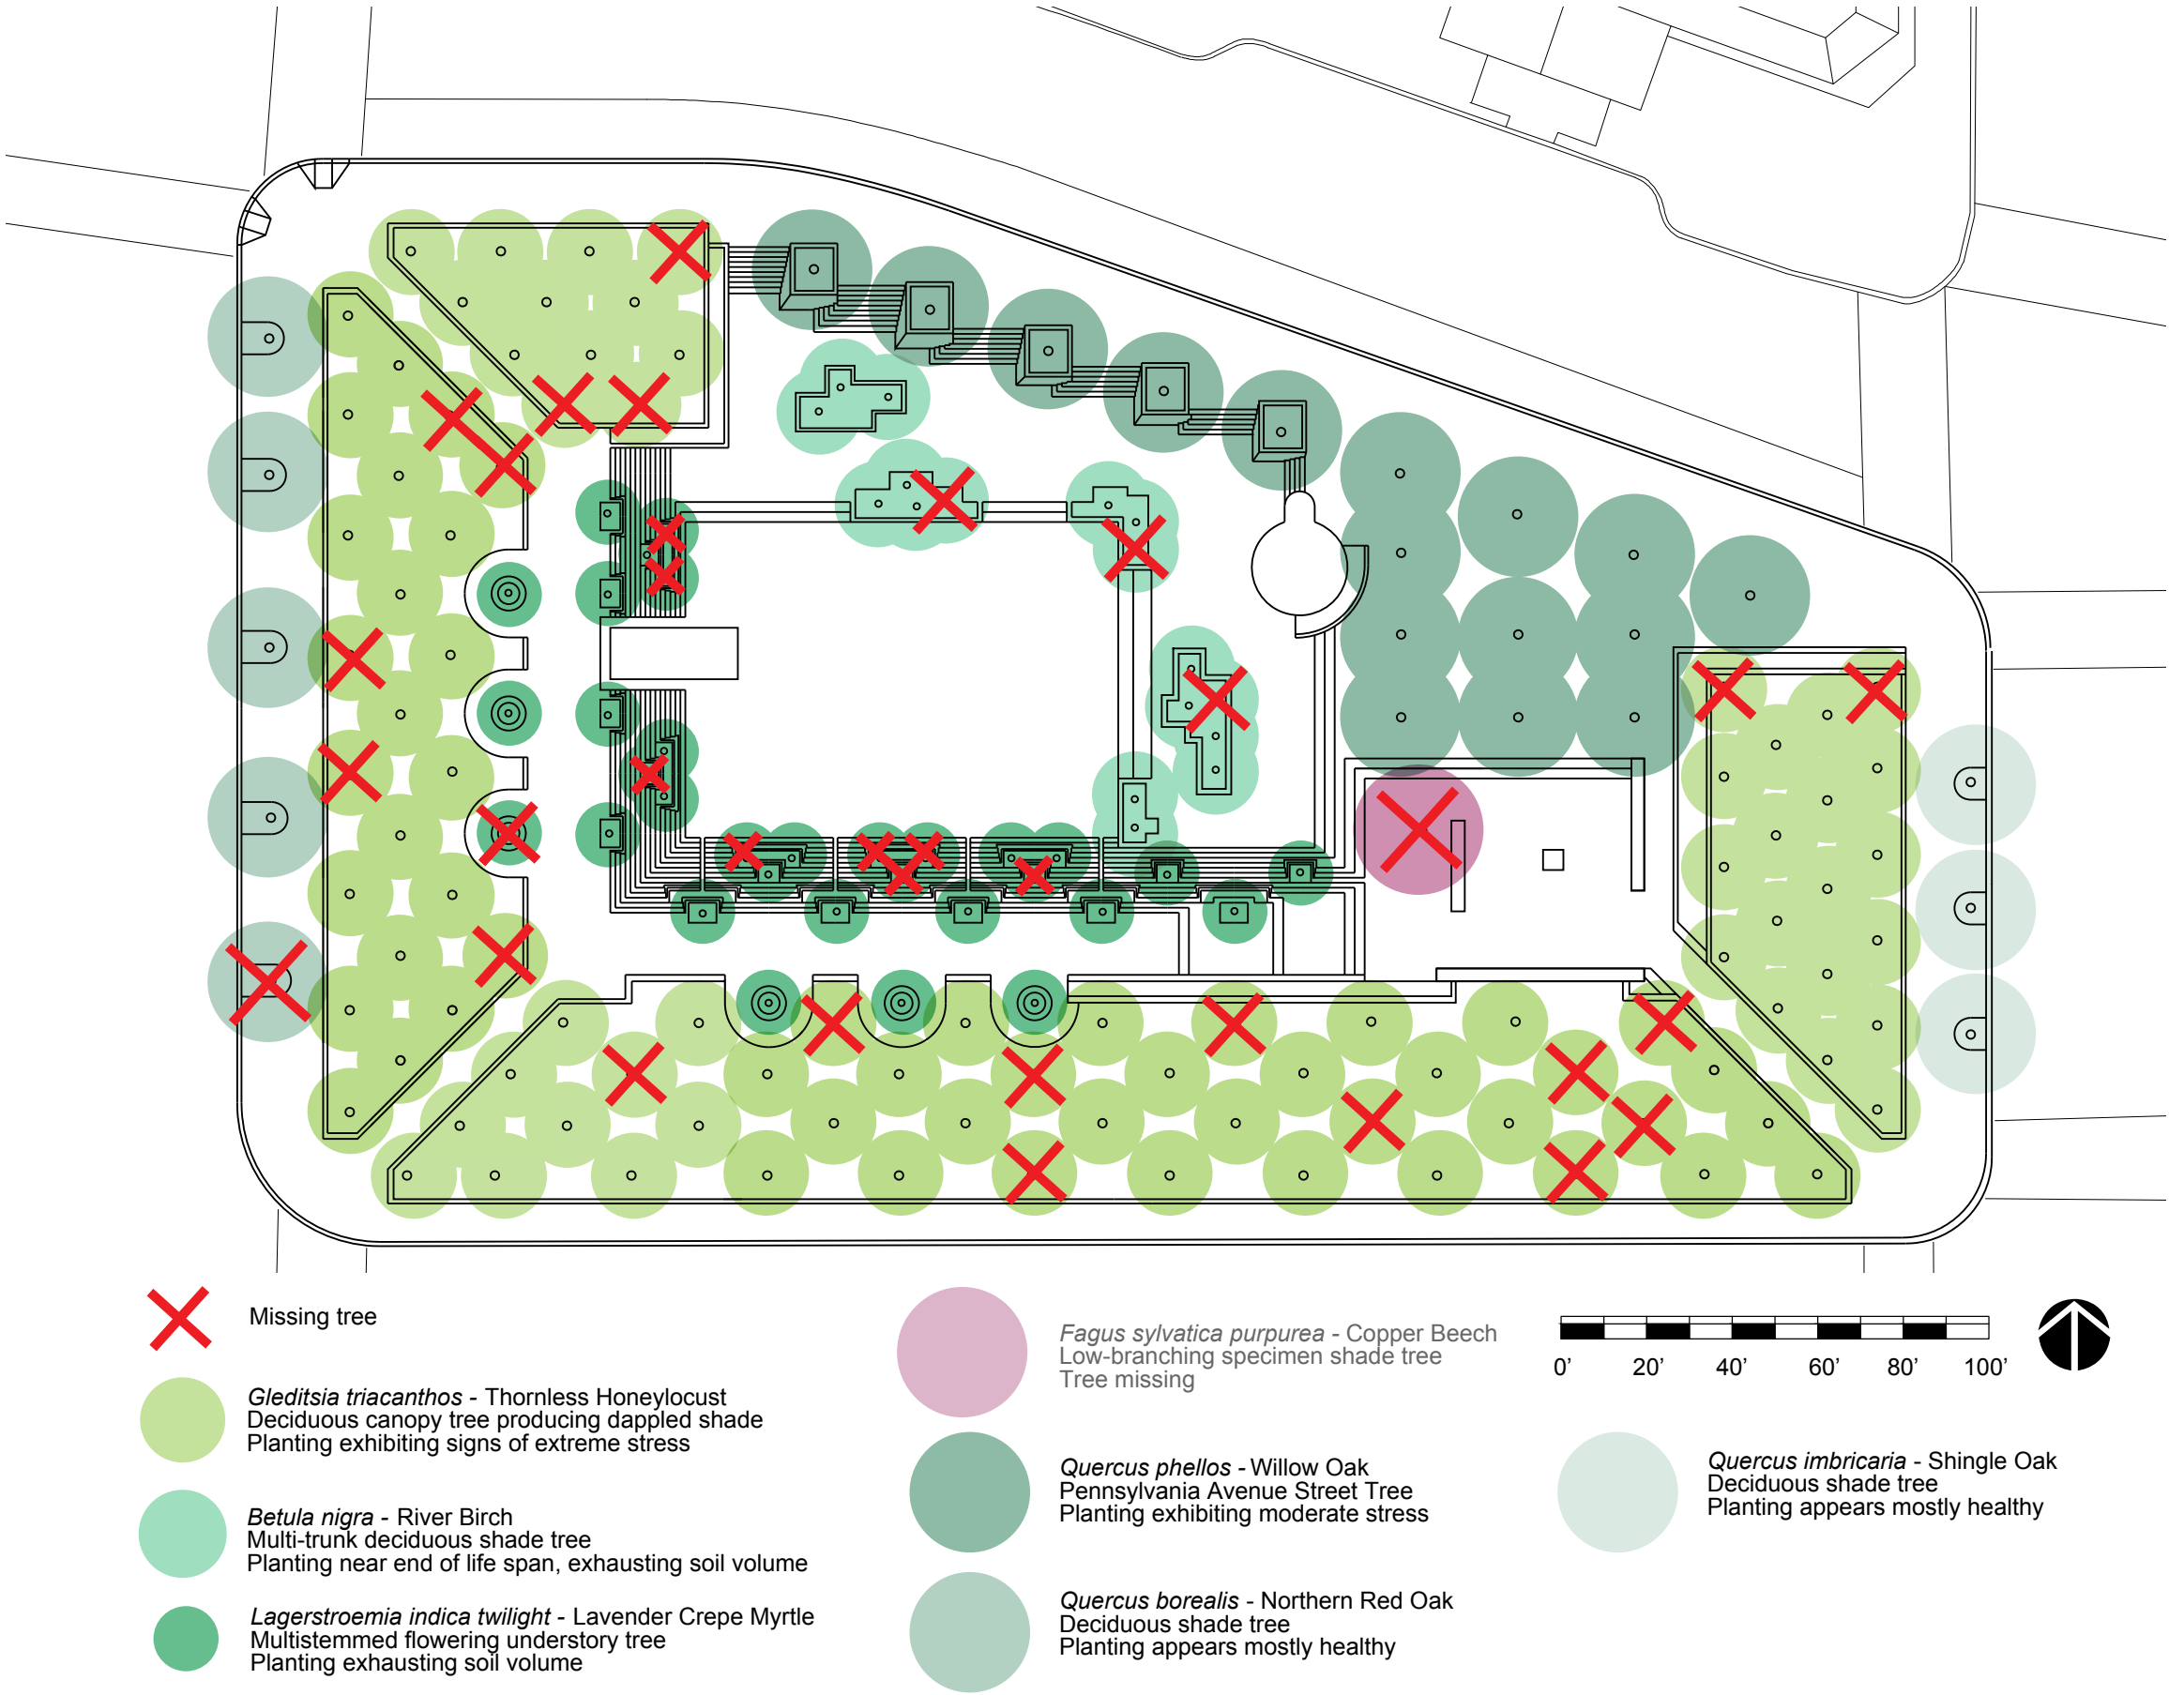
VEGETATION MITIGATION: OEHME VAN SWEDEN PLANTING PLAN

Potential treatments

- Root Collar Excavation
- Repair of Girdling Roots
- Pruning
- Soil Improvements
