CULTURAL LANDSCAPE REPORT FOR THE GREEN HILL PARCEL

FREDERICK LAW OLMSTED NATIONAL HISTORIC SITE
BROOKLINE, MASSACHUSETTS

Olmsted Center for Landscape Preservation
National Park Service, Boston, Massachusetts, 2017

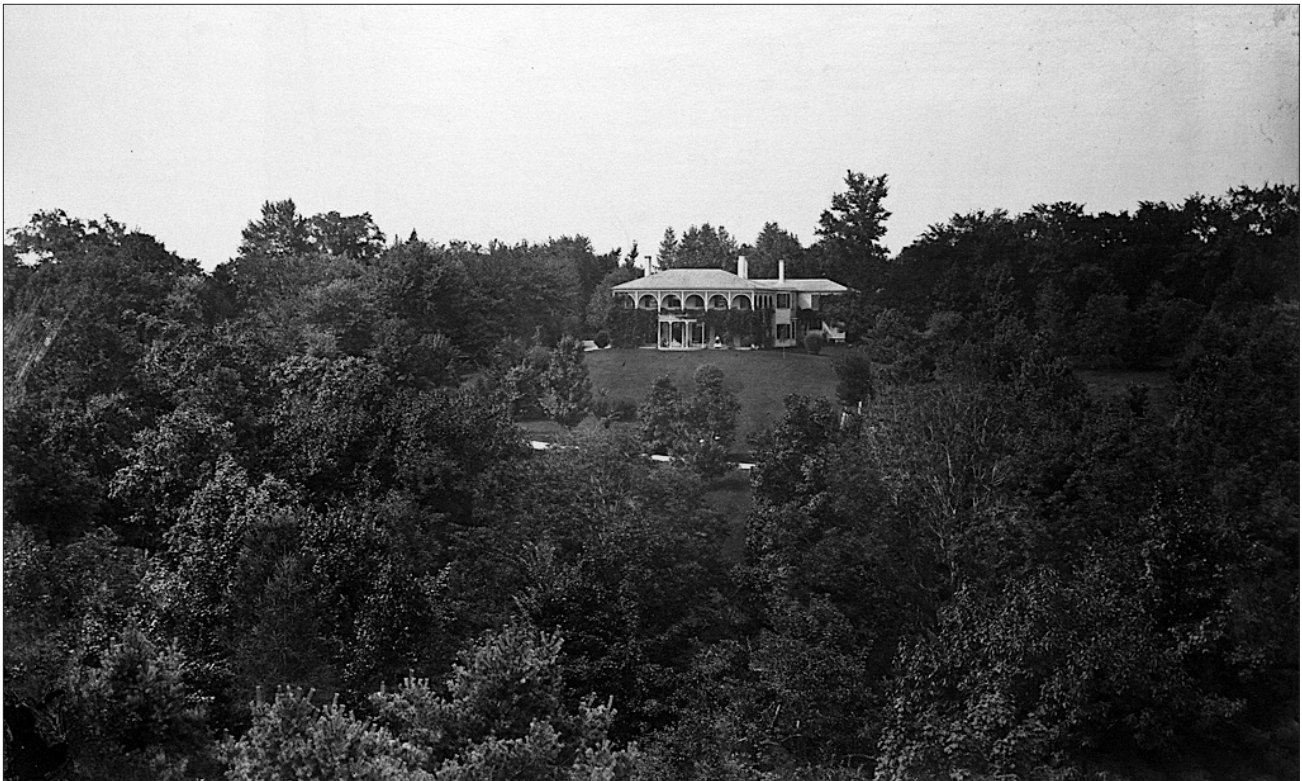
Figure 2. Aerial view of Green Hill showing a dense canopy of ornamental trees along Warren Street, with the Green Hill driveway and vine-clad house beyond. Several tree species are identifiable, including white pine, beech, sugar maple, and possibly spruce and horsechestnut. The size of the specimens on the hillside suggest that at least some were intentionally planted. View looking west, circa 1864 (National Gallery of Art).

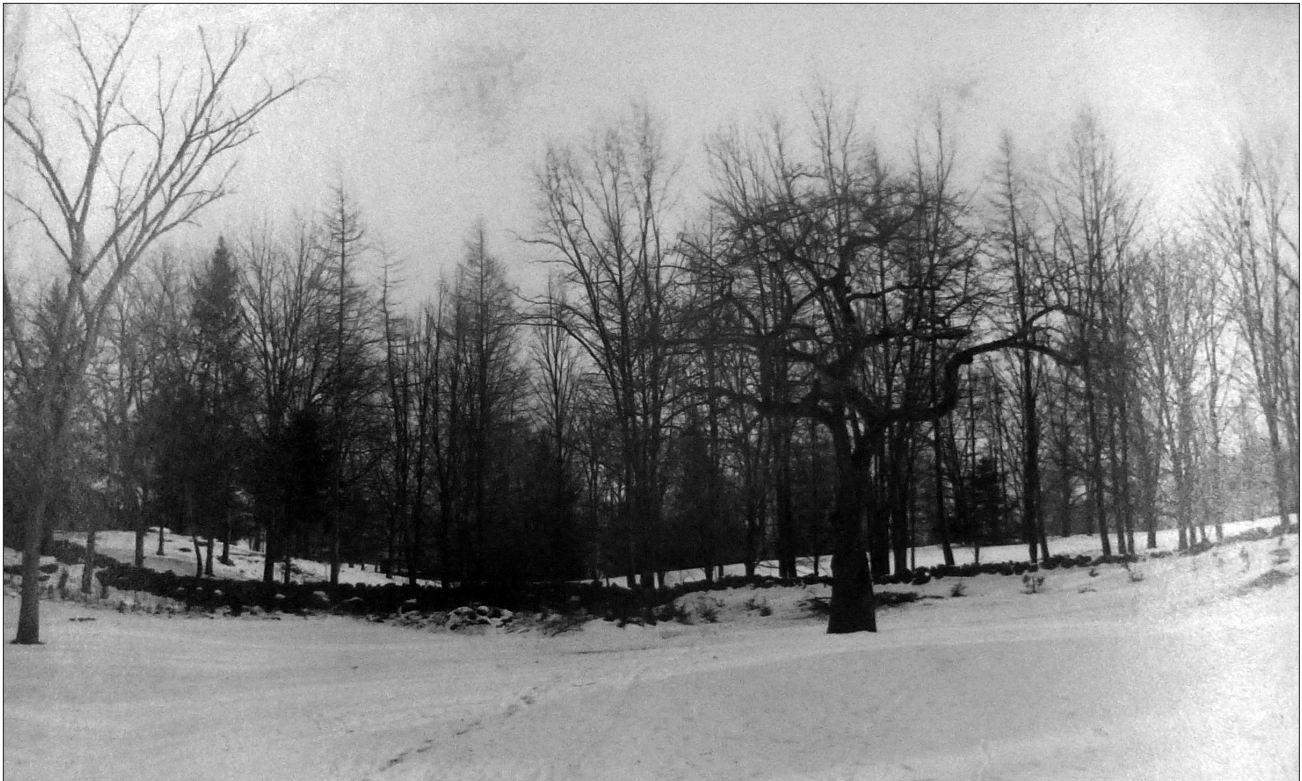
Figure 4. View across the south lawn at Fairsted showing the Gardner property beyond the stone wall. A border of deciduous trees along the property line adjoined an open lawn/meadow. View looking southeast, early 1885 (J.C. Olmsted Papers, Scrapbook 1 (1884-1885), photograph #28: "Lawn of 99 Warren St." Courtesy of the Frances Loeb Library, Harvard University Graduate School of Design).

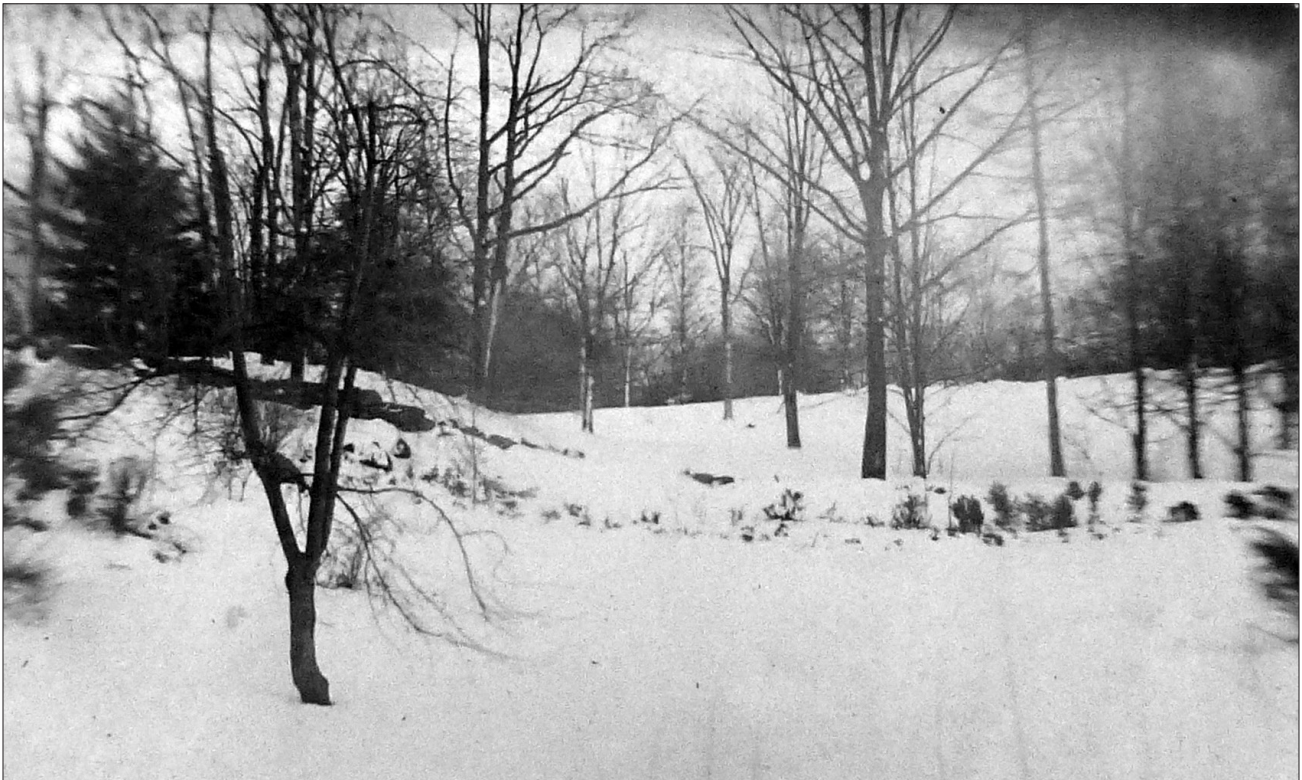
Figure 5. View across the south lawn at Fairsted showing the Gardner property beyond the stone wall. Beyond the treeline at the property boundary, the character of the landscape was more open, with scattered trees over lawn/meadow. View looking southeast, late 1886 (J.C. Olmsted Papers, Scrapbook 2 (1885-1888), photograph #86: "Lawn at 99 Warren St." Courtesy of the Frances Loeb Library, Harvard University Graduate School of Design).

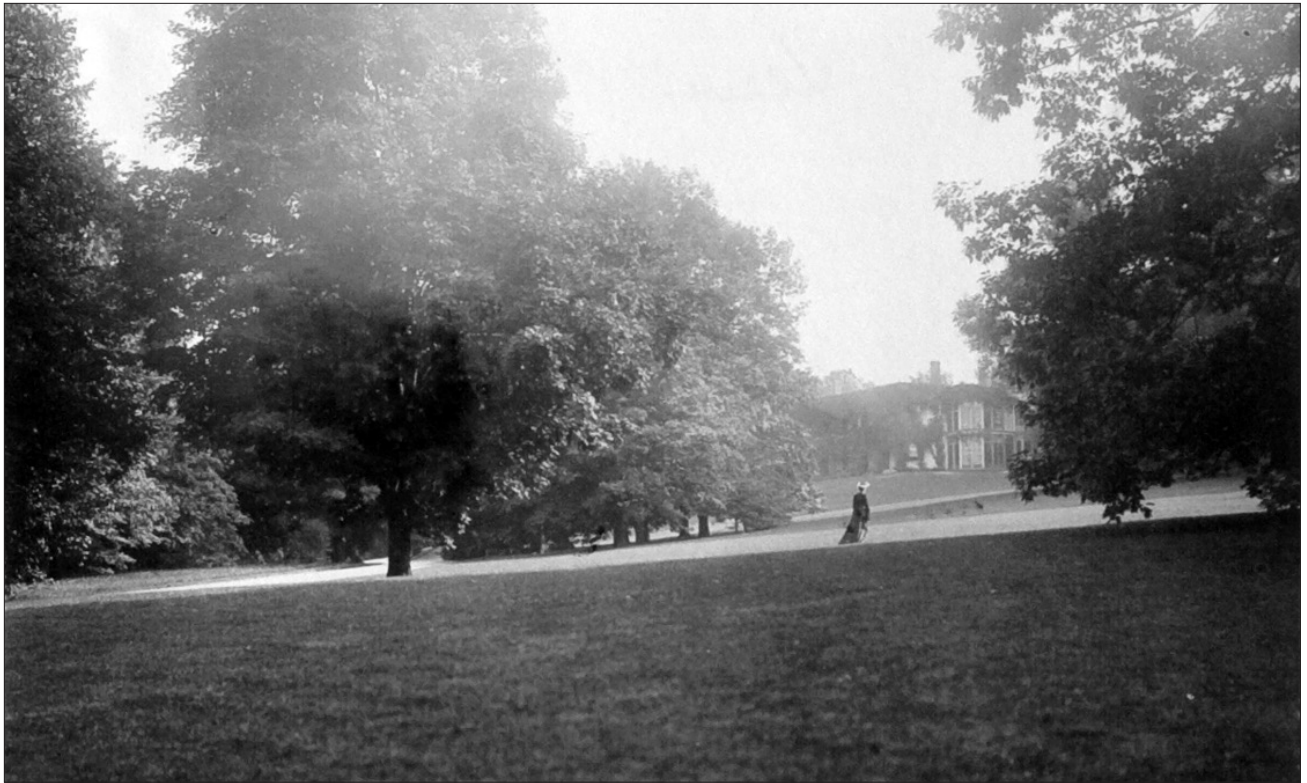
Figure 6. View of the Gardner mansion from the northern corner of the property. The entrance drive, lined with mature deciduous trees, is visible along the left side of the photograph. View looking south, 1902 (*Isabella Stewart Gardner walking at Green Hill*, Guest book 7, Isabella Stewart Gardner Museum, Boston).

The impact of the mansion’s siting is evident in a view from Isabella Stewart Gardner’s Guest Book, along with the manicured lawn planted with specimen deciduous trees that carpeted the hillside to the east of the building (Figure 6). A photograph taken by neighbor John Charles Olmsted shows the character of the northern portion of the Green Hill property around the same time, in late winter

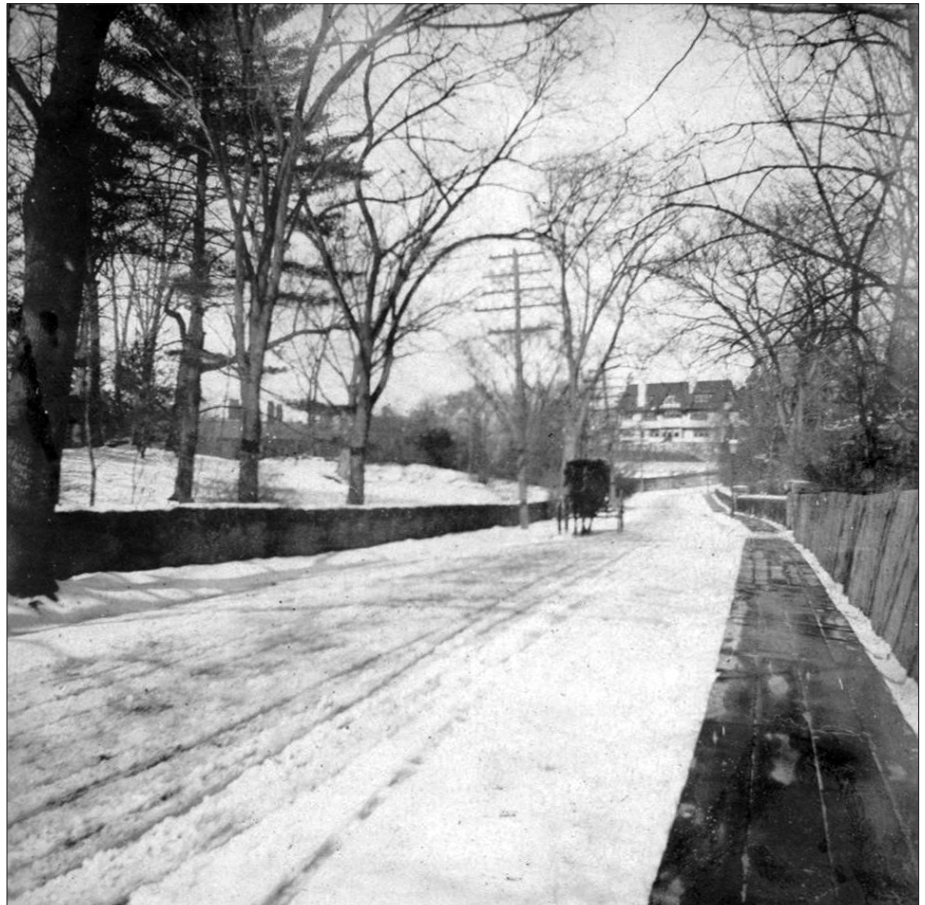
Figure 7. "View along Warren Street towards Hood's place," taken by J.C. Olmsted, shows the character of vegetation at the northern end of the Green Hill property and absence of a fence along the stone wall that borders the road. View looking north, March 7, 1900 (Courtesy of the National Park Service Frederick Law Olmsted National Historic Site, Olmsted photo #00673-01-ph06).

Historic Condition: The construction date of the stone wall that borders the Warren Street line with the Green Hill property is not known. However, the wall was in place by the turn of the century, when it is shown in photographs taken in 1900 by John Charles Olmsted (see Figure 7) and between 1900 and 1905 by T.E. Marr (see Figures 8–12). From just after the turn of the twentieth century (post-1900) until at least 2001, the southern stretch of the wall was topped by a spruce pole fence that matched the spruce pole fence that borders Fairsted. Spruce pole fencing is first evidenced in photographs along the northern stretch of the wall in the 1930s.

pole fence (or possibly the entire fence) was installed after 1900 (see Figure 7).¹⁸ However, the spruce pole fence is well documented along the northern portion of the Green Hill property in photographs taken by Harry D. Perkins of the Olmsted Brothers firm in the 1930s (Olmsted NHS archives photographs #673-145 and 673-146).¹⁹

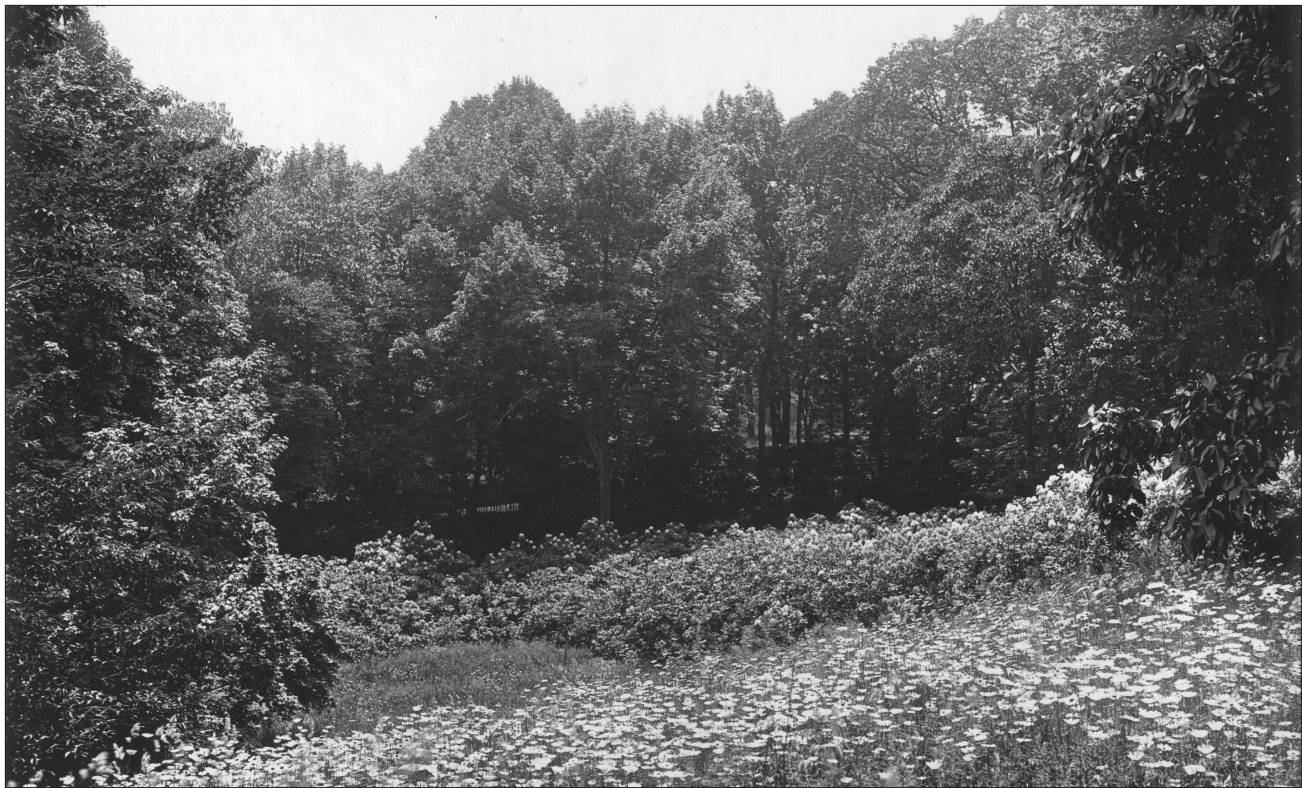
Figure 8. View from the upper end of the driveway across the embankment that leads down to Warren Street. The meadow is replete with daisies and bordered by a dense planting of rhododendron. A horsechestnut appears at the right edge of the image frame and a beech at the left. View looking east, most likely 1900-05 (T.E. Marr and Son, *Green Hill*, Isabella Stewart Gardner Museum, Boston).

(Figure 7). The eastern portion of the estate, from the mansion down to Warren Street, is also well documented by a series of photographs from around the turn of the twentieth century taken by Thomas E. Marr, a noted Boston photographer commissioned by Gardner to photograph her homes, Green Hill, 152 Beacon Street, and Fenway Court (Figures 8–16).

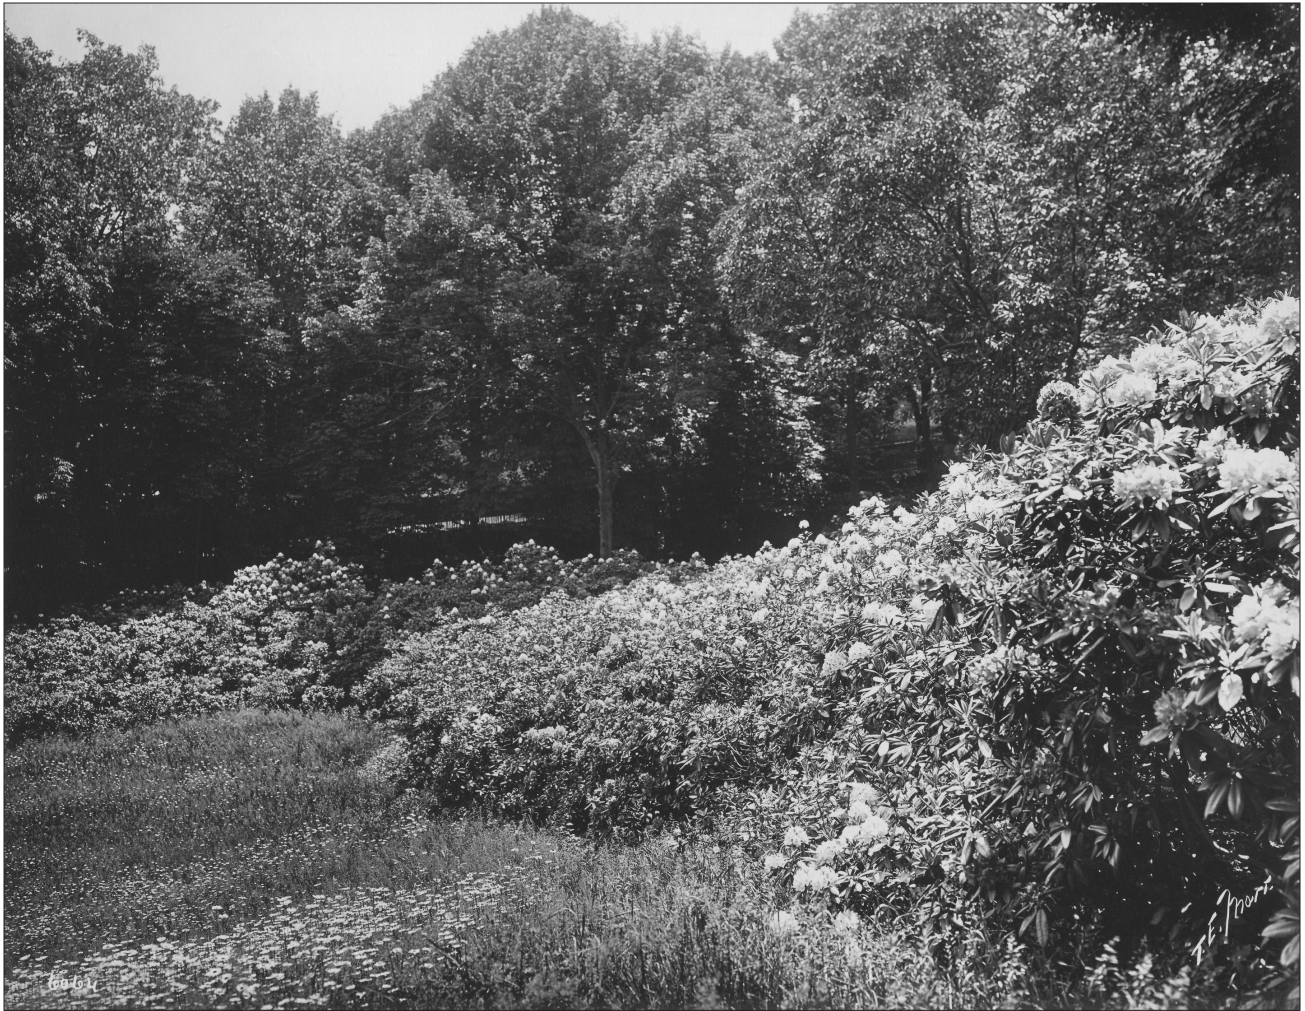
Figure 9. View of the embankment adjacent to the Gardner mansion, showing rhododendron lining the slope, proximate to the property line. View looking east, most likely 1900-05 (T.E. Marr and Son, *Green Hill*, Isabella Stewart Gardner Museum, Boston).

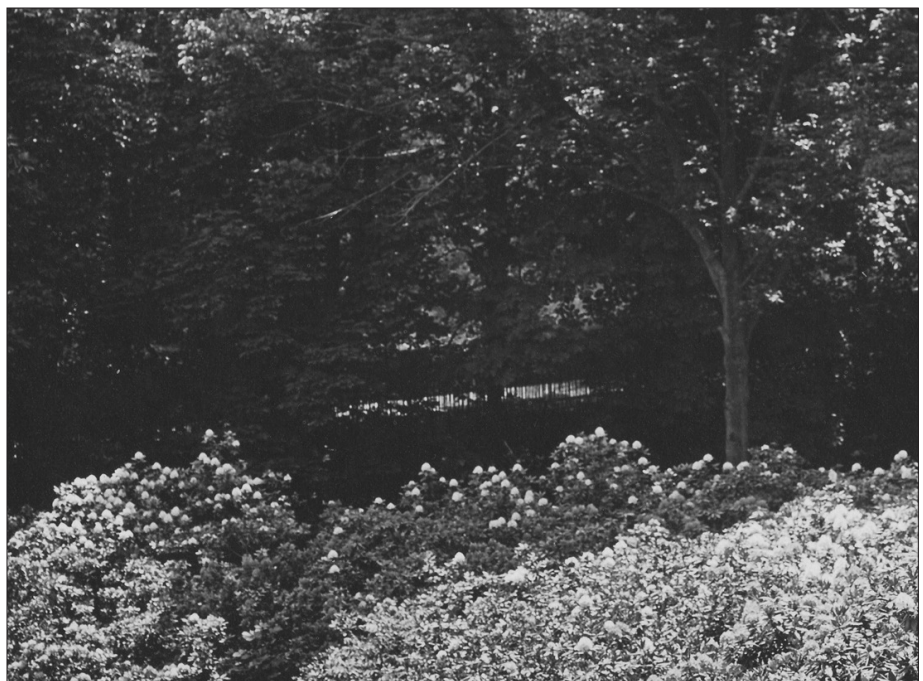
Figure 10. Detail of the view down the Gardner mansion embankment (Figure 9), showing the silhouette of the spruce pole fence that lined the property's border with Warren Street (center). View looking east, most likely 1900-05 (T.E. Marr and Son, *Green Hill*, Isabella Stewart Gardner Museum, Boston).

Historic Condition: From just after the turn of the twentieth century until at least 2001, a spruce pole fence stood on top of the southern extent of the stone wall that borders the Warren Street line with the Green Hill property. This fence segment is first documented by photographs of the Gardner estate taken between 1900 and 1905 by T.E. Marr (see Figures 8–12).

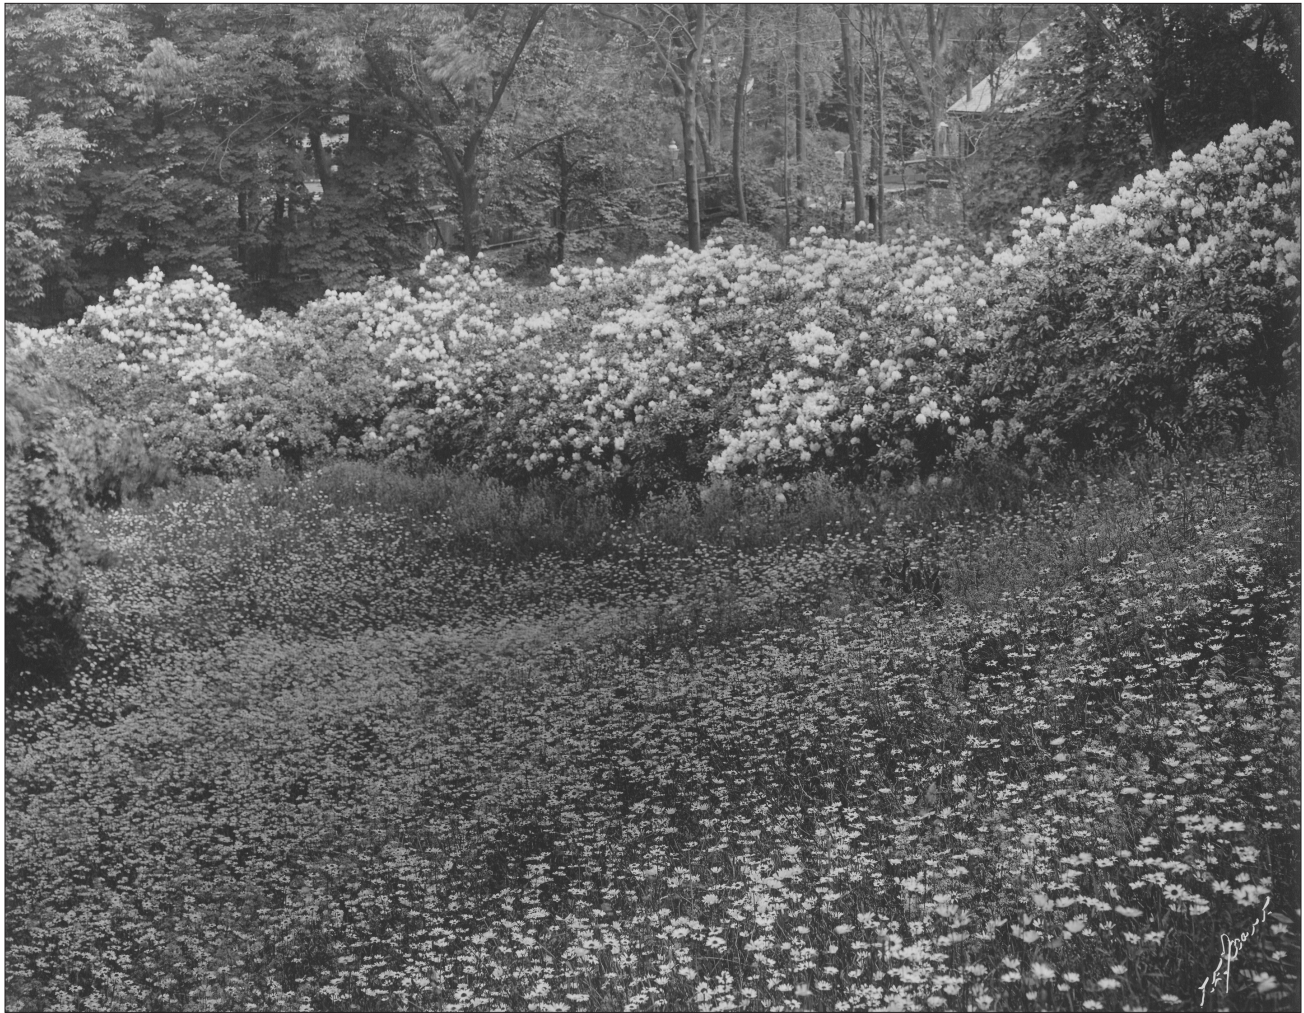
Figure 11. View down the embankment adjacent to the Gardner mansion showing the corner of a building on the Julia Goddard estate, since demolished. View looking southeast, most likely 1900-05 (T.E. Marr and Son, *Green Hill*, Isabella Stewart Gardner Museum, Boston).

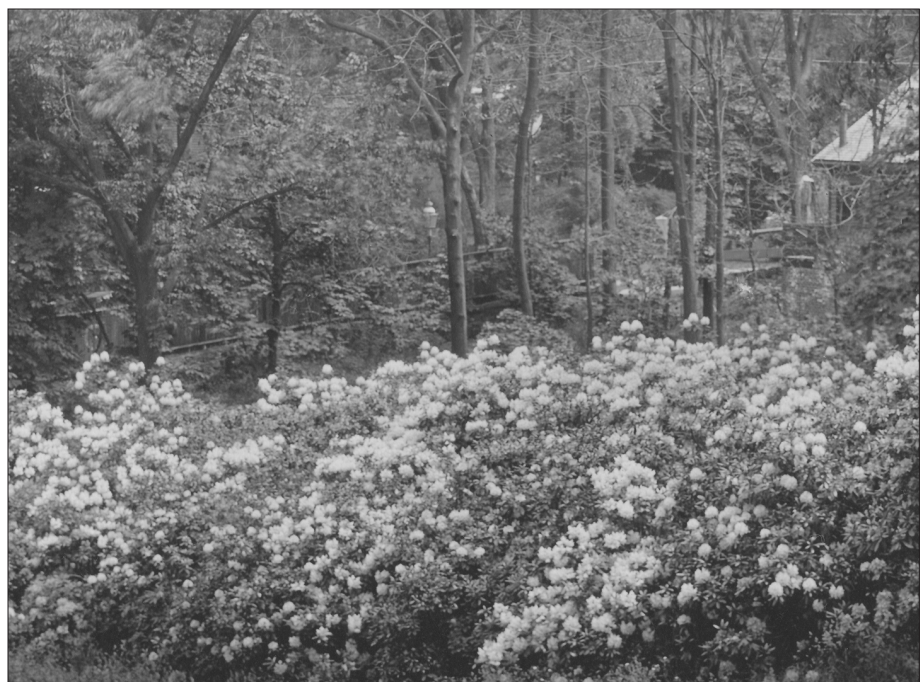
Figure 12. Detail of the view down the Gardner mansion embankment (Figure 11), showing the spruce pole fence that lined the property's border with Warren Street. The stone wall is also visible at its base, along with gas lamps lining the street. View looking southeast, most likely 1900-05 (T.E. Marr and Son, *Green Hill*, Isabella Stewart Gardner Museum, Boston).

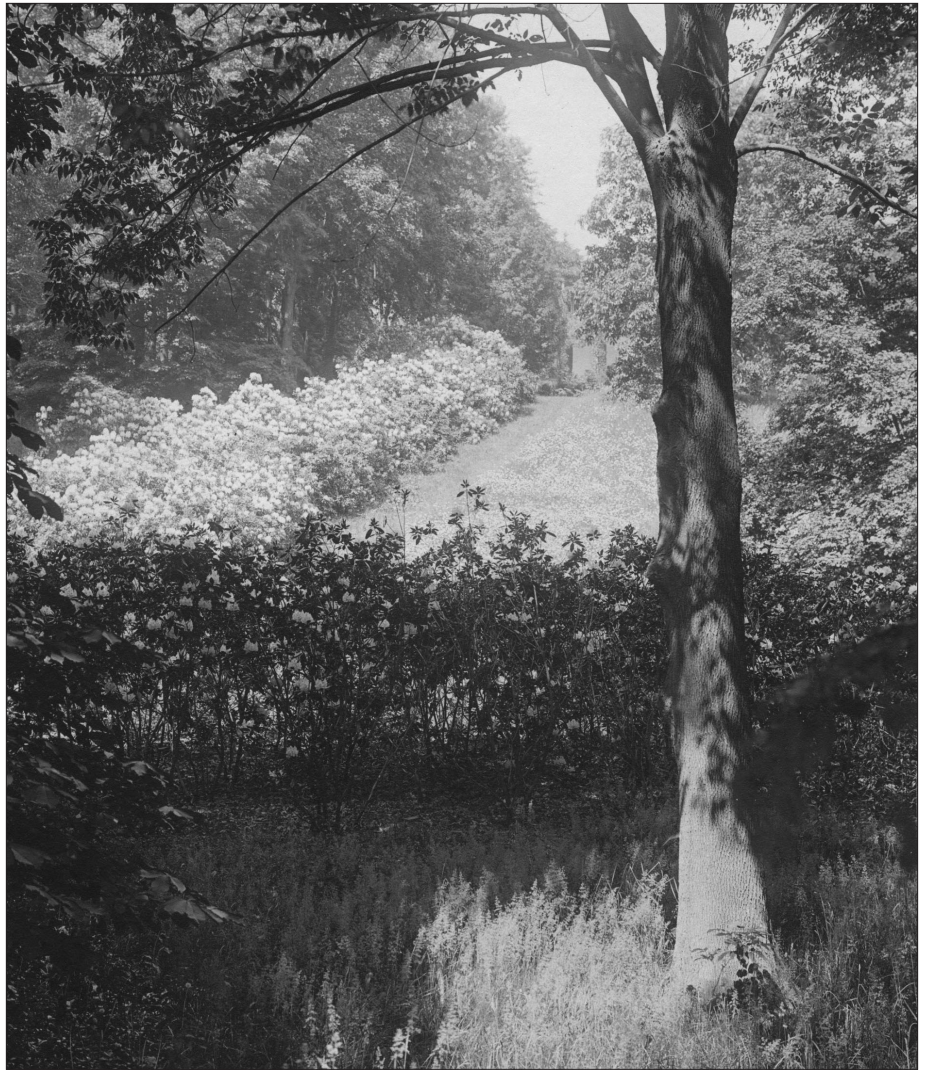
Figure 14. View of the embankment adjacent to the Gardner mansion (comparable to Figure 13), showing a wider view of the embankment area, including a sugar maple at right. View looking west, most likely 1900-05 (T.E. Marr and Son, *Green Hill*, Isabella Stewart Gardner Museum, Boston).

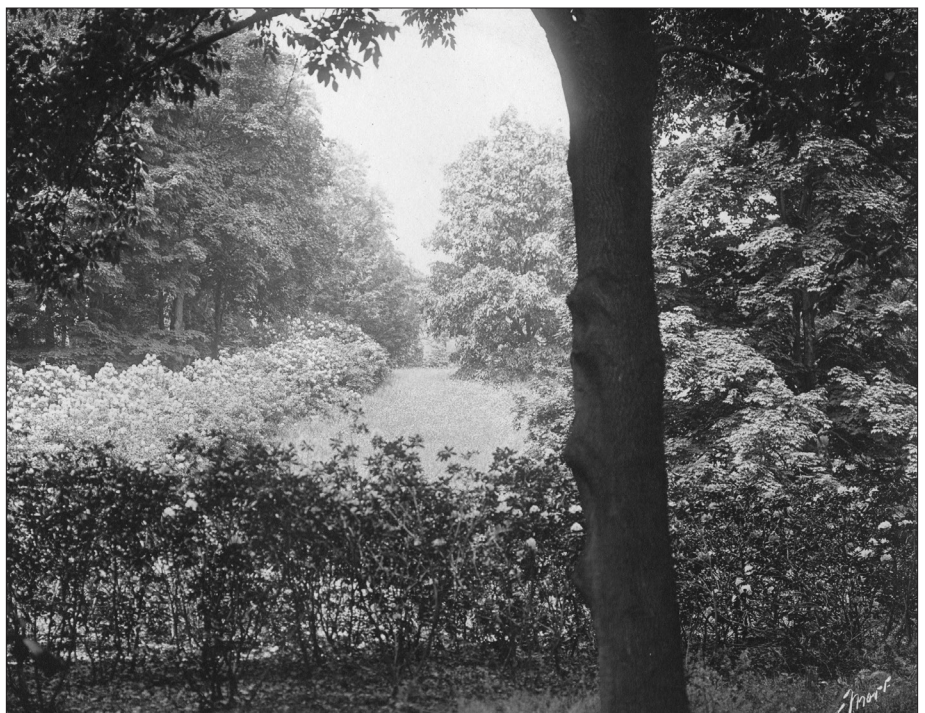
Figure 15. View looking down the slope from the Gardner mansion entrance drive showing the daisy covered meadow and rhododendron-lined property line to the south (right). The spruce pole that bordered Warren Street is visible at the top of the image. View looking east, most likely 1900-05 (T.E. Marr and Son, *Green Hill*, Isabella Stewart Gardner Museum, Boston).

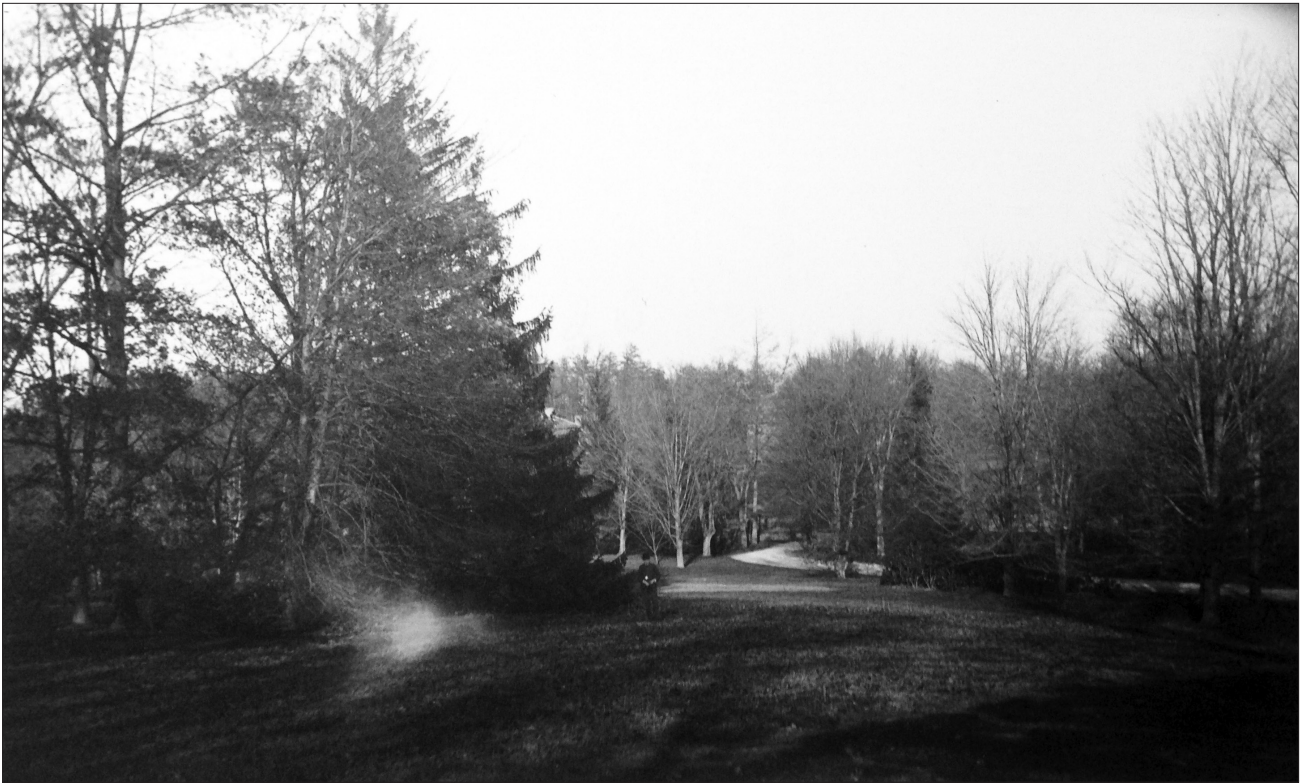
Figure 17. View of the entrance to the Gardner estate from the vicinity of the barn. The tree-lined entrance drive is visible at center. The drive is also bordered by limited shrub planting. View looking east, 1890-1905 (Courtesy of Historic New England, Gardner Photo Album).

The Green Hill entrance gate area is well documented by a series of photographs from another circa 1890–1905 Gardner family photo album (Figures 17–21). These views are the earliest to show the property’s distinctive wrought iron and stone entrance gate, although they were most likely constructed long before the photographs were taken, perhaps contemporary with the 1806 mansion. Around the turn of the twentieth century, the photographs show that the drive was loosely lined with deciduous trees, planted particularly densely near the entrance gate, as they remain today.

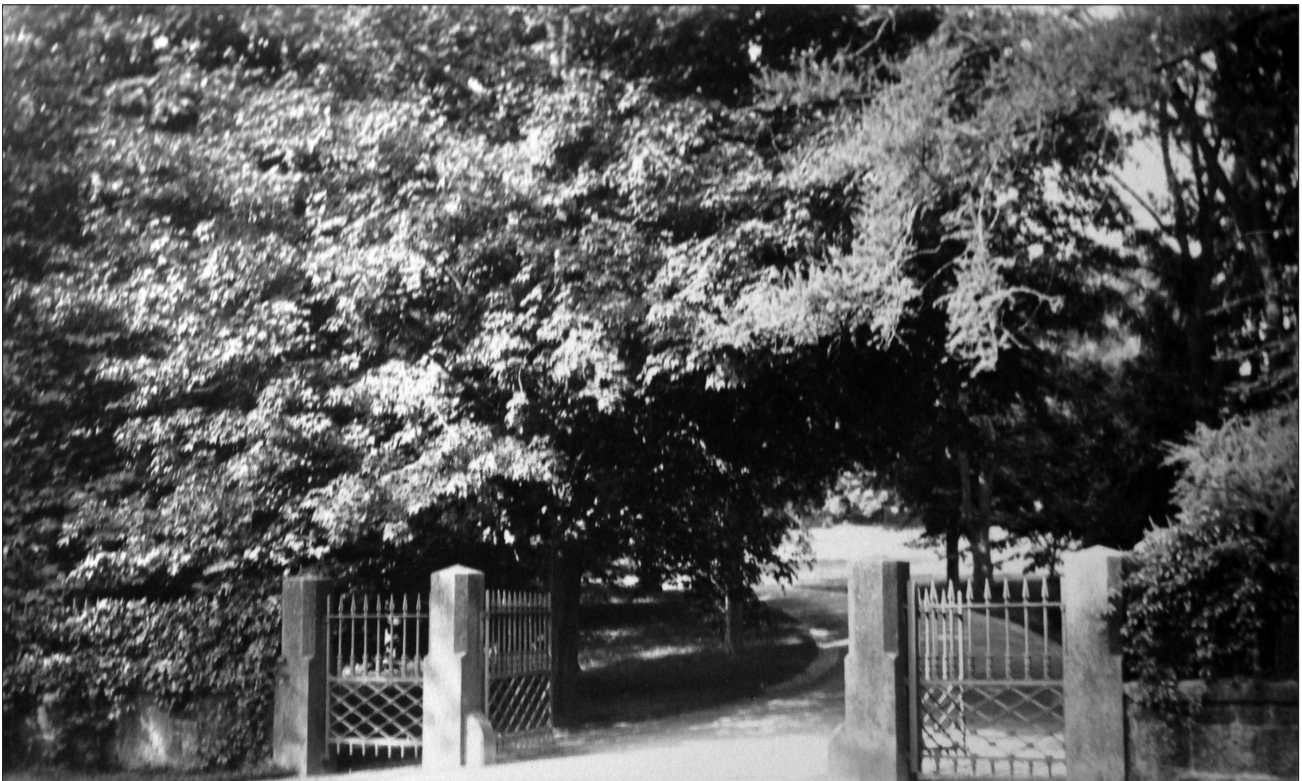
Figure 18. View of the Gardner estate entrance gates from Warren Street. The iron fence is clad in vines, with ornamental deciduous and evergreen trees beyond. View looking west, 1890-1905 (Courtesy of Historic New England, Gardner Photo Album).

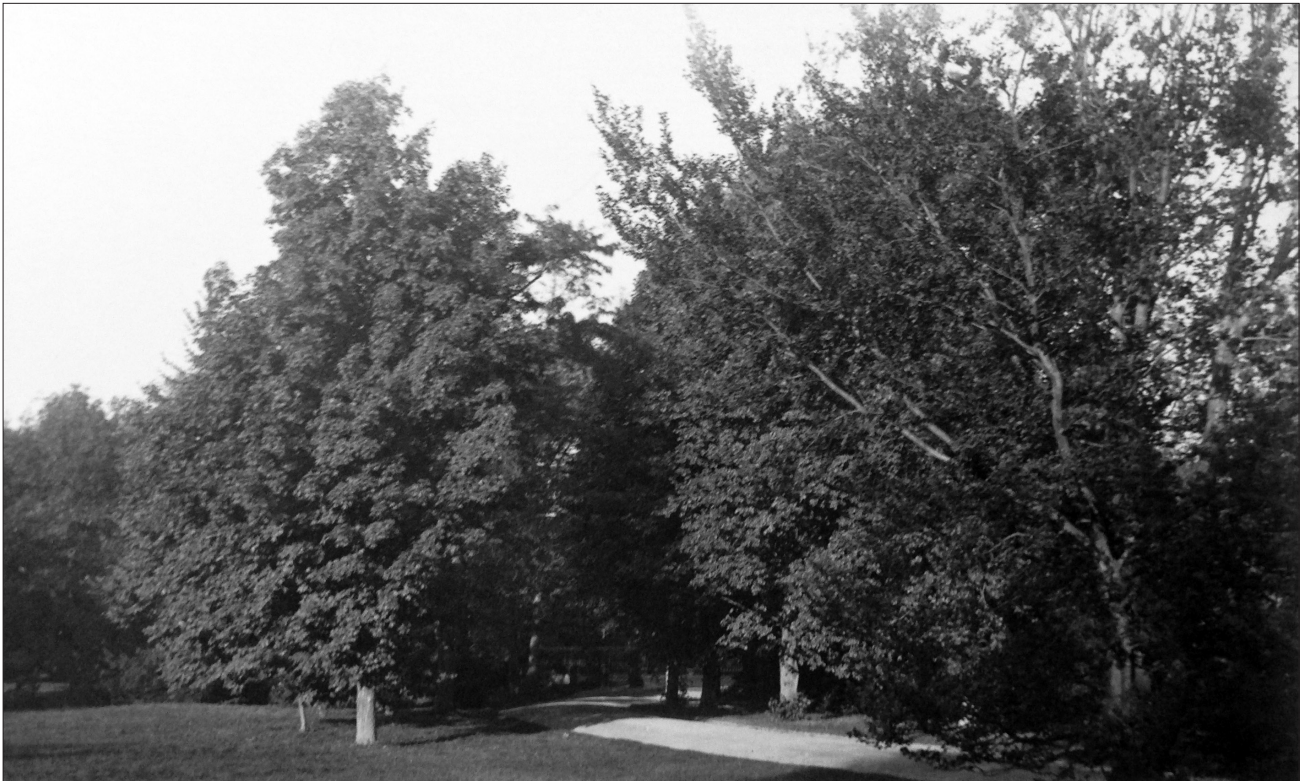
Figure 19. View of the Gardner estate entrance gate from the lawn area adjacent to the entrance drive. A beech is visible at right and a sugar maple at left. View looking northeast, 1890-1905 (Courtesy of Historic New England, Gardner Photo Album).

was lined with rhododendron. On the northern portion of the parcel, historic photographs suggest that the landscape was maintained in mown lawn and meadow grass (see Figure 19), thus enabling views across the northern portion of the parcel from Fairsted.

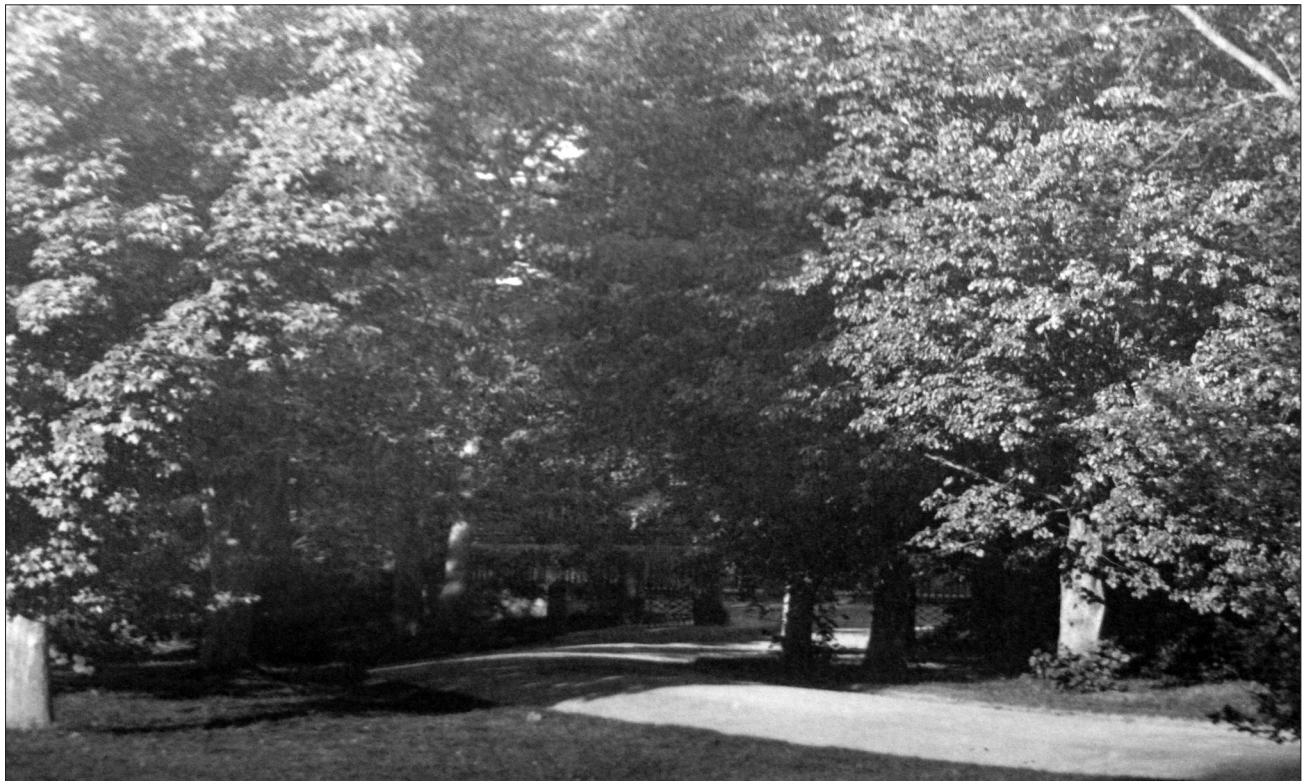
Figure 20. Detail of a view of the Gardner estate entrance gate (Figure 19), showing the silhouette of the gates (center). View looking northeast, 1890-1905 (Courtesy of Historic New England, Gardner Photo Album).

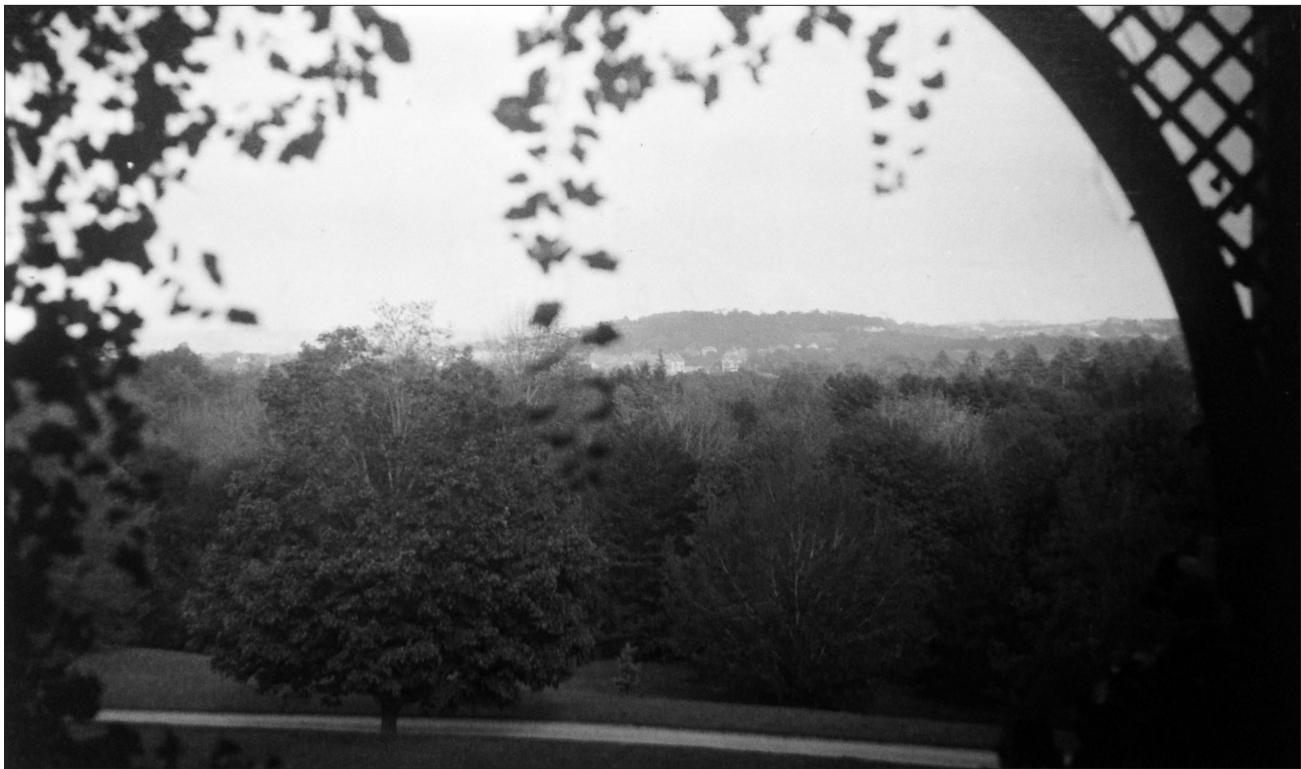
Figure 21. View from the Gardner mansion showing the embankment area. The beech tree that remains at the base of the embankment today is visible at center, immediately to the right of the young tree. Mission Hill is visible beyond. View looking east, 1890-1905 (Courtesy of Historic New England, Gardner Photo Album).

Figure 25. View just beyond the entrance drive, at the base of the slope. The Gardner mansion is to the right, Warren Street to the left. A mature beech, now in decline, is visible at center. This same tree is visible in Figure 21, taken 1890-1905. View looking south, 2015 (OCLP).

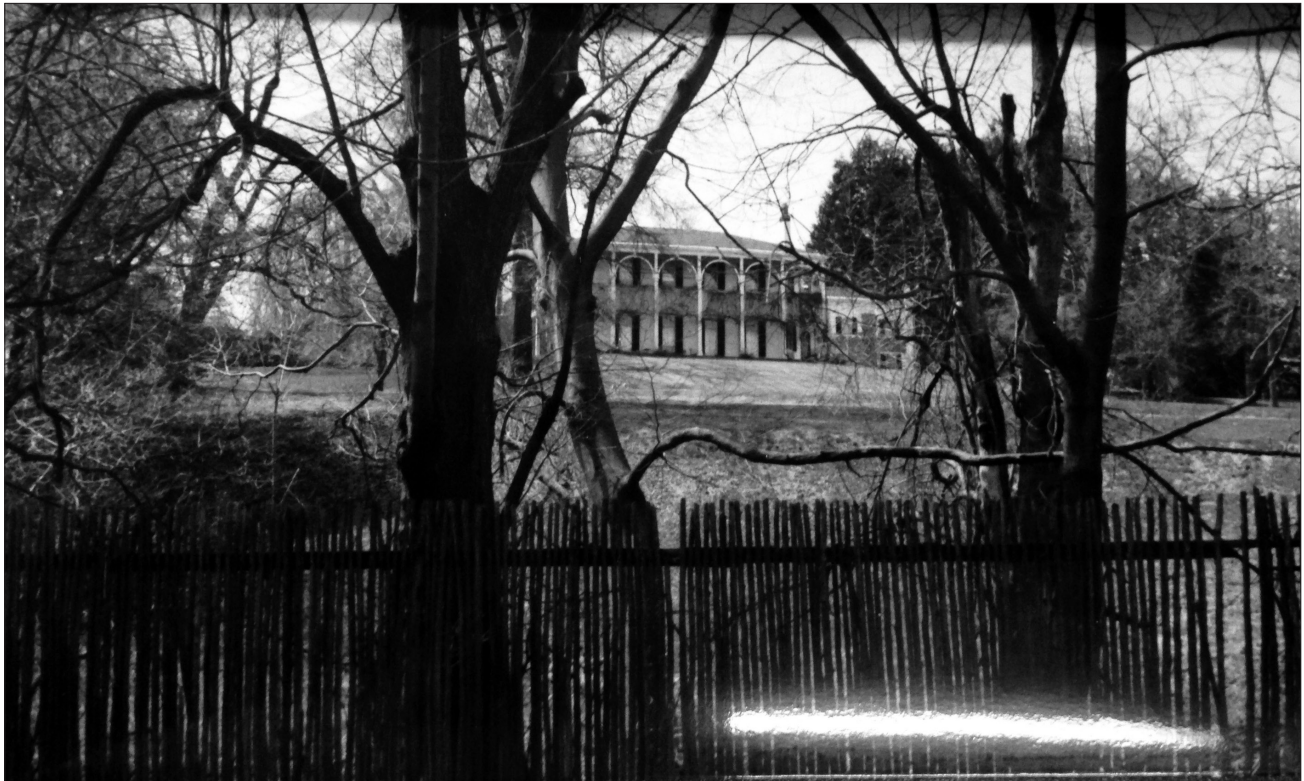
Figure 23. The former Gardner mansion from Warren Street, prior to rehabilitation. The spruce pole fence and several middle-aged trees are visible in the foreground. View looking west, 2001 (Courtesy of Historic New England, Robert Bayard Severy Photograph Collection).

Figure 29. View to the former Gardner mansion from Warren Street, showing the low, mortared stone wall that borders the sidewalk. A carpet of lily-of-the-valley is visible on the topographic rise at the base of the wall. Note that light is dappled as a result of the dense canopy. Compare this view with Figure 23, taken 2001. View looking west, 2015 (OCLP).

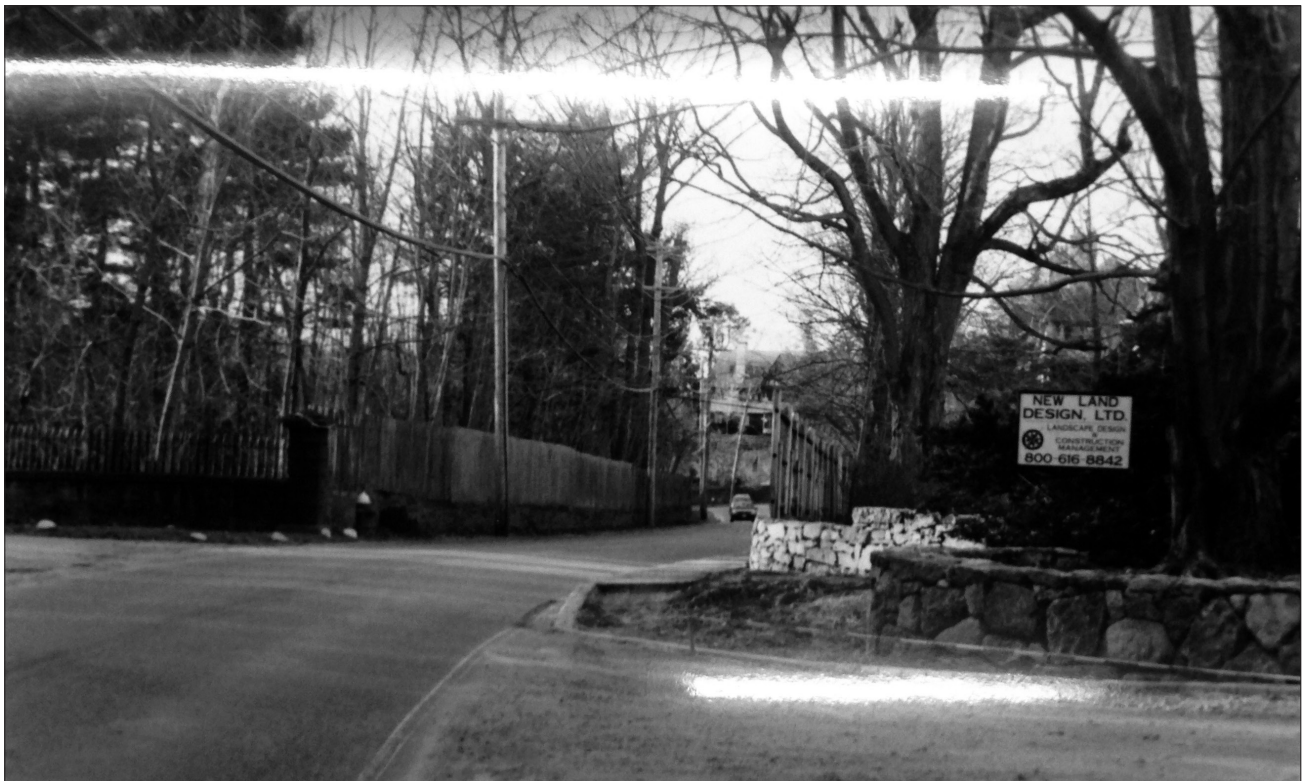
Figure 24. Warren Street from the driveway opposite the former Gardner estate. The entrance gates are visible at left, along with sections of spruce pole fence, stockade fence, and spruce pole fence alternating in the direction of Fairsted. View looking north, 2001 (Courtesy of Historic New England, Robert Bayard Severy Photograph Collection).

Figure 33. View along Warren Street showing the carved stone end pier associated with the entrance gate, and spruce pole fence, stockade fence, and spruce pole fence segments alternating in the direction of Faristed. Compare this view with Figure 24, taken 2001. View looking northwest, 2015 (OCLP).

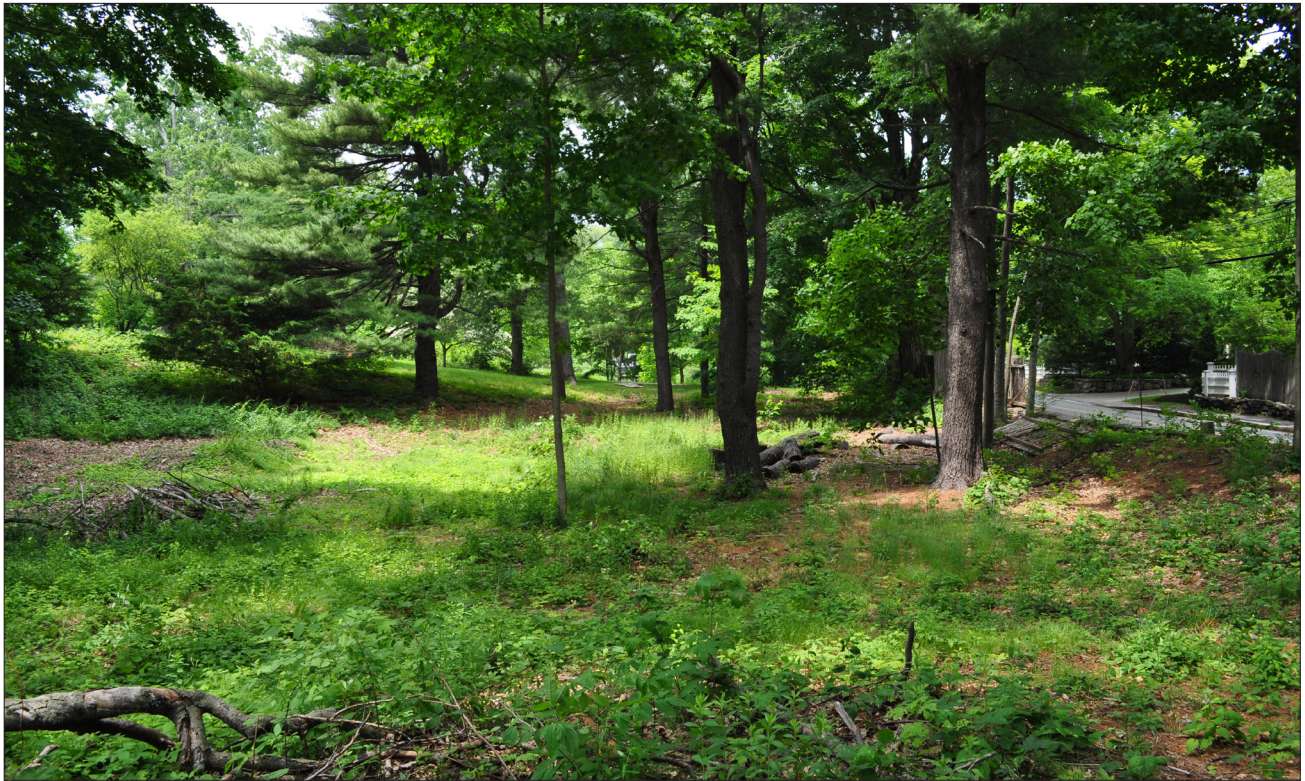
Figure 26. View from the topographic rise on the south side of the Gardner estate entrance drive showing Warren Street at right, along with a collapsed section of spruce pole fence. Several historic white pine trees are visible from this vantage point. Fairsted is located at center, beyond heavy foliage. View looking north, 2015 (OCLP).
