CULTURAL LANDSCAPE REPORT FOR THE GREEN HILL PARCEL

FREDERICK LAW OLMSTED NATIONAL HISTORIC SITE
BROOKLINE, MASSACHUSETTS

Olmsted Center for Landscape Preservation
National Park Service, Boston, Massachusetts, 2017

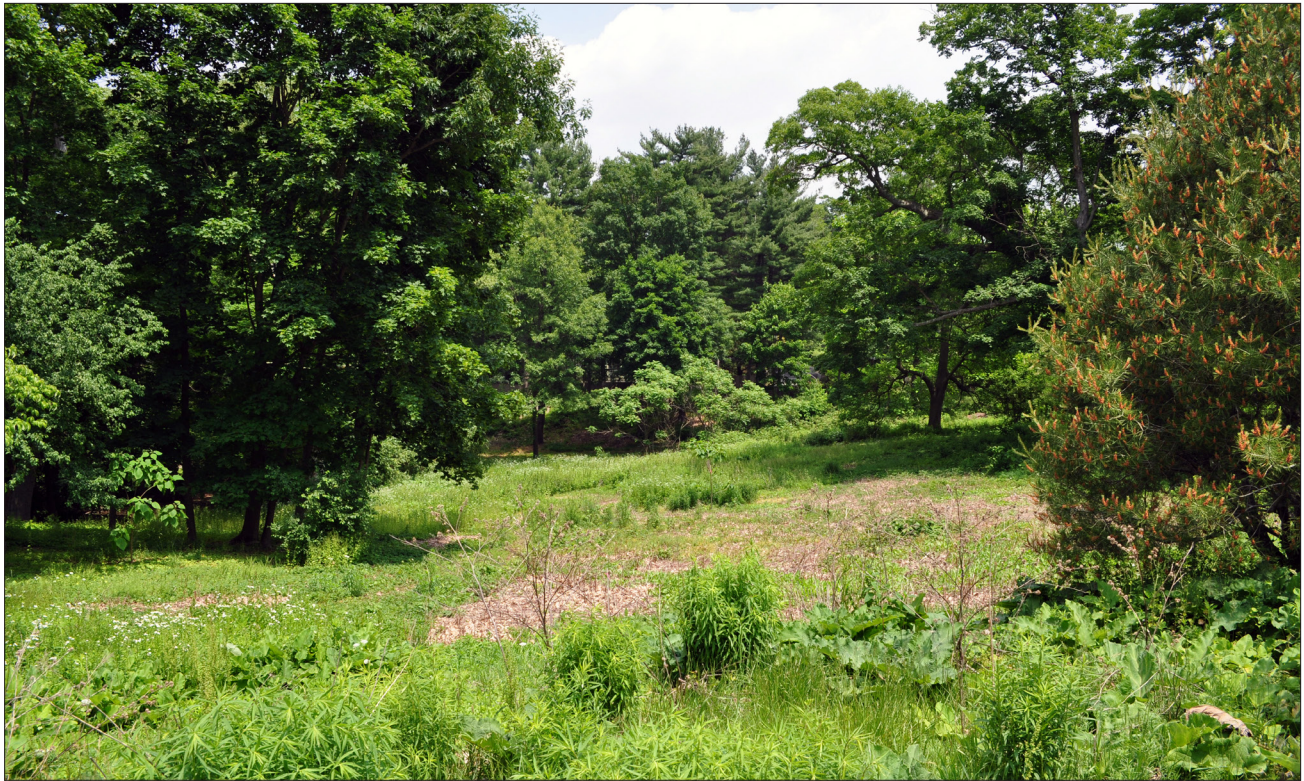
Figure 27. View from the top of the slope adjacent to the 111 Warren Street entrance drive. Fairsted is located to the left. Norway maples and a catalpa are visible, along with a scrub herbaceous layer in this sun-exposed area. The ornamental pine at right is on the property of 111 Warren Street. View looking east, 2015 (OCLP).

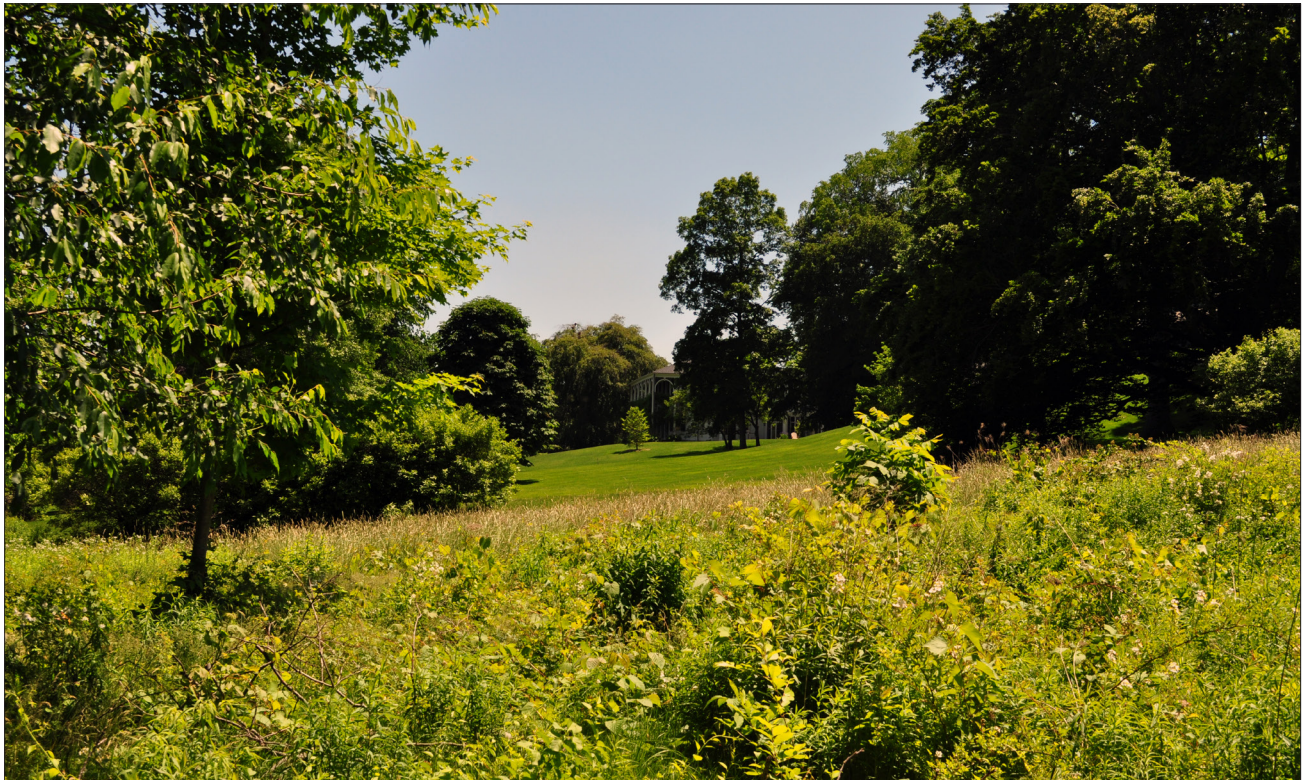
Figure 28. View from the vicinity of the historic tennis court looking toward the former Gardner mansion, at center. The scrub herbaceous layer in the foreground is property of NPS. The manicured lawn beyond is property of 111 and 135 Warren Street. View looking southwest, 2015 (OCLP).

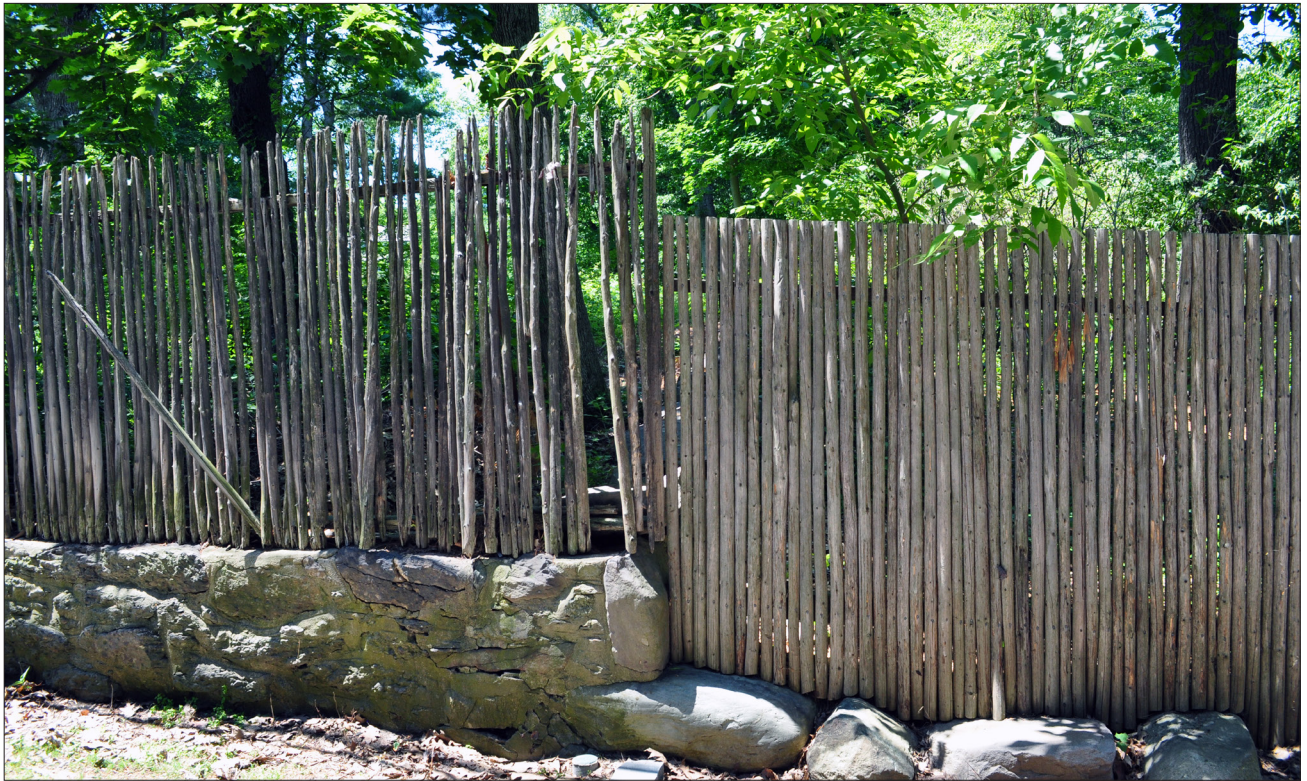
Figure 30. Detail of the spruce pole fence that borders the Green Hill parcel (left) at its juncture with the Fairsted spruce pole fence (right). The Green Hill fence is in poor condition, set on a mortared stone wall, while the Fairsted fence is in good condition, set above loose boulders. While the fences have similar designs, the density of spruce poles on the two fences varies considerably. View looking west, 2015 (OCLP).

leaning and missing spruce poles (Figures 30 and 31). Bracing was installed behind portions of the fence after the National Park Service acquired the property to prevent further loss (Figure 32).

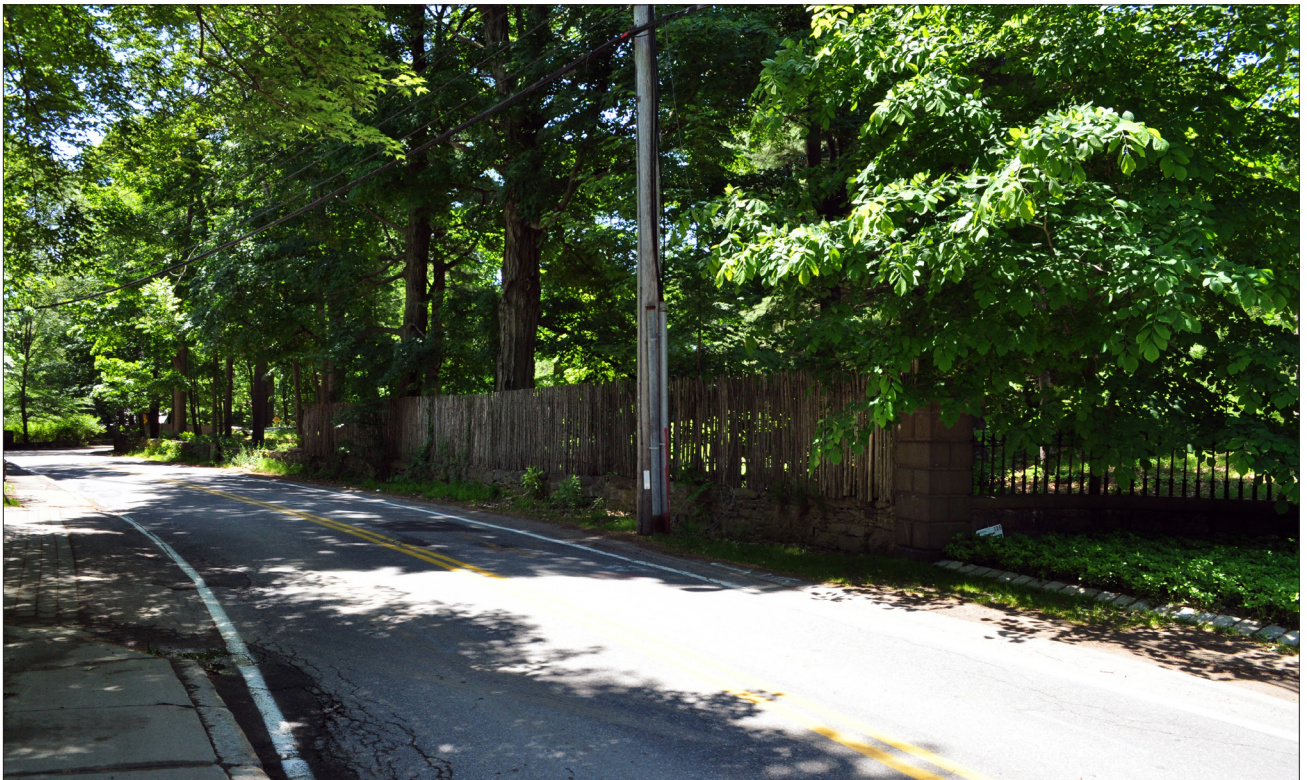
Figure 31. View along Warren Street from opposite the entrance gates. A short spruce pole fence segment is visible at center, set on the mortared stone wall, adjacent to the entrance gate's carved stone end pier. Several historic trees are also visible, including sugar maples and an American linden. A young yellowwood stands to the right. View looking southwest, 2015 (OCLP).

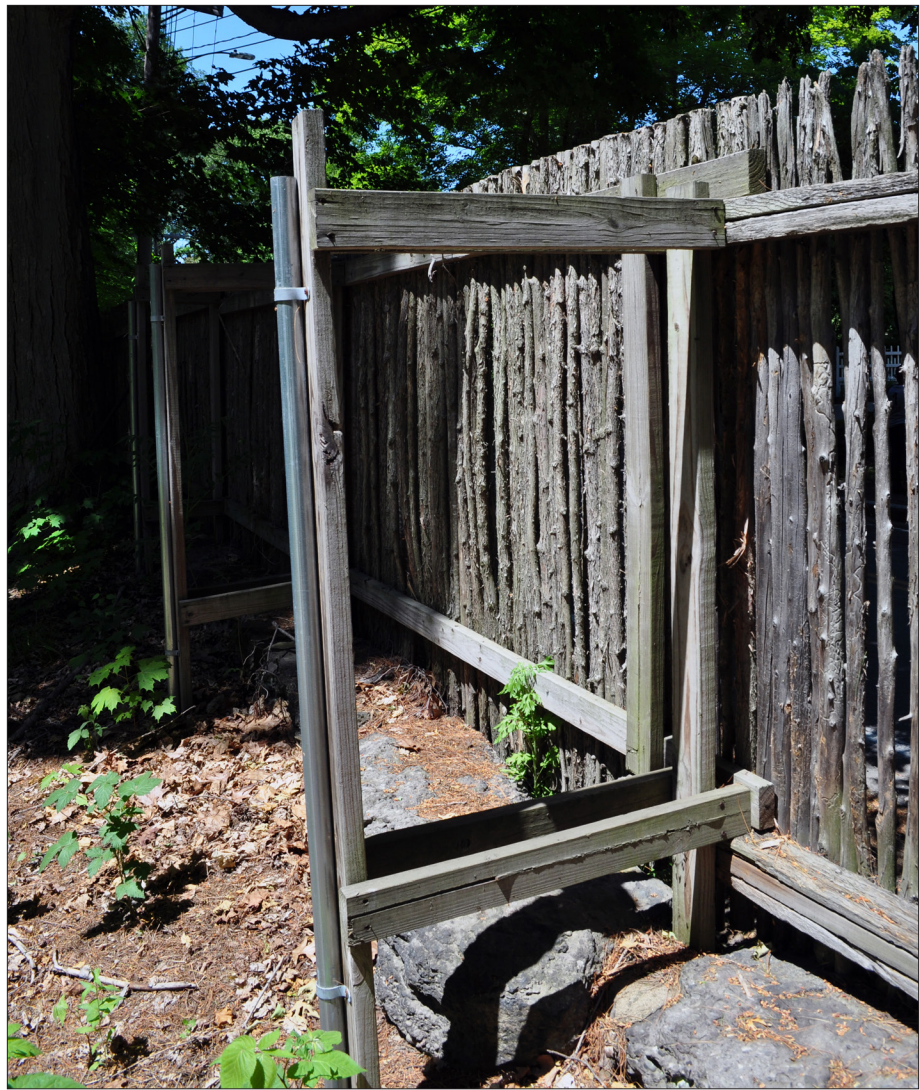
Figure 32. Detail of the spruce pole fence at its present southern extent showing contemporary bracing designed to keep the deteriorated fence upright. View looking north, 2015 (OCLP).

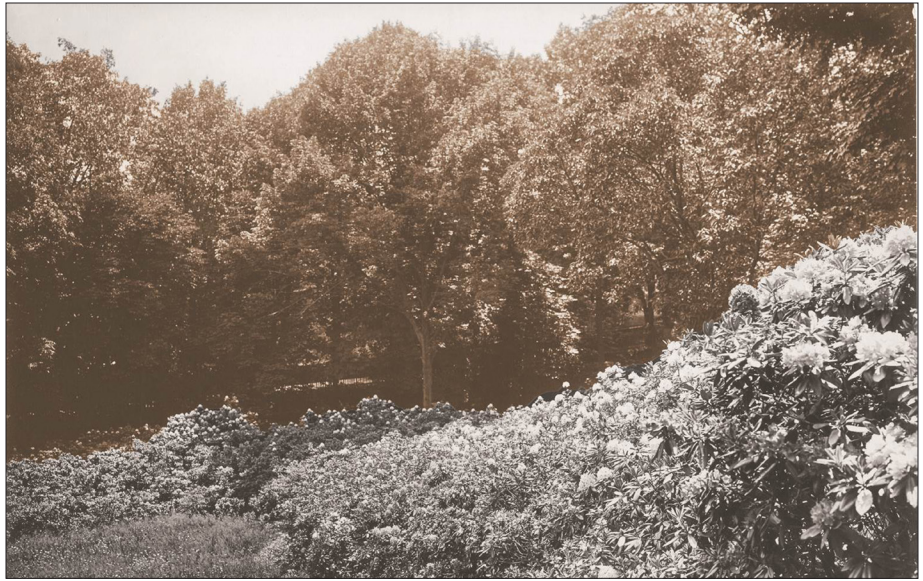
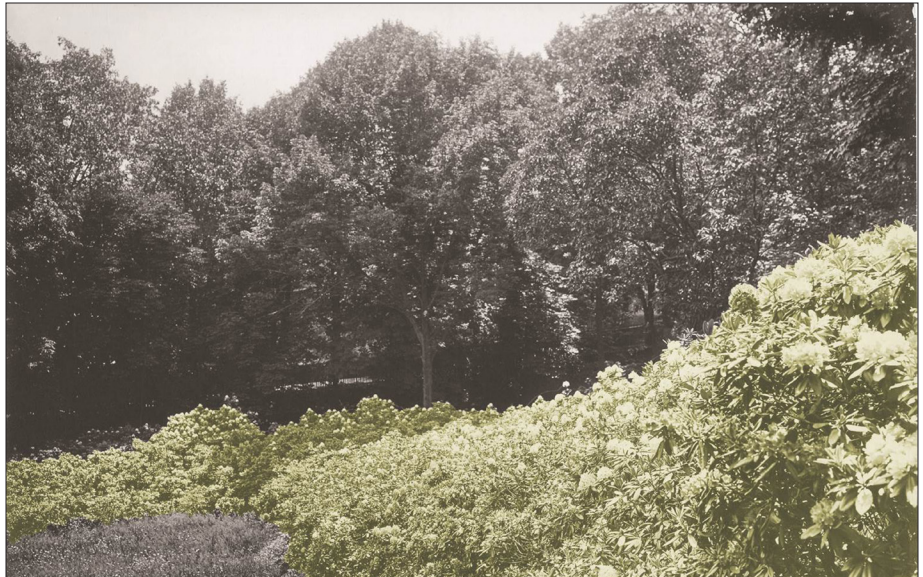
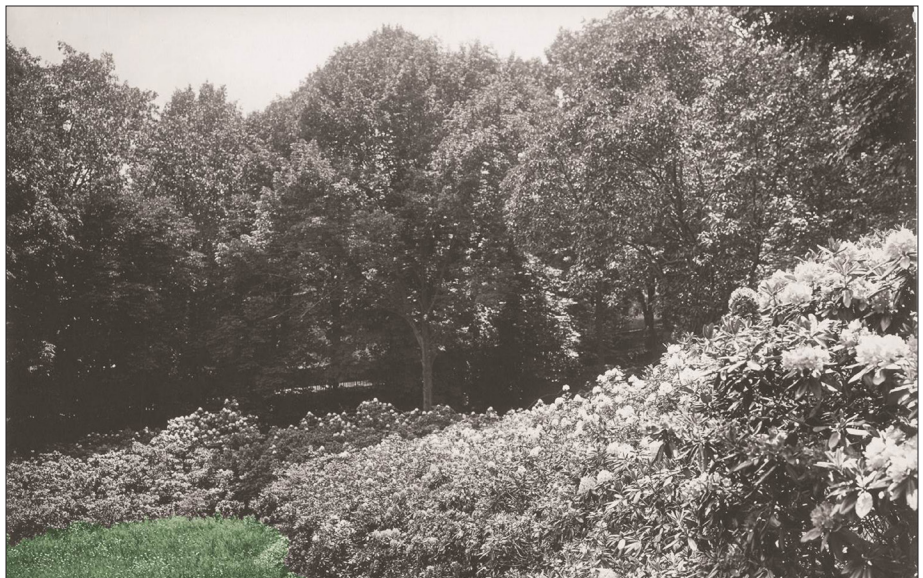
Figure 34. View of the embankment adjacent to the Gardner mansion, showing the woodland zone (top, orange), screen zone (middle, yellow), and meadow zone (bottom, green). View looking east, most likely 1900-05 (T.E. Marr and Son, *Green Hill*, Isabella Stewart Gardner Museum, Boston, annotated by OCLP).

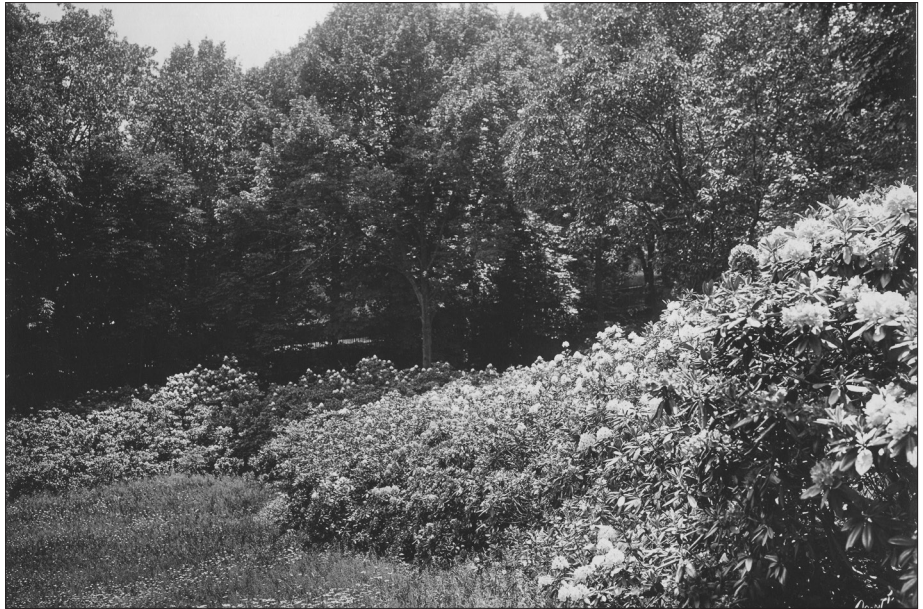
Figure 36. View down the embankment adjacent to the former Gardner mansion showing a prevalence of invasive species in the foreground. View looking east, 2016 (OCLP).

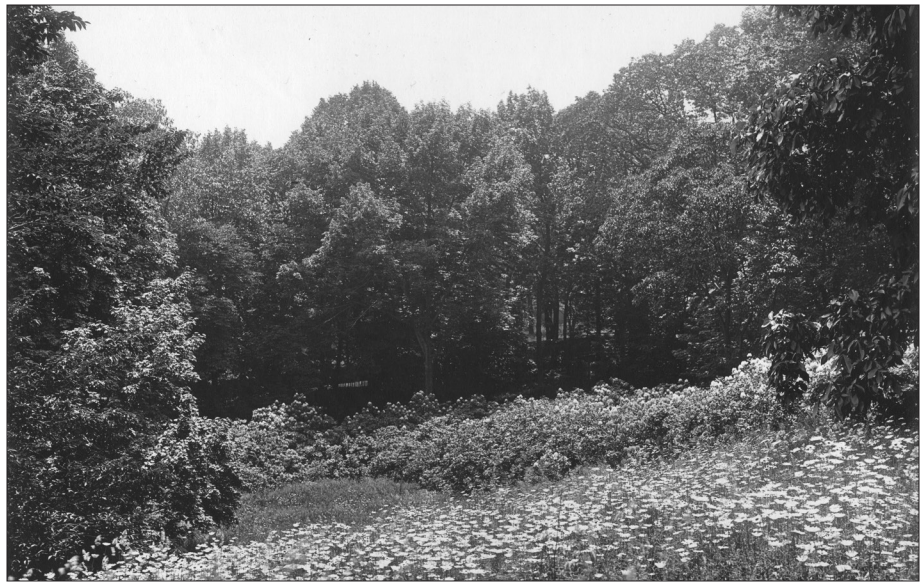
Figure 38. View down the embankment showing invasive species in the foreground, as well as Warren Street in the background. View looking east, 2016 (OCLP).

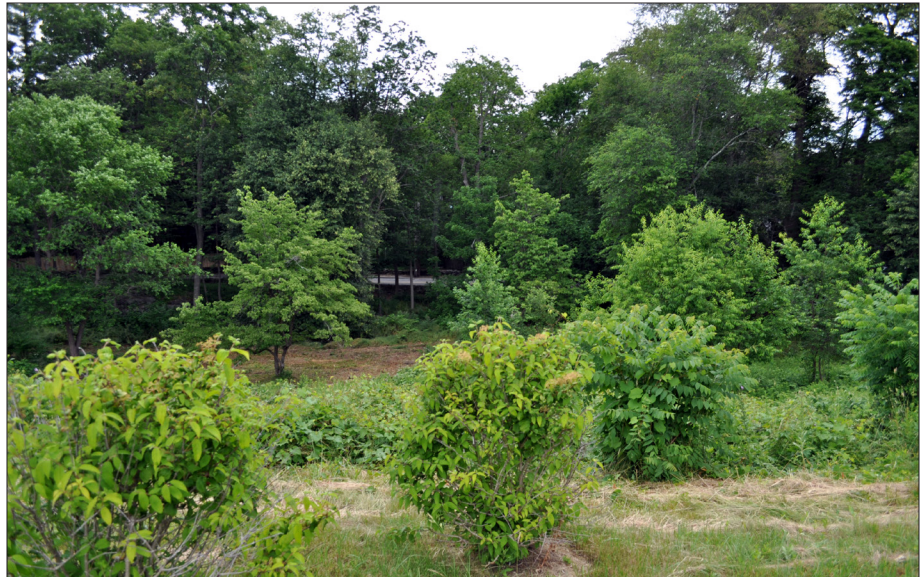
Figure 39. Photosimulation showing the reestablished meadow planting and specimen trees. Vista marked B on Drawings 2 and 3. Proposed view looking east, 2016 (OCLP).

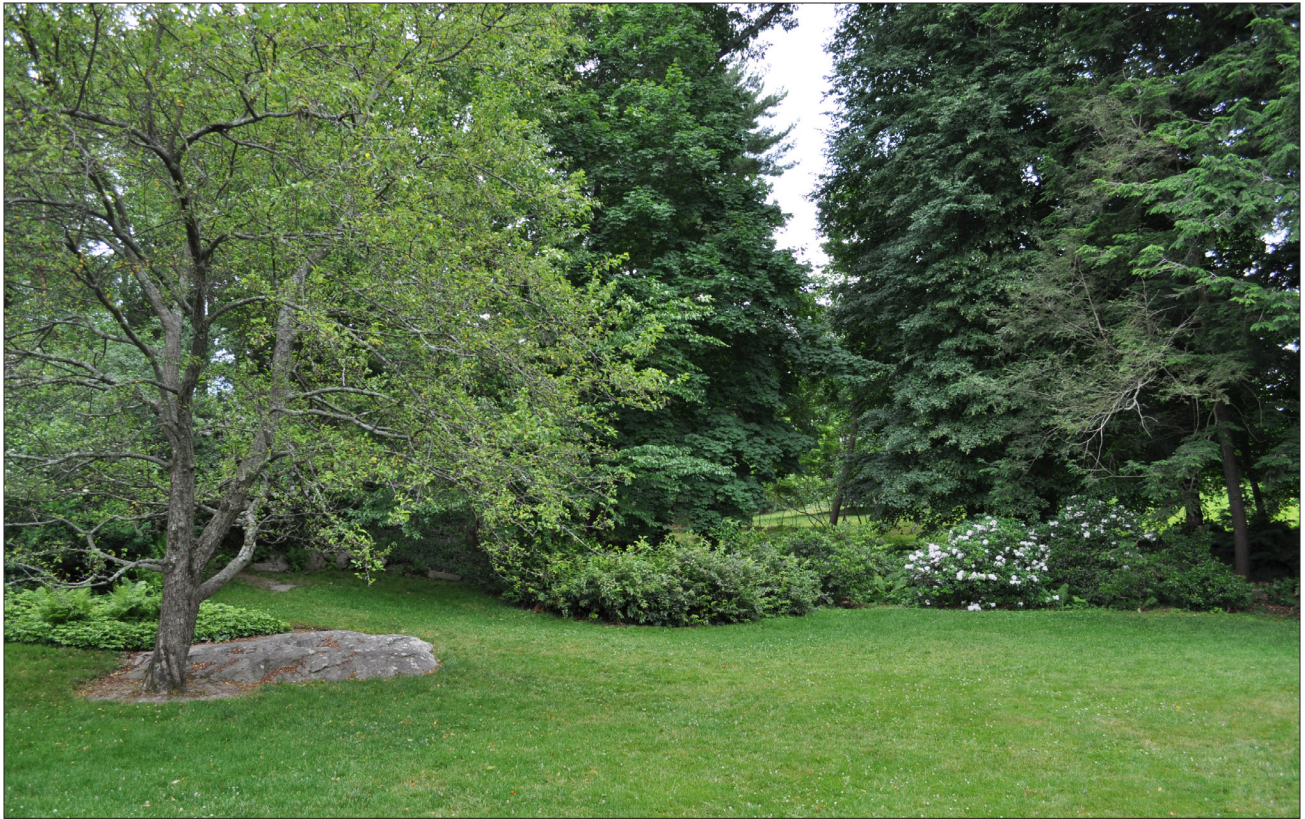
Figure 40. View from Fairsted's south lawn into the former Gardner property. Image depicts obstruction of the viewshed by *Acer platanoides* (Norway maple). View looking north, 2016 (OCLP).

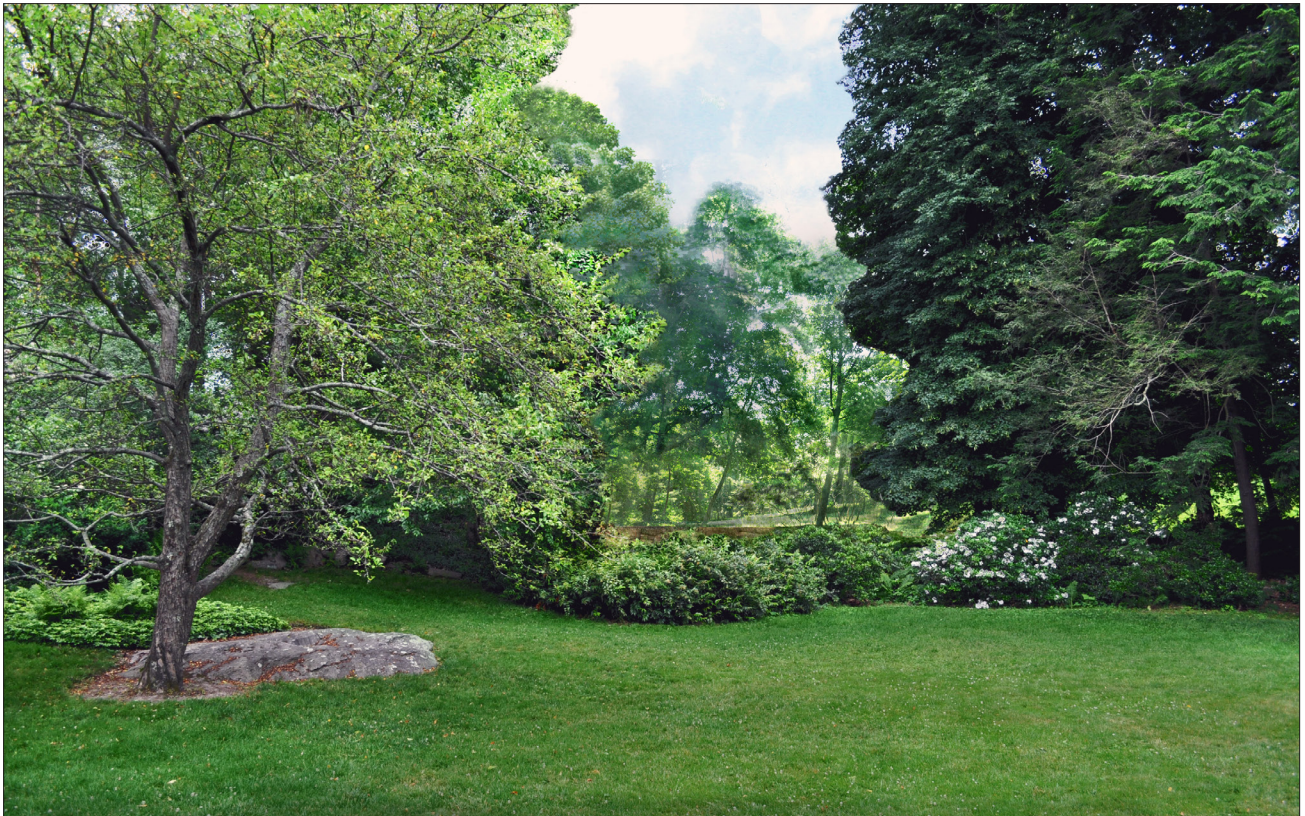
Figure 41. Photosimulation showing the reestablished view to the former Gardner property from the South Lawn of Fairsted. Visata marked A on Drawings 2 and 3. Proposed view looking north, 2016 (OCLP).

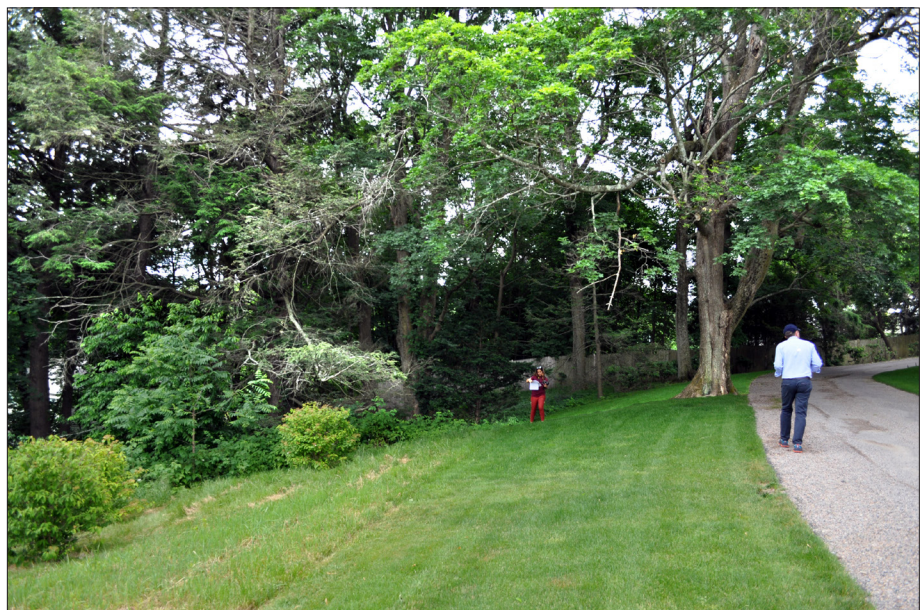
Figure 43. View along entrance drive, on the southern edge of the parcel, towards the former Gardner mansion driveway. *Tsuga canadensis* (Canadian hemlock) are visible in background and are used for privacy screening. View looking north, 2016 (OCLP).

VG-5. Phase-out Canadian hemlocks

Description: While the exact planting date of the Canadian hemlocks (*Tsuga canadensis*) is not known, they do not appear in historic images from about the turn of the twentieth century. It is likely that they were added late in the Gardner family's ownership to screen views. Canadian hemlocks on the southern edge of the parcel act as a useful privacy screen for the residential drive beyond the park's boundaries. However, these hemlocks are disease-prone and currently require monitoring and treatment for woolly adelgid and spider mites (Figure 43). Since some of these hemlocks are showing noticeable signs of decline and are non-contributing, it will be better for long-term maintenance to phase this species out of the Green Hill parcel and replace them with trees that have a similar character.

Considerations: The Canadian hemlocks growing along the southern edge of the Green Hill parcel should be phased out as part of an effort to control the spread of woolly adelgid. Some of these hemlocks are already in decline and should be prioritized for the first round of replacements. There are ten hemlocks to be replaced. To minimize the visual impact of replacement, existing trees might be replaced in small groups of two or three over a period of ten years. The Canadian hemlocks might appropriately be replaced with conifers that have similar growth habit and leaf formation such as white spruce (*Picea glauca*), red spruce (*Picea rubens*), or balsam fir (*Abies balsamea*). Chinese hemlock (*Tsuga chinensis*) is comparable to Canadian hemlock and is woolly adelgid resistant. However, this species is not yet available through the nursery trade. As Chinese hemlocks are released by nurseries, they should be considered for substitute planting.

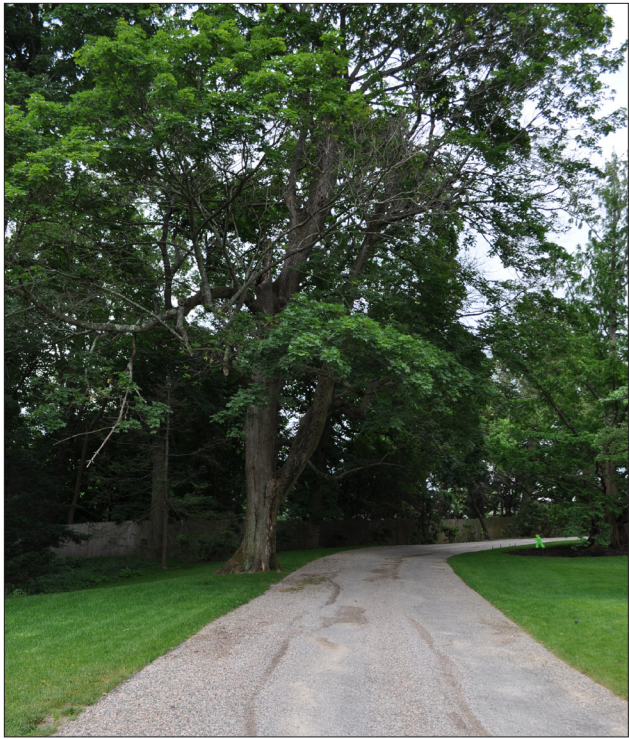
Figure 44. View along the former Gardner mansion entrance drive showing the area to be planted with a dense screen of shrubs to obscure views of Warren Street if the spruce pole fence is not replaced. View looking south, 2016 (OCLP).

Considerations: Vegetation might appropriately be planted adjacent to the stone wall (refer to Figure 39) and at the crest of the embankment to provide a sense separation from Warren Street (Figures 44 and 45). Vegetation within the screen planting zone (refer to Drawing 2) will primarily be made up of low branching sub-canopy trees and shrubs that grow between 3 and 15 feet high (also see Drawings 5 and 6). The screen will have the benefit of enhancing the privacy of residents adjacent to Green Hill and can also enhance the ecosystem services of the site. Shrubs and small trees on the Green Hill parcel can provide habitat for animals that are already known to live in Brookline, such as small mammals and migratory birds.³³

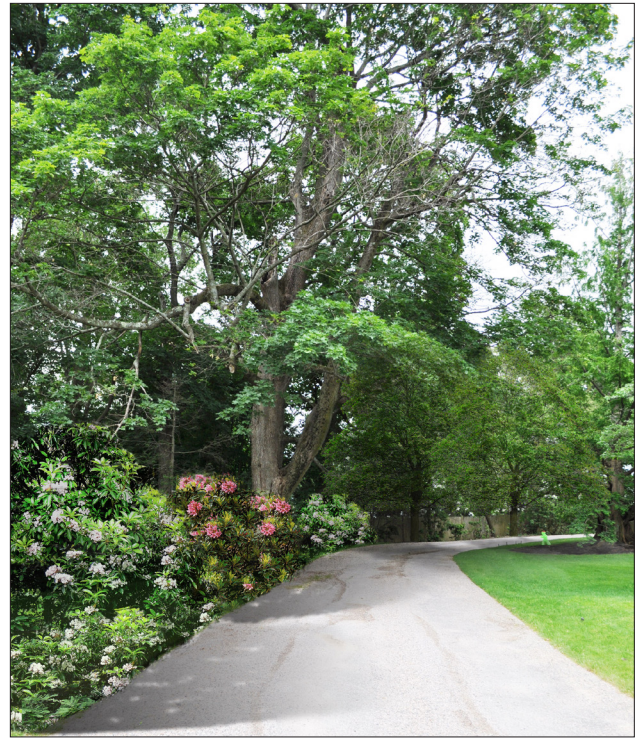
Figure 45. Photosimulation of rhododendron planting along the former Gardner mansion entrance drive to obscure views to Warren Street. Vista marked C on Drawings 2 and 3. Proposed view looking south, 2016 (OCLP).

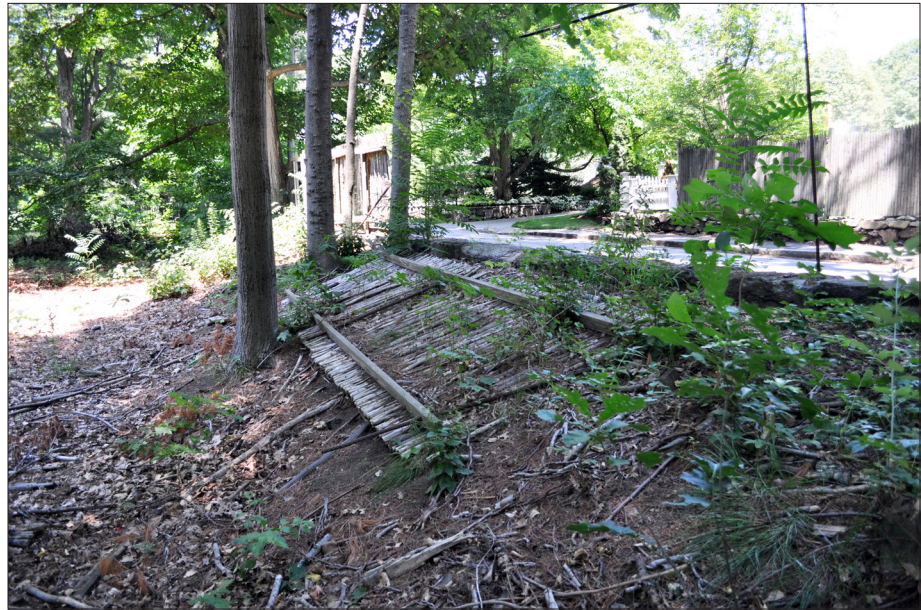
Figure 46. View of fallen spruce pole fence section along Warren Street. View looking north, 2016 (OCLP).

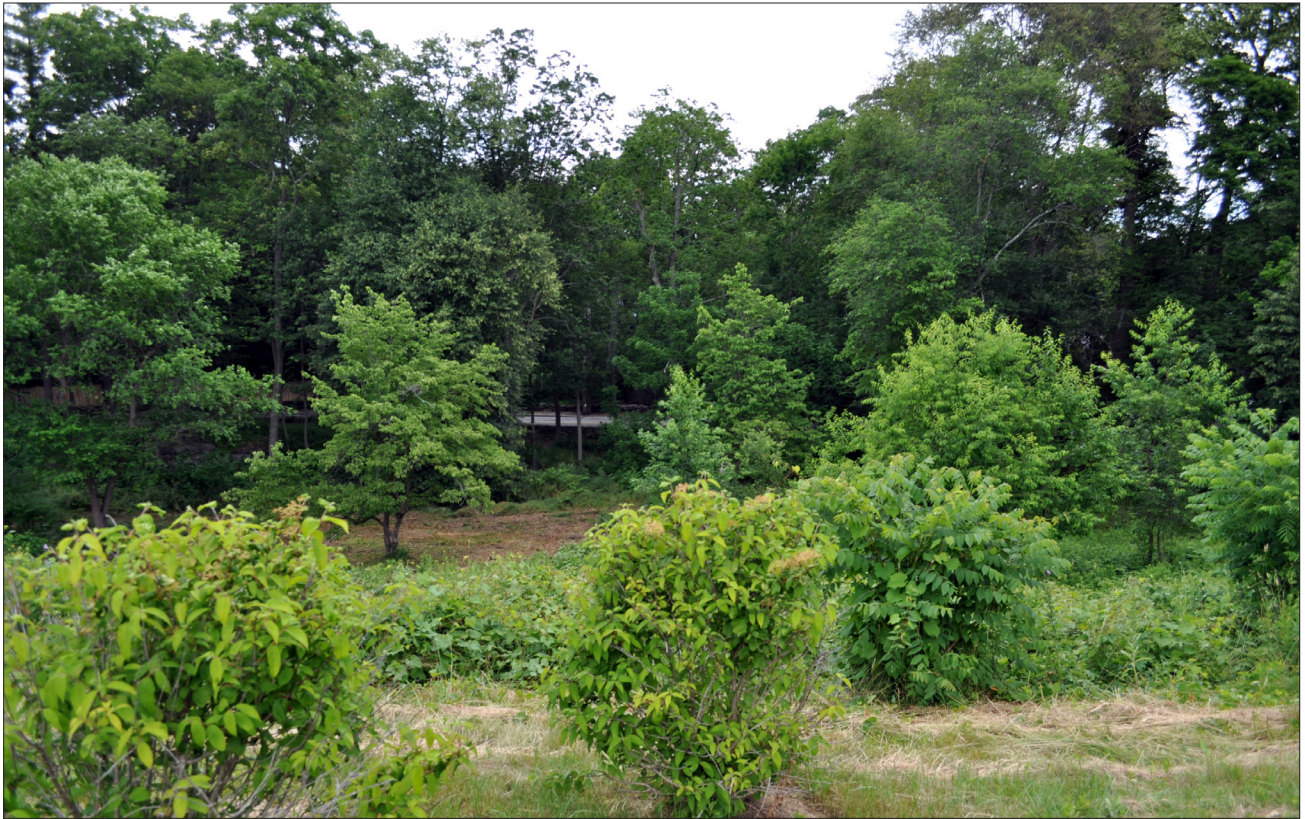
Figure 47. View down the embankment showing invasive species in the foreground, as well as a view of the Warren Street in the background. View looking east, 2016 (OCLP).

loss. Replacement of the spruce pole fence, set to a height of 5 feet, will effectively screen the Green Hill parcel from the adjoining road, while reestablishing the post-1900 character of the landscape (refer to Drawings 3, 5, and 6; Figures 47 and 48). Drawing 10 provides a schematic detail for construction of a replacement spruce pole fence on top of the stone wall. This detail shows the use of metal brackets to attach the fence posts to the wall at approximately 8' on center (eliminating the need for rear bracing) and the installation of two stringers on which to attach the spruce pole pickets.

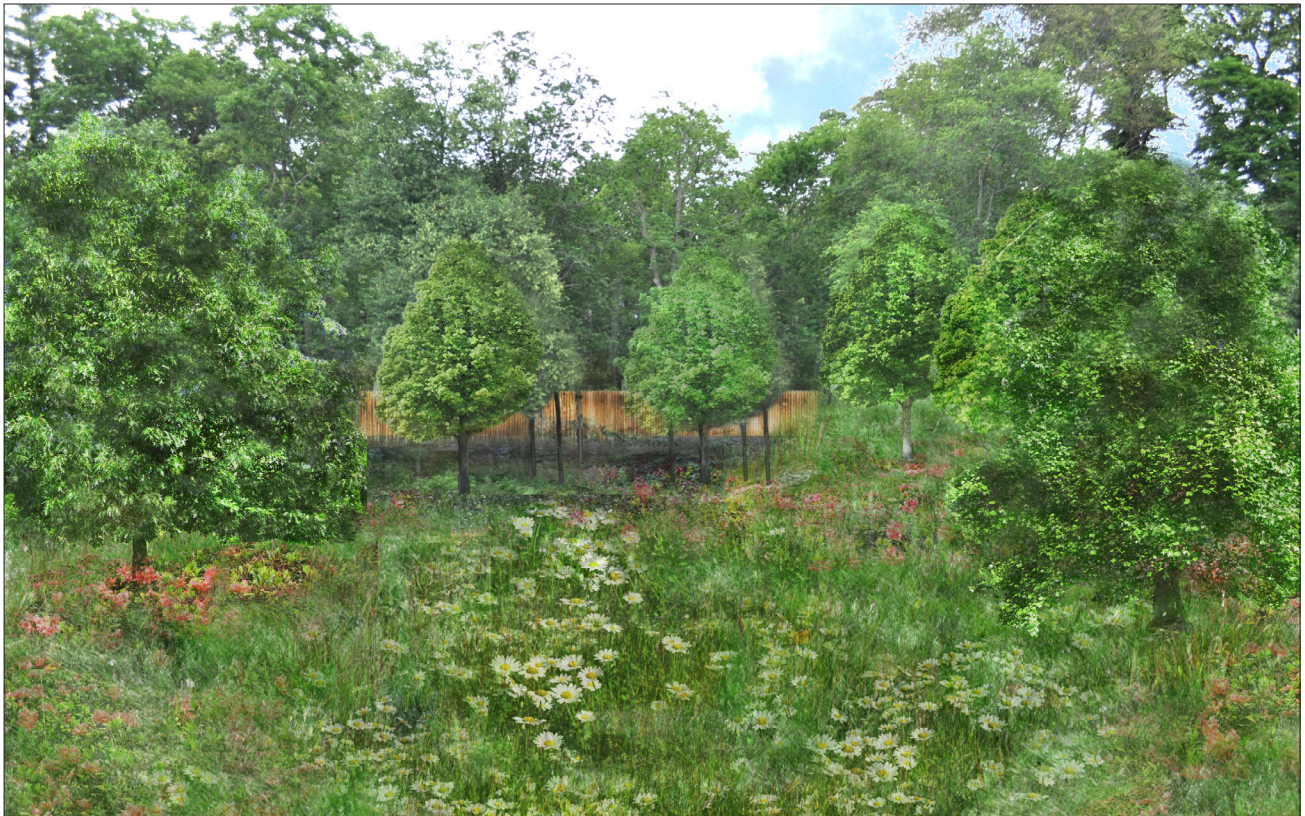
Figure 48. Photosimulation showing the reestablished meadow planting, specimen trees and spruce pole fence along the low stone wall that borders Warren Street. Vista marked B on Drawings 2 and 3. Proposed view looking east, 2016 (OCLP).

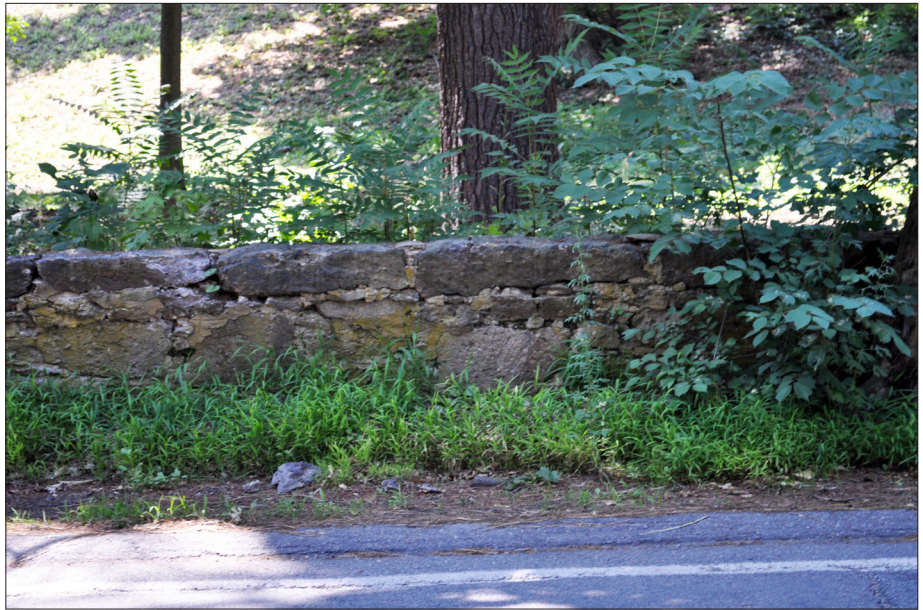
Figure 49. View of stone wall along Warren Street, looking toward the former Gardner mansion. View looking west, 2016 (OCLP).

SSF-2. Repair stone wall along Warren Street

Description: The stone wall along Warren Street is likely the oldest landscape features on the site. Along its southern extent, the wall is retaining, supporting a portion of Warren Street. By the turn of the twentieth century, the wall was well documented in historic photographs. The stone wall extends approximately 850 feet along Warren Street, and varies in height from 16-inches to 36-inches above grade. The wall is composed of dry-laid Roxbury puddingstone and is held together with mortar. Portions of the wall are deteriorated and in need of repair and repointing (Figure 49). Repair of the stone wall along Warren Street is a critical in maintaining the historic character of the Green Hill parcel and will aid in visitor understanding of the site. If the spruce pole fence that once stood on top of the wall is replaced, the repair of the wall is also essential to provide a foundation for the fence. The National Park Service Historic Preservation Training Center inspected the wall on May 11, 2015 and provided a cost estimate for its repair.

Considerations: The portions of the wall that has shifted over time will be dismantled and re-laid. The joints should be tuck pointed to match existing historic mortar joints. Vegetation along the wall should be removed, and the entire wall should be treated with D/2 biological solution to prevent further deterioration and improve appearance. The recommended preservation

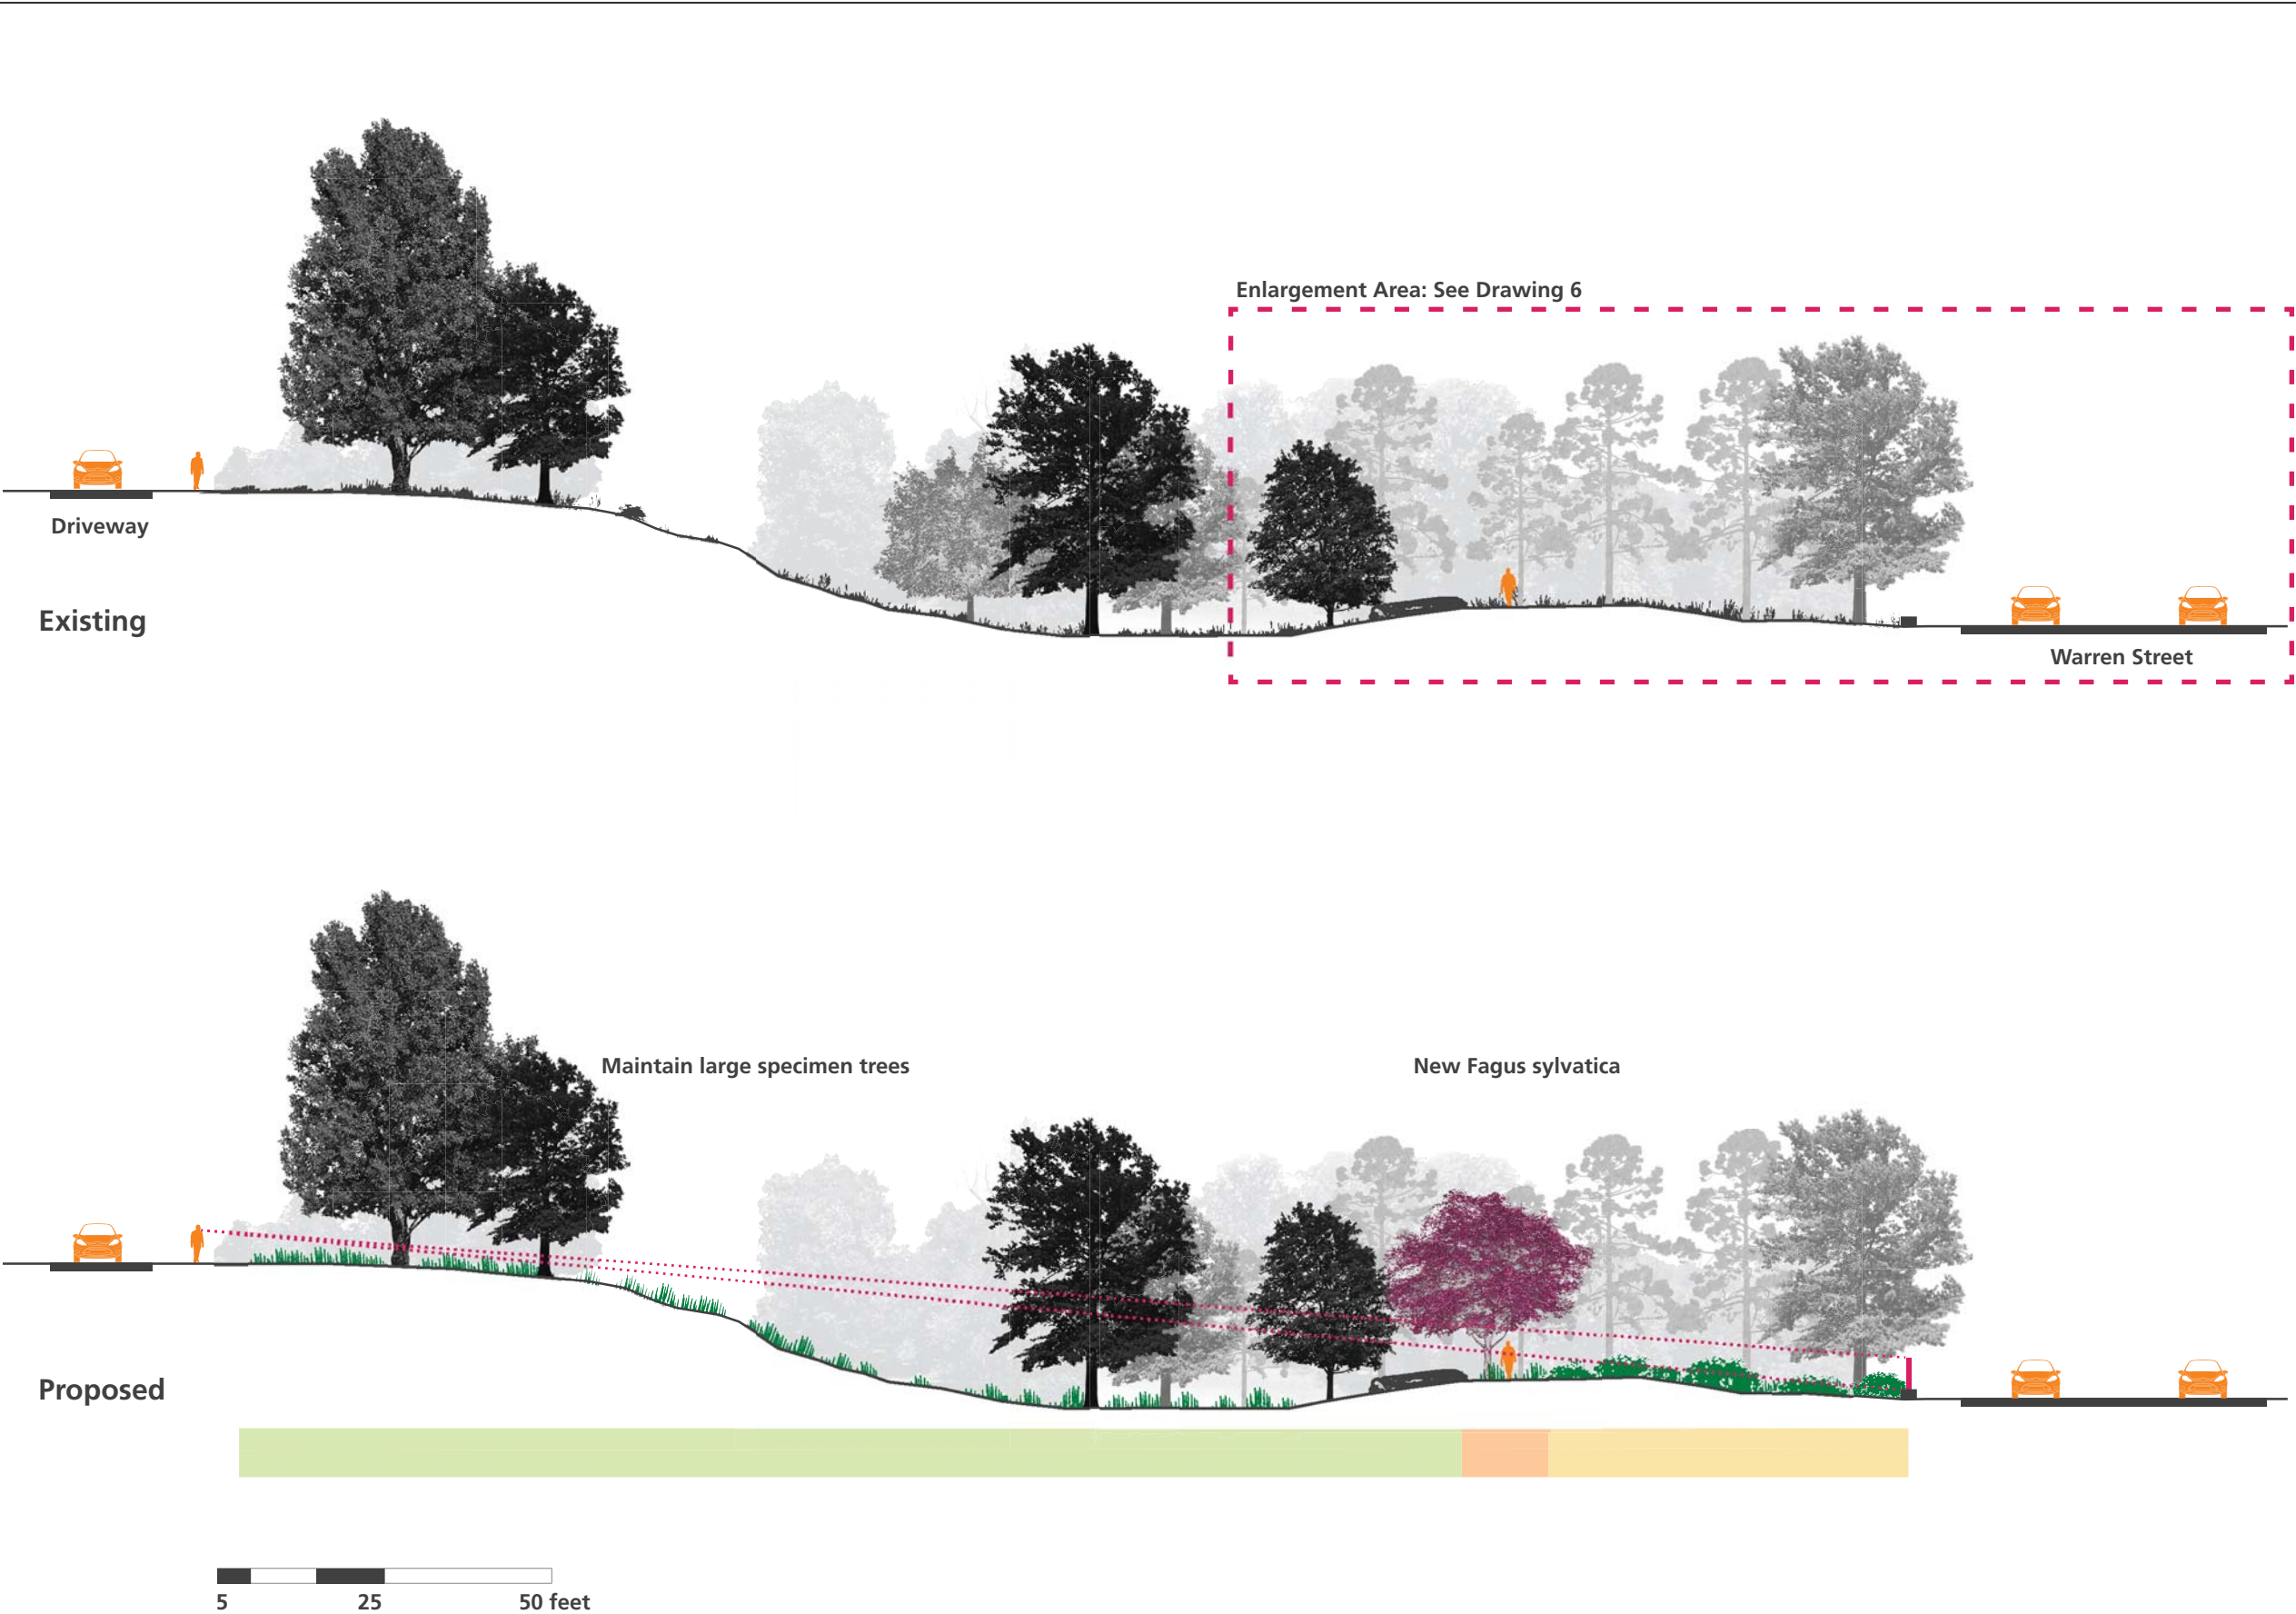
Drawing 5

Section 2 Enlargement Screening Options

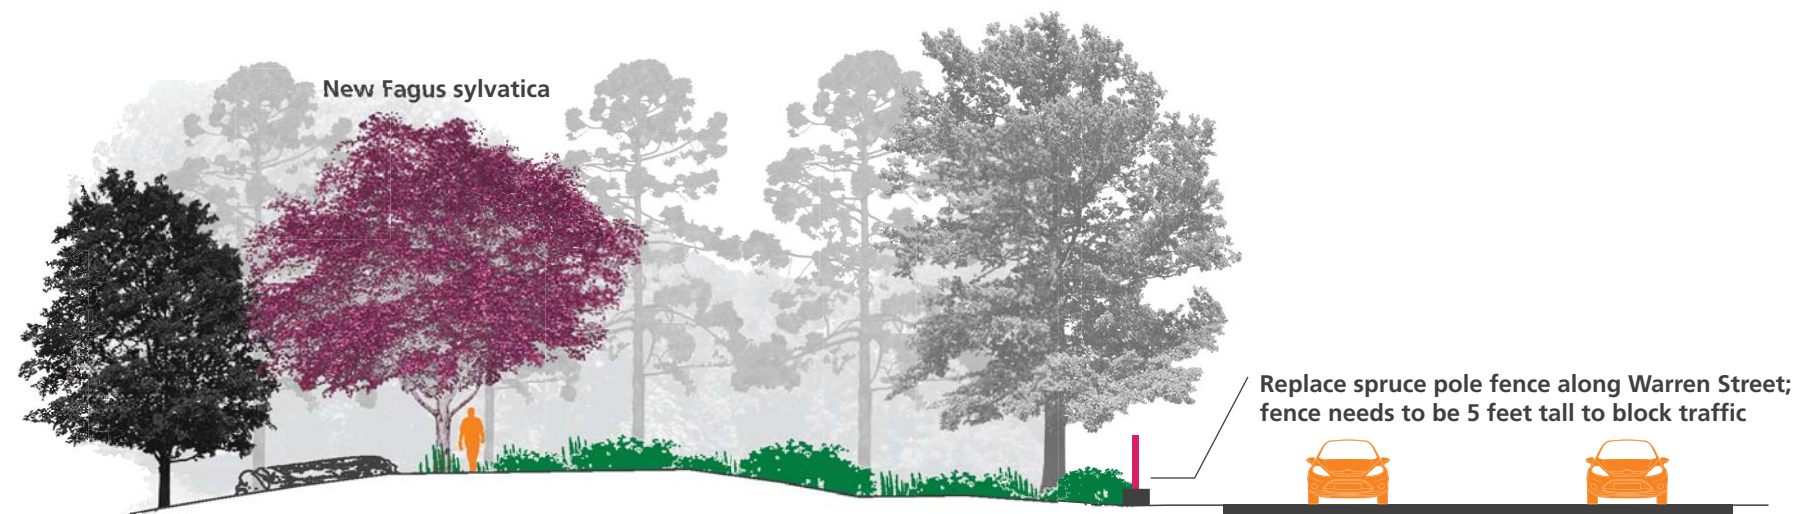
Option 2: Spruce Pole Fence
