CULTURAL LANDSCAPE REPORT FOR THE GREEN HILL PARCEL

FREDERICK LAW OLMSTED NATIONAL HISTORIC SITE
BROOKLINE, MASSACHUSETTS

Olmsted Center for Landscape Preservation
National Park Service, Boston, Massachusetts, 2017

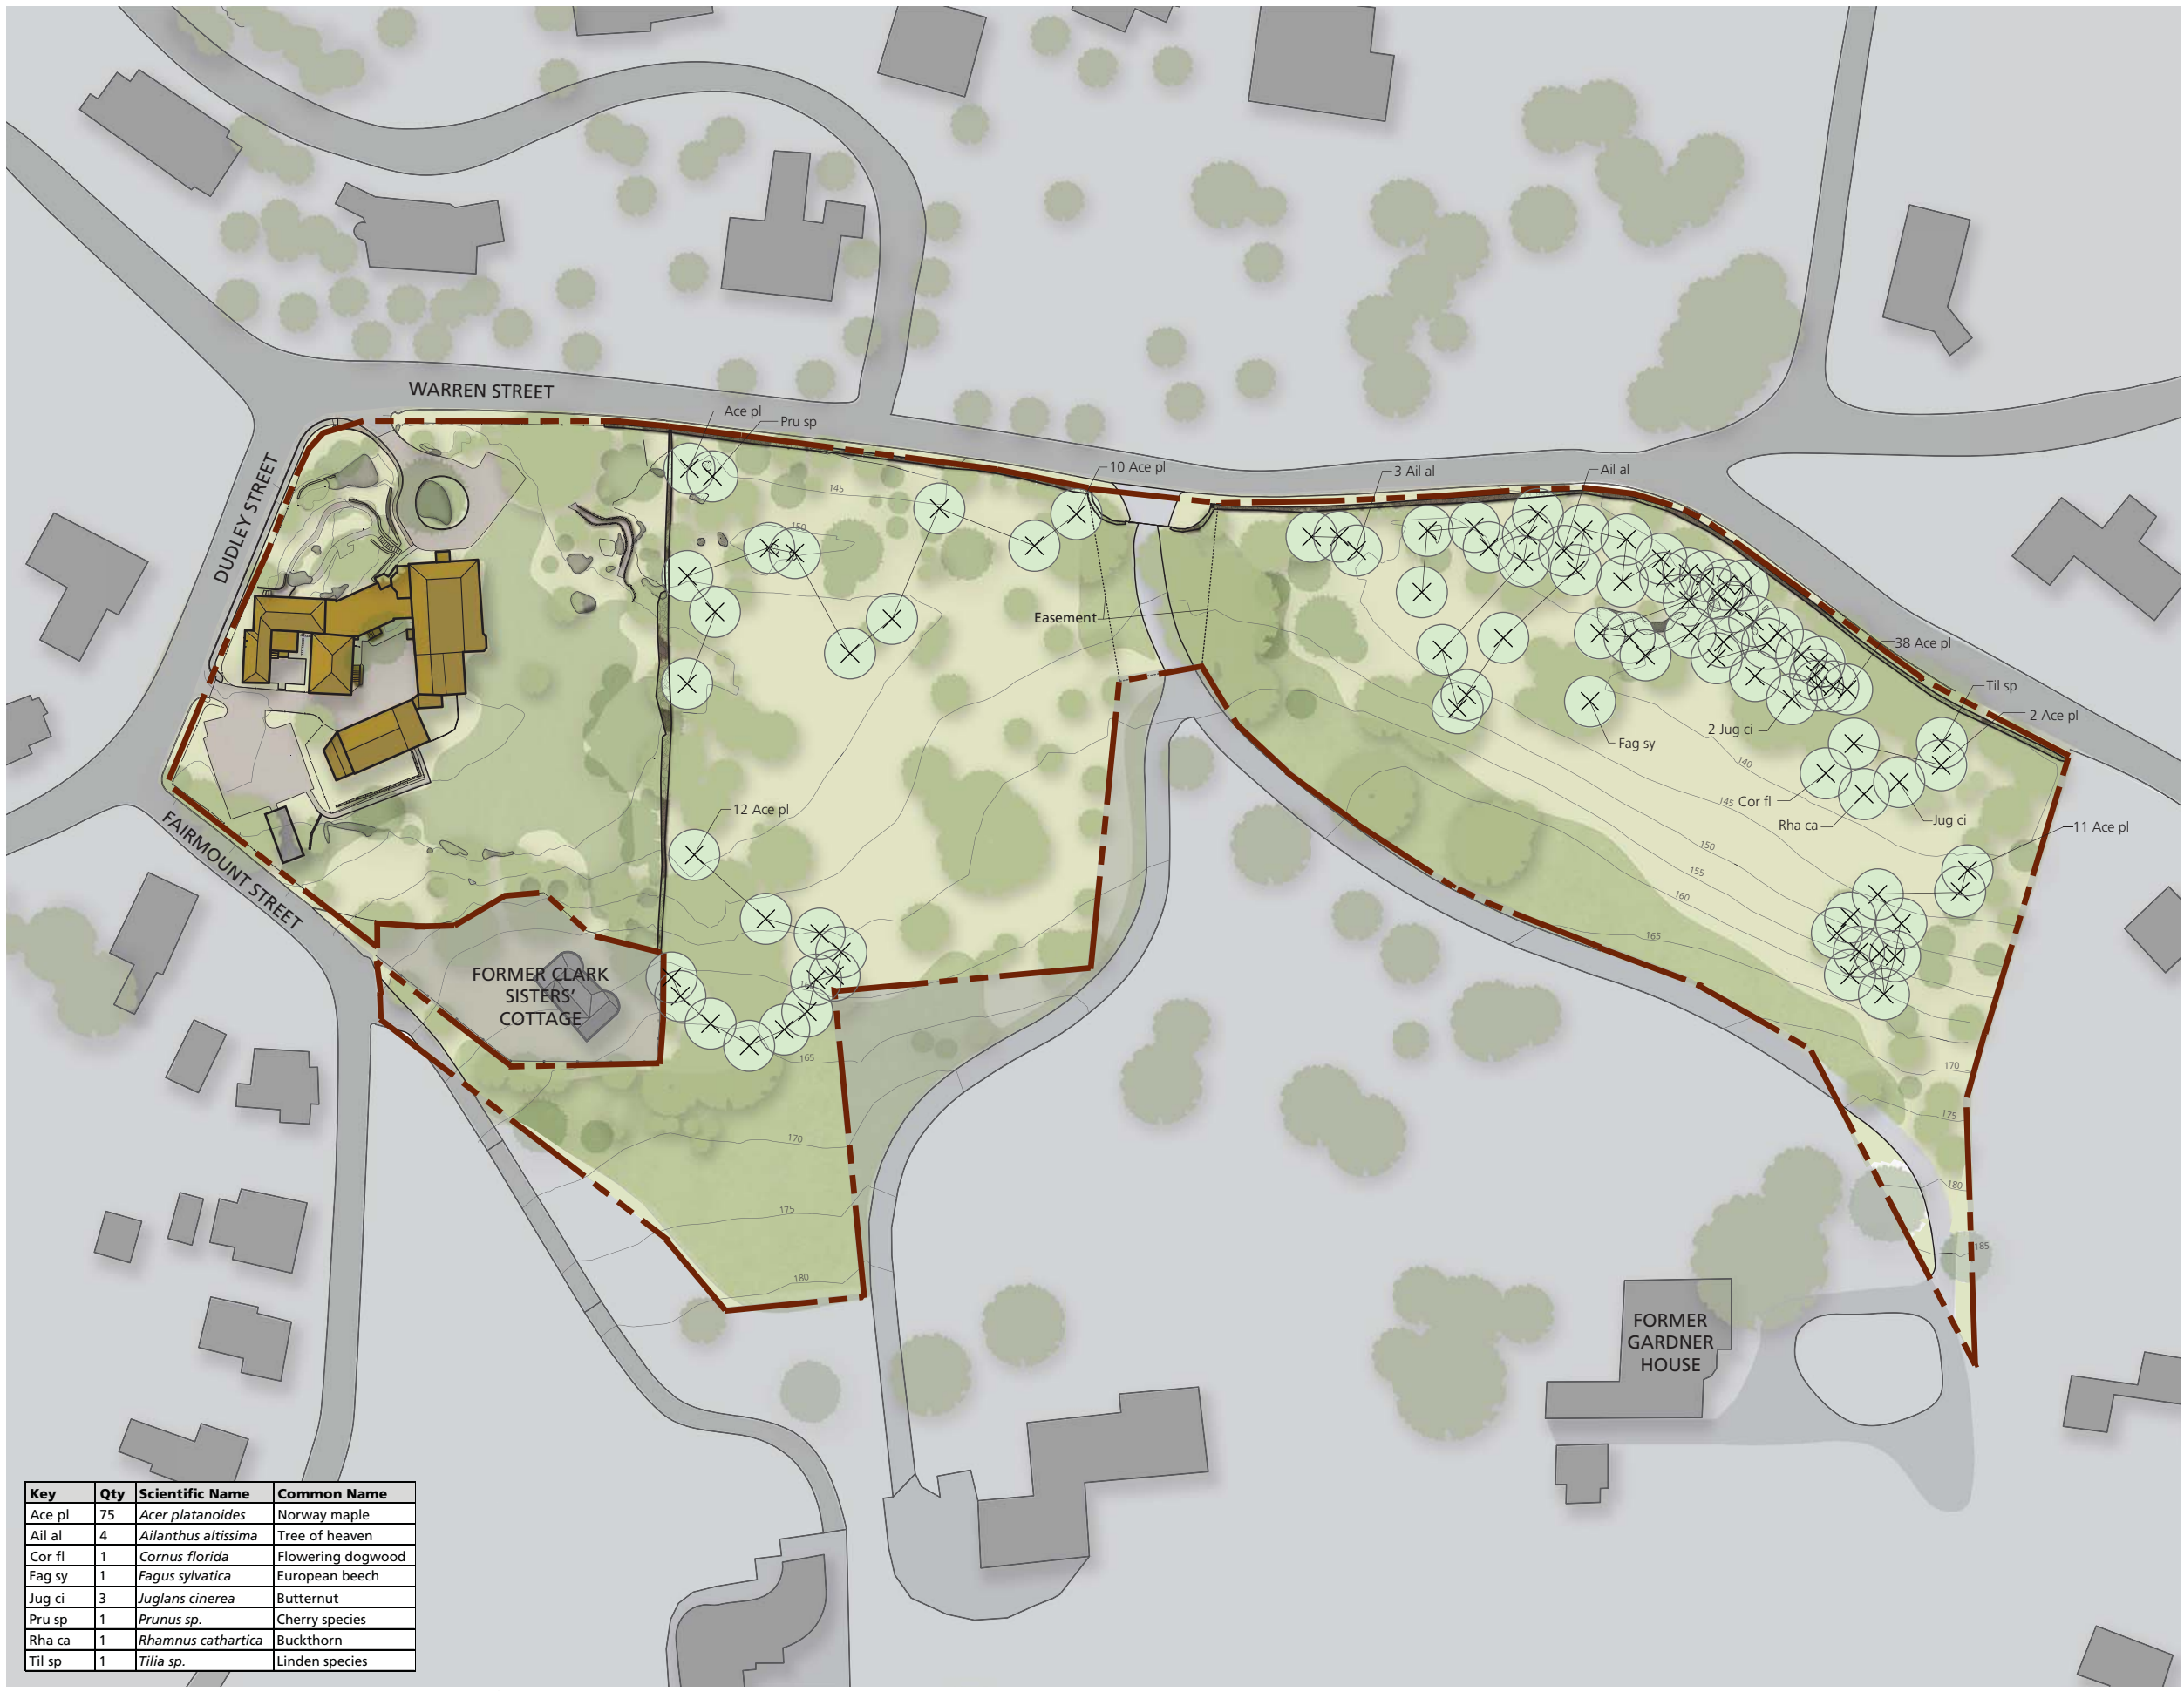
Cultural Landscape Report
Green Hill Parcel
Frederick Law Olmsted
National Historic Site
Brookline, Massachusetts
Removal Plan
Canopy & Subcanopy Trees

Key	Qty	Scientific Name	Common Name
Ace pl	75	<i>Acer platanoides</i>	Norway maple
Ail al	4	<i>Ailanthus altissima</i>	Tree of heaven
Cor fl	1	<i>Cornus florida</i>	Flowering dogwood
Fag sy	1	<i>Fagus sylvatica</i>	European beech
Jug ci	3	<i>Juglans cinerea</i>	Butternut
Pru sp	1	<i>Prunus sp.</i>	Cherry species
Rha ca	1	<i>Rhamnus cathartica</i>	Buckthorn
Til sp	1	<i>Tilia sp.</i>	Linden species

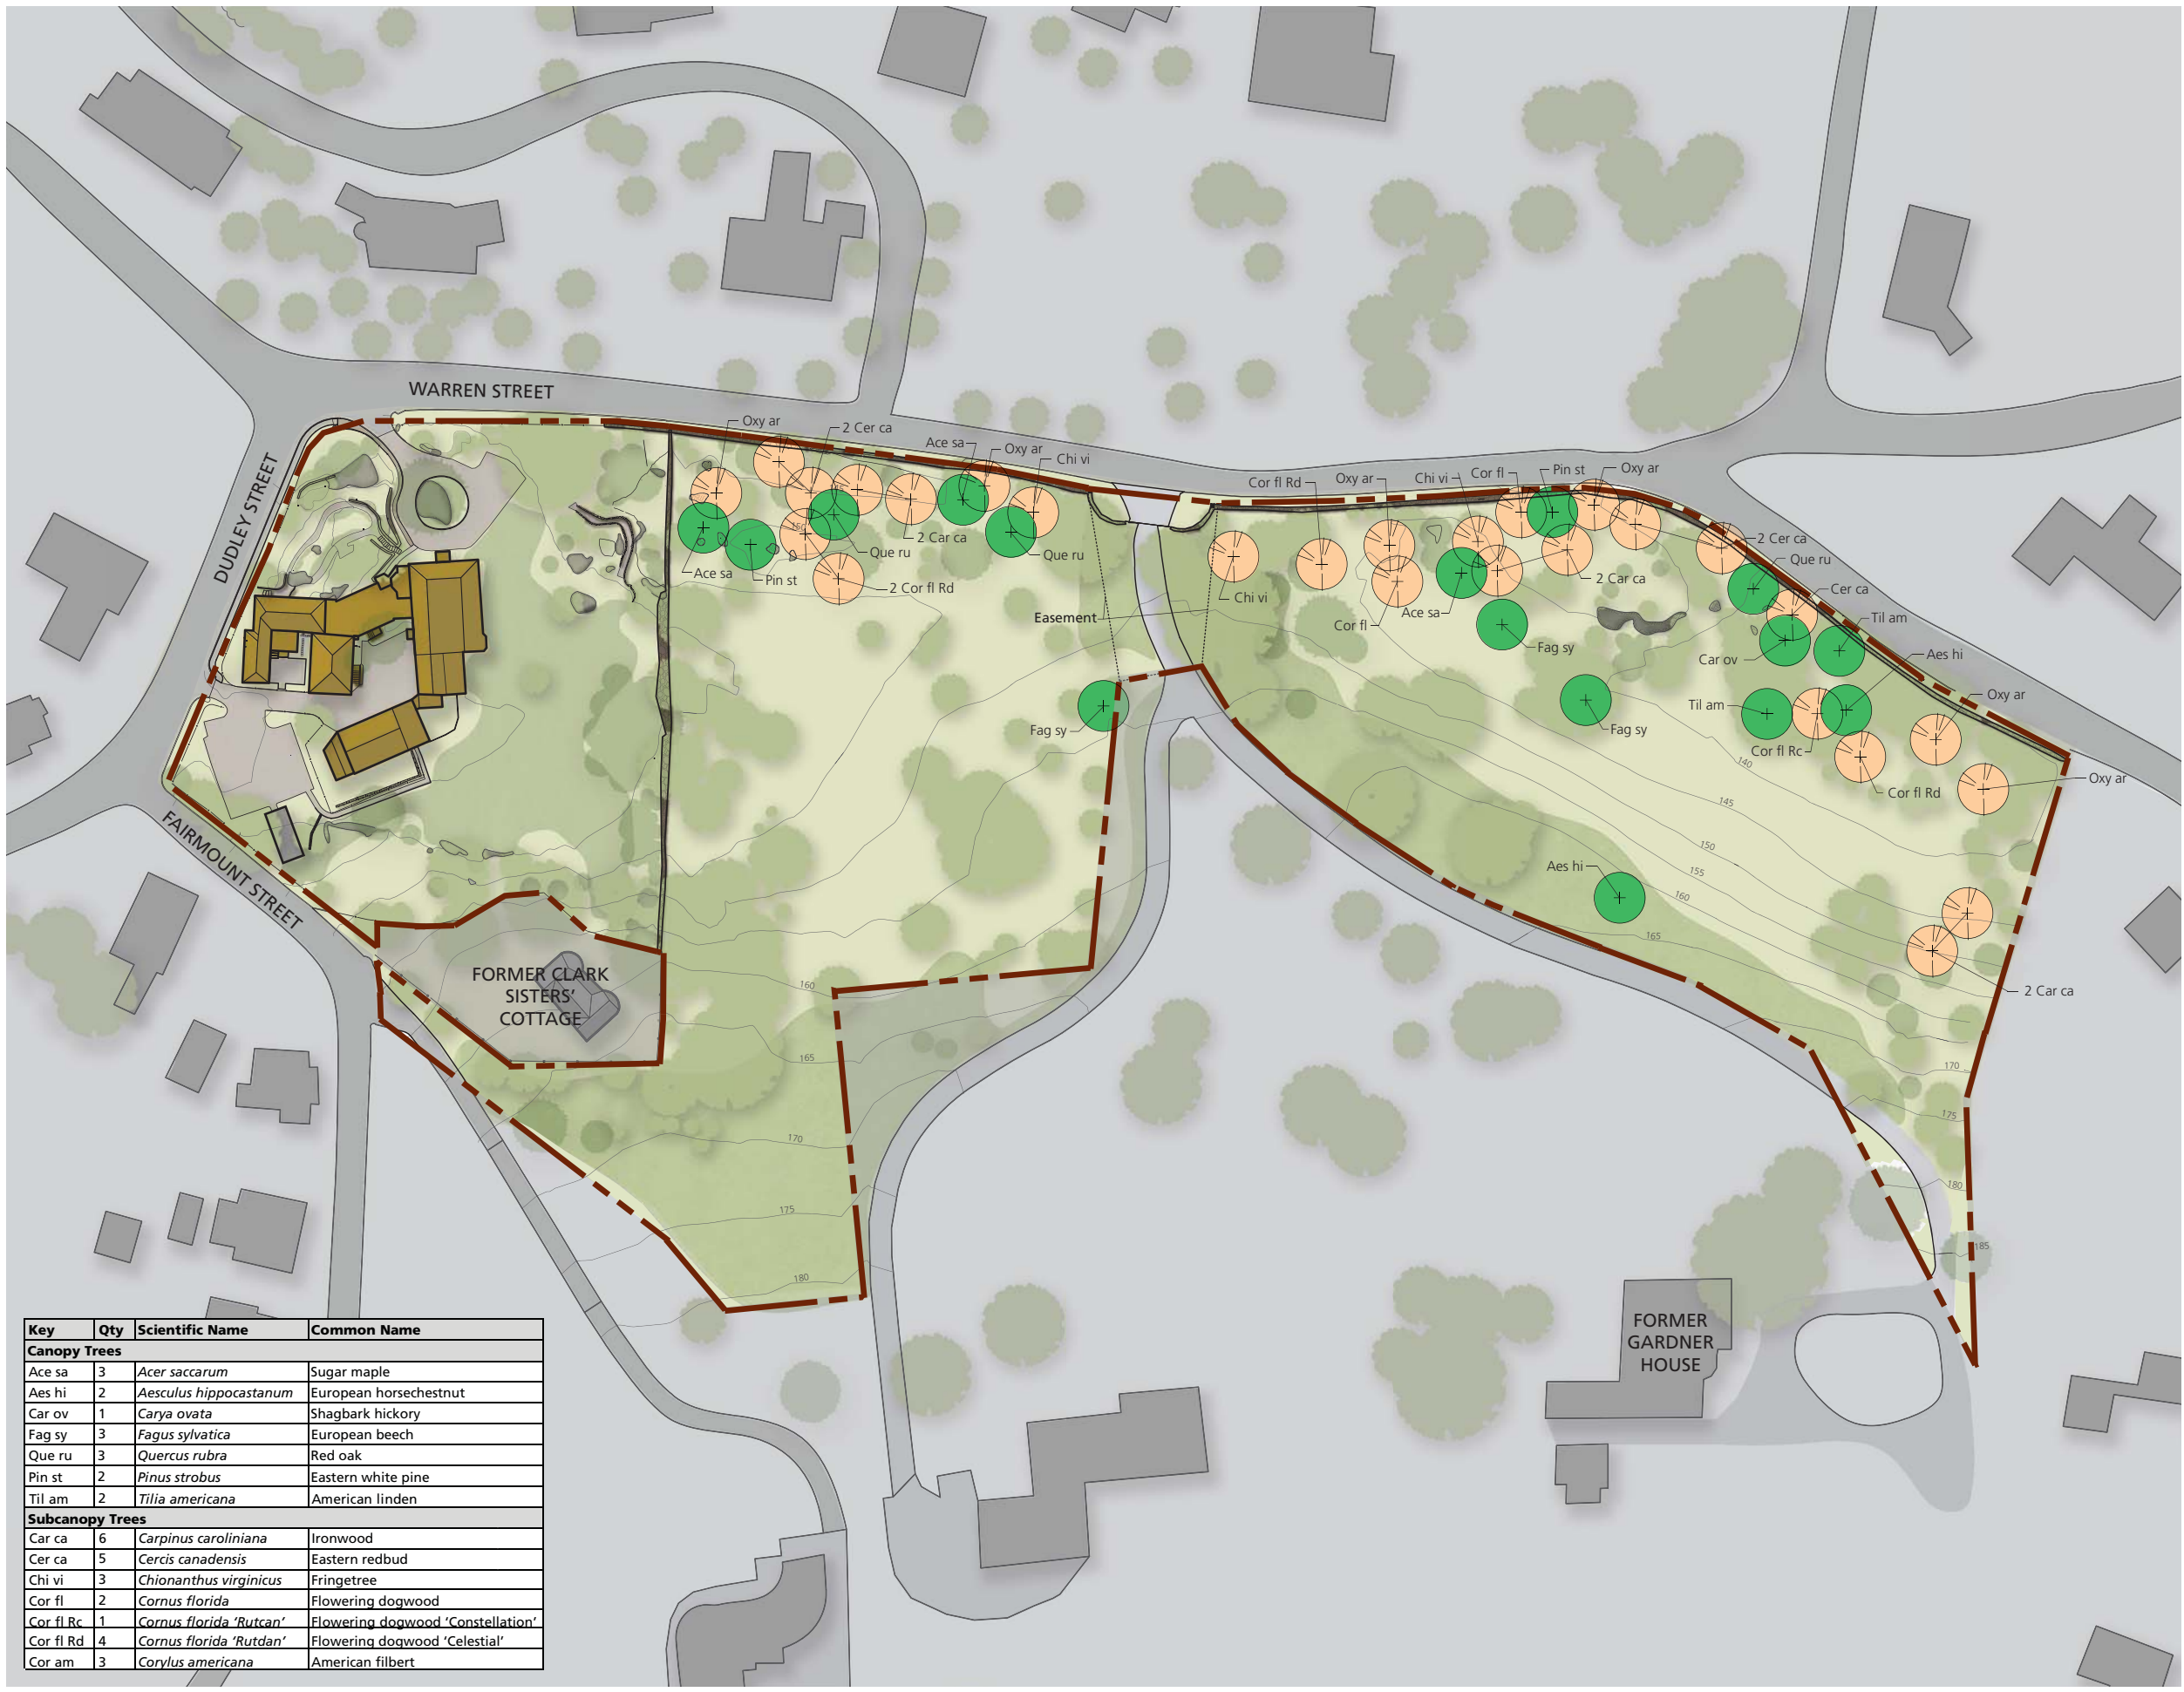
Cultural Landscape Report
Green Hill Parcel
Frederick Law Olmsted
National Historic Site
Brookline, Massachusetts
Planting Plan
Canopy & Subcanopy Trees
