Agency Official 106 Effect Report

Replacement of Roof & Paint Exterior Brick Walls at the Bowman-Hite Farmhouse

Cedar Creek and Belle Grove National Historical Park

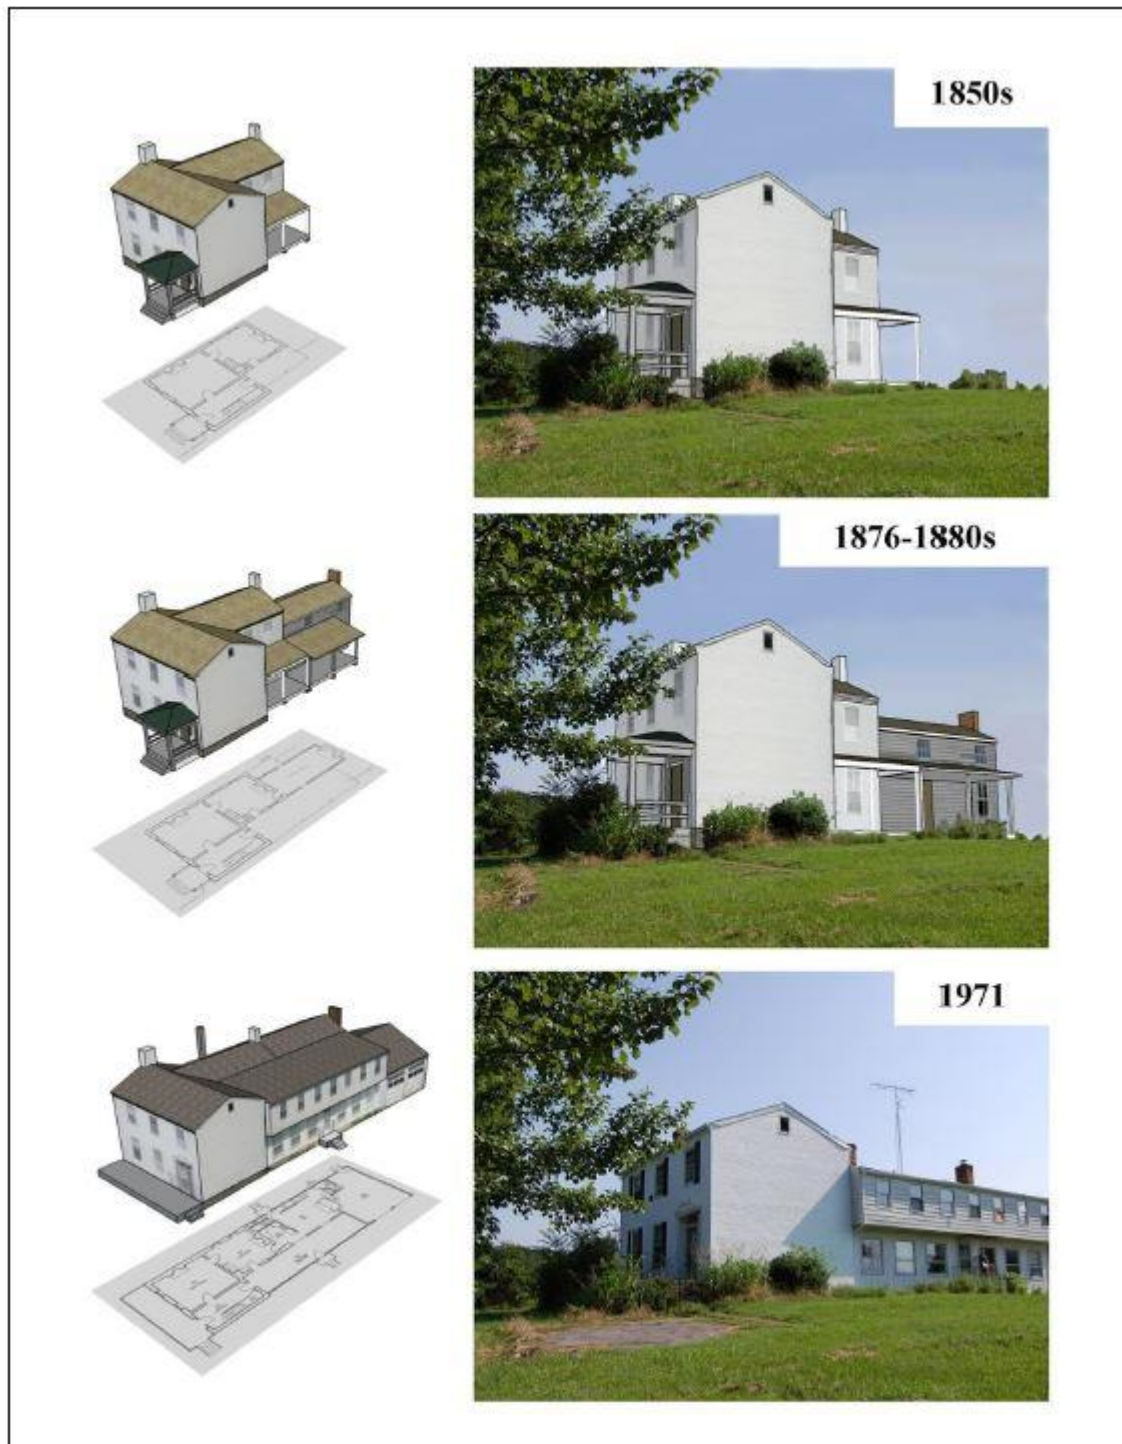
Figure 48: The development of the Bowman-Hite farmhouse from the 1850s until 1971. (Models created by Michael Spencer, 2011; Plan drawings by Brian Townes, 2010)

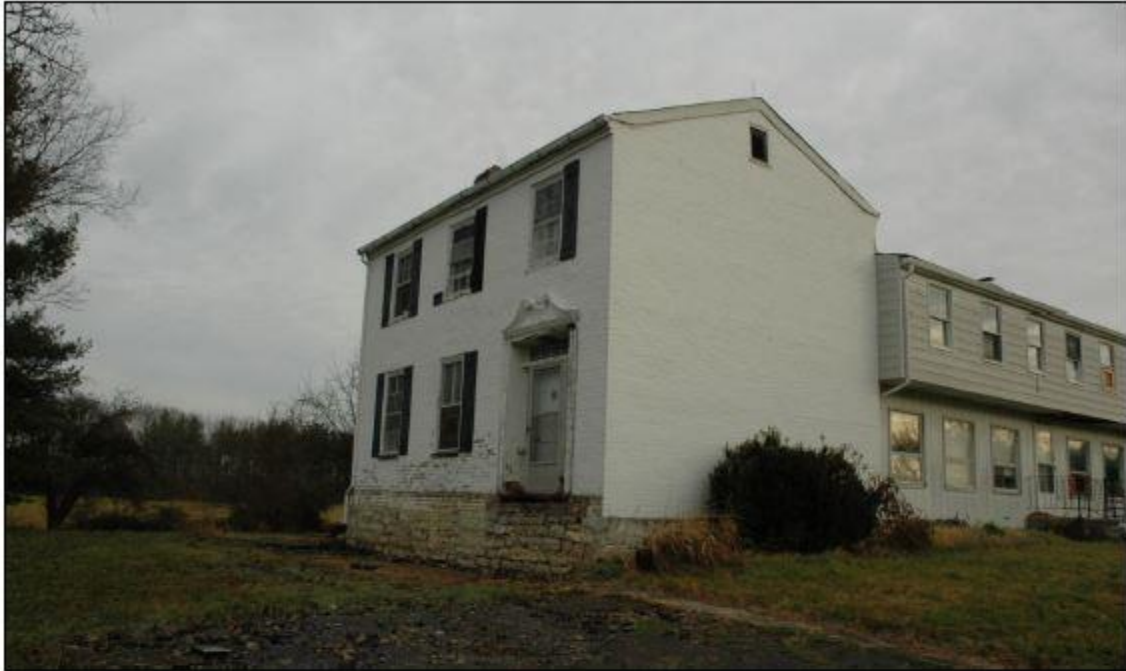
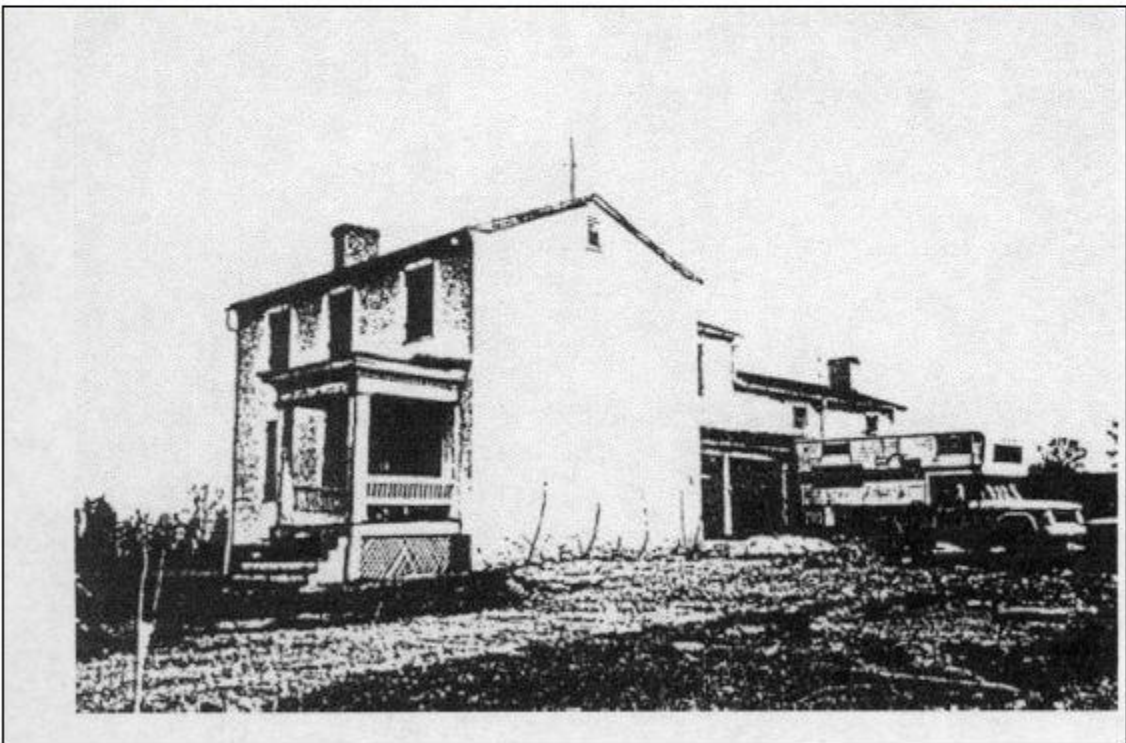
Figure 26: Both images show the southwest corner of the Bowman-Hite farmhouse. The top image shows the building in 2011, whereas the bottom image is from ca. 1971, shortly after the Whitham's purchased the property. Note the presence of the Greek Revival front porch, as well as the side porch and rear frame addition in the lower image. (Top photograph by Michael Spencer, 2011; Bottom photograph by unknown photographer, Department of Historic Resources, 1971)

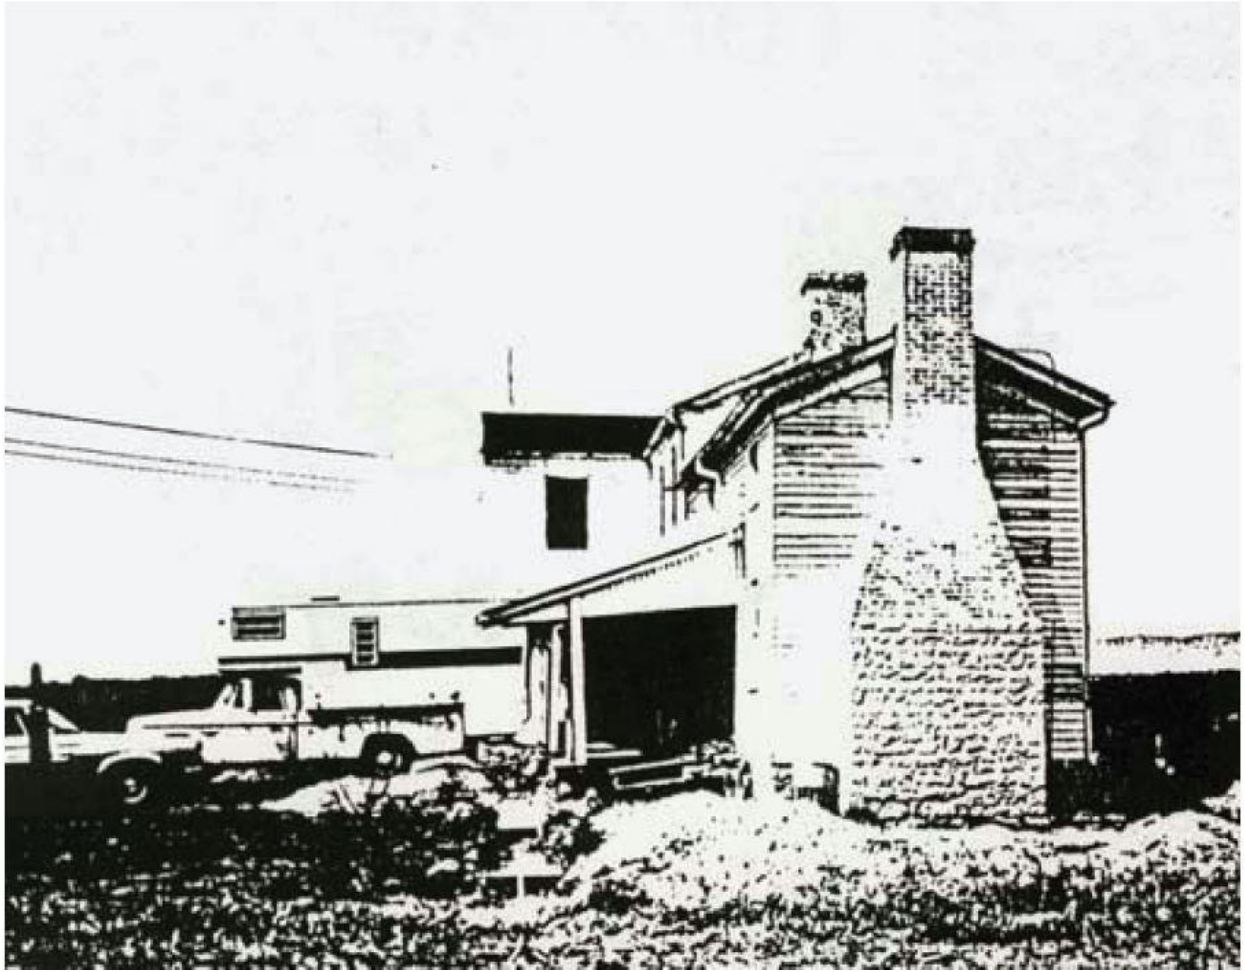
View of the east elevation showing from 1969 showing the footprint of the ca. 1870s house before the 1970s addition.

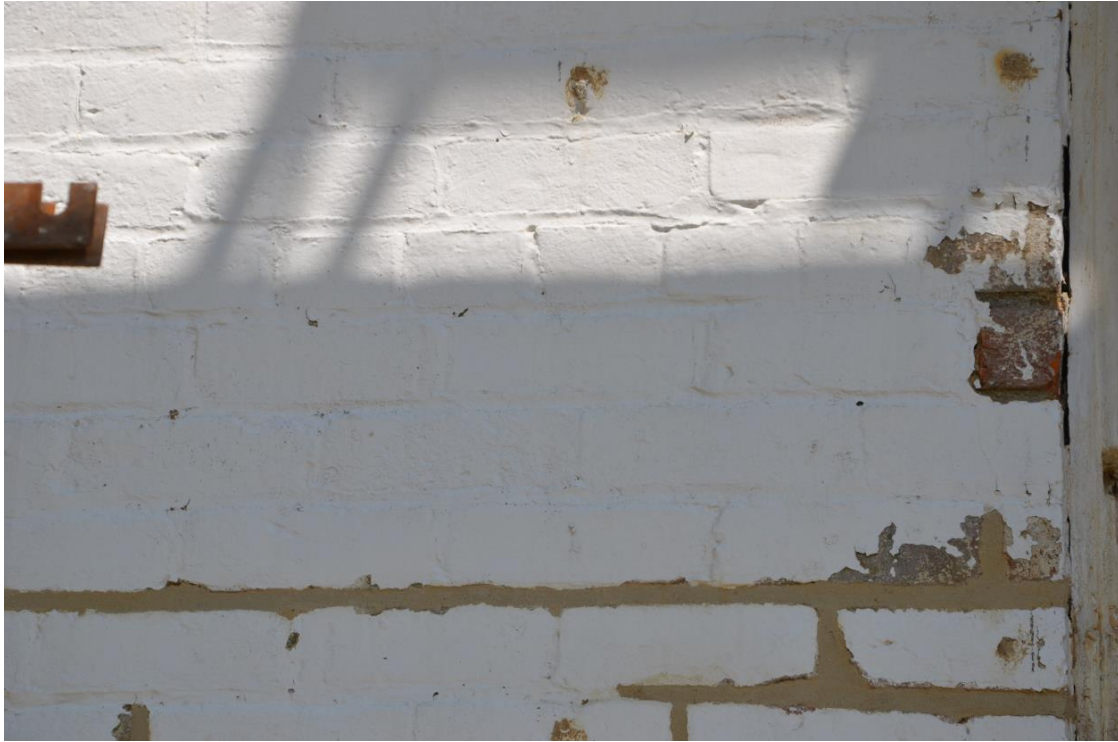
Exterior masonry that shows: brick current condition and masonry work completed by HPTC.

In preparation for this project the park has paid for a historic paint analysis to be done on the exterior brickwork in order that all treatments will be as historically accurate as possible. This project will involve repainting the south, west, and north elevations of the exterior brick walls.

HPTC shall perform the preservation tasks necessary to clean by power-wash at low pressure the exterior brick surface. Intact paint will not be removed, areas of loose paint will be removed. Bare surfaces will be primed prior to application of finish paint. Color will match existing

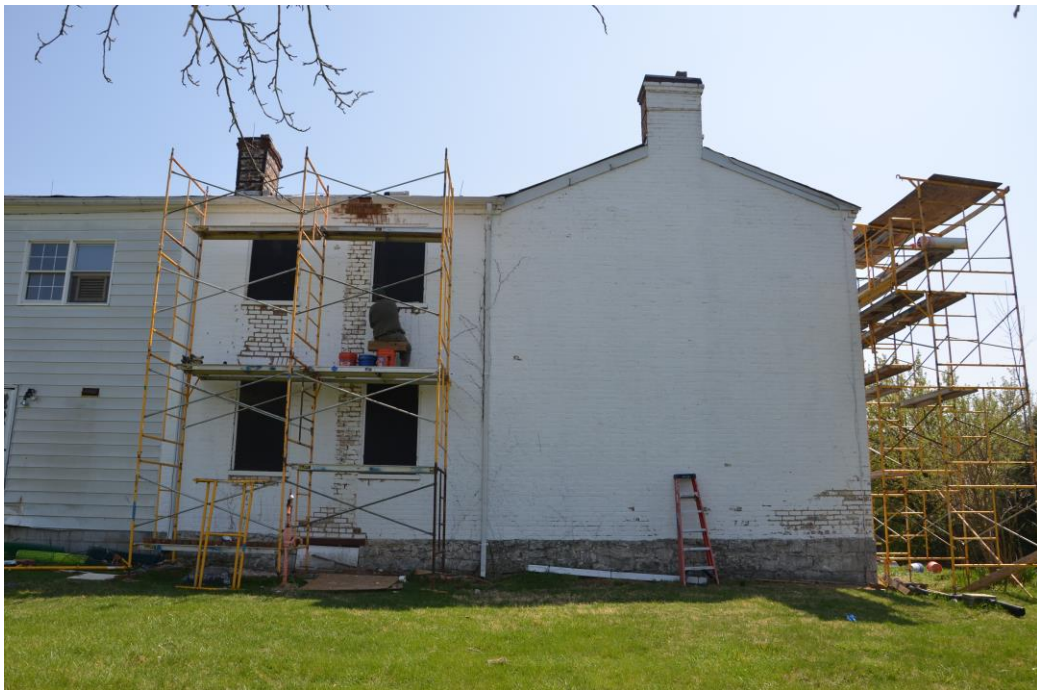
North elevation of Bowman-Hite House. Painting would stop at vinyl siding.

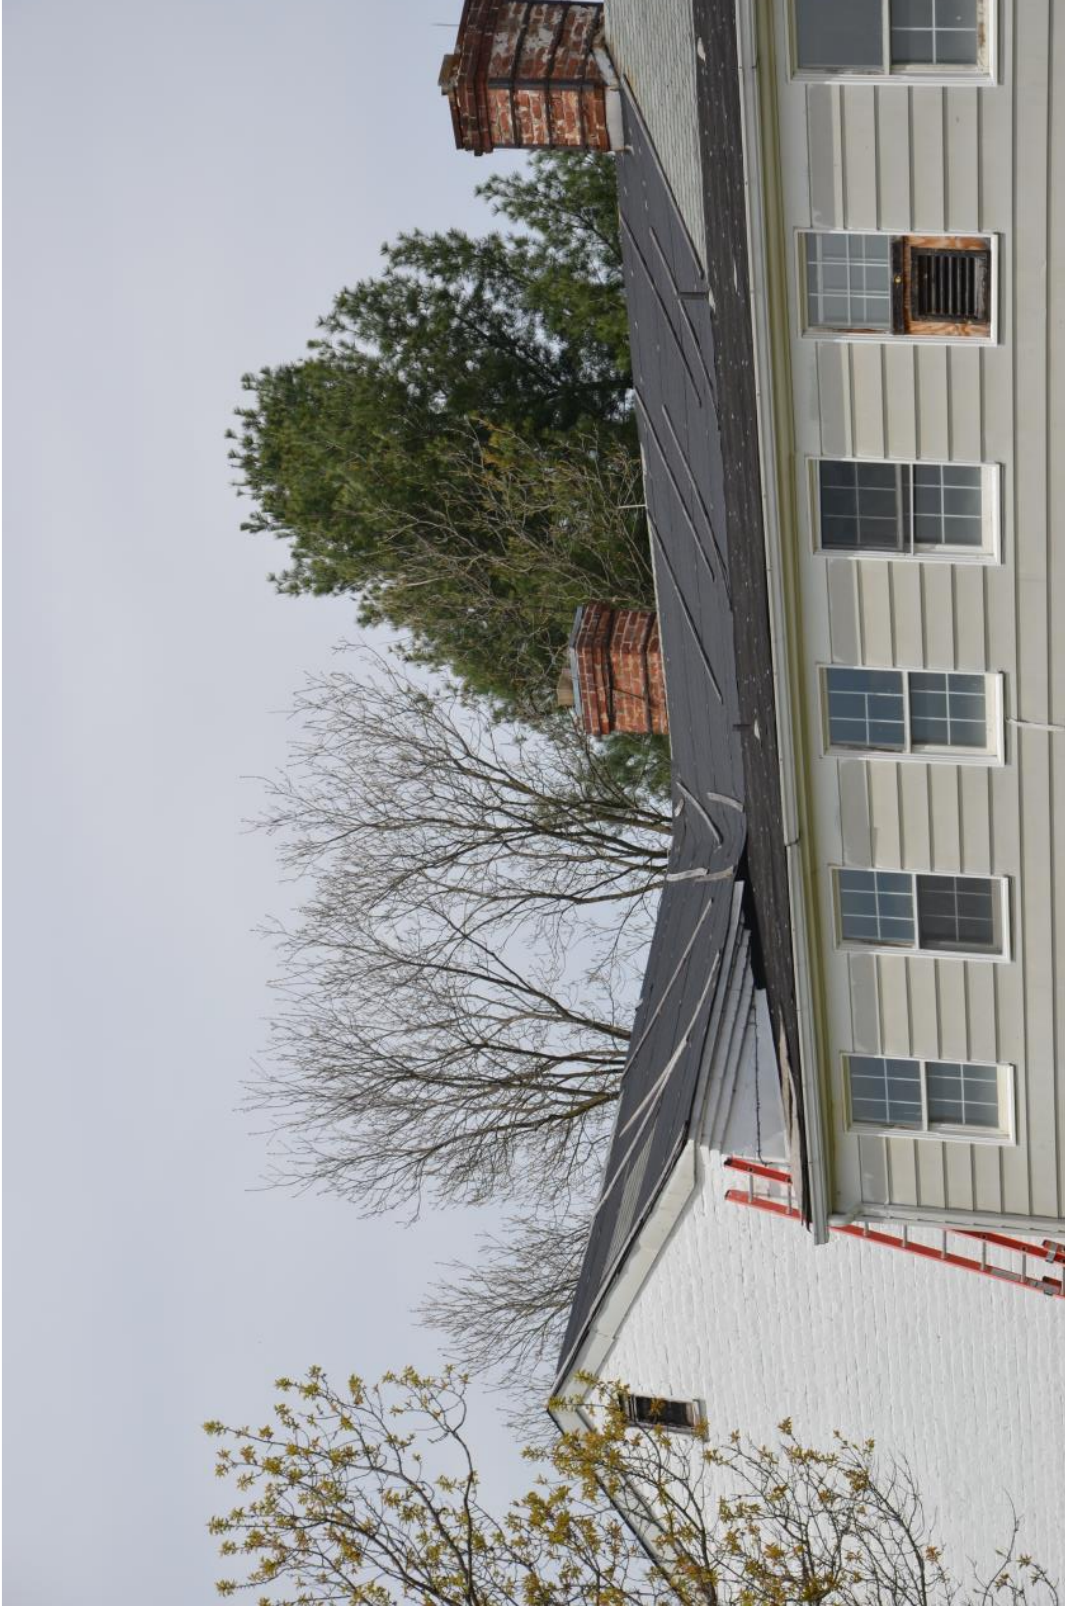
The current roofing materials is inadequate and is causing water damage to this historic resource. The leaking roof is also jeopardizing the work that HPTC has recently completed on both the windows and exterior brick walls. NPS historic engineers have concluded that, “Overall, the Bowman-Hite Farmhouse roof was found to be in poor condition...Certain features are in critical condition and nearing a point of complete failure.”²

Exterior condition of rolled asphalt roof.

- Existing asphalt rolled roofing will be removed and disposed of
- Nails used to attach prior roofs will be removed from the sheathing
- Rafters, plates and ceiling joists will be inspected for damage and repaired where necessary
- Deteriorated and structurally unsound sheathing will be replaced in kind
- Install galvanized gutter brackets
- Repair, prep & paint wood rake boards; replace in kind if needed

- Full length 21” wide panels in true standing seam double lock
- Double lock at ridge junction/single lock at eaves
- Chimneys will be re-flashed

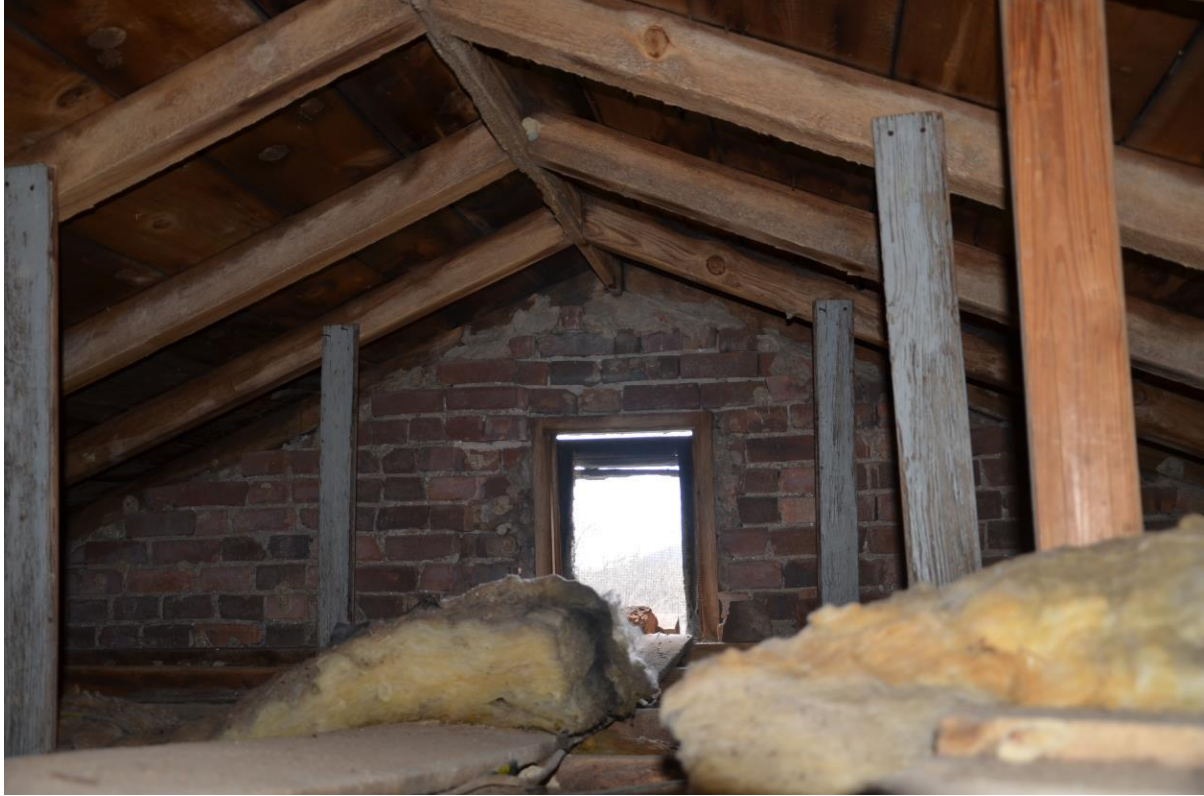
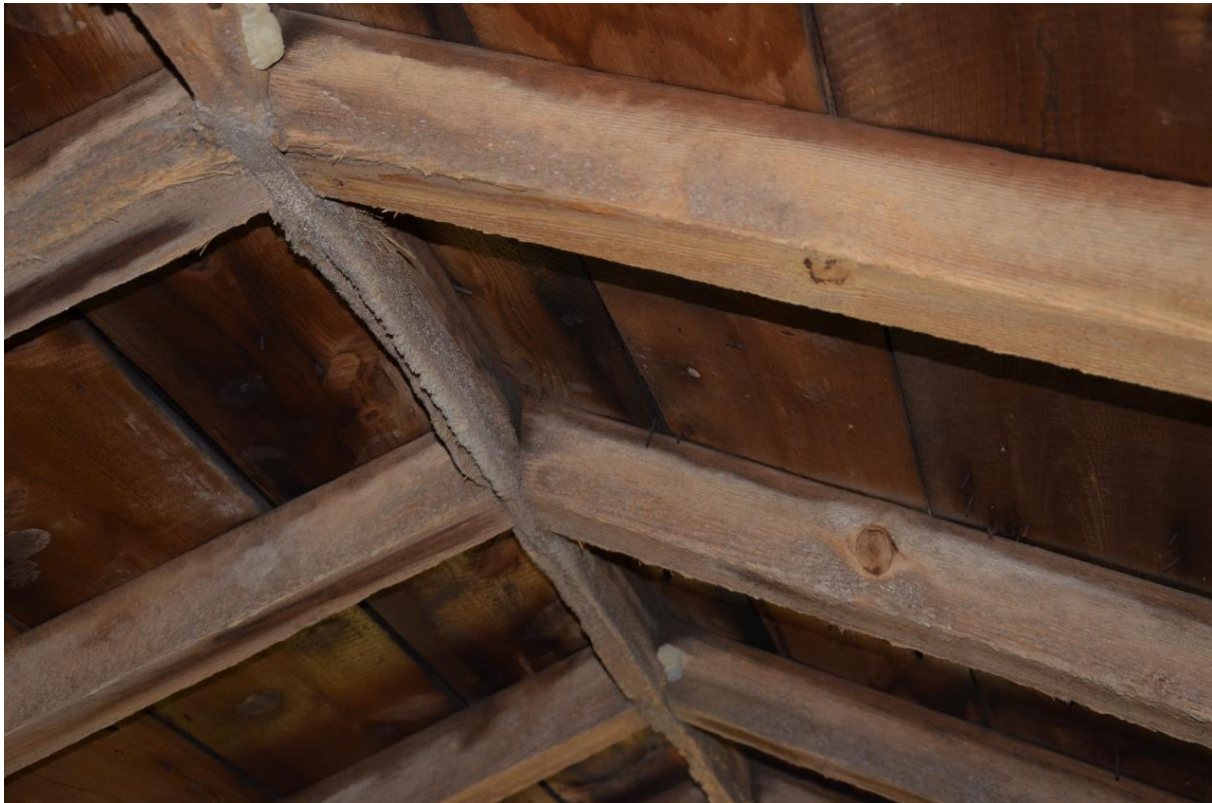
Photographs inside attic show water damage to sheathing, framing, and masonry. Note mold.

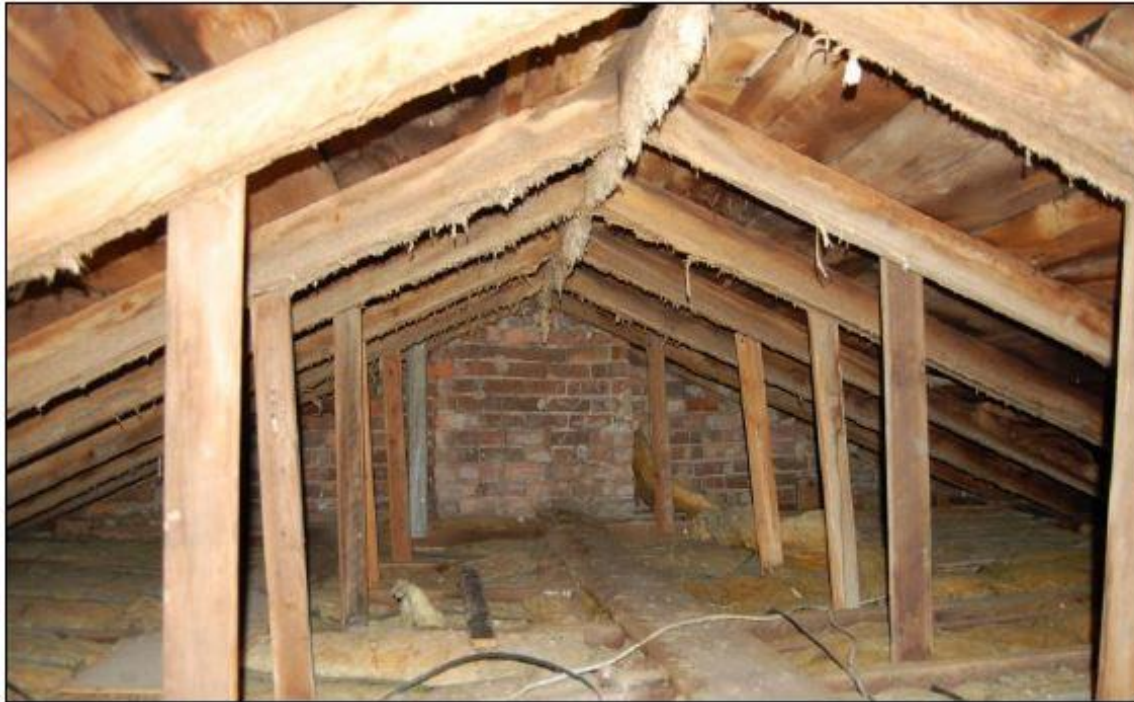
The internal framing of the roofing structure today contains elements of the original 1850s construction and the balloon construction from the 1870s assembly. Michael Spencer describes the roof construction when he wrote, “attic joists, rather than resting inside pockets, sit atop the wall. Because of their position, the ends of the joists are tapered to coincide with the pitch of the roof, a typical technique used by carpenters when dealing with brick corbelling at the cornice line. This feature also indicates that the current roof pitch of the structure has been maintained since its

Figure 37: Bowman-Hite's common rafter system with ridgeboard, something typically found in later-19th century balloon frame structures. This system may have replaced the original roof during the ca. 1876-1880s alterations although this cannot be entirely confirmed. (Photograph by Michael Spencer, 2011)

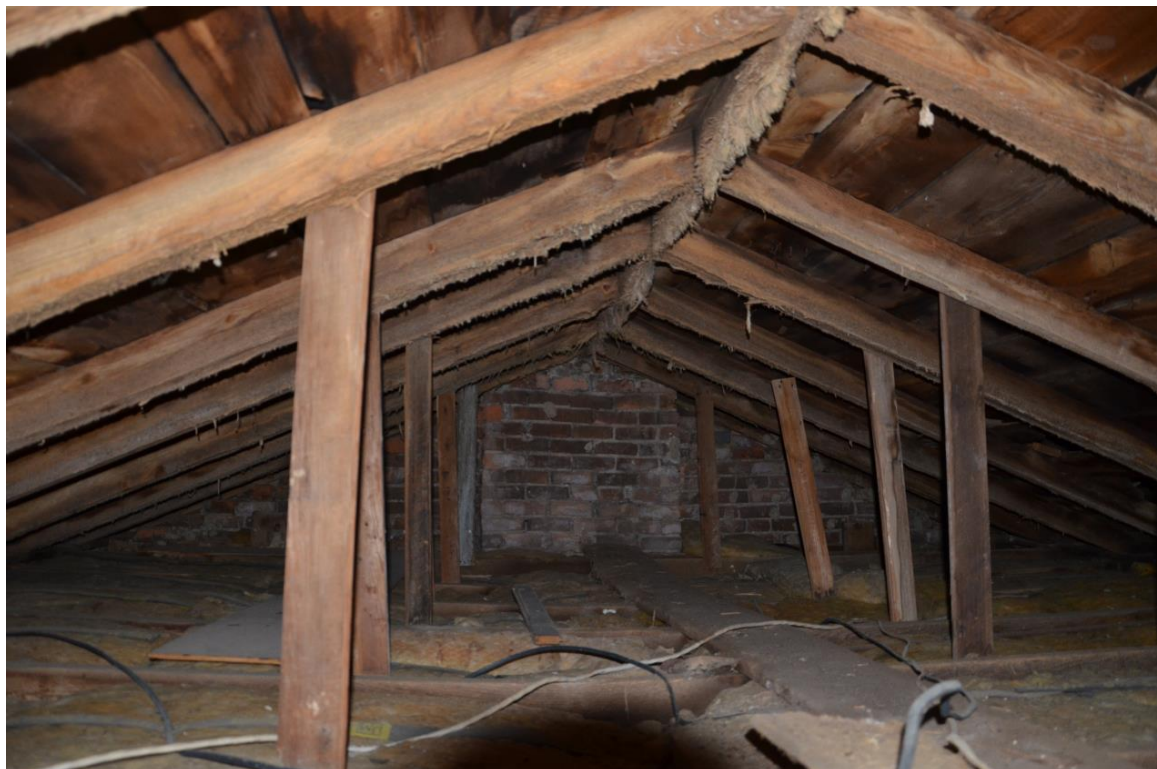
Note same image taken in 2018 shows continued water damage.

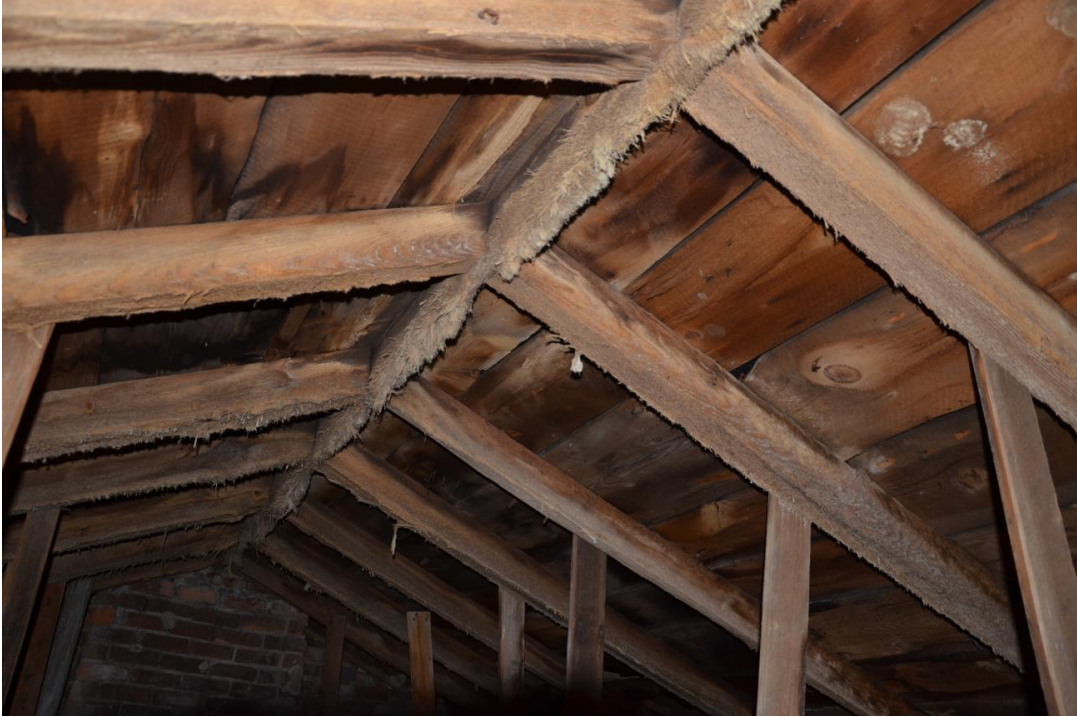
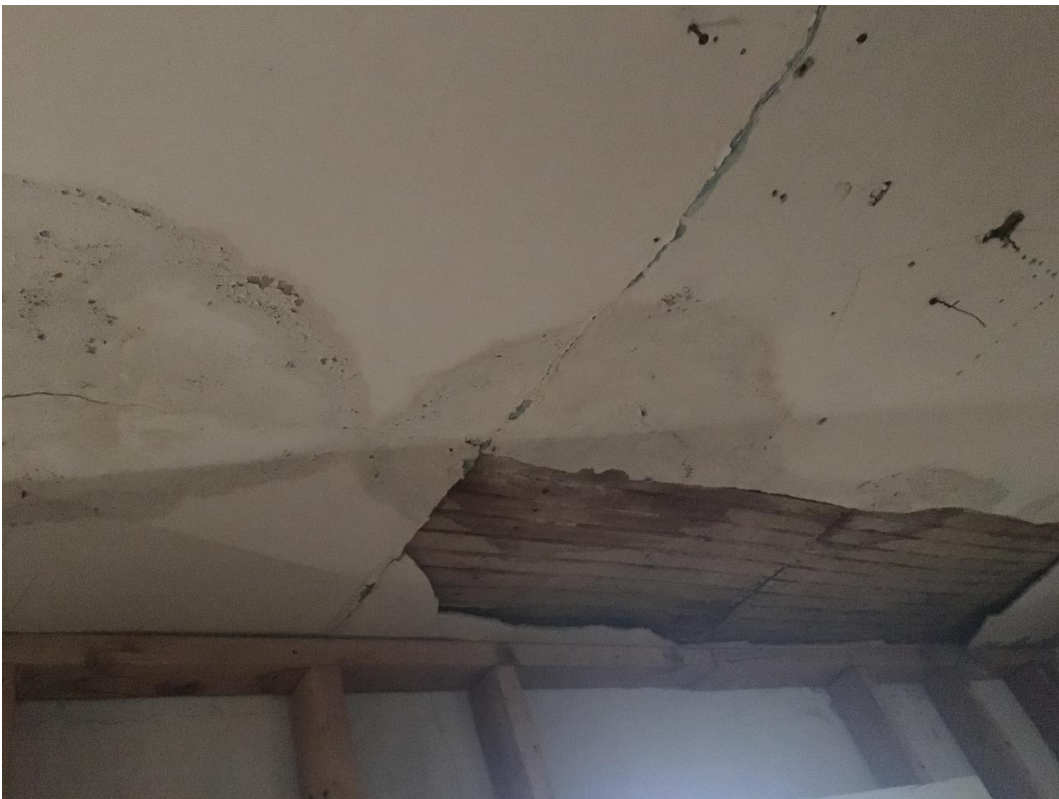
Water damage from inadequate roofing material.
