State of Alaska, Department of Natural Resources, OHMP Dry Bay ORV Trails Trip Report

DATE: August 22, 2006

SUBJECT: Dry Bay ORV Trails
Trip Report

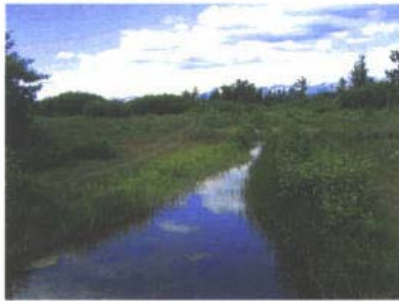
Photo 1. Doame River wetland drainage.

We located an un-cataloged, low-flow drainage about 600' west of the Doame River that flooded an abandoned ORV trail (see Photo 1). Several salmonids were observed swimming in the tire-track channel, we captured coho and stickleback in five traps. This ephemeral channel probably connects to the Doame River or neighboring streams during high flows or floods, and is created by channeling water from nearby wetlands. If the deeply incised abandoned ORV trail was not present, I doubt this channel would exist. New ORV trails that bypass the drainage are established on both sides of the channel and do not cross the drainage.

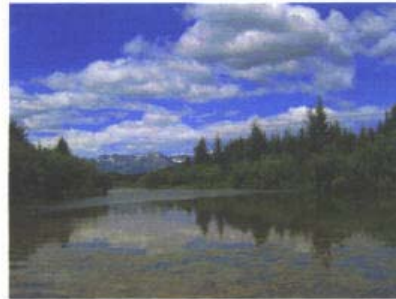
Photo 2. Lake southeast of the EAR.

About 300' southeast of the EAR crossing, we located an un-cataloged lake that drains adjacent wetlands and may provide overflow relief to the EAR during flood events (see Photo 2). Three traps set in the lake captured coho and sockeye salmon and stickleback. Aerial photographs suggest that the lake's two stream outlets drain directly to the EAR. The adjacent ORV trail probably does not impact this lake system, except if trail erosion runoff drains to the lake during wet conditions. I will nominate this lake and outlet stream for inclusion in the Catalog.

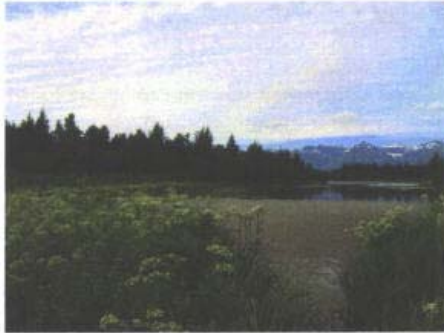
Photo 3. Lake southwest of the EAR.

Along the ORV trail about ¼ mile southwest from the EAR crossing, the trail crosses a 10' wide, un-cataloged lake and outlet drainage (see Photo 3). Aerial photographs indicate that the outlet drains directly to the EAR a few hundred feet downstream, although we did not verify this. Seven traps set in the lake and outlet captured coho and sockeye salmon and stickleback. Some bank undercutting near the narrow crossing entrances are evident, and small rock appears to have been placed in the streambed to strengthen the crossing. If this crossing remains open, it should be clearly marked and the banks sculpted for entry and hardened. Additional hardening of the streambed may also be beneficial. I will nominate this lake and outlet drainage for inclusion in the Catalog.

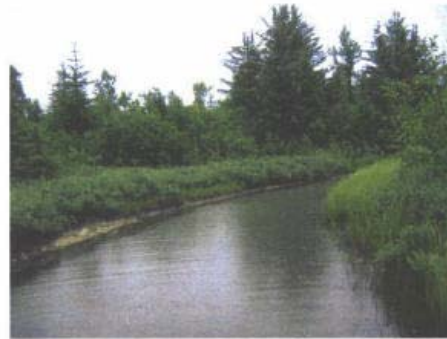
Photo 4. Small pool in the ORV trail.

About 1 mile west of EAR along the trail, we observed several dead coho and stickleback in a small isolated pool in the trail (see Photo 4). A 2-minute seine tow of about ½ the pool captured coho and sockeye salmon and stickleback. Most of the fish appeared unhealthy, having large heads and skinny bodies, which is probably due to competition within the small pool. We could not identify a nearby

anadromous water body where the fish might have originated, and speculate that the pool would probably not exist if the trail was not deeply incised. The connection might be more obvious during higher flows and could warrant further investigation before making trail maintenance recommendations at this location.

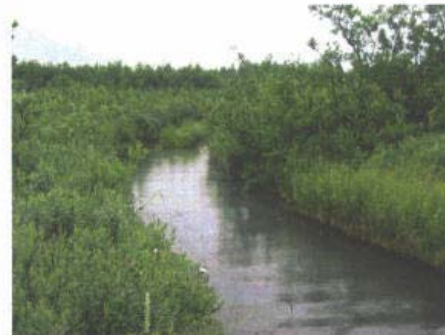
Photo 5. Lower EAR wetland drainage (trail).

This drainage has experienced significant bank erosion from ORV crossings, from wave action undercutting the banks and a deeply incised track, causing the drainage to backwater along the perpendicular trail (see Photo 5). Two seine tows captured hundreds coho and sockeye salmon and stickleback. Due to the erosion situation and because the western portion of this loop trail provides access to the area, this crossing should be closed. I will nominate this drainage for inclusion in the Catalog.

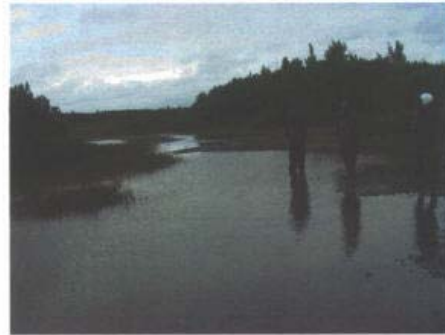
Photo 6. Lower Dog Salmon Creek drainage.

Although we did not sample for fish, this drainage probably does not connect to Dog Salmon Creek (see Photo 6). Stickleback were observed several hundred feet up and downstream of the crossing. Primary streambed substrate is small rock. Because a safer, more defined crossing is available in the upper reach of Dog Salmon Creek, this crossing should also be closed.

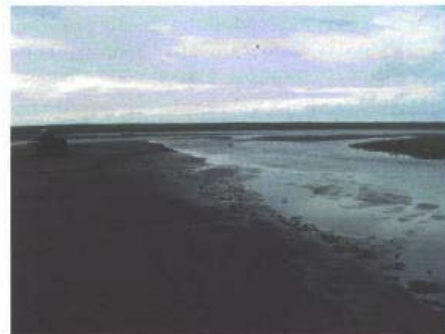
Photo 7. Dog Salmon Creek estuary.

The estuarine crossing of Dog Salmon is heavily tidally influenced (see Photo 7), and only accessible during low tide and low flows. Evidence of any ORV crossing is washed away with each tidal cycle. Due to the limited access, ORV crossings probably only occur when few fish are present, thereby causing minimal impacts to salmonids. Stream substrate at the crossing consisted of sand with some natural gravel, and may cause temporary increased sedimentation during ORV crossings. Efforts to stabilize or clearly mark the crossing would probably be washed away in the next tide or flood. We did not sample for fish.

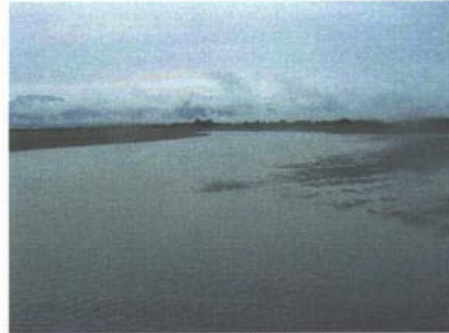
Photo 8. East slough of Alsek River.

Two seine tows captured starry flounders and staghorn sculpin, no salmonids were observed. This backwatered slough is cataloged as part of Alsek River (see Photo 8). Stream crossing access is only available during low tides and low flows, as this reach is heavily tidally influenced. The substrate of this crossing site and of the greater tidal flats area is loose sand and silt. Thus, other than increased sedimentation, ORV crossings at this slough probably have few long-term impacts to fish. Efforts to stabilize or clearly mark the crossing site would probably be washed away during the next tide or flood.

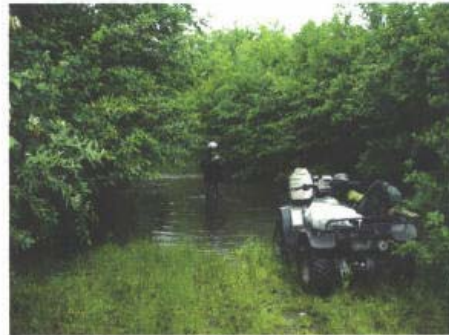
Photo 9. Isolated pools on abandoned trail.

We located several small pools flooding an abandoned trail, the largest pool was about knee-deep and 20' x 20' (see Photo 9). The pools probably result from lack of trail maintenance; trail access is now obtained along the tidal flats. Although we did not sample for fish, we did not observe any salmonids and doubt any connection to anadromous waters occurs. However, during high water the pools may connect to one another and flood the trail.
