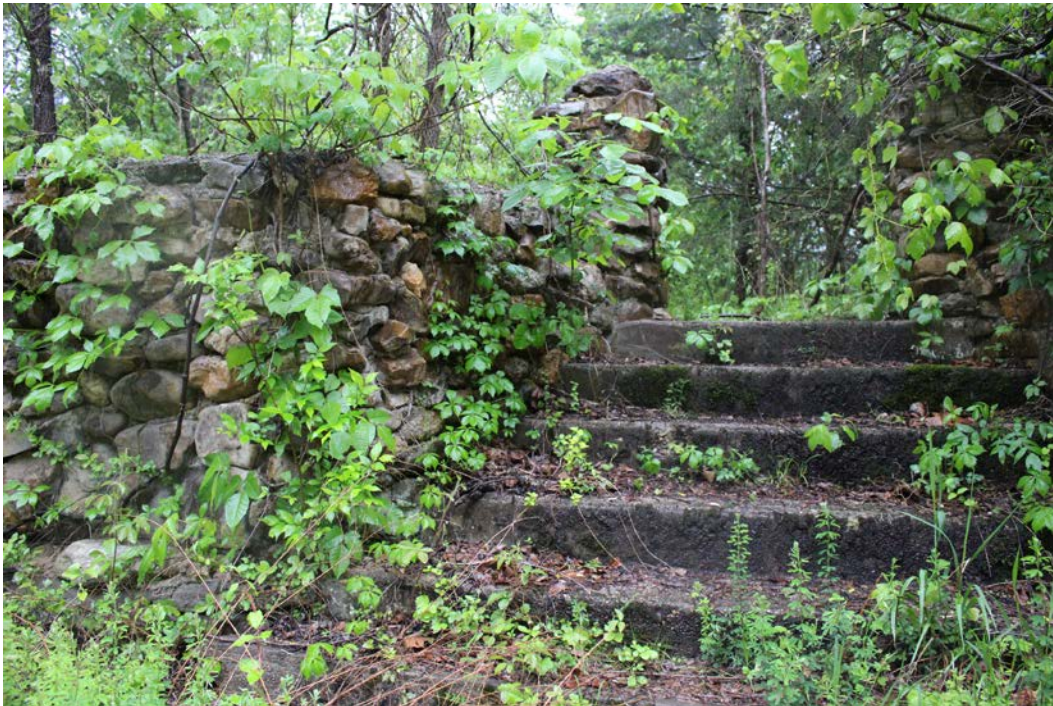
Figure 3-156. Hicks Wall, cobblestone columns and concrete stairs. (Mundus Bishop 2017)

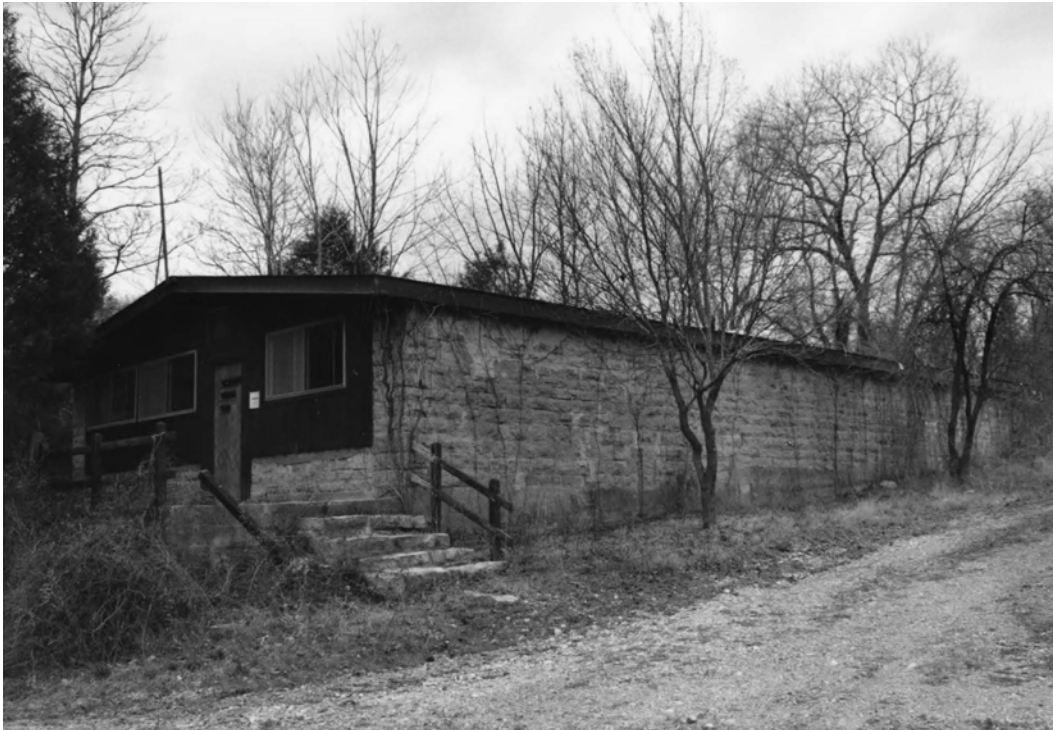
Figure 3-157. Hicks General Store, after renovation into NPS staff housing, 1984. (S. Rogers, BUFF Archives)

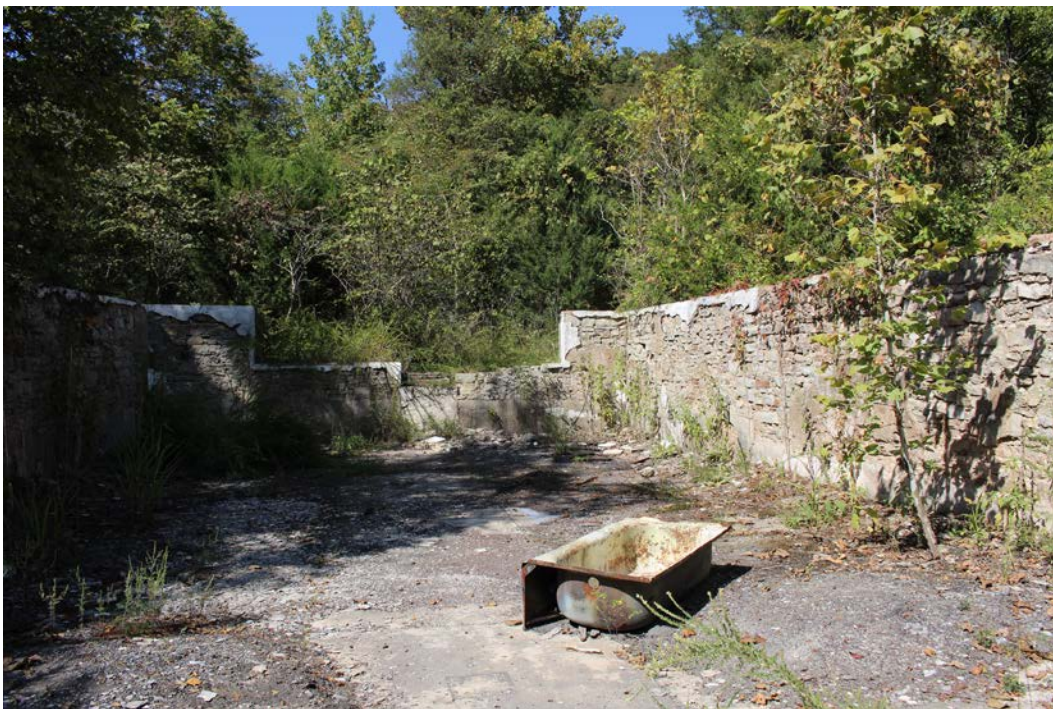
Figure 3-158. Hicks General Store ruins interior. (Mundus Bishop 2017)

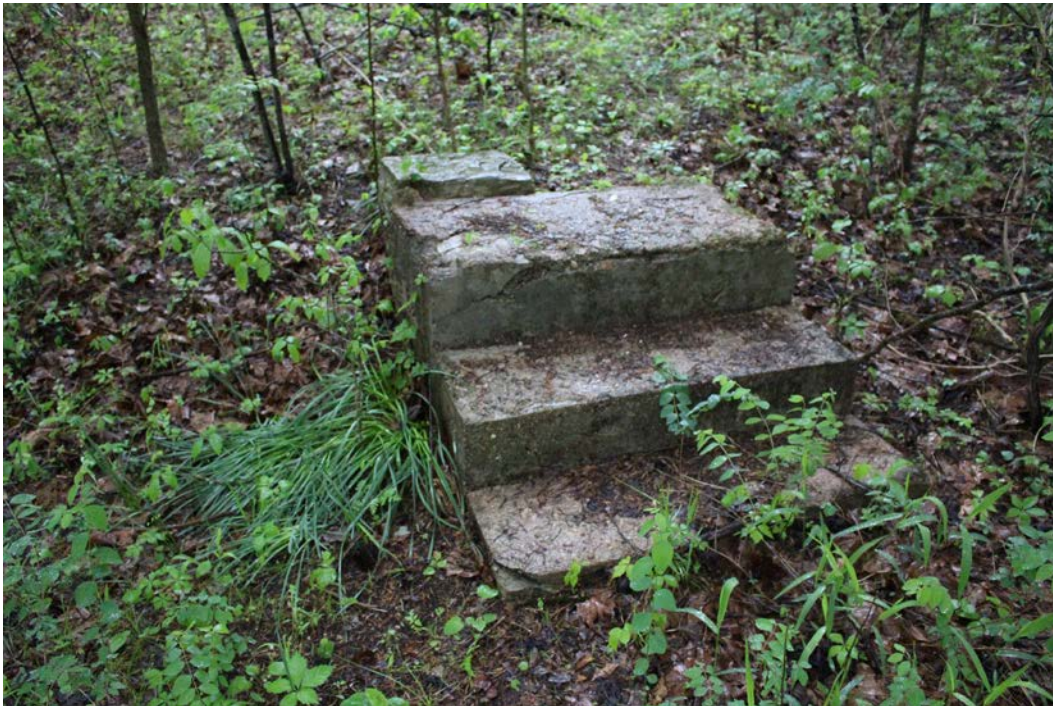
Figure 3-160. Concrete stairs at Hicks Hotel ruins. (Mundus Bishop 2017)
